**ADDENDUM NO. 1  
PUBLIC WORKS BID NO. 2018-007  
REHAB UPPER HEIGHTS GROUND STORAGE TANK**

# Water Tank Evaluation Report

## Upper Heights Ground Storage Reservoir

Prepared for City of Alamogordo, New Mexico

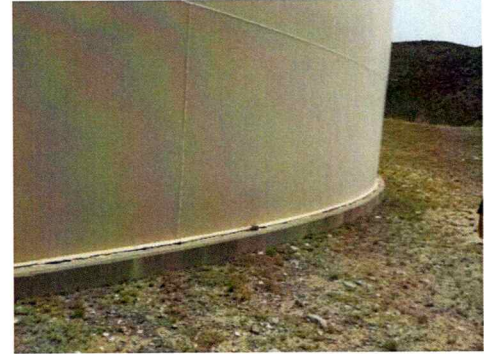
<b>Location:</b>	Exterior		
<b>Area:</b>	Shell (Lower)		
<b>Adhesion:</b>	2A		
<b>Overall Condition:</b>	Fair		
<b>Dry Film Thickness:</b>	<b>Minimum</b>	<b>Maximum</b>	<b>Average</b>
	1.5	3.9	2.8

Condition	Severe	Advanced	Moderate	Slight	None/NA
<b>Rusting</b>				●	
<b>Blistering</b>					●
<b>Cracking</b>					●
<b>Peeling</b>					●
<b>Pitting</b>					●
<b>Chalking</b>		●			
<b>Delamination</b>					●

**Comments:** Slight rusting in localized areas, advanced chalking throughout

Complete removal and replacement with a new epoxy/polyurethane coating system offers a long-term solution to the existing system. All surfaces should be prepared to an SSPC SP-6 or equal "Commercial Blast" level of cleanliness. This should be followed by a zinc/polyamide-epoxy/acrylic-polyurethane coating system. To avoid fugitive dust emissions and/or paint drift, a full-containment structure will need to be constructed.

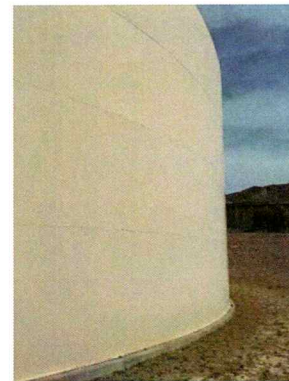
<b>Location:</b>	Exterior		
<b>Area:</b>	Shell (Mid)		
<b>Adhesion:</b>	-		
<b>Overall Condition:</b>	Fair		
<b>Dry Film Thickness:</b>	<b>Minimum</b>	<b>Maximum</b>	<b>Average</b>
	-	-	-

Condition	Severe	Advanced	Moderate	Slight	None/NA
<b>Rusting</b>					●
<b>Blistering</b>					●
<b>Cracking</b>					●
<b>Peeling</b>					●
<b>Pitting</b>					●
<b>Chalking</b>		●			
<b>Delamination</b>					●

**Comments:** Advanced chalking throughout

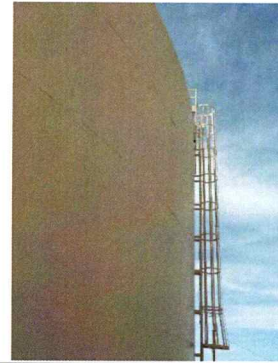
<b>Location:</b>	Exterior		
<b>Area:</b>	Shell (Upper)		
<b>Adhesion:</b>	-		
<b>Overall Condition:</b>	Fair		
<b>Dry Film Thickness:</b>	<b>Minimum</b>	<b>Maximum</b>	<b>Average</b>
	-	-	-

Condition	Severe	Advanced	Moderate	Slight	None/NA
Rusting				●	
Blistering					●
Cracking					●
Peeling					●
Pitting					●
Chalking		●			
Delamination					●
<b>Comments:</b> Slight rusting along seams, advanced chalking throughout

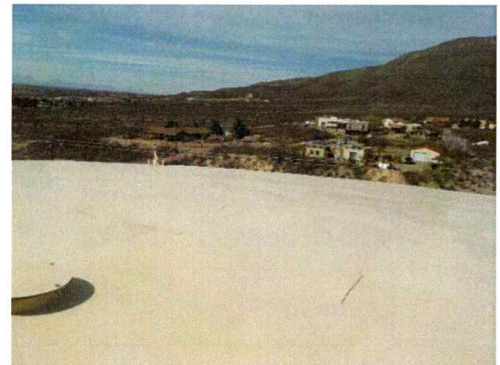
<b>Location:</b>	Exterior		
<b>Area:</b>	Roof		
<b>Adhesion:</b>	-		
<b>Overall Condition:</b>	Fair		
<b>Dry Film Thickness:</b>	<b>Minimum</b>	<b>Maximum</b>	<b>Average</b>
	2.7	6.3	4.6

Condition	Severe	Advanced	Moderate	Slight	None/NA
Rusting			●		
Blistering					●
Cracking					●
Peeling					●
Pitting					●
Chalking		●			
Delamination					●
<b>Comments:</b> Moderate rusting at penetrations, advanced chalking throughout

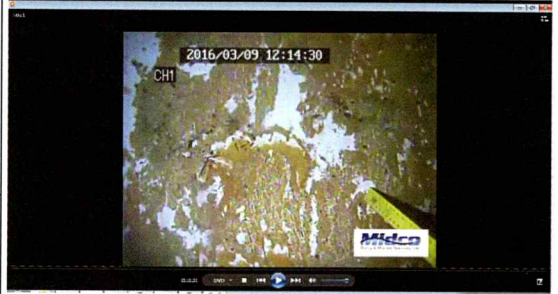
<b>Location:</b>	Interior		
<b>Area:</b>	Floor		
<b>Adhesion:</b>	-		
<b>Overall Condition:</b>	Fair		
<b>Dry Film Thickness:</b>	<b>Minimum</b>	<b>Maximum</b>	<b>Average</b>
	-	-	-

Condition	Severe	Advanced	Moderate	Slight	None/NA
Rusting				●	
Blistering					●
Cracking					●
Peeling					●
Pitting					●
Chalking			●		
Delamination					●
<b>Comments:</b> Rigid sediment throughout. Based on observed coatings, slight rusting in localized areas, moderate chalking throughout

All surfaces should be abrasive blasted to a Society for Protective Coatings (SSPC) SP-10 "Near White" standard of cleanliness. Surface discontinuities such as erection marks, weld spatter, and sharp fins should be removed by grinding, and re-blasted to achieve a uniform surface profile consistent with the coating manufacturer's product recommendation. This would also include all applicable structural repairs and modifications.

Following surface preparation, all surfaces should receive a two to three-coat application (depending on product manufacturer) of a zinc/epoxy-polyamide coating system certified in accordance with ANSI/NSF standard 61.

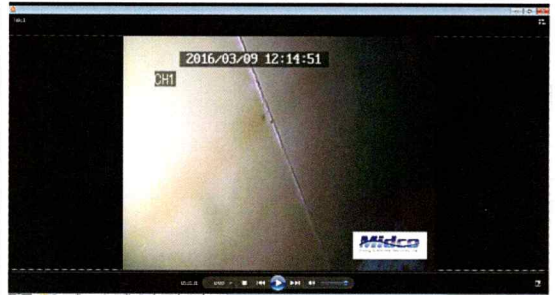
<b>Location:</b>	Interior		
<b>Area:</b>	Shell		
<b>Adhesion:</b>	-		
<b>Overall Condition:</b>	Fair		
<b>Dry Film Thickness:</b>	<b>Minimum</b>	<b>Maximum</b>	<b>Average</b>
	-	-	-

Condition	Severe	Advanced	Moderate	Slight	None/NA
Rusting			●		
Blistering					●
Cracking					●
Peeling					●
Pitting					●
Chalking			●		
Delamination					●
<b>Comments:</b> Moderate rusting and rust bleed above the high water line at roof rafter attachments, moderate chalking throughout

1. Seal the following with elastomeric caulk to inhibit the occurrence of rust bleed:
  - Gaps in the lapped plates including the collar to roof plate, roof to roof radial/torus plates, and roof rafters (seams above the normal waterline)
  - Roof openings and other roof penetrations

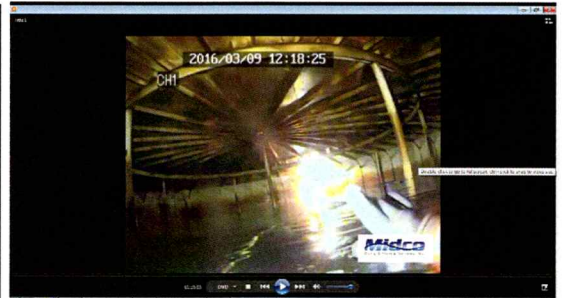
<b>Location:</b>	Interior		
<b>Area:</b>	Columns		
<b>Adhesion:</b>	-		
<b>Overall Condition:</b>	Poor		
<b>Dry Film Thickness:</b>	<b>Minimum</b>	<b>Maximum</b>	<b>Average</b>
	-	-	-

Condition	Severe	Advanced	Moderate	Slight	None/NA
Rusting			●		
Blistering					●
Cracking				●	
Peeling				●	
Pitting					●
Chalking			●		
Delamination					●
<b>Comments:</b> Moderate rusting throughout, slight cracking and peeling in localized areas, moderate chalking throughout

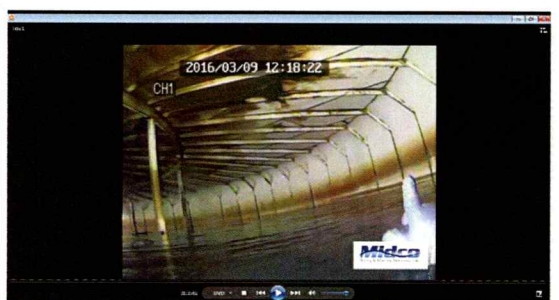
<b>Location:</b>	Interior		
<b>Area:</b>	Roof		
<b>Adhesion:</b>	-		
<b>Overall Condition:</b>	Poor		
<b>Dry Film Thickness:</b>	<b>Minimum</b>	<b>Maximum</b>	<b>Average</b>
	-	-	-

Condition	Severe	Advanced	Moderate	Slight	None/NA
Rusting		●			
Blistering					●
Cracking			●		
Peeling			●		
Pitting					●
Chalking			●		
Delamination					●
<b>Comments:</b> Advanced rusting with rust bloom throughout, moderate cracking and peeling at rafters, moderate chalking throughout
