GEOTECHNICAL ENGINEERING REPORT

SUBGRADE EXPLORATION

11TH STREET IMPROVEMENTS

August 1, 2013

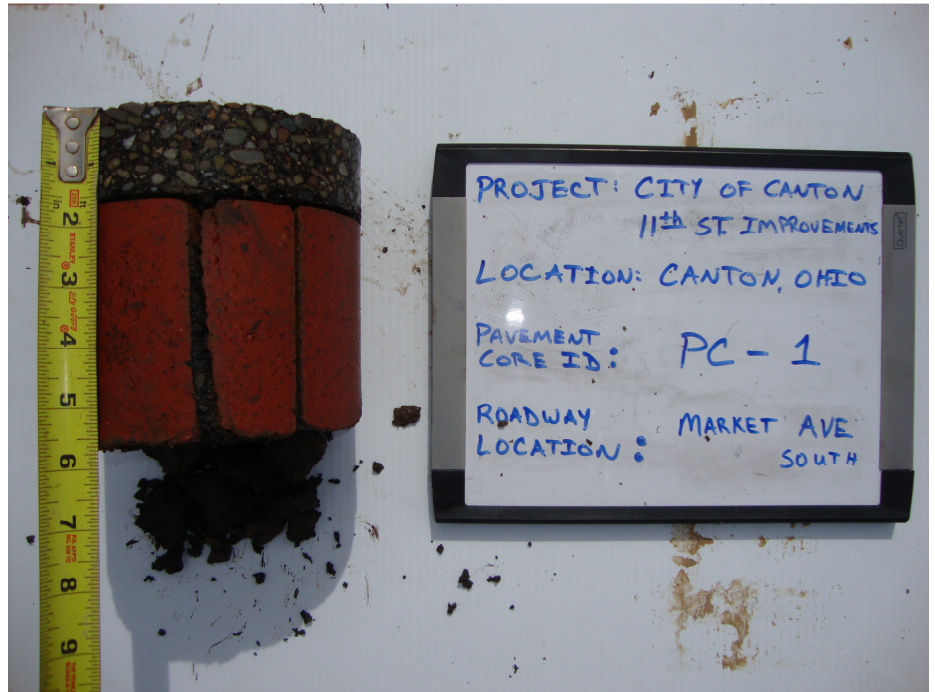
Pavement Core PC – 1

Core Location: Market Ave

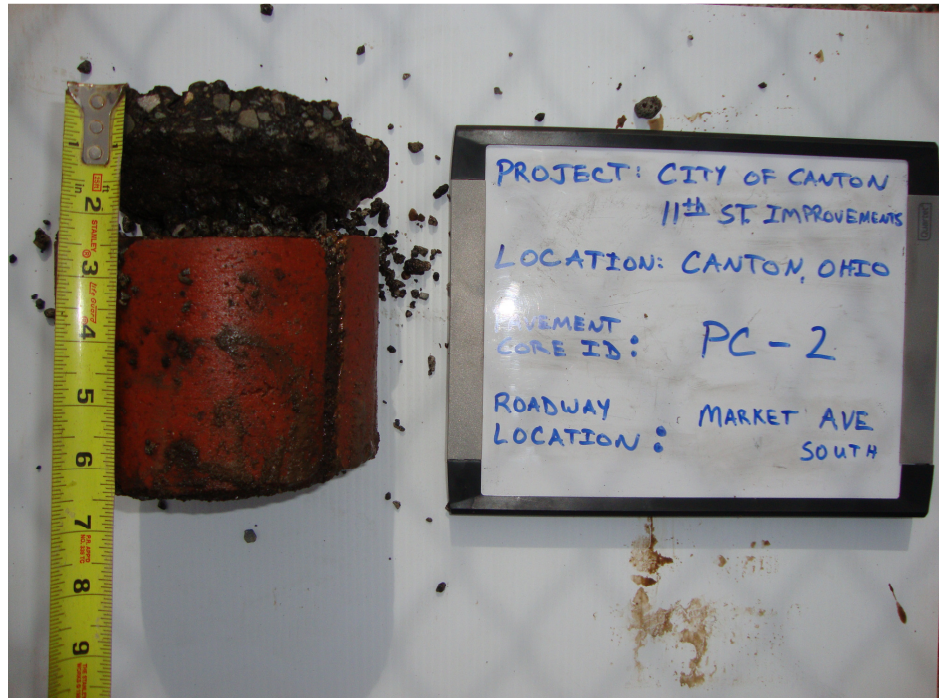
Photo No. 2

Pavement Core PC - 2

Core Location: Market Ave

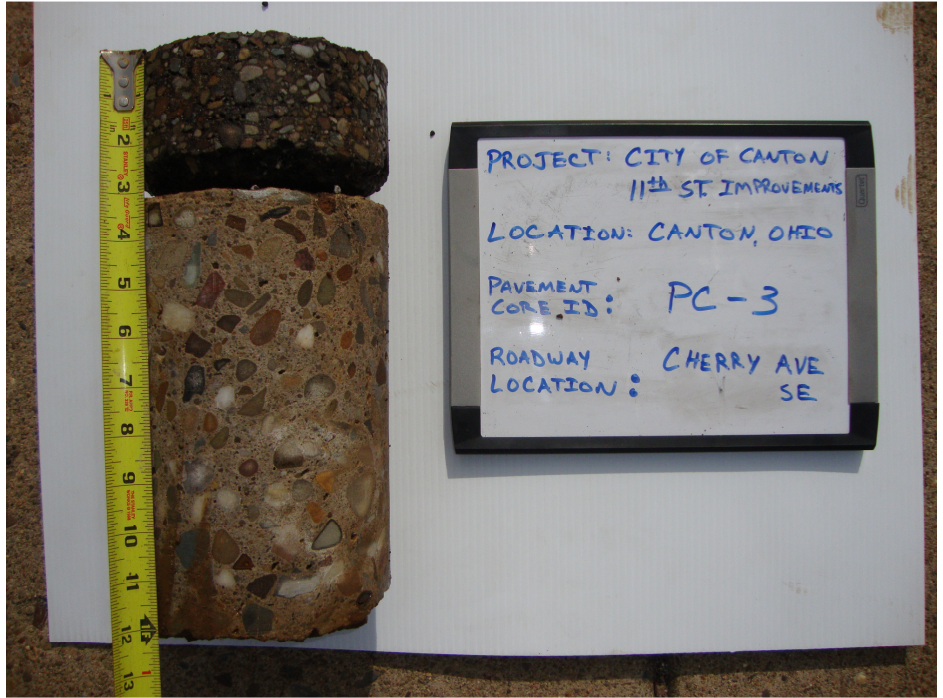
Pavement Core PC - 3

Core Location: Cherry Ave
