July 26, 2019

Re: Geotechnical Engineering Services – Pavement Evaluation Report
Stryker Road Resurfacing from North Olivia Drive to US-27
Highlands County, Florida
Highlands County Project No.: 18008
TSF File No. 7111-19-206

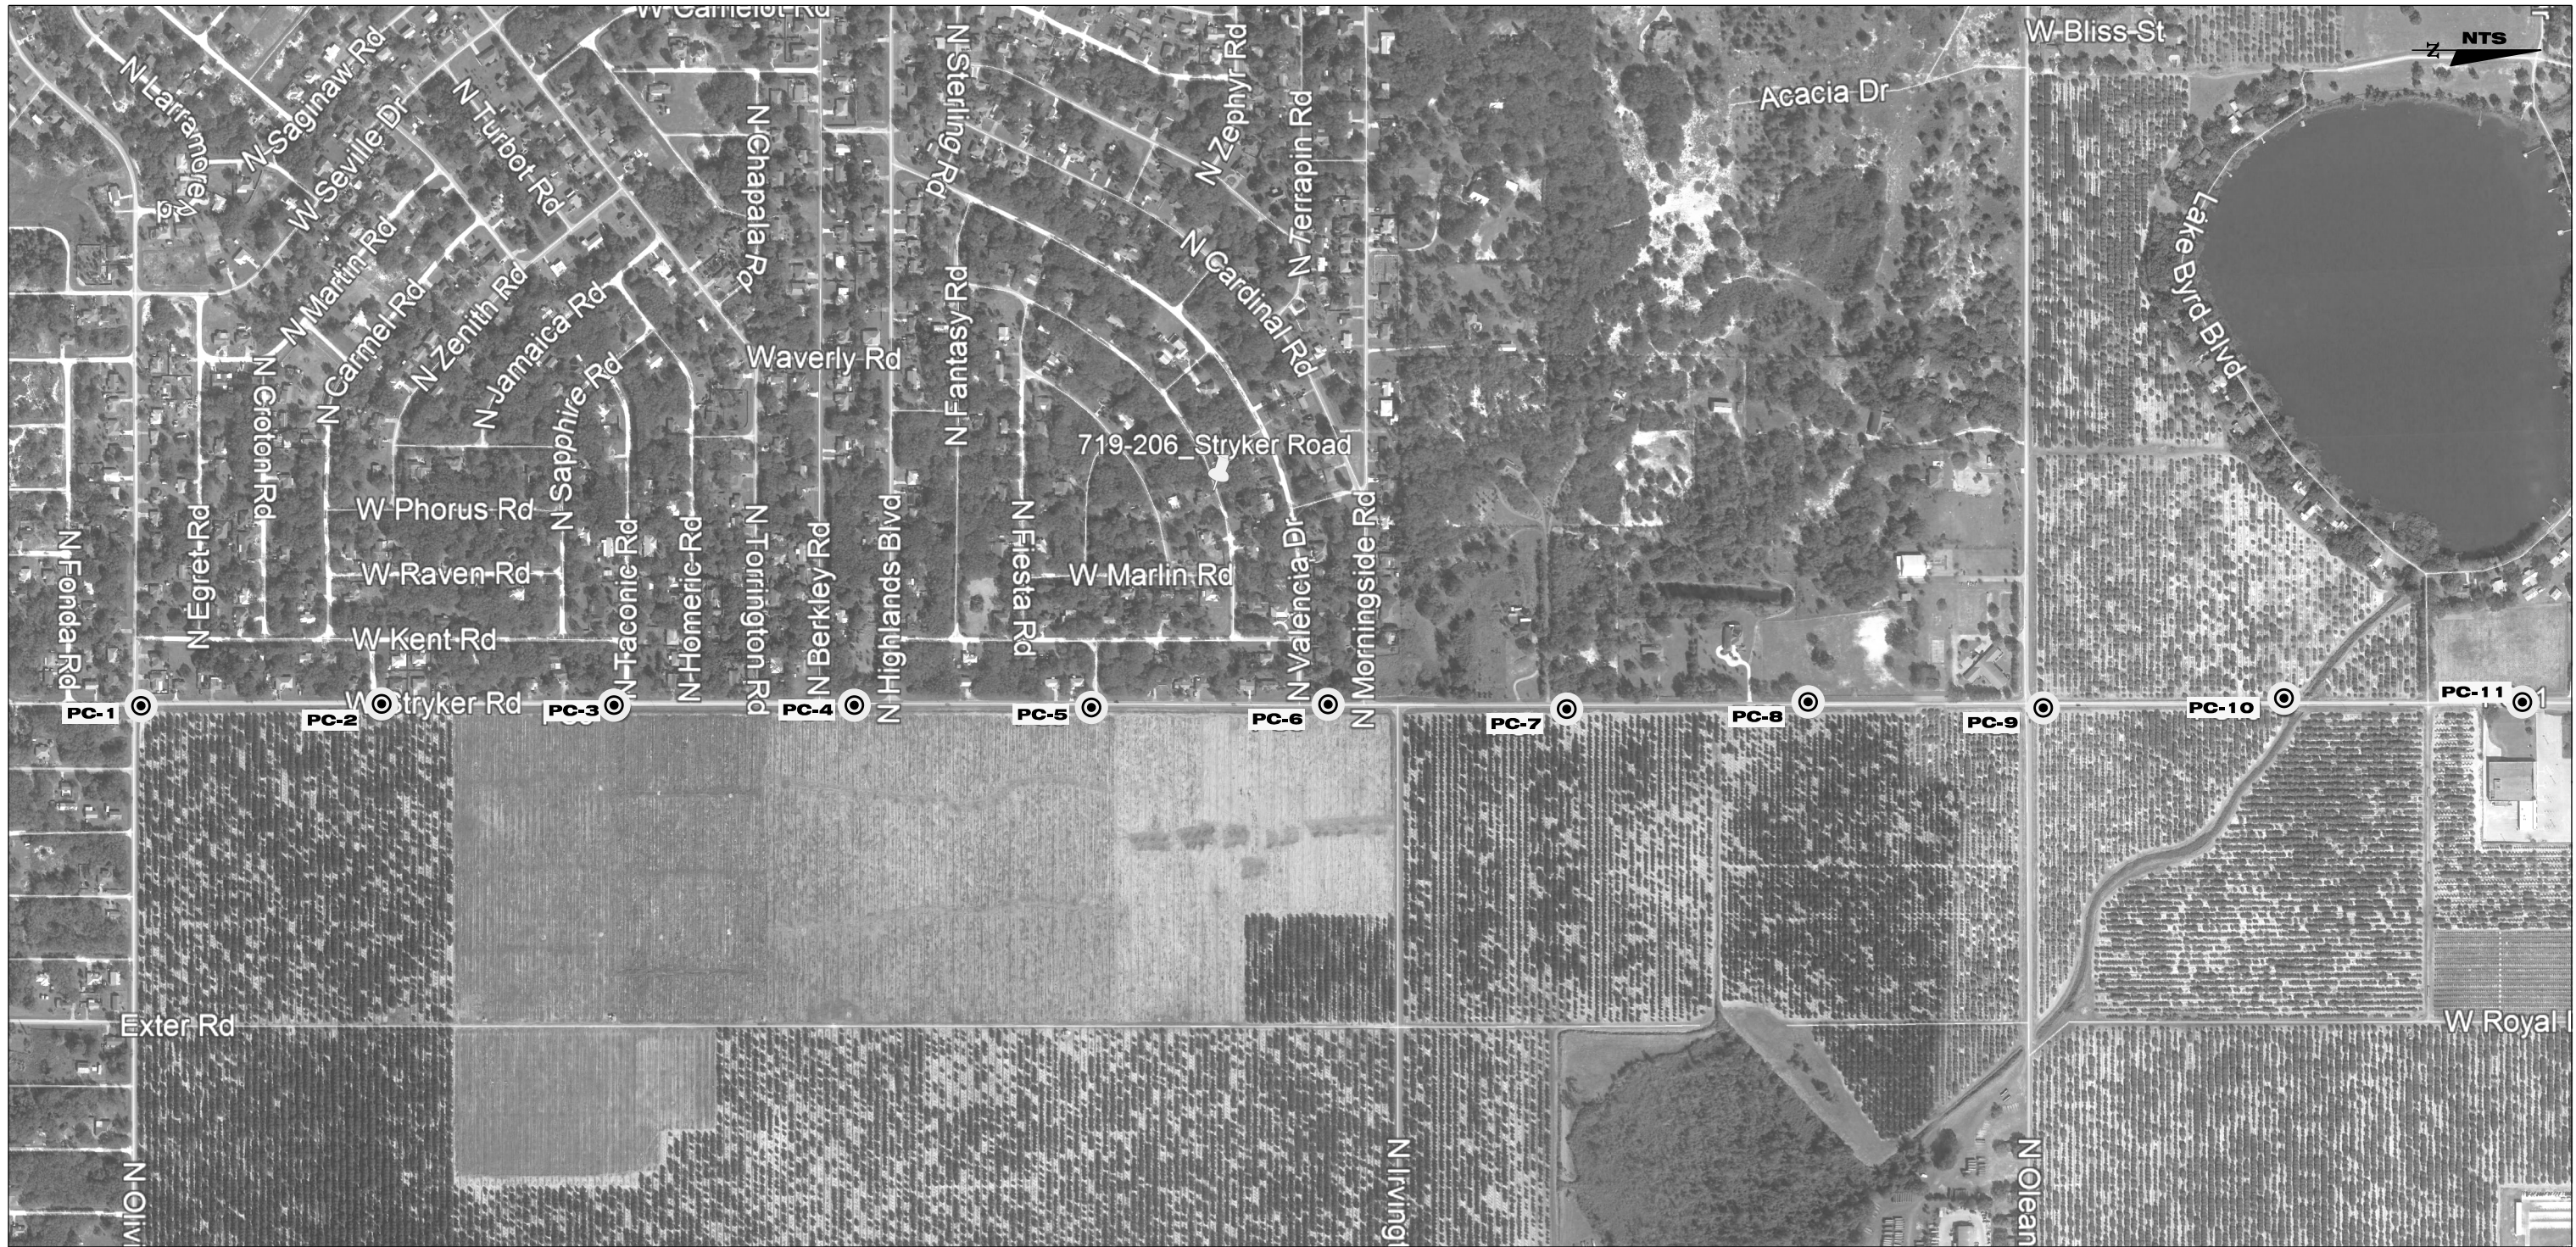
PAVEMENT CORE LOCATION PLAN

A total of eleven (11) asphalt cores were obtained from the existing road. Core information is shown in the Appendix. (Pavement Evaluation Coring and Condition Data Sheet)

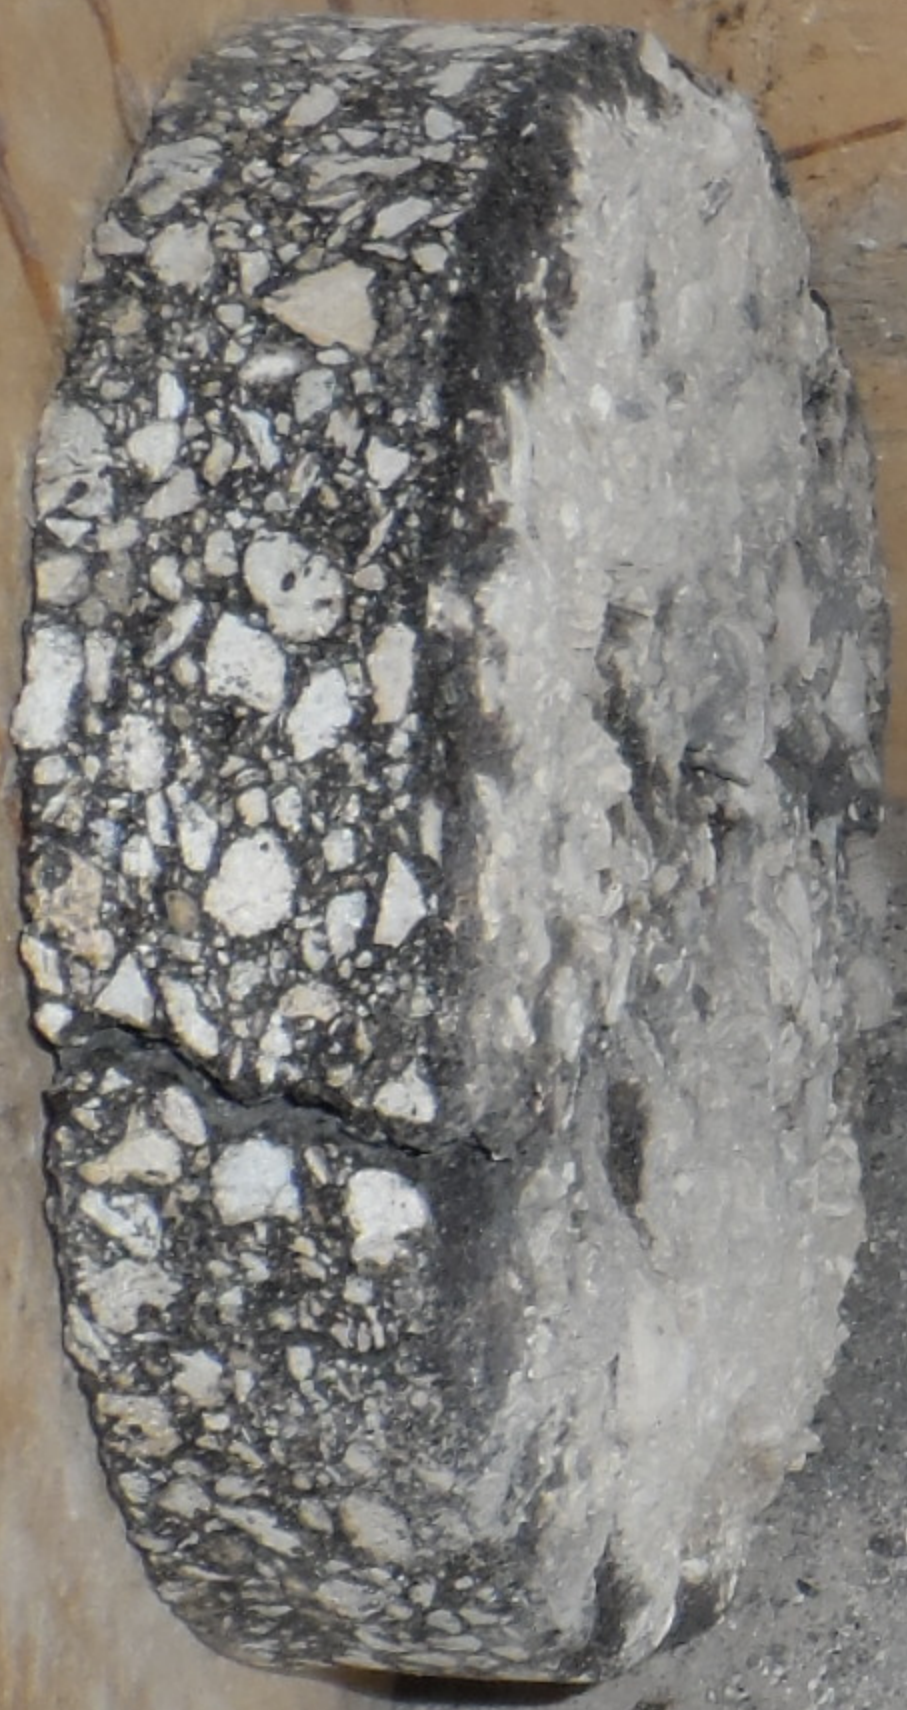
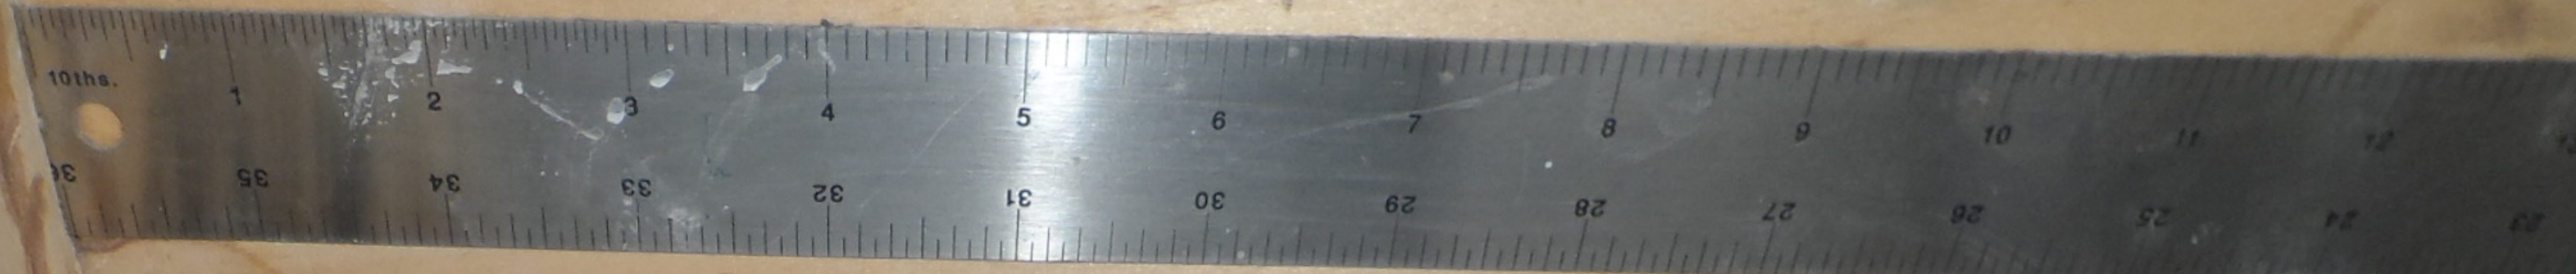
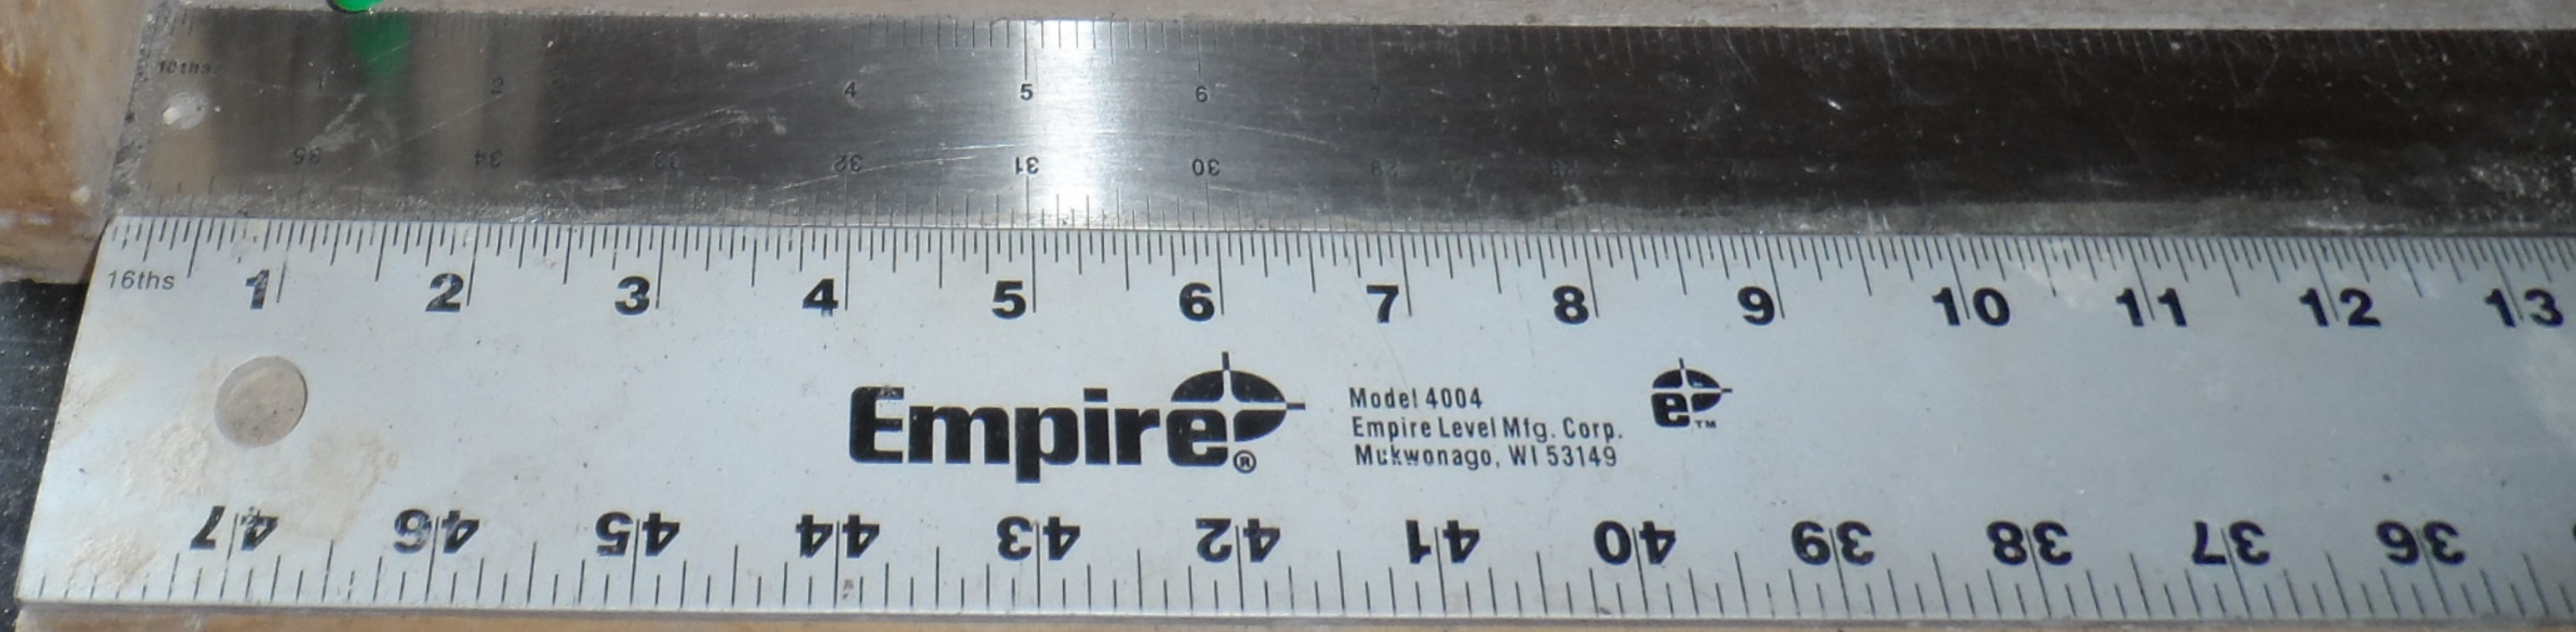
PAVEMENT CORE
PC-1

Project#	7111-19-206
Core #	PC-1
Layer 1	1.2
Layer 2	
Layer 3	
Layer 4	
Layer 5	
Layer 6

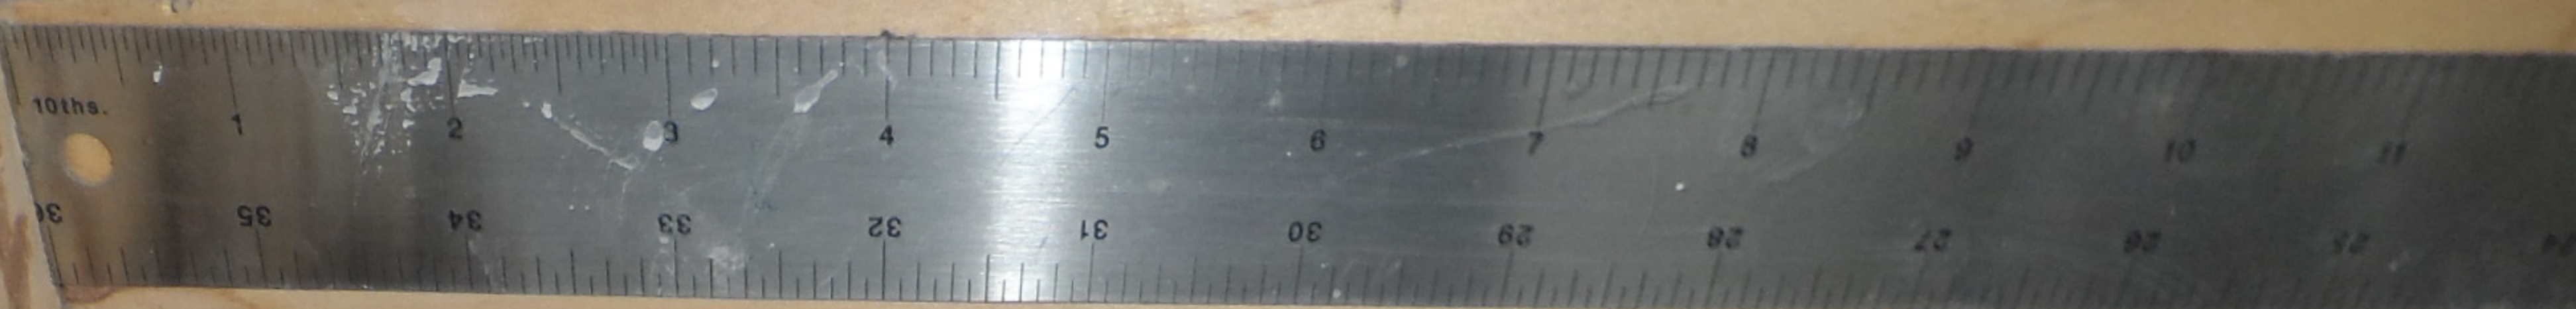
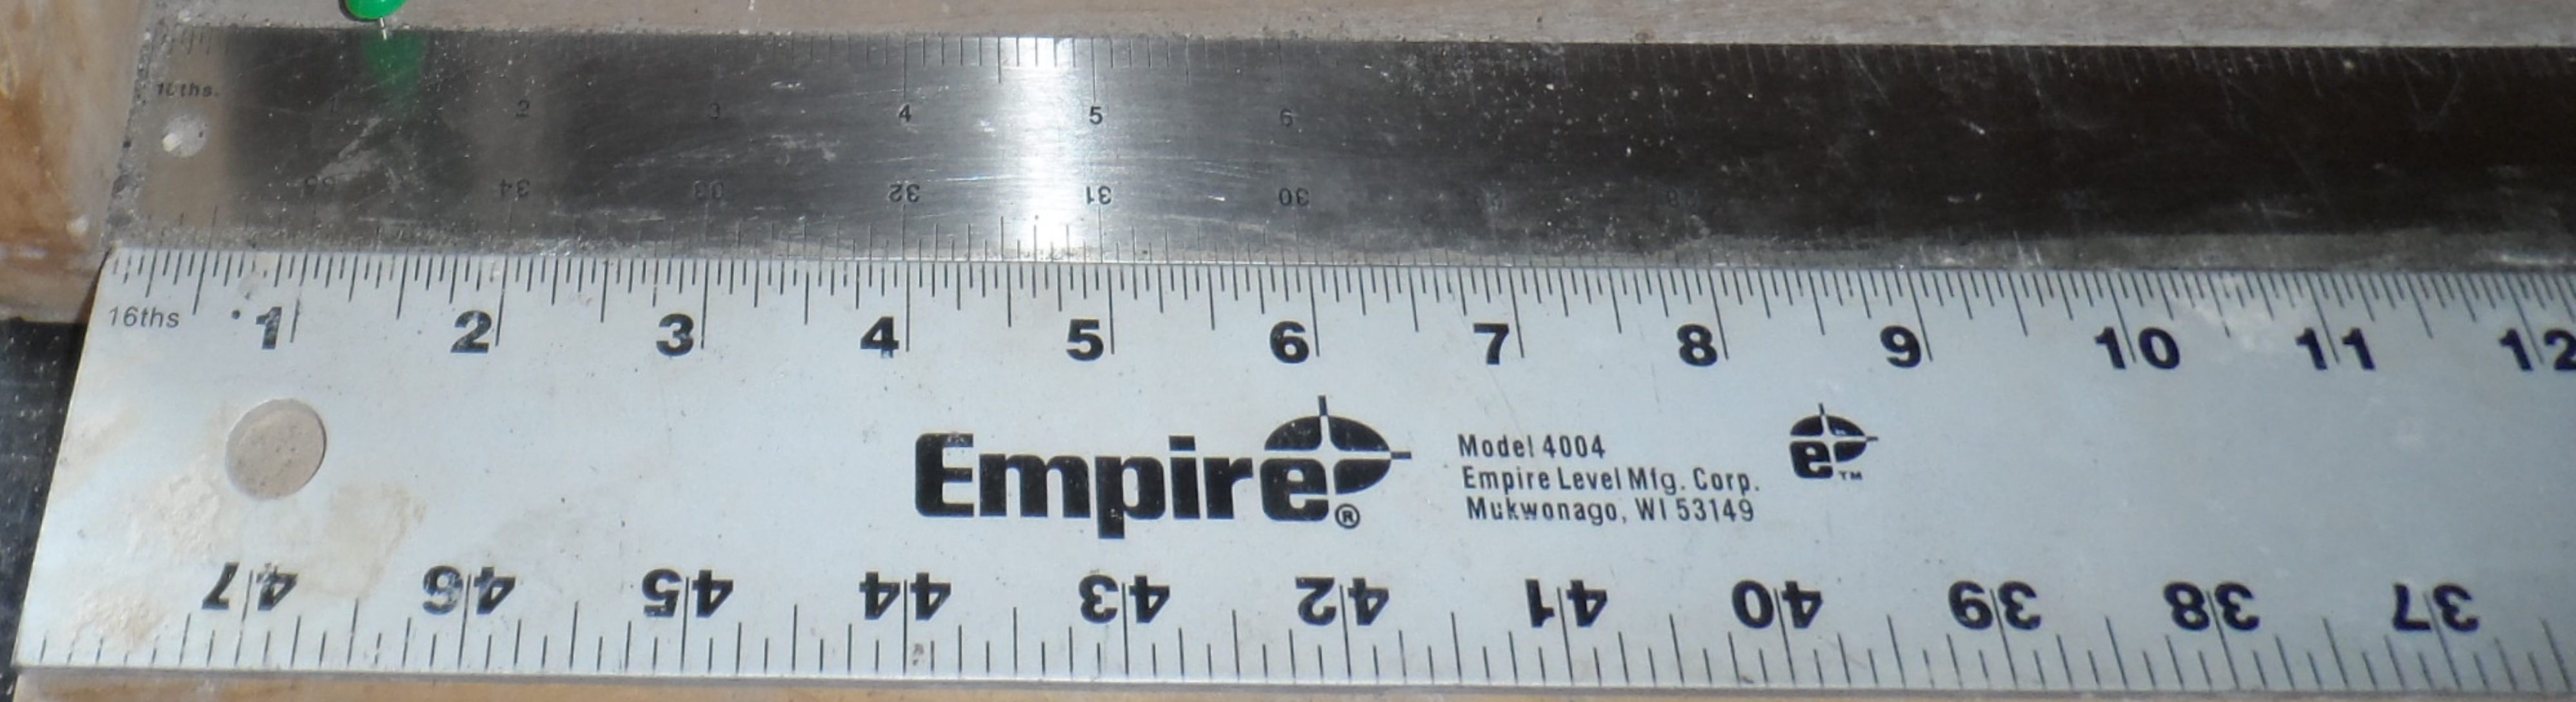
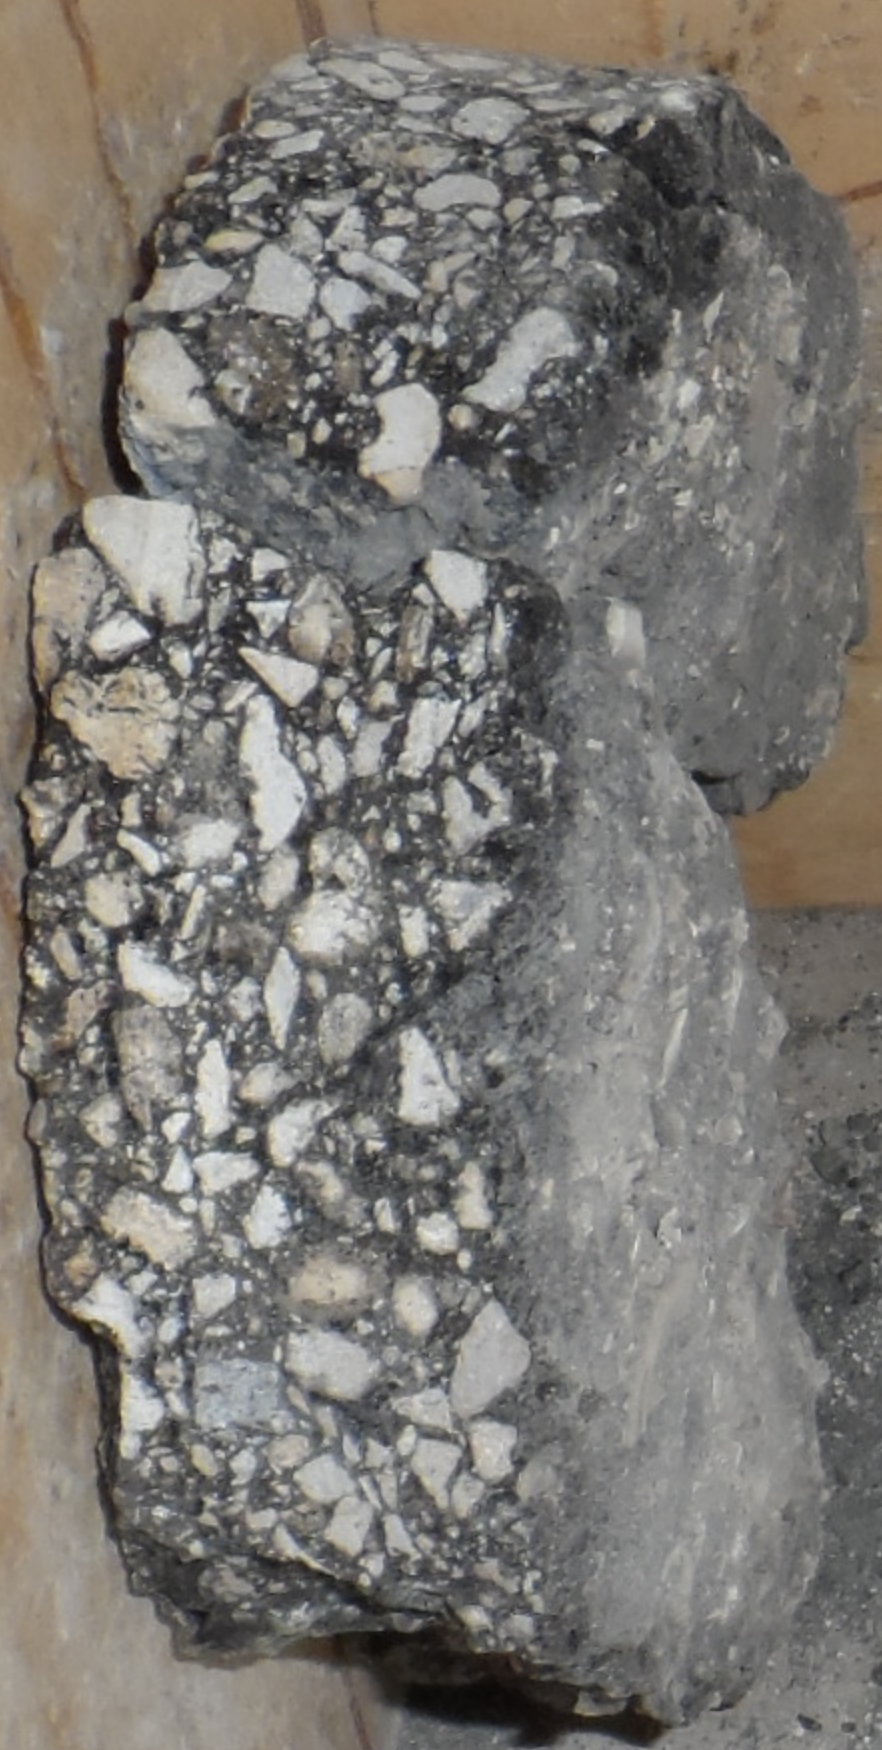
Project#	711-19-206
Core #	PC-2
Layer 1	1-2
Layer 2	
Layer 3	
Layer 4	
Layer 5	
Layer 6

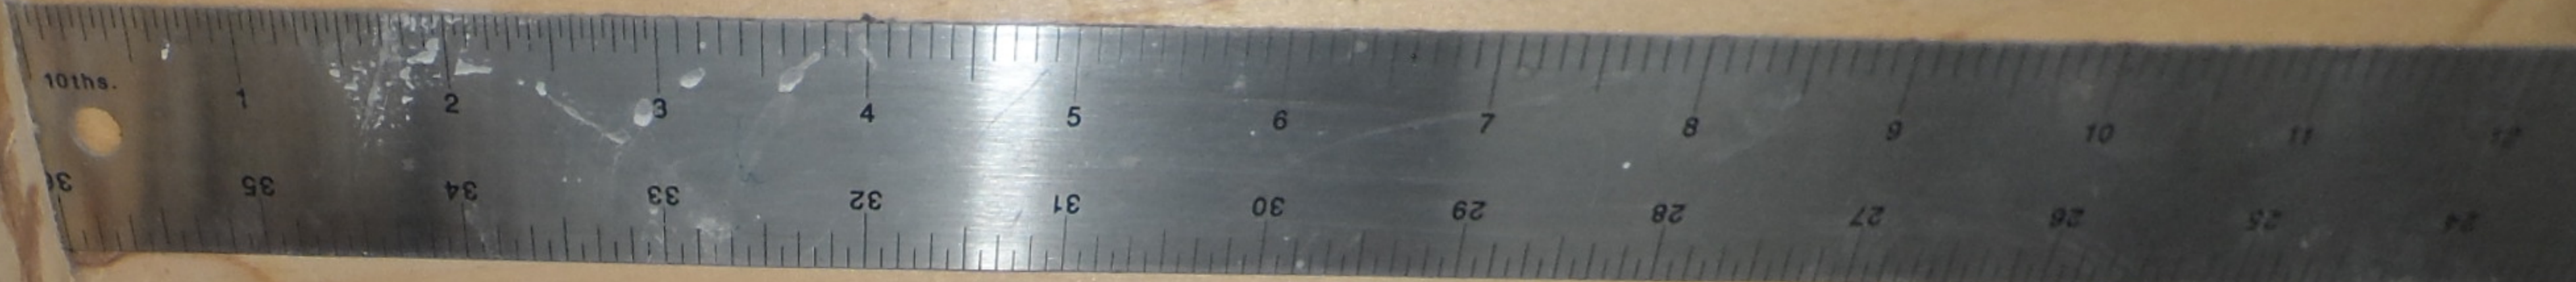
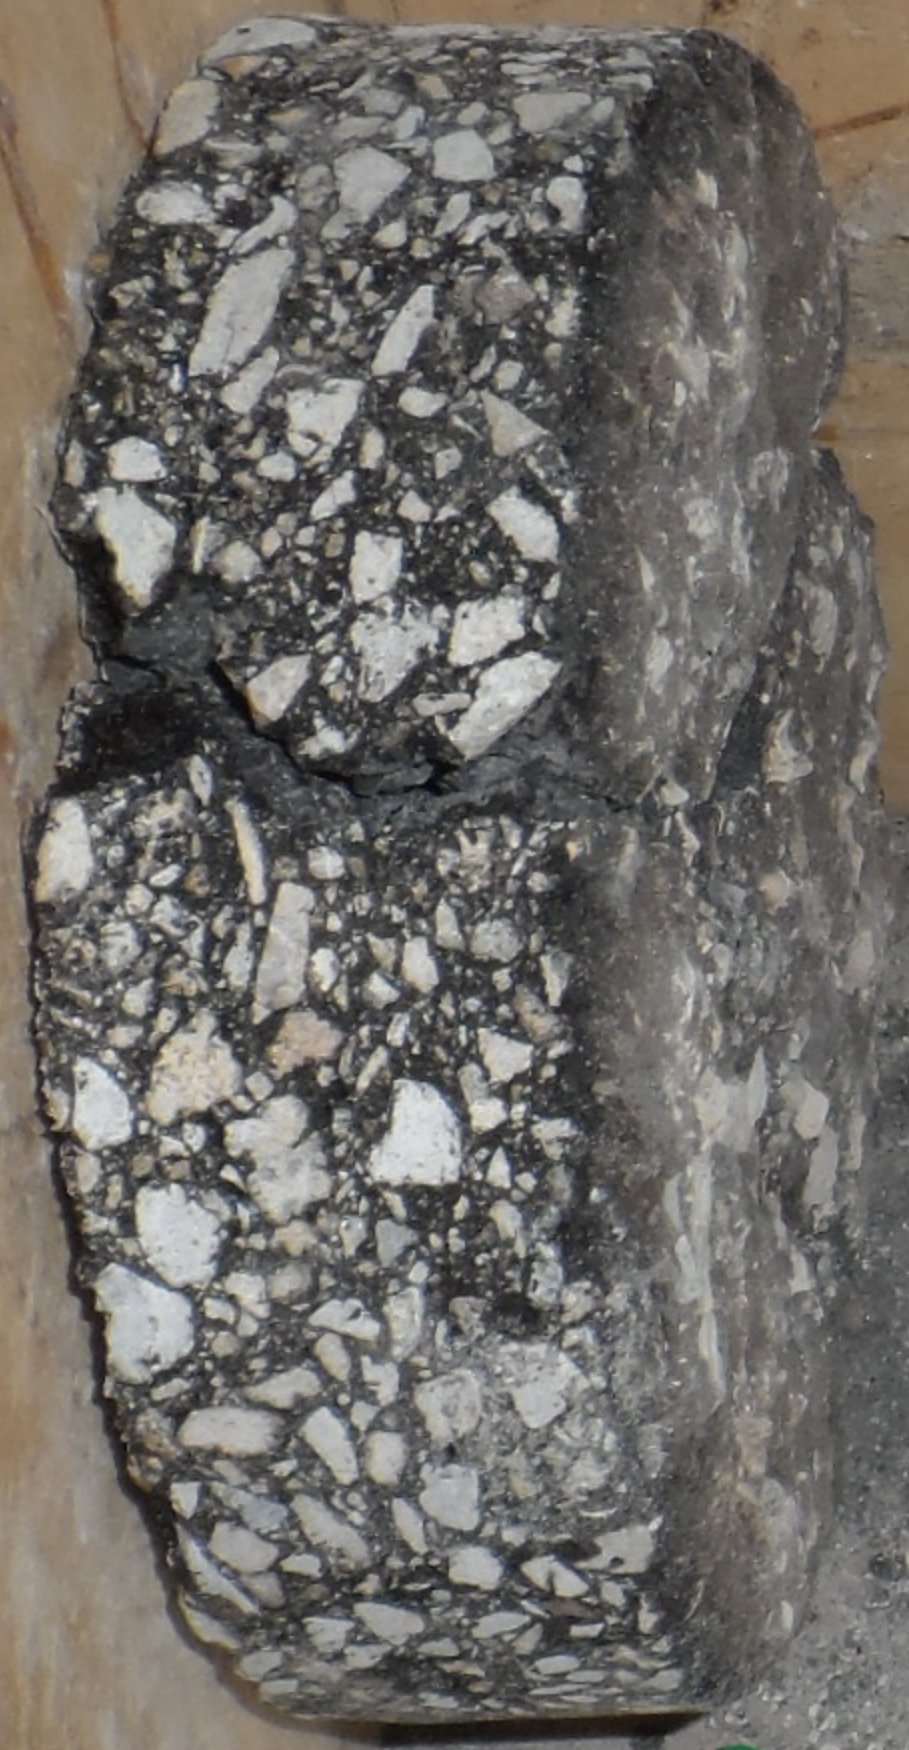
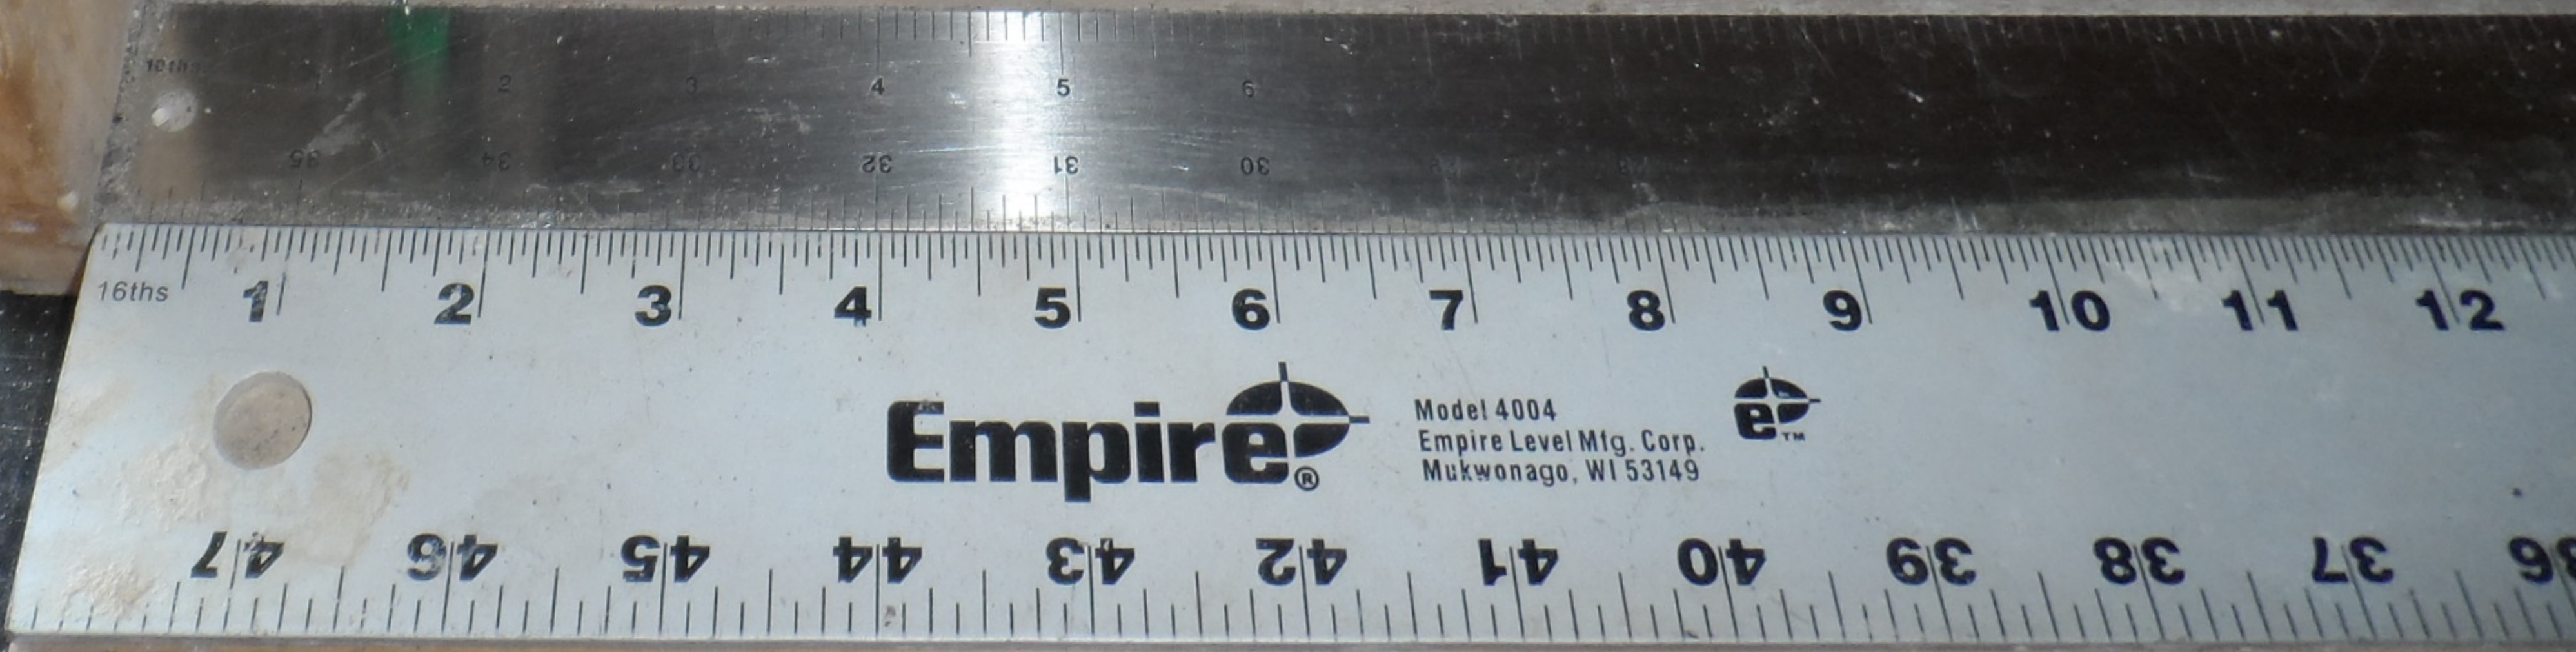
PAVEMENT CORE
PC-3

Project#	7111-19-206
Core #	PC-3
Layer 1	1.4
Layer 2	
Layer 3	
Layer 4	
Layer 5	
Layer 6

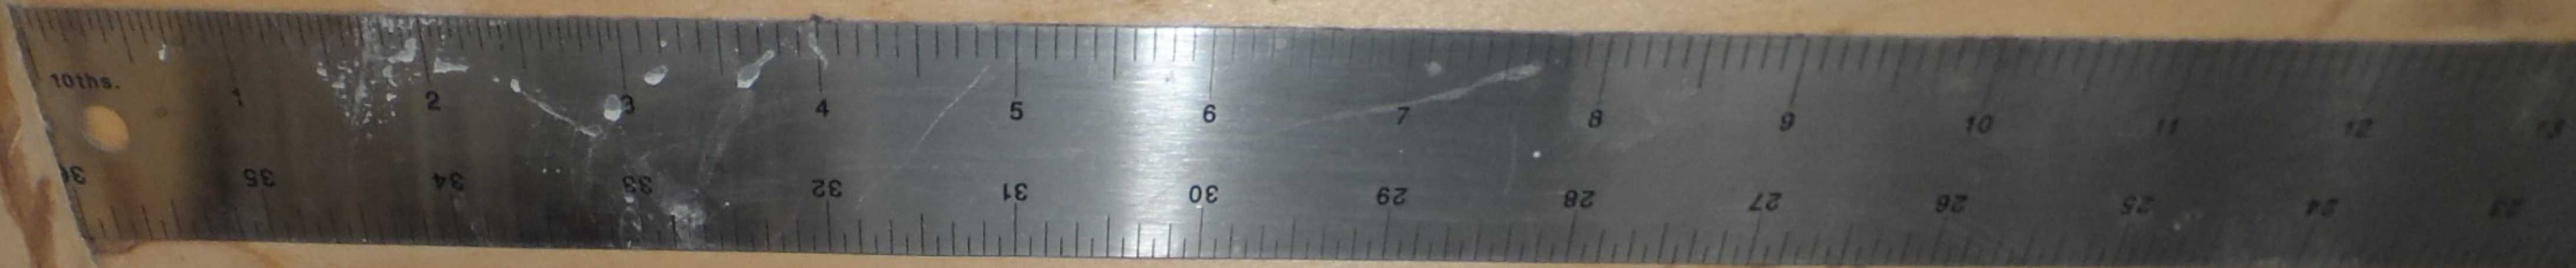
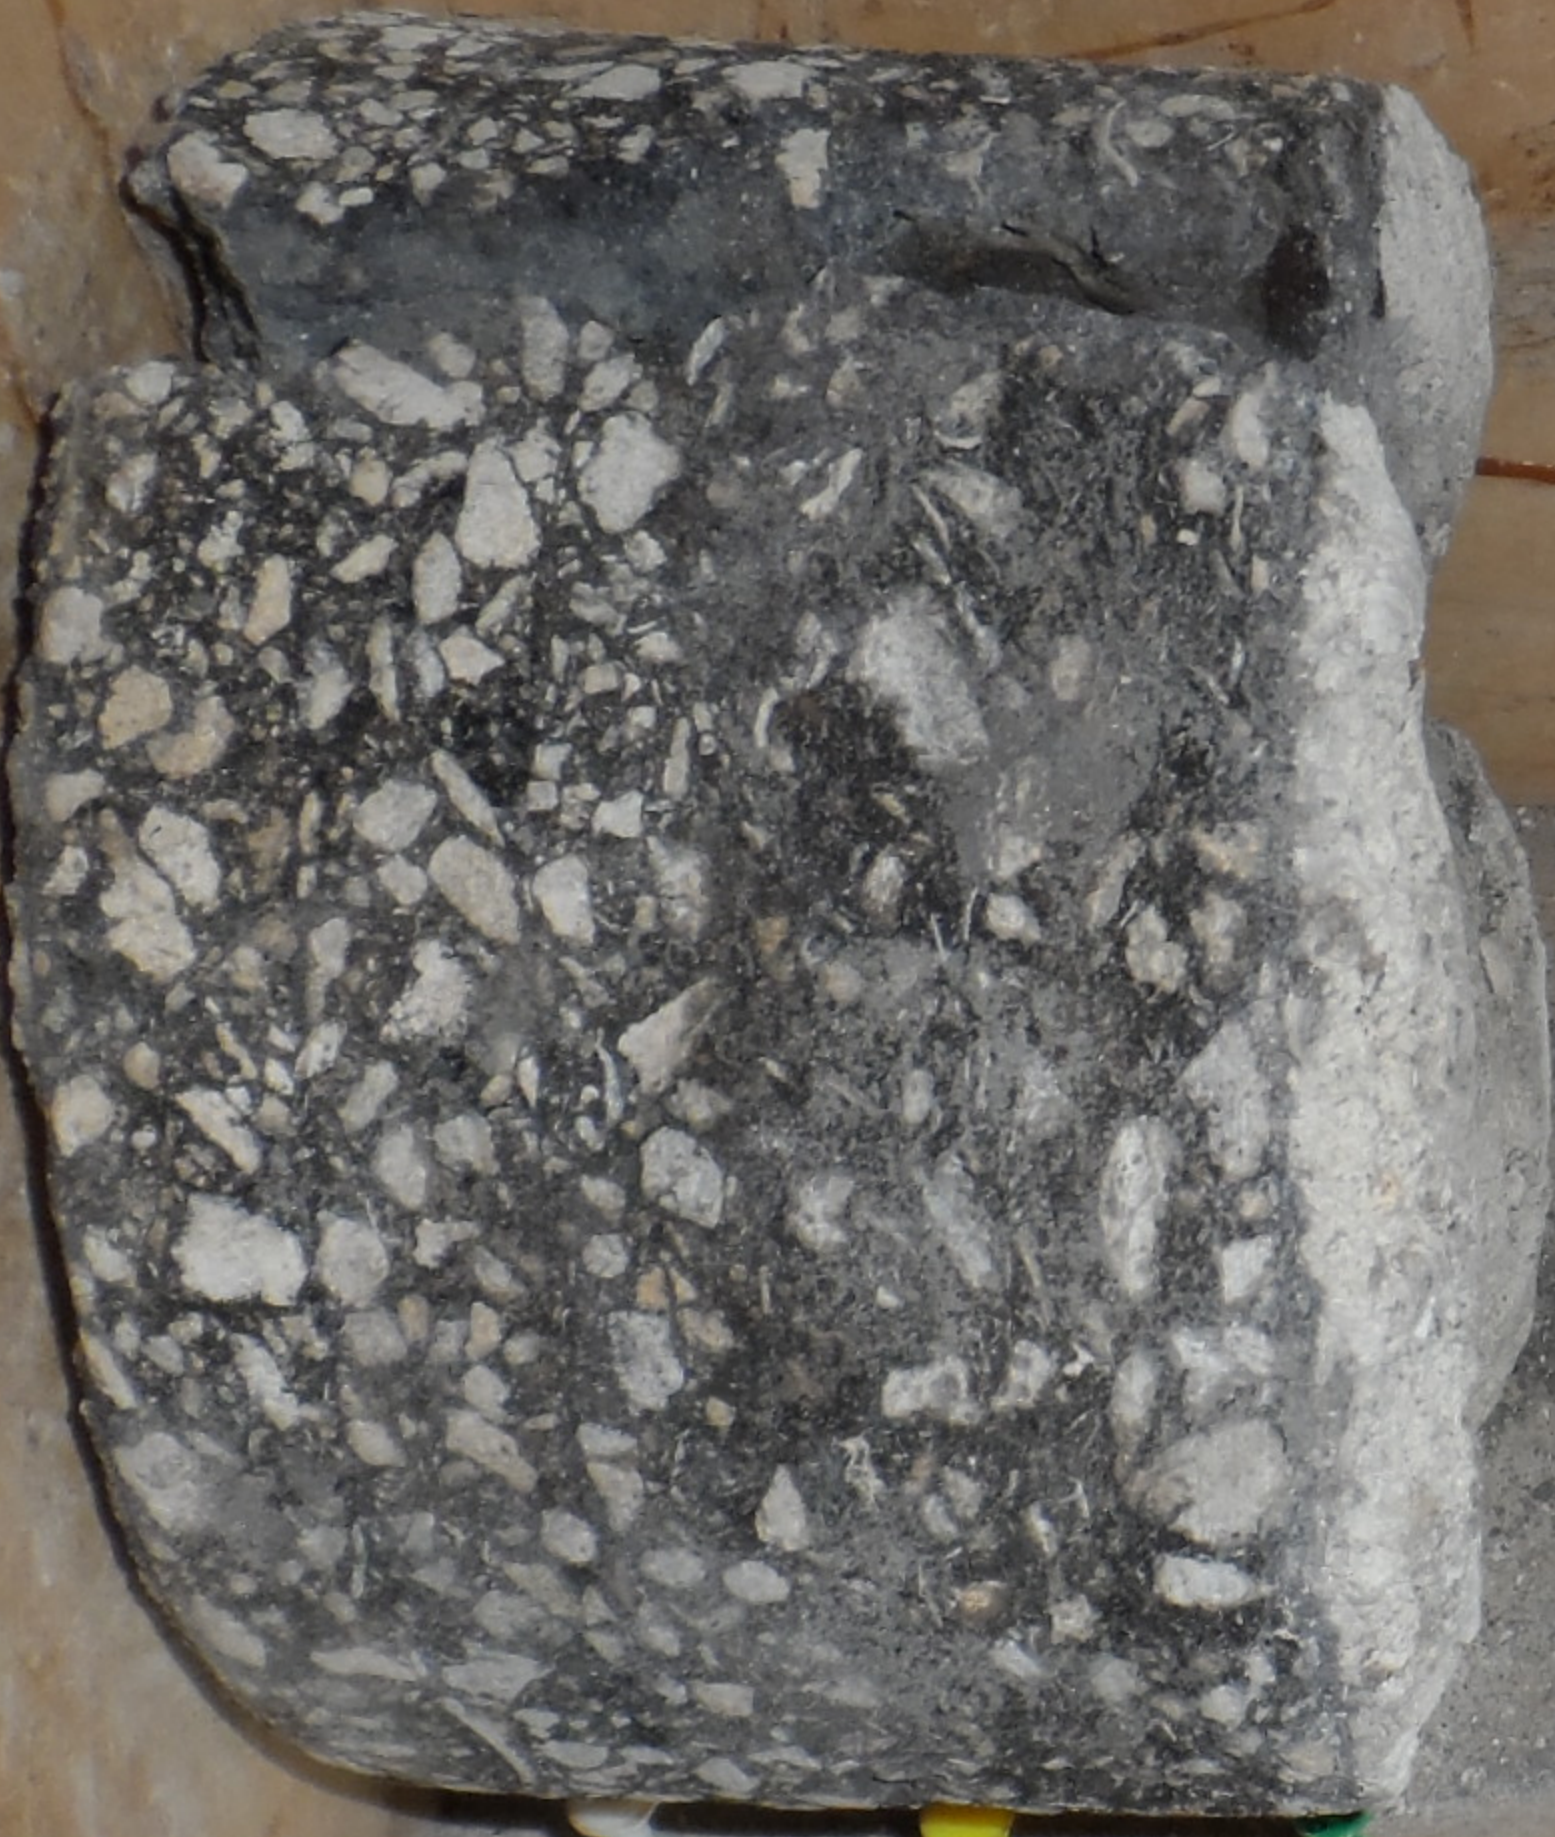
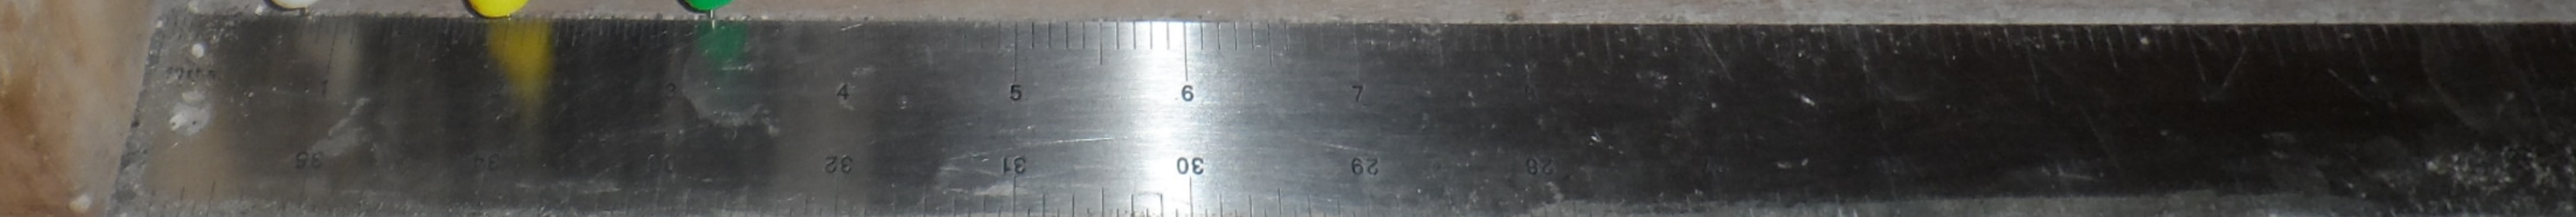
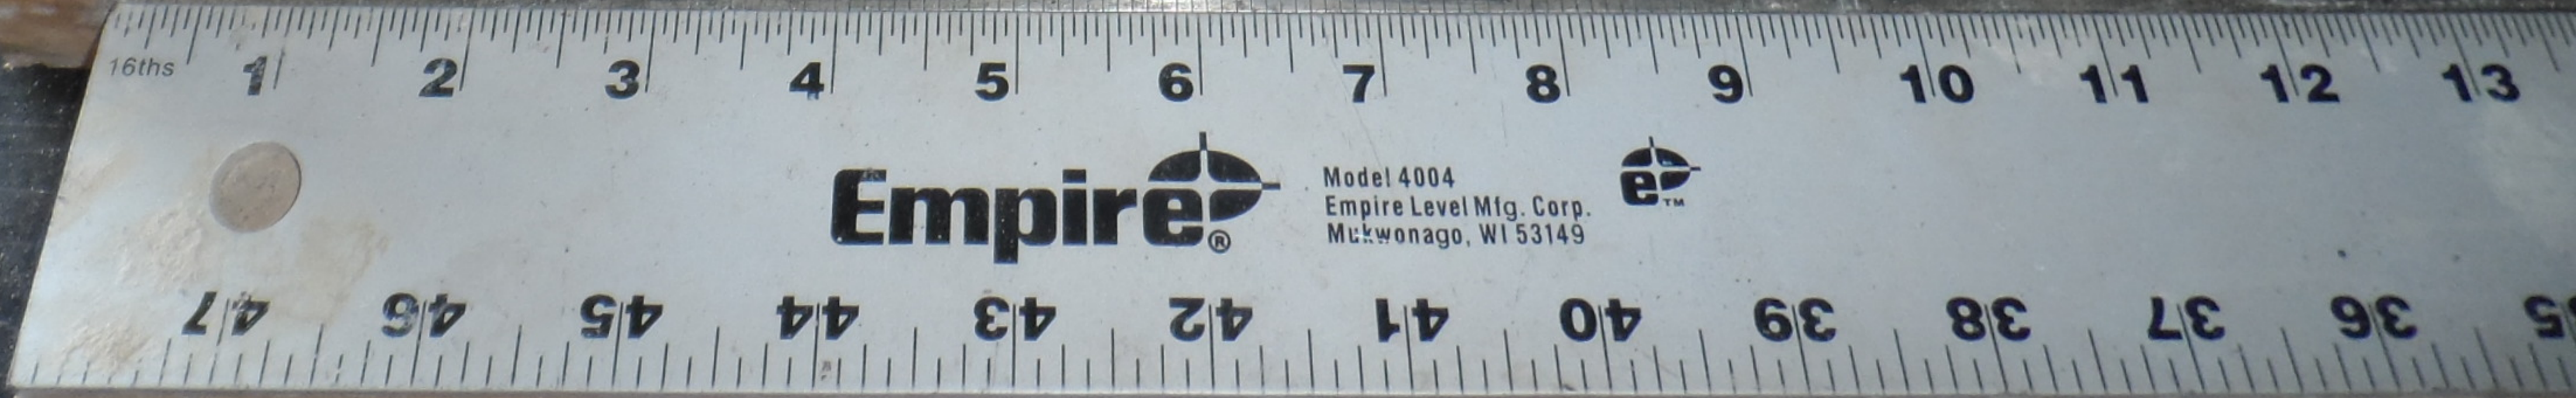
Project#	7111-19-206
Core #	PC-4
Layer 1	0.8
Layer 2	1.2
Layer 3	1.2
Layer 4	
Layer 5	
Layer 6
