July 26, 2019

Re: Geotechnical Engineering Services – Pavement Evaluation Report
Stryker Road Resurfacing from North Olivia Drive to US-27
Highlands County, Florida
Highlands County Project No.: 18008
TSF File No. 7111-19-206

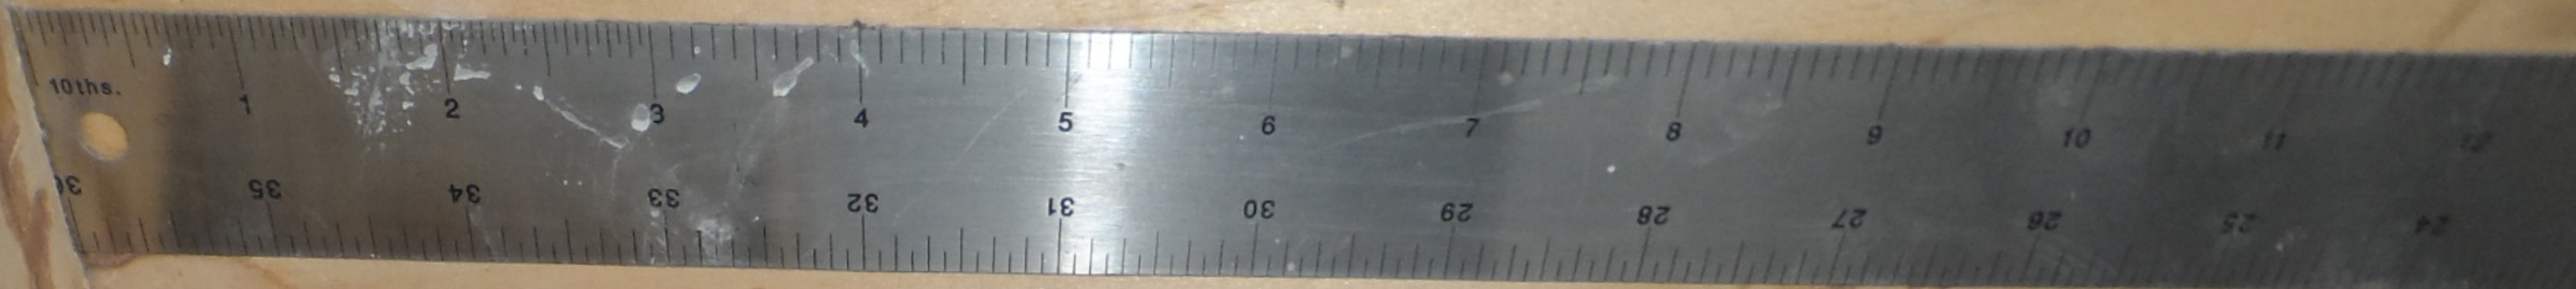
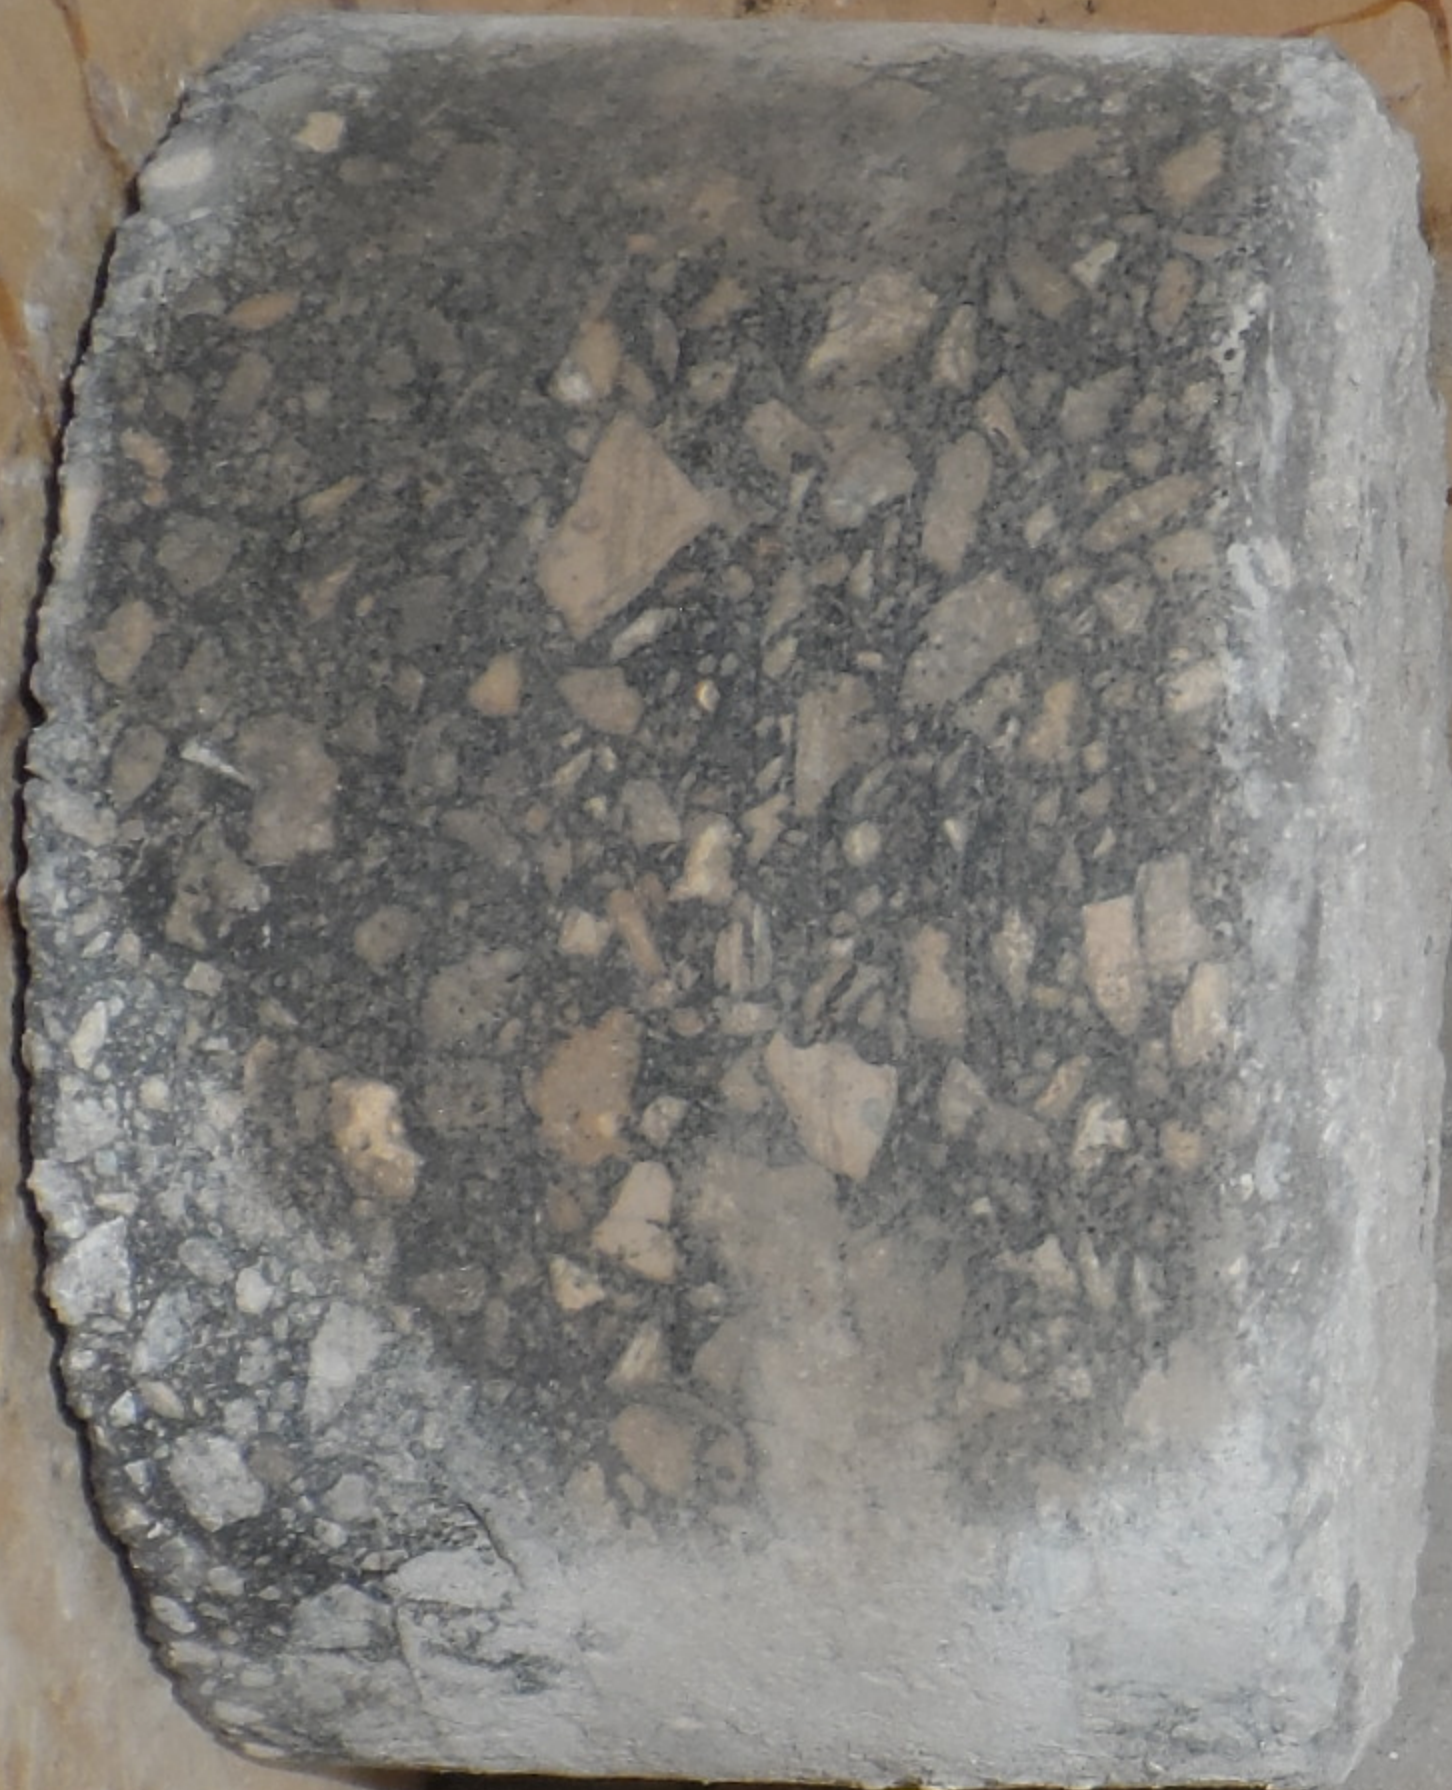
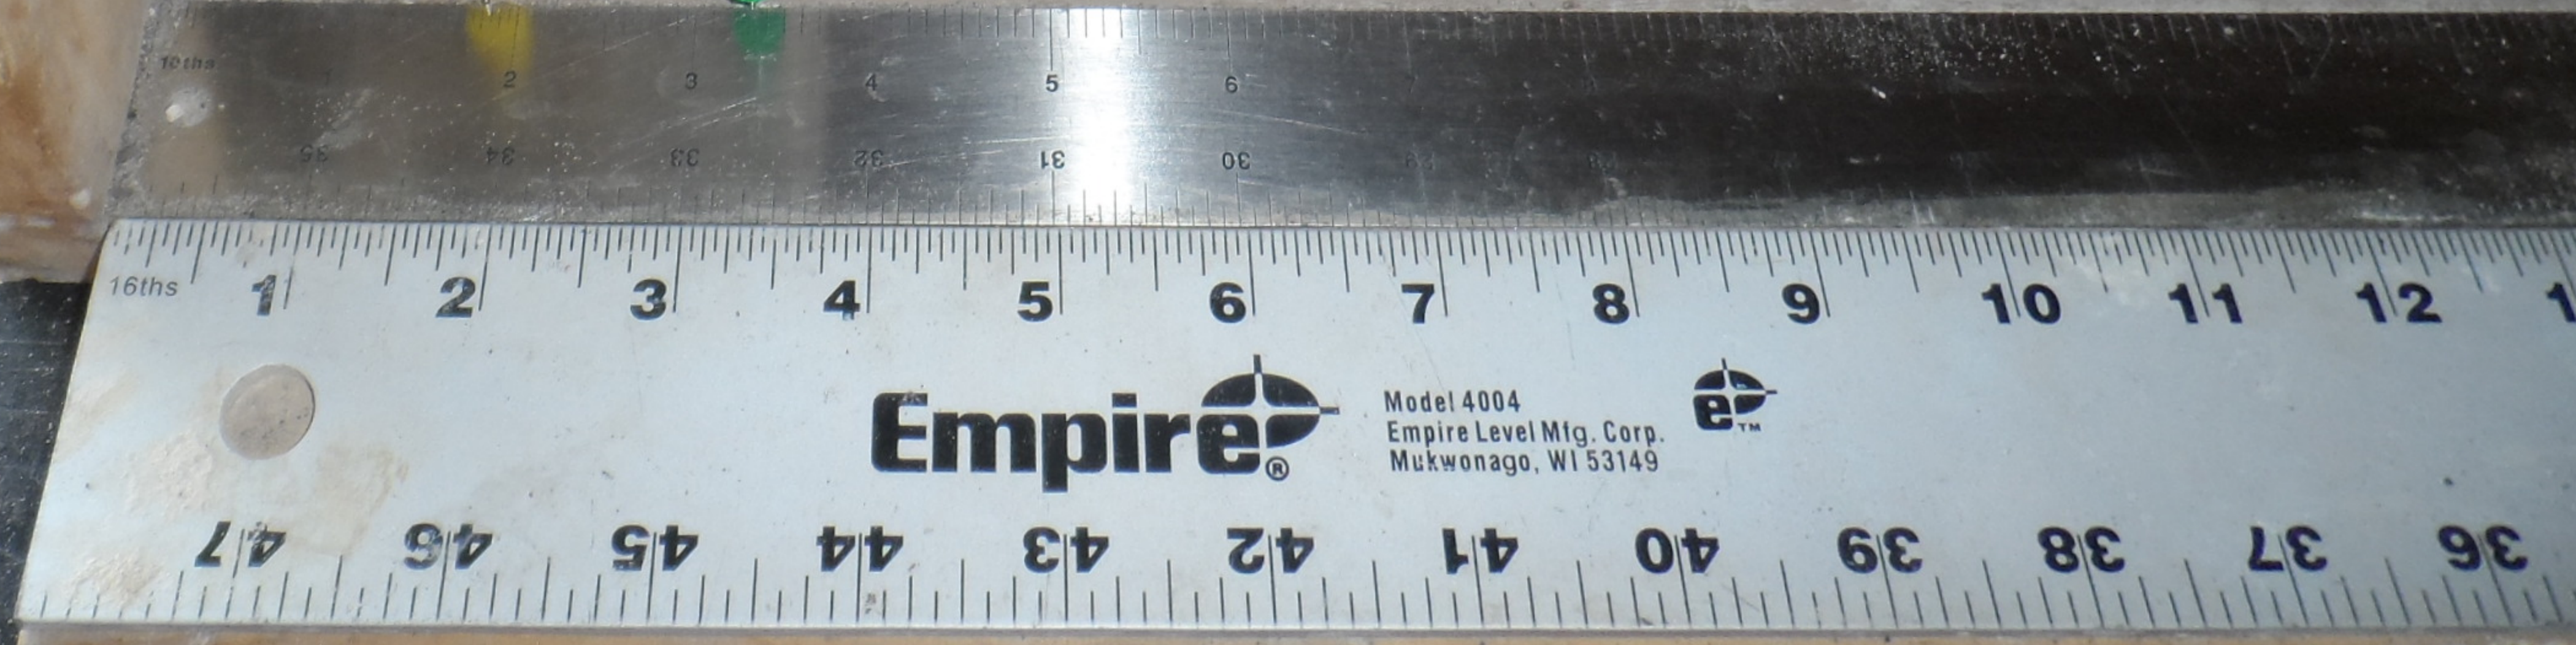
PAVEMENT CORE
PC-5

Project#	7111-19-206
Core #	PC-5
Layer 1	1.8
Layer 2	1.5
Layer 3	
Layer 4	
Layer 5	
Layer 6	
by: TSF

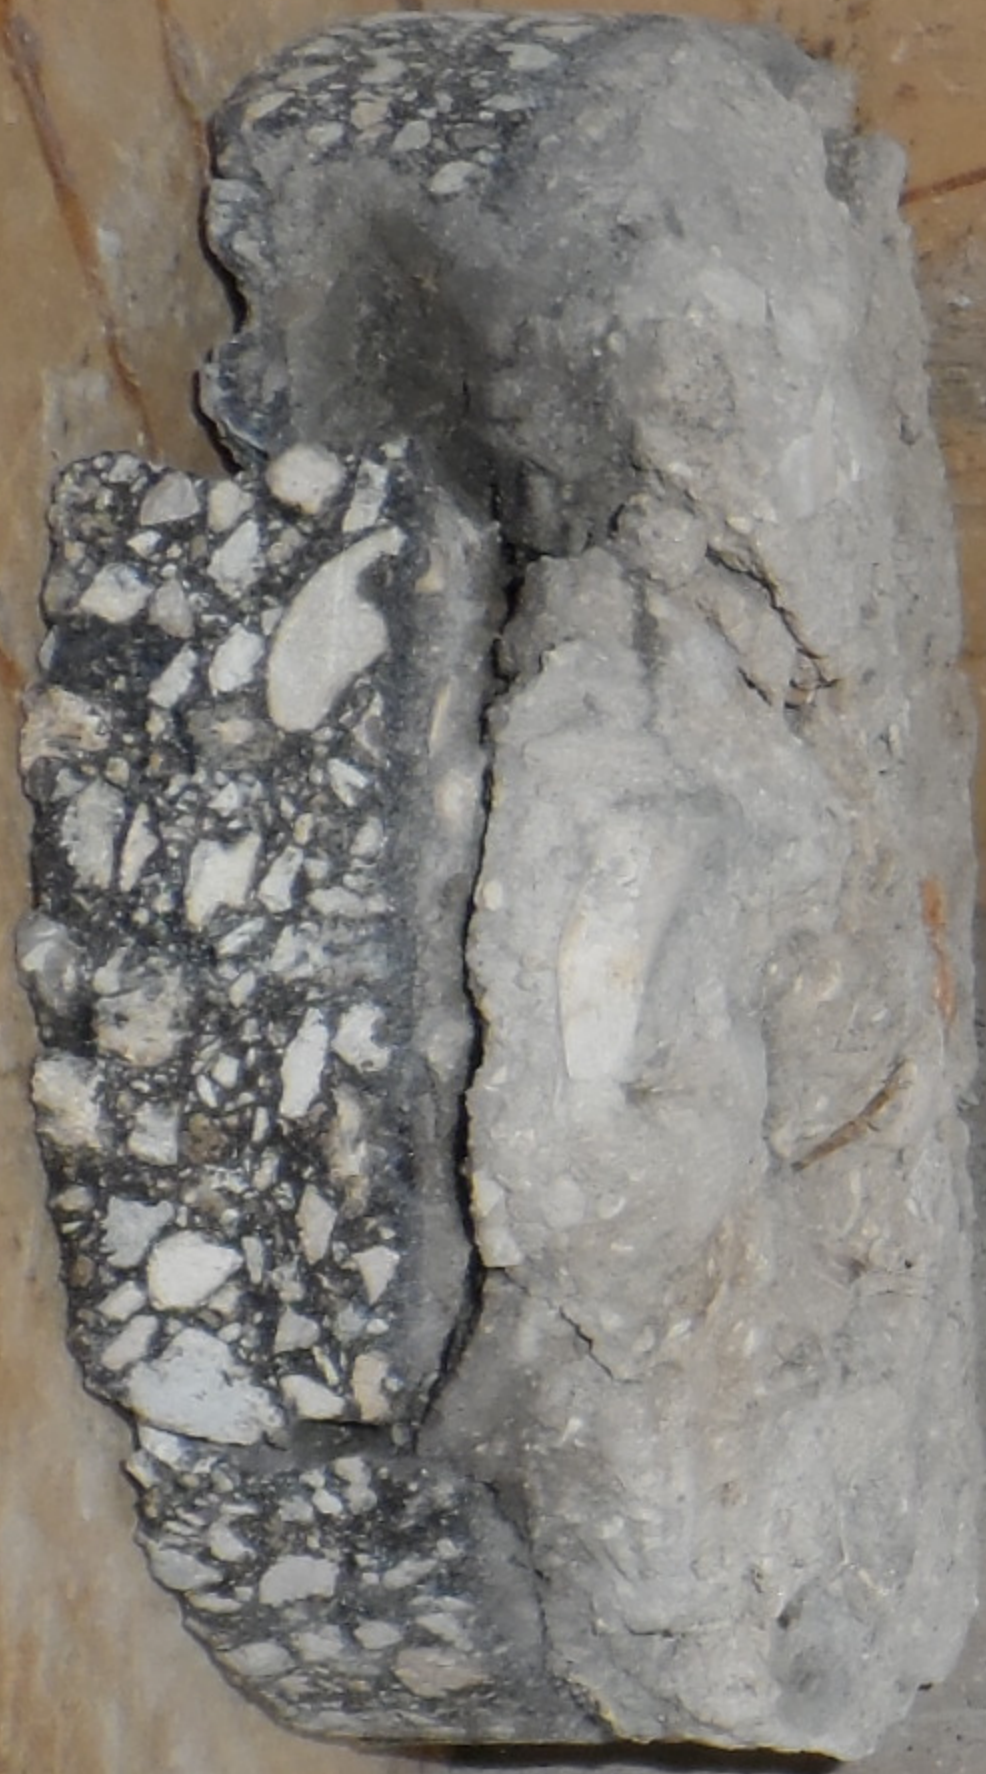
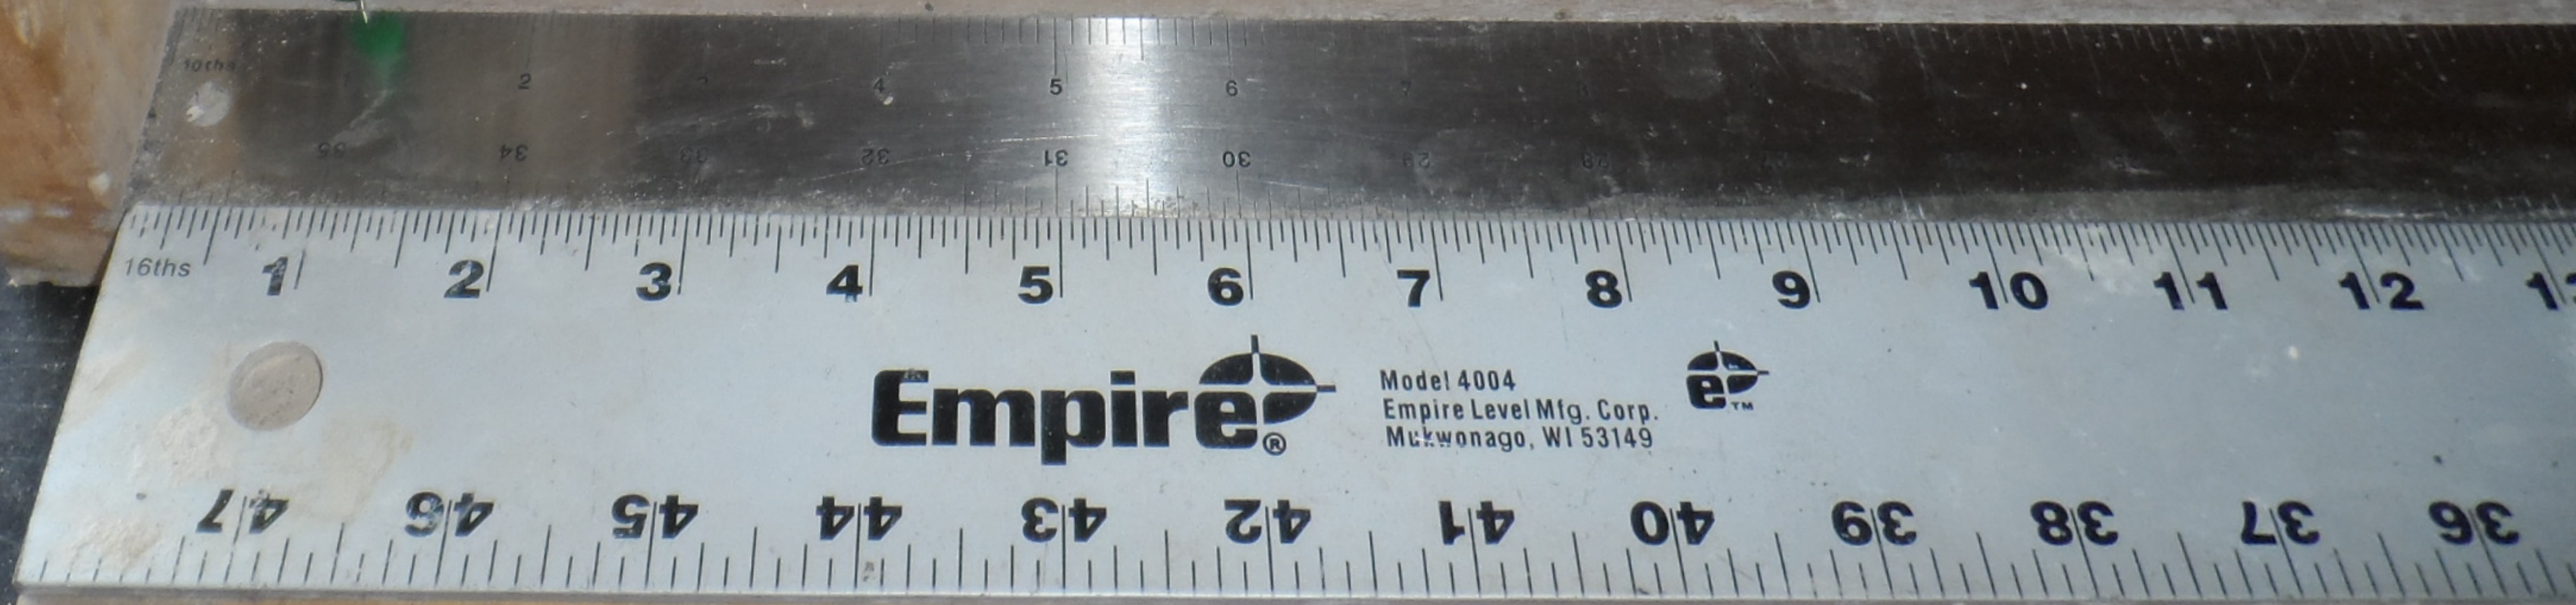
Project#	7111-19-206
Core #	PC-6
Layer 1	1.0
Layer 2	
Layer 3	
Layer 4	
Layer 5	
Layer 6

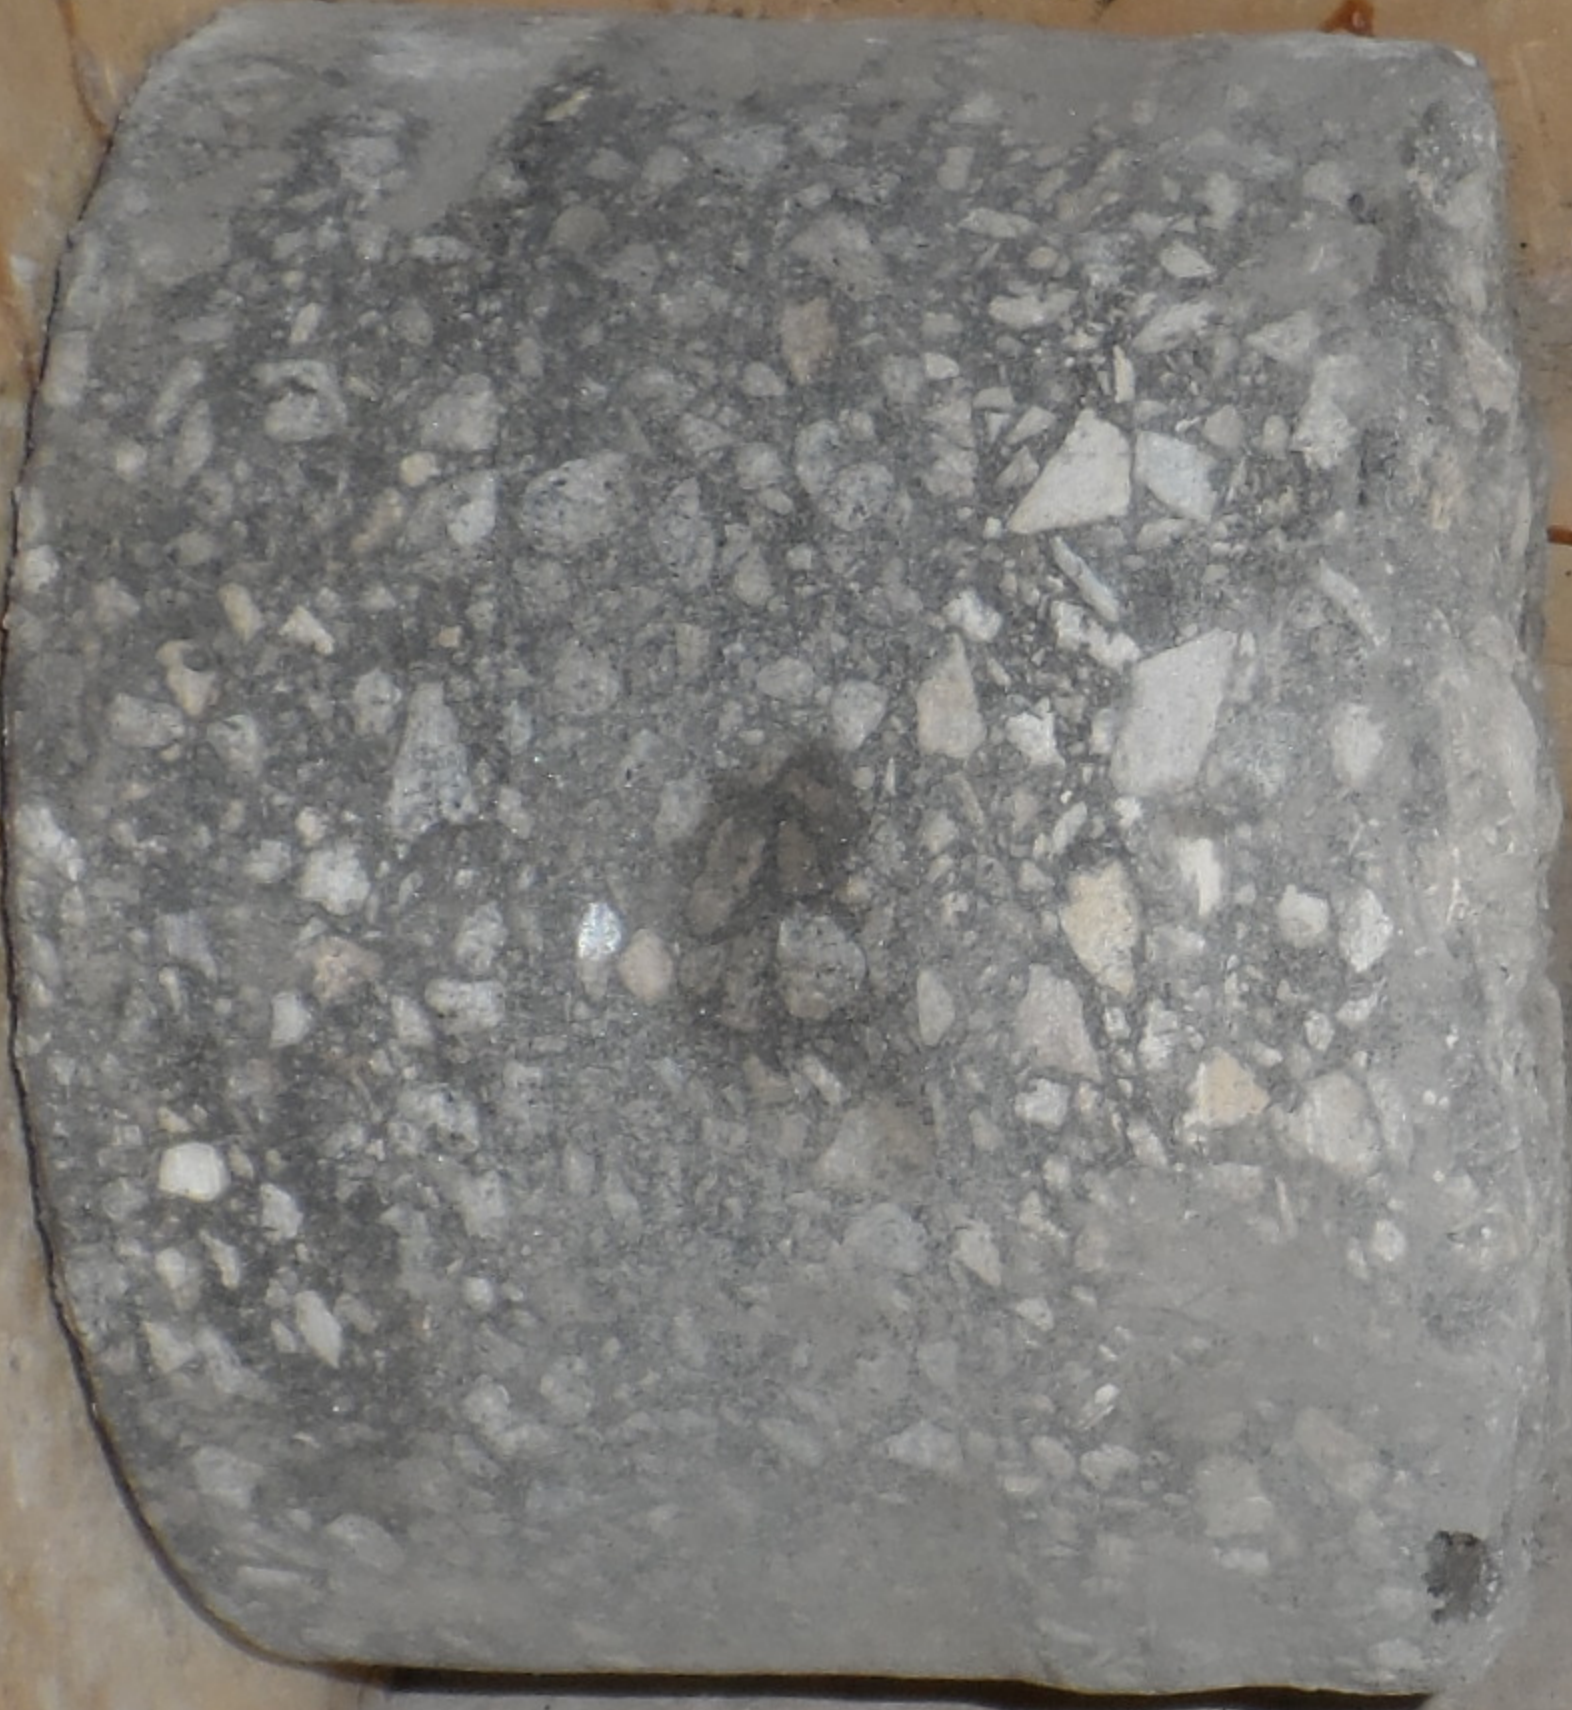
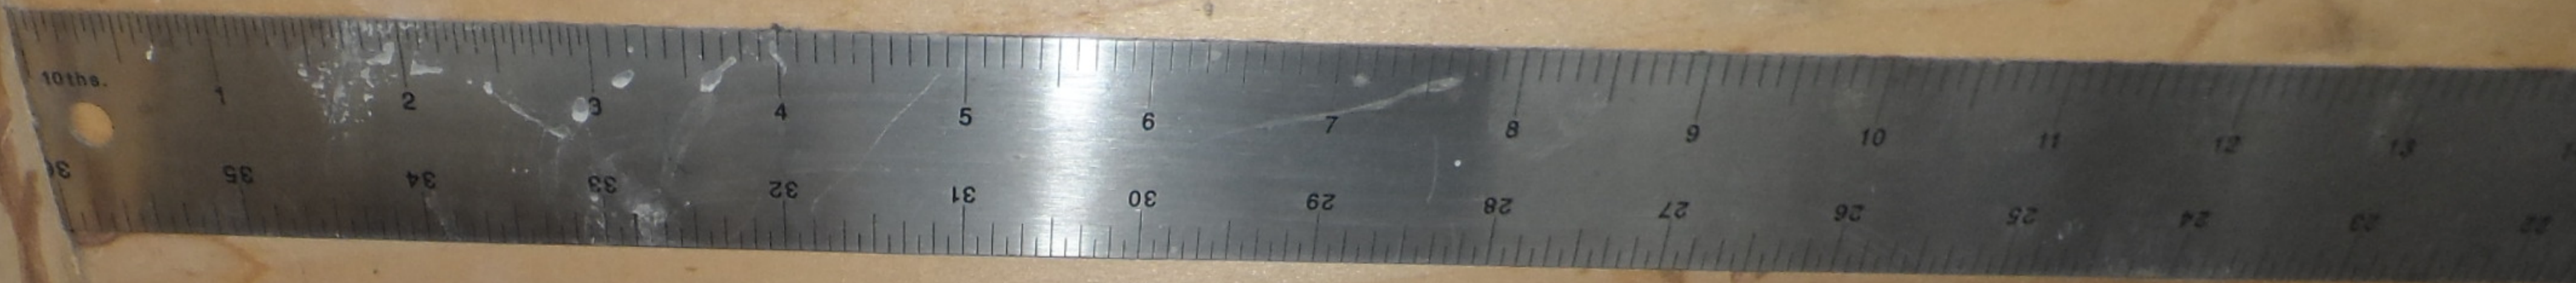
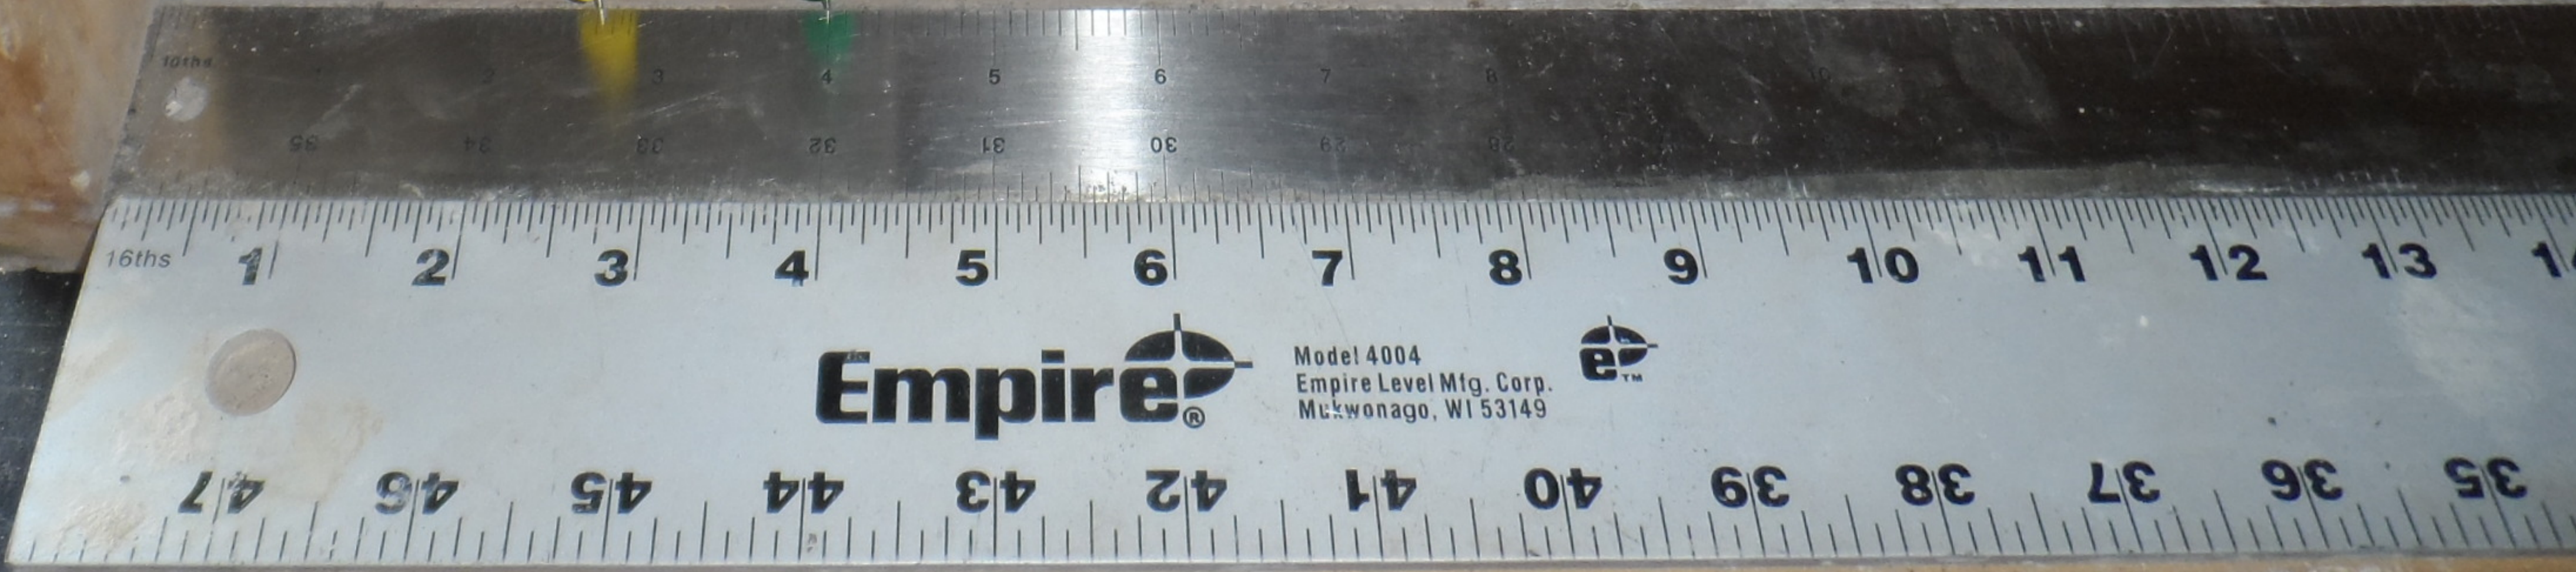
PAVEMENT CORE
PC-7

Project#	7111-18-206
Core #	PC-7
Layer 1	2.6
Layer 2	1.4
Layer 3	
Layer 4	
Layer 5	
Layer 6	
by: TSF

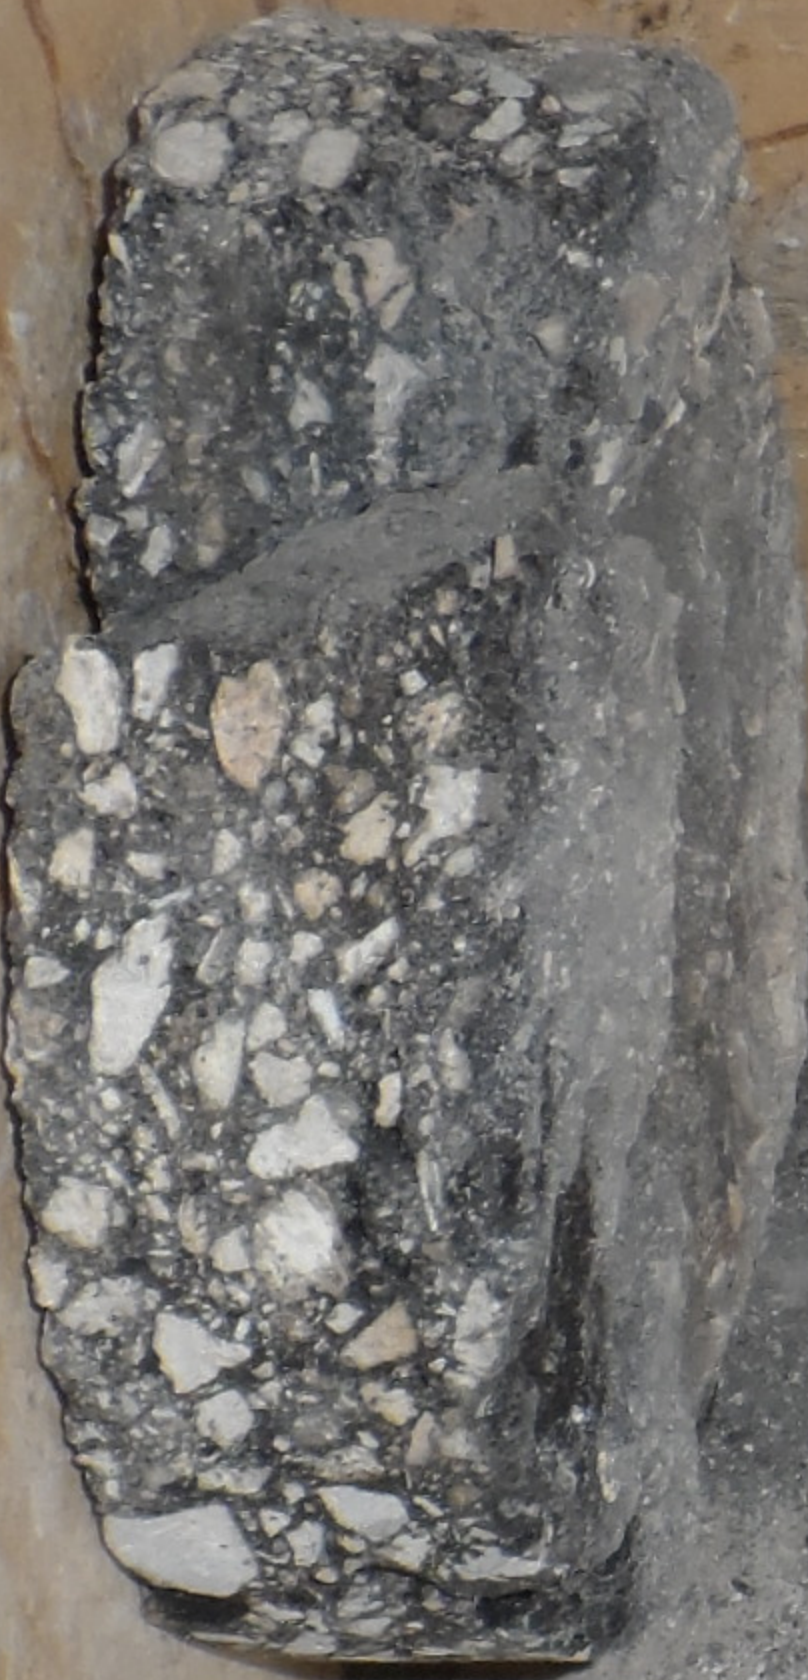
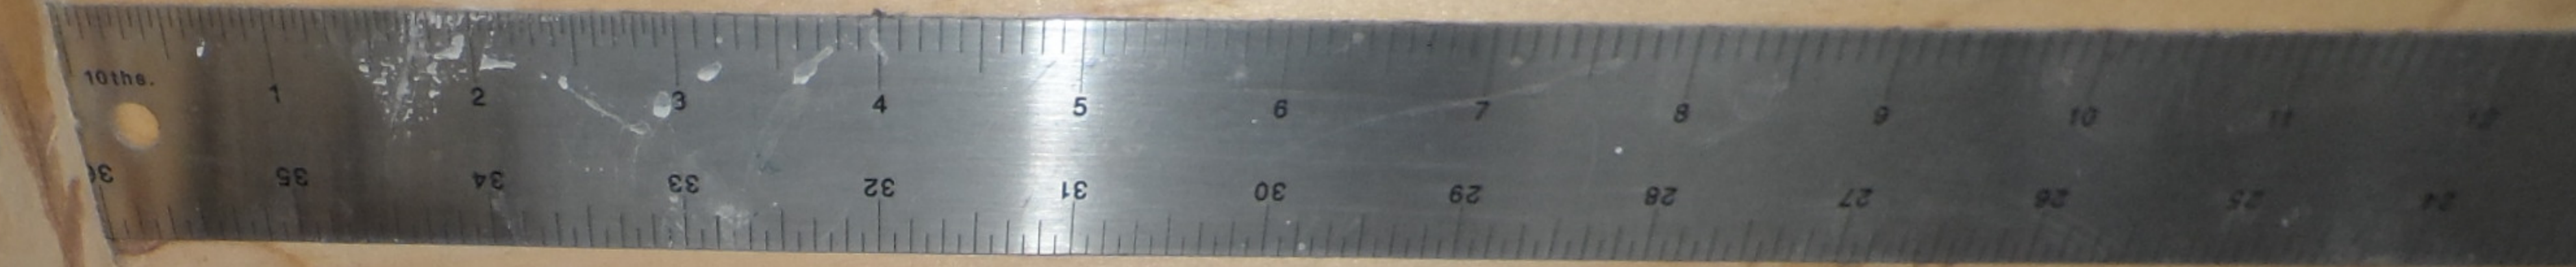
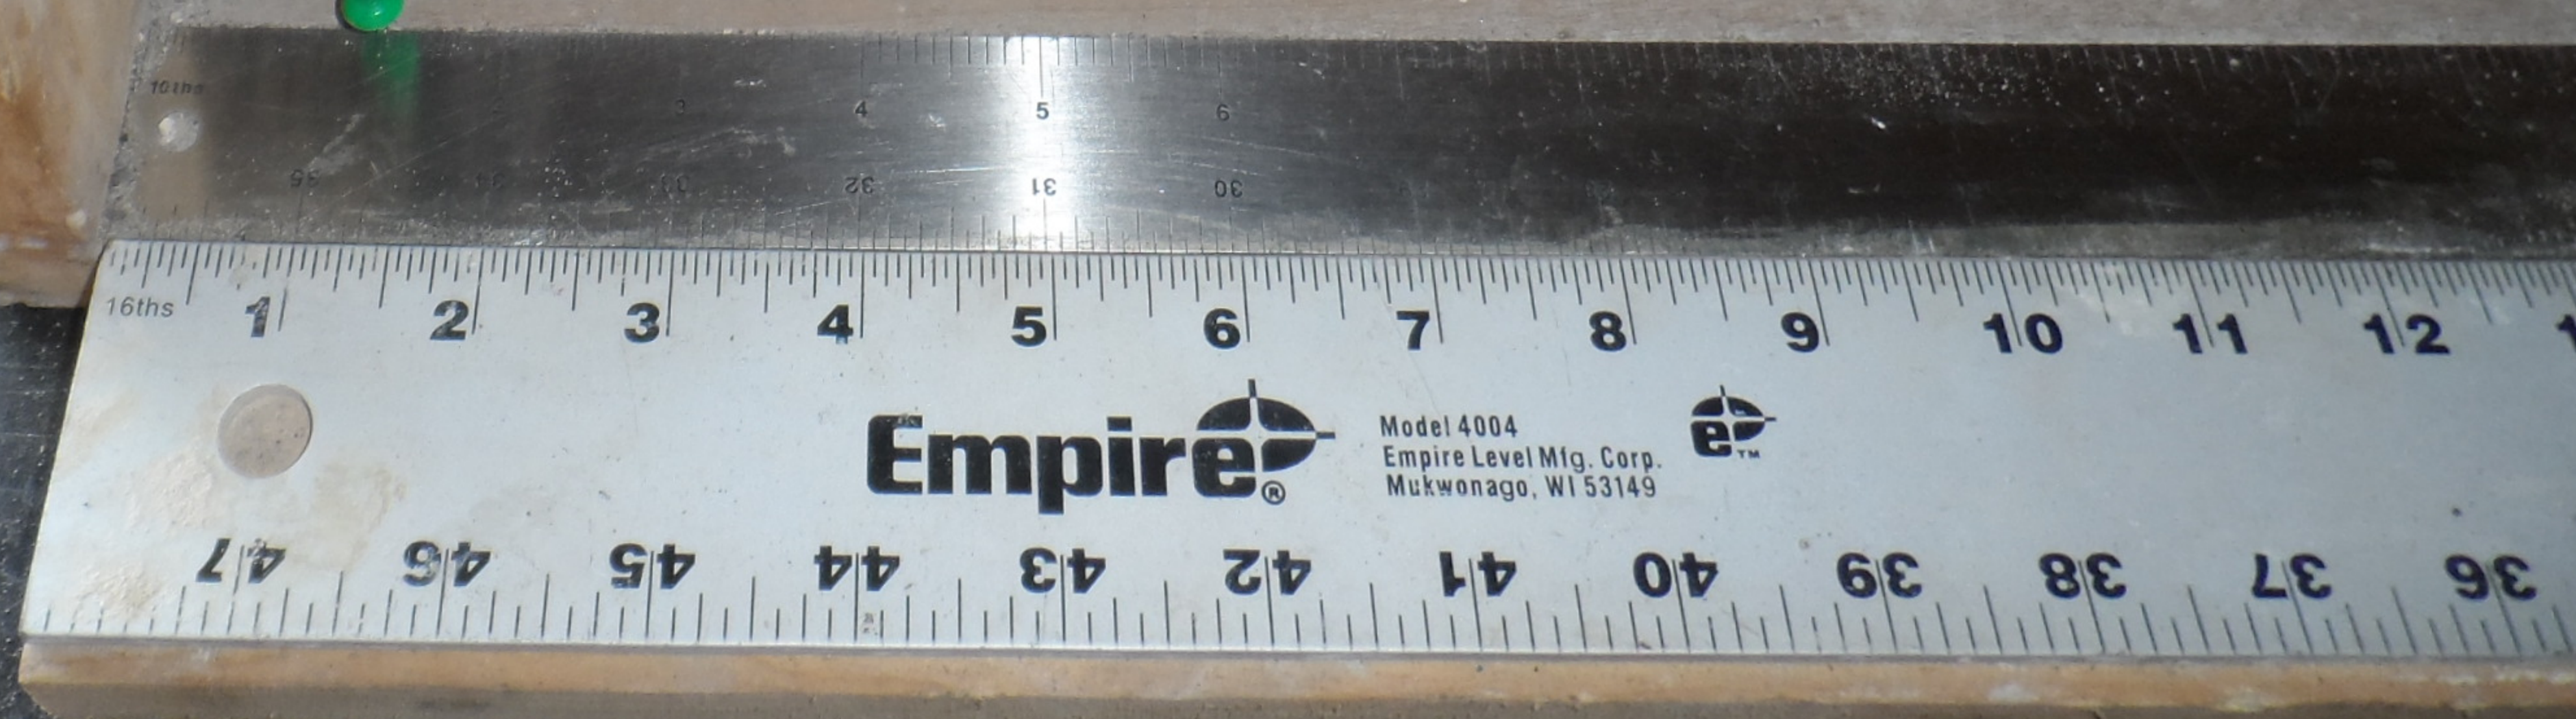
Project#	7111-19-206
Core #	PC-8
Layer 1	1.3
Layer 2	
Layer 3	
Layer 4	
Layer 5	
Layer 6

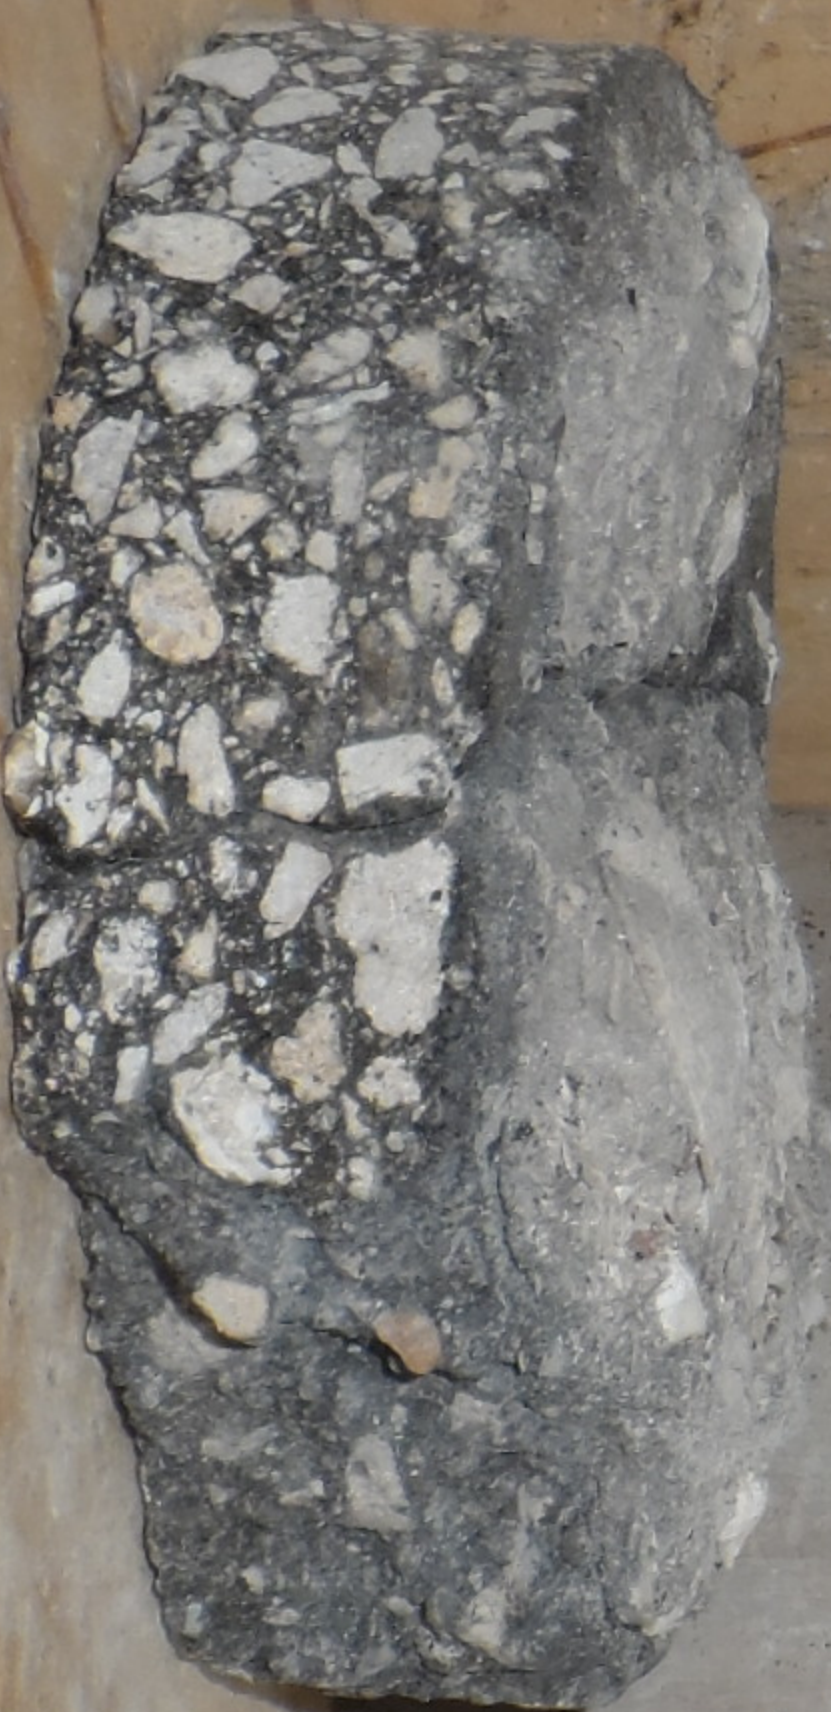
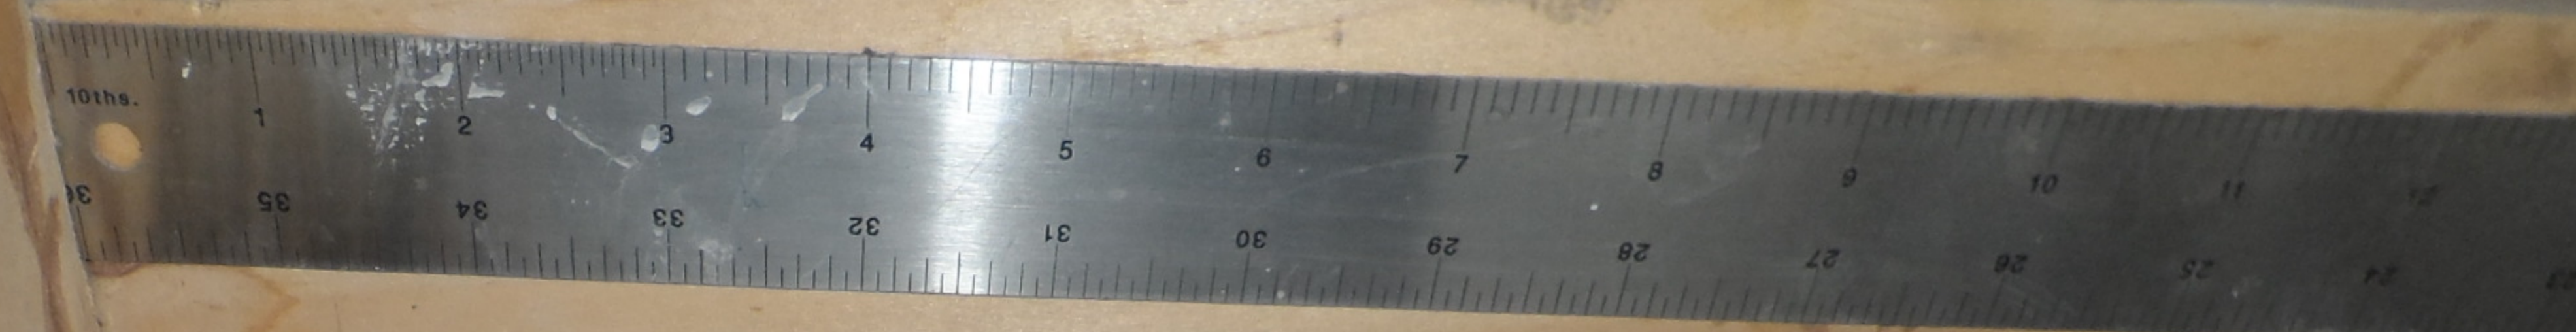
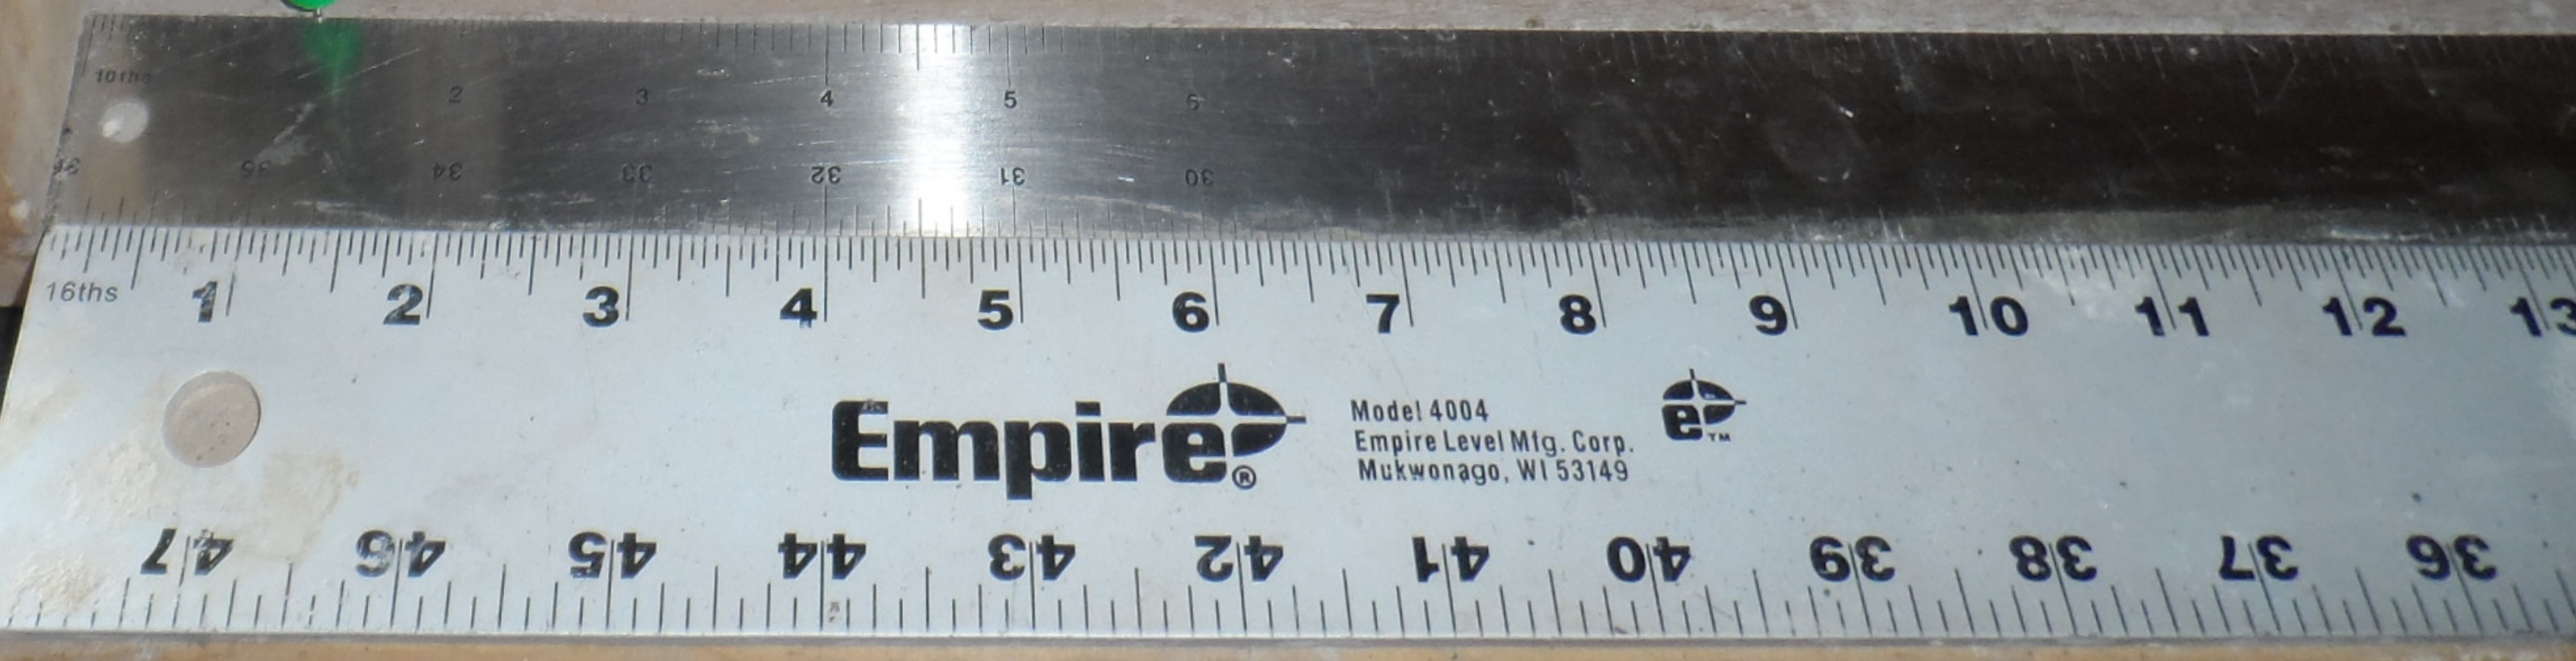
Project#	7111-13-206
Core #	PC-9
Layer 1	1.2
Layer 2	
Layer 3	
Layer 4	
Layer 5	
Layer 6
