July 26, 2019

Re: Geotechnical Engineering Services – Pavement Evaluation Report
Stryker Road Resurfacing from North Olivia Drive to US-27
Highlands County, Florida
Highlands County Project No.: 18008
TSF File No. 7111-19-206

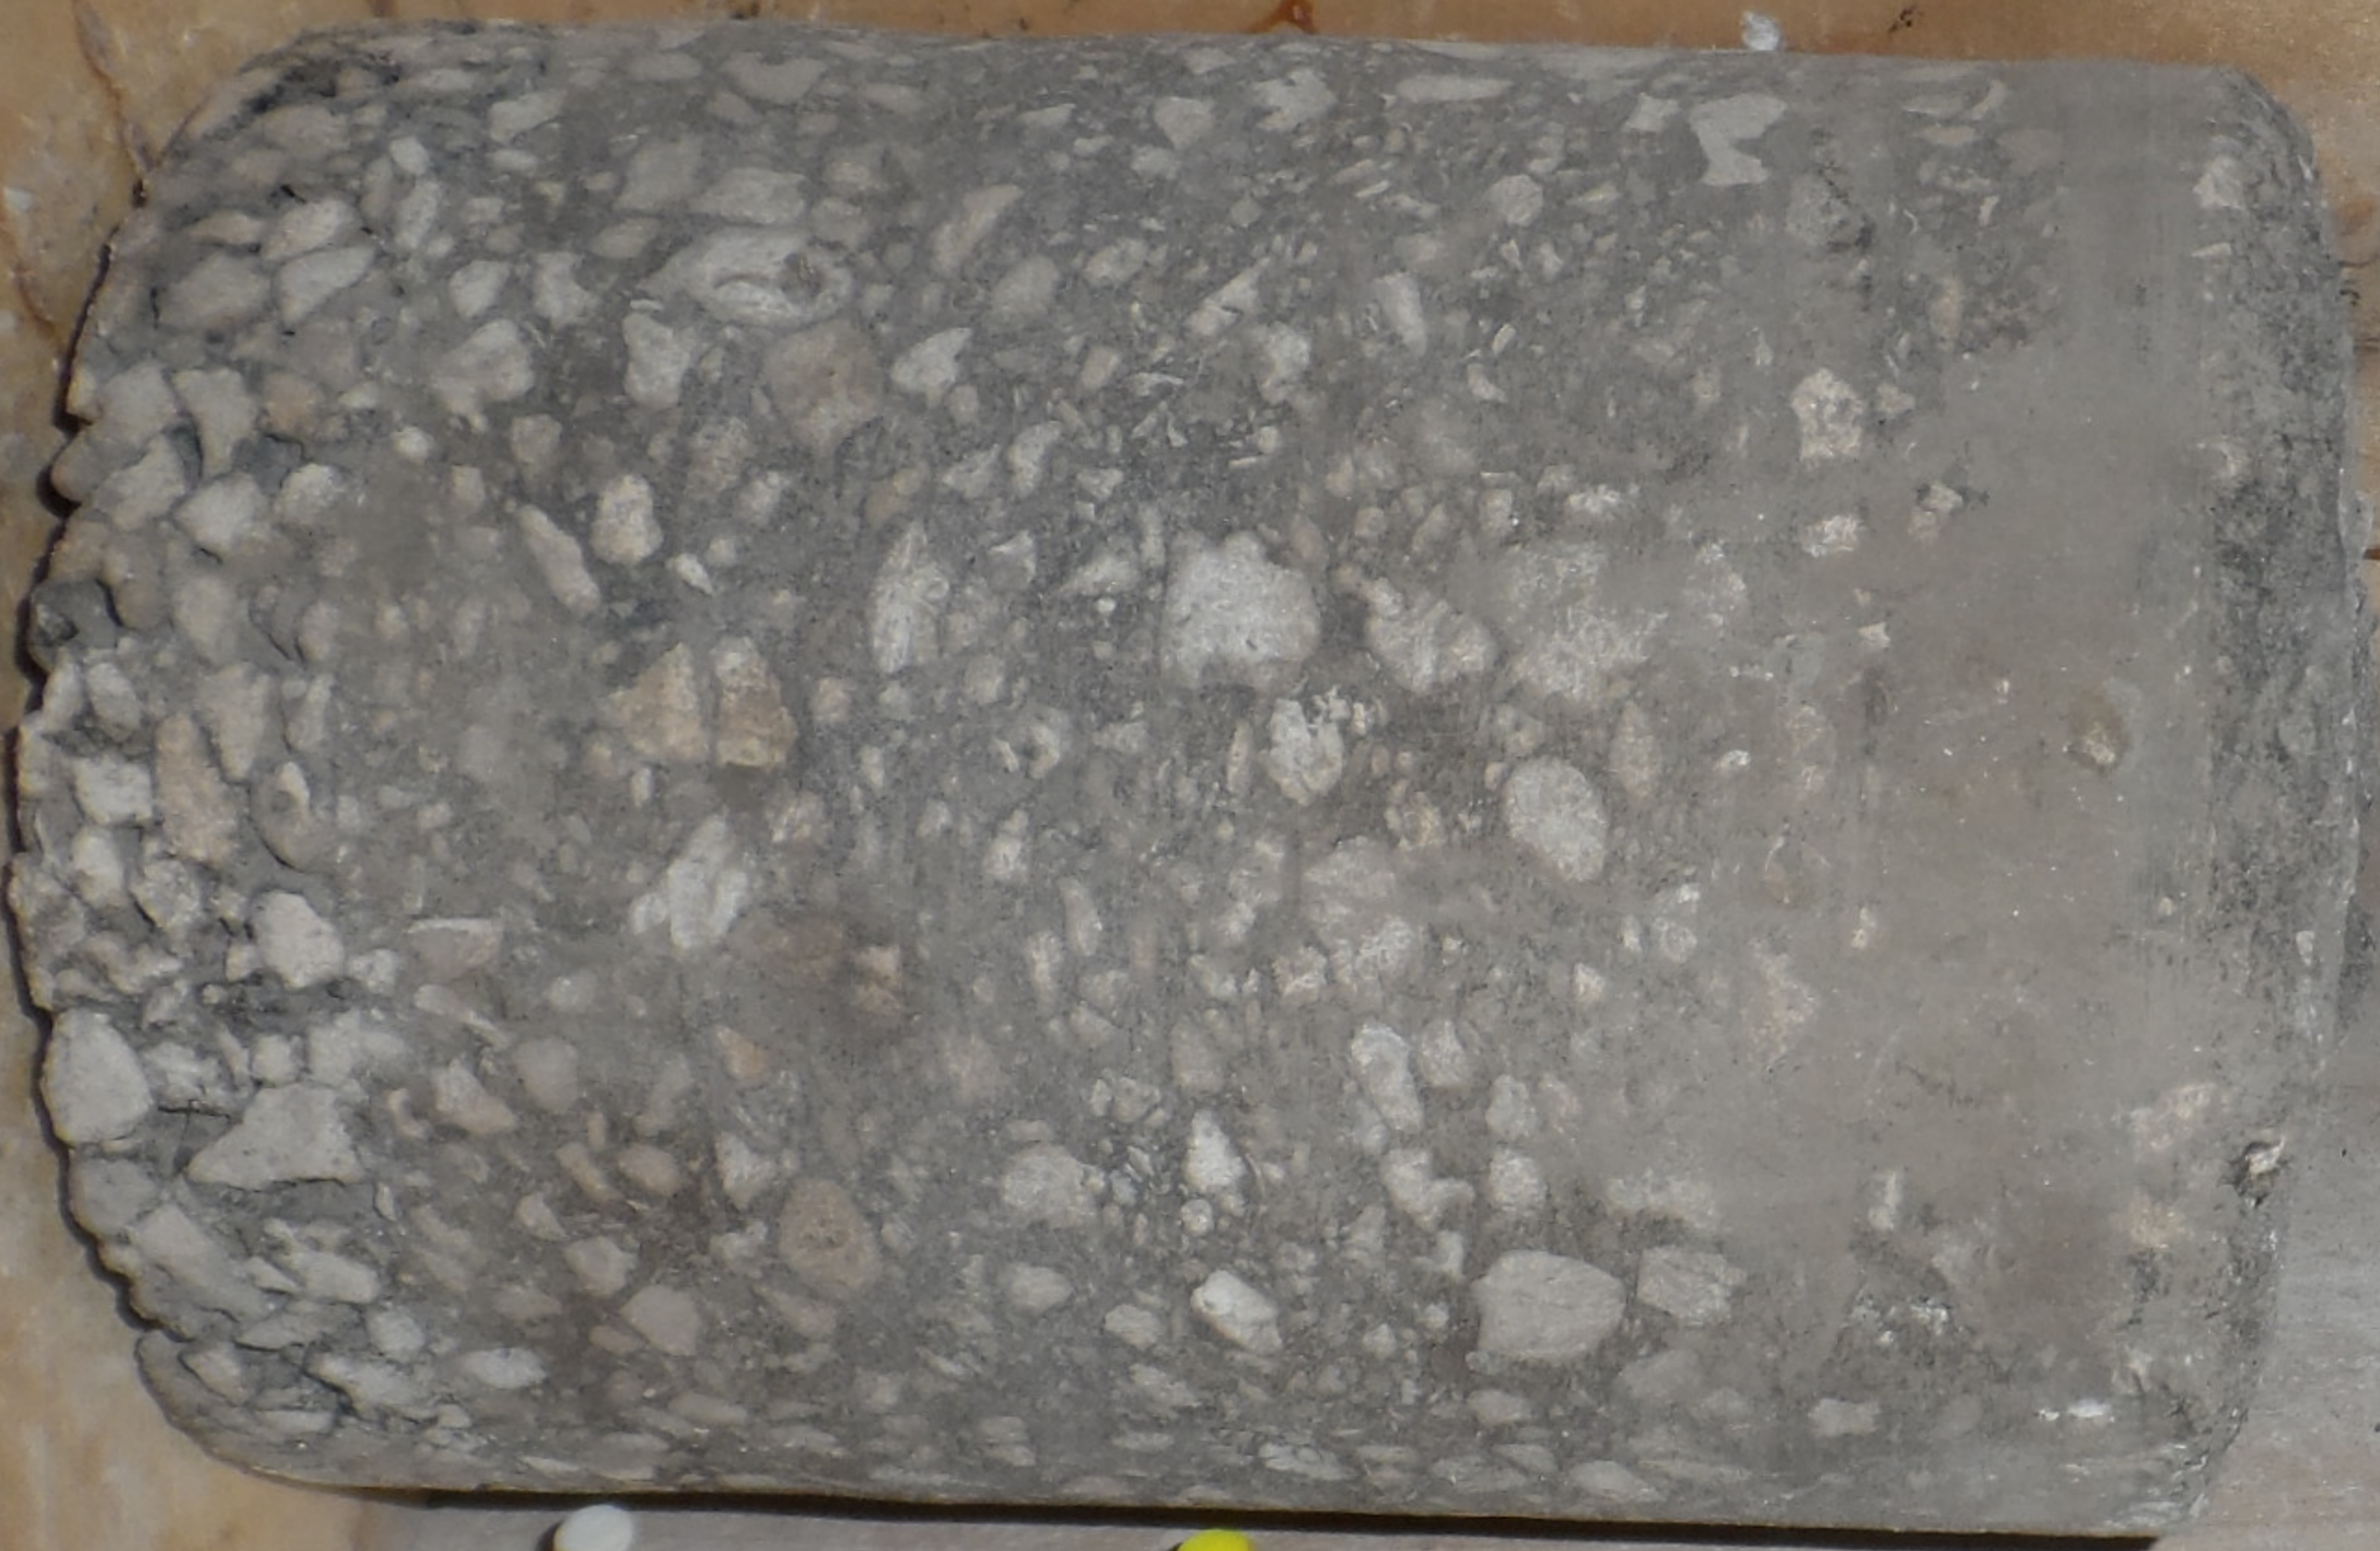
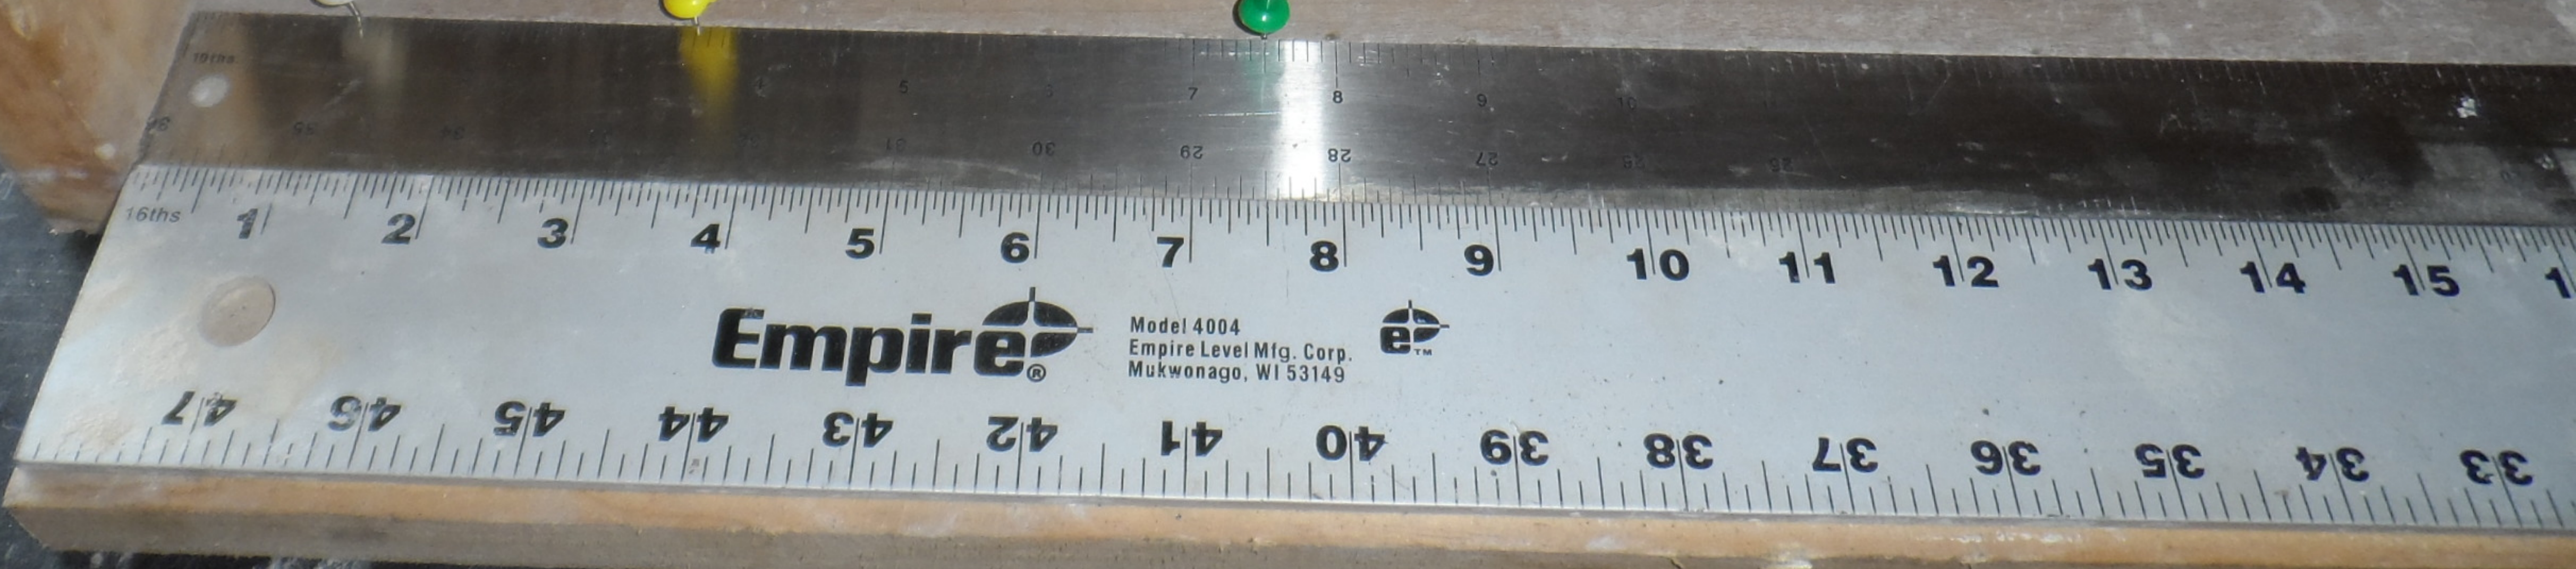
PAVEMENT CORE PC-11

Project#	7111-13-206
Core #	PC-11
Layer 1	F.C 1.1
Layer 2	2.4
Layer 3	4.0
Layer 4	
Layer 5	
Layer 6	
by:	TSE
