SUBJECT: Addendum #3 to Quote Request, # 37728, Install new 60-inch Aluminum Flap Gate on S-259 Discharge Pipe

Attachment:
S-259 Inspection Report 2-12-20

STRUCTURE S-259
INSPECTION DATE: 2/12/2020

Double Barrel, 54" Diameter x 205' Long

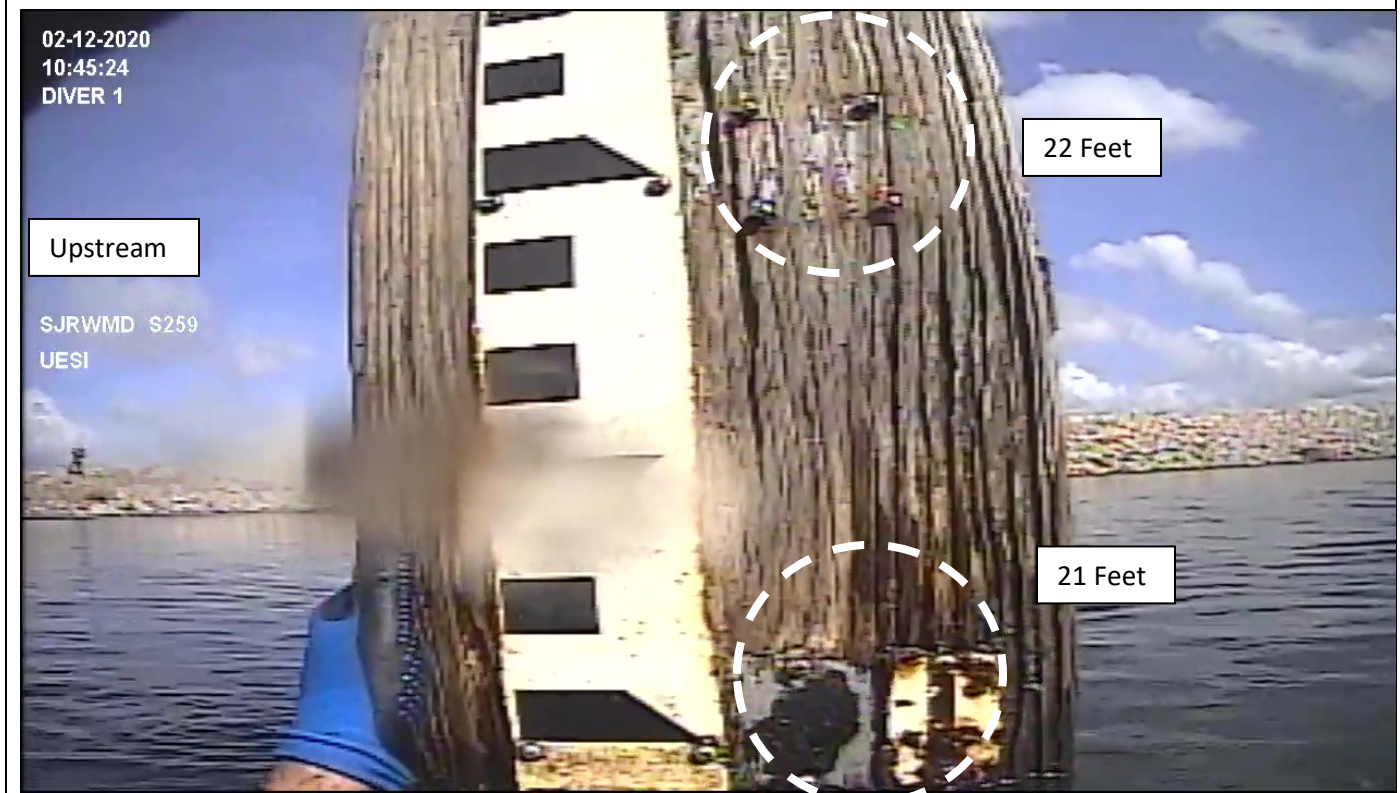
<p>Item No.: DS1000</p> <p>Additional Items</p>	<p>Rating: C-3</p>	<p>Photo Description: Upstream staff gauge with missing numbers</p>
---	--------------------	---

Deficiency: The elevation numbers from 17 and 20 to 22 are missing.

Probable Cause: The corrosion was due to chemical attack from the water and isolated areas of galvanic corrosion due to contact of dissimilar metals.

Recommendation: Replace the gauge numbering from 22 to 17 as necessary.
