Apex Project Number 0617-111

January 5, 2018

Reference: Asbestos Assessment Services
Cammie Clagett Courts
Phase 2 - 9 Buildings (42 Units)
Highland Street Area
Spartanburg, South Carolina

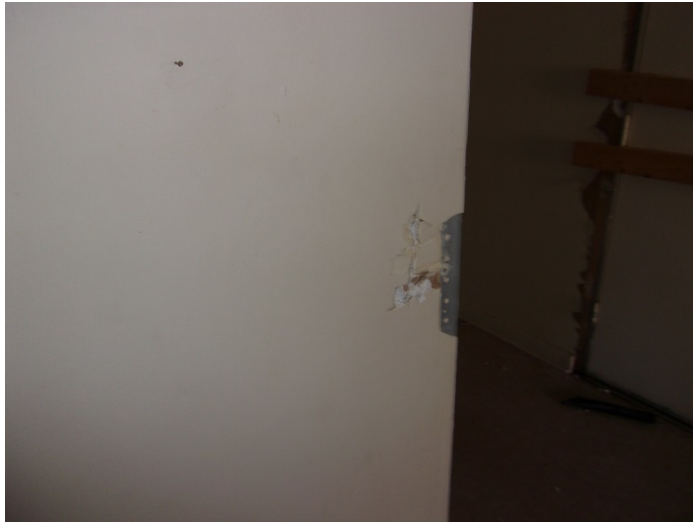
Photo 1 – Typical view of drywall with joint compound and tape throughout buildings 1-6 & 36-38.

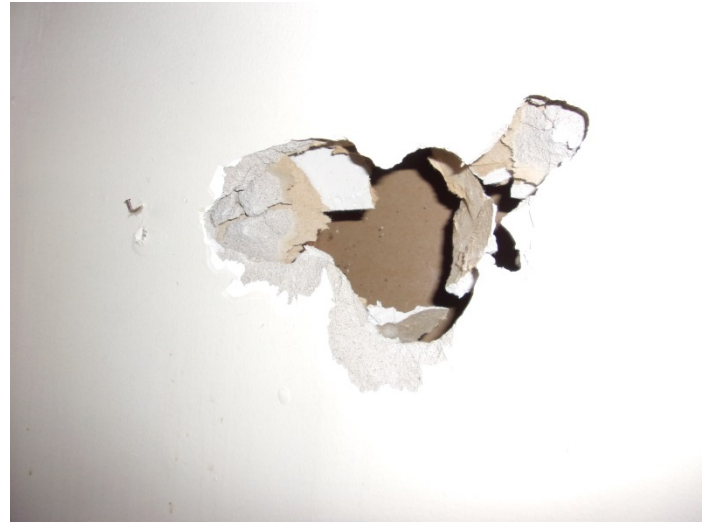
Photo 2 – Typical view of drywall with joint compound and tape throughout buildings 1-6 & 36-38.

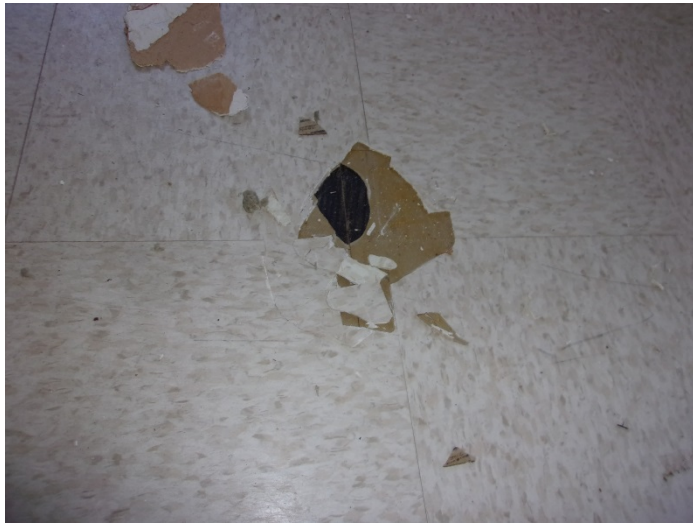
Photo 3 – Typical view of 12'' x 12'' tan speckled floor tile & mastic over 2nd layer of floor tile & mastic over concrete throughout buildings 1-6 & 36-38.

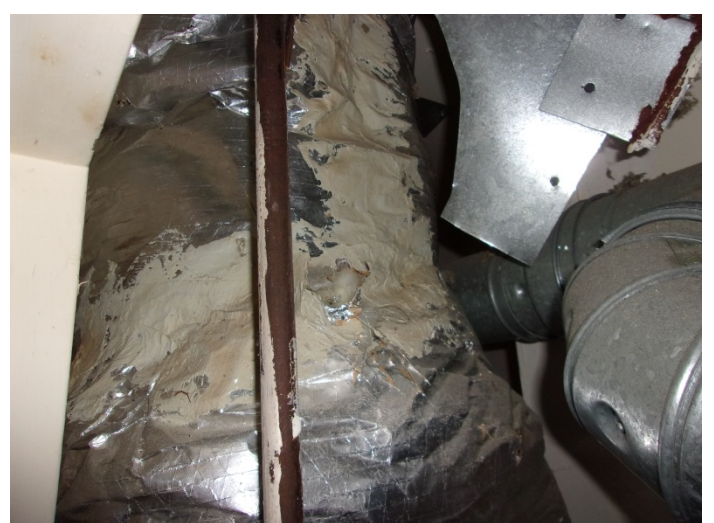
Photo 4 – Beige HVAC mastic above the ceiling and in HVAC closet in building 37.

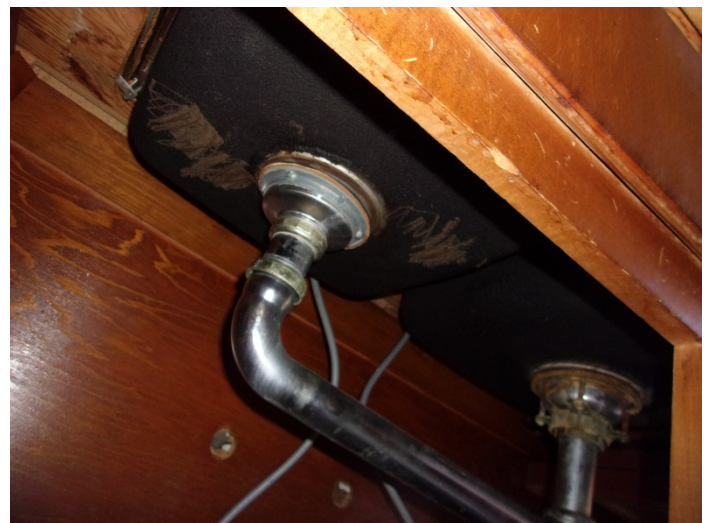
Photo 6 – Typical view of the black kitchen sink coating in buildings 1-6 & 36-38.

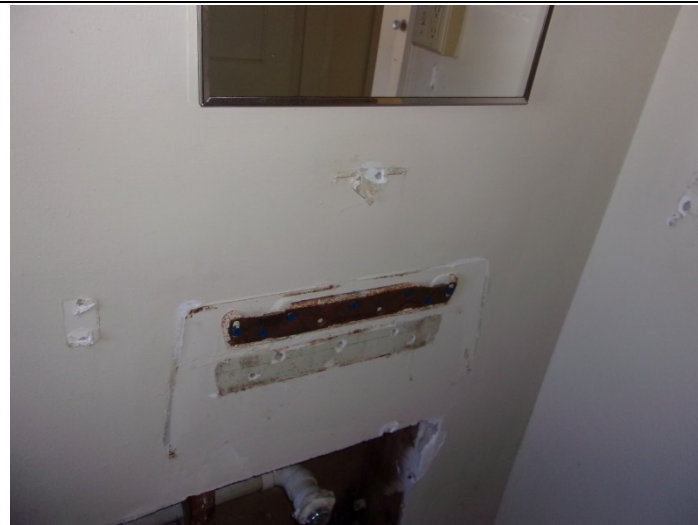
Photo 7 – Typical view of the bathroom sink caulk in buildings 1-6 & 36-38.

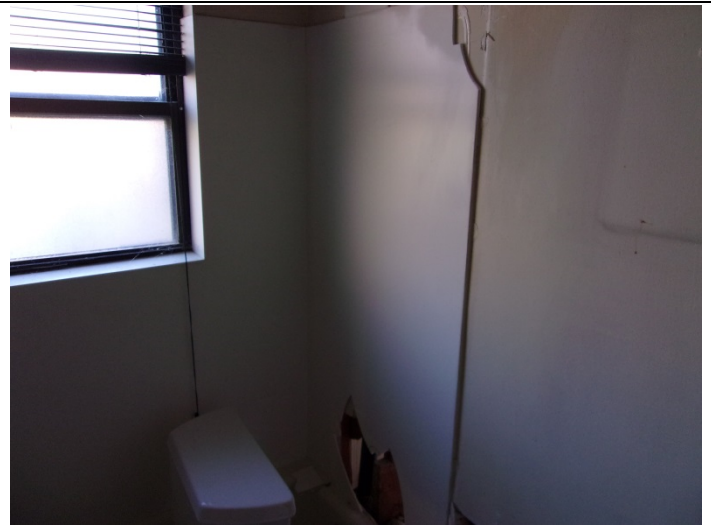
Photo 8 – Typical view of the shower stall caulk in buildings 1-6 & 36-38.

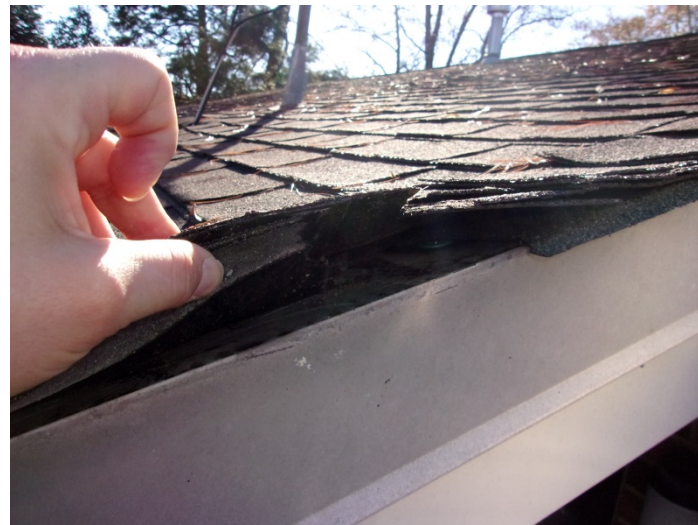
Photo 9 – Typical view of the roof shingles & felt on the main roof and awning roofs on buildings 1-6 & 36-38.

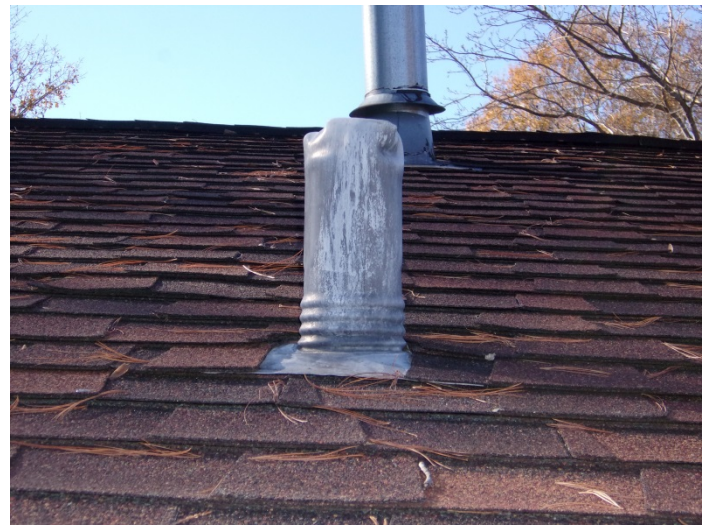
Photo 10 – Typical view of the paint coated roof vents on buildings 1-6 & 36-38.

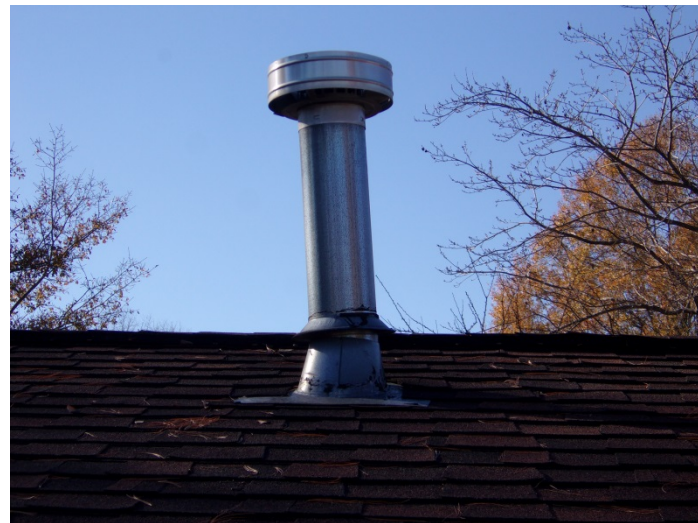
Photo 11 – Typical view of black & black/gray mastic/tar on roof penetrations on buildings 1-6 & 36-38.

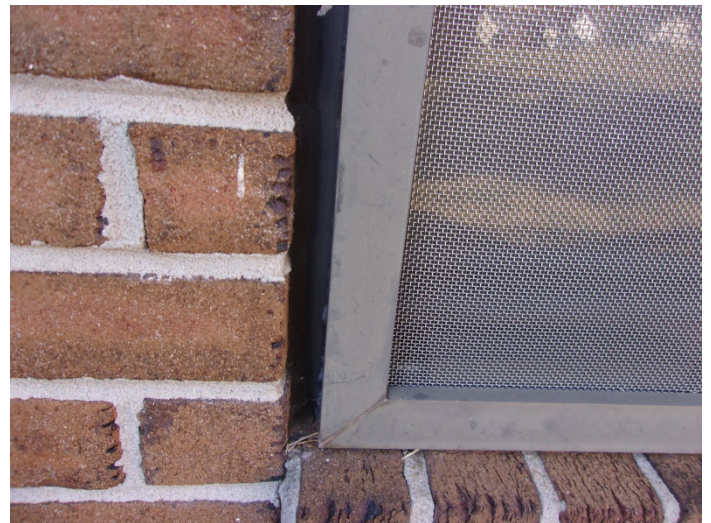
Photo 12 – Typical view of the black and brown interior and exterior window caulk in buildings 1-6 & 36-38.

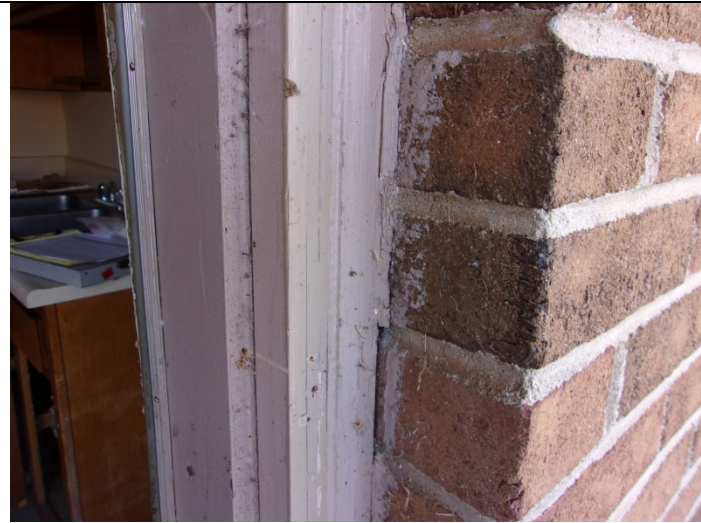
Photo 13 – Typical view of the door caulk in buildings 1-6 & 36-38.

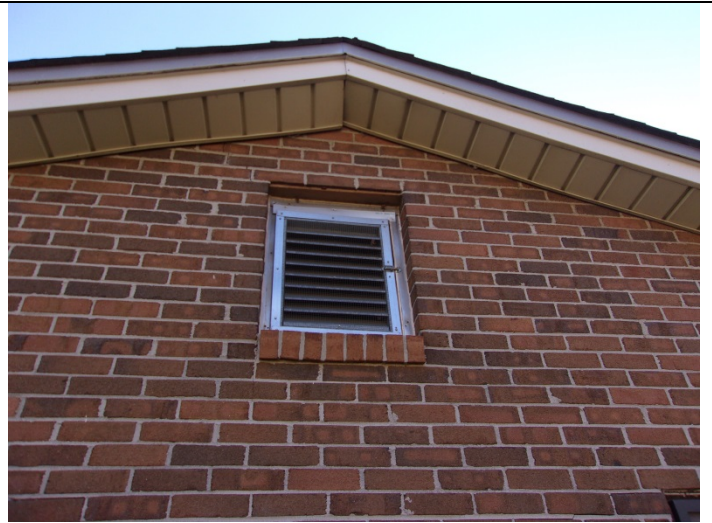
Photo 14 – Typical view of roof gable vents with caulk on buildings 1-6 & 36-38.

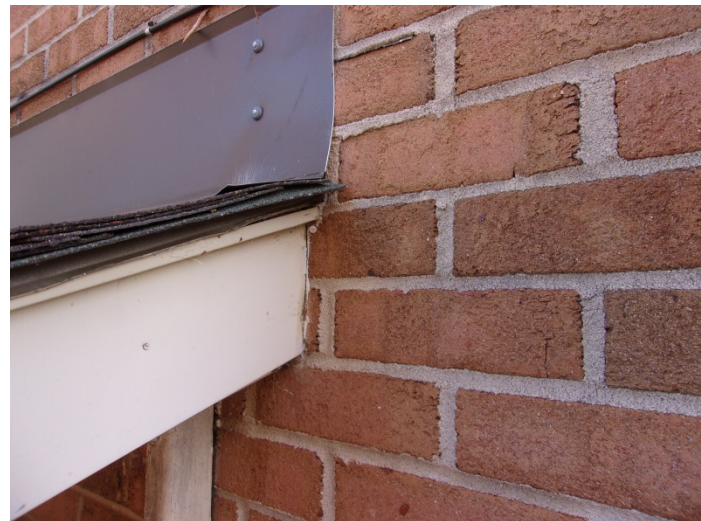
Photo 15 – Typical view of the caulk on the awning & flashing on buildings 1-6 & 36-38.

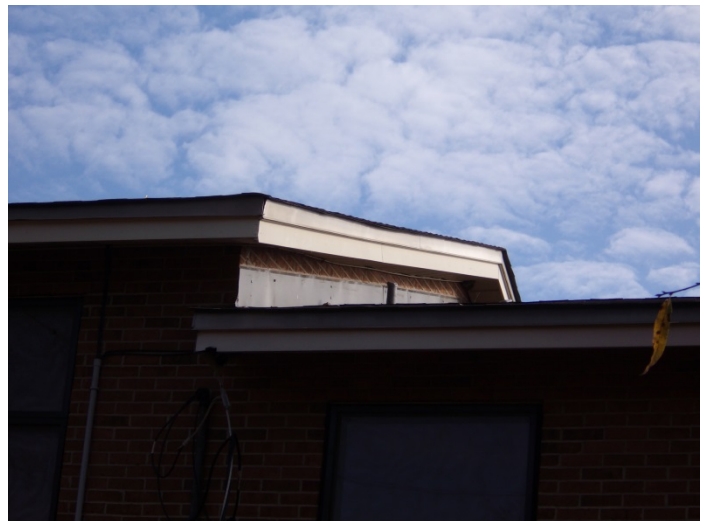
Photo 16 – Typical view of the caulk on the main roof flashing on buildings 1-6 & 36 & 38.

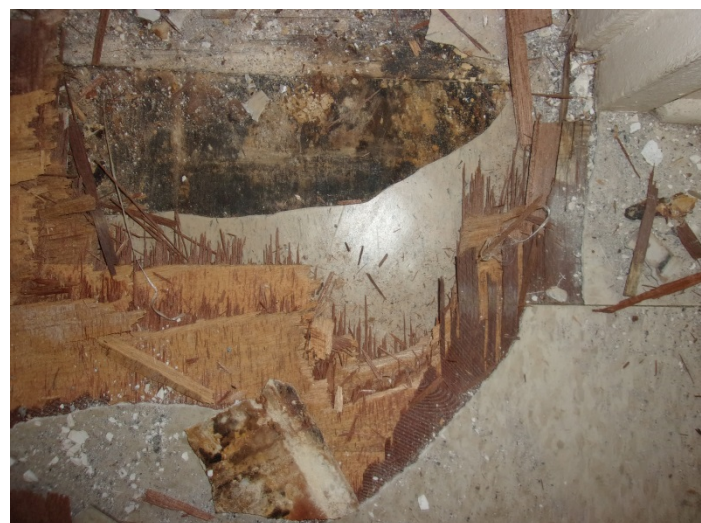
Photo 17 – Typical view of 12" x 12" tan speckled floor tile & mastic over 2nd layer of floor tile & mastic under wood throughout buildings 1-6 & 36-38.

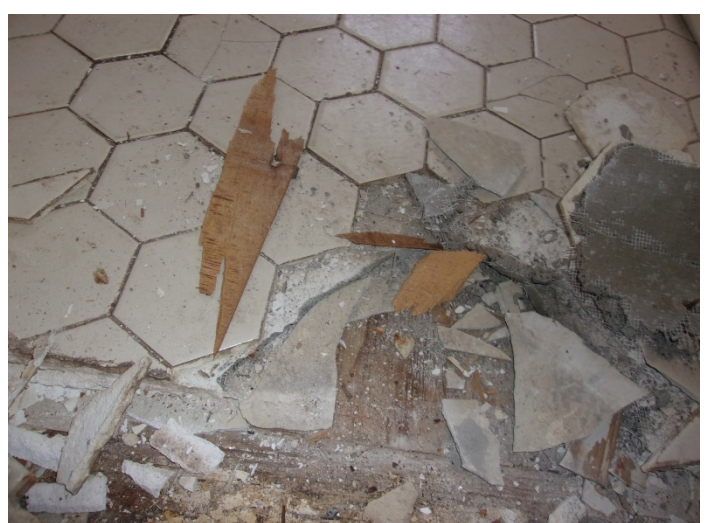
Photo 18 – Typical view of ceramic tile with wood & vinyl flooring beneath throughout buildings 1-6 & 36-38.

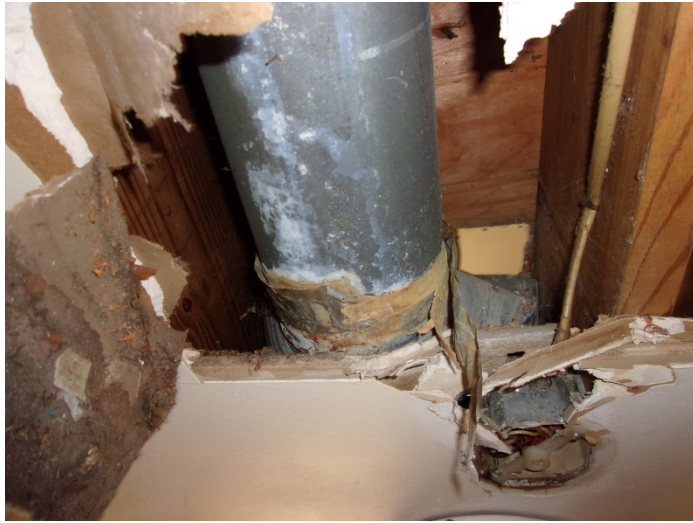
Photo 19 – Typical view of HVAC tape & mastic above the ceilings throughout buildings 1-6 & 36 & 38.

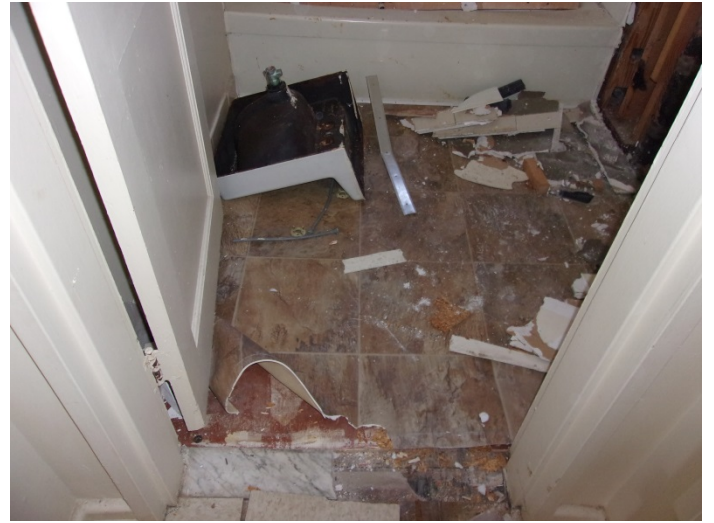
Photo 20 – Typical view of vinyl flooring & mastic in portions of the buildings (no ceramic tile exists).

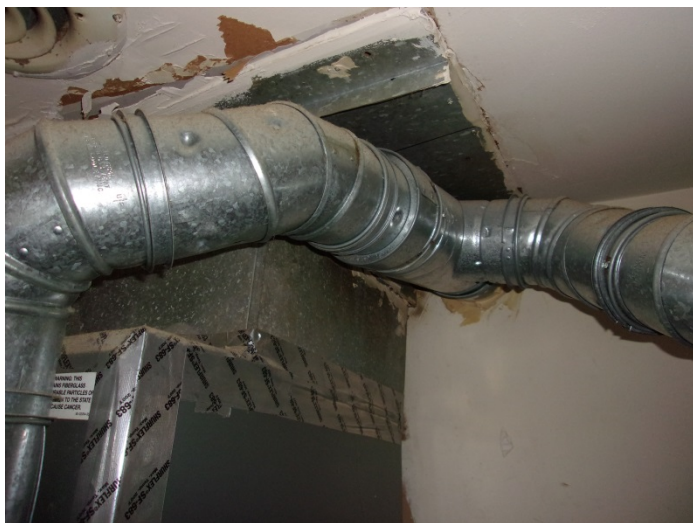
Photo 21 – Typical view of caulk on the HVAC units throughout the HVAC closets in buildings 1-6 & 36-38.

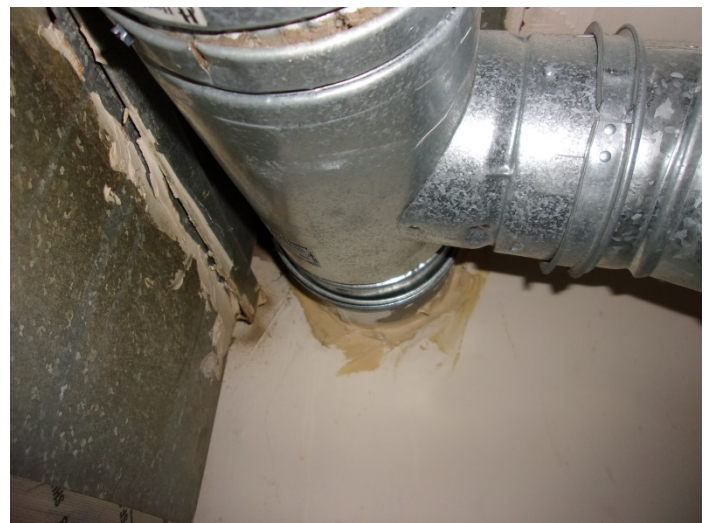
Photo 22 – Typical view of caulk on the HVAC units throughout the HVAC closets in buildings 1-6 & 36-38.

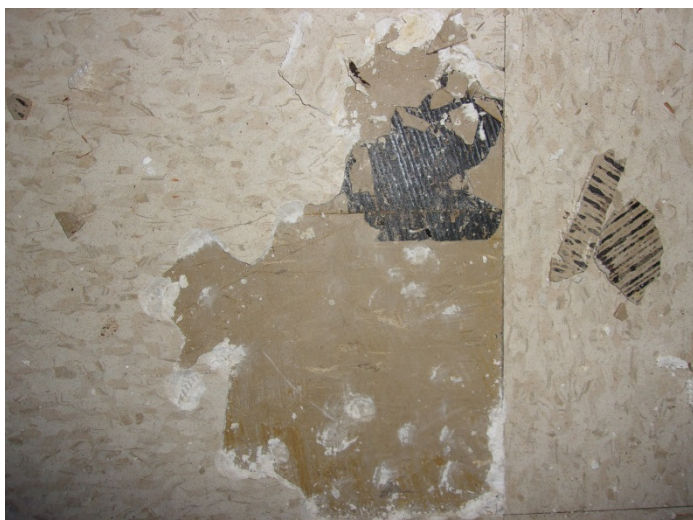
Photo 23 – Typical view of 12"x12" brown streaked floor tile and mastic (bottom layer) assumed positive in Buildings 7 to 35.
