Apex Project Number 0920-148

Reference: Limited Asbestos Assessment

City of Spartanburg Fire Station 2

Limited Asbestos Assessment Report City of Spartanburg Fire Station 2 Spartanburg, South Carolina September 25, 2020

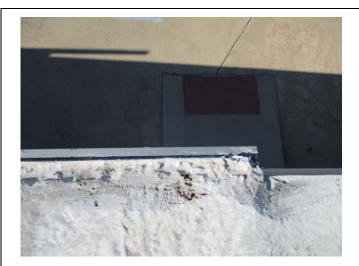
Photo 7 - Roof caulk on roof edges.
