ADDENDA# 2

**RFQ NO. 3001-0-2019, ARCHITECTURAL/ENGINEERING DESIGN SERVICES
RFQ NO. 3002-0-2019, CONSTRUCTION MANAGEMENT AT RISK SERVICES
REPLACE MARTIN COUNTY SCHOOL DISTRICT'S JENSEN BEACH (JBES) &
PALM CITY ELEMENTARY (PCES) SCHOOLS**

2017 AHERA RE-INSPECTION
Jensen Beach Elementary
2525 NE Savannah Road
Jensen Beach, Florida
S&ME Project No. 4484-17-070-B

2525 NE Savannah Road
Jensen Beach, Florida 34957
January, 2018

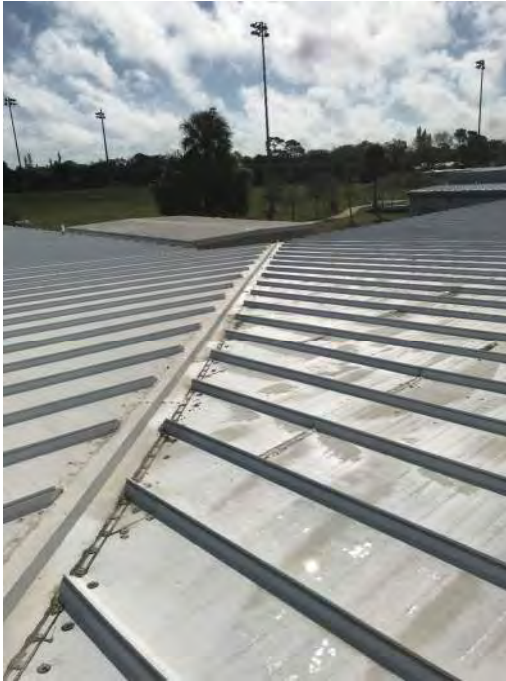
Buildings 2, 3 & 5 Finish Failing

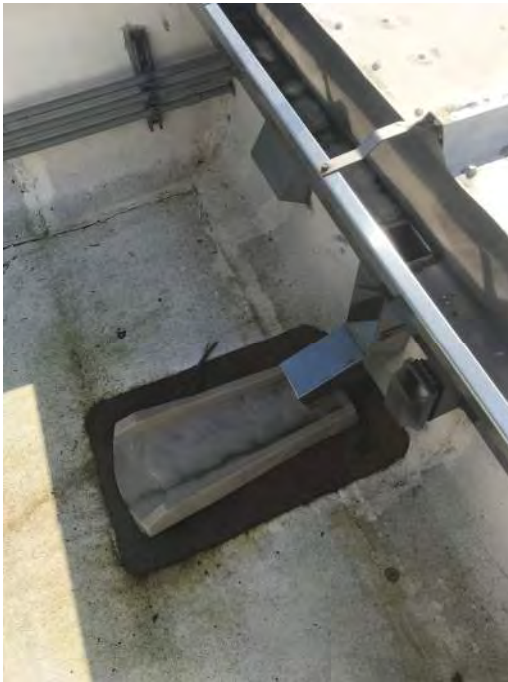
Buildings 2, 3 & 5 Slash Block at HVAC Unit

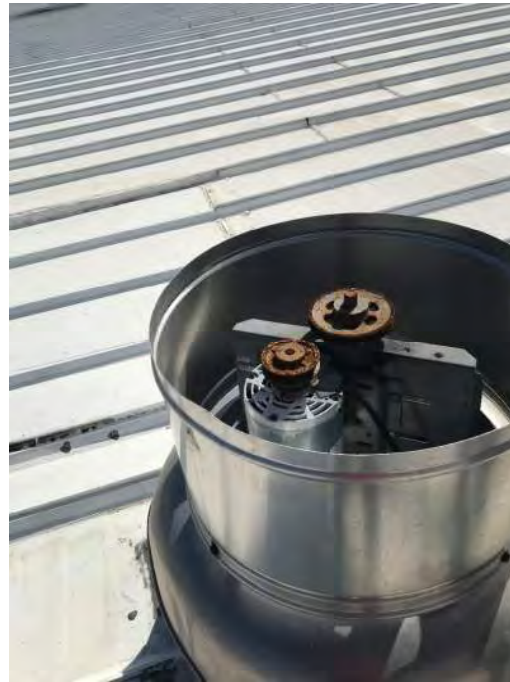
Buildings 2, 3 & 5 Top of Hood Missing

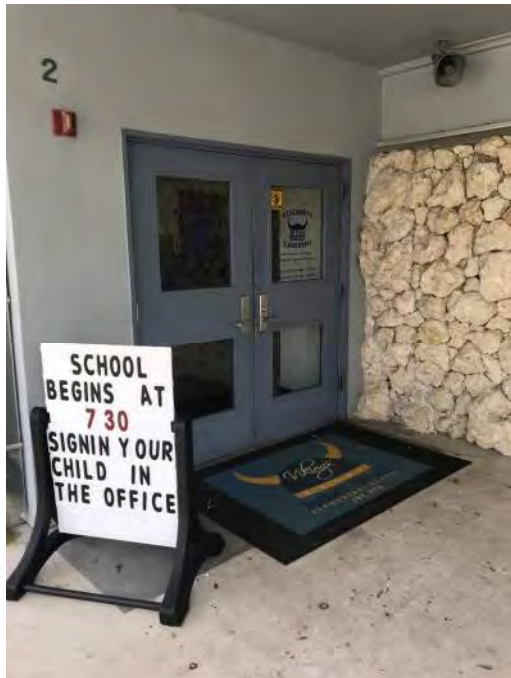
The exterior doors, door frames and windows show wear and corrosion. They do not meet current Energy Code requirements nor do they meet the current wind pressure requirements from the 2017 Florida Building Code.

The doors and windows should be replaced. None of the facility was constructed to current wind codes. Especially vulnerable are those parts of the buildings structure around fenestrations. The exterior should have subsurface investigation to determine if reinforcing is required to meet current wind load requirements. Although the exterior of the building do not meet current FBC requirements and must be "hardened".

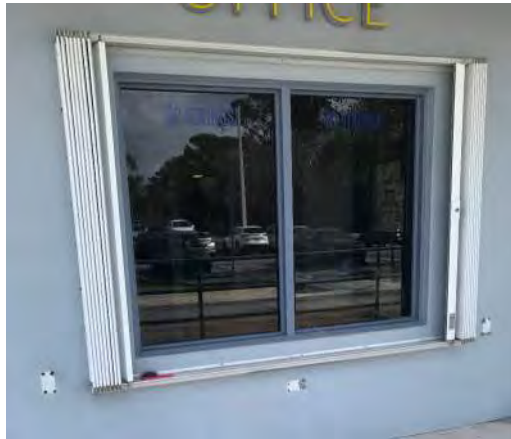
Buildings 2, 3 & 5 Existing Window Does Not Meet FBC Pressure Requirements

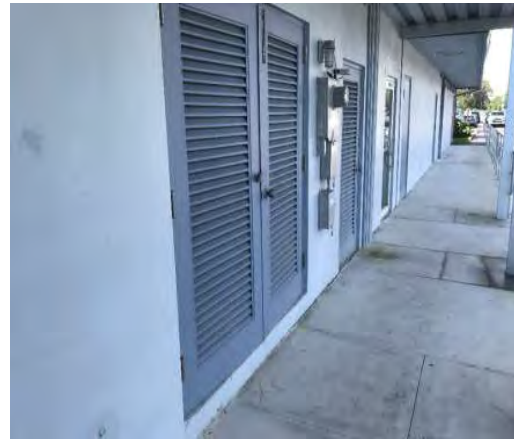
Buildings 2, 3 & 5 Door and Hardware Not ADA Compliant

The door hardware for both exterior and interior doors is not ADA compliant and needs to be brought up to current requirements. This includes levers, hinges, strikes, closers, thresholds, panic hardware and weather proofing. The exterior and interior doors, door frames and interior view panels show wear and the finishes are worn and faded.

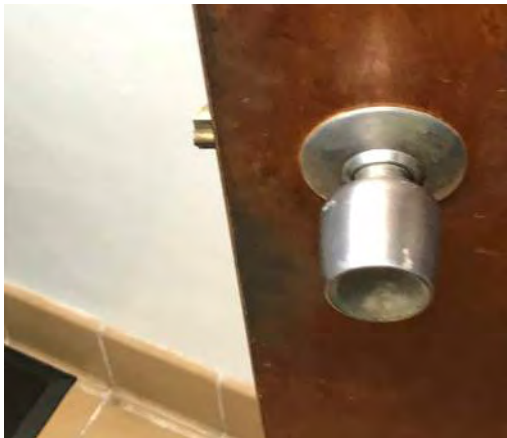
Buildings 2, 3 & 5 Door and Hardware Not ADA Compliant

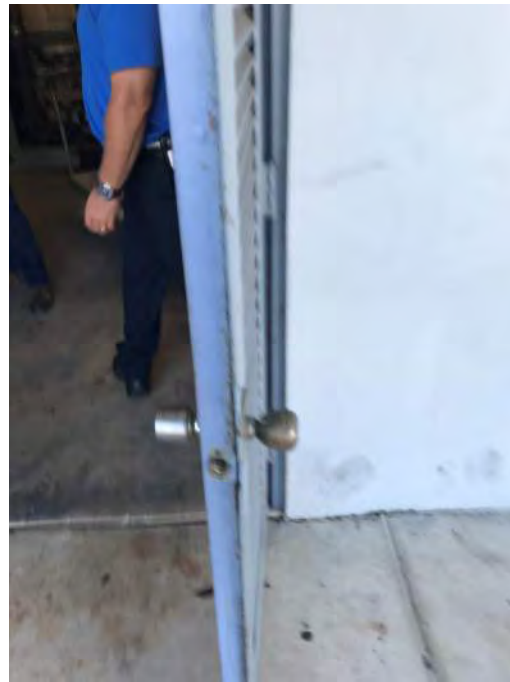
Buildings 2, 3 & 5 Door and Hardware Not ADA Compliant and is Corroded

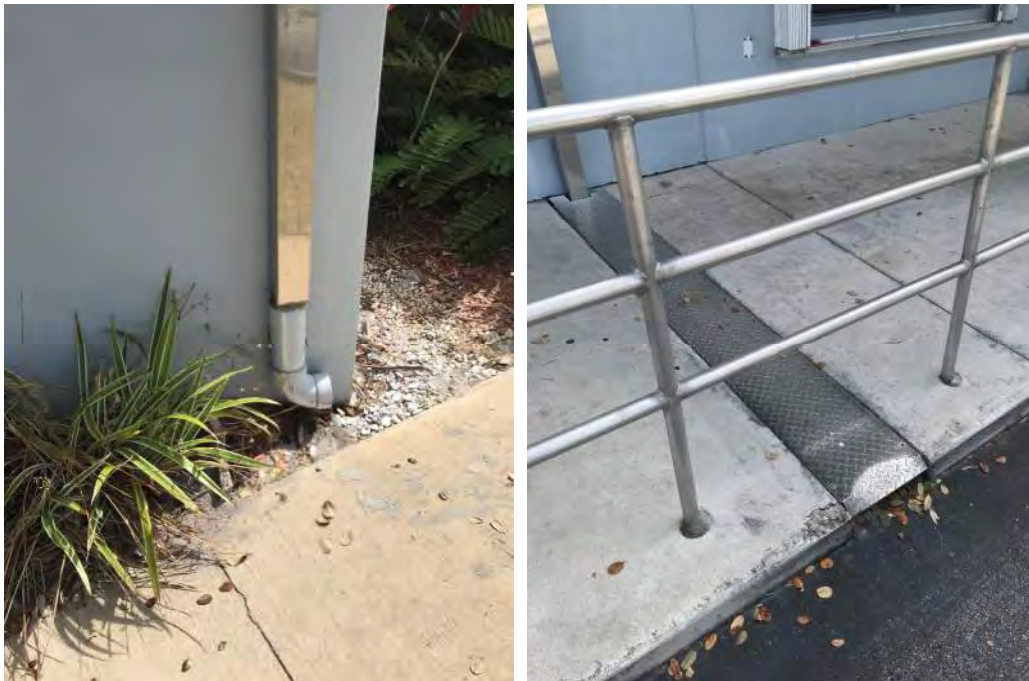
The concrete sidewalks connected with Buildings 2, 3 and 5 need some minor repair. In several place downspout drain directly on them.

Storm Drainage Not Tied in to the Underground Storm Sewer System

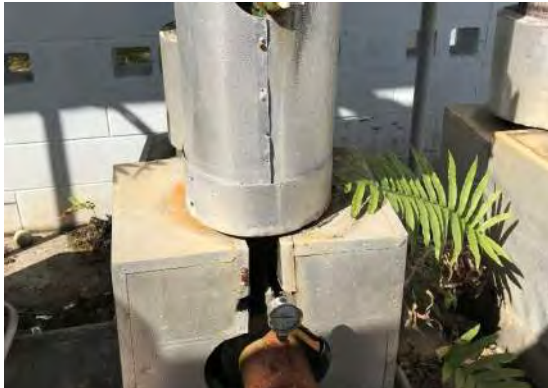
Degraded Insulation

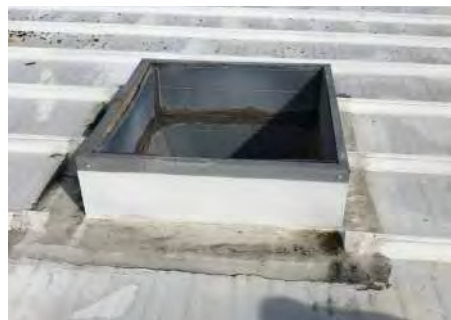
Weather Cover Removed by Irma

Rainwater is likely flowing freely into the unit and draining out via the condensate drain. Unit mixing box access door would not open. Interior condition could not be assessed.

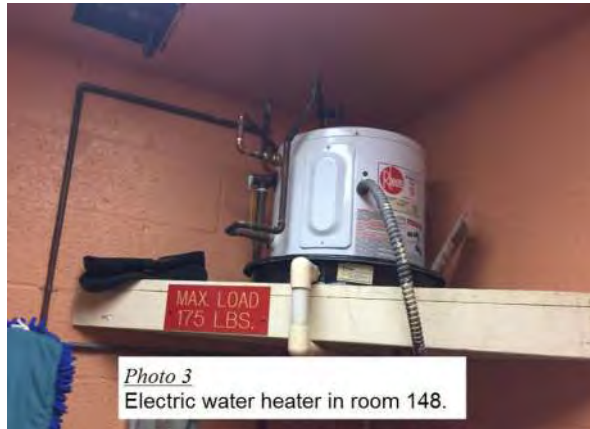
- The water heaters are not piped according to the current plumbing code requirements (see 2017 FPC, sections 502, 503, 504 and, section 607).
- Hot water recirculating system piping does not exist and therefore does not meet the plumbing code requirements, where applicable. (See 2017 FPC section 607.2).

Photo 3
 Electric water heater in room 148.

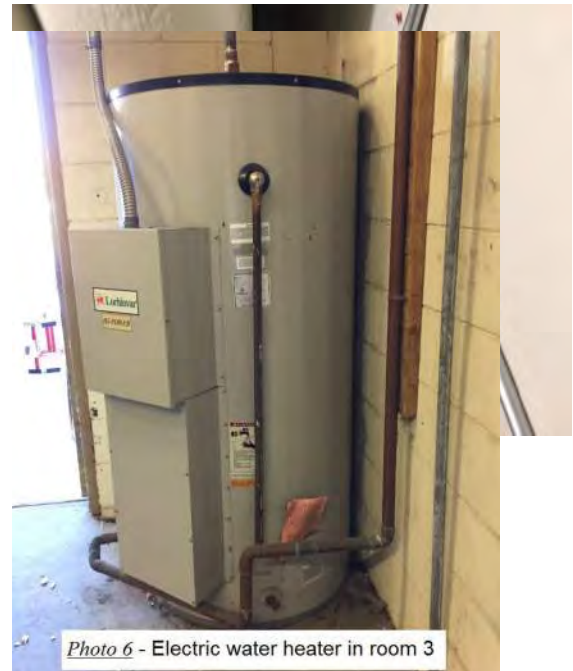
Photo 6 - Electric water heater in room 3

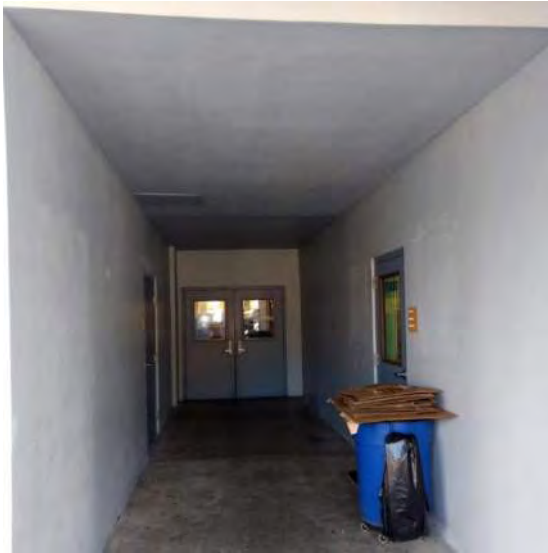
Exterior Lighting Needed

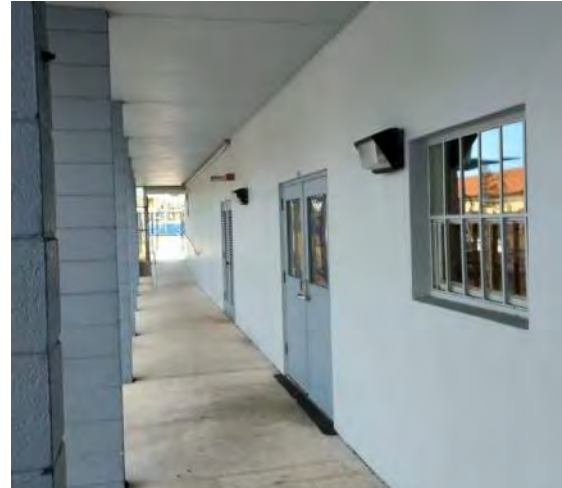
Exterior lighting – Site lights in parking lot and over the cover playground area with Metal halide or High pressure sodium, recommend replacement site lighting looked dated with LED. Exterior wall mounted lights on building face are low hung. Building Engineer reported this is issue for vandals. One exterior corridor has no lighting and this creates a safety

Exterior Lighting Accessible to Vandals

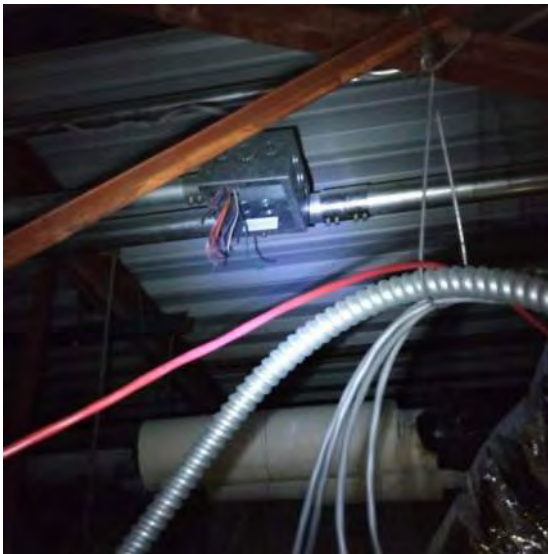
Power Distribution - Panels mixed between Eaton, Culter Hammer, Westinghouse, Federal Pacific, Gould, and Square D. Panels are in rough shape, with rust, latches not latching. Recommend new electrical grid replacement with one vendor for ease of maintenance. All panels look to be fair to poor shape and at end of life. Exposed power distribution wiring was observed above the ceiling.

Exposed Wiring above Ceiling

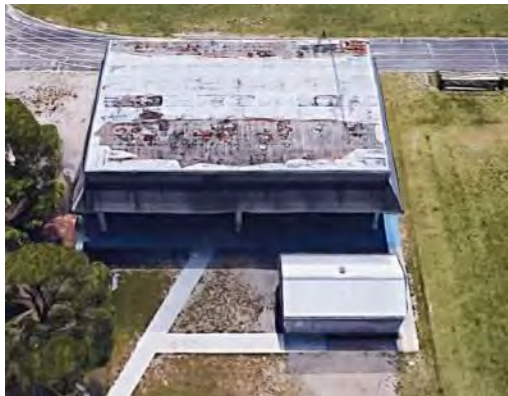
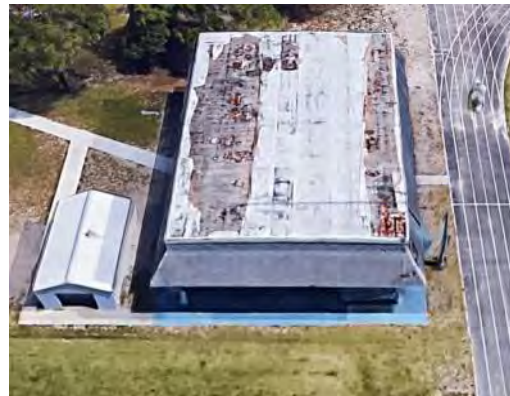
During the onsite review of the existing roof, is a mansard roof with a barrel vault is in extremely poor condition. No as built for this roof replacement were available, but the FISH report note it's date of construction to 1993. The roof in all areas appears to be failing.

Buildings 6 Looking East and North Damaged from Hurricane

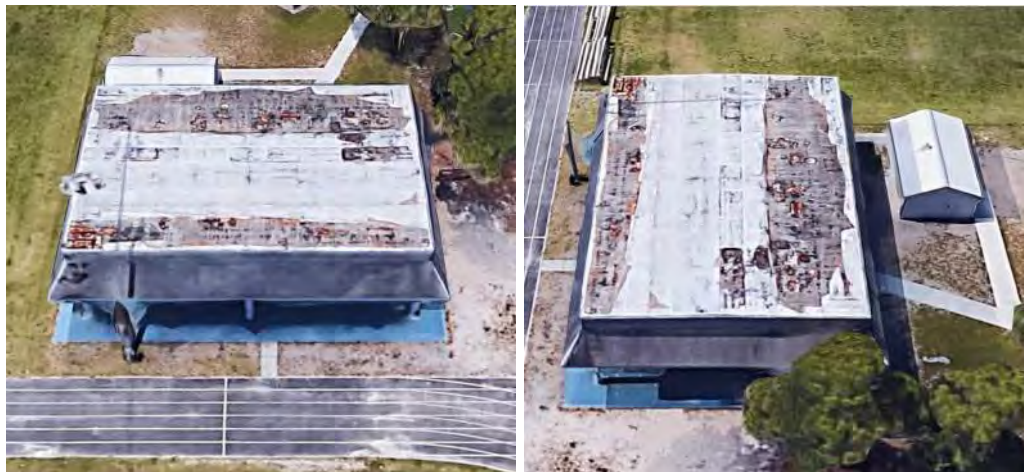
Buildings 6 Looking West and South Damaged from Hurricane

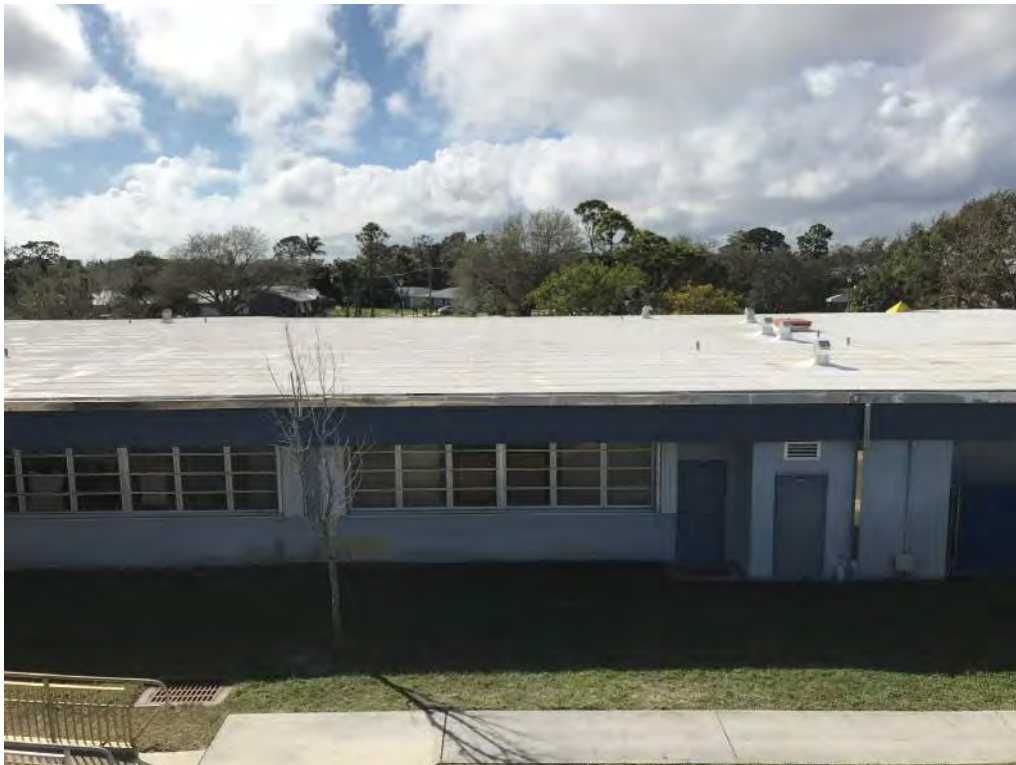
Building 9 Windows & Doors Does Not Meet Current FBC and ADA Requirements

The doors and windows should be replaced. None of the facility was constructed to current wind codes. Especially vulnerable are those parts of the buildings structure around fenestrations. The exterior should have subsurface investigation to determine if reinforcing is required to meet current wind load requirements. Although the exterior of the building finishes refreshing and they would not meet the current FBC requirements and must be “hardened”.

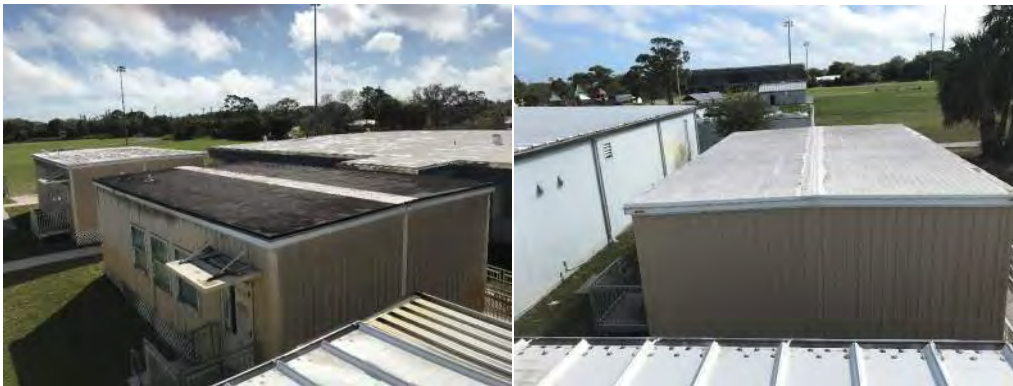
Buildings 99 and 9902 Do Not Meet Current FBC Wind Pressure and ADA Requirements and are in an Extreme Disrepair

1. The portable classrooms appear to need to be removed from campus and replaced with new classrooms in a new facility.

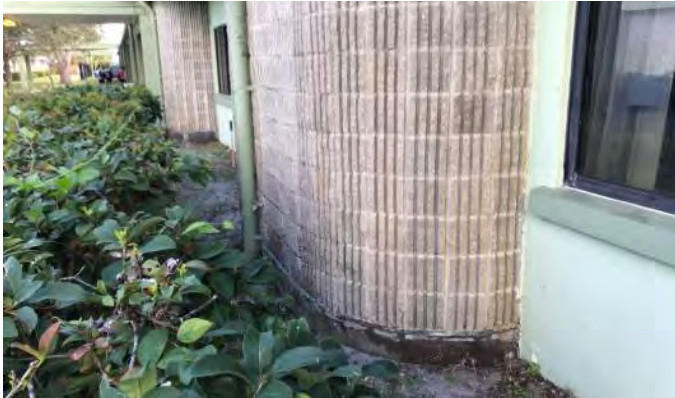
Evidence of water infiltration and the resulting black mold was present on the exterior of this building and most of the buildings. Additional information confirming that water infiltration is occurring in this building's exterior wall is that the steel angle supporting the ribbed CMU veneer located at the base of the wall was extremely corroded and requires replacement. Given the degree of decay of this structural support it is uncertain how long the veneer will remain intact and certainly does not meet the Florida Building Code wind load requirements. The Facility's Maintenance Service Manager showed the Castaldi team a video of an exterior wall being repaired that while filming failed completely and collapsed leaving the interior space of the wall exposed.

Water Infiltration in Exterior Wall and Corrosion of Fluted CMU Masonry Ledge

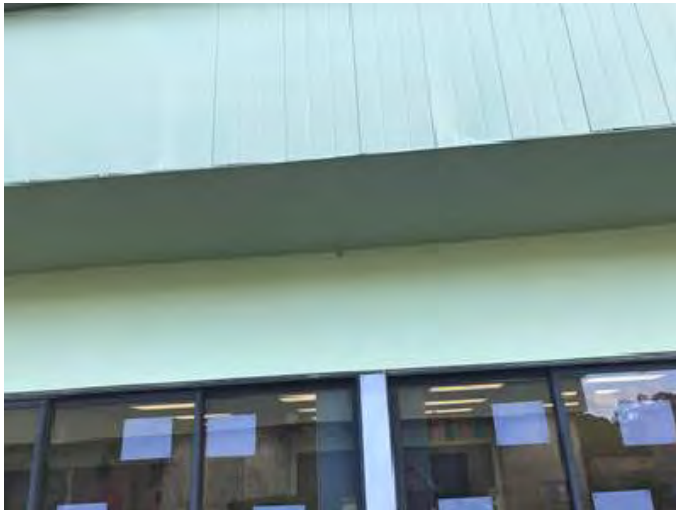
The fascia at the roof edge is failing and has numerous gaps allowing water infiltration.

Fascia Allowing Water Infiltration

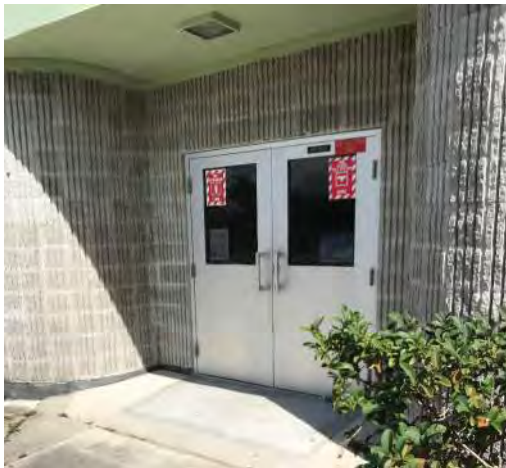
Non-Compliant ADA Hardware

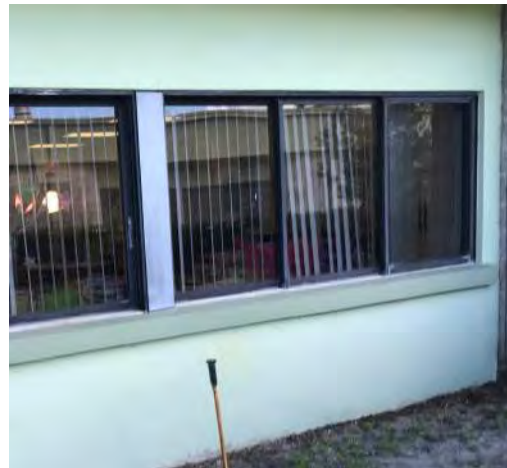
Windows Do Not Meet Current
FBC Pressure Requirements

None of the facility building envelope assemblies and or systems were constructed to current wind codes. Especially vulnerable are those parts of the buildings structure around fenestrations. The exterior CMU should be exposed at every opening, and sufficient reinforcing added along with infill of the CMU cells with concrete.

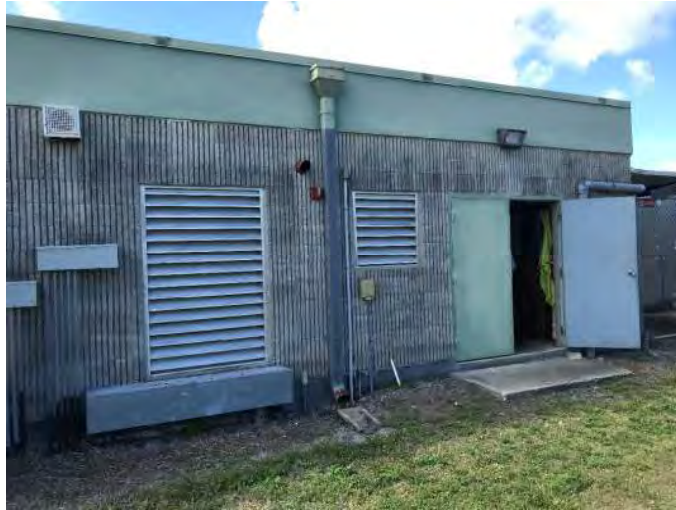
Building 8, Fluted CMU Showing
Mold, Corrosion Occurring to
Louvers and Door & Non-
Compliant ADA Hardware

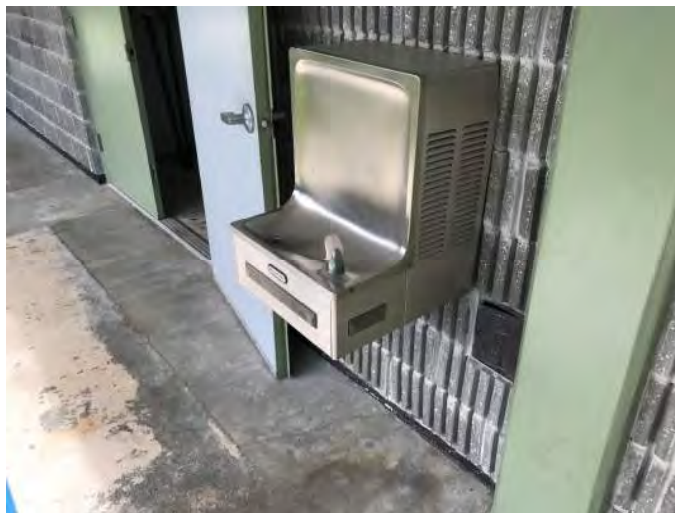
Non-Compliant ADA Drinking
Fountain

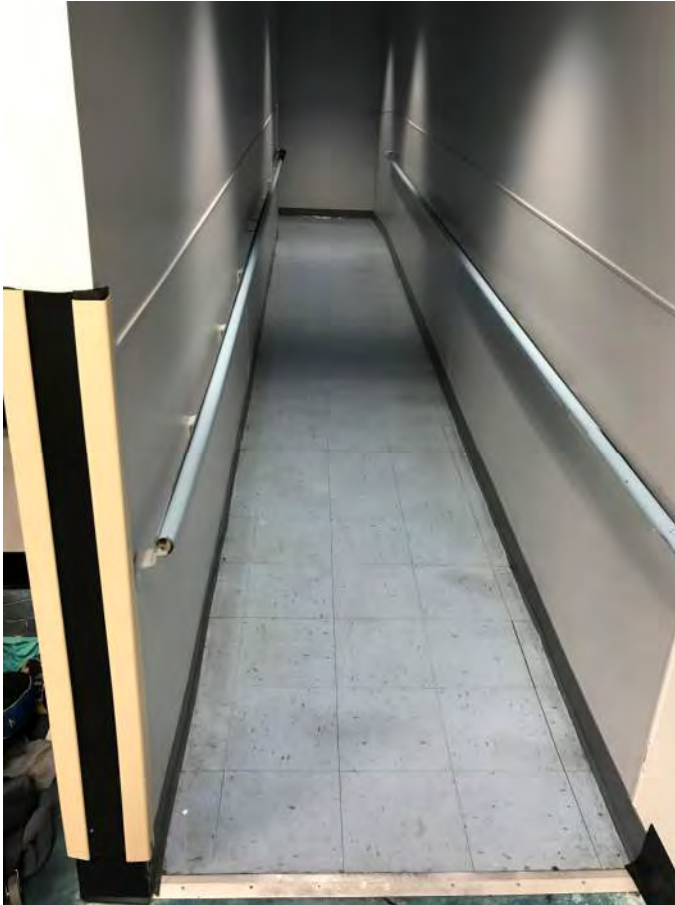
Non-Compliant ADA Handrails and Faded and Damaged Finishes

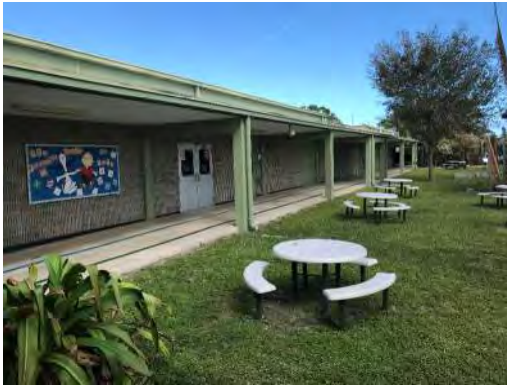
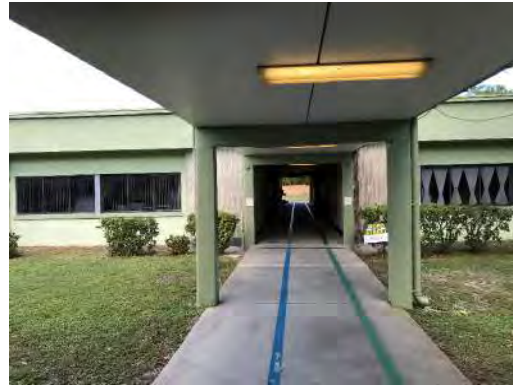
The exterior corridors and covered walkways do not meet current code requirements for light and need to be for safety reasons and vandalism.

Exterior Corridors and Covered Walkways Lighting Do Not Meet Current FBC Requirements,

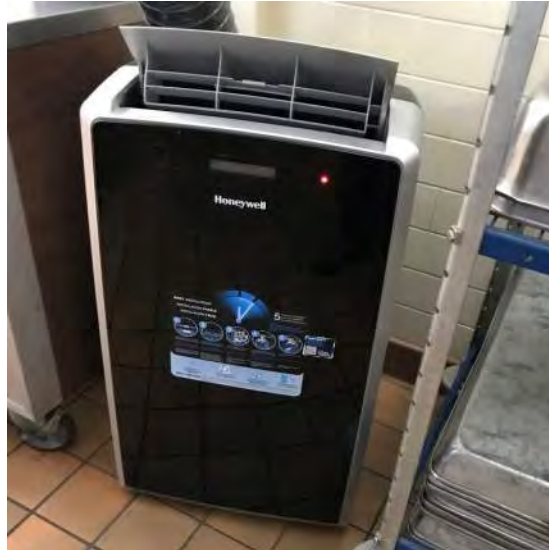
Spot Cooler used in Kitchen

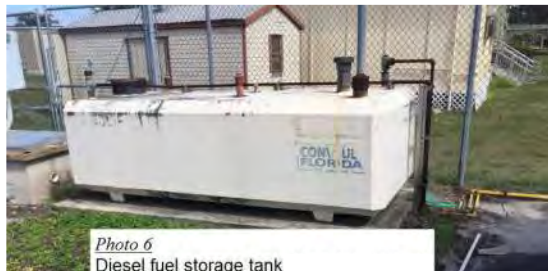
Photo 6
 Diesel fuel storage tank

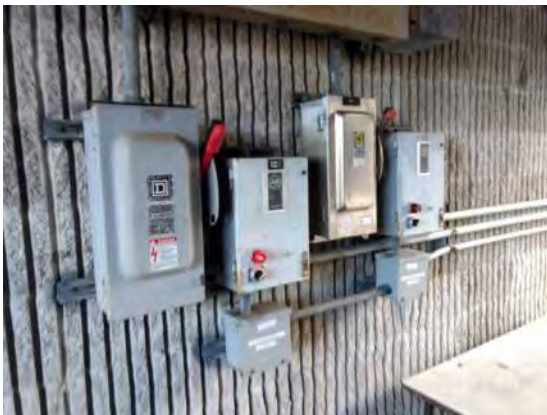
Mix of Manufacturers

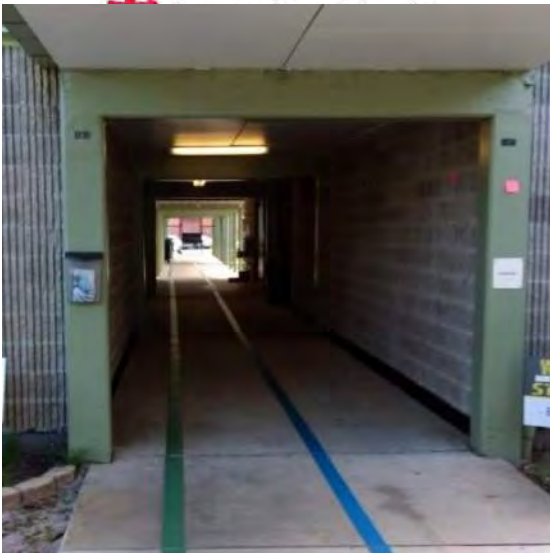
Insufficient Exterior Corridor Lighting

building and from the roof. Recommend adding site lighting for safety to both front drop off and bus drop off. Recommend rewiring exterior lighting controls for better control and energy savings. Will require additional lighting in spaces to meet minimum foot candle levels.
