Structural Condition Assessment Report

Harborwalk Timber Boardwalk and Floating Docks

September 28, 2023

Prepared for:
City of Georgetown, SC

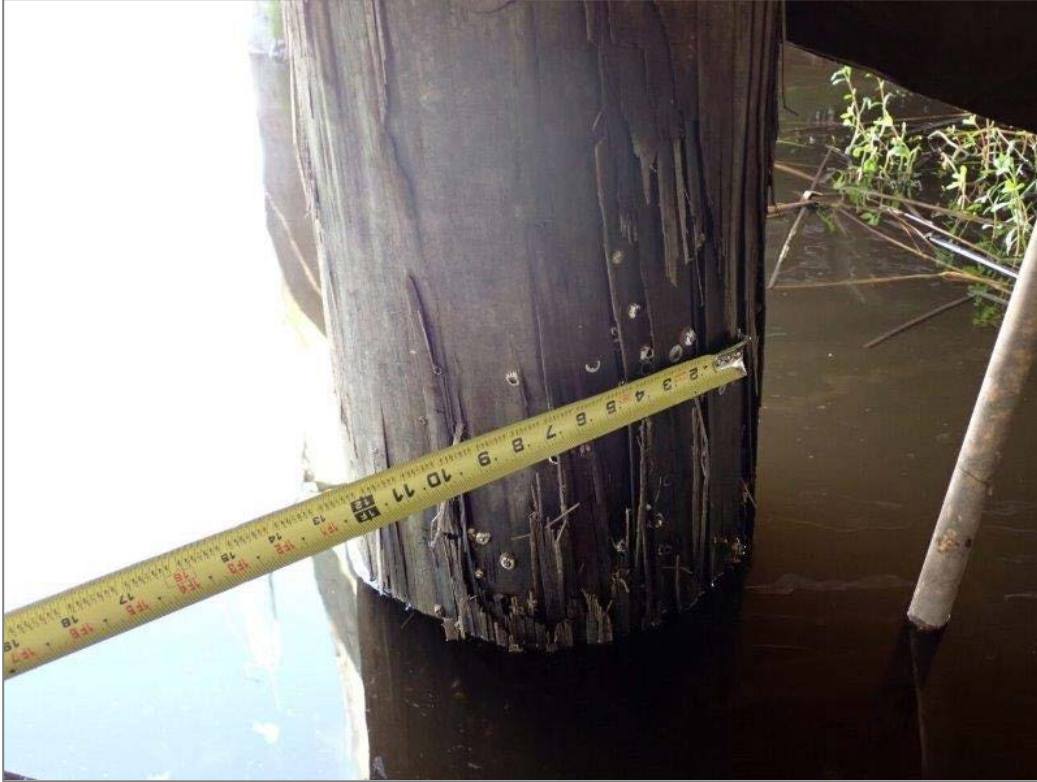
1. Timber Piles- approximately 90 percent of piles exhibited rot and/or fungal decay with less than 5 percent section loss in Minor Condition (Photograph 1). Approximately 10 percent of the piles exhibited marine borer activity near/below the low-water line. Moderate Condition

Photo 1: Pile – Minor Rot or Fungal Decay

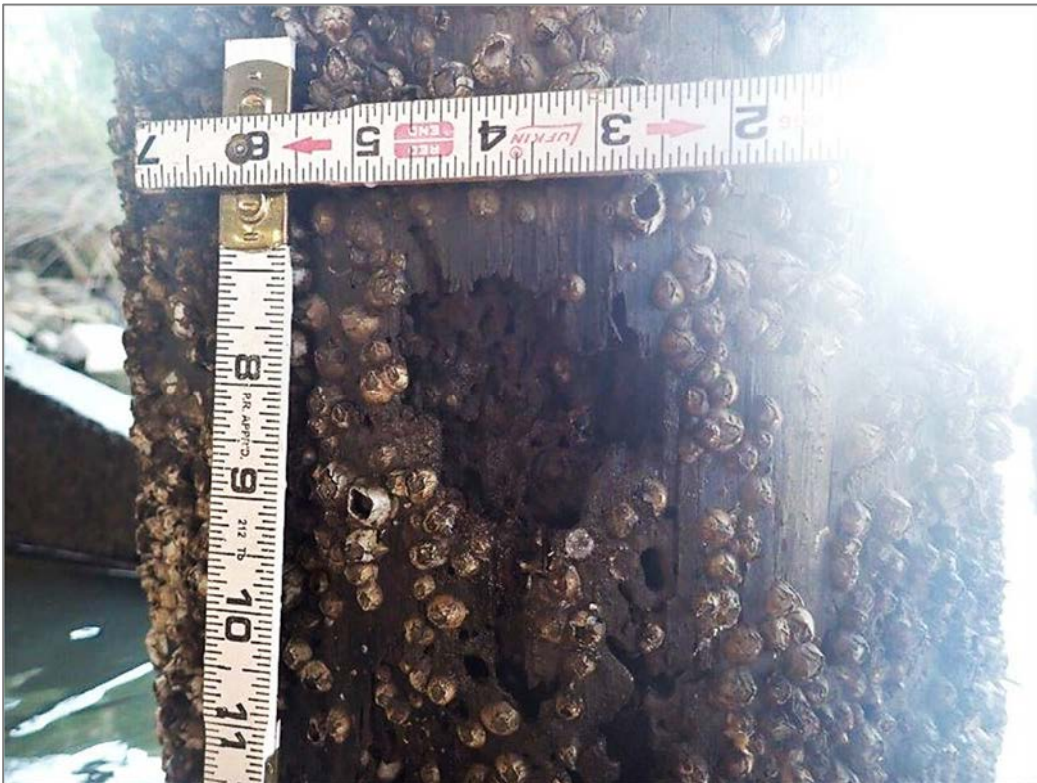
marine borer activity was typically localized to a quadrant of the pile and estimated maximum section loss of approximately 15 percent (Photo 2). With the exception of the piles with observed marine borer activity, the wood treatment appears to be functioning.

Photo 2: Pile – Moderate Marine Borer Activity

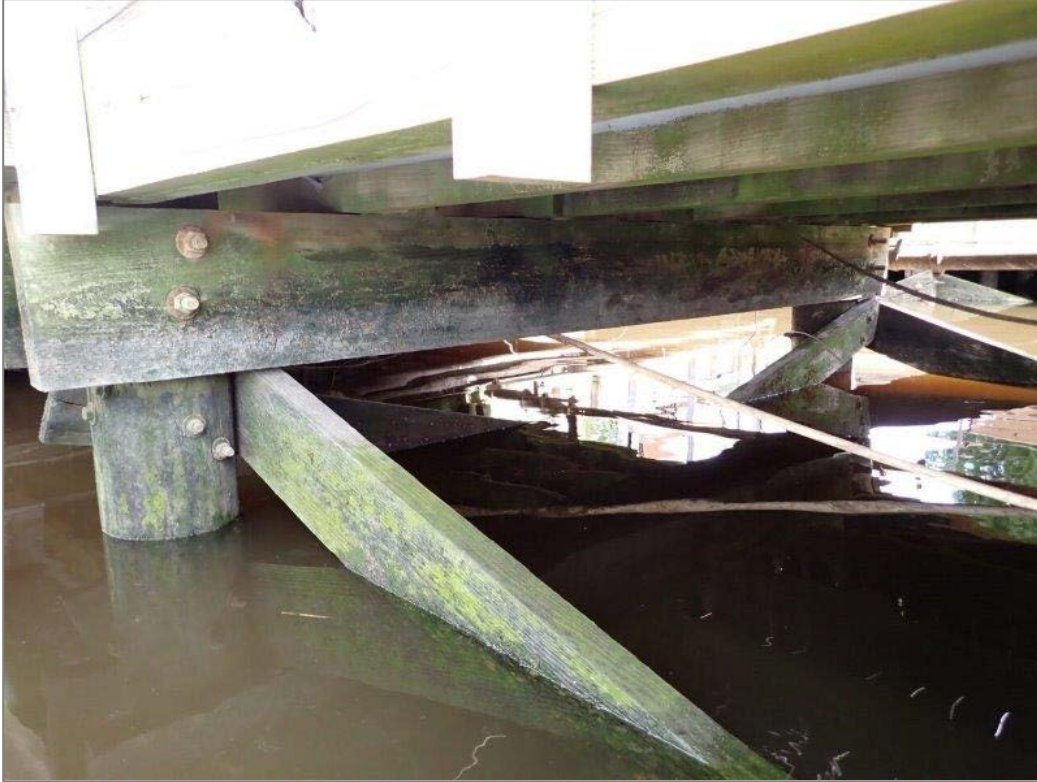
2. Split Cap/Pile Cap- Approximately 95 percent of the caps were in Minor Condition: all exhibited rot and/or fungal decay with negligible section loss (Photograph 3). Approximately 50 percent of the caps also exhibited minor checking less than 1/8 in. wide that had not penetrated through the entire member cross section. The remaining 5 percent were in Major Condition with splits that penetrated the full width of the member and extended up to its full length. The caps rated in Major Condition are outlined in Section 2.2.2.

Photo 3: Cap – Minor Rot or Fungal Decay

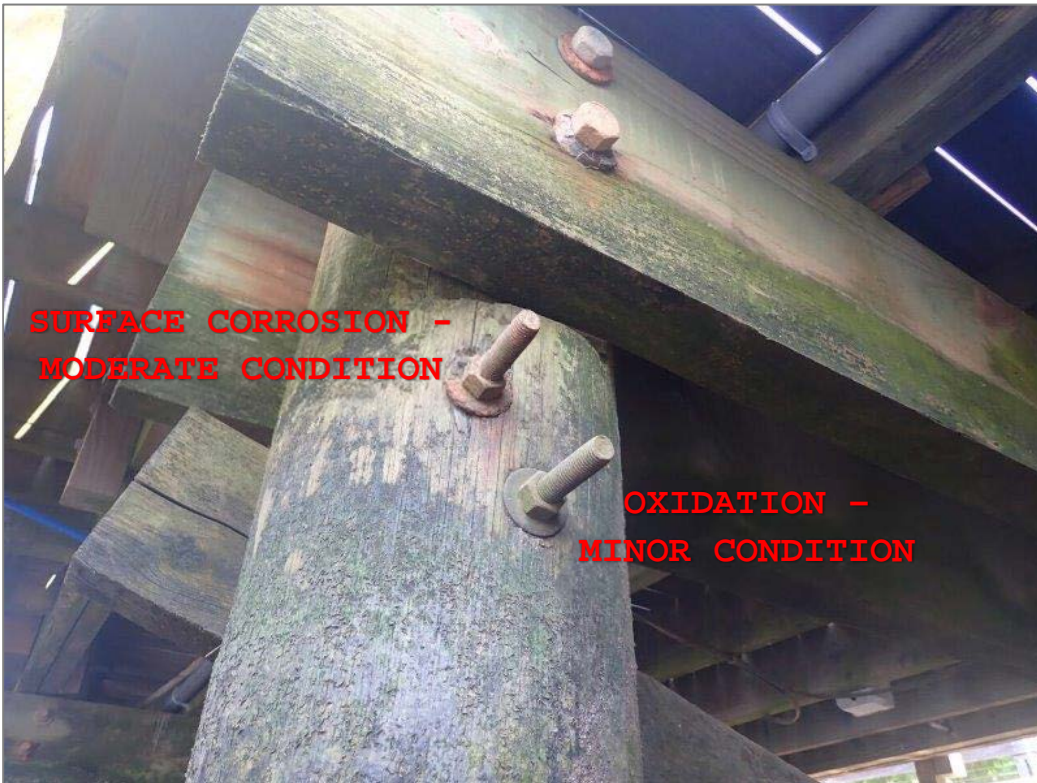
3. Connection Hardware- Approximately 75 percent of the connection hardware was in Minor Condition with surface rust and oxidation of the galvanized coating (Photograph 4). Approximately 20 percent of the connection hardware was in Moderate Condition with pitting and flaking corrosion that was typically localized to the washer and bolt (Photograph 5). The remaining 5 percent was in Major Condition with 25-to-50 percent section loss (Photograph 6); the significantly corroded hardware was typically located within the tidal/splash zone and was connecting cross bracing to piles (not a primary structural connection).

Photo 4: Hardware – Minor Surface Corrosion

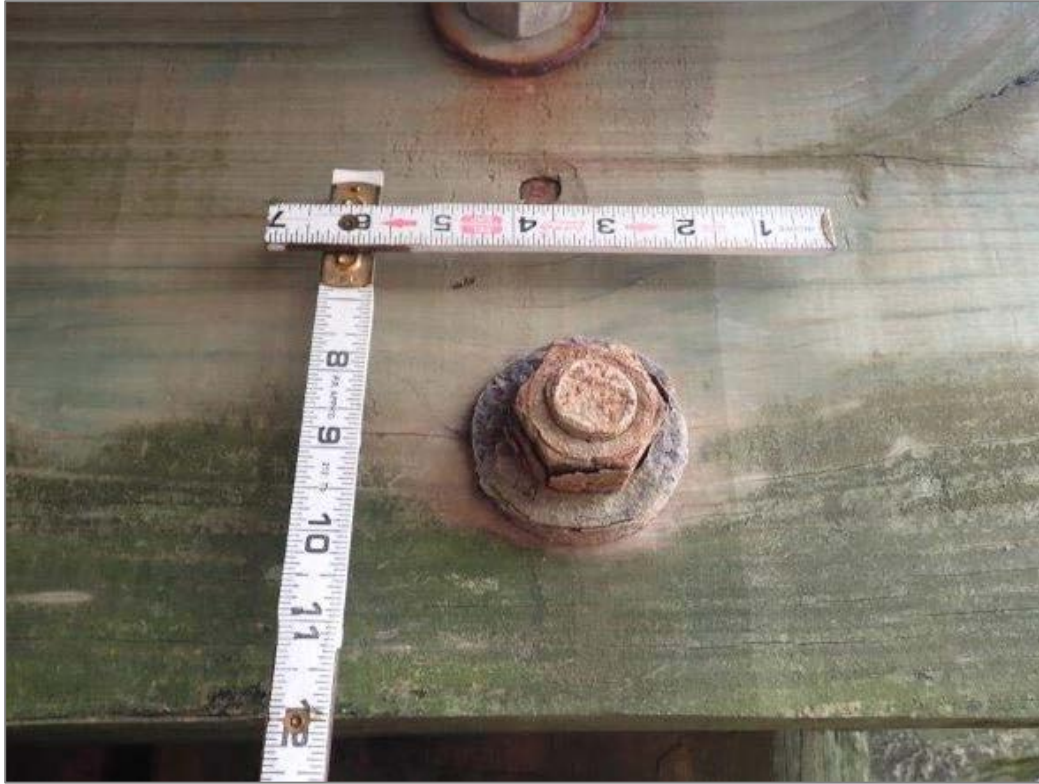
Photo 5: Hardware – Moderate Flaking Corrosion

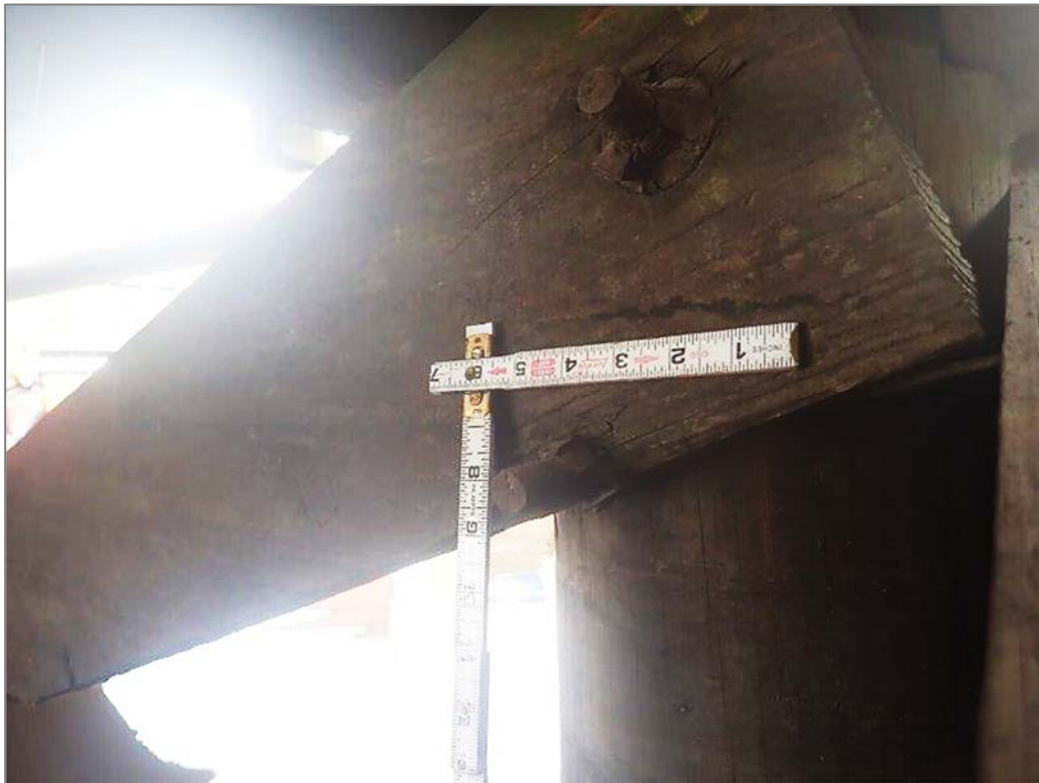
Photo 6: Hardware – Major Corrosion with Section Loss

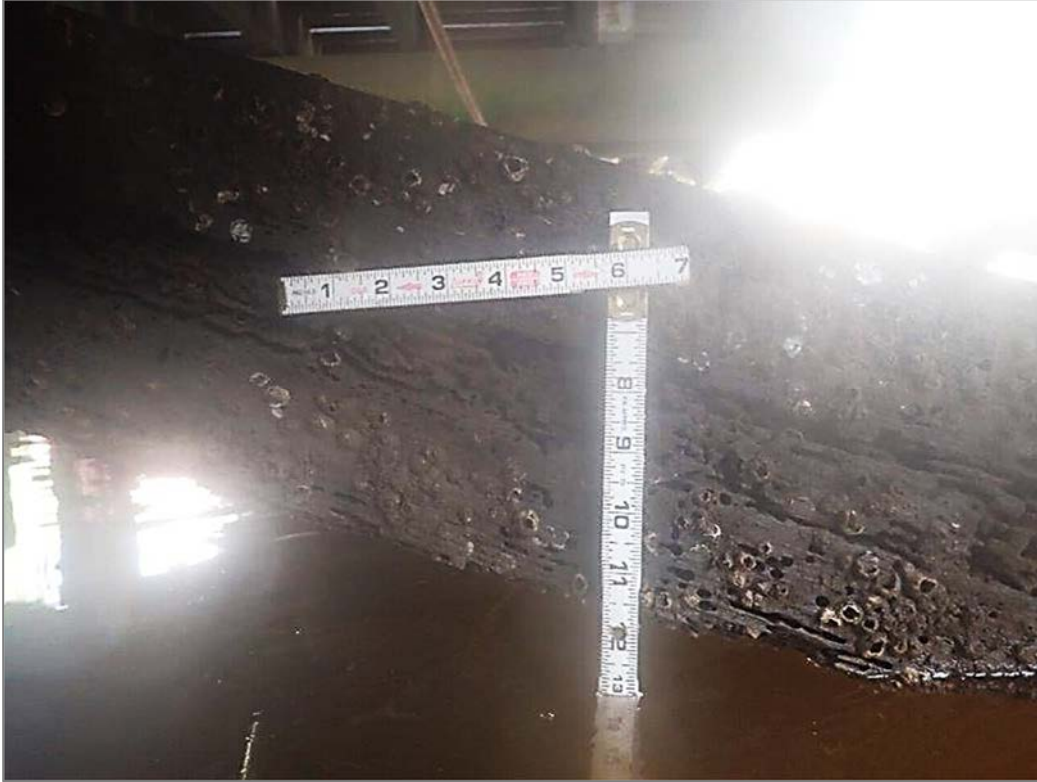
4. Cross Bracing- Approximately 20 percent of the braces were observed to have marine borer activity with section loss up to 25-to-50 percent of the cross section in Major Condition (Photograph ~~PHOTO~~ 7). The remaining 80 percent exhibited rot and/or fungal decay primarily within the tidal/splash zone; approximately 5-to-10 percent section loss in Moderate Condition was typically observed in this zone (Photograph 8).

Photo 7: Cross Bracing – Major Marine Borer Activity

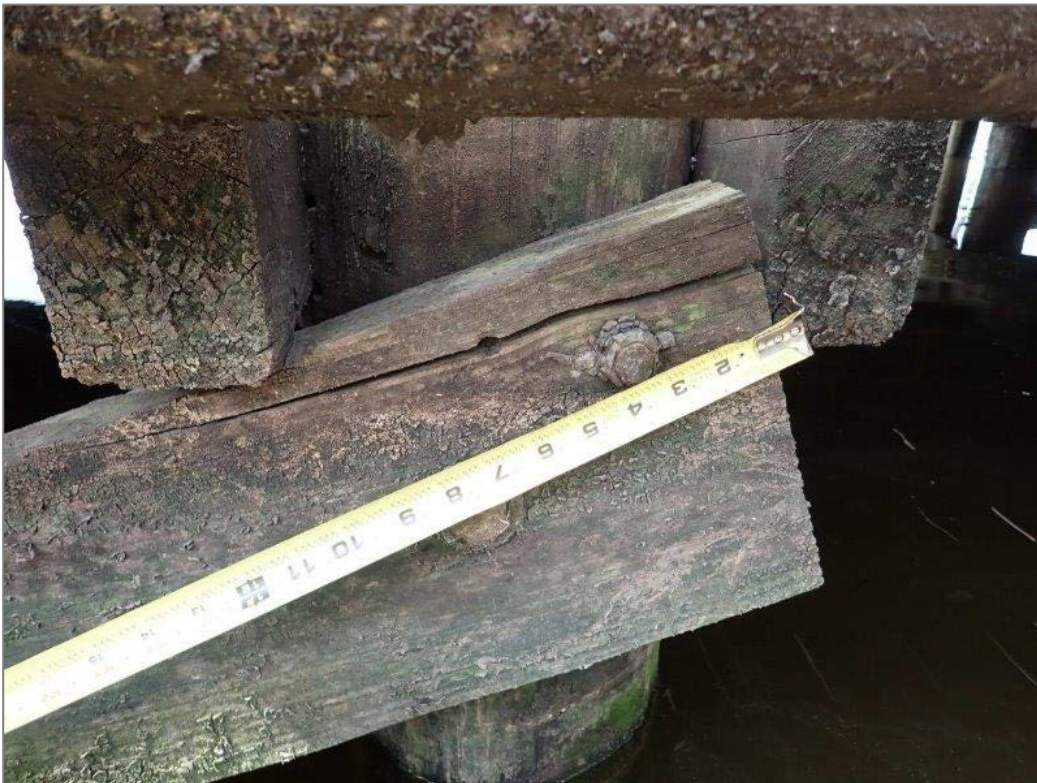
Photo 8: Cross Brace – Moderate Decay or Fungal Rot

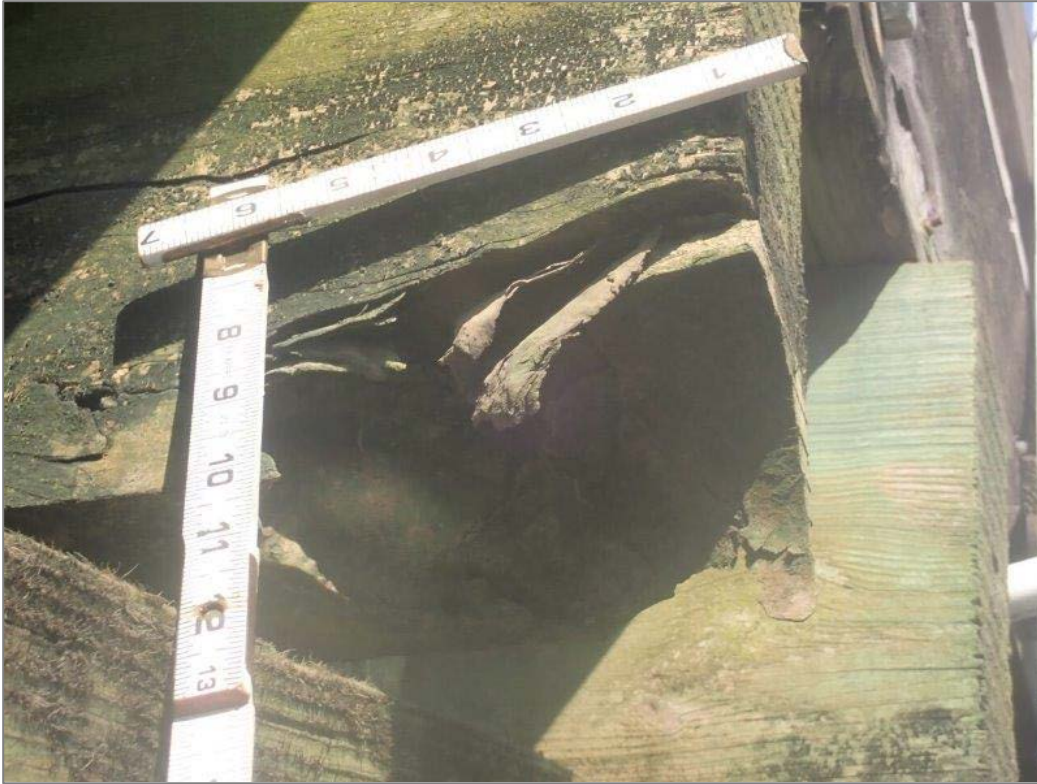
ELEMENT	DEFECT	DIMENSION	STATION	RATING
Cap	Shake with Associated Area of Section Loss	4 in wide by 6 in long by full member width	0+90	Major (Photograph 9)
Cross Bracing	Split	1/8 in wide by 10 in long by full member width	2+50	Major (Photograph 10)
Cap	Split	1/2 in wide by full length of member by full member width	2+66	Major (Photograph 11)
Cap	Split	1/8 in wide by 24 in long by full member width	6+52	Major (Photograph 12)
Cap	Split	1/8-in wide by 16-in long by full member width	9+26	Major (Photograph 13)
Cross Bracing	Decay at Connection	100 percent loss of section	12+40	Severe (Photograph 14)

Photo 9: Cap – Major Full Width Split/Shake with Area of Associated Section Loss, Station 0+90

- Pile Caps – Repair the deficient split caps listed in Table 1. Splitting in the caps with minor and moderate ratings should be monitored on a two-year above-water inspection cycle.
- Cross Bracing – Repair deficient cross bracing and cross bracing connections at Station 12+40.

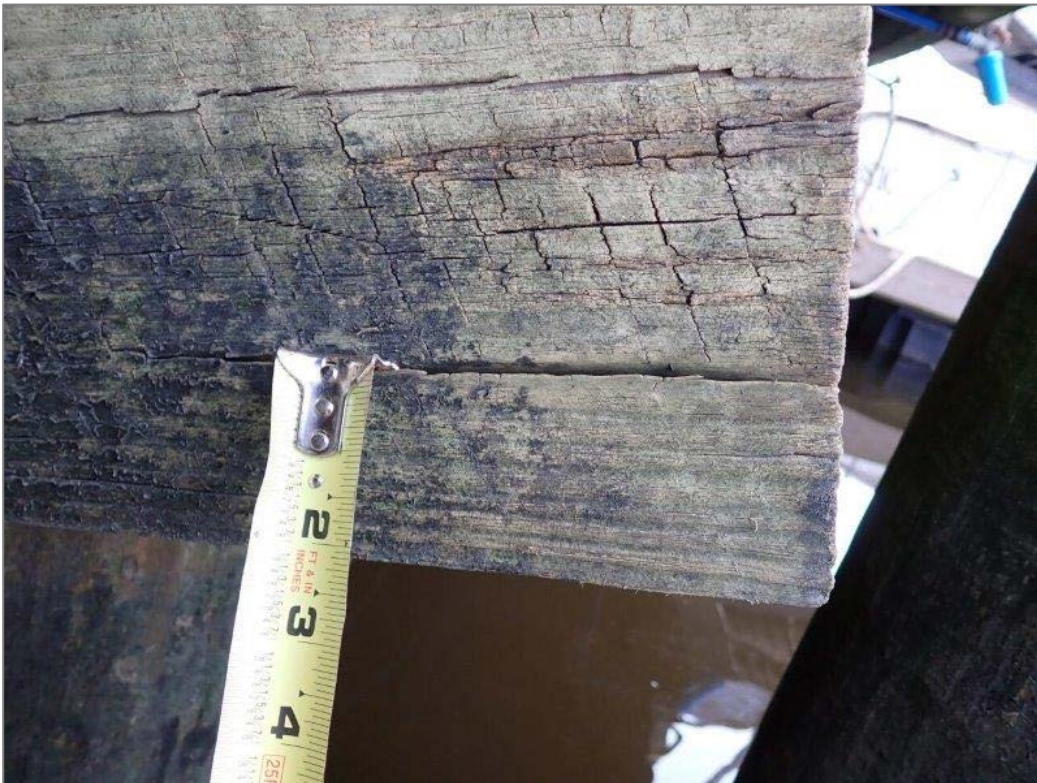
Photo 10: Cross Bracing – Major Full Width Split, Station 2+50

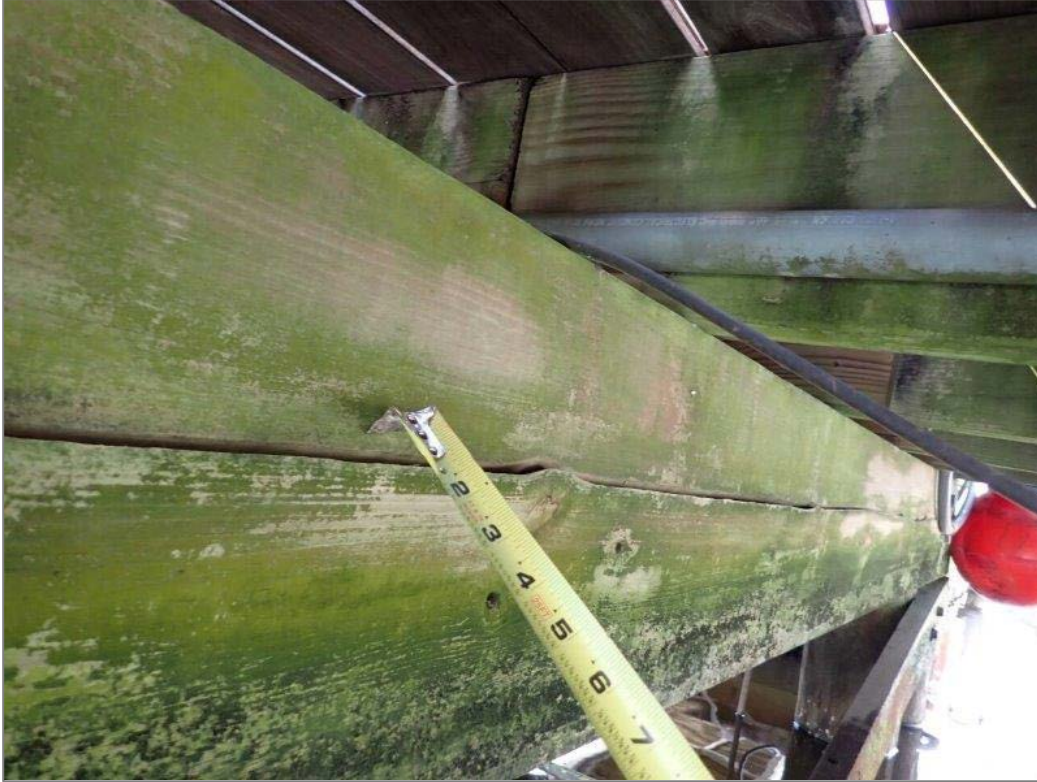
Photo 11: Cap – Major Full Width Split, Station 2+66

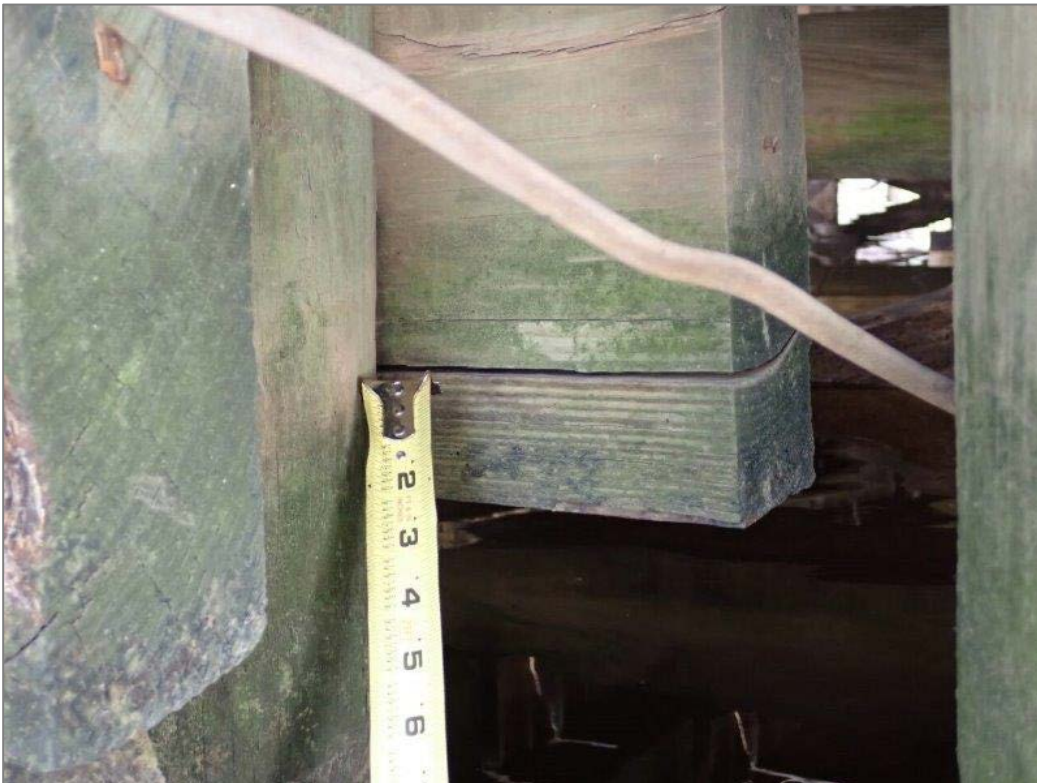
Photo 12: Cap – Major Full Width Split, Station 6+52

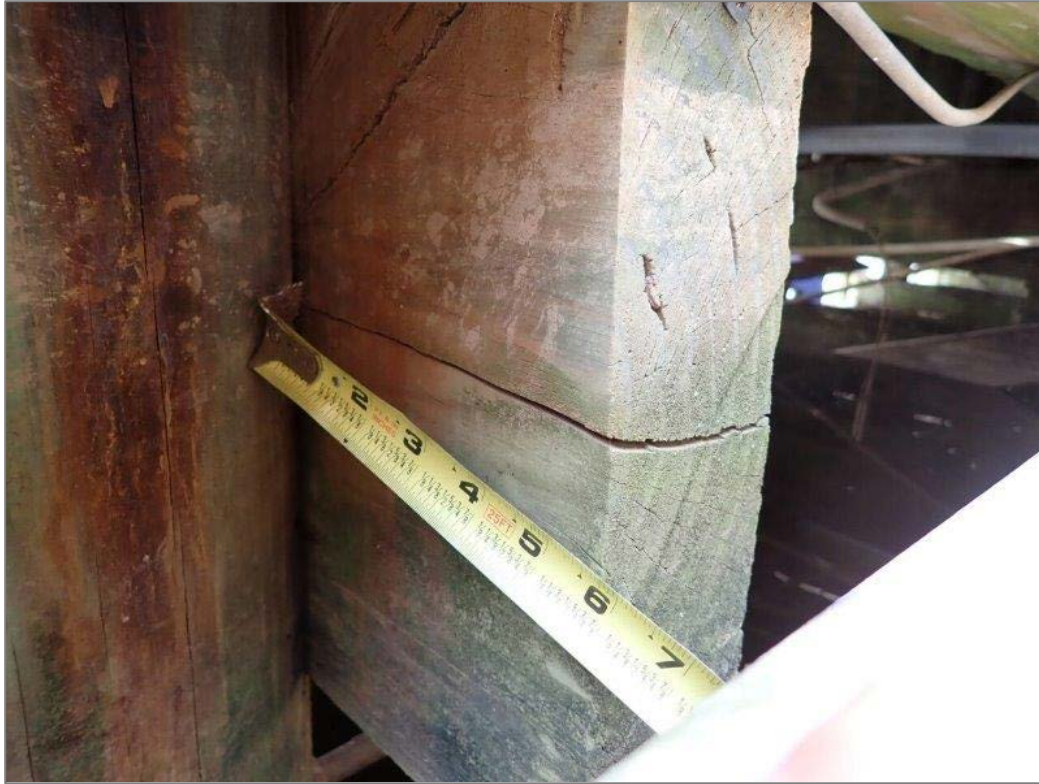
Photo13: Cap – Major Full Width Split, Station 9+26

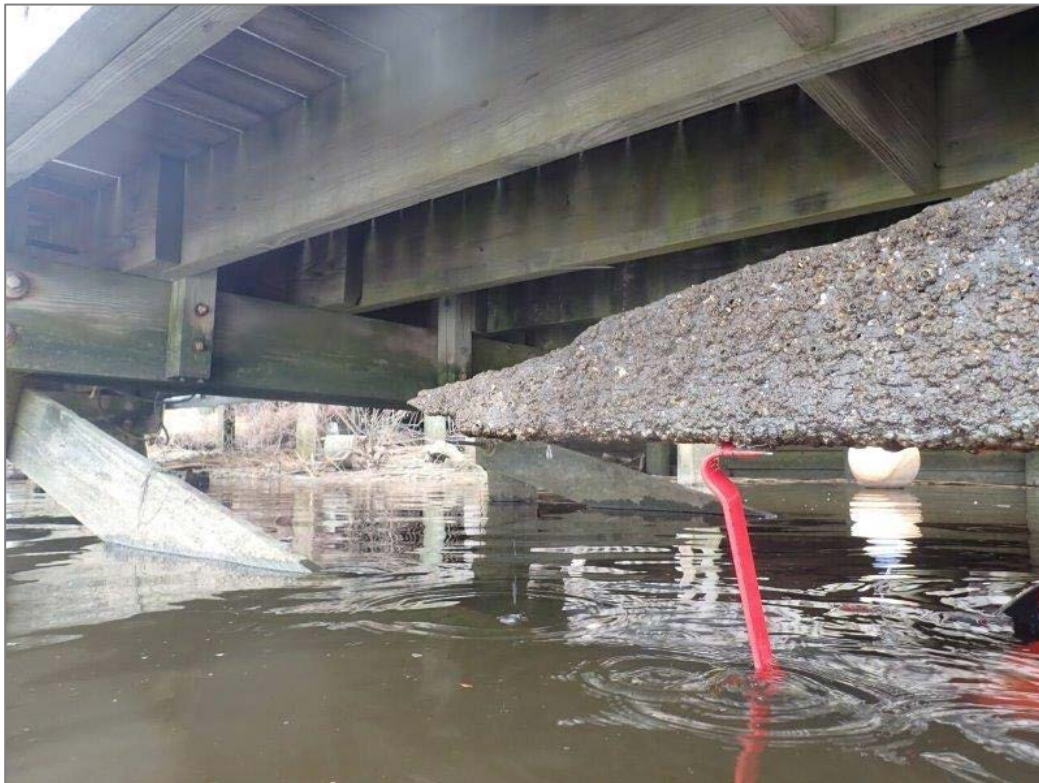
Photo 14: Cross Bracing – Severe Decay with 100 Percent Loss of Section, Station 12+40

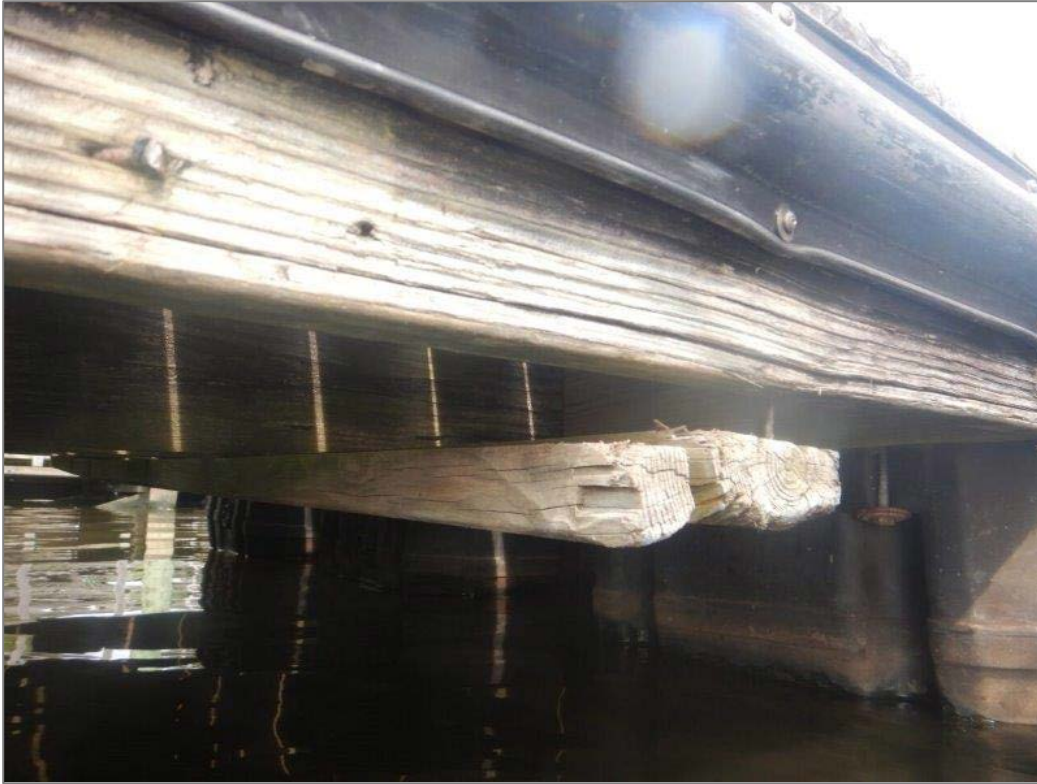
Photo 15: Floating Dock Frame – Minor Checking and Connection Hardware Failure, Screven St. Floating Dock

- Timber Piles – The missing steel cable retainers should be replaced at the East floating dock.
- Timber Frames – the isolated timber frame connection failures on the underside of both floating docks should be repaired.

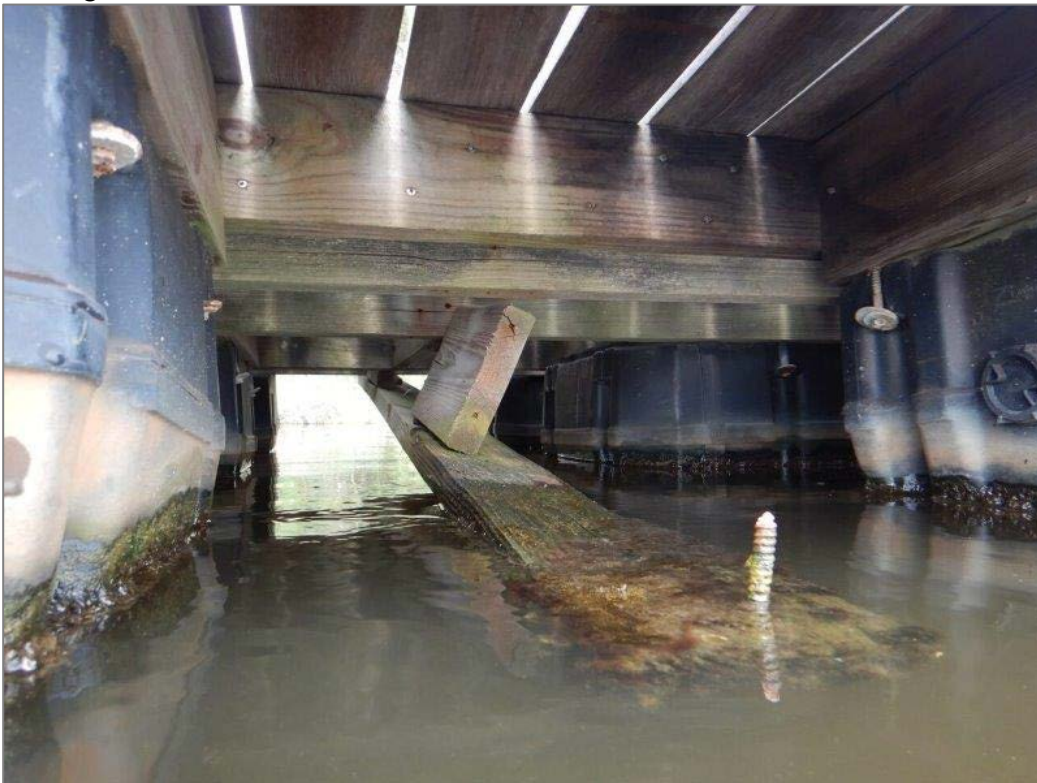
Photo 16: Floating Dock Frame – Connection Failure, Screven St. Floating Dock

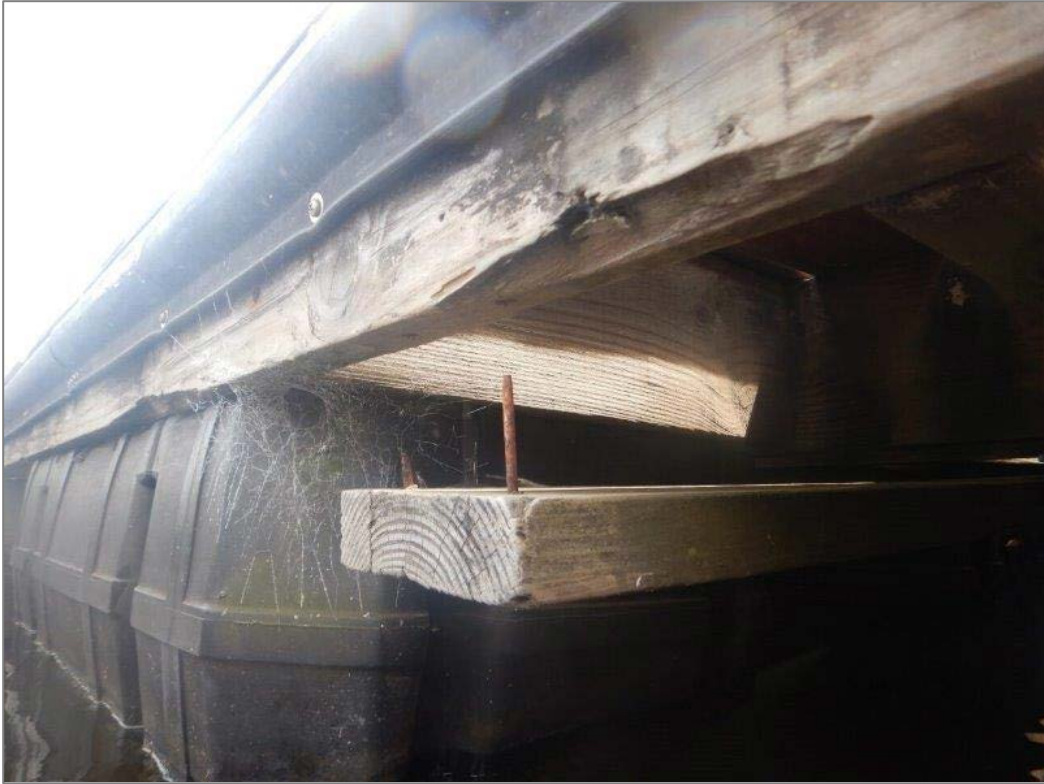
Photo 17: Floating Dock Frame – Connection Failure, Broad St. Floating Dock
