Asbestos & Lead Based Paint Assessment

City of Spartanburg
369 Farley Street
Spartanburg, South Carolina

Project Number: 0815-163

April 7, 2017

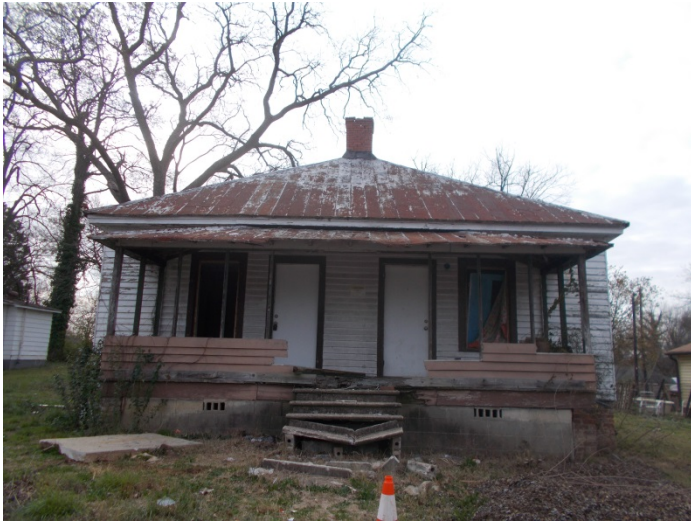
Photo 1 -- 369 Farley Street in Spartanburg, SC.

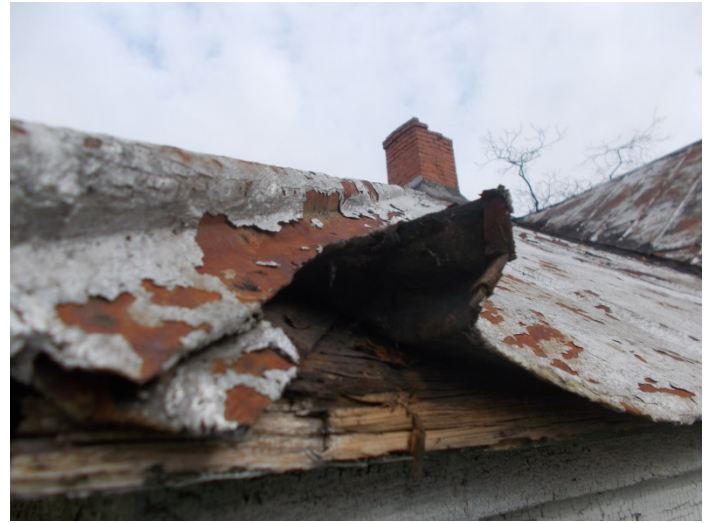
Photo 2 – Silver and black metal roof sealant.

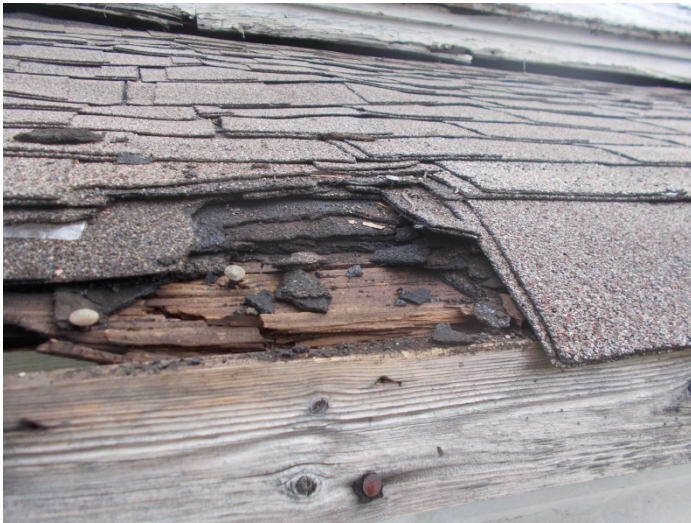
Photo 3 – Roof shingles (6 layers) and no felt.

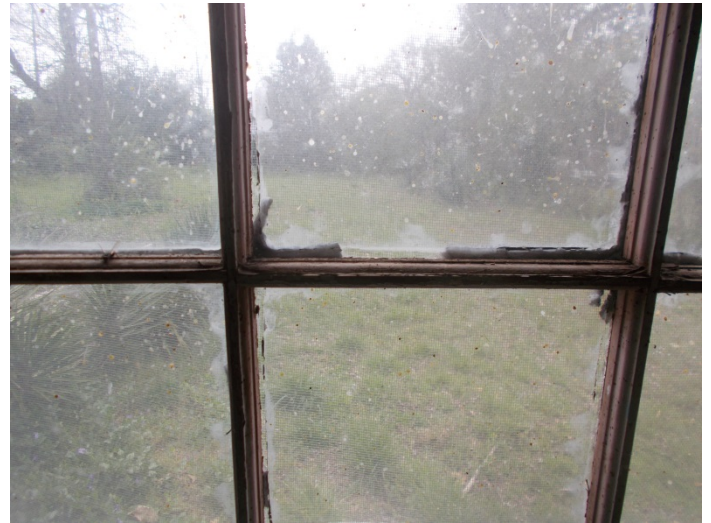
Photo 4 – Wooden window glazing.

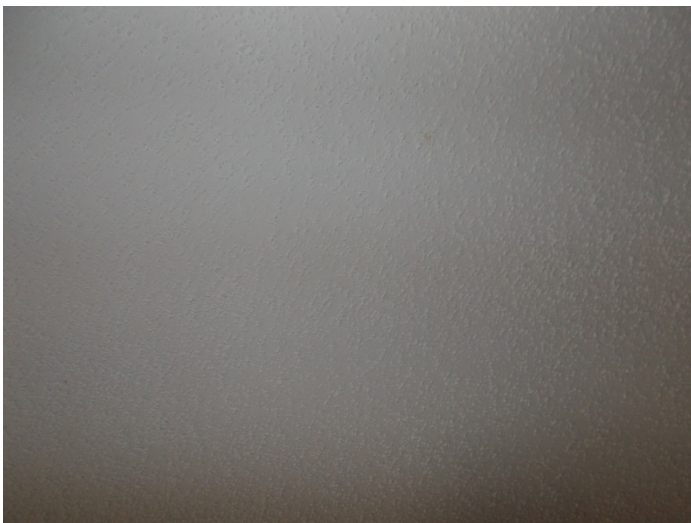
Photo 5 – Popcorn ceiling texture throughout.

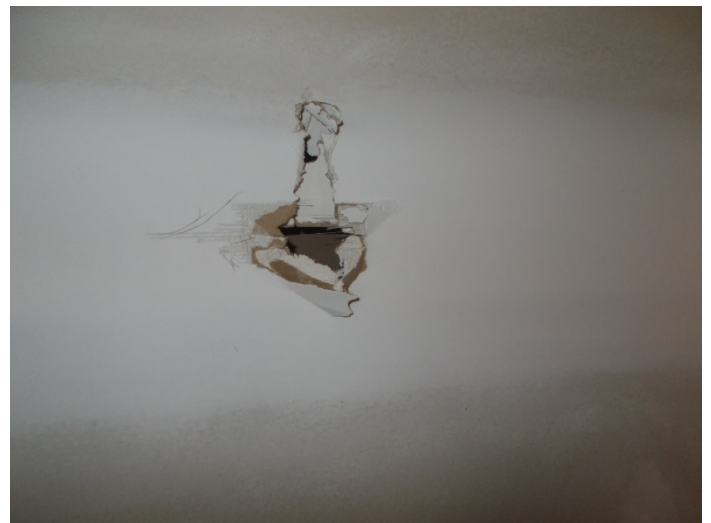
Photo 6 – Drywall with joint compound and tape.

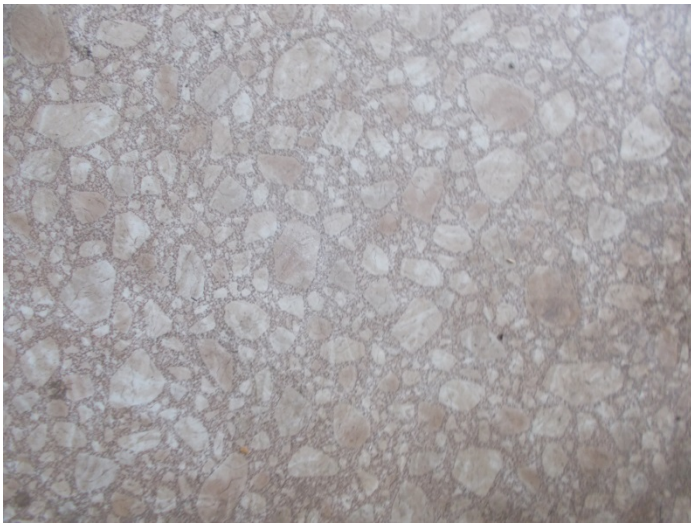
Photo 7 – Rock pattern vinyl floor with no mastic.

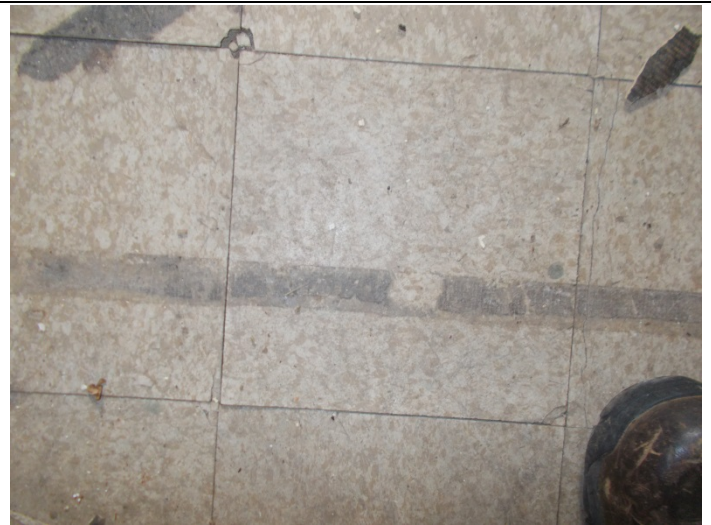
Photo 8 – 9"x9" beige speckled pattern vinyl floor tile with mastic.

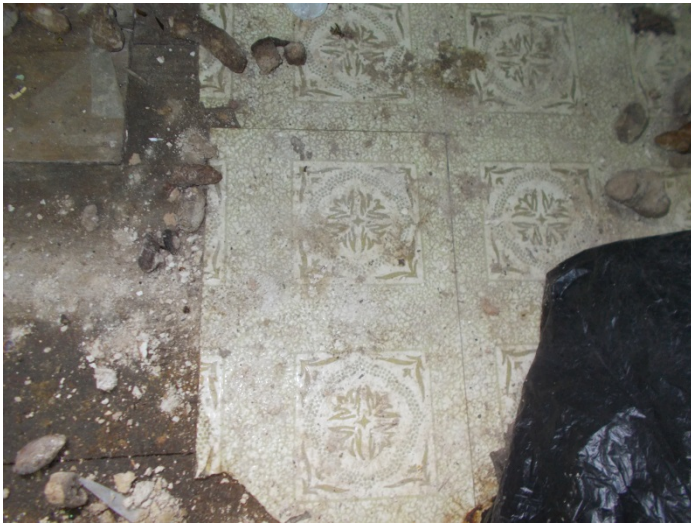
Photo 9 – 12"x12" sand dollar pattern self-stick floor tile.

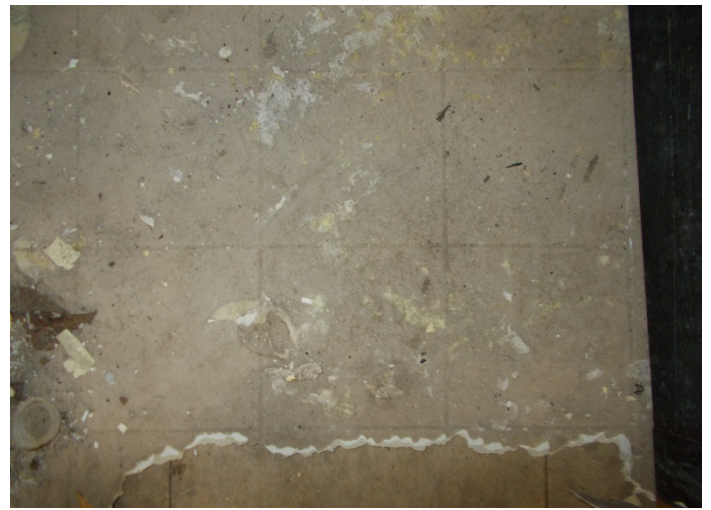
Photo 10 – Cream square pattern vinyl floor with no mastic.

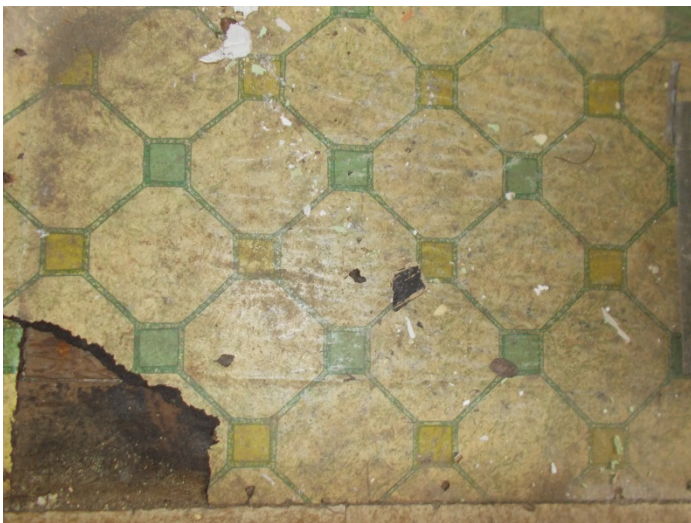
Photo 11 – Yellow/Green pattern vinyl floor with mastic.

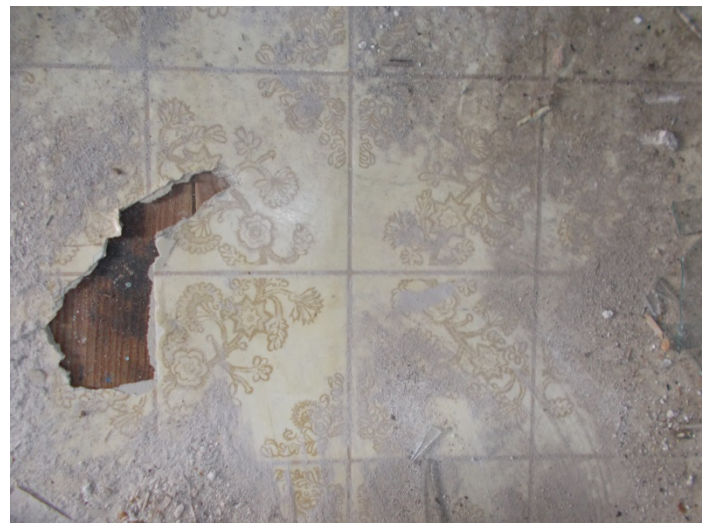
Photo 12 – Tan square flower pattern vinyl floor with no mastic.
