PRE-DEMOLITION ASBESTOS CONTAINING MATERIALS SURVEY REPORT

St. James Baptist Church
329 New York Avenue
Spartanburg, South Carolina 29304

ISSUE DATE: September 20, 2017

F&R PROJECT NUMBER: 65V-0090

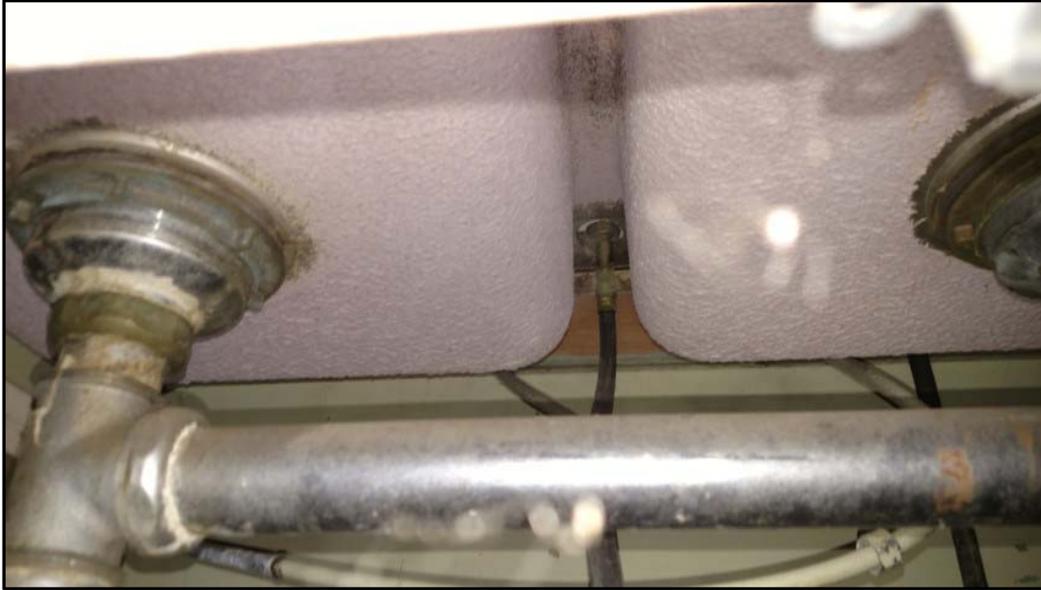
The identified asbestos containing materials (ACMs) include the gray coating located on the bottom of the sink in the kitchen area on the basement level of the building and joint compound located on wallboard covered walls and ceilings in select areas throughout the building. F&R notes that wallboard covered walls in the kitchen area on the basement level are unfinished and joint compound was not observed on these walls.

Photograph 3: View of gray coating located on the bottom of the kitchen sink. The sink coating contains **8% Chrysotile**.

Prior to demolition activities, F&R recommends that all identified ACMs be appropriately removed, handled, and disposed of by a South Carolina licensed Abatement Contractor utilizing appropriately accredited personnel. F&R further recommends that an asbestos abatement specification, should these materials be removed, be developed and incorporated into the overall project prior to the commencement of demolition activities. Asbestos abatement specifications define the Abatement Contractor's scope of work and outline the requirements and procedures that must be followed during the course of the Project. The intent of the asbestos abatement specification is to give performance requirements for the Abatement Contractor so that the Project can be completed safely and in compliance with all applicable federal, state, and local regulations.

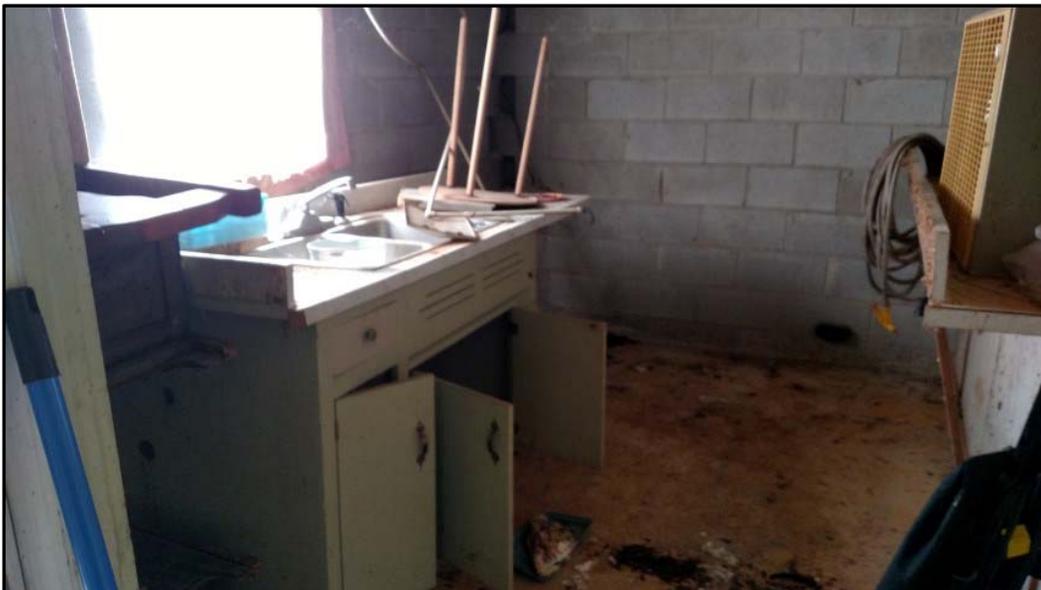
Photograph 4: Additional view of sink with identified asbestos coating. The sink is located on the basement level of the building.

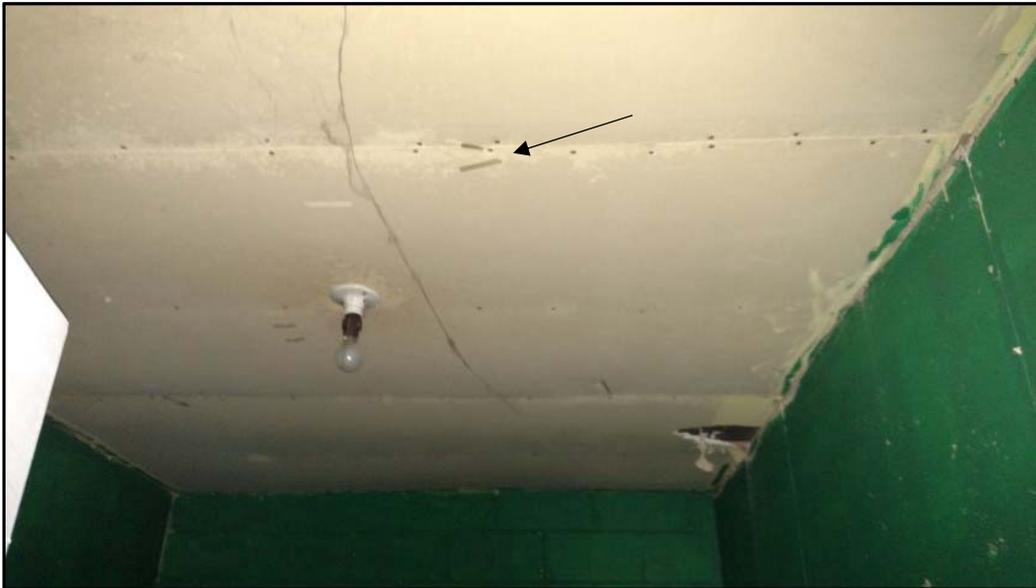
Photograph 5: View of joint compound sampling point on the ceiling of a basement room. Joint compound associated with wallboard located in isolated areas throughout the building was identified as **2% and 3% Chrysotile**.

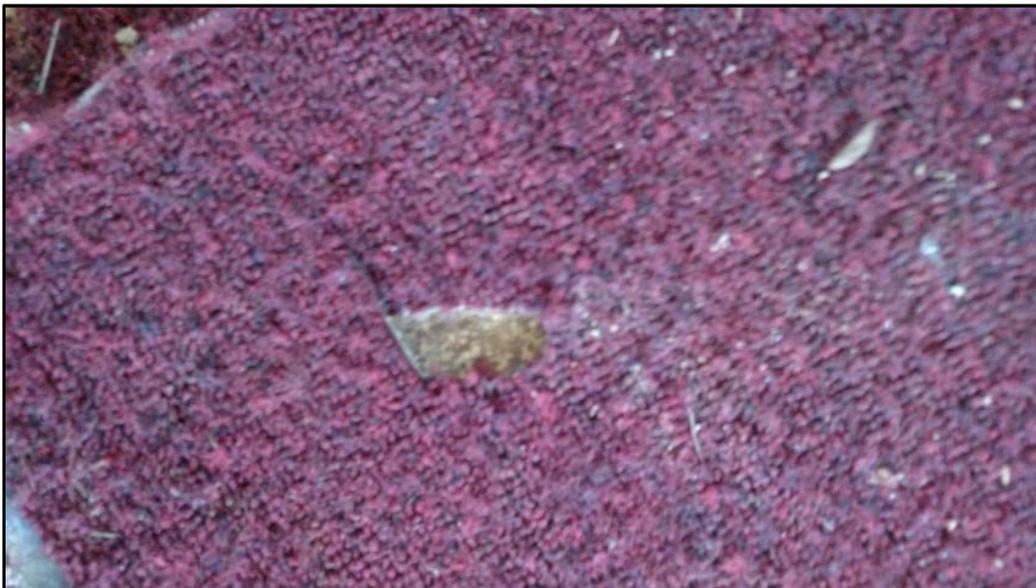
Photograph 6: View of cream mastic sampling point associated with red carpeting located in the main worship on the first floor of the church (None Detected).

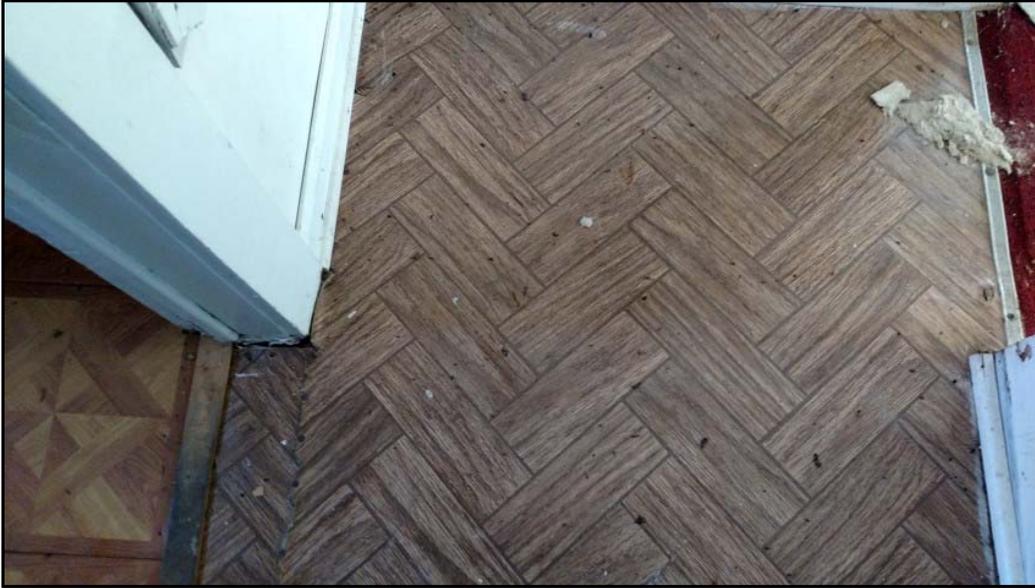
Photograph 7: View of brown rectangle sheet flooring / mastic located at the entrance to the men's and women's restrooms (None Detected)

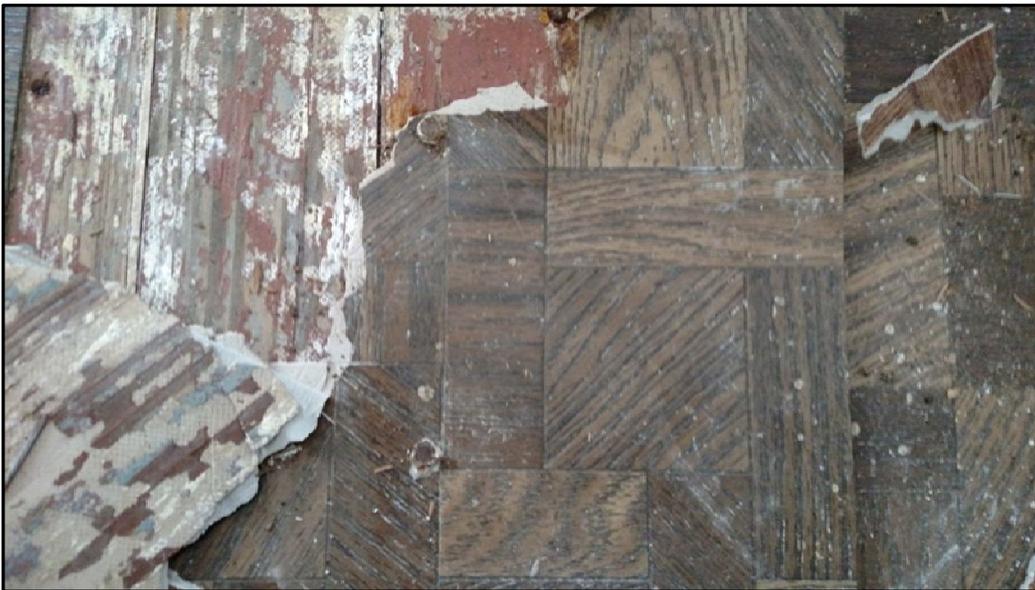
Photograph 8: View of dark brown small rectangles sheet flooring / mastic sampling point (None Detected). Minimal mastic was observed with the sheet flooring which was observed to be nailed in-place with mastic in isolated areas.

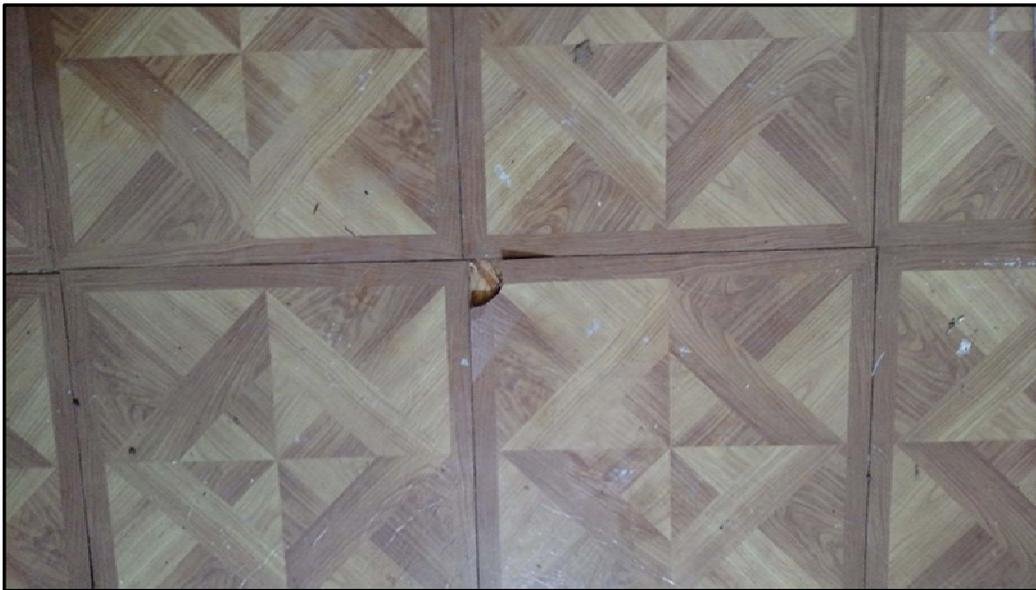
Photograph 9: View of light brown square pattern self-stick tiles located on the men's and women's restroom floors (None Detected).

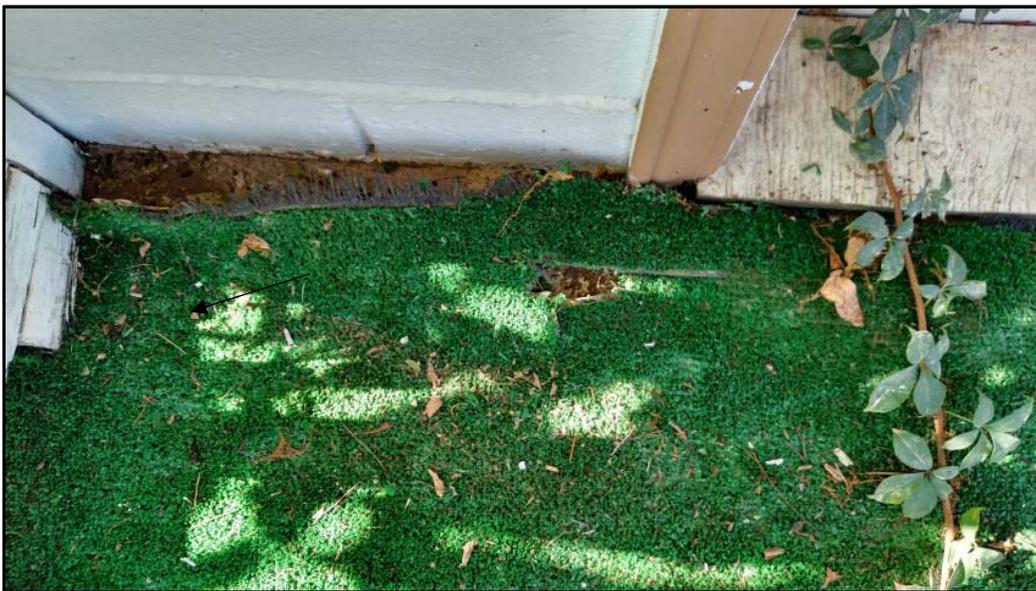
Photograph 10: View of brown carpet mastic sampling point associated with the green outdoor carpet located on the exterior porches and stairs (None Detected).

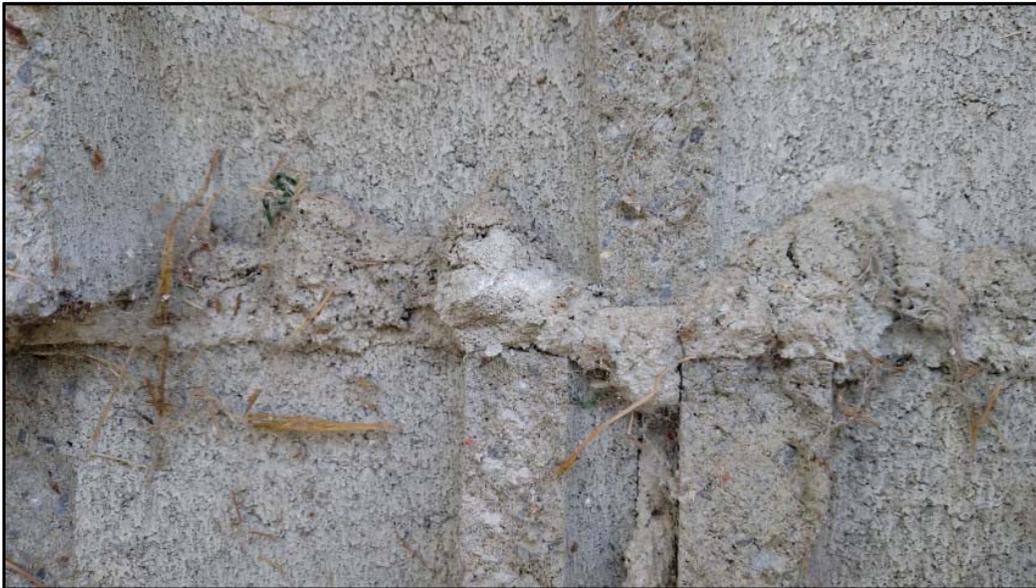
Photograph 11: View of mortar sampling point associated with CMU block walls
(None Detected).

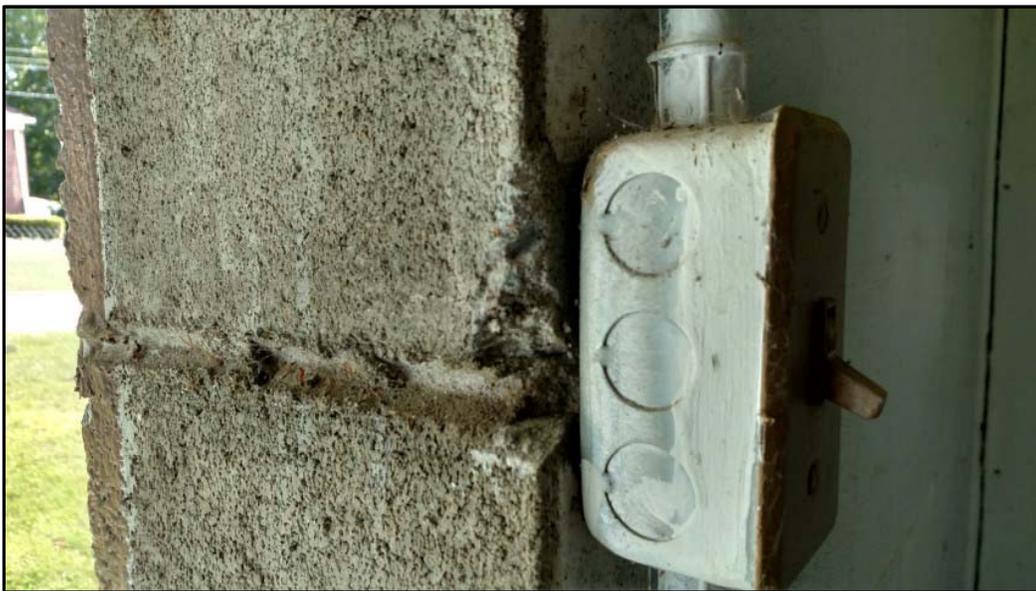
Photograph 12: View of CMU block (masonry) sampling point at the main entrance of
the church (None Detected).

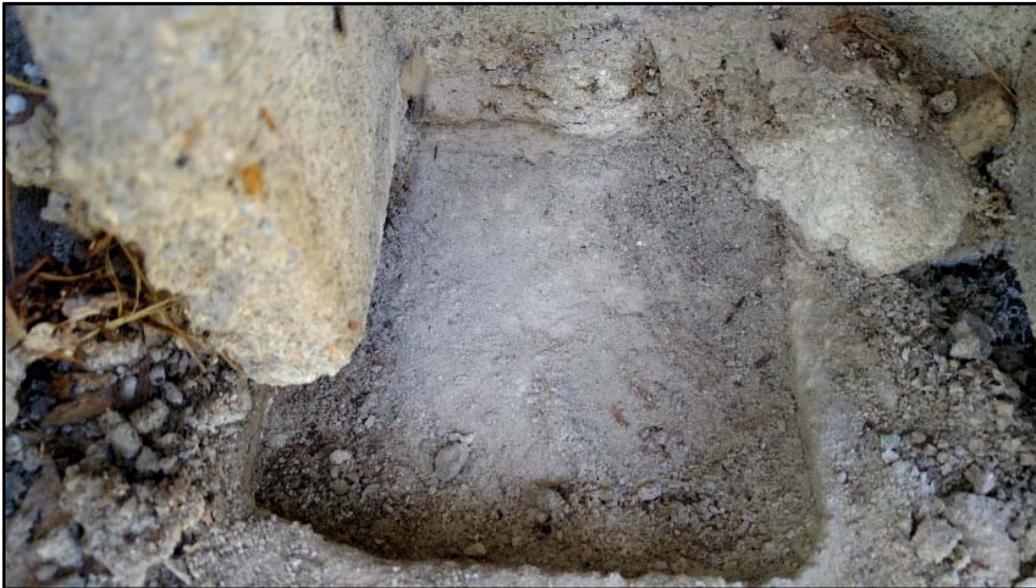
Photograph 13: View grout block fill associated with CMU block walls (None Detected).

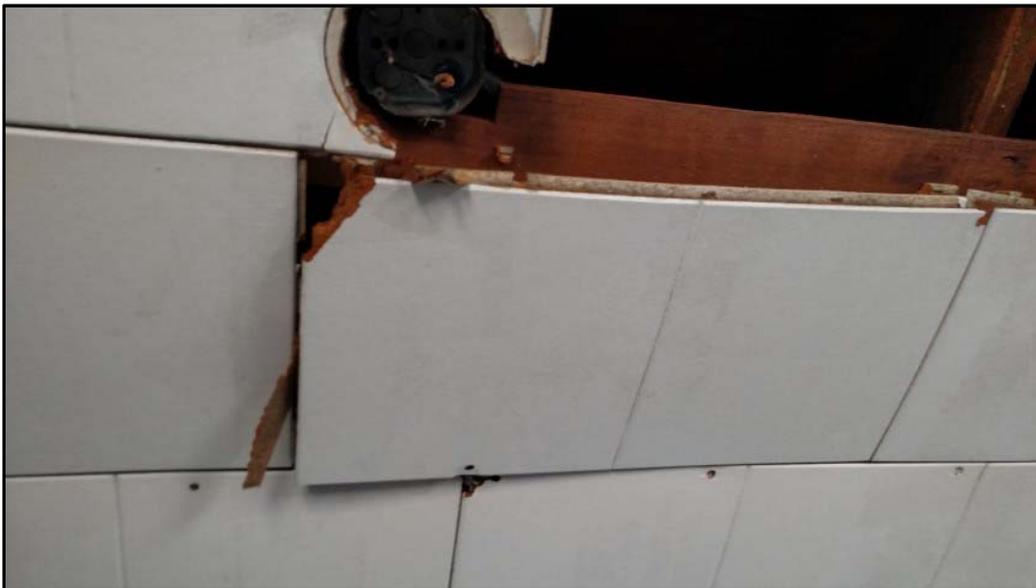
Photograph 14: View of 1'X2' brown fiber board ceiling tile located on the first floor of the building (None Detected).

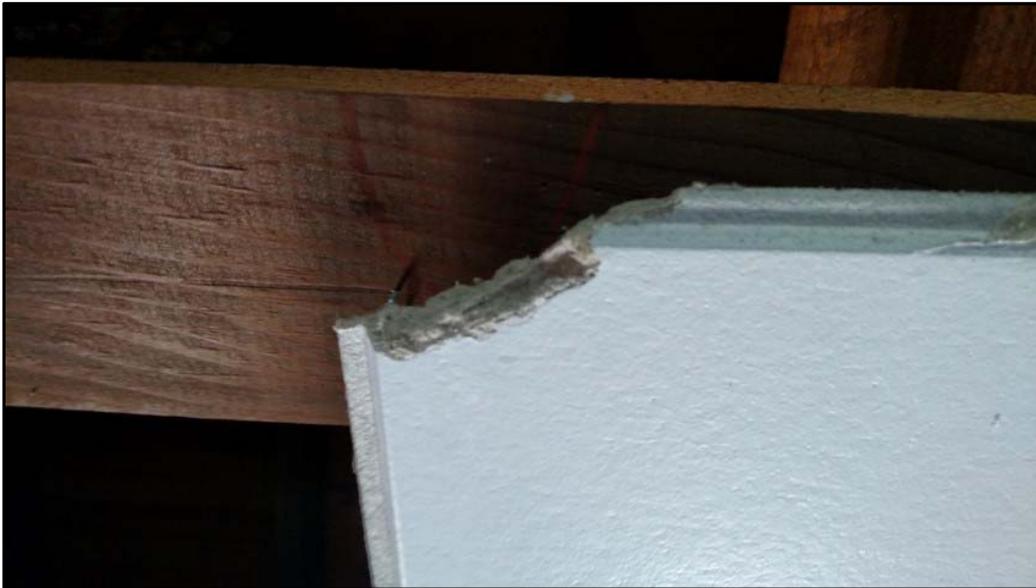
Photograph 15: View of 1'X1' gray fiber board ceiling tile located on approximately 15% of the first floor ceiling (None Detected).

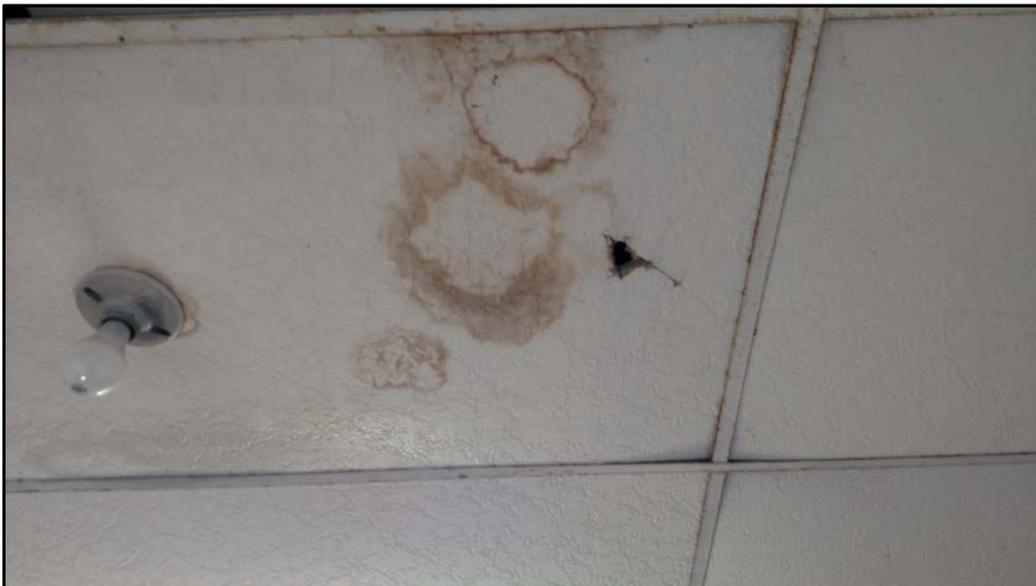
Photograph 16: View of 2'X4' light gray fiber board ceiling tile with white outer sheeting located in an isolated office behind the stage (None Detected).

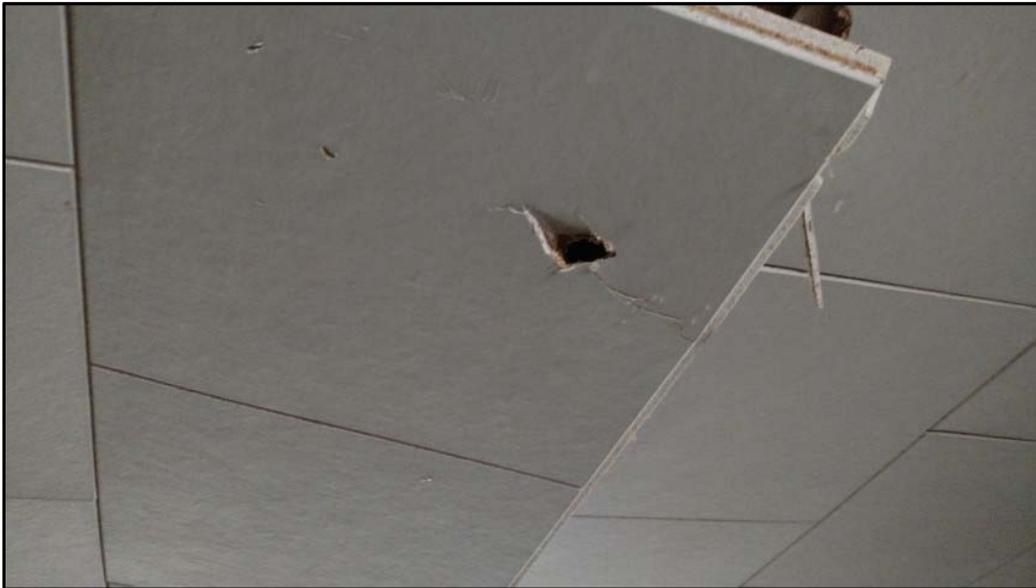
Photograph 17: View of 1'X2' light brown fiber board ceiling tile with white outer sheeting located on the ceiling on the basement level of the building (None Detected).

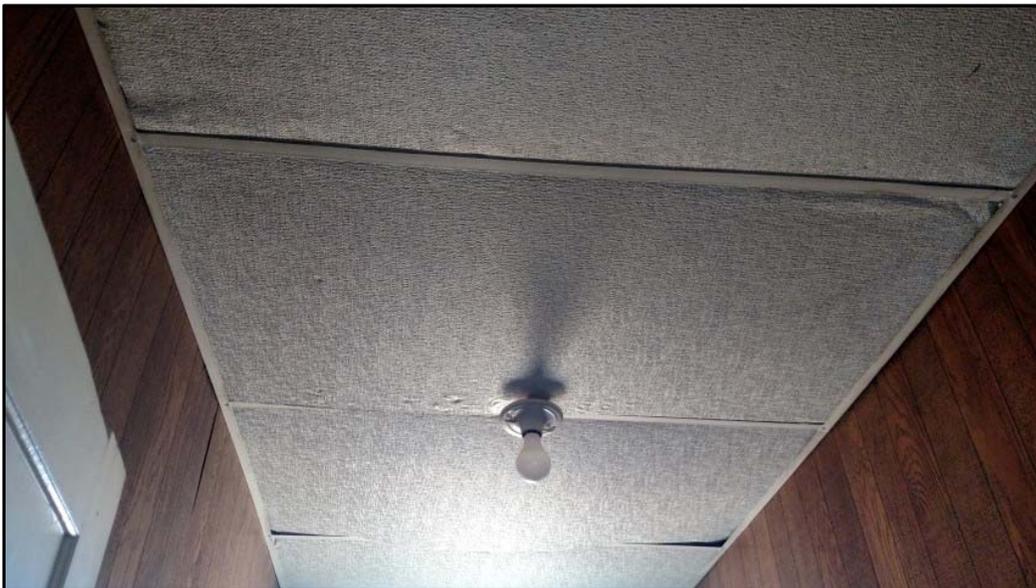
Photograph 18: View of 2'X4' yellow fibrous ceiling tile with white outer sheeting located on the ceiling of the restrooms on the first floor of the building (None Detected).

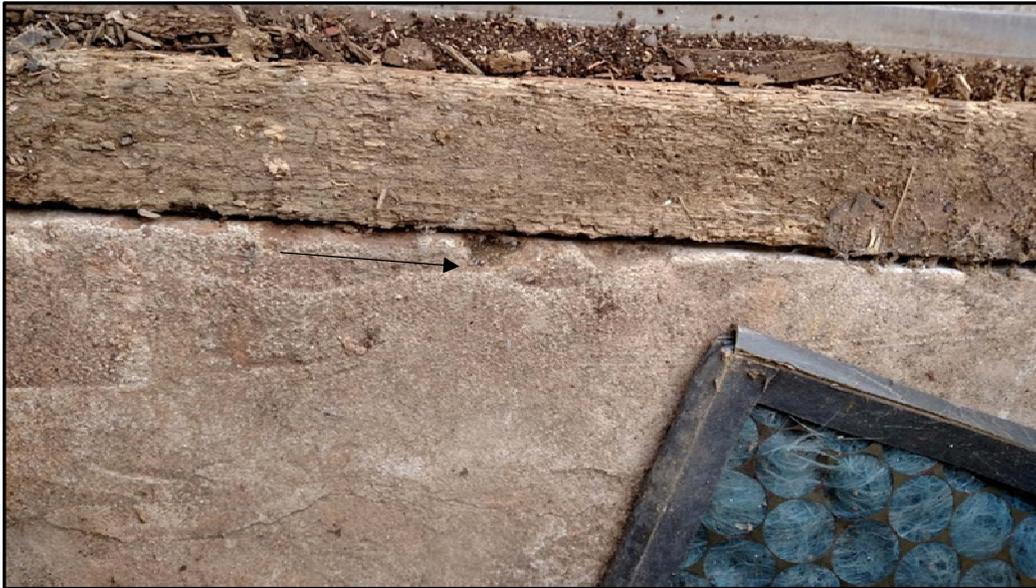
Photograph 19: View of concrete slab sampling point on the basement level of the building (None Detected).

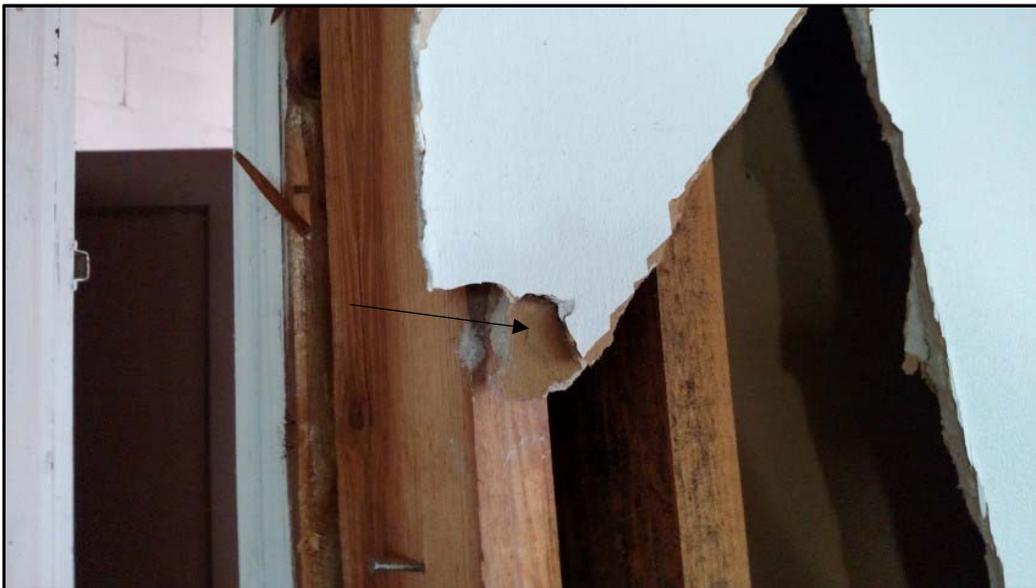
Photograph 20: View of wallboard sampling point on the first floor of the building (None Detected).

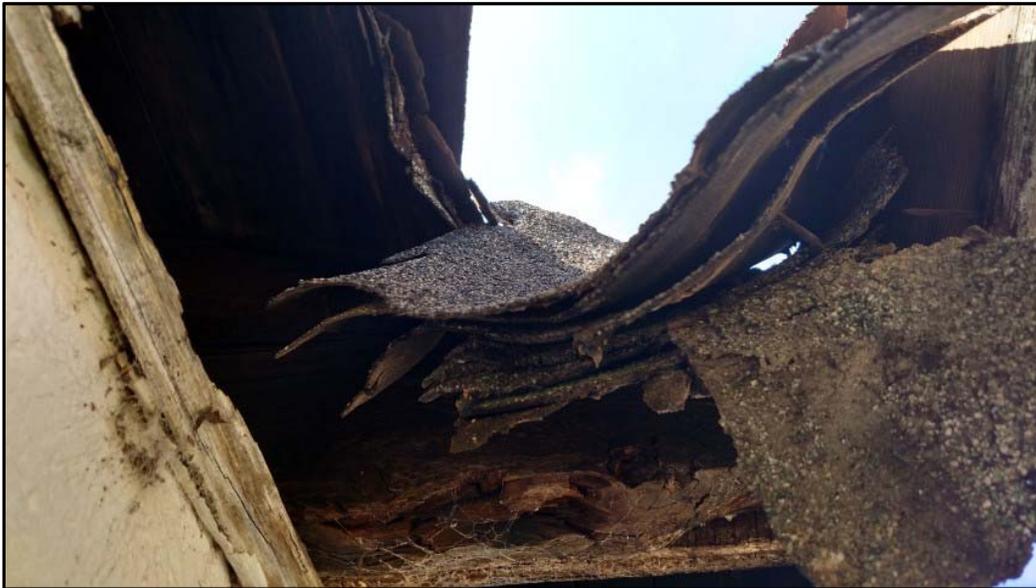
Photograph 21: View of asphalt roofing shingle sampling point (None Detected).

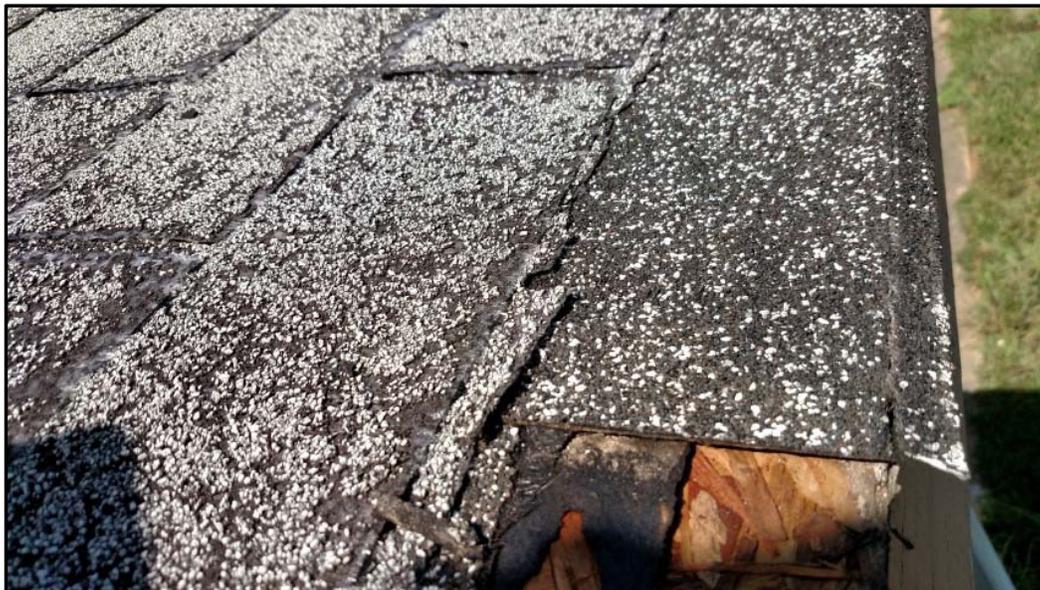
Photograph 22: View of tar paper and asphalt shingle sampling point on the porch roof (None Detected). Two types of tar paper were observed on the roof of the building. Both tar papers were Non-Detect for asbestos.

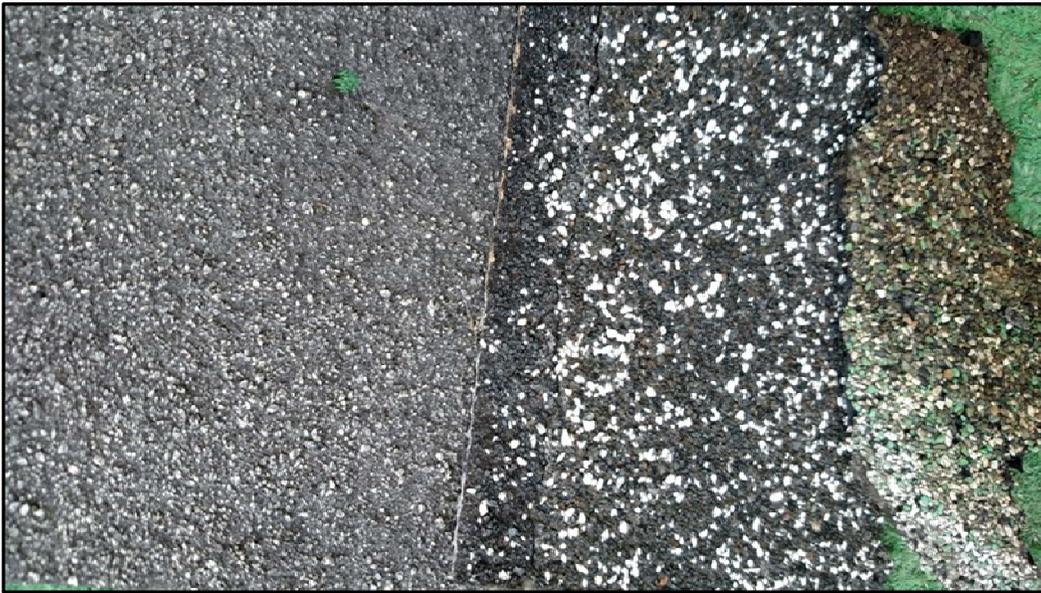
Photograph 23: View of three types of roof shingles sampled on the roof of the building (None Detected).

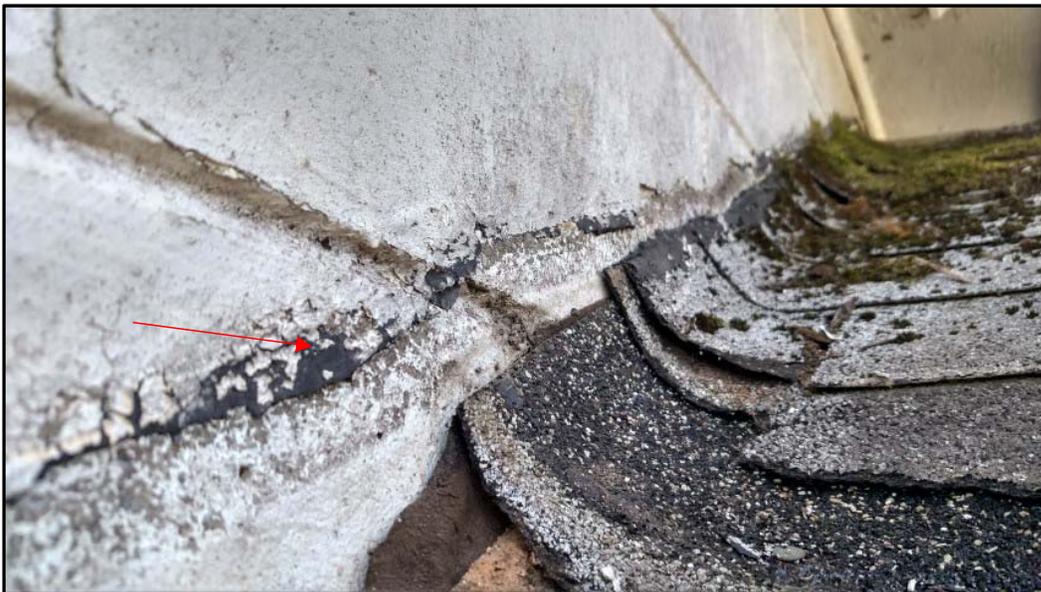
Photograph 24: View black mastic (tar like) sampling point along the seam of the roof (None Detected).

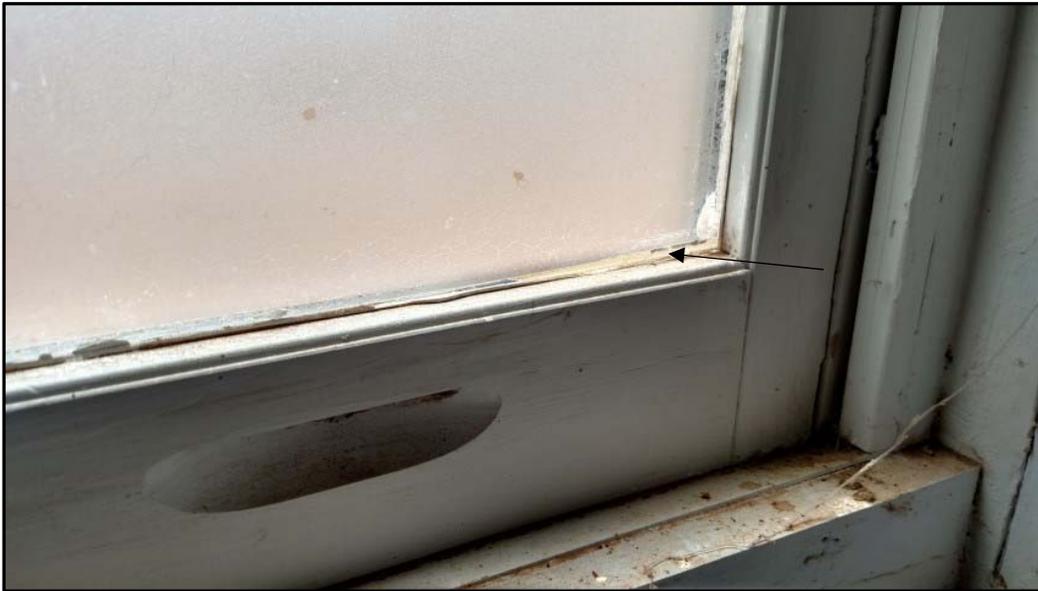
Photograph 25: View of white caulk sampling point on a window on the first floor of the building (None Detected).

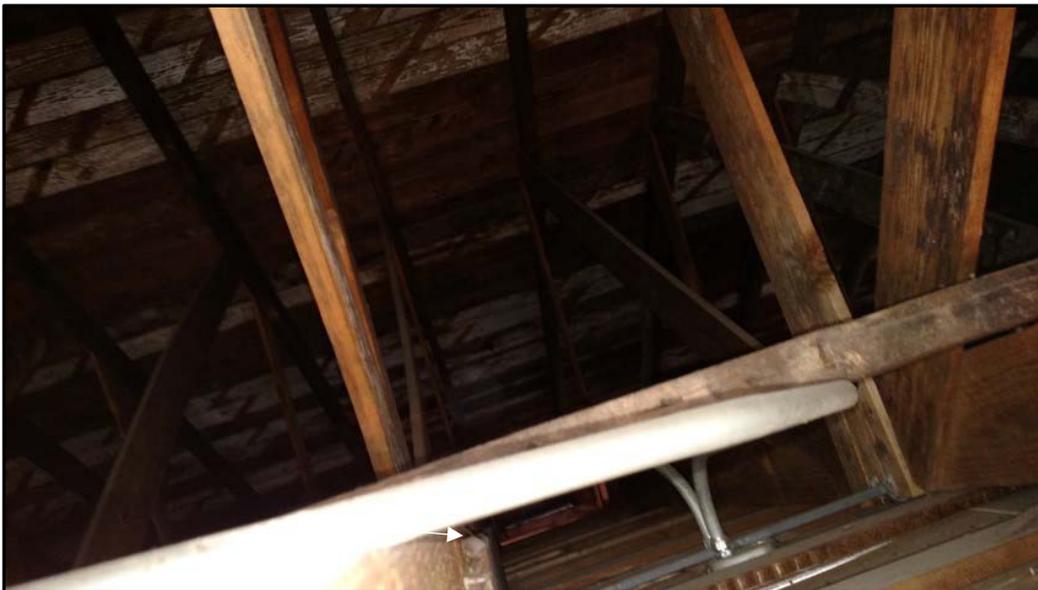
Photograph 26: View of attic area above the ceiling on the first floor. No thermal system insulation materials were observed in the attic area.

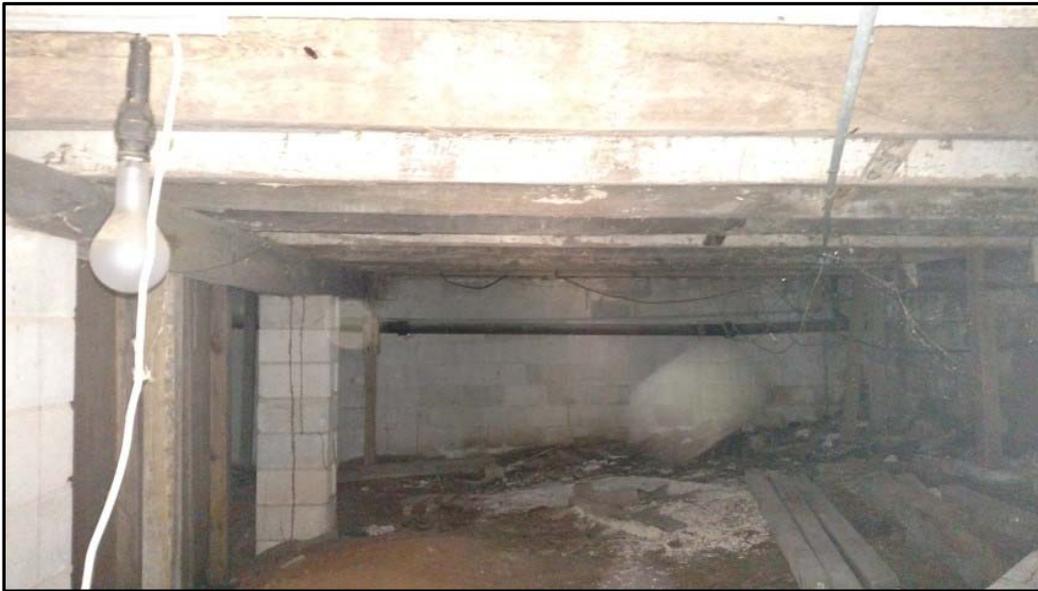
Photograph 27: View of crawl space. No thermal system insulation or other suspect asbestos containing materials were observed in the crawlspace.

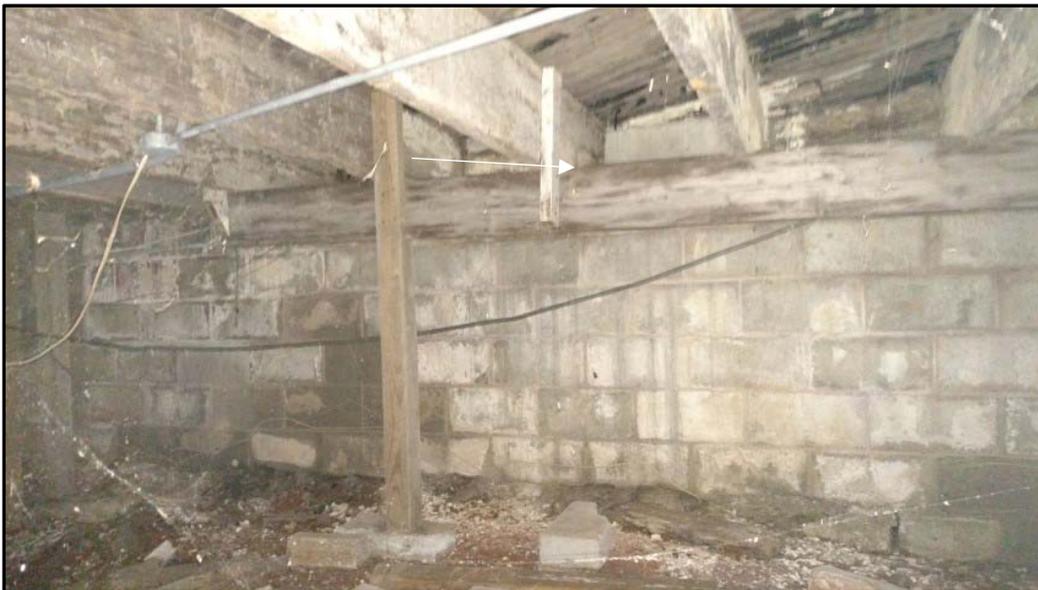
Photograph 28: Additional view of crawl space. No suspect asbestos containing materials were observed in the crawlspace.

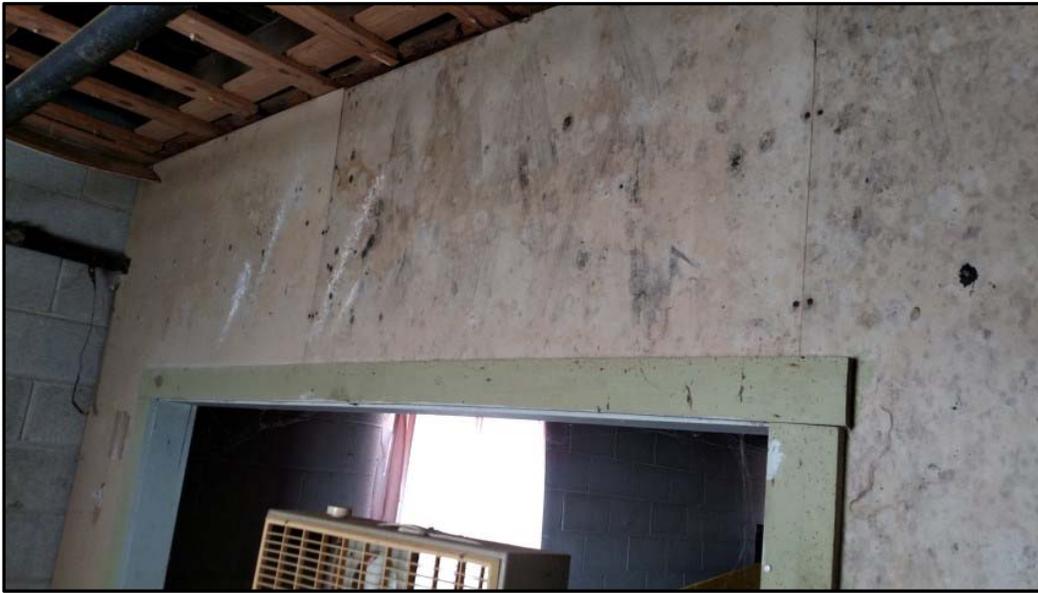
Photograph 28: View of wallboard covered wall located in the kitchen area on the basement level of the building. No joint compound was observed on this wall and as such, this wall is not included in the calculated square footage for joint compound.
