PRE-DEMOLITION ASBESTOS & LEAD-BASED PAINT INSPECTION REPORT

F&R PROJECT NUMBER: 65U-0065

SPARTANBURG AIRPORT ASBESTOS AND LEAD INSPECTIONS
101 VERMONT AVENUE, SPARTANBURG, SC 29304

Date of Report: June 27, 2016

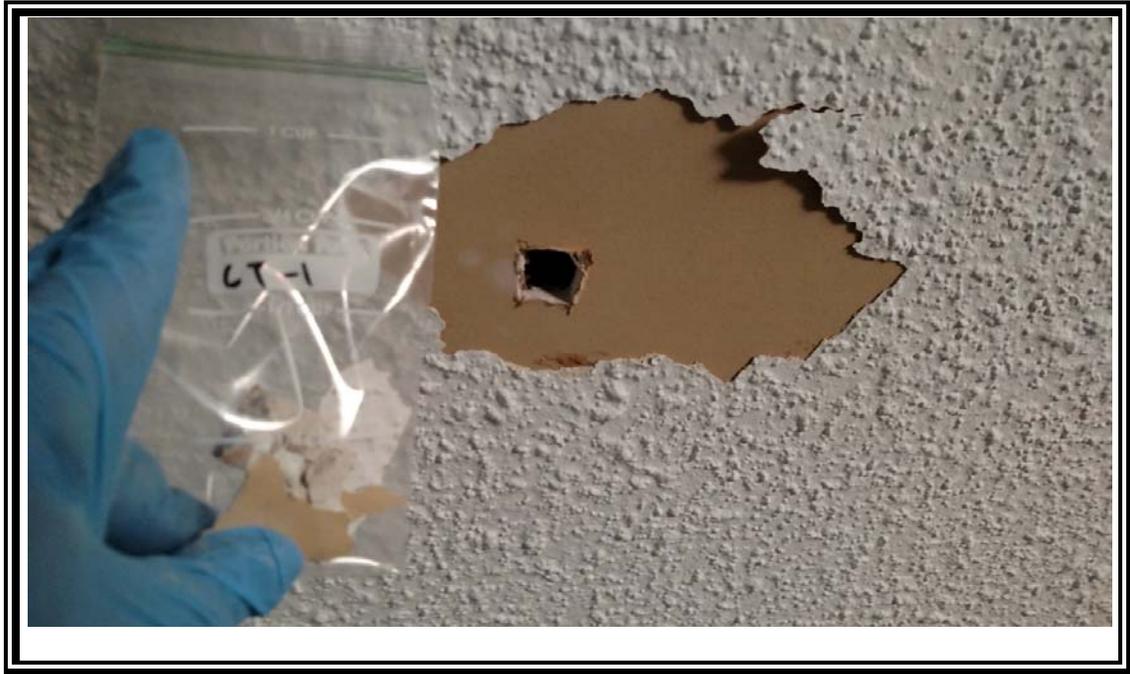
1. View of the ceiling texture sample in the bedroom.

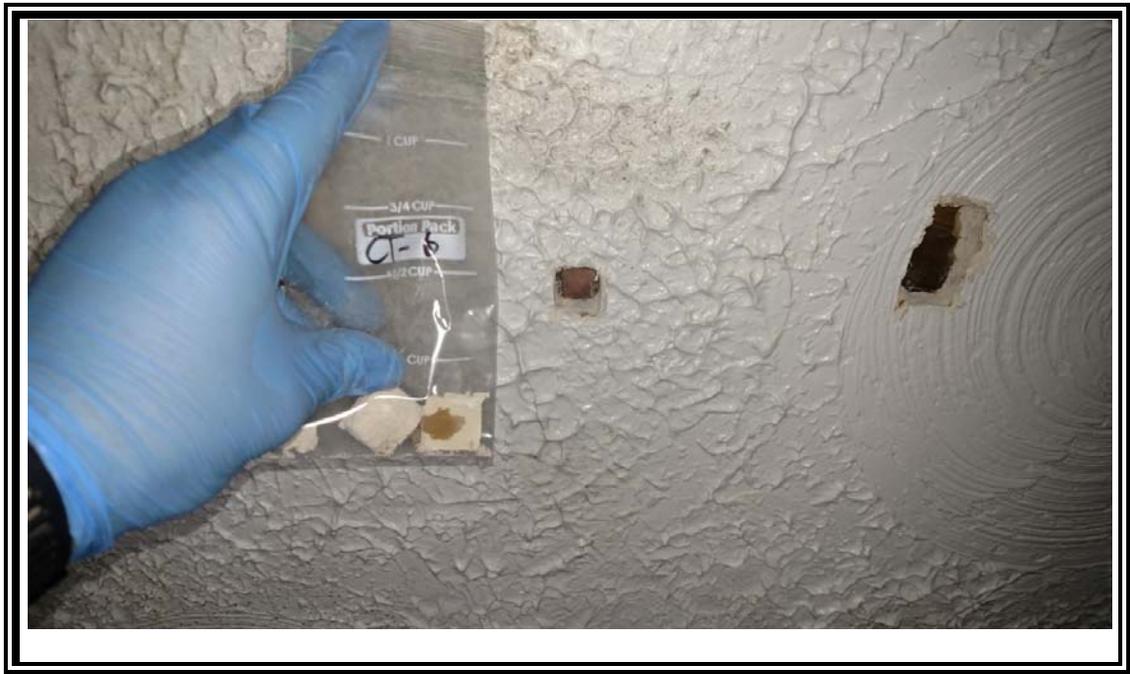
2. View of the ceiling texture sample in the bathroom.

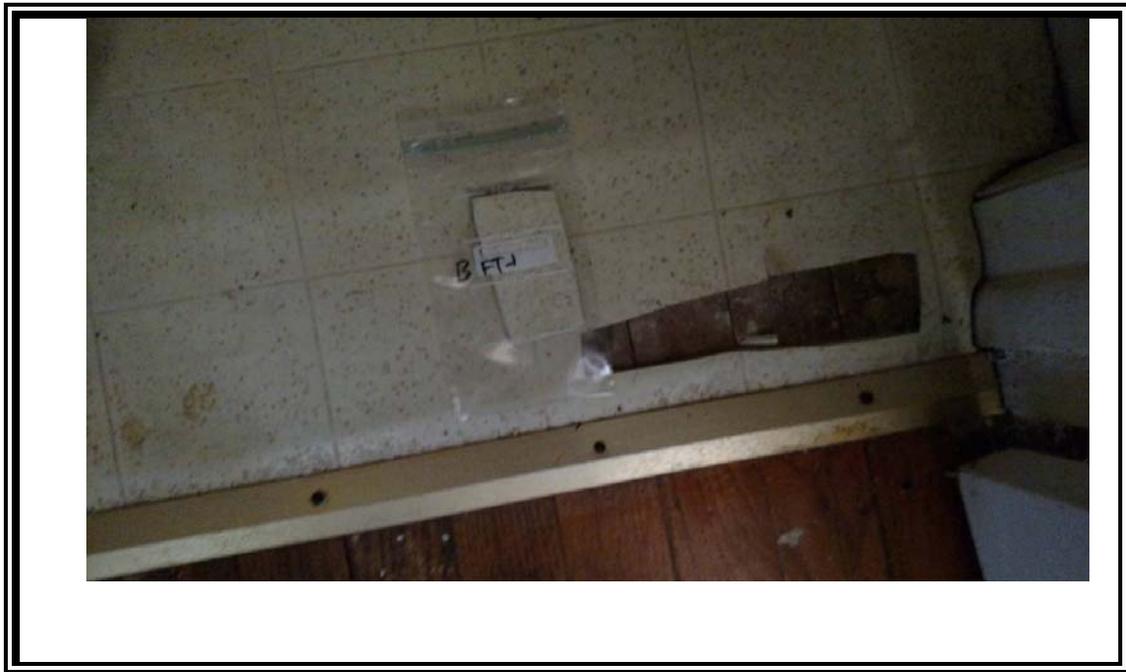
3. View of the floor tile sample in the bedroom bathroom.

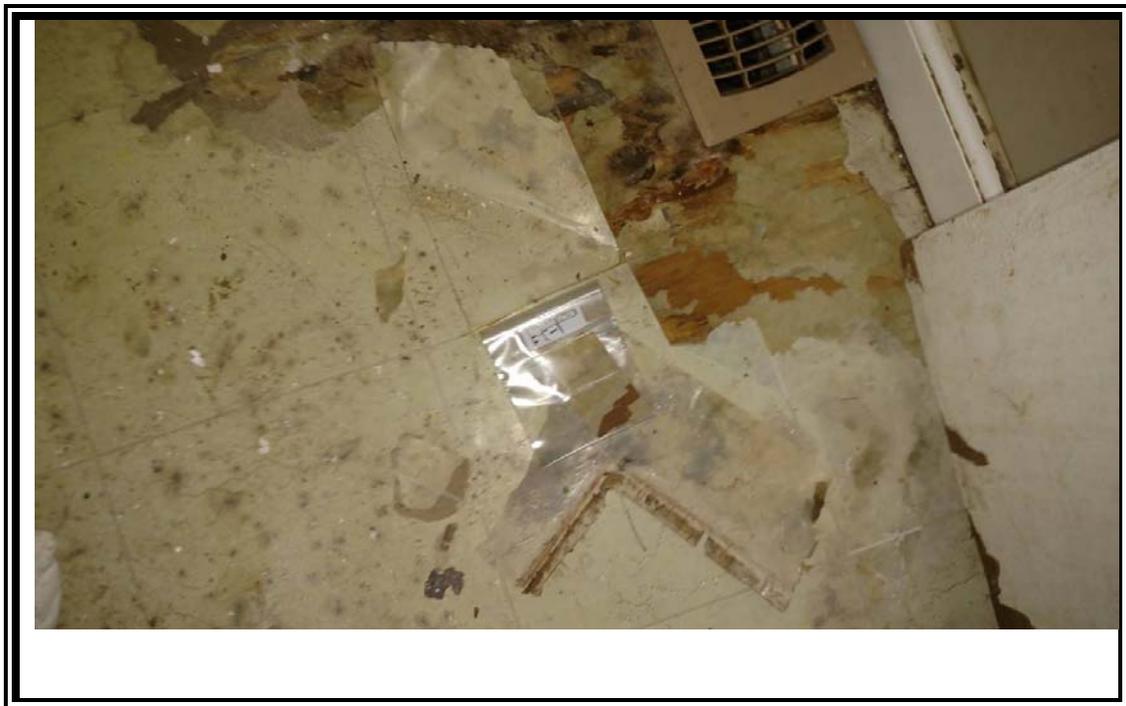
4. View of the floor tile sample in the hallway bathroom.

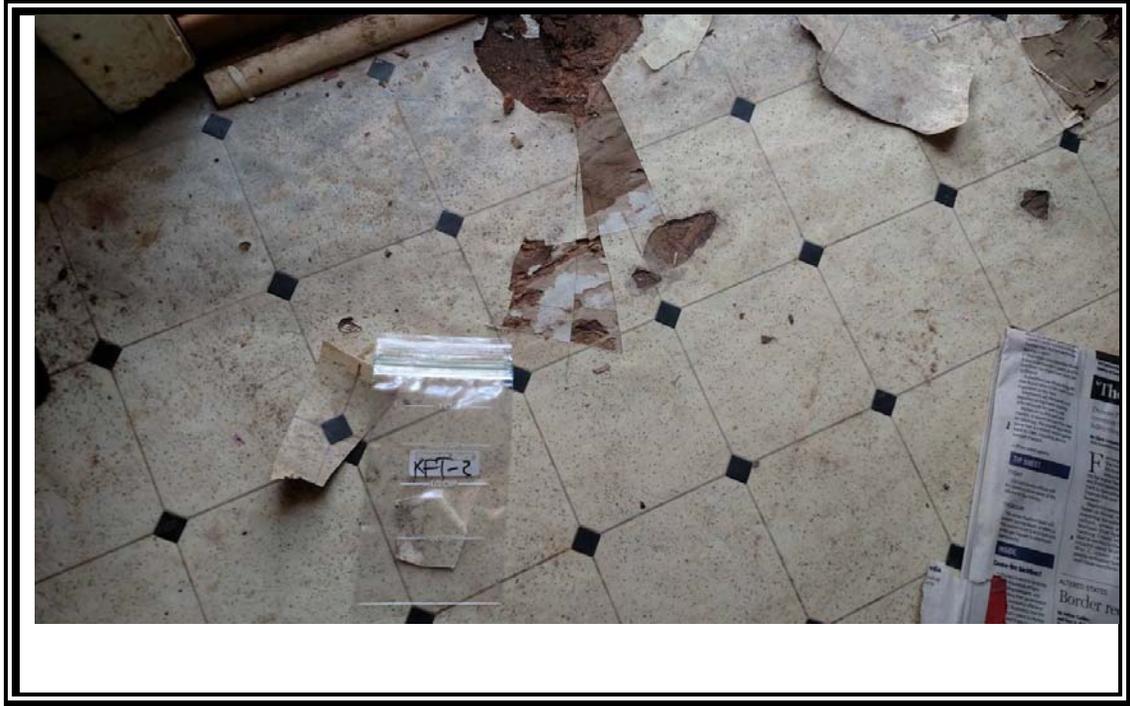
5. View of the floor tile sample in the kitchen and laundry room.

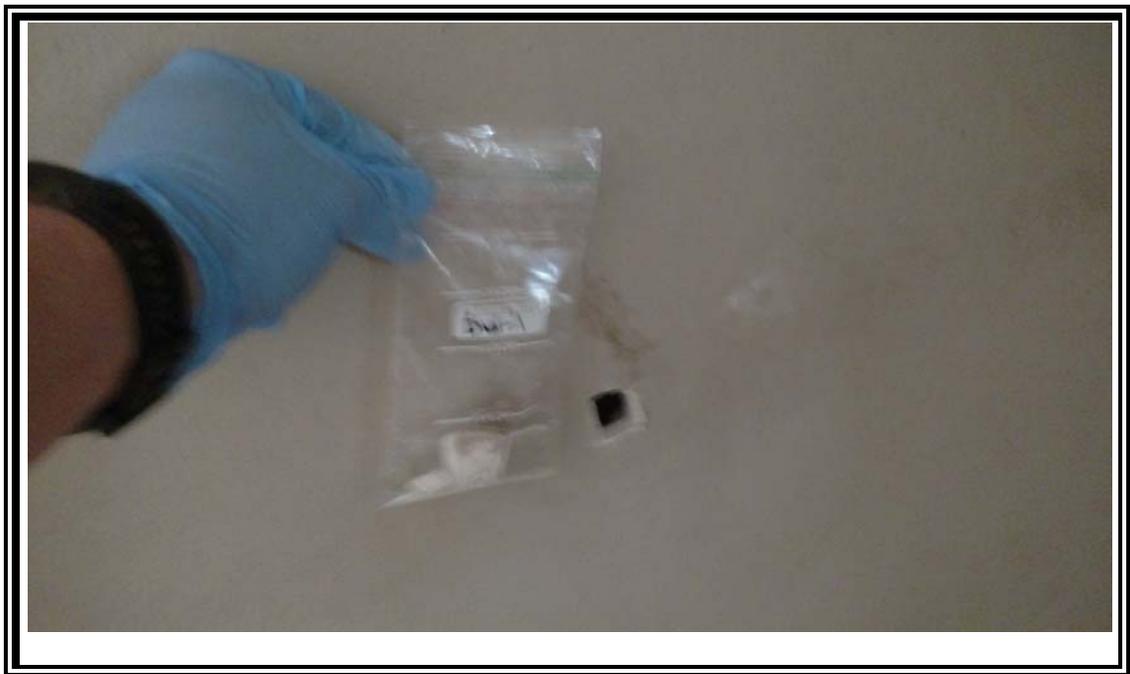
Based on the analytical results of F&R’s sampling of accessible suspect materials, asbestos containing materials were identified as the joint compound on all drywall components of the house. The texture finishes were found to be negative

6. View of the drywall and joint compound sample in the bedroom.

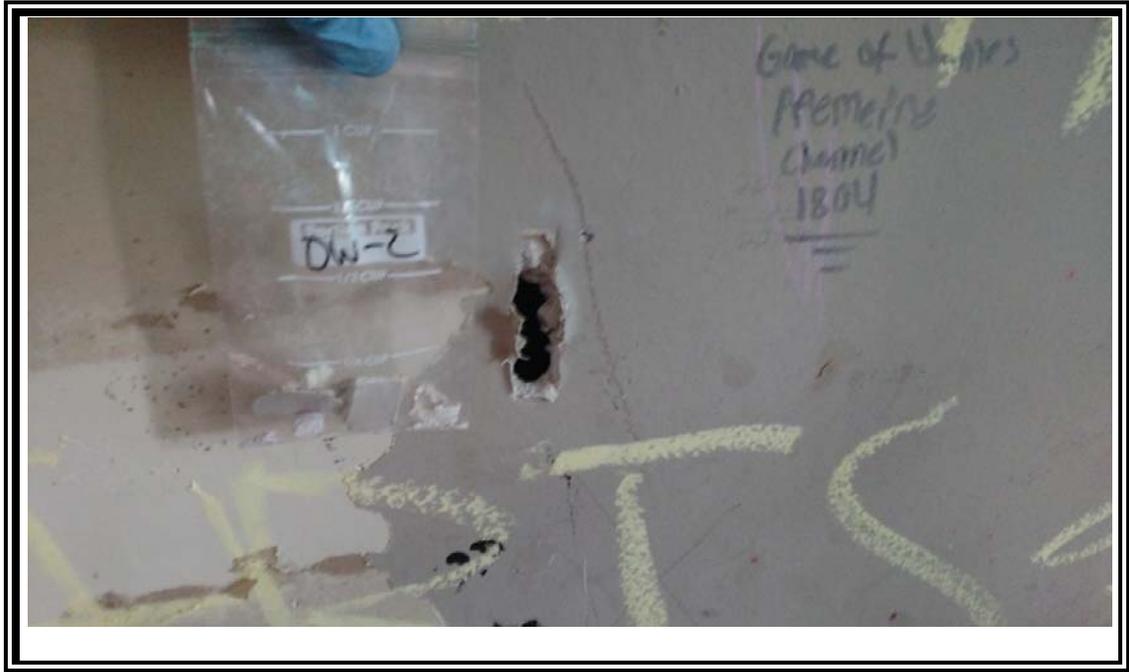
9. View of the drywall and joint compound sample in the bedroom.

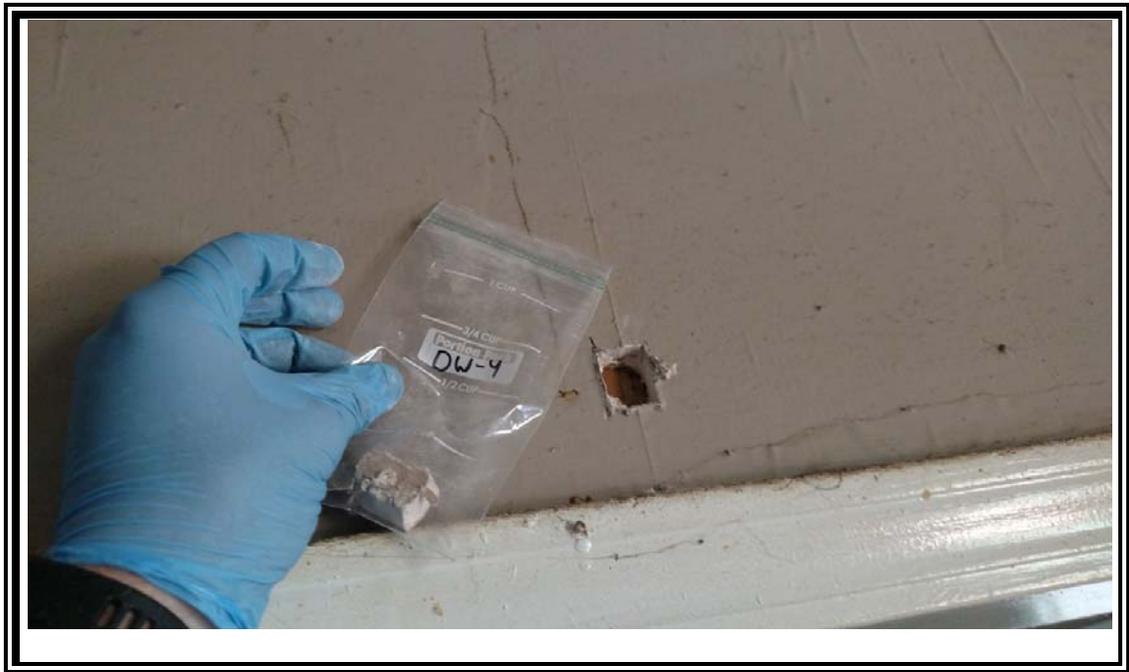
10. View of the drywall and joint compound sample in the kitchen.

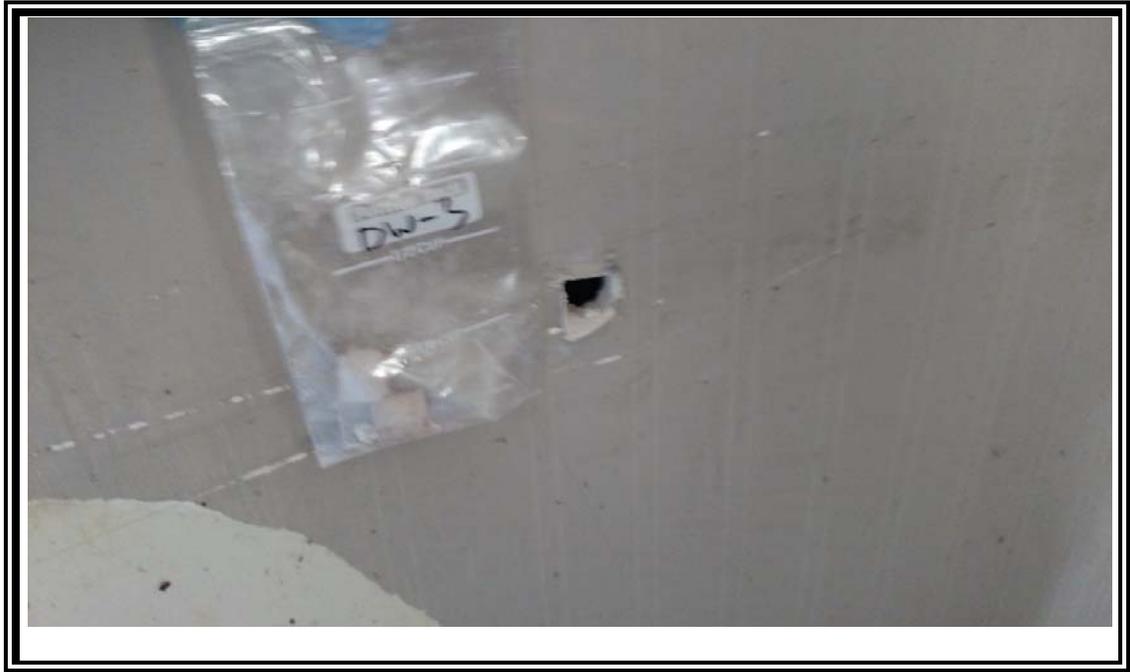
11. View of the drywall and joint compound sample in the kitchen.

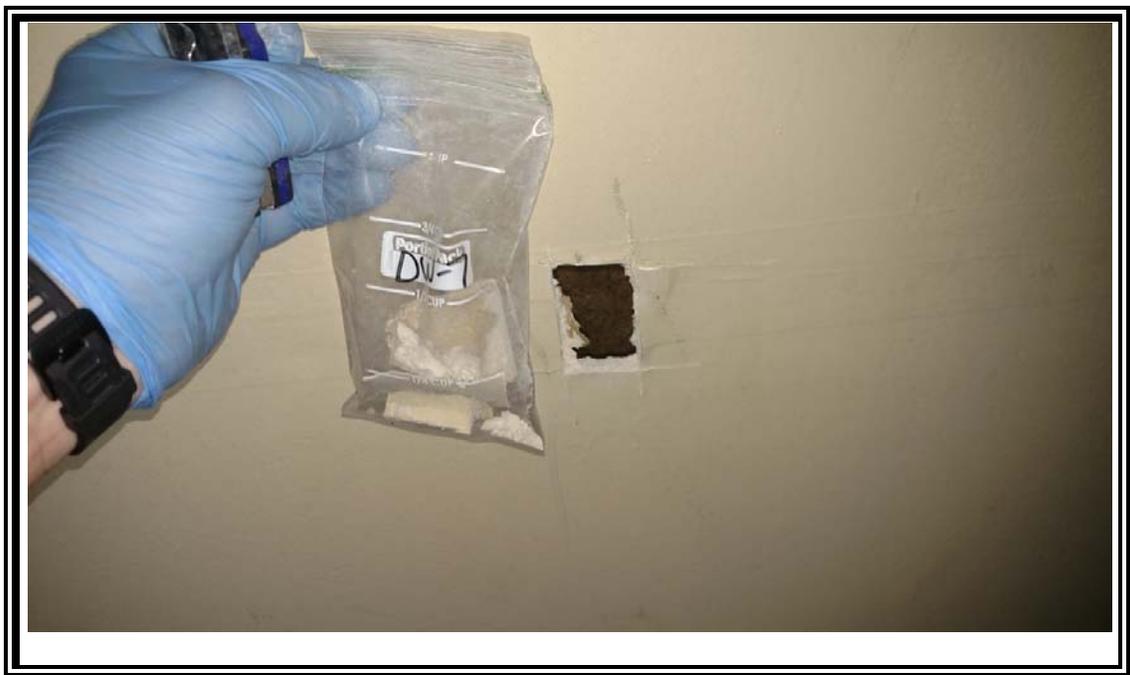
12. View of the drywall and joint compound sample in the garage.

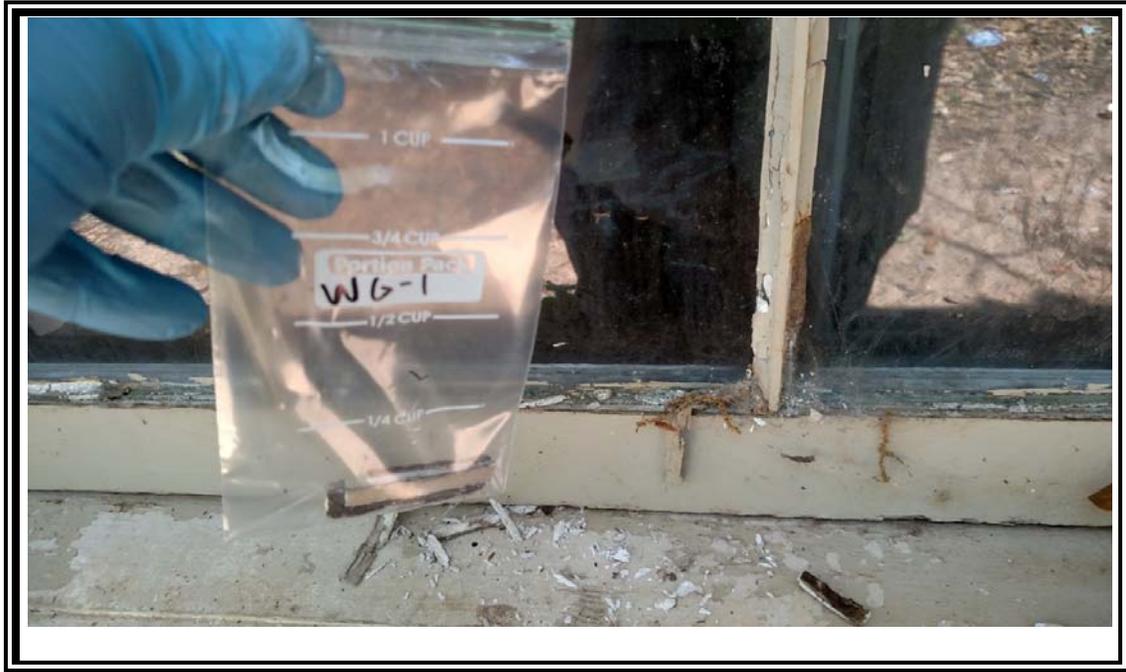
13. View of the window glazing on the exterior window.

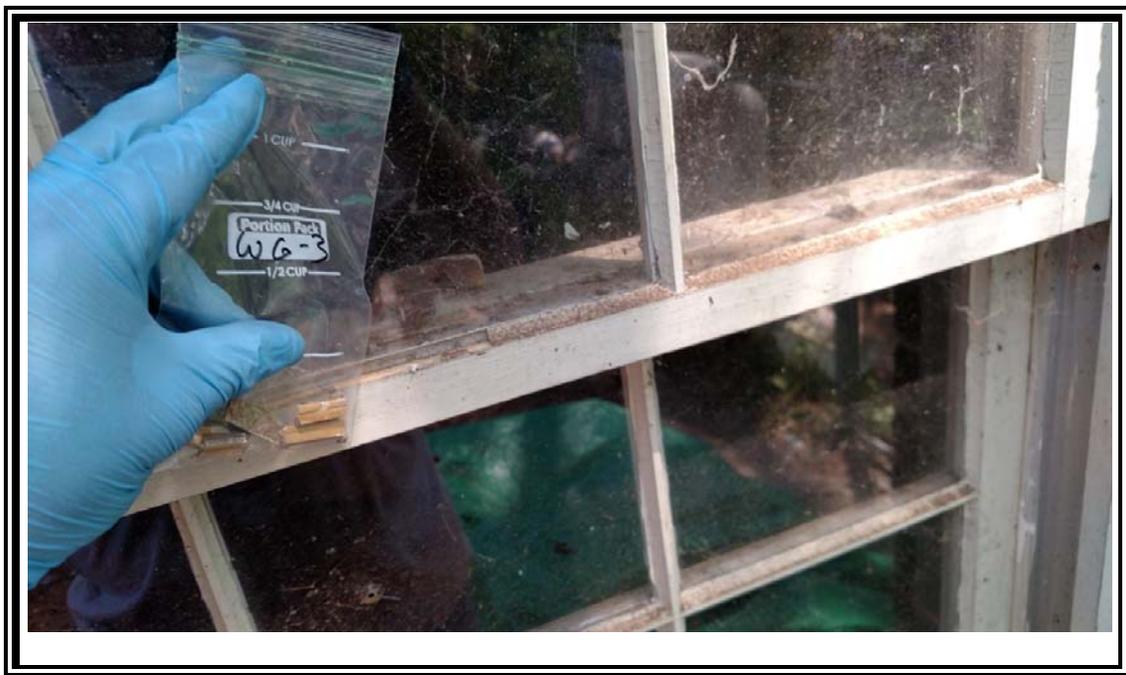
14. View of the window glazing on the exterior window.
