PRE-DEMOLITION ASBESTOS INSPECTION REPORT

F&R PROJECT NUMBER: 65U-0005

Forensics Storage Building 100 South Spring Street Spartanburg, South Carolina

Date of Report: April 21, 2016

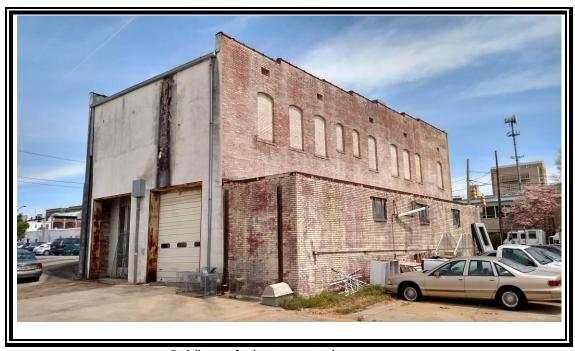
2. View of plaster exterior on rear.

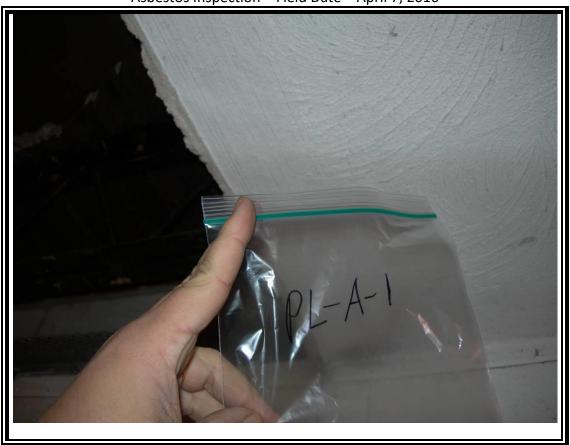
3. View of plaster ceiling.

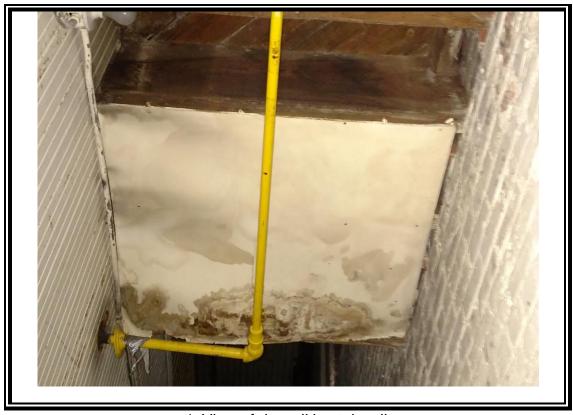
4. View of drywall in stairwell.

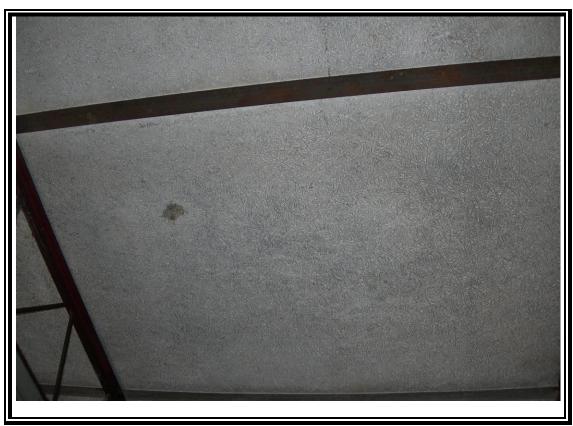
5. View of roof deck on east side of the building.

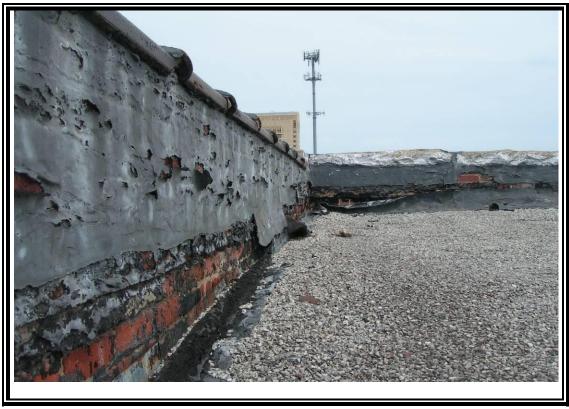
The positive samples represented the roof flashing on the roof parapet walls. None of the four (4) samples of non-friable organically bound (NOB) materials analyzed by Transmission Electron Microscopy (TEM) were determined to contain asbestos greater than 1%.

6. View of roof flashing on main roof.

A state licensed asbestos abatement contractor must then remove all RACM from the facility, before any demolition or renovation activity begins, that would break up, dislodge, or similarly disturb the material or preclude access for subsequent removal.

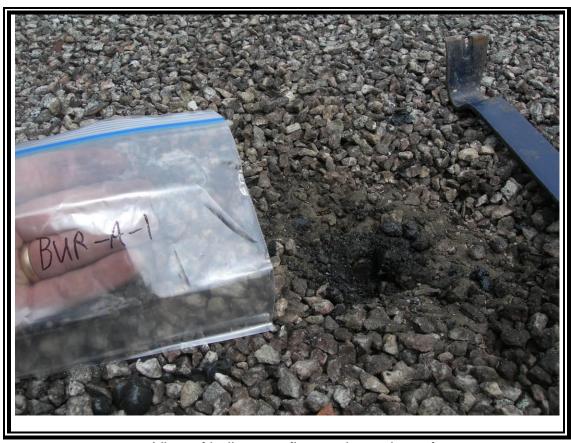
7. View of built up roofing on the main roof.

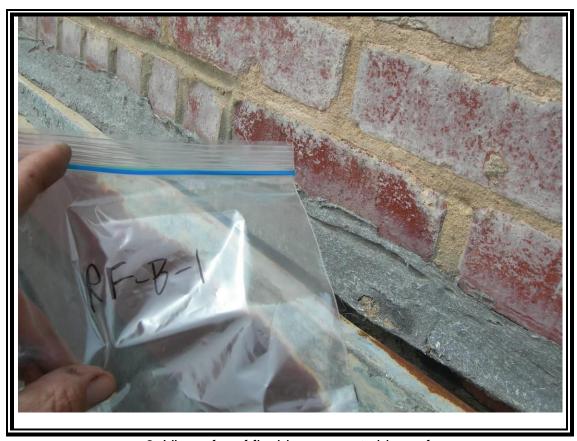
8. View of roof flashing on east side roof.

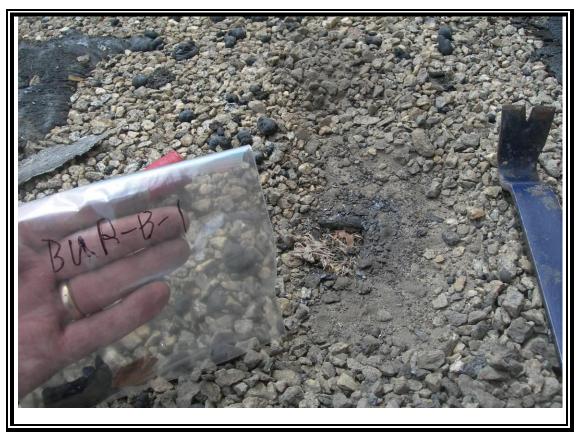
9. View of built up roofing on east side roof.

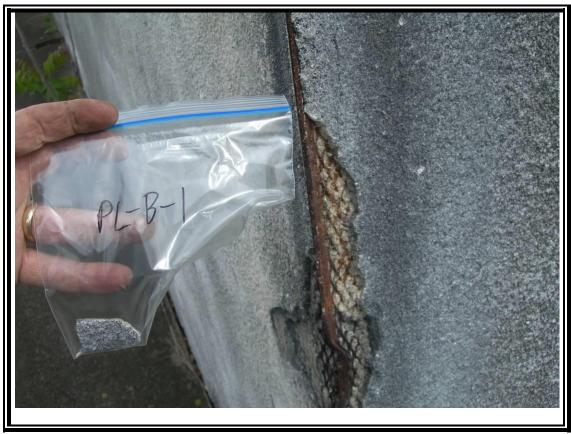
10. View of exterior plaster.

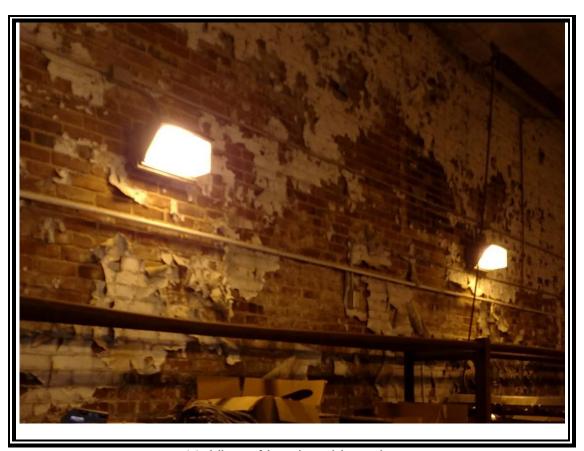
Both of the paint chip samples collected from the interior walls of the garage area were found to contain more than 0.5% lead by weight, which is a regulated material under a variety of federal laws and is identified as "lead-based paint".

11. View of interior white paint.

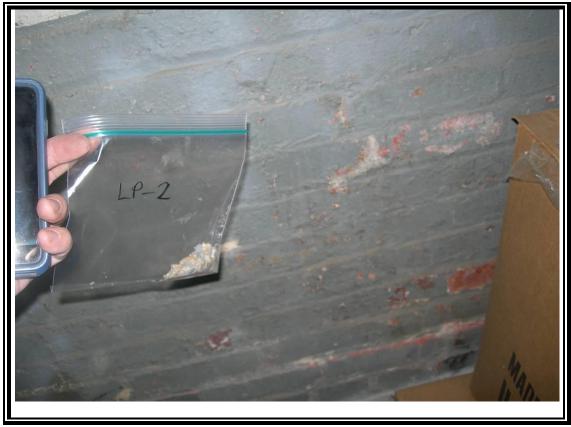
12. View of interior gray paint.
