July 15, 2019

Ms. Kenya M. Anderson, MSP
Highlands County Board of County Commissioners
Engineering Department
505 South Commerce Avenue
Sebring, Florida 33870

Subject: Pavement Evaluation
CR 623 (Kenilworth Boulevard)
Between Haywood Taylor Boulevard and Mini Ranch Road
Sebring, Florida

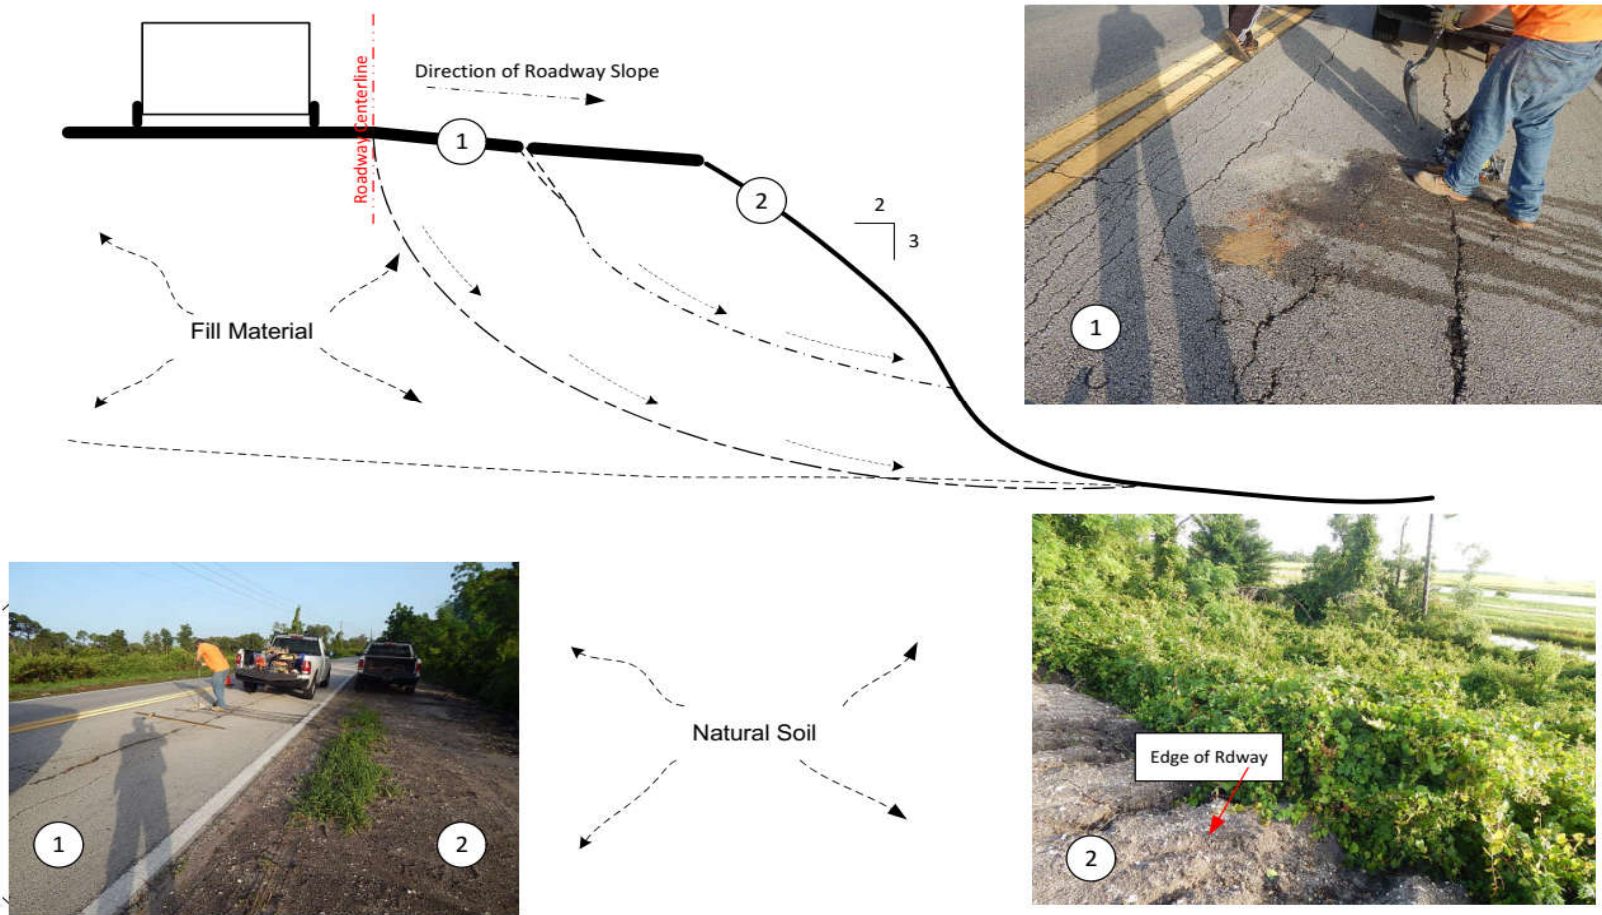
Figure 2 provides a typical section of what appears to be occurring in the fill portion of the roadway in the area of Cores 2 & 3 and eastward. It is estimated that the embankment slope in this area is at least a 2H:3V and steeper. Moreover, there appears to be some newly placed fill at the shoulder of the roadway (see photo insert in Figure 2).

The tension cracks shown in the section and photo inserts (Figure 2) are indicative of slope movement as illustrated in the section. If this slope is not stabilized movement will continue and cracking will continue in the new pavement.

Typical Stability Section in Area of Cores 2 & 3

For the fill section of roadway at the approximate location of Cores 2 and 3 and eastward, the north side of the roadway should be filled to attain a slope of ideally 1V:2H. This will provide the most cost effective solution to stabilizing the slope. Fill placed on the slope should be compacted by the movement of earthmoving equipment.

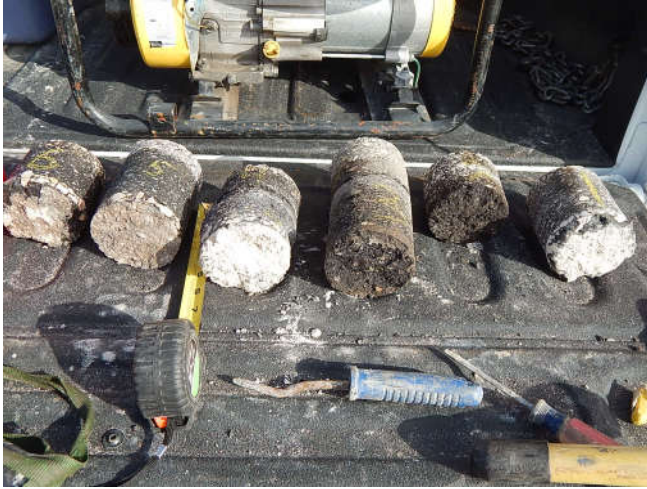
The thickness of the asphalt pavement was found to vary from 3.5 to 8.5 inches, see Table 2 and Photo 1. This is a wide range in thickness for a relatively short distance of 1.2 miles of roadway and likely reflects the many repairs that have been performed on the roadway. There is no correlation between the quality of the asphalt and its thickness. As stated earlier, many of the asphalt overlays are a weakly bonded asphaltic matrix with random shell fragments. This asphalt has substandard strength and at some time during the life of the pavement was placed to compensate for roadway settlement indicative of deep seated problems.

Photo 1: Six cores obtained in the drilling (arranged consecutively one on right six on left)

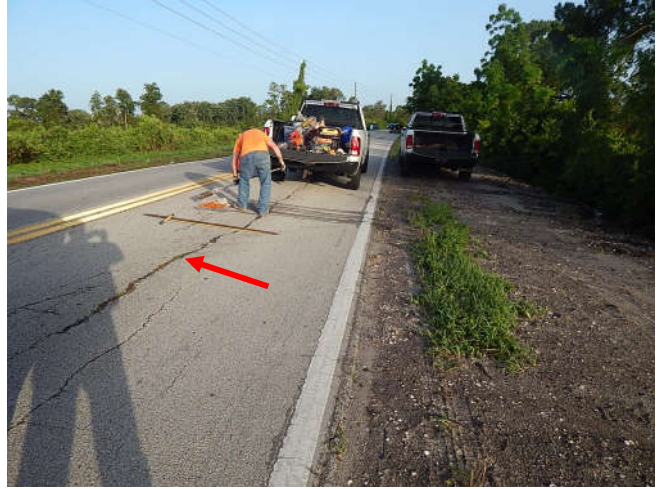
Photo 2: Location of Core No. 2 looking west (note porous longitudinal crack allowing water to enter asphalt pavement)

It is recommended that once a year all cracks in the roadway be sealed to extend the life of the asphalt. Sealing the cracks will divert water to the edge of the roadway rather than allowing the water into the asphalt to accelerate erosion of the asphalt.

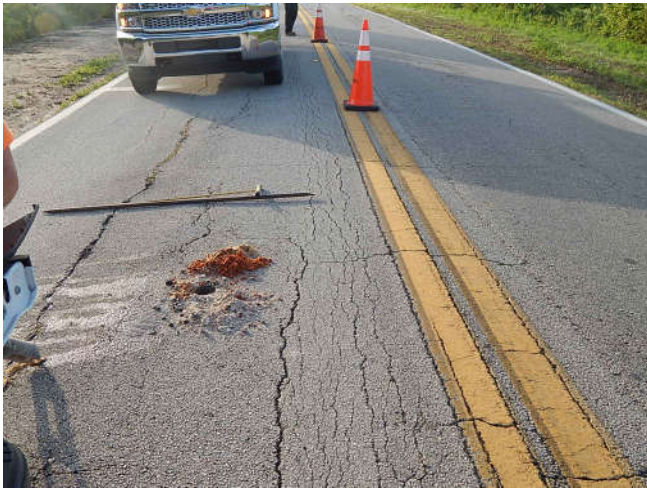
Photo 3: Location of Core No. 2 looking east

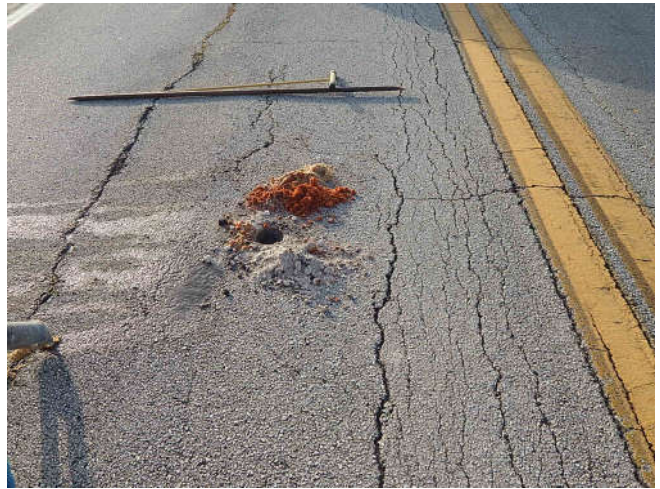
Photo 4: Close-up of Photo 3

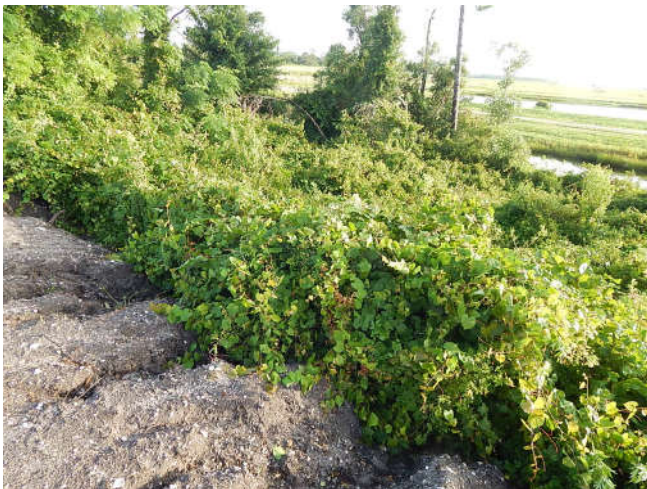
Photo 5: Looking North from location of Core No. 3. Note: new fill and large change in elevation to north

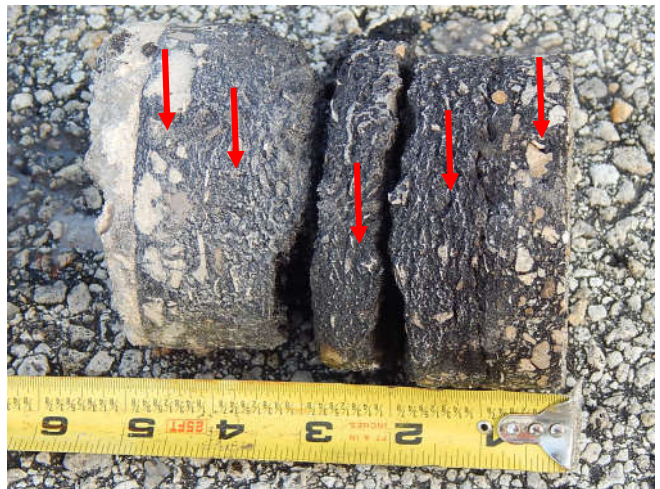
In general, the section of roadway studied was found to be in poor but serviceable condition. It is estimated that this portion of roadway is at least 20 years old and cores drilled in the roadway show evidence of at least five overlays, see Photo 6. A variety of problems were found in the roadway resulting from poor drainage and insufficient structural support of the pavement.

As stated, the pavement in the portion of the roadway studied is in poor but serviceable condition. The asphalt shows multiple signs of distress mostly from strength and permeability deficiencies in underlying asphalt overlays, see attached photos. At least five separate overlays were found in some of the asphalt cores some of these overlays are estimated to be over 20 years old.

Photo 6: Close-up of Core No. 4, note that the five overlays present in the core.

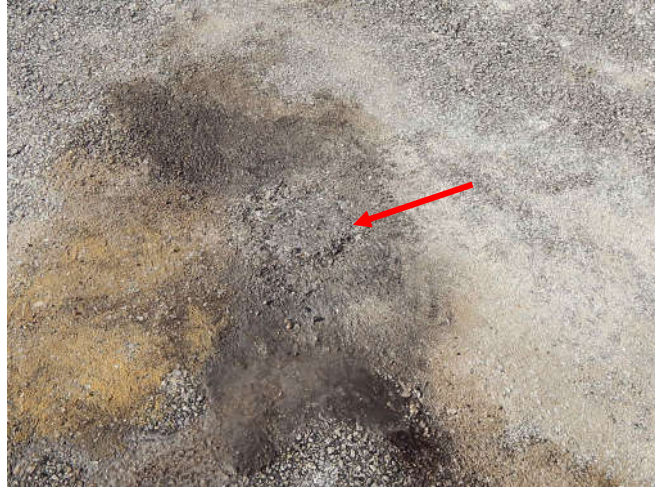
Photo 8: Patched asphalt

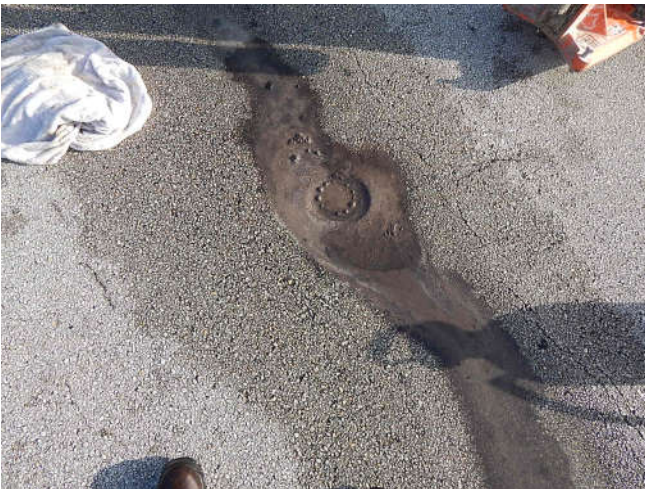
The older overlays found in the cores appear to have very low strength. These overlays consist of about 20% shell aggregate in a matrix of weathered asphalt. In contrast, modern-day asphaltic concrete is a combination of approximately 95% stone, sand, or gravel bound together by asphalt cement. In modern-day asphalt, load is spread to the subgrade by grain-to-grain contact. In the older asphalt load is not distributed (reduced) by aggregate interlock resulting in higher non-uniform stresses carried deeper into the roadway pavement. These higher non-uniform stresses result in deterioration of the road surface.

An example of the low strength of the asphalt binder is seen in the low resistance required to advance the core barrel in this asphalt. Photos 9 and 10 show the cuttings during coring of the asphaltic material. The material appeared to have the consistency of a loose sand.

Photo 9: Weak asphalt matrix washing out of core hole C-4

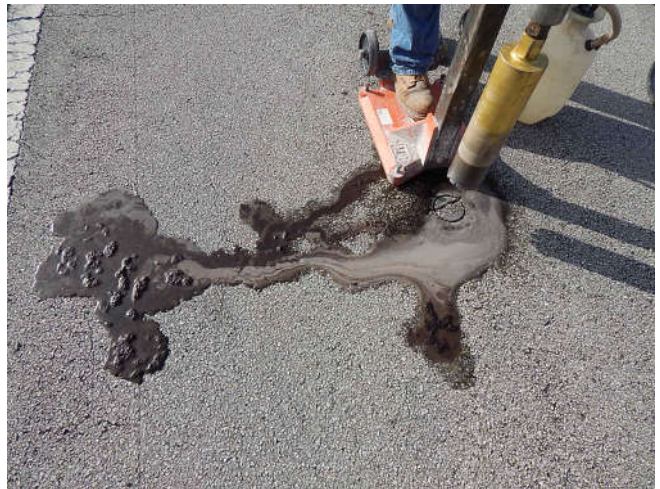
Photo 10: Weak asphalt matrix washing out of core hole C-4

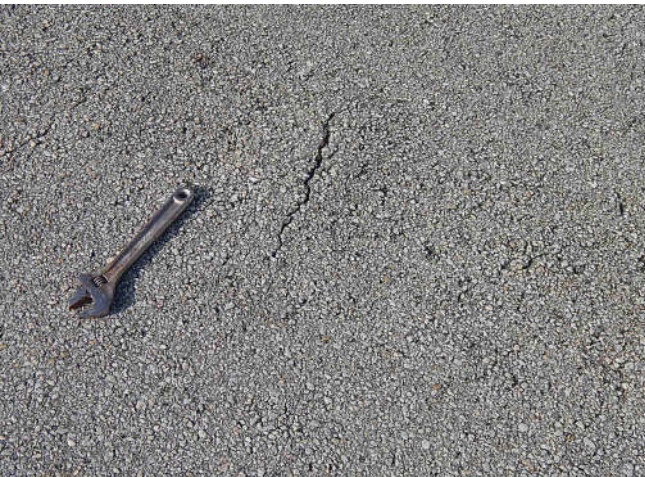
Besides strength issues, a major concern with any roadway is drainage. At this site, a significant contributor to roadway deterioration is water infiltrating the asphalt along CR 623. Water is introduced into the pavement by surface cracking and the general high porosity of the asphalt surface. These conditions permit water to enter the pavement section and subsequently forced out of the pavement by high pore pressures created from roadway traffic. The water follows the path of least resistance which is upward through the asphalt to the ground surface, see Photos 11 and 12. This process helps to weaken and degrade the asphalt pavement.

Photo 11: Release of water trapped between lifts causes uplift of asphalt

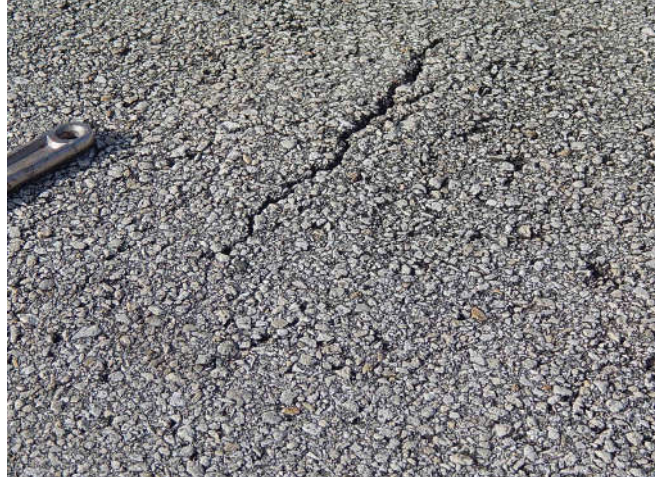
Photo 12: Close-up of Photo 11, note porous surface of asphalt
