March 9, 2020

Subject: Geotechnical Investigation for Roadway Improvements  
CR 623 (Kenilworth Boulevard)  
Between Haywood Taylor Boulevard and Mini Ranch Road  
Sebring, Florida

ATC Project No.  
Z520840003

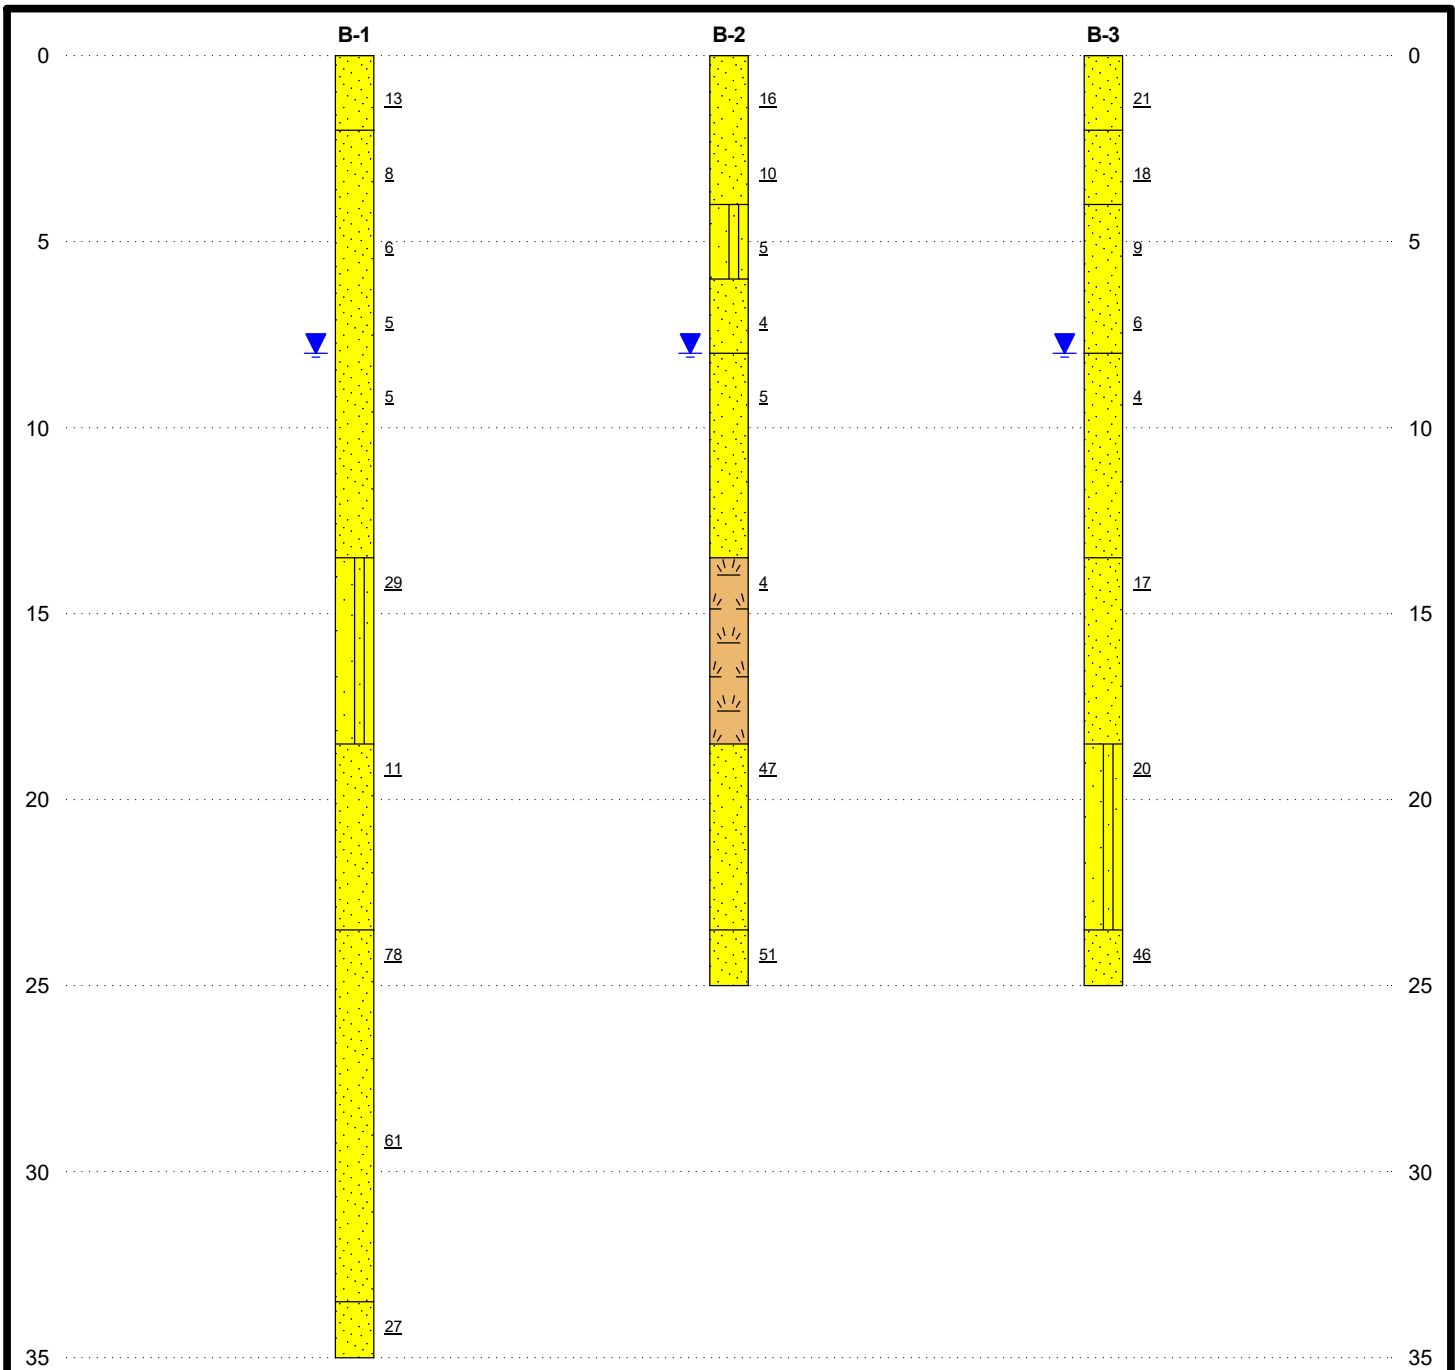
Figure 2 provides a typical section of what is occurring in the fill portion of the roadway in the area of the three borings drilled for this investigation. It is estimated that the embankment slope is about 1V:2H and the height of the embankment above the broad flat area to the north is about 15 feet.

A further complication is the fill used for the roadway was likely not compacted when it was placed. This is seen in the loose sand (low N-values) found in the borings, illustrated in the Figure 2 profile and in Table 1.

A further negative feature found in the embankment is organic material occurring in boring B-2. In general, organic material is associated with low strength conditions; however, the position (depth) of the organic material is where one would expect a shear surface to occur. Depending on the distribution and thickness of the organic soil, it may have a controlling effect on the stability.

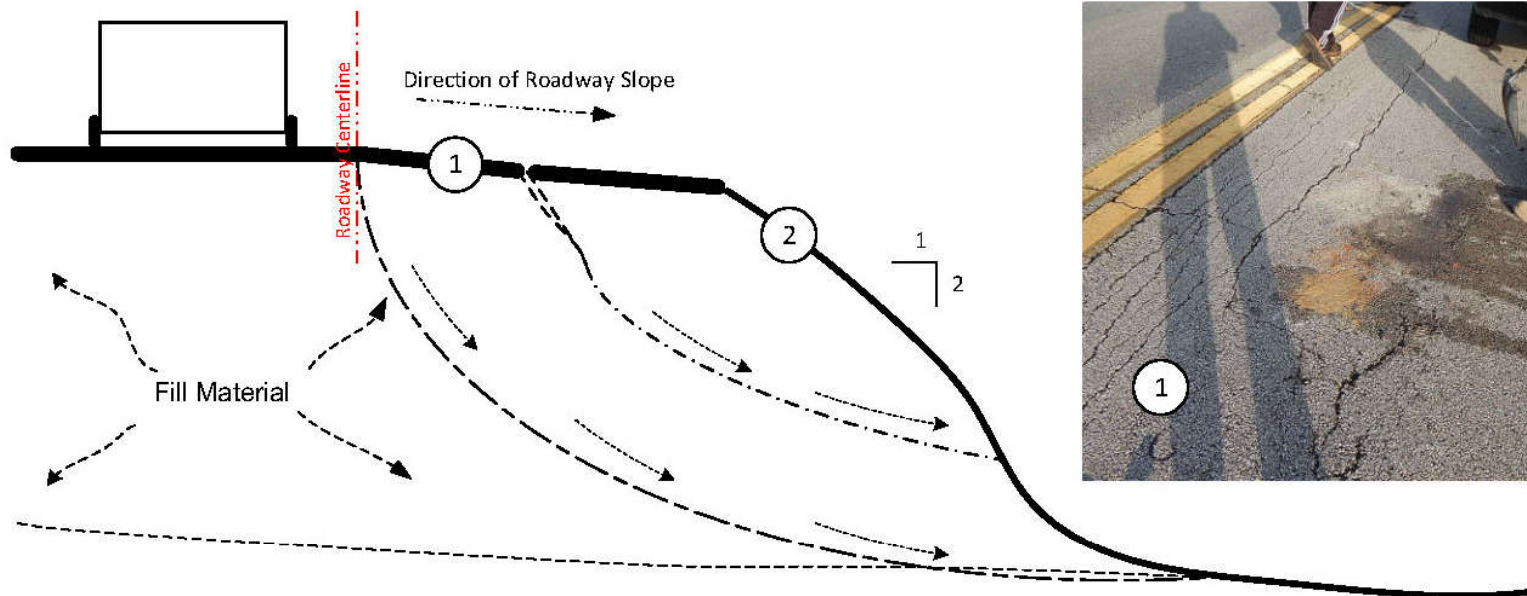
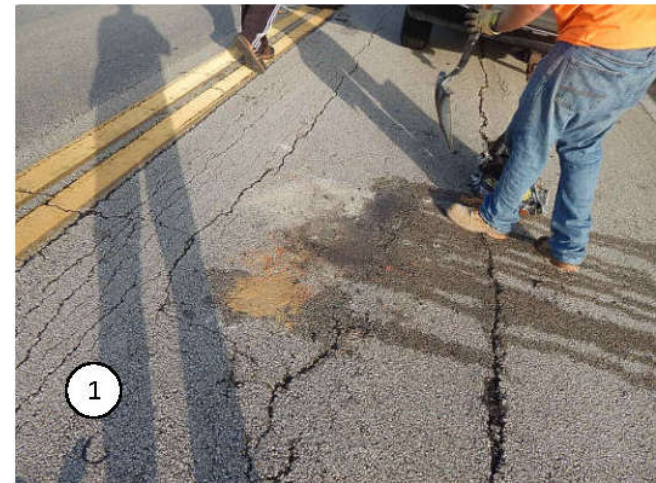
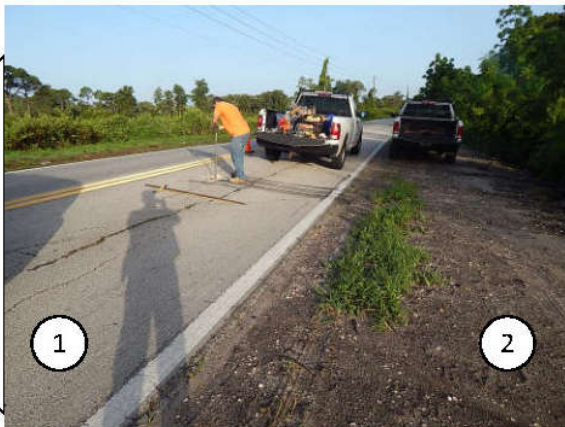
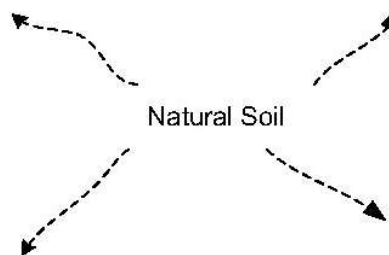
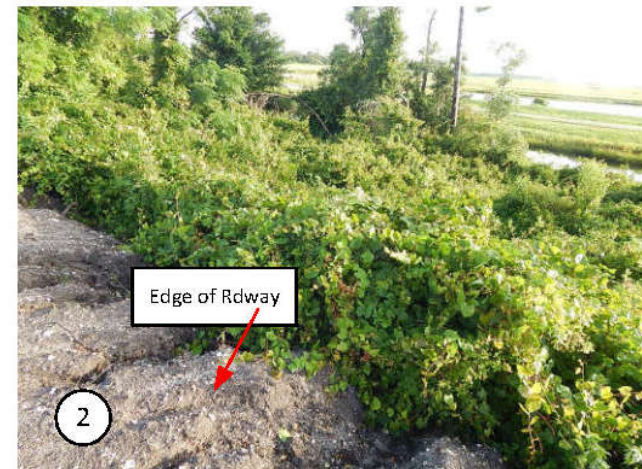
Figure 3  
Typical Stability Section

For the most part, the studied section of roadway appears to have been developed by a combination of cut on the south side of the roadway and fill on the north side of the roadway. It is the north side of the roadway that has developed tension cracks that extend in an approximate north-south directions (see Figure 3 in Appendix 1). These cracks indicate that the roadway is moving downward as shown in the figure.

The tension cracks shown in Figure 3 are indicative of slope movement as illustrated in the figure. The presence of these tension cracks suggests that there are existing failure surfaces in the slope that must be mitigated to prevent further cracking in new or renovated pavement. If this slope is not stabilized, cracking will continue in the new pavement.

The most cost effective method of stabilizing the slope is to first remove the vegetation on the side slope in the areas where longitudinal cracking occurs. Following removal of the surface vegetation, the slope should be inspected for any zones of debris or zones of concentrated organic material. If present and of sufficient extent, these zones could serve as a plane for slippage. If such a condition exists, it may indicate fill was dumped on existing debris or organic material which could serve as a plane of weakness. Remediation of the presence of deposits of organic material and other conditions will depend on the type of material and its vertical and horizontal extent.

Following removal of the vegetation growing on the slope and inspection of the slope, the slope should be flattened to attain a slope as close to 1V:3H as possible. This should be accomplished by adding fill to the slope to extend the toe of the slope closer to the drainage ditch near the toe of slope. Prior to placing fill on the slope, the existing slope should be scarified and the new granular fill placed in a maximum loose lifts thickness of 18-inches. The new fill should be tracked-in by the use of a dozer or other tracked vehicle.

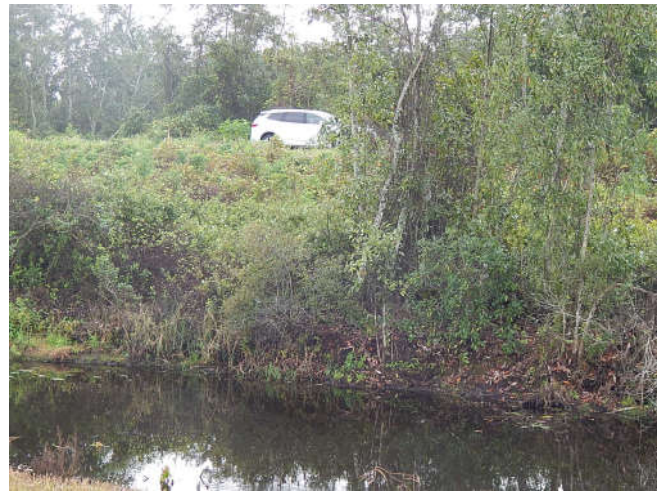
Photo 4: View of slope below roadway (in the area of B-1)

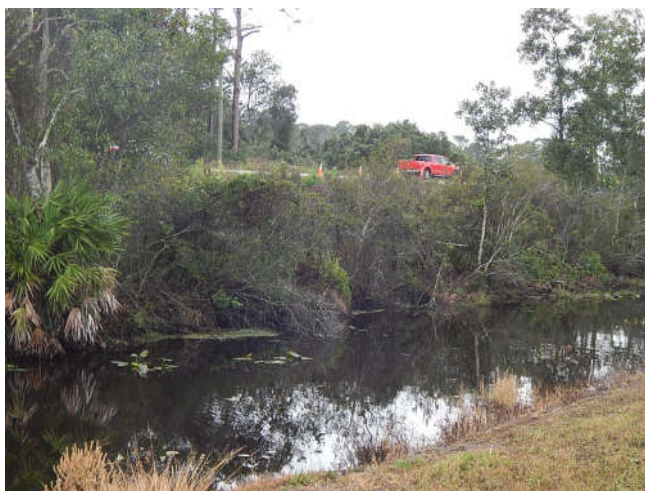
Photo 8: Roadway slope in the vicinity of B-2

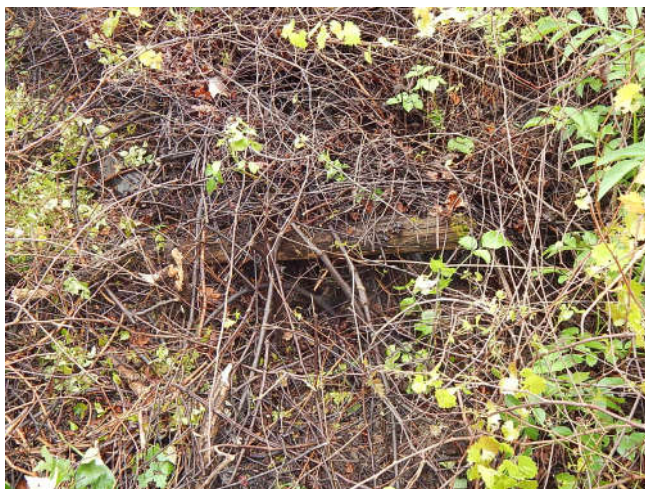
Debris consisting of tires and wood materials was exposed in some areas of the slope (see site photos in Appendix 3). It is suspected that some of the debris consists of material thrown down the slope by passing traffic although there is some evidence that the material may have been in the original fill used to form the embankment. The presence of this material has a negative impact on slope stability since it may define a zone of weakness in the slope.

Photo 10: Various debris was found in the slope (tires, timber etc)

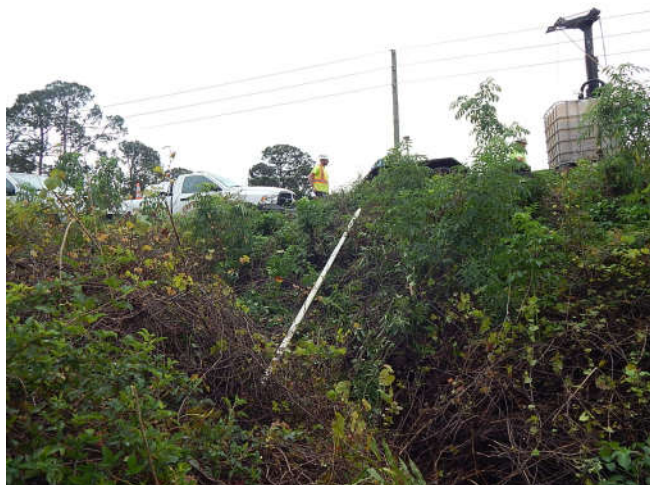
Photo 11: Typical vegetation covering slope (5 foot rod on slope)

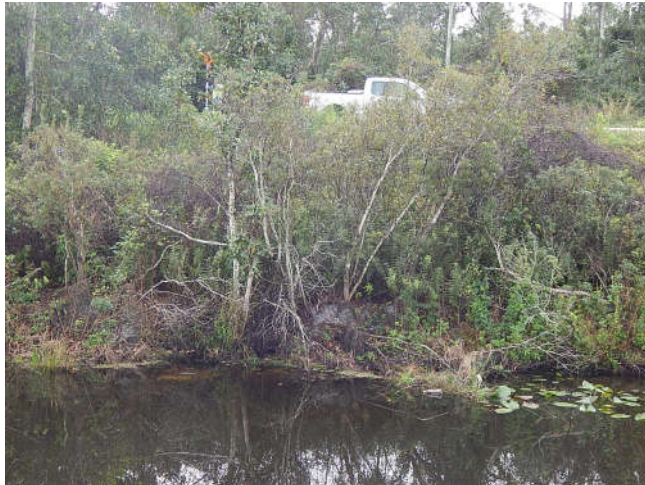
Groundwater was found in all borings at a depth of approximately 8.0 feet bls. Groundwater was not found to intersect the downstream slope face in any areas visible from limited observation of the cleared slope face and from observations made at the toe of slope (see photos in Appendix B). Note, accurate groundwater measurements can only be accomplished by the use of observation wells or piezometers that are monitored for a minimum period of 48 hours. It is expected that groundwater movement will follow the embankment slope and intersect the ground surface at the stream found at the toe of slope.

Photo 12: Stream flow at the base of the slope
