Asbestos & Lead Based Paint Assessment

City of Spartanburg
130 Duncan Street
Spartanburg, South Carolina 29306

Project Number: 0519-118

June 24, 2019

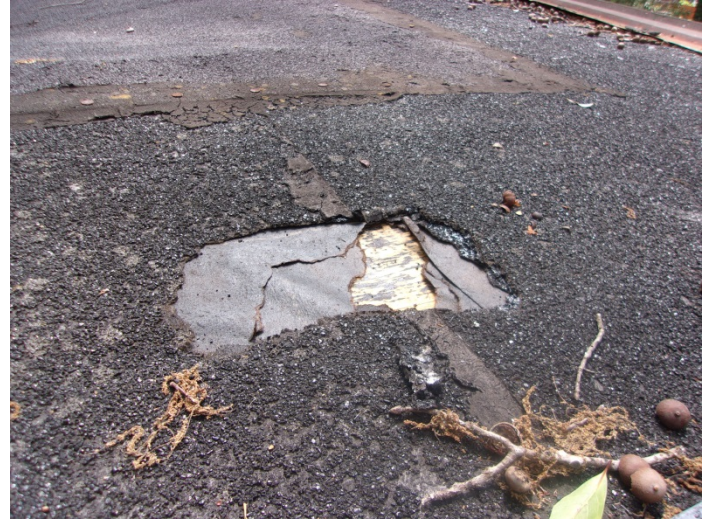
- Approximately 400 SF of roll roof shingles (1 layer) with felt (1 layer) & tar on the house roof.
- Approximately 20 SF of tar on 2 chimneys and 4 roof vents.
- Approximately 10 SF of 9" x 9" tan floor tile (floor tile only) in the kitchen landing.
- Approximately 240 SF of 9" x 9" black floor tile (floor tile only) under carpet in the big left room.

Photo 2 – Roll roof shingles with felt & tar on the house roof

1. Demolish the residence with ACM in place and dispose of the waste stream as friable Regulated Asbestos Containing Materials (RACM) and delivered to an asbestos approved hazardous waste landfill for disposal.

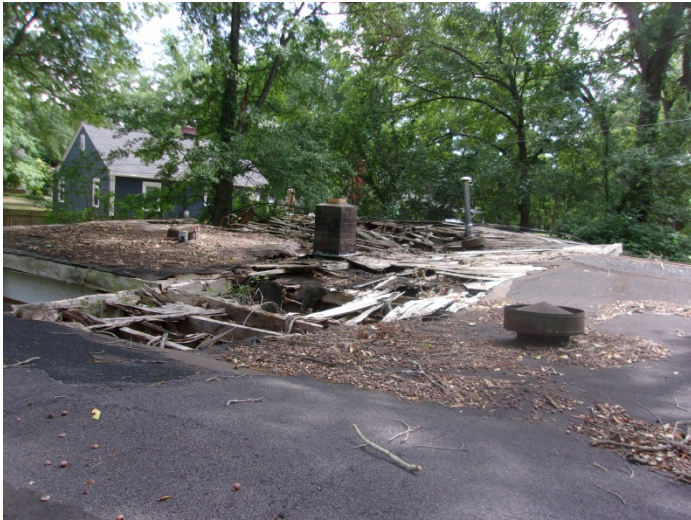
Photo 3 – Tar on 2 chimney's & 4 vents & roll roof shingles with felt & tar on the house roof

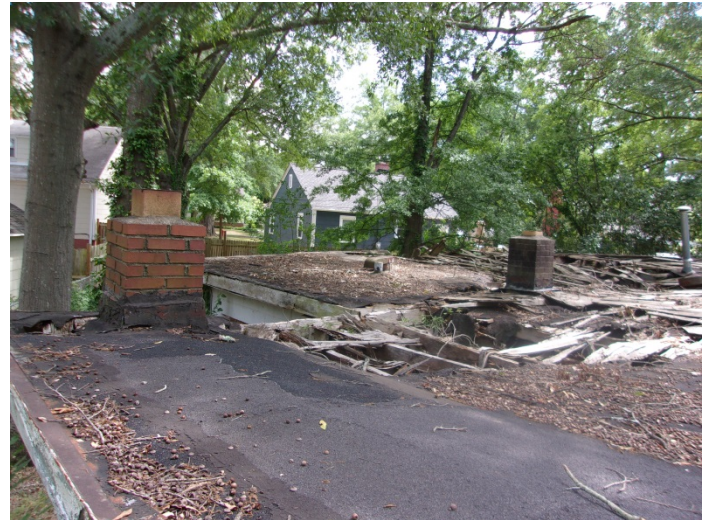
Photo 4 – Tar on 2 chimney's & 4 vents & roll roof shingles with felt & tar on the house roof

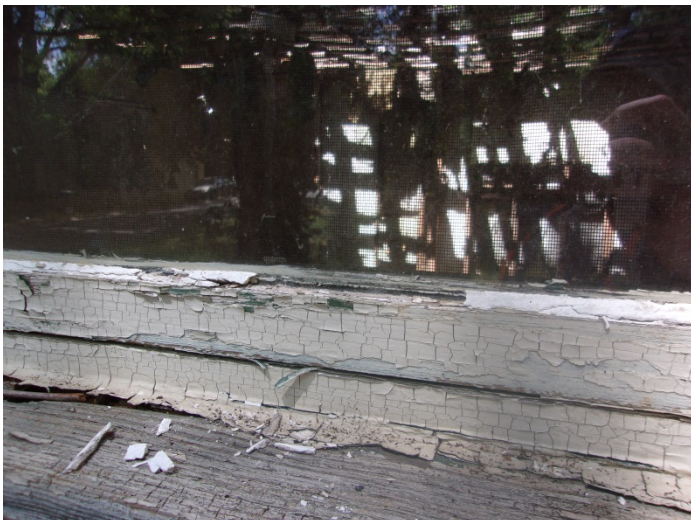
Photo 5 – Wooden window glazing

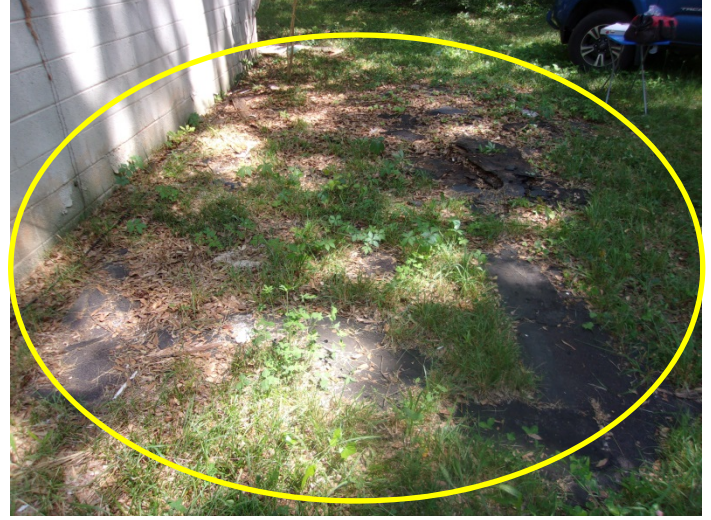
Photo 6 – Roll roof shingles & built-up roofing debris pile on the ground to the right side of the front of the house

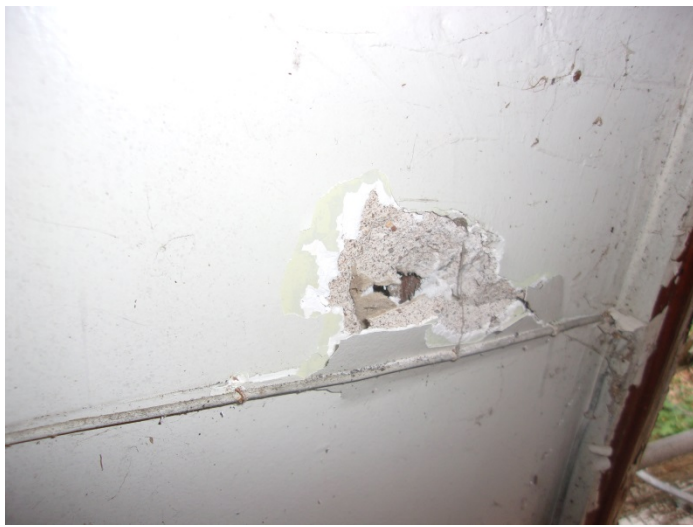
Photo 7 – Plaster & finish throughout on the walls

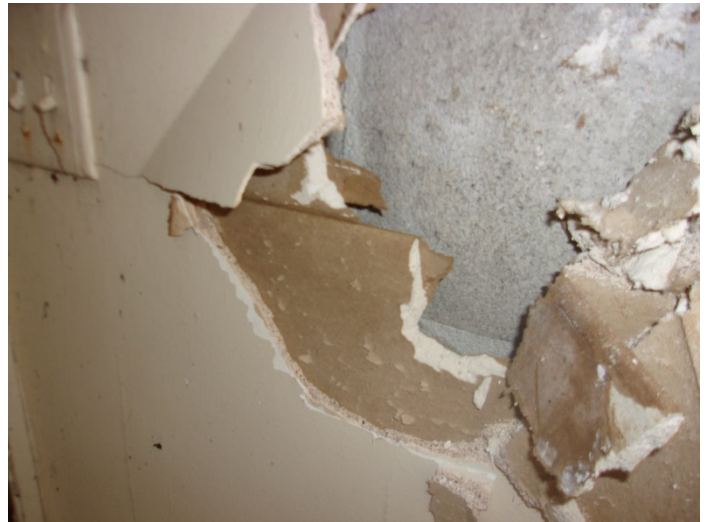
Photo 8 – Unfinished drywall beneath the plaster walls throughout

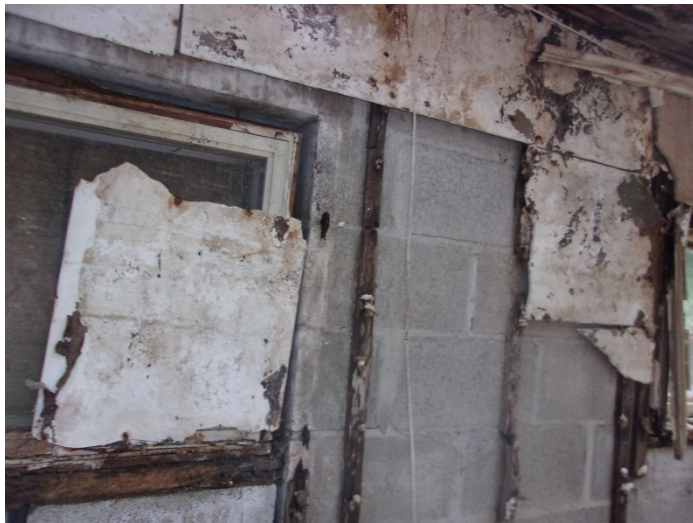
Photo 9 – Unfinished hard white wall beneath the plaster walls throughout

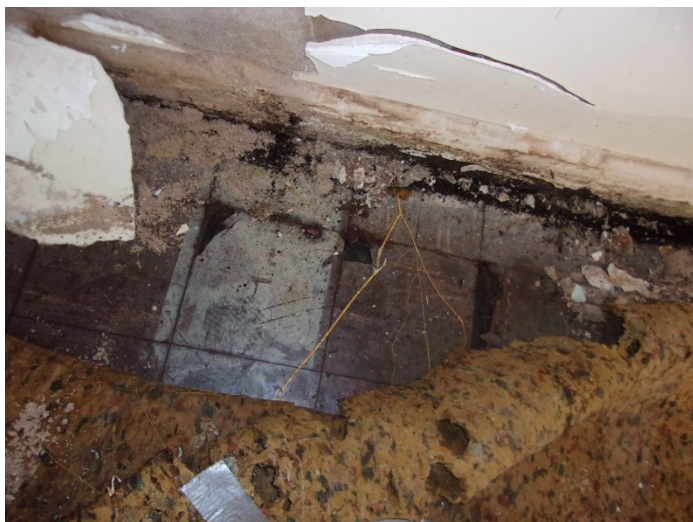
Photo 11 – 9" x 9" black floor tile & black mastic in the left big room under carpet

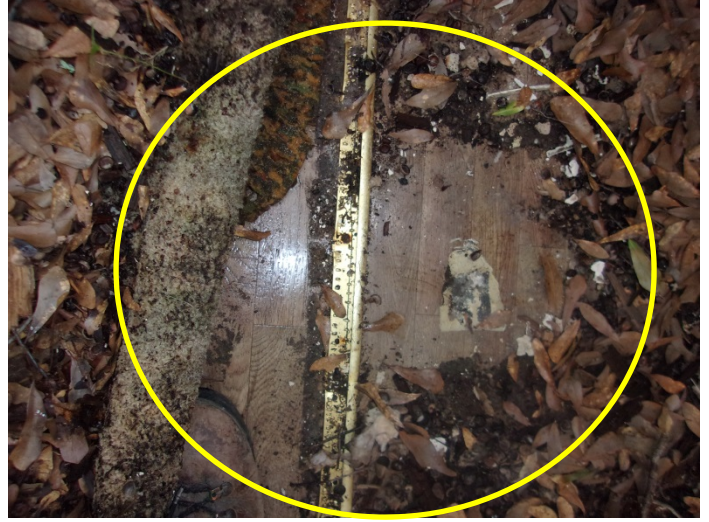
Photo 12 – Wooden plank pattern vinyl floor & mastic in the kitchen landing, bathroom, right big room under carpet & front door entry

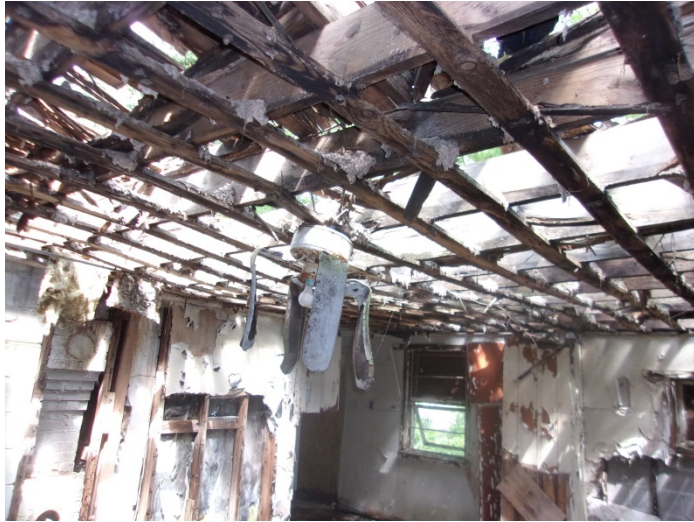
The roof of the residence is either missing or is collapsed and the framing above the ceiling is exposed throughout. Portions of the roof/ceiling appear to be unstable. No roofing materials were observed within the residence. A large amount of leaf litter was observed throughout the floors of the residence. A full assessment and sampling was performed throughout the residence, however safety concerns may exist due to unstable roofing while performing abatement activities on the roof and inside the residence. Apex recommends that the building be demolished in place and materials be treated and disposed of as friable ACM.

Photo 13 – View of right room with the damaged ceiling & missing lining/roof

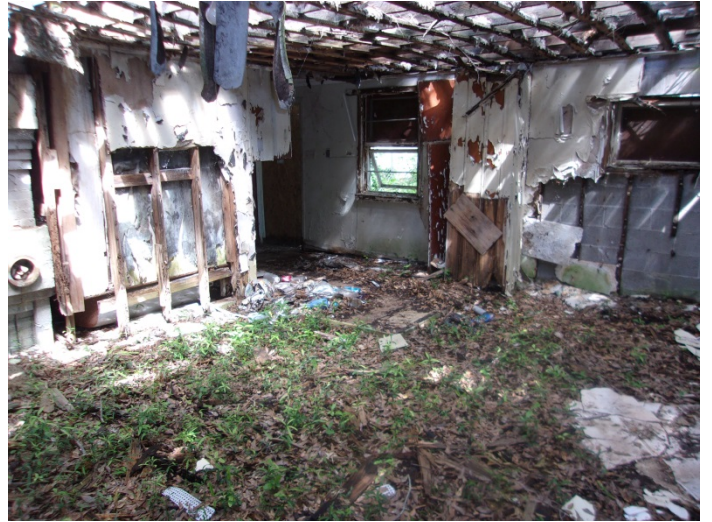
Photo 14 – View of right room with the damaged ceiling & missing lining/roof & large amount of leaf litter on floor

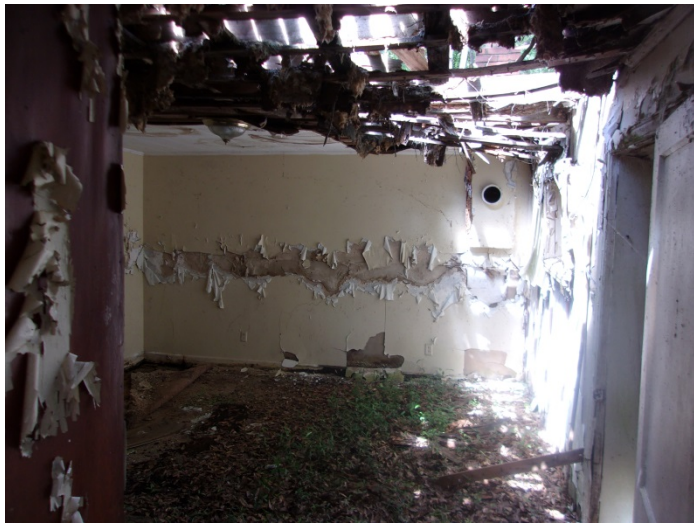
Photo 15 – View of the left room with the damaged & collapsed ceiling/roof & large amount of leaf litter on floor
