Asbestos & Lead Based Paint Assessment

City of Spartanburg
158 Bomar Avenue
Spartanburg, South Carolina 29306

Project Number: 0519-118

July 22, 2019

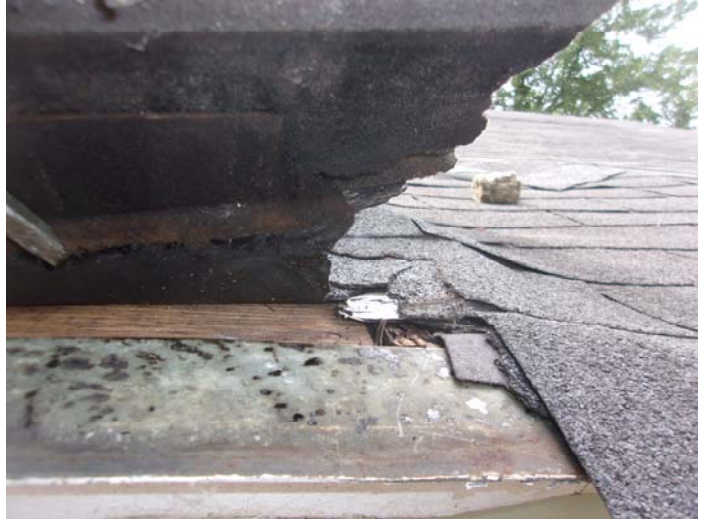
Photo 2 – Roof shingles & felt

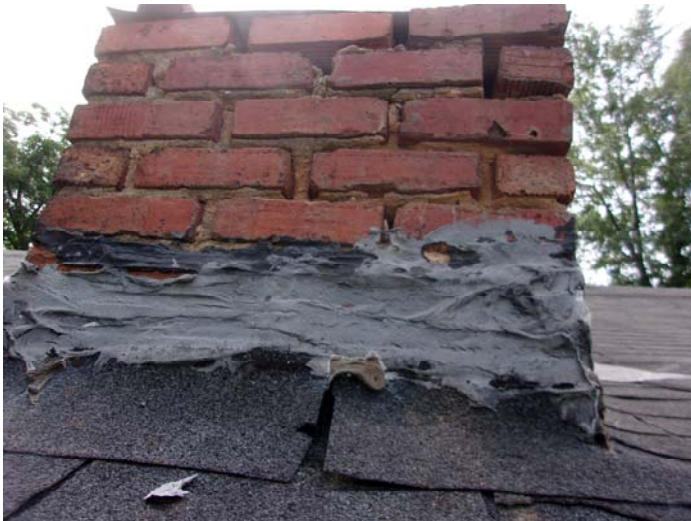
- Approximately 2,850 SF of drywall wall & ceiling systems throughout. Drywall systems also exist beneath wooden wall panels & 12" x 12" wooden ceiling tiles on a grid system.
- Approximately 18 LF of tar on 3 chimneys.

Photo 3 – Chimney with tar

1. Abate the asbestos containing materials in the structure prior to renovation or demolition.
2. Follow applicable asbestos regulations during renovation or demolition of the structure. You should be aware that stringent requirements are imposed upon anyone renovating or demolishing a structure in which ACM will be disturbed. This work must be performed in accordance with OSHA asbestos regulations, 29 CFR 1910 & 1926, and NESHAP asbestos regulations 40 CFR 61, subpart M. South Carolina regulations require the accreditation of personnel who work in the asbestos field and notification and permitting fees for asbestos removal projects. There is a 10 working day notification period required prior to abatement of asbestos in a facility. Failure to take proper precautions and actions to protect human

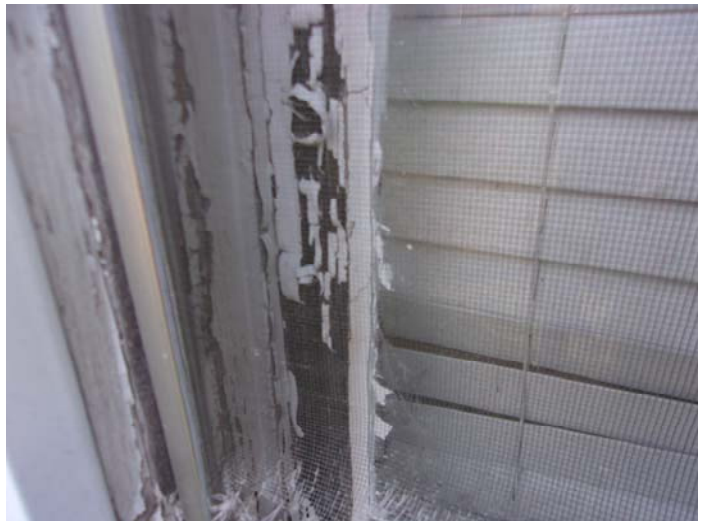
Photo 4 – Wooden window glazing

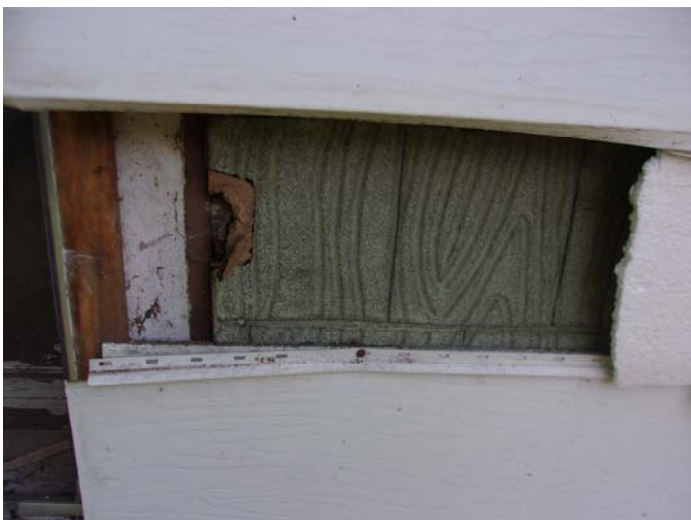
Photo 5 – Pressboard siding with shingle layer under metal

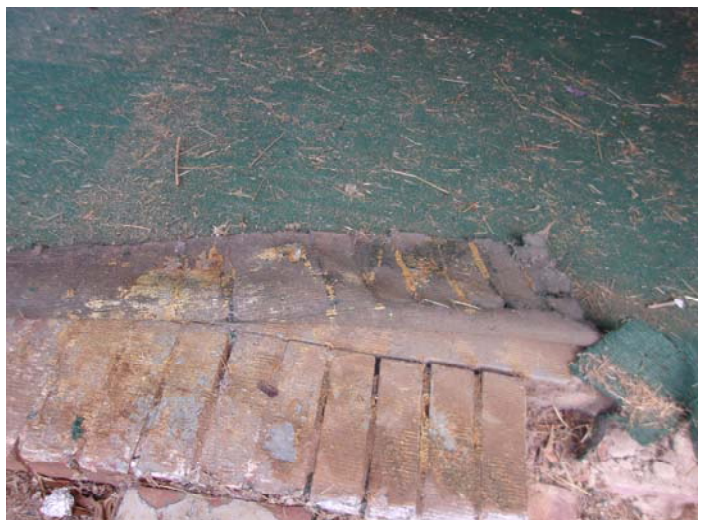
Photo 6 – Adhesive under green carpet on front porch

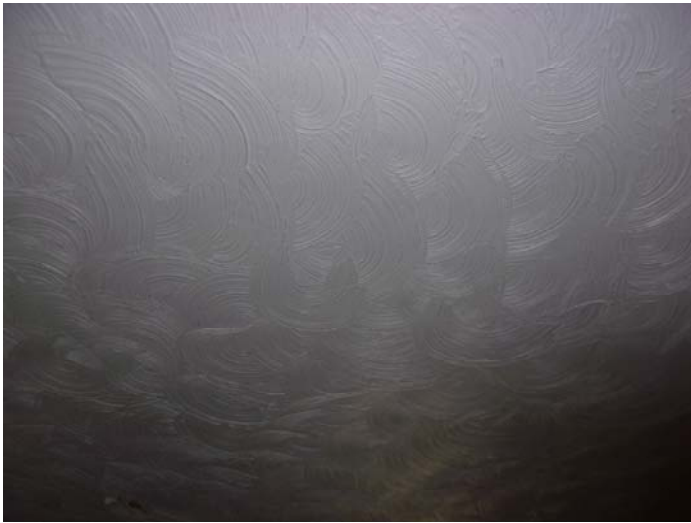
Photo 7 – Swirl pattern ceiling texture in the living room

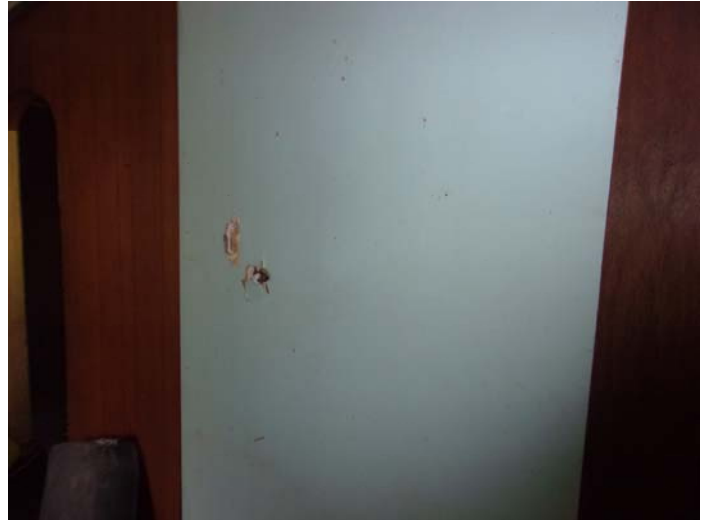
Photo 8 – Drywall with joint compound & tape under wooden wall panels

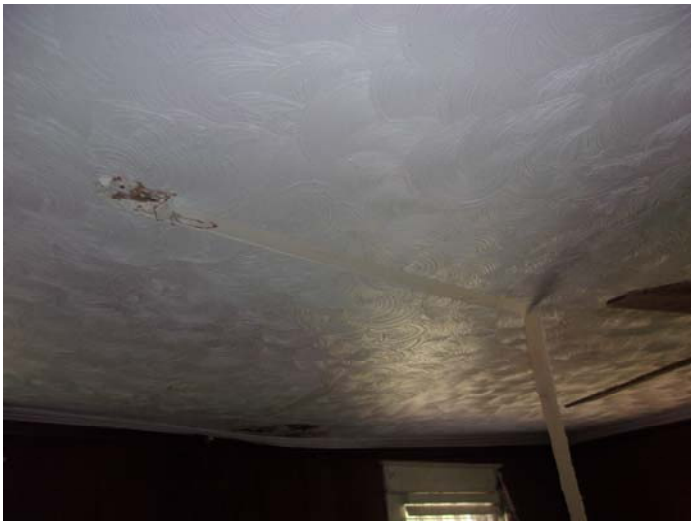
Photo 9 – Drywall with joint compound & tape

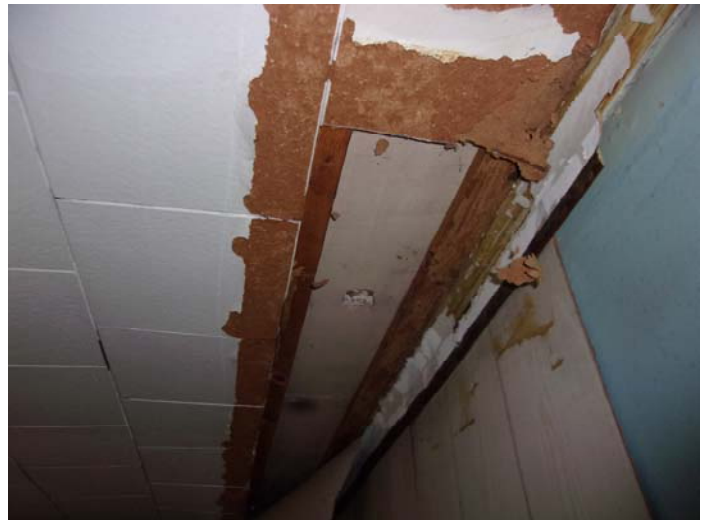
Photo 10 – Drywall with joint compound & tape under 12" x 12" wooden ceiling tiles

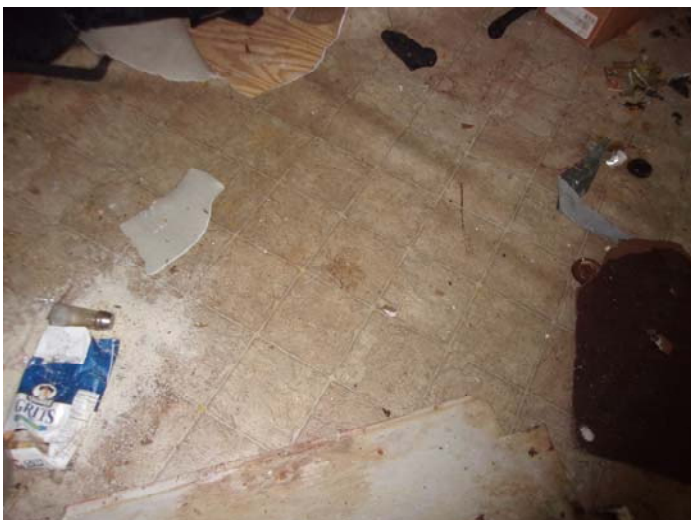
Photo 11 – Tan square pattern vinyl floor with no mastic in the kitchen

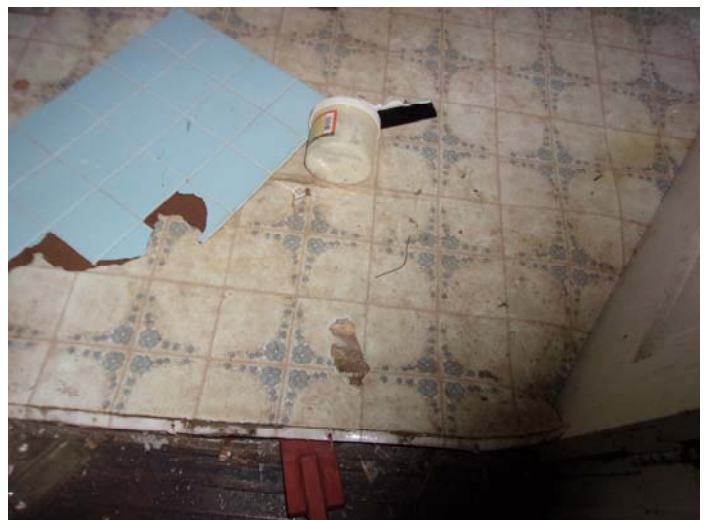
Photo 12 – Tan square & blue flower pattern vinyl floor & mastic in the bathroom

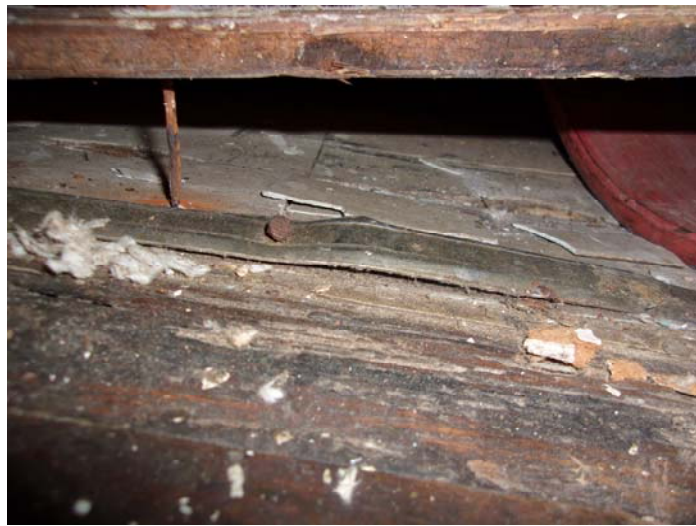
Photo 13 – White floor tiles & mastic in the bathroom under wooden flooring
