## **Asbestos & Lead Based Paint Assessment**

City of Spartanburg  
558 Hugh Street  
Spartanburg, South Carolina 29301

Project Number: 0519-118

July 22, 2019

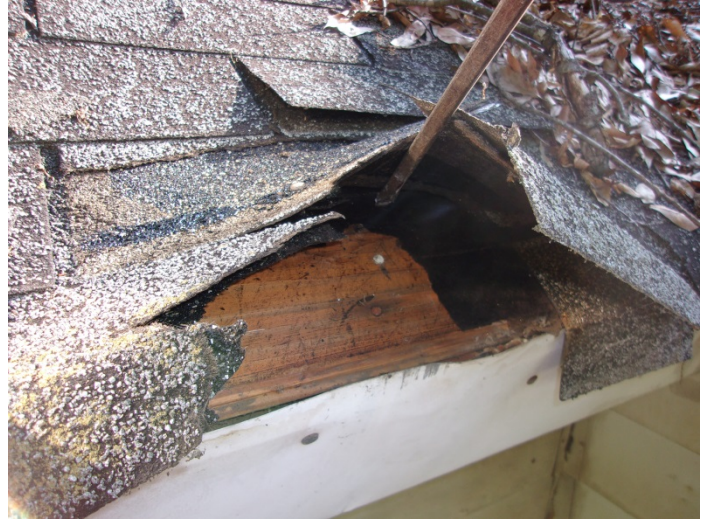
Photo 2 – Roof shingles & felt

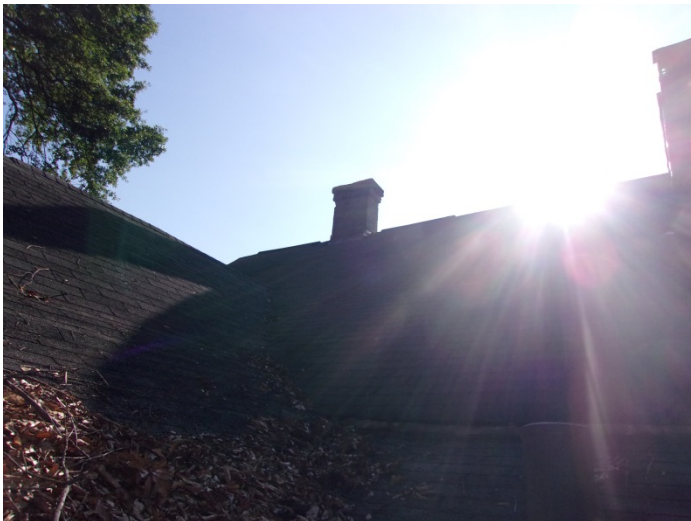
- Approximately 5 windows with gray caulk on the metal wrapping on the casings.
- Approximately 12 LF of tar on 2 chimneys – assumed positive.

Photo 3 – Chimney with tar – assumed positive

1. Abate the asbestos containing materials in the structure prior to renovation or demolition.
2. Follow applicable asbestos regulations during renovation or demolition of the structure. You should be aware that stringent requirements are imposed upon anyone renovating or demolishing a structure in which ACM will be disturbed. This work must be performed in accordance with OSHA asbestos regulations, 29 CFR 1910 & 1926, and NESHAP asbestos regulations 40 CFR 61, subpart M. South Carolina regulations require the accreditation of

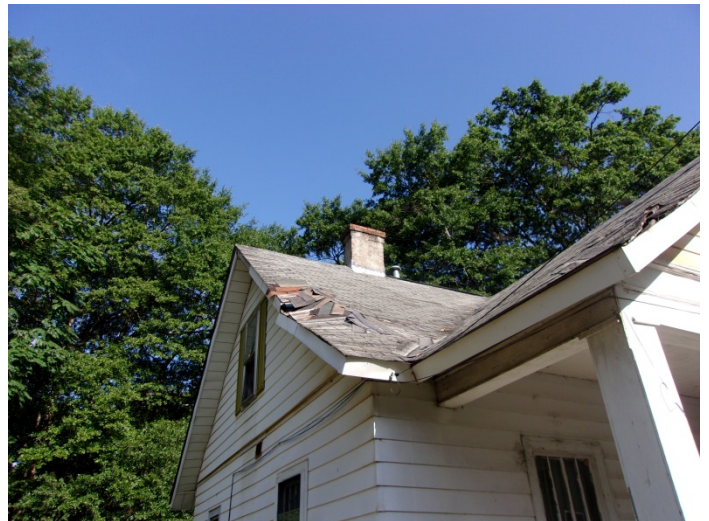
Photo 4 – Chimney with tar – assumed positive

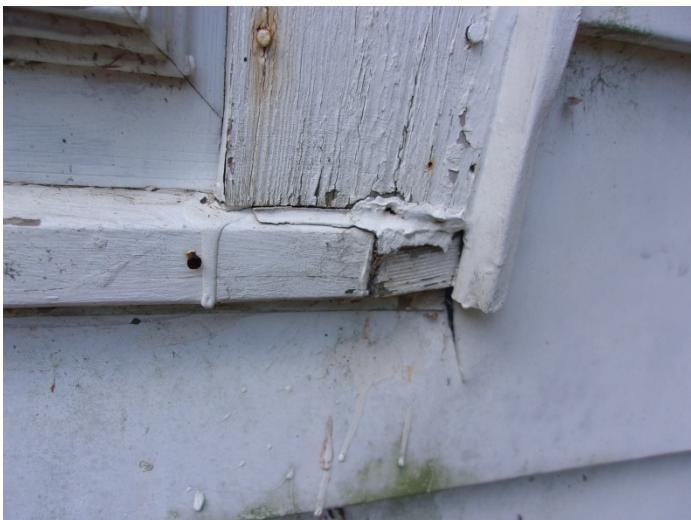
Photo 5 – White caulk on wooden window casing with no metal wrapping

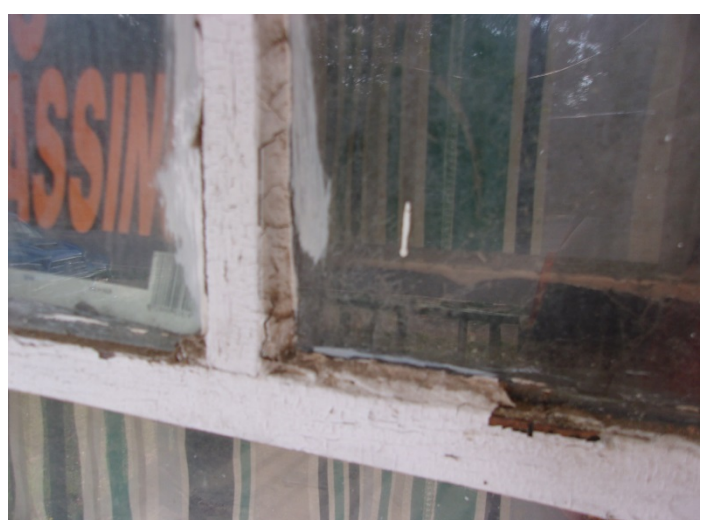
Photo 6 – Wooden window glazing

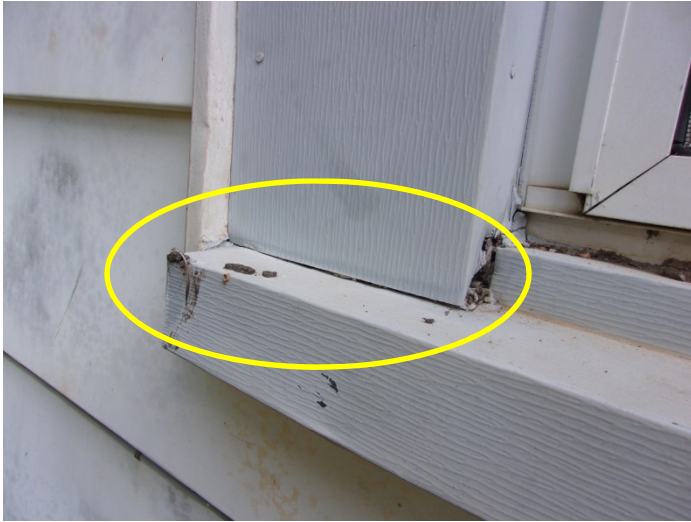
Photo 7 – Gray caulk on the metal wrapping over window casings

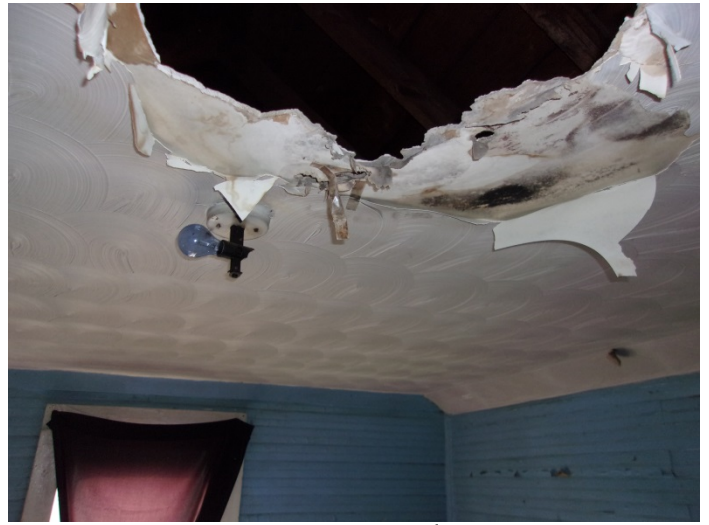
Photo 8 – Swirl ceiling texture in the 2<sup>nd</sup> floor front bedroom

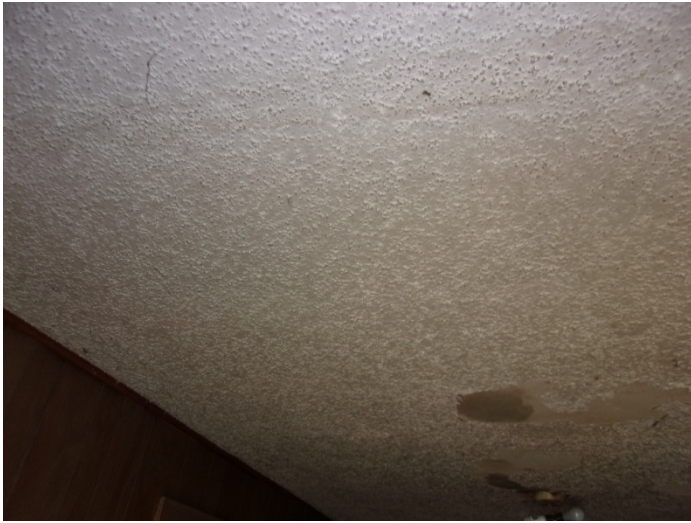
Photo 9 – Popcorn ceiling texture throughout 1<sup>st</sup> floor except in bathroom

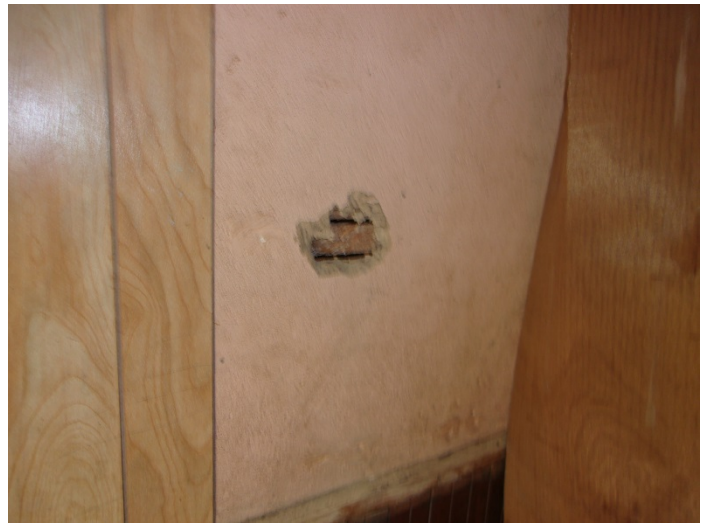
Photo 10 – Plaster with no finish throughout the 1<sup>st</sup> floor

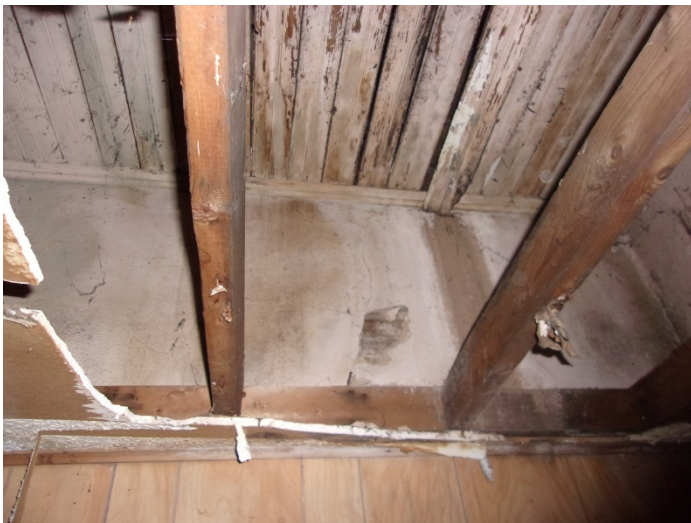
Photo 11 – Plaster with no finish throughout the 1<sup>st</sup> floor

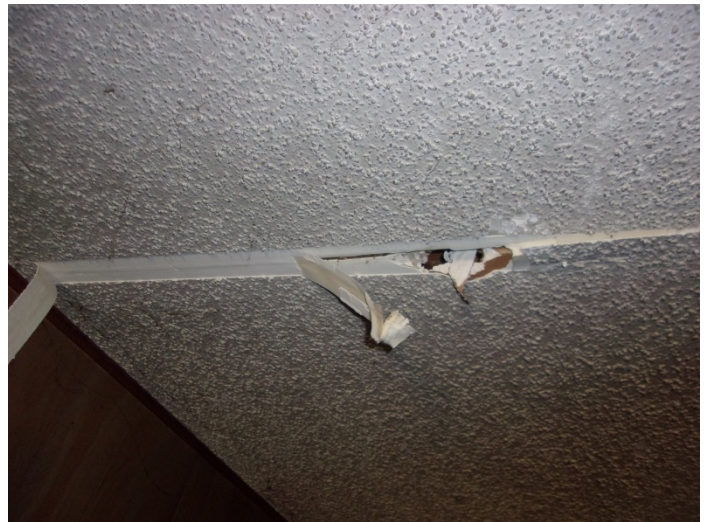
Photo 12 – Drywall with joint compound & tape throughout 1<sup>st</sup> floor ceilings; 1<sup>st</sup> floor back hallway & bathroom walls & ceilings; 2<sup>nd</sup> floor front bedroom ceiling

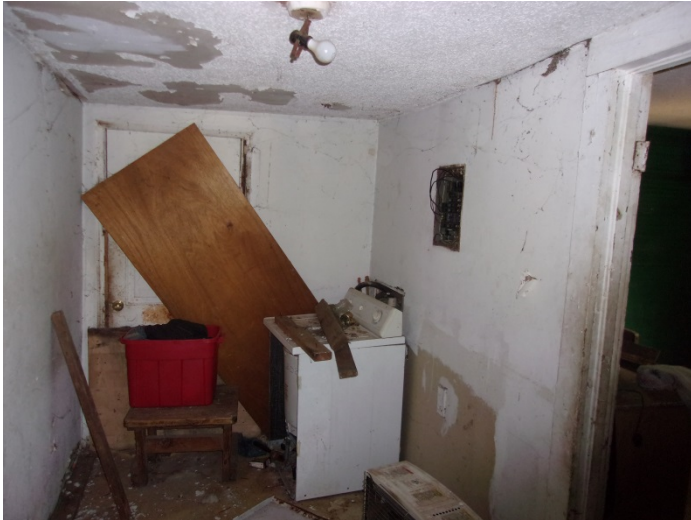
Photo 13 – Drywall with joint compound & tape throughout 1st floor ceilings; 1st floor back hallway & bathroom walls & ceilings; 2nd floor front bedroom ceiling

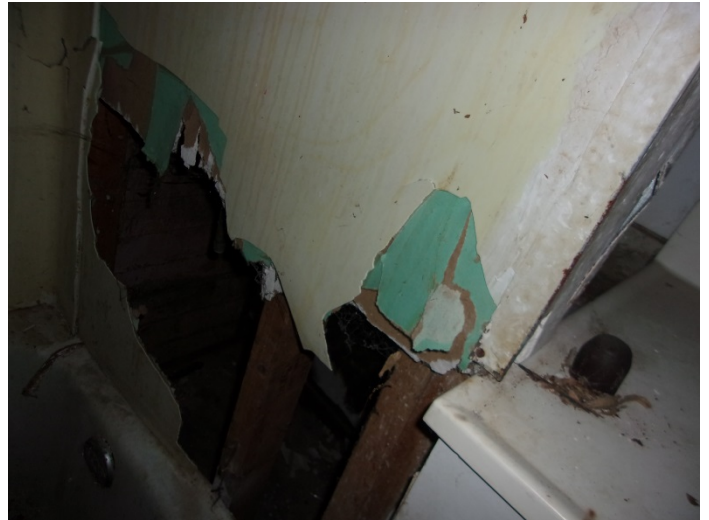
Photo 14 – Mastic beneath bathtub surround in the bathroom

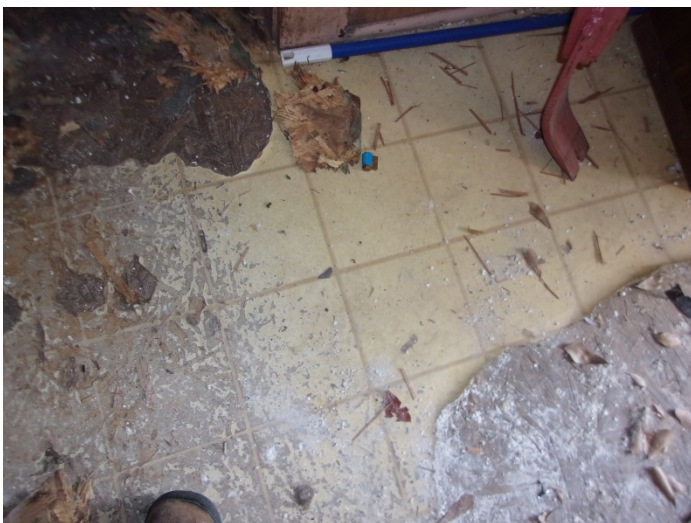
Photo 15 – Yellow medium square pattern vinyl floor & mastic in the front hallway

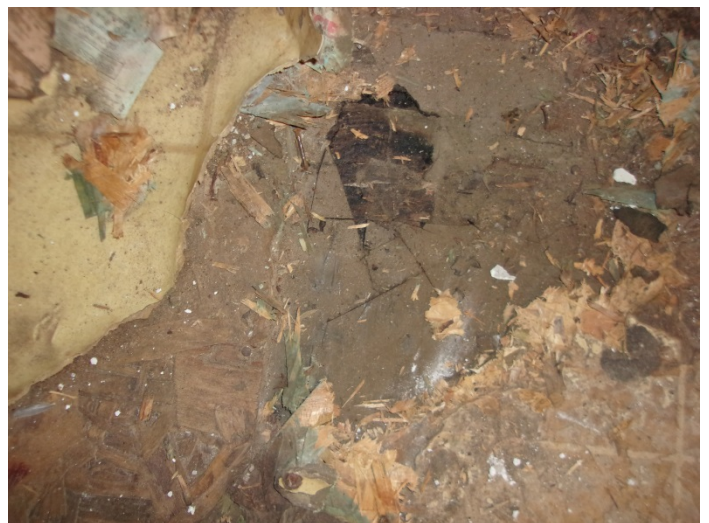
Photo 16 – Black vinyl floor & mastic in the front hallway under wood

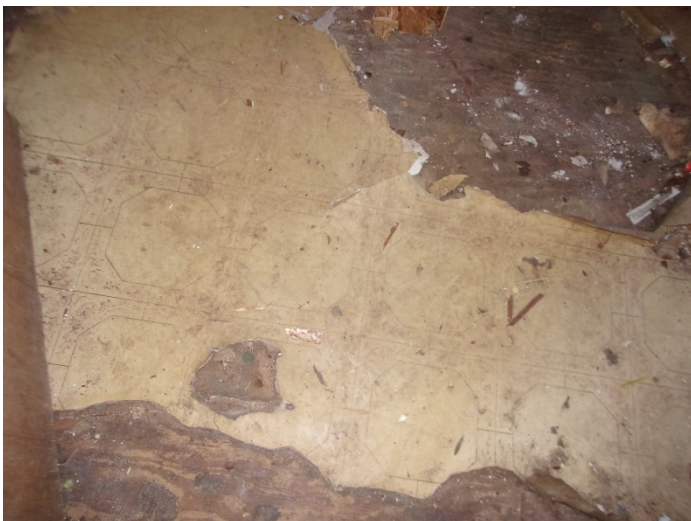
Photo 17 – Yellow square & floral pattern vinyl floor with no mastic in the back hallway

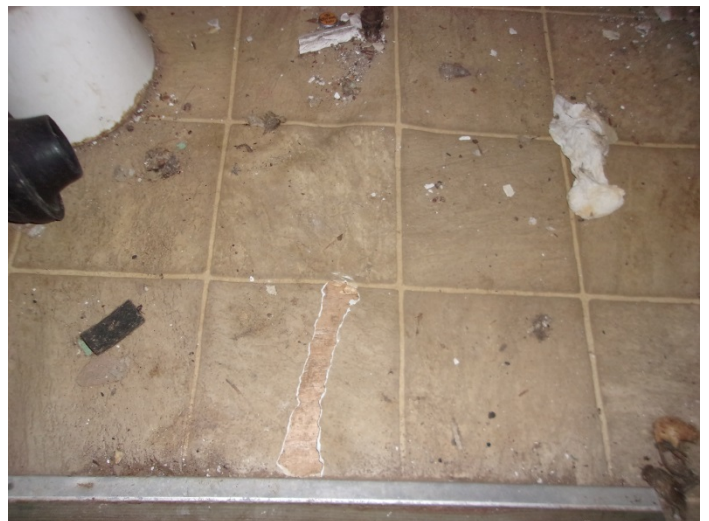
Photo 18 – Tan square pattern vinyl floor with no mastic in the bathroom

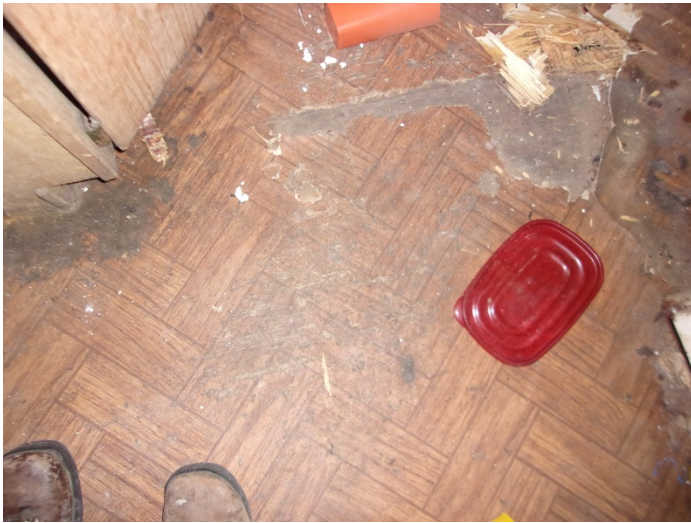
Photo 19 – Brown wooden pattern vinyl floor & mastic in the kitchen

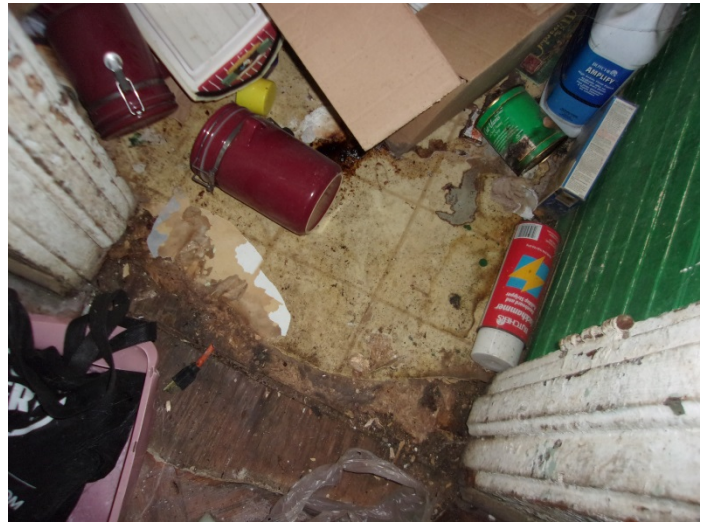
Photo 20 – Beige square pattern vinyl floor & mastic in the kitchen pantry

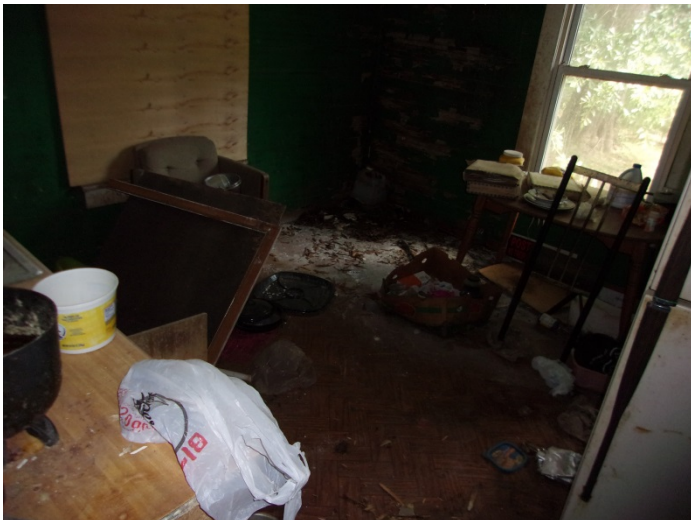
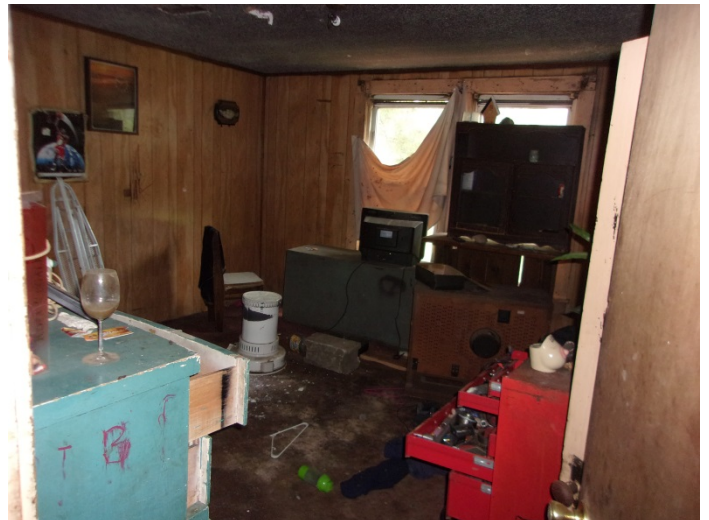
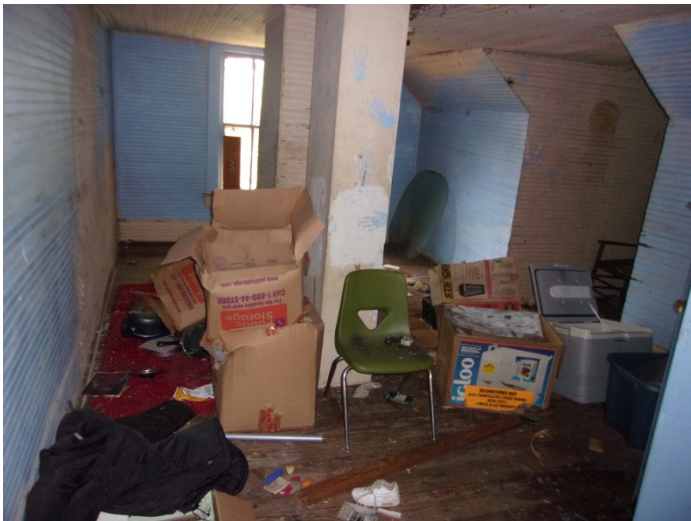
Photo 21 – Typical view of large amounts of household items & debris

Photo 22 – Typical view of large amounts of household items & debris

Photo 23 – Typical view of large amounts of household items & debris

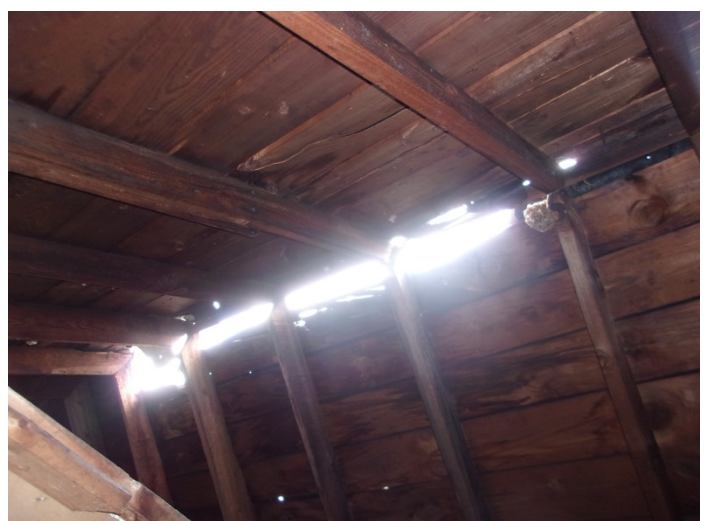
Photo 24 – View of damage to roof & ceiling
