Asbestos & Lead Based Paint Assessment

City of Spartanburg
567 Farley Avenue
Spartanburg, South Carolina 29301

Project Number: 0519-118

July 22, 2019

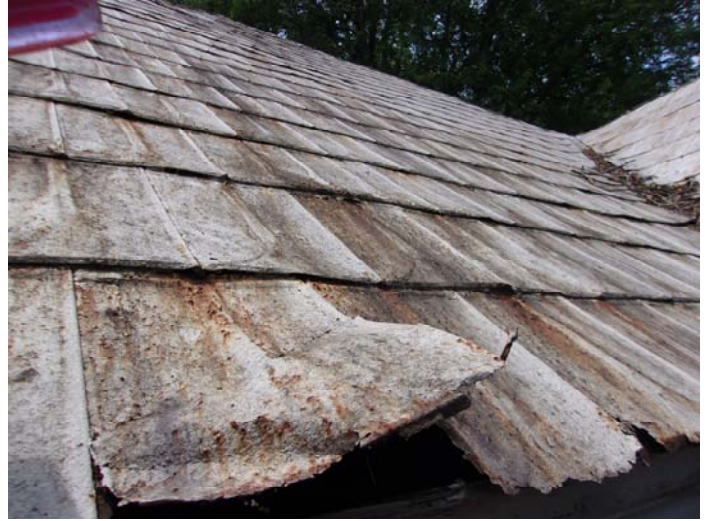
- Approximately 1,600 SF of metal roof sealant.

Photo 2 – Metal roof sealant

1. Abate the asbestos containing materials in the structure prior to renovation or demolition.
2. Follow applicable asbestos regulations during renovation or demolition of the structure. You should be aware that stringent requirements are imposed upon anyone renovating or demolishing a structure in which ACM will be disturbed. This work must be performed in accordance with OSHA asbestos regulations, 29 CFR 1910 & 1926, and NESHAP asbestos regulations 40 CFR 61, subpart M. South Carolina regulations require the accreditation of personnel who work in the asbestos field and notification and permitting fees for asbestos removal projects. There is a 10 working day notification period required prior to abatement of asbestos in a facility. Failure to take proper precautions and actions to protect human health and the environment can result in penalties, danger to personnel, and construction delays.

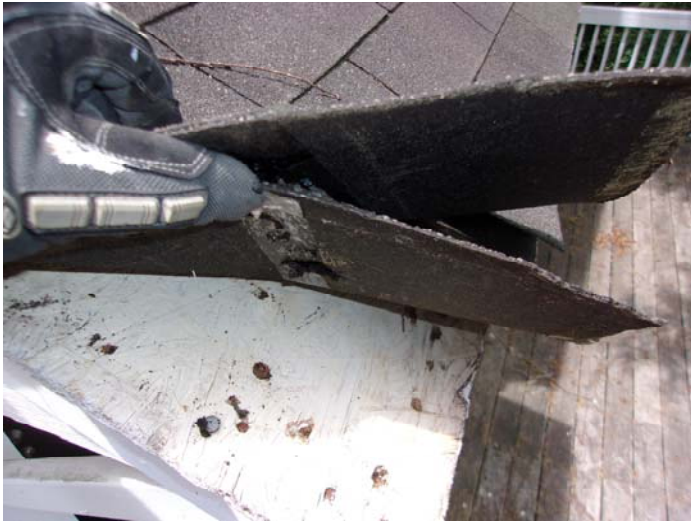
Photo 3 – Roof shingles & no felt on the front door awning

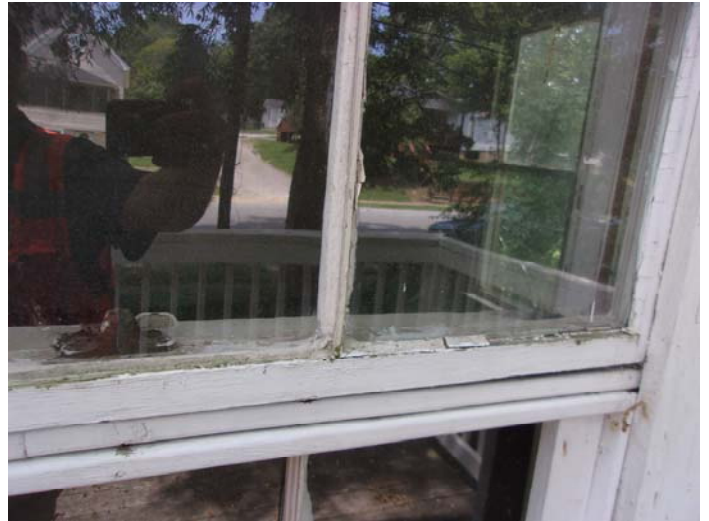
Photo 4 – Wooden window glazing

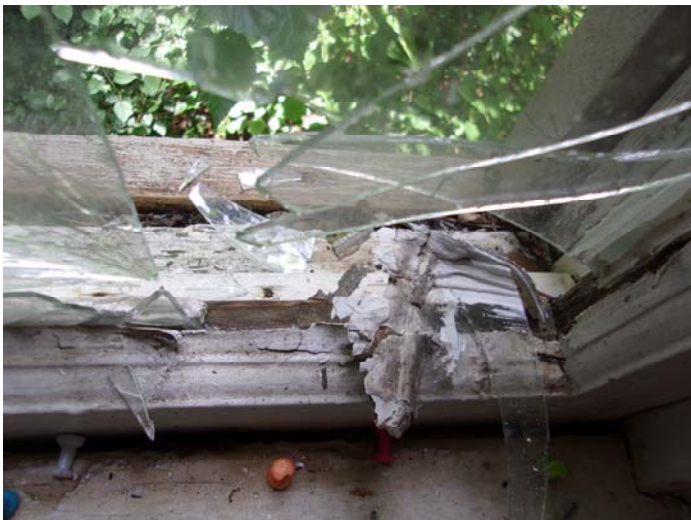
Photo 5 – Caulk on the glass panes on the wooden windows

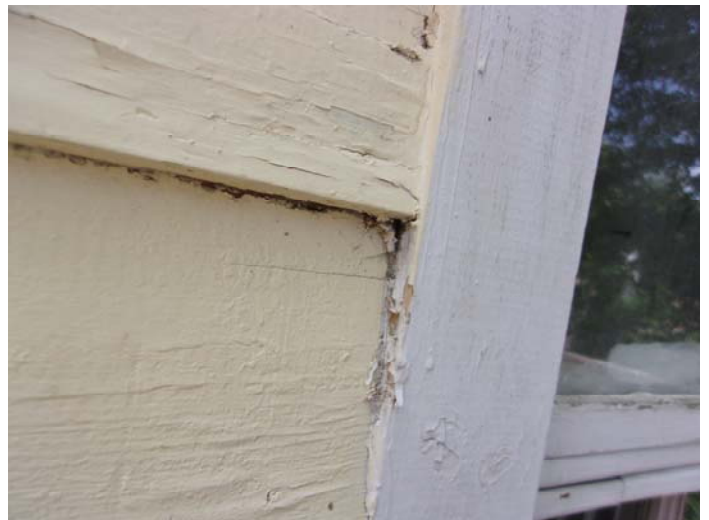
Photo 6 – Caulk on the wooden window casings

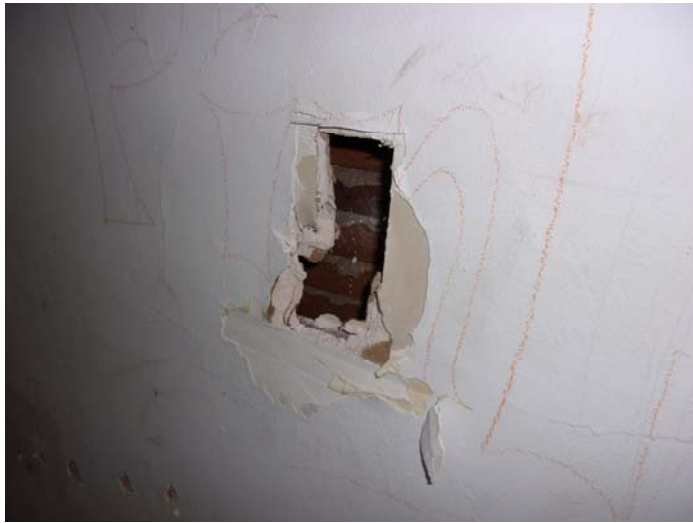
Photo 7 – Drywall with joint compound & tape throughout

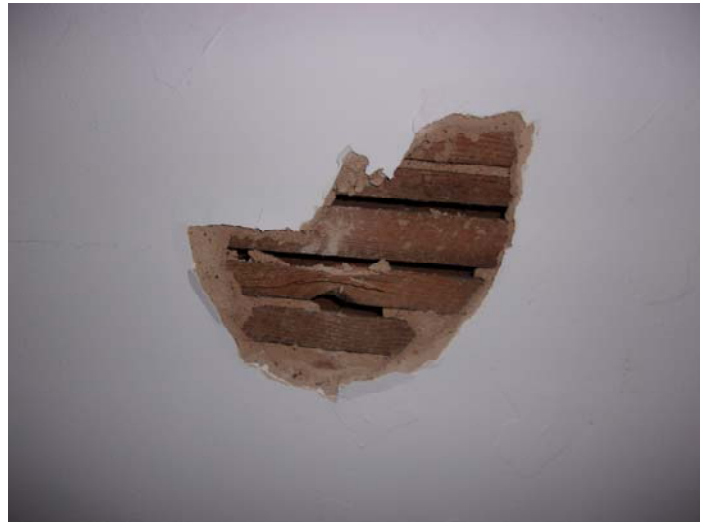
Photo 8 – Plaster with finish throughout

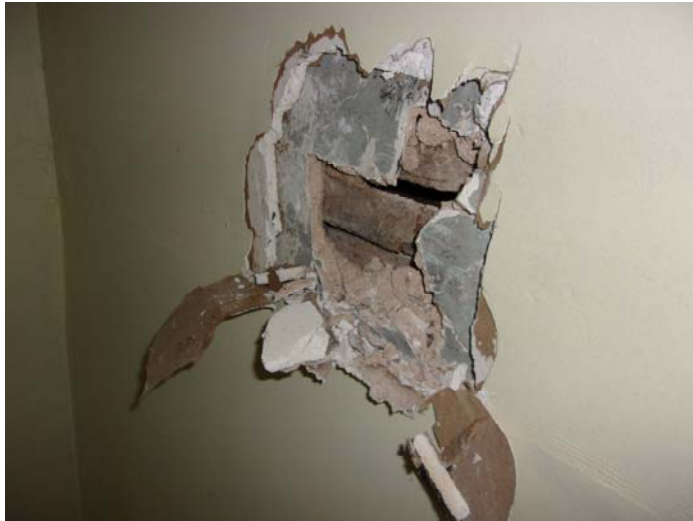
Photo 9 – Drywall with joint compound & tape over plaster with finish

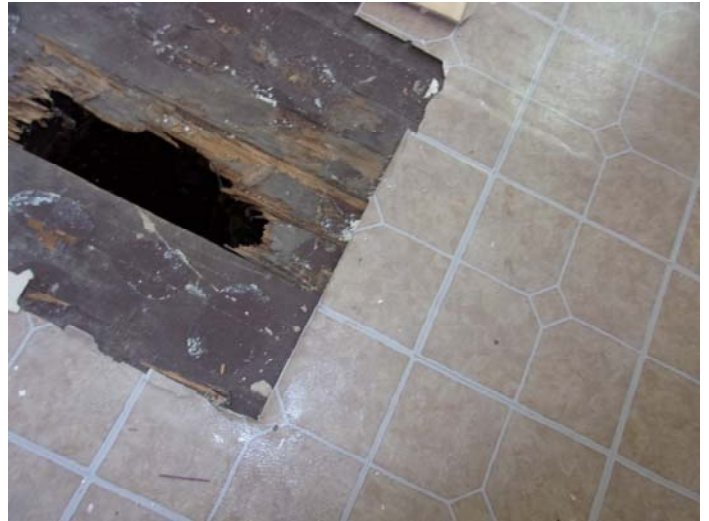
Photo 10 – Gray square diamond pattern self-stick floor tile & mastic in the main level – front left room

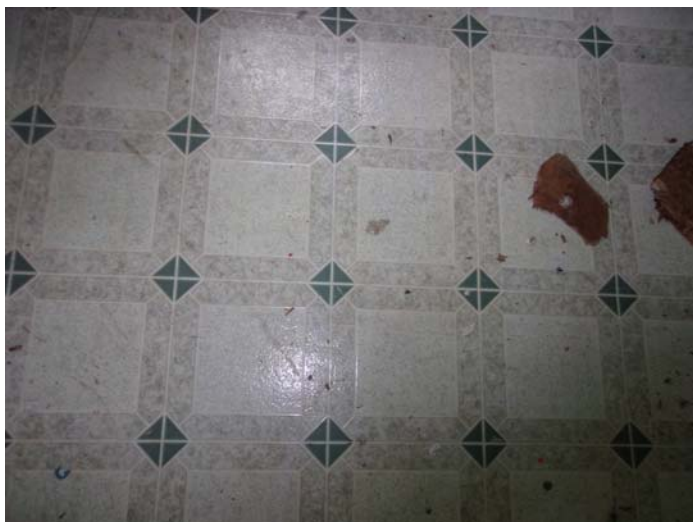
Photo 11 – Gray square blue diamond pattern vinyl floor & mastic in the main level – laundry room & bathroom

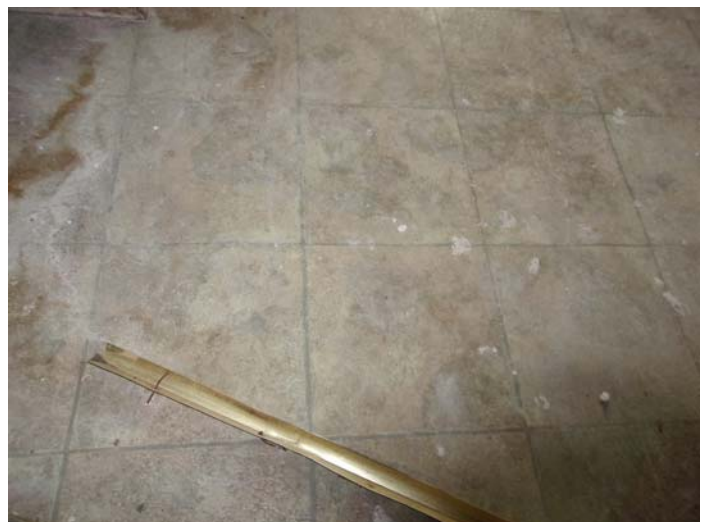
Photo 12 – Beige square pattern vinyl floor & mastic in the main level - kitchen

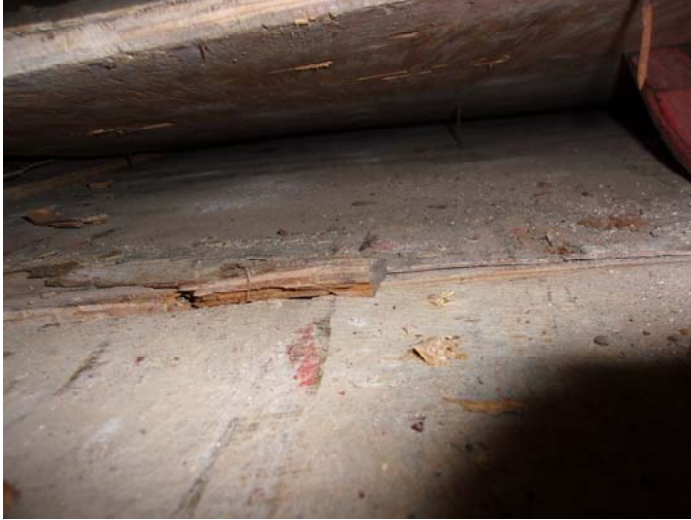
Photo 13 – Dark flooring with no mastic in the main level – kitchen under wood

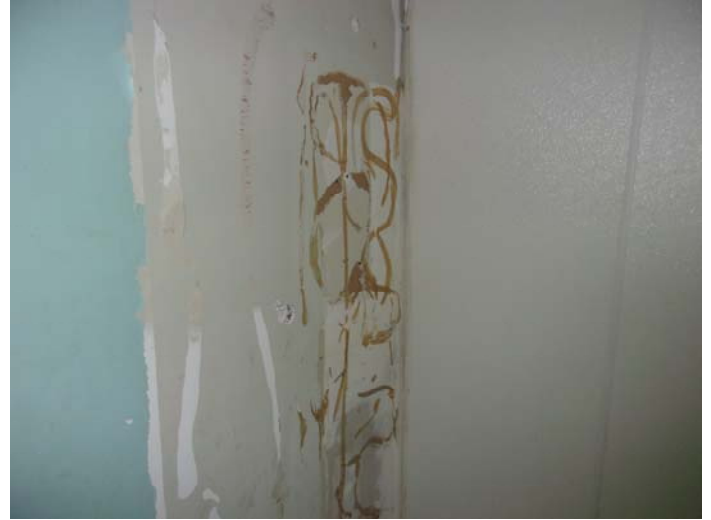
Photo 14 – Mastic under tub/shower surround in the main level - bathroom

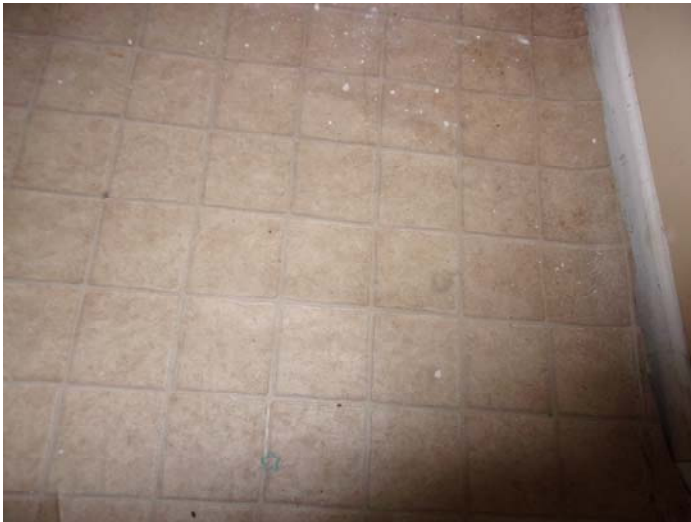
Photo 15 – Beige small square vinyl floor & leveling compound in the basement - hallway
