Asbestos & Lead Based Paint Assessment

City of Spartanburg
595 Charlevoix Street
Spartanburg, South Carolina 29303

Project Number: 0519-118

June 24, 2019

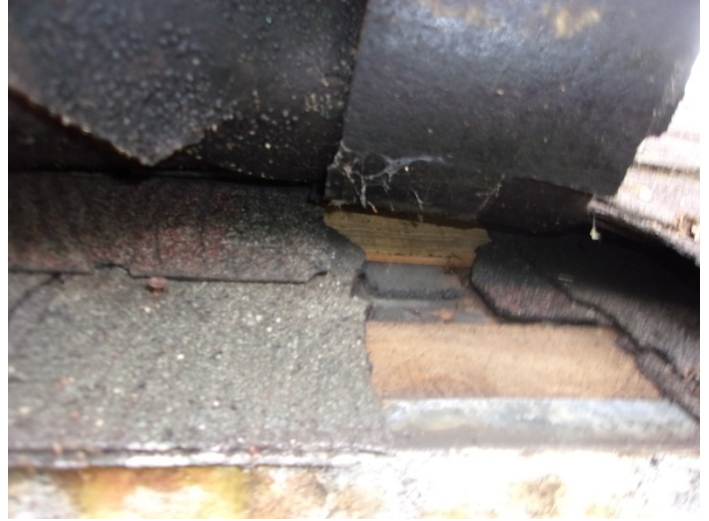
Photo 2 – Roof shingles & no felt on the roof

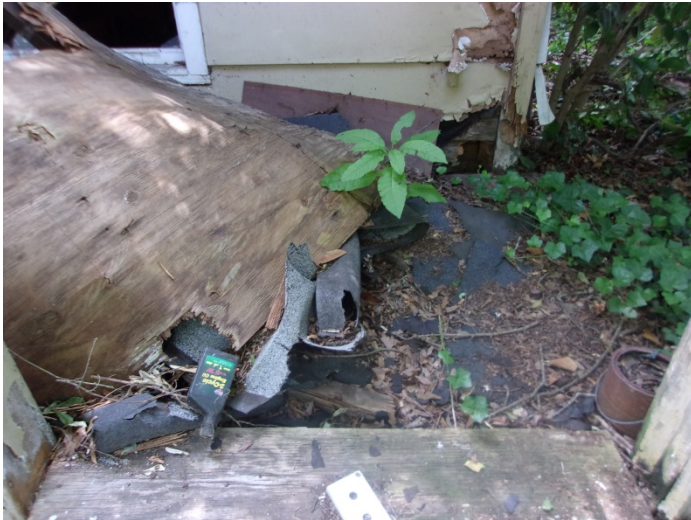
Photo 3 – Roll roofing & felt on the front porch roof & adjacent area & back portion of the house roof

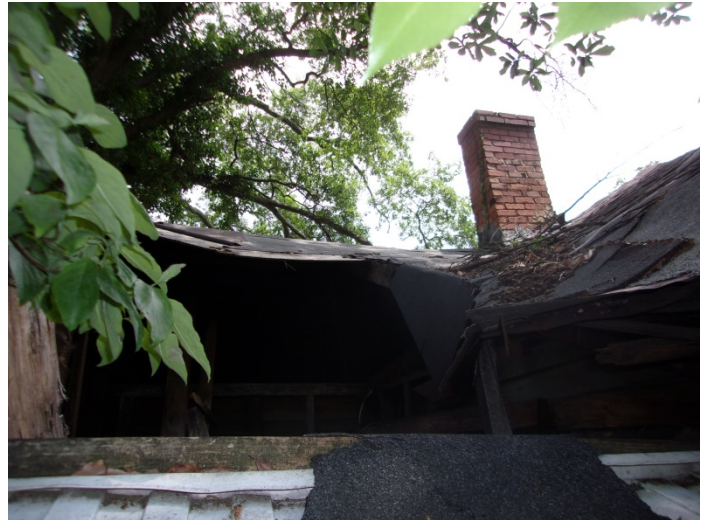
Photo 4 – Roll roofing & felt on the front porch roof & adjacent area & back portion of the house roof

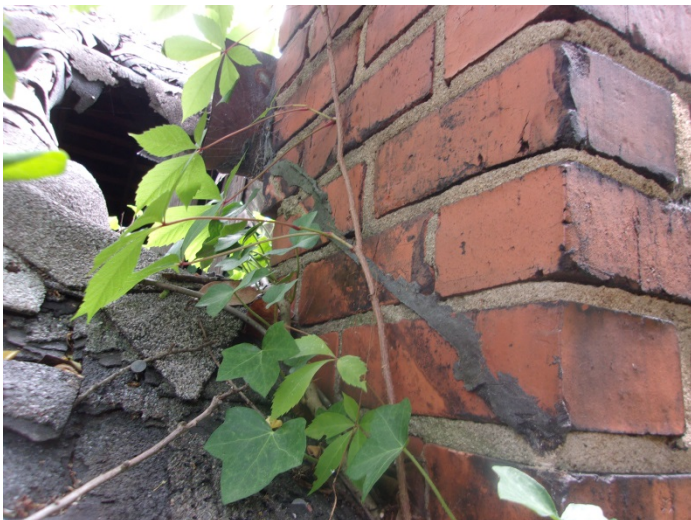
- Approximately 12 LF of tar on 2 chimneys.

Photo 5 – Chimney tar on 1 of 2 chimneys

1. Abate the asbestos containing materials in the structure prior to renovation or demolition.

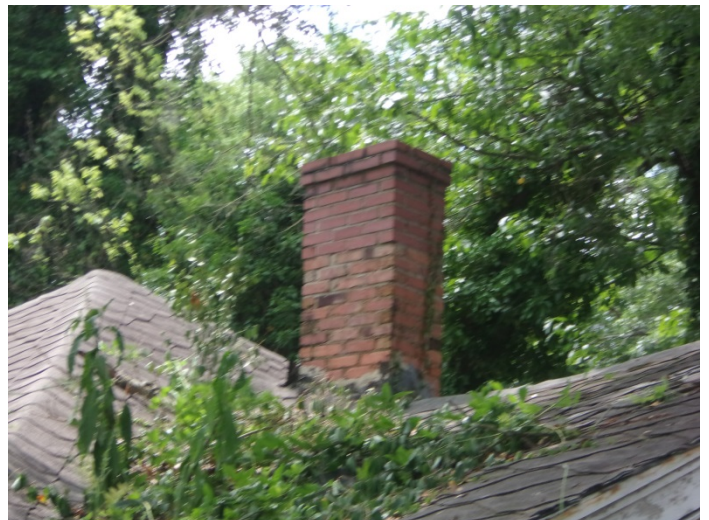
Photo 6 – Chimney tar on 1 of 2 chimneys

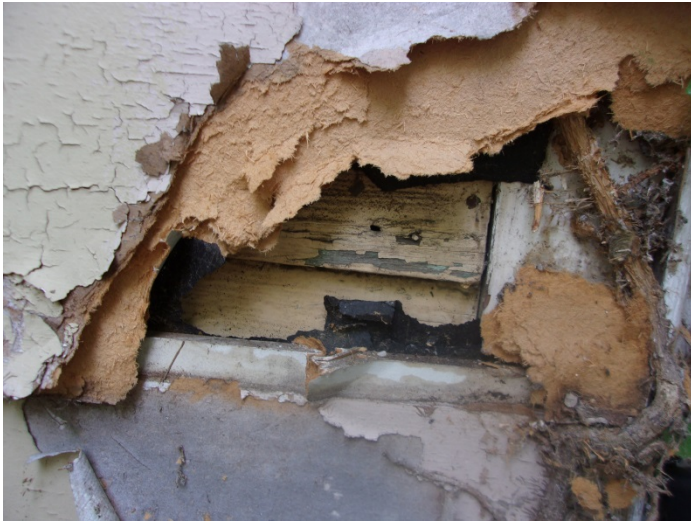
Photo 7 – Felt paper beneath wooden pressboard siding

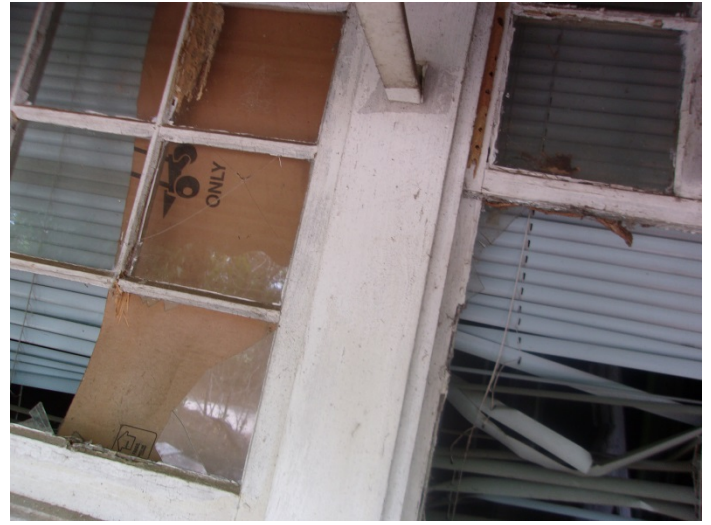
Photo 8 – Wooden window glazing & caulk on glass panes

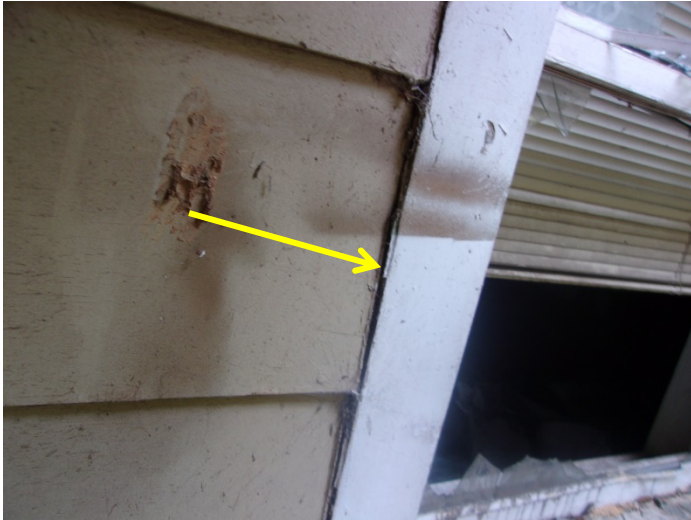
Photo 9 – Window caulk on the wooden casings

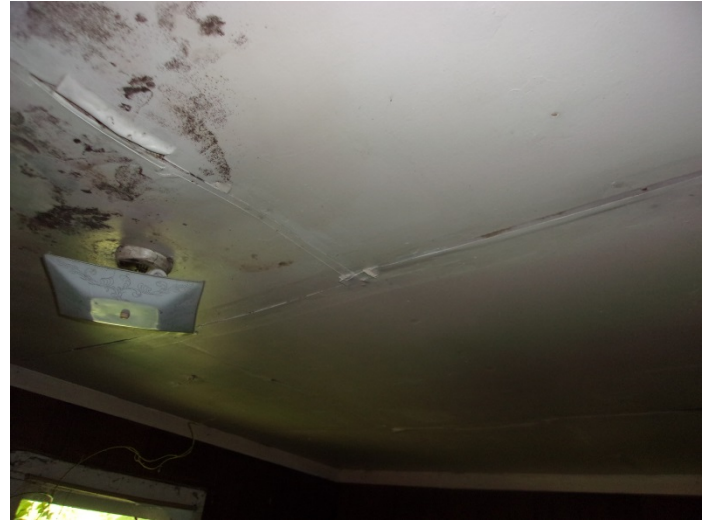
Photo 10 – Drywall with joint compound & tape throughout

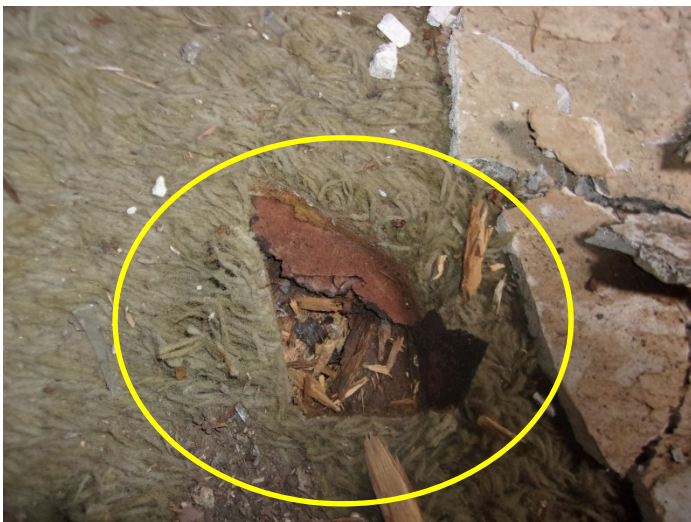
Photo 11 – Black pattern vinyl floor with felt backing in the front right bedroom under carpet

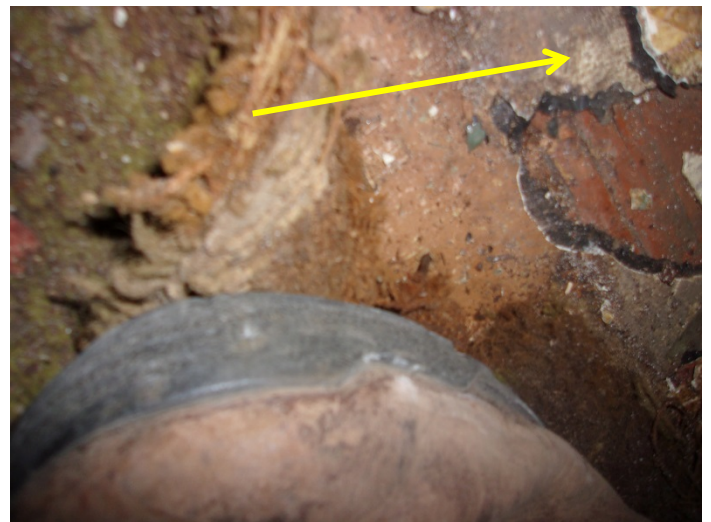
Photo 12 – Brown pattern vinyl floor with felt backing in the living room (under carpet) & dining room (3rd layer)

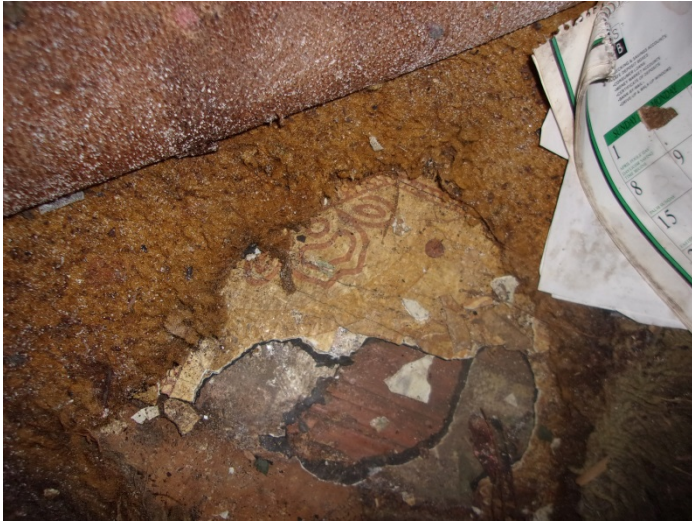
Photo 13 – Orange pattern vinyl floor & mastic over brown vinyl floor with felt backing in the dining room (1st & 2nd layers)

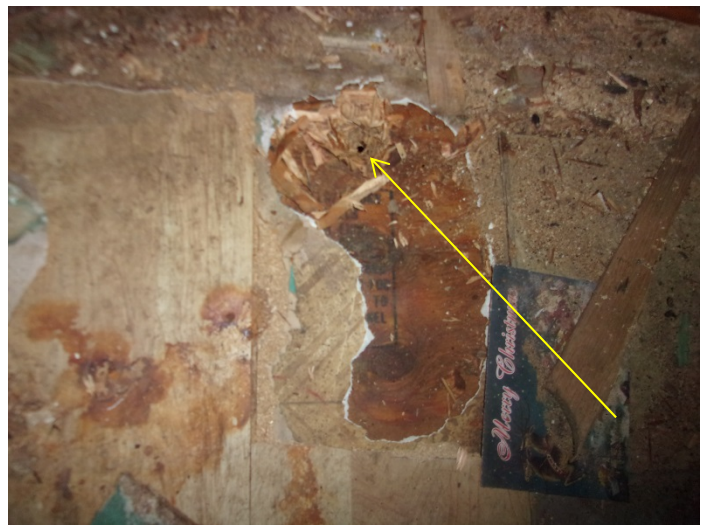
Photo 14 – Yellow pattern vinyl floor & mastic in the kitchen under wood

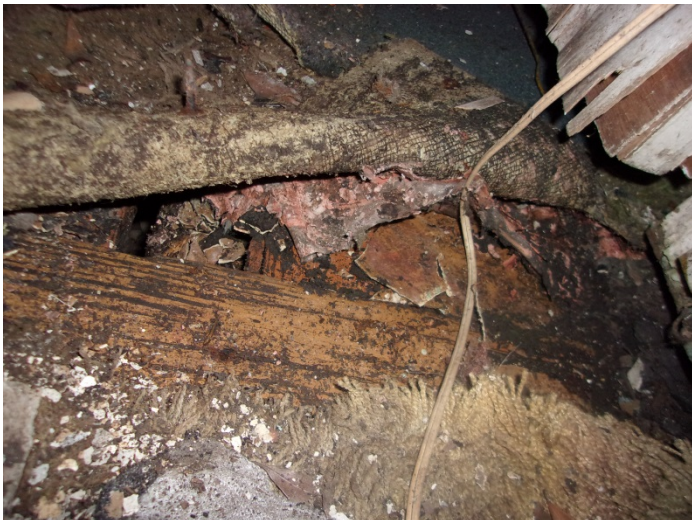
Photo 15 – Brown/black pattern vinyl floor with felt backing in the middle left bedroom under carpet

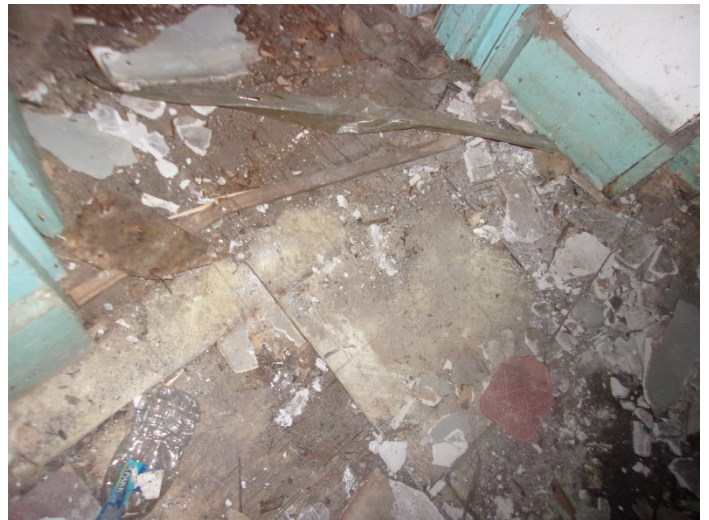
Photo 16 – Grey square pattern vinyl floor & mastic in the bathroom hallway (partially under wood)

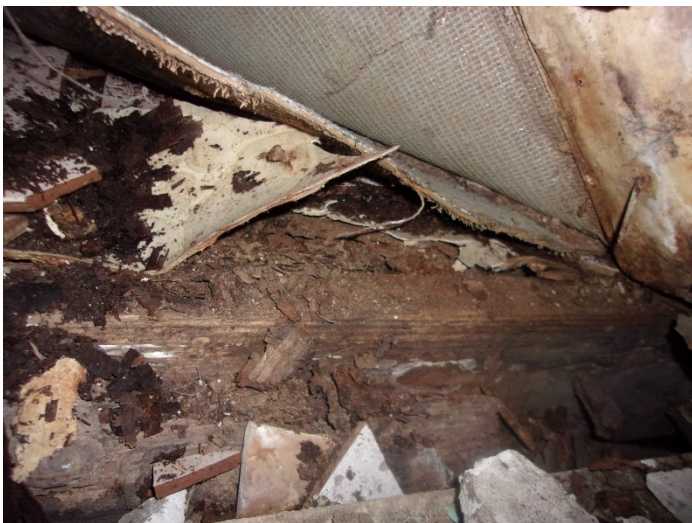
Photo 17 – White pattern vinyl floor with no mastic in the bathroom under carpet

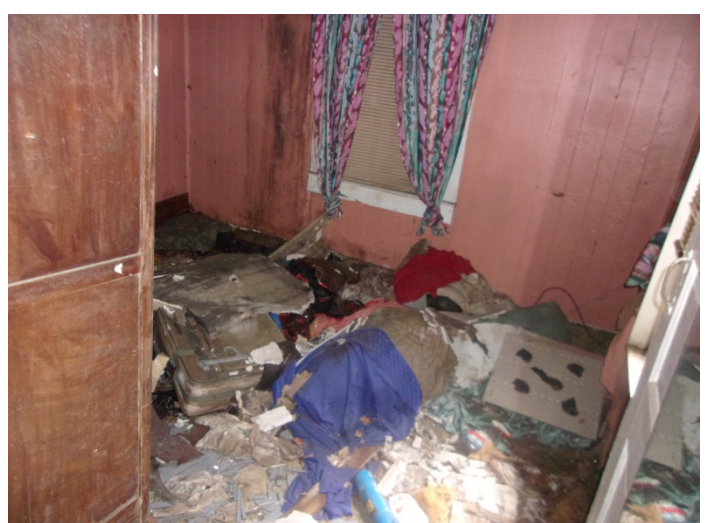
Photo 18 – Typical view of unstable & collapsed flooring

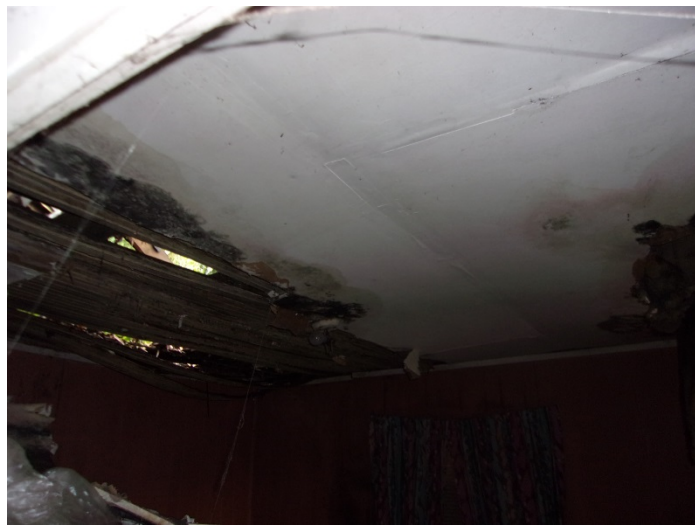
Photo 19 – Typical view of unstable & collapsed ceiling

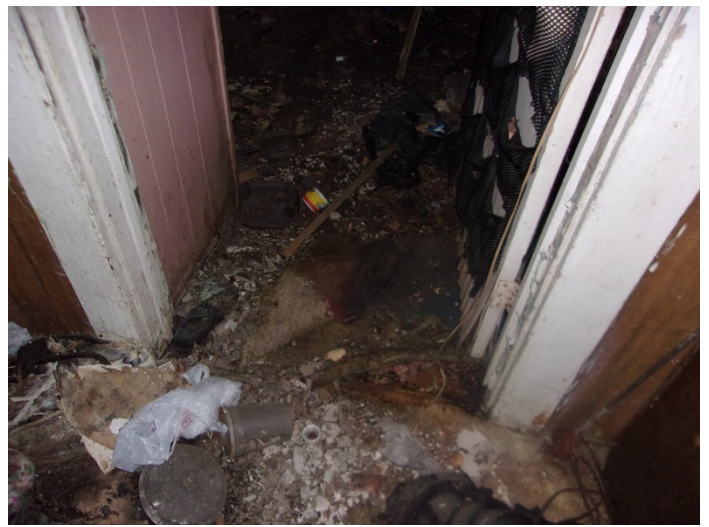
Photo 20 – Typical view of unstable & collapsed flooring

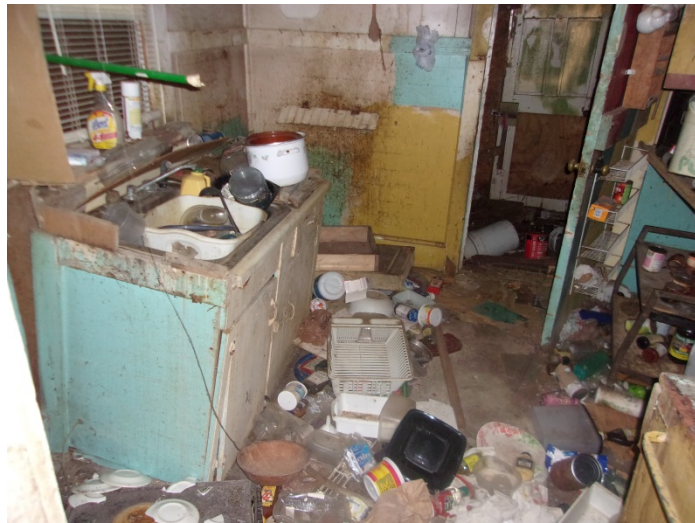
Photo 21 – Typical view of large amount of household items & debris throughout

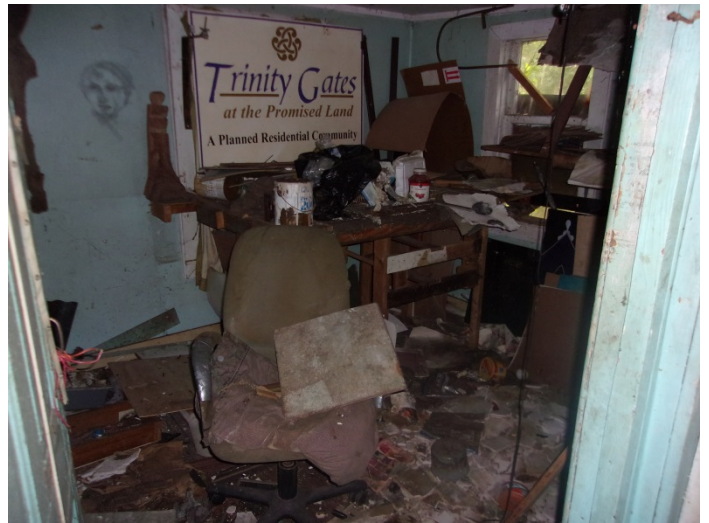
Photo 22 – Typical view of large amount of household items & debris throughout
