June 14, 2022

Subject: Asbestos-Containing Materials Survey
100 North Main Street
Clinton, Tennessee
GEOServices Project No. 24-22910
Tennessee Asbestos Firm Accreditation # A-F-1822-105020

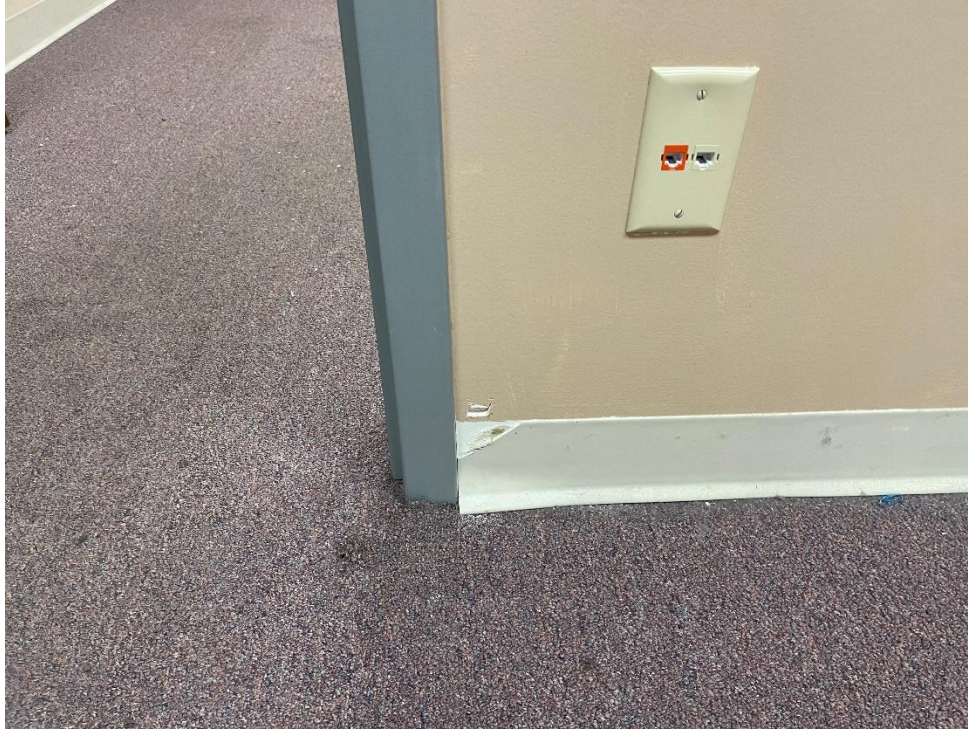
Photograph 1: View of the carpet floor.

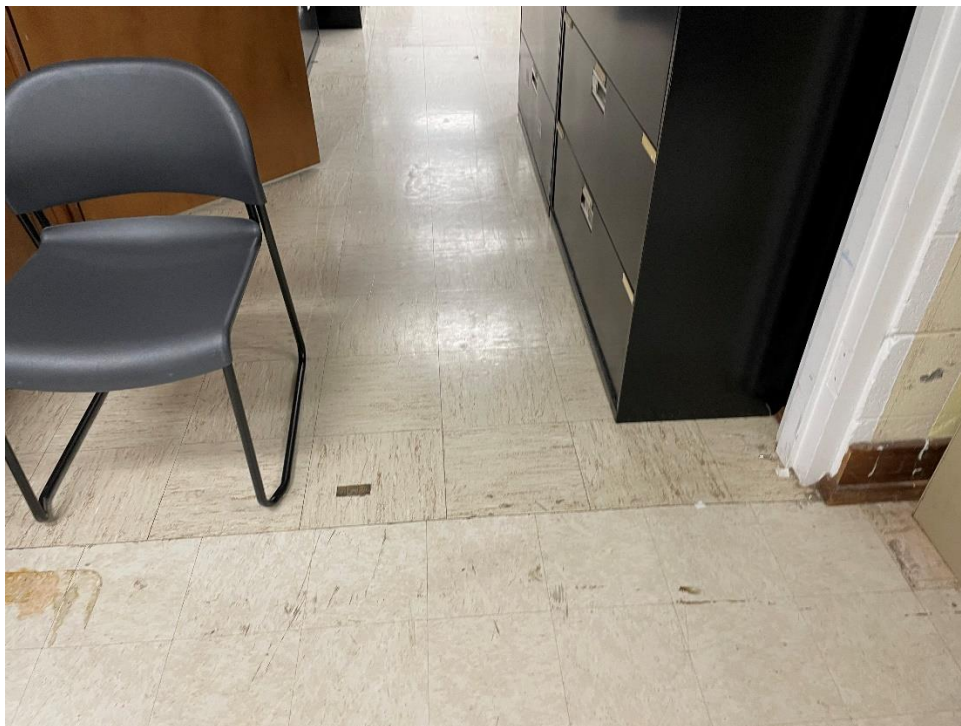
- Tile mastic in Room 125 was found to be ACM. As a result, all tile and mastic should be considered to be ACM. All 9x9 floor tile in the building should be considered ACM.
- Mastic in the Break Room was found to be ACM. As a result, the mastic and tile it is adhered to should be considered to be ACM. All the black mastic should be considered ACM.

Photograph 2: View of tile floor in the breakroom.

The locations should not be considered specific locations but treated as homogeneous areas for the entire structure where material is encountered. All asbestos abatement work shall be performed in accordance with all applicable Federal, State and Local rules and regulations. A licensed abatement contractor must perform the removal of all friable and non-friable ACM.

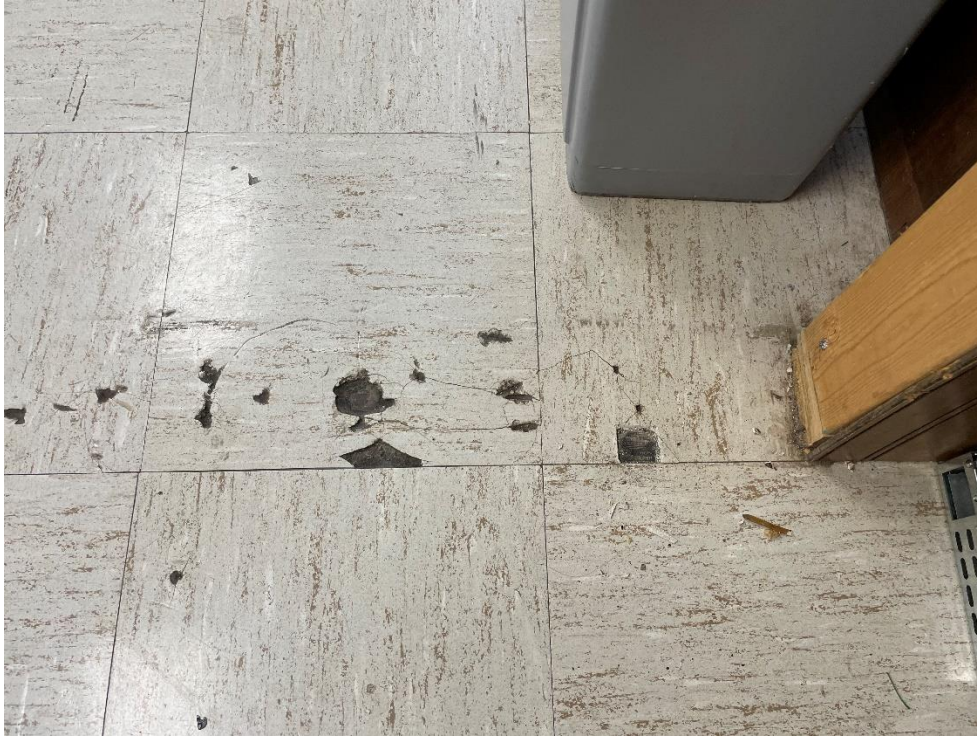
Photograph 3: Additional view of tile floor in the breakroom.

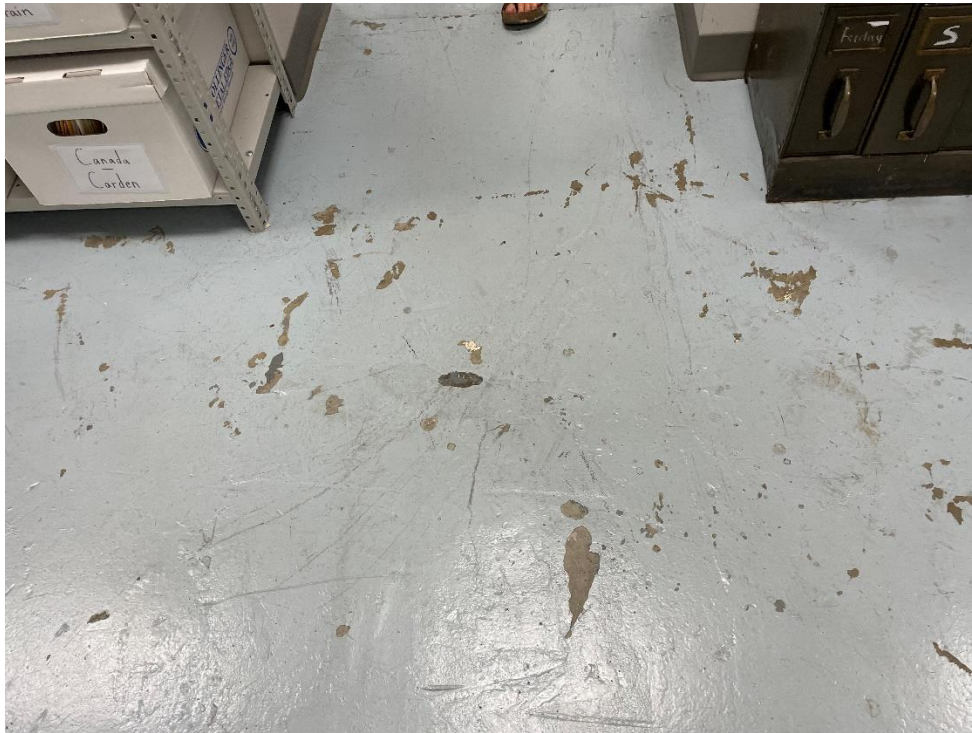
Photograph 4: View of concrete floor in archivist room.

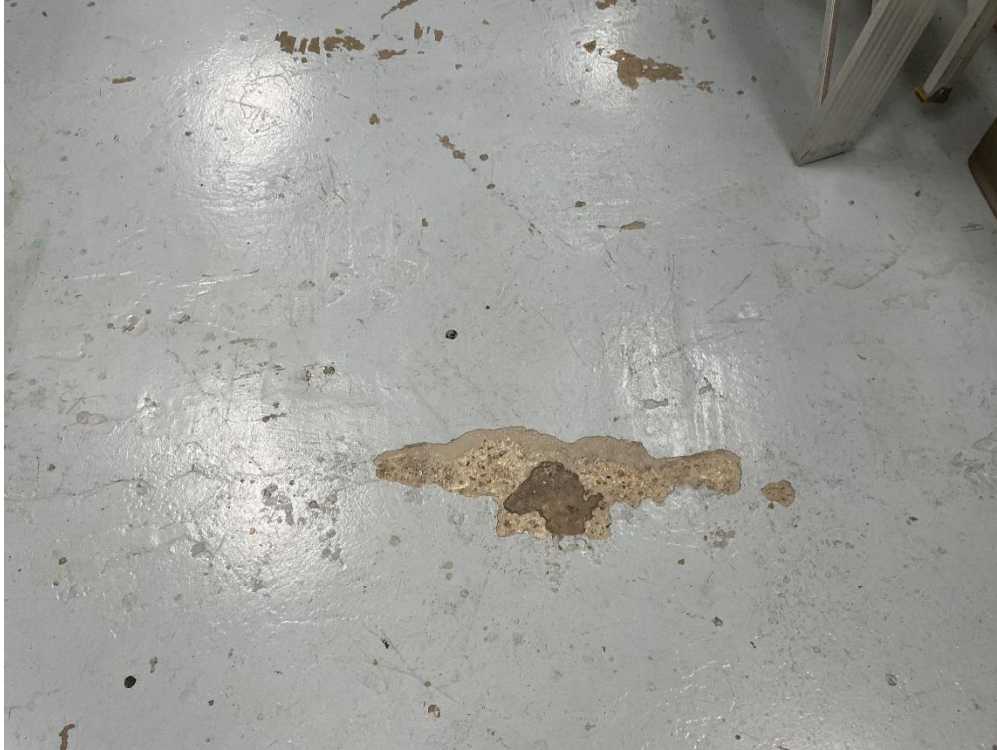
Photograph 5: Additional view of concrete floor in the archivist room.

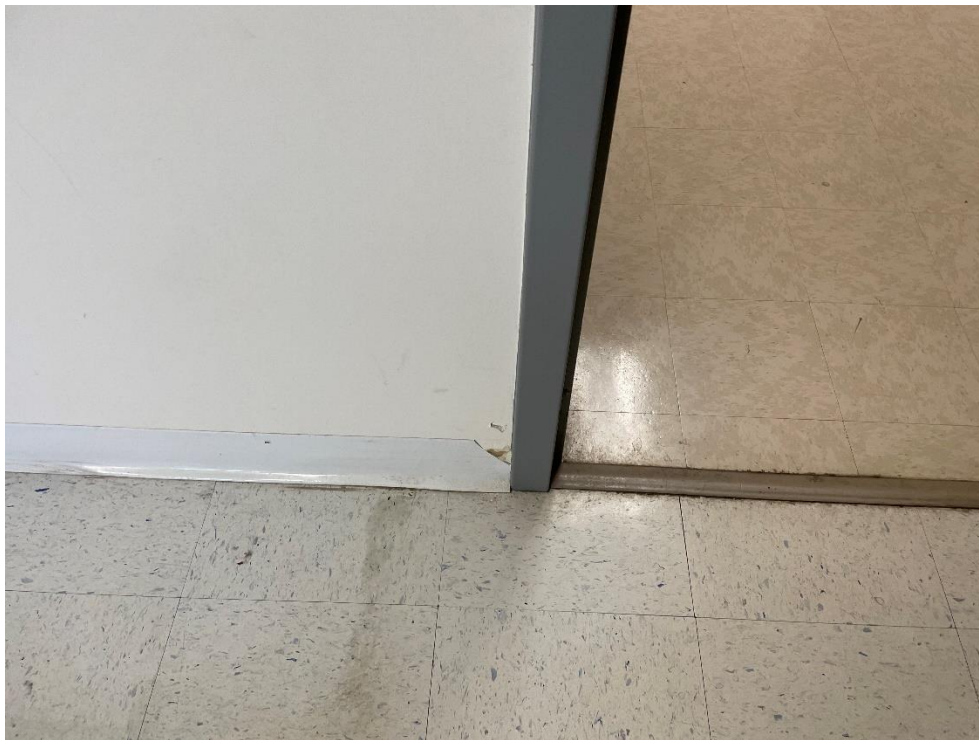
Photograph 6: View of floor at clerk office doorway.

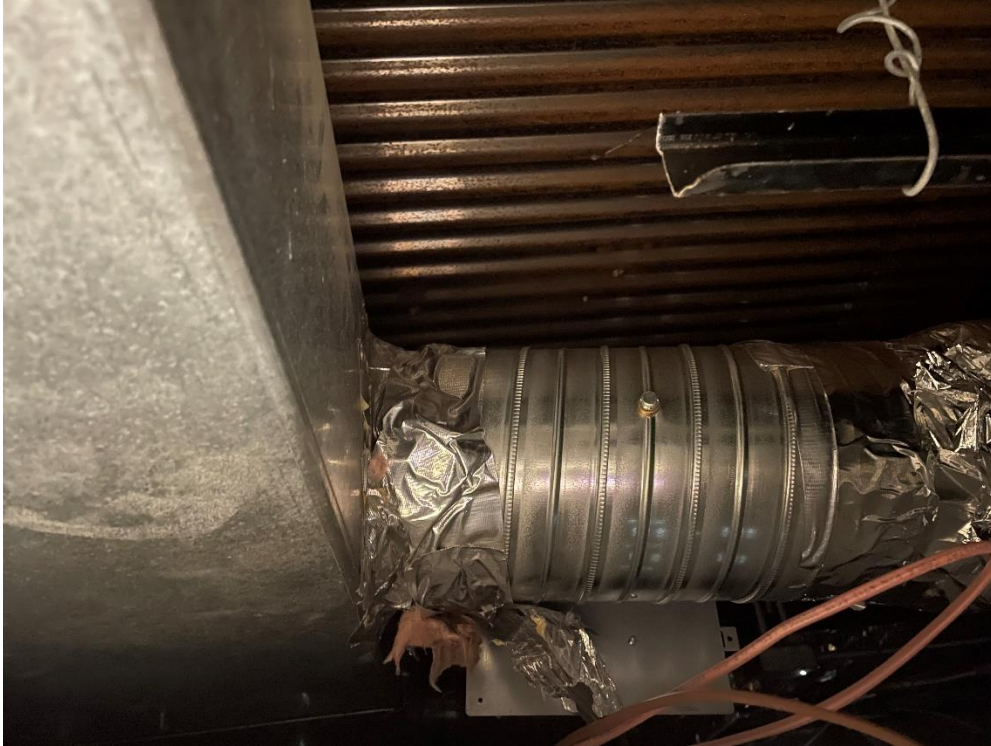
Photograph 7: View of the roll board connected to the furnace.

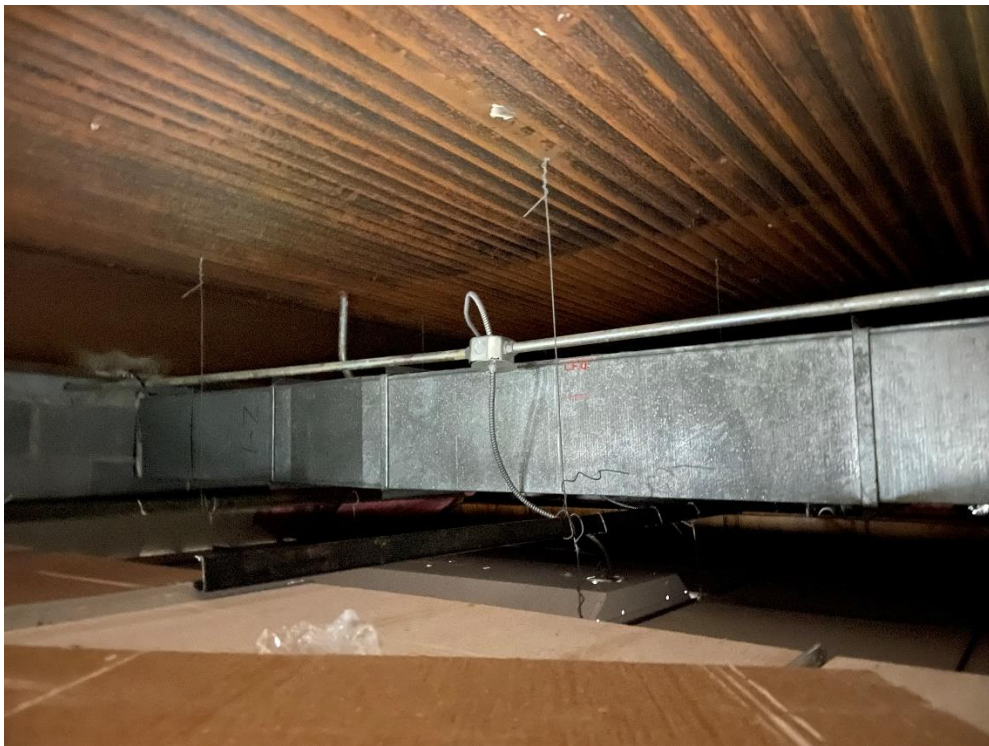
Photograph 8: Additional view of the airduct.

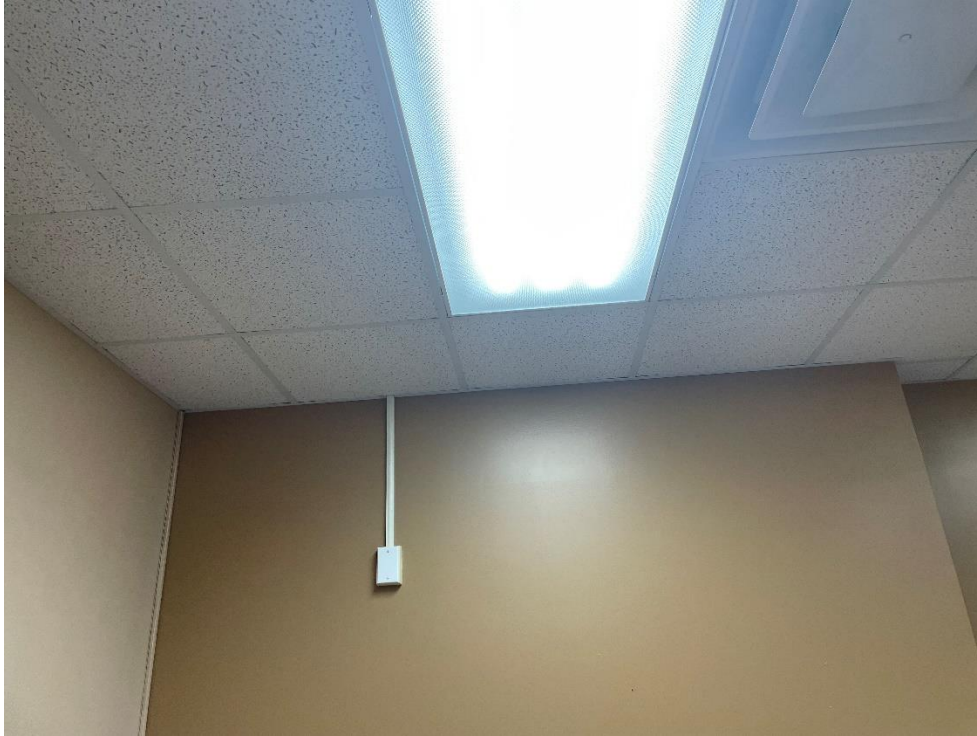
Photograph 9: View of ceiling.

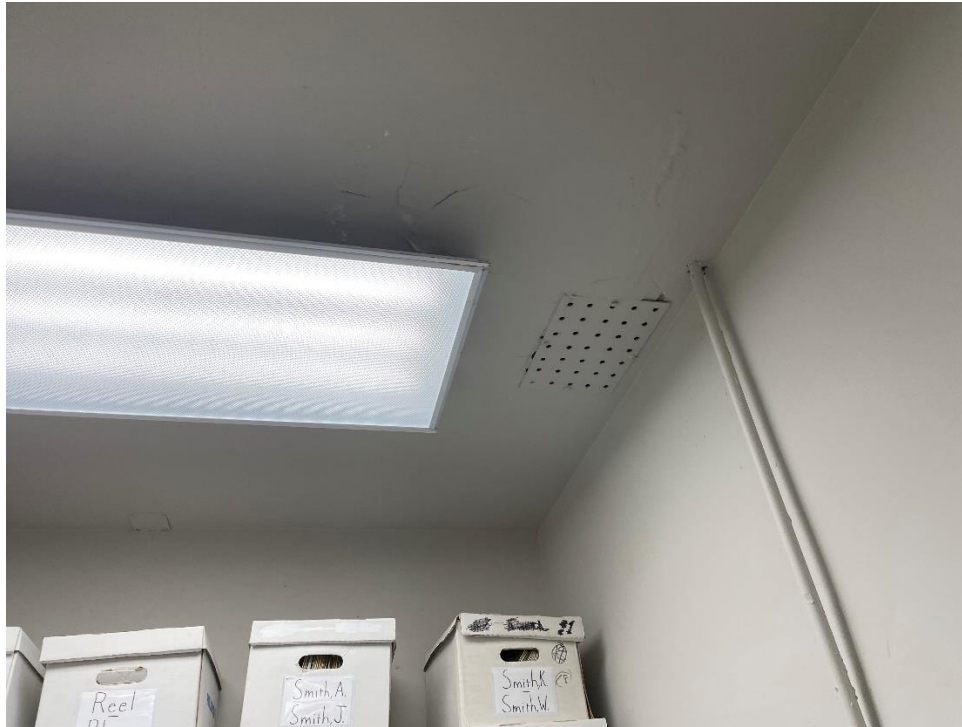
Photograph 10: View of ceiling in the archivist floor.

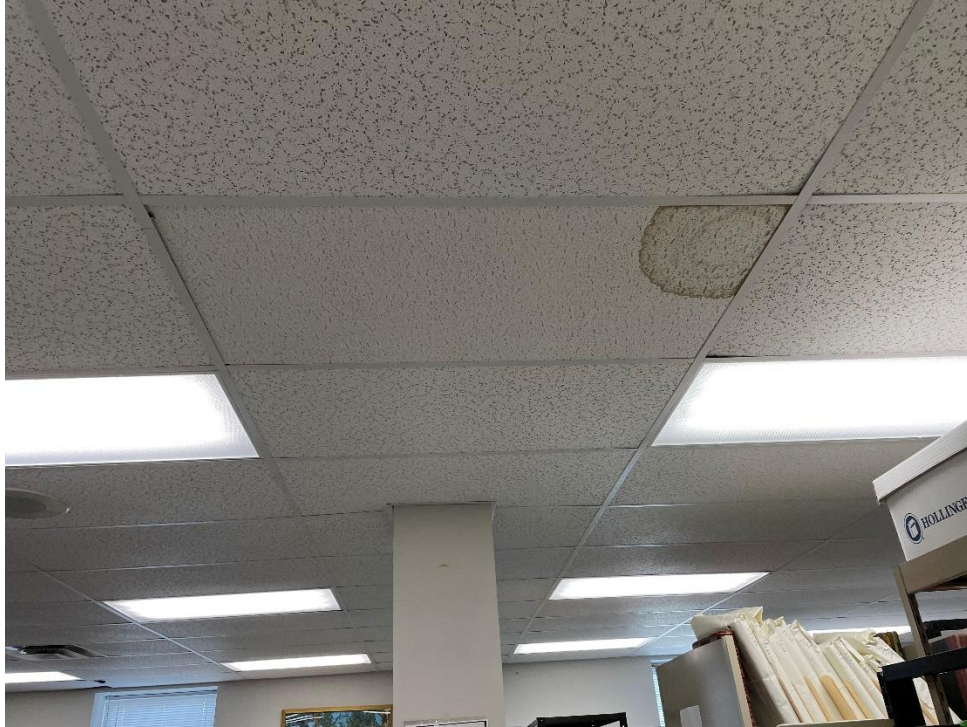
Photograph 11: View of ceiling in the archivist floor.
