Asbestos & Lead Based Paint Assessment

City of Spartanburg 447 Brawley Street Spartanburg, South Carolina

Project Number: 0417-66

November 3, 2017

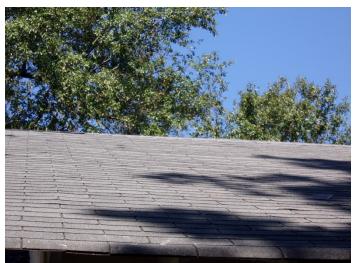
Photo 2 – Roof shingles and no felt.

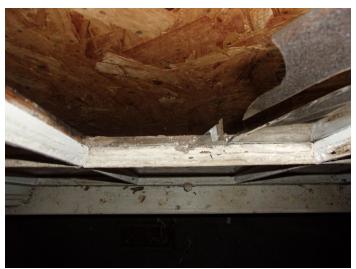
Photo 3 – Wooden window glazing.

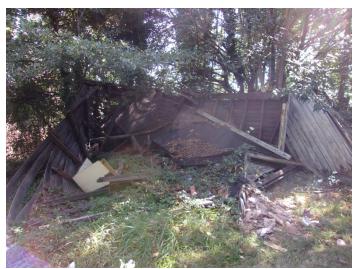
Photo 4 – Collapsed exterior shed with roofing materials.

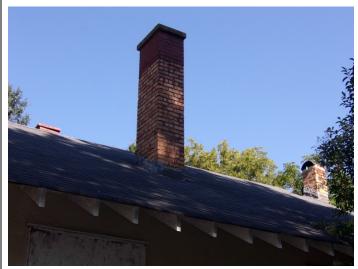
- Approximately 45 SF of beige vinyl flooring & mastic under wood in the bathroom.
- Approximately 12 LF of chimney mastic/tar on 2 chimneys assumed positive.

Photo 5 – Mastic on 2 chimneys assumed positive.

- 1. Abate the asbestos containing materials in the structure prior to renovation or demolition.
- 2. Follow applicable asbestos regulations during renovation or demolition of the structure. You should be aware that stringent requirements are imposed upon anyone renovating or demolishing a structure in which ACM will be disturbed. This work must be performed in accordance with OSHA asbestos regulations, 29 CFR 1910 & 1926, and NESHAP asbestos regulations 40 CFR 61, subpart M. South Carolina regulations require the accreditation of personnel who work in the asbestos field and notification and permitting fees for asbestos removal projects. There is a 10 working day notification period required prior to abatement of asbestos in a facility. Failure to take proper precautions and actions to protect human health and the environment can result in penalties, danger to personnel, and construction delays.

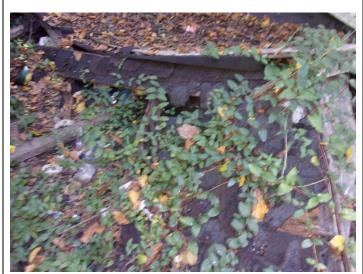
Photo 6 – Collapsed exterior shed with roofing materials.

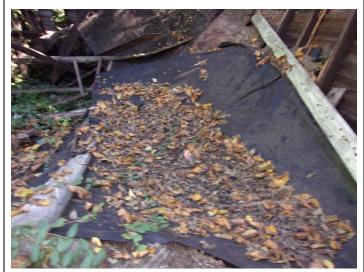
Photo 7 – Collapsed exterior shed with roofing materials.

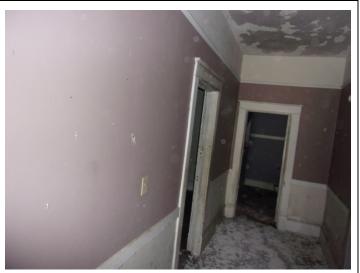
Photo 8 – Plaster with finish throughout

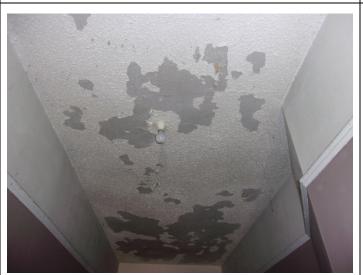
Photo 9 – Popcorn ceiling texture in the front hallway, front left bedroom & dining room.

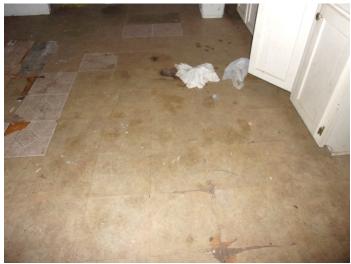
Photo 10-12" x 12" brown self-stick floor tile with no mastic in the kitchen over wood.

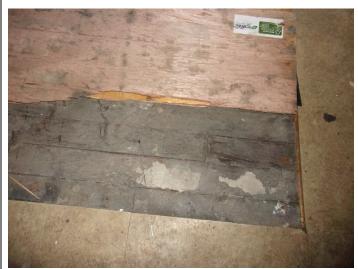
Photo 11 – felt paper in the kitchen under wood.

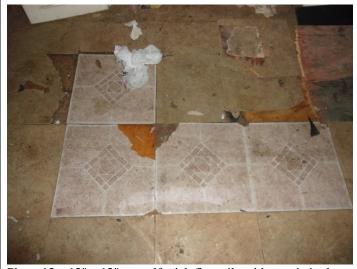
Photo 12 - 12" x 12" tan self-stick floor tile with mastic in the kitchen over wood (patch).

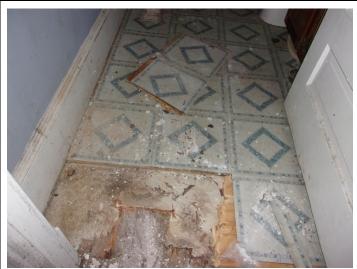
Photo 13 - 12" x 12" blue self-stick floor tile with mastic (top layer over wood) over beige vinyl flooring with mastic 2^{nd} layer under wood) in the bathroom.
