STRUCTURAL ENGINEERING ASSESSMENTS, PC
A STRUCTURAL CONSULTING / FORENSIC ENGINEERING FIRM

Re: Circle Drive Warehouse
226 Circle Drive
Gatlinburg, Tennessee 37738
SEA Project #: 240-16

As requested, Structural Engineering Assessments, PC made a site visit on December 15, 2016, to the referenced location to provide a visual assessment regarding potential fire or fire related structural damage to the steel framed structure.

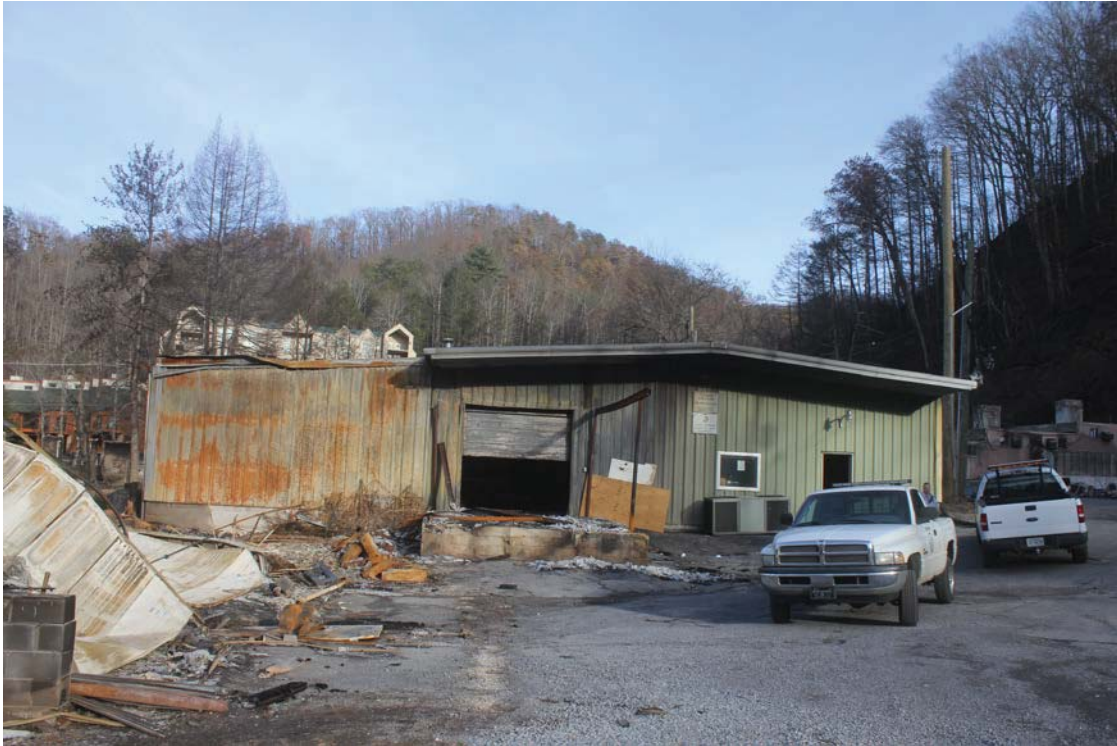
The majority of the fire related damage appears to be located on the west exterior wall (See Photographs #1 and #2), adjacent to the northwest corner of the building and the east exterior wall (See Photographs #3 and #4), adjacent to the northeast corner of the building.

Photograph #1 – West Exterior Wall

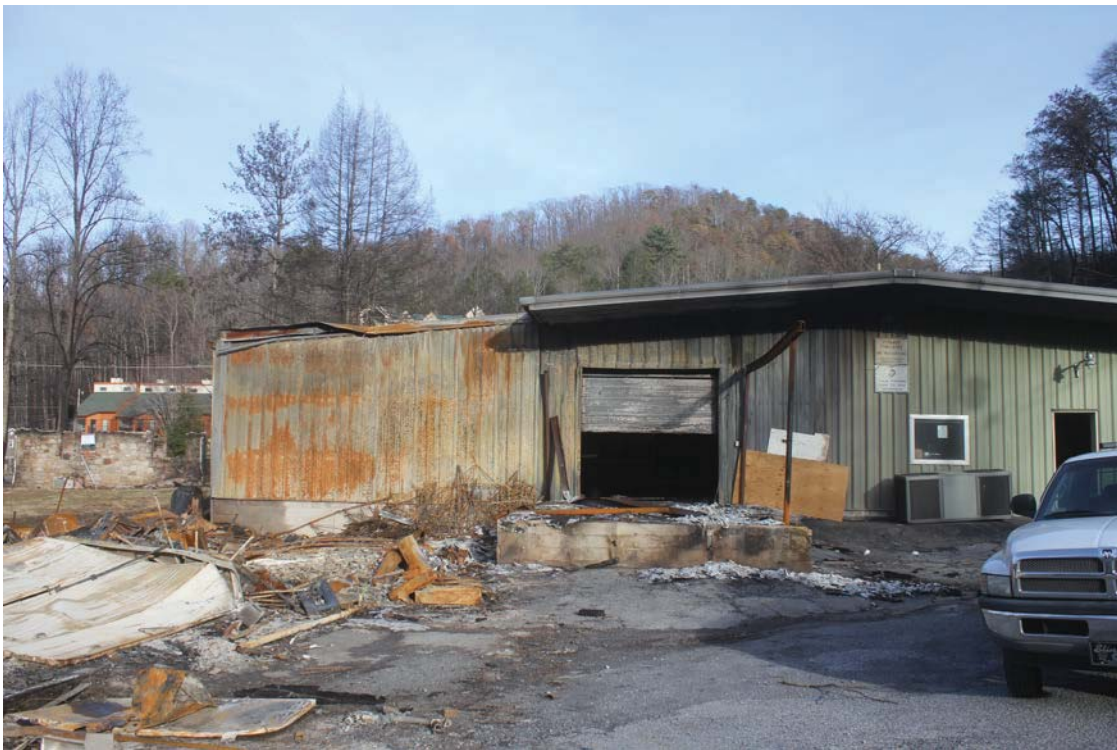
Photograph #2 – West Exterior Wall

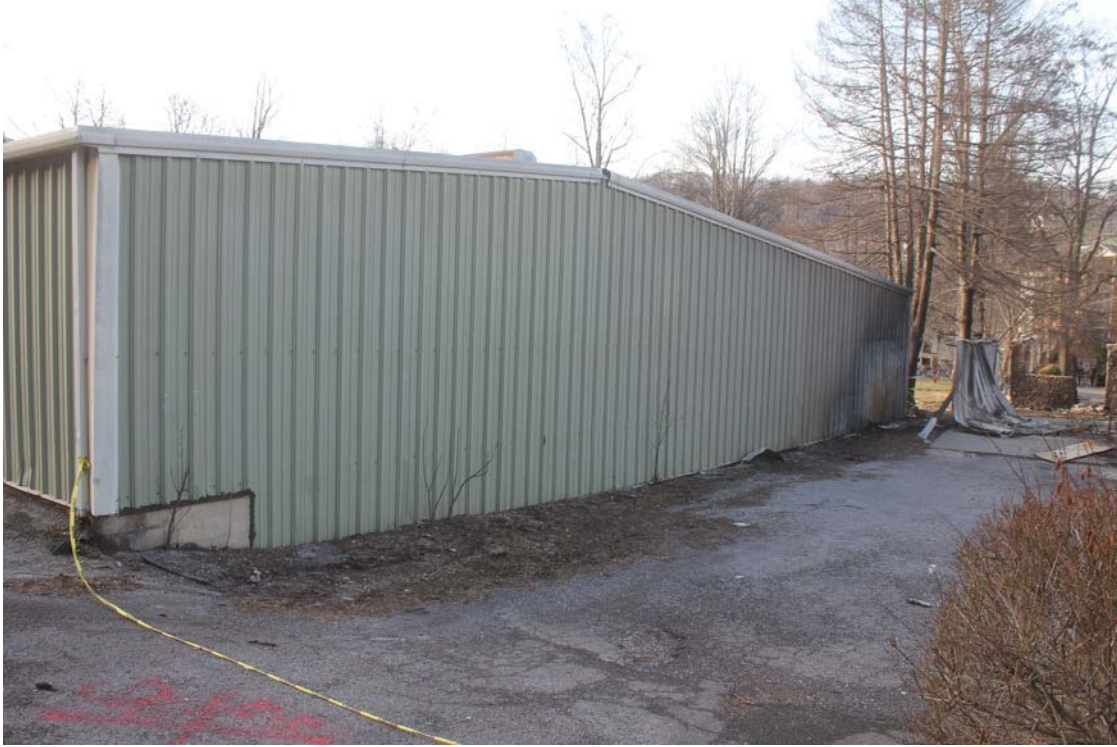
Photograph #3 – East Exterior Wall

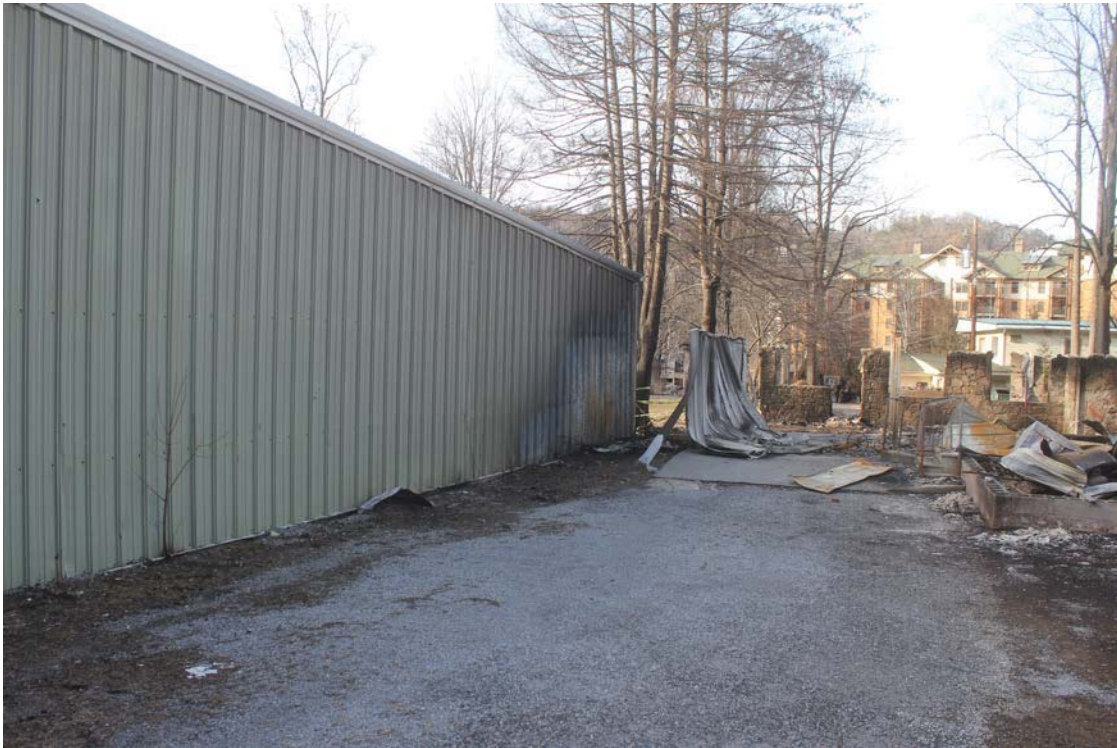
Photograph #4 – East Exterior Wall

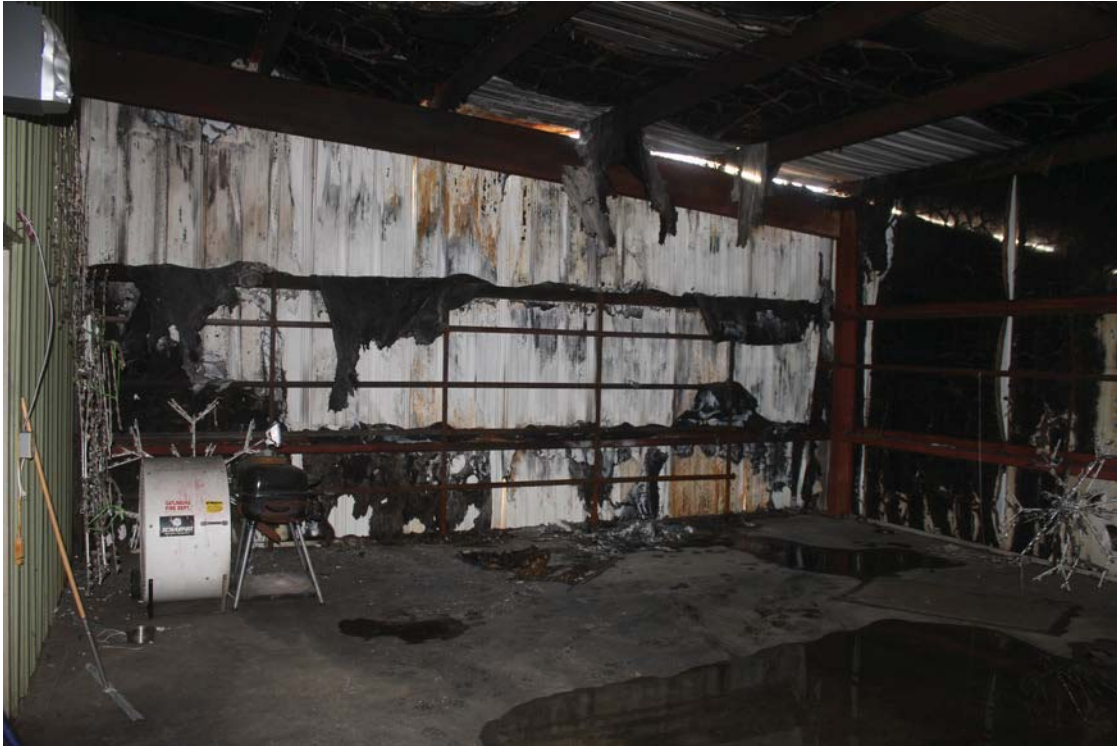
Photograph #5

1. The metal wall panels (See Photograph #5) on the west end of the building displayed significant heat related damage and the wall girts (See Photograph #6) displayed signs of distortion from the heat of the fire.
2. The metal roof panels (See Photographs #7 and #8) above the west end of the building displayed signs of heat related damage, but the steel purlins and pre-engineered steel

Based on the noted observations, the fire related damage appears to be localized to the exterior metal panels and secondary structural components. We recommend replacing the steel wall girts on the west end of the building, adjacent to the northwest corner of the building. The exterior metal wall panels and roof panels should be removed and replaced with new panels.

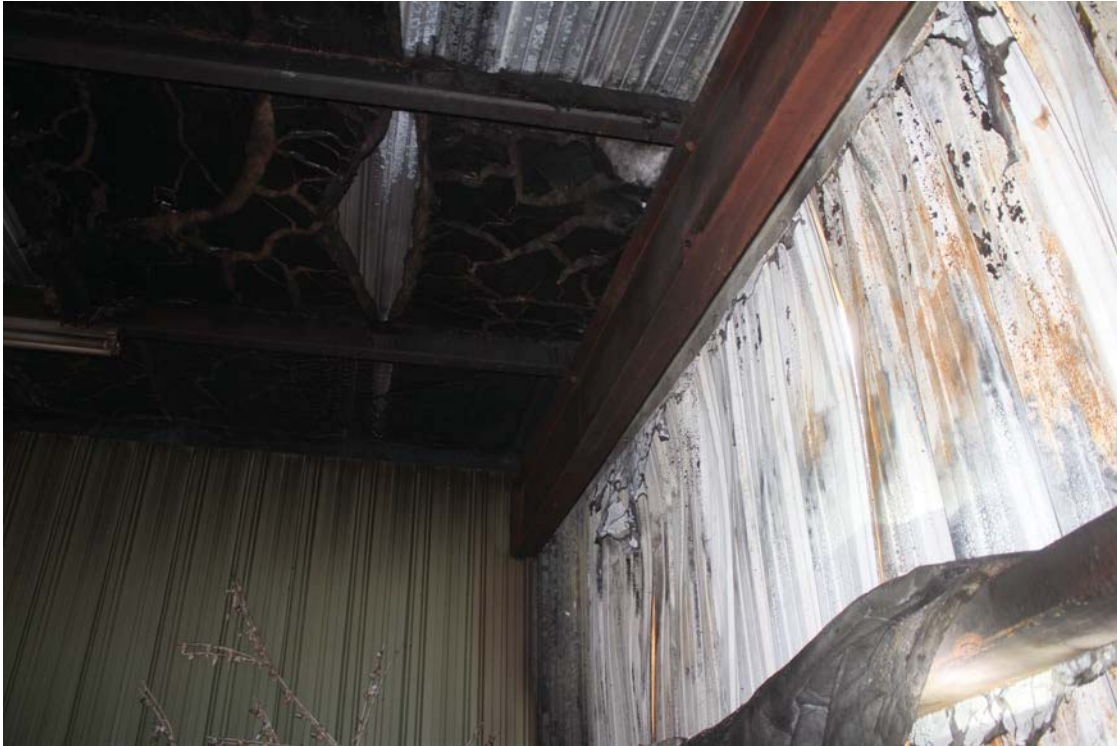
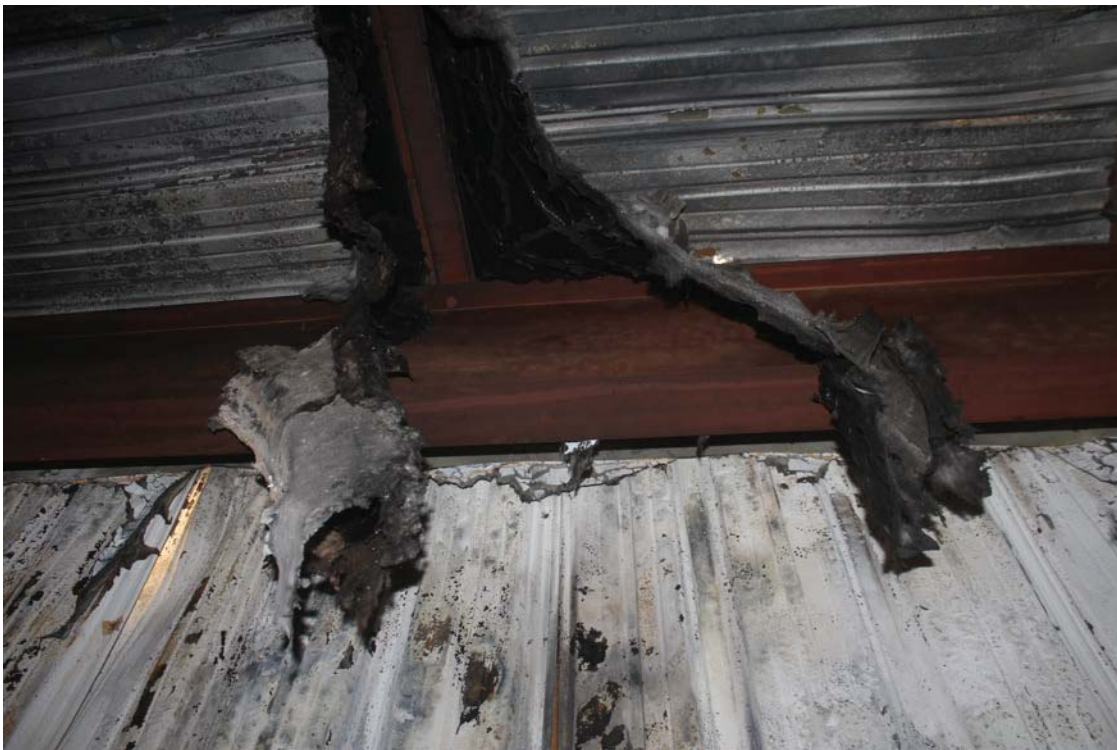
moment frames (See Photographs #9 and #10) did not appear to suffer any loss of structural integrity from the heat of the fire.

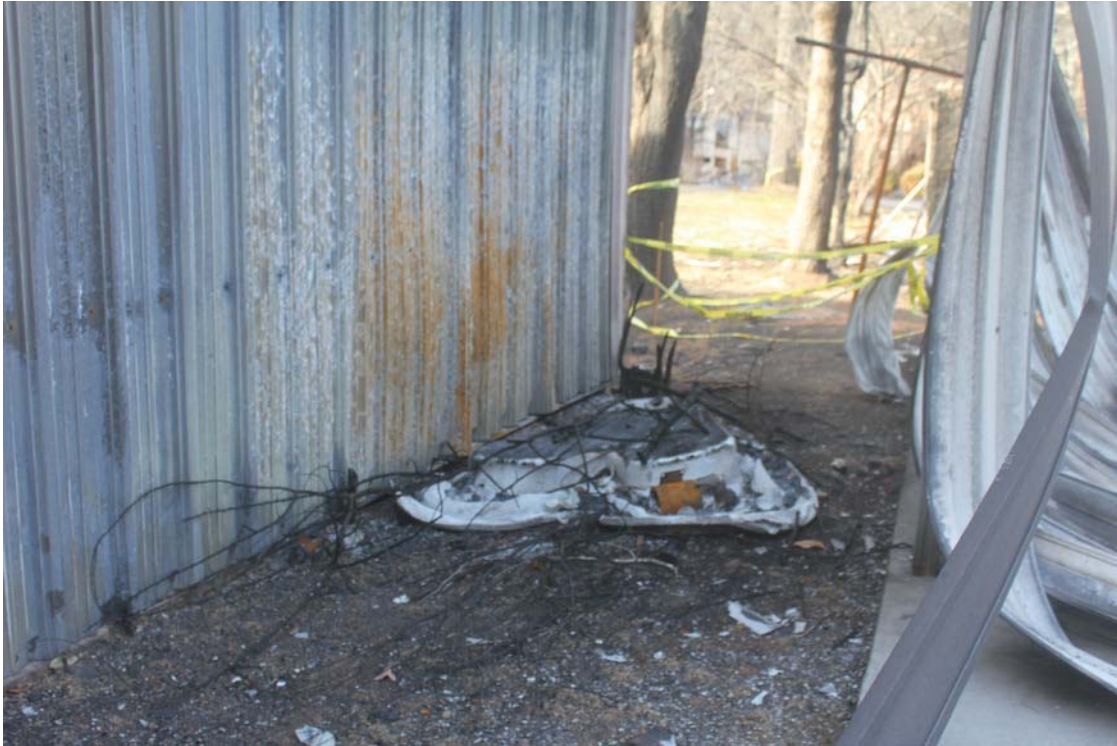
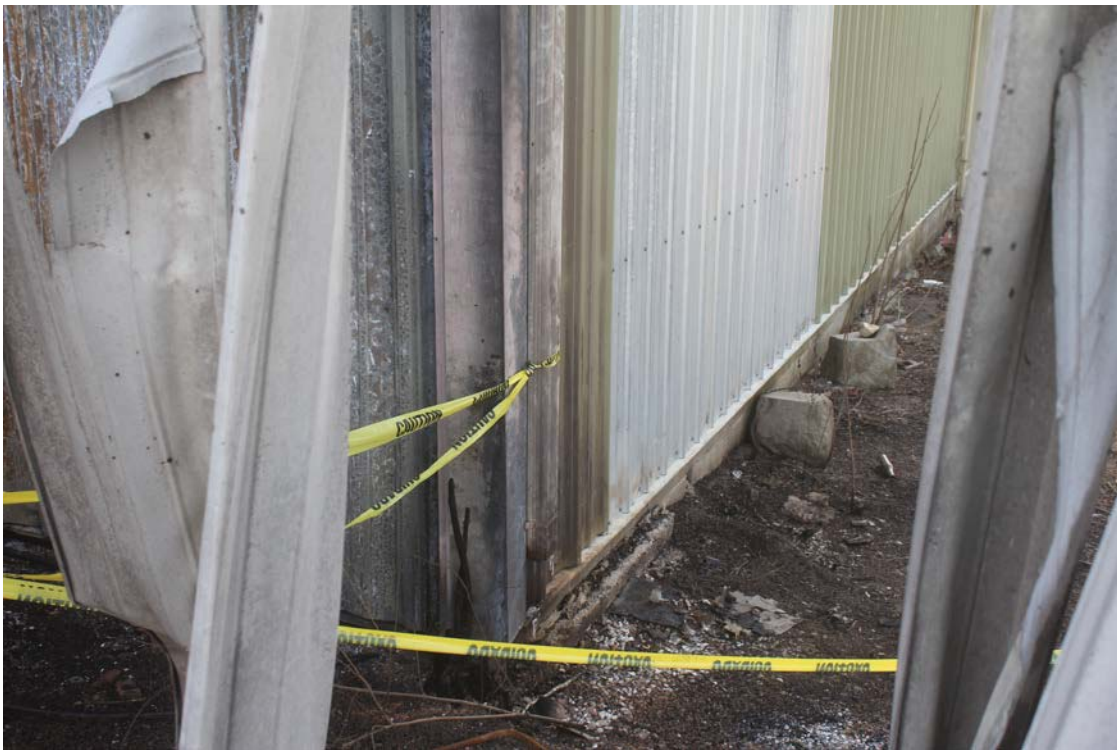
3. The metal wall panels (See Photographs #11 and #12) on the east end of the building displayed significant heat related damage, but the wall girts (See Photographs #13 and #14) did not appear to suffer any loss of structural integrity from the heat of the fire.
4. The metal roof panels, the steel purlins and pre-engineered steel moment frames (See Photographs #15 and #16) above the east end of the building did not appear to suffer heat related damage or suffer any loss of structural integrity from the heat of the fire.
