# **PRE-DEMOLITION ASBESTOS & LEAD-BASED PAINT INSPECTION REPORT**

**F&R PROJECT NUMBER: 65U-0065**

SPARTANBURG AIRPORT ASBESTOS AND LEAD INSPECTIONS  
650 CALIFORNIA BOULEVARD, SPARTANBURG, SC 29304

Date of Report: June 10, 2016

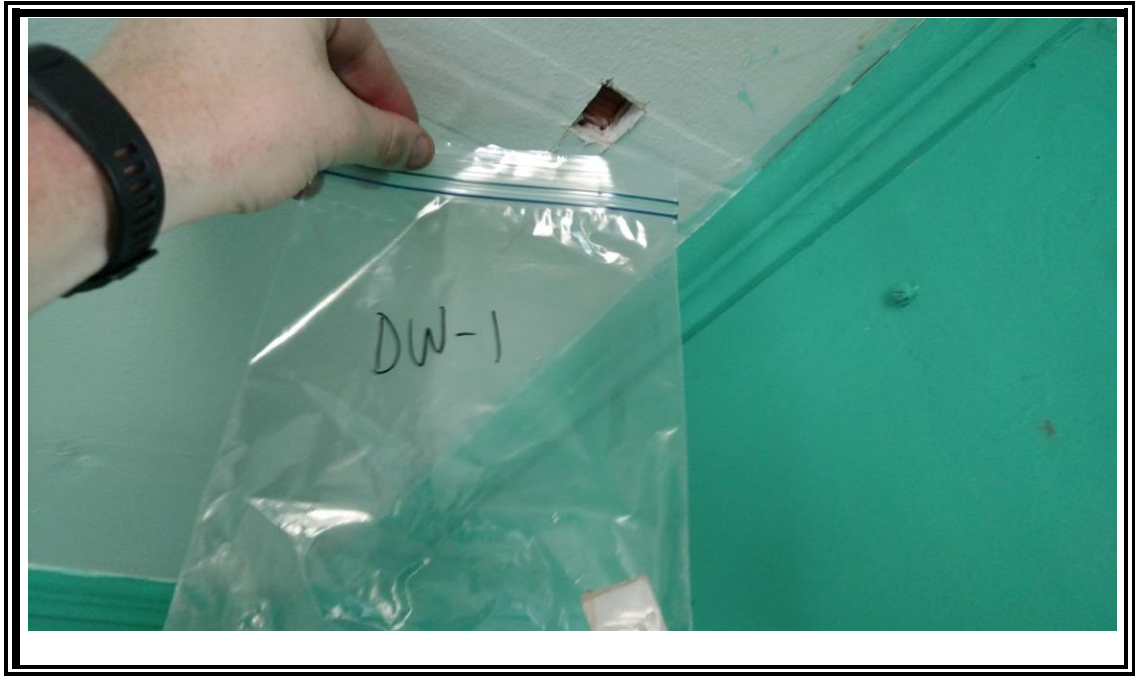
Based on the analytical results of F&R's sampling, asbestos containing materials were identified in the drywall joint compound and the chimney mastic.

1. View of the drywall sample in dining room at 650 California Blvd.

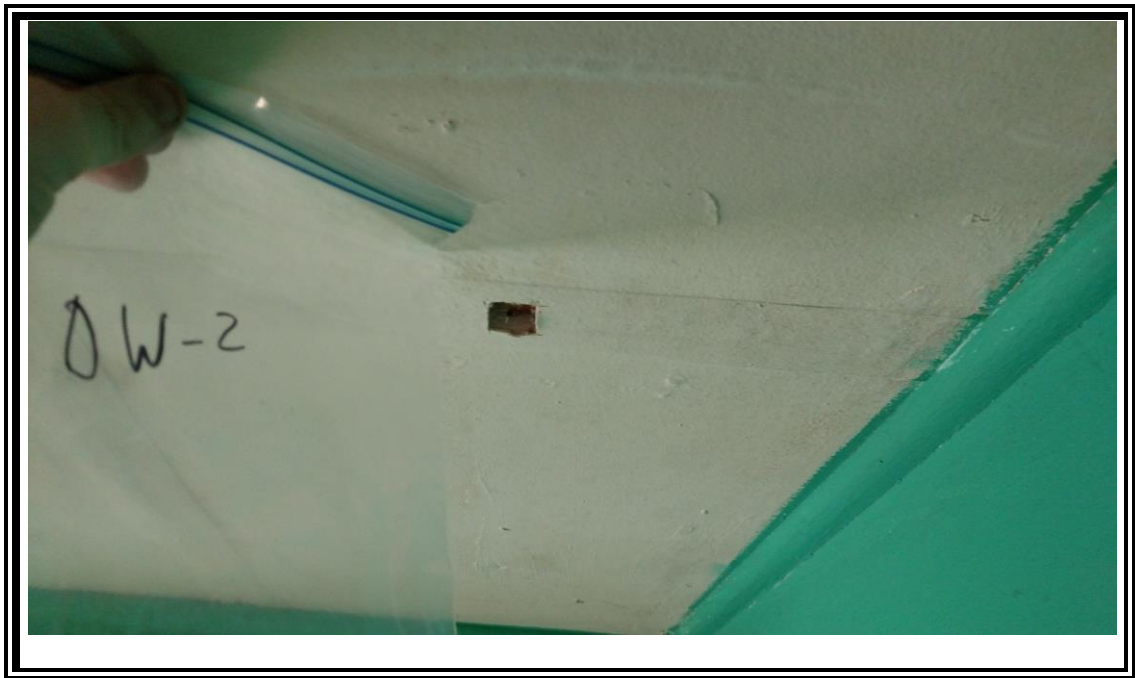
2. View of the drywall sample in kitchen at 650 California Blvd.

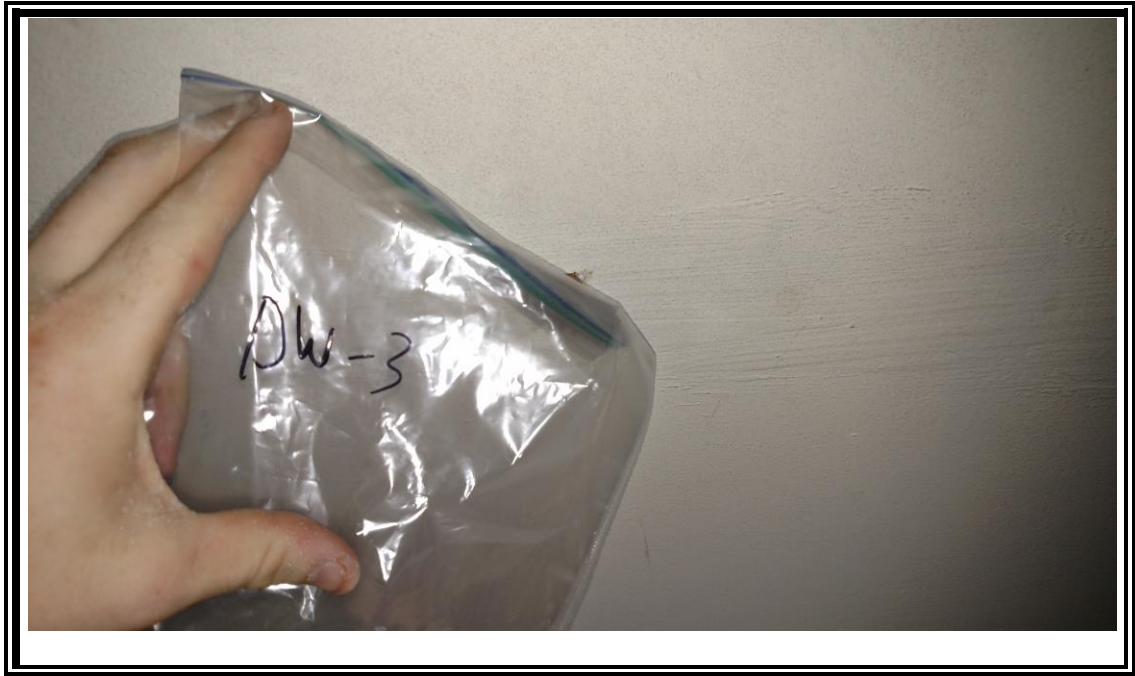
3. View of the drywall sample in living room at 650 California Blvd.

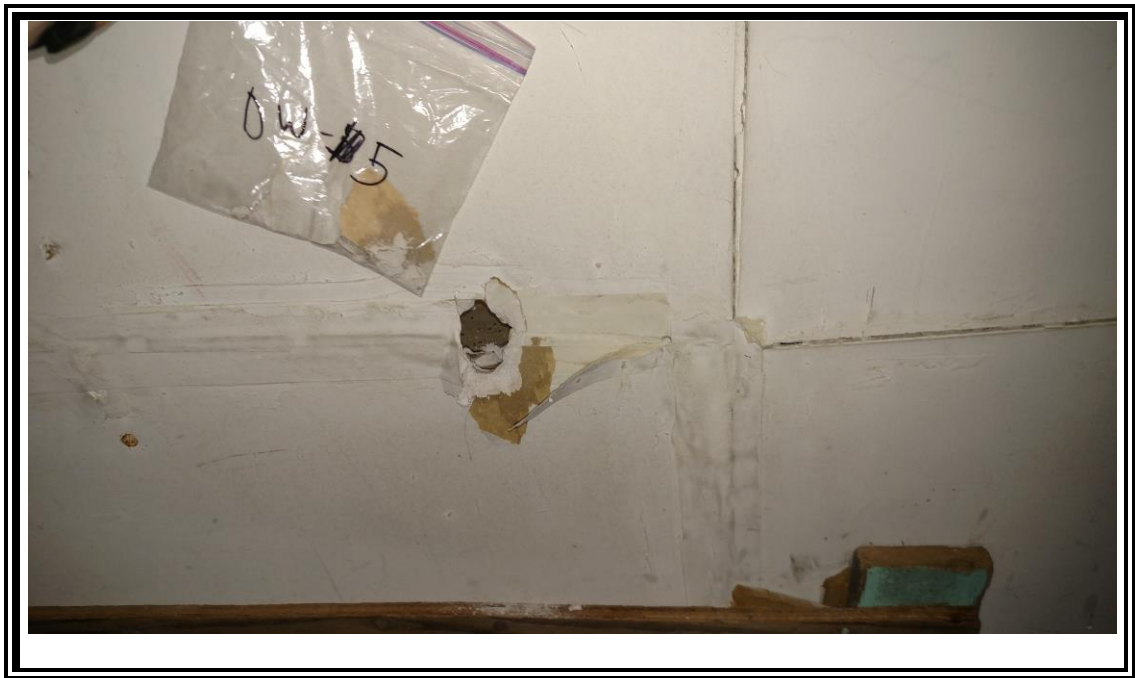
4. View of the drywall sample in the bedroom at 650 California Blvd.

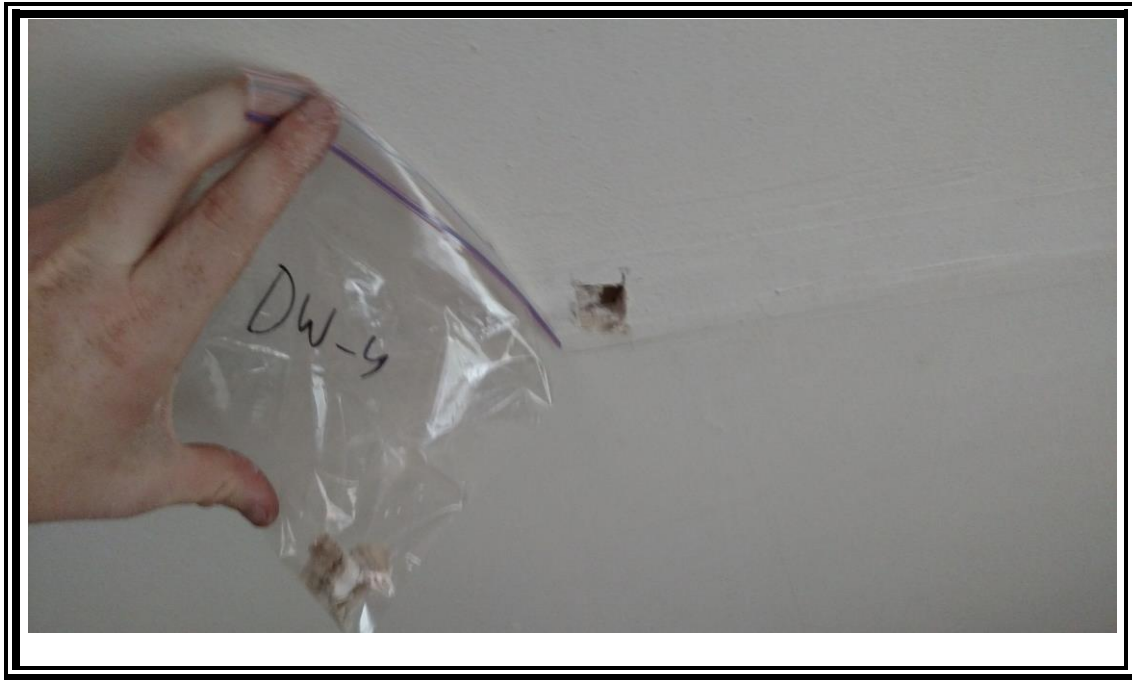
5. View of the drywall sample in the bedroom at 650 California Blvd.

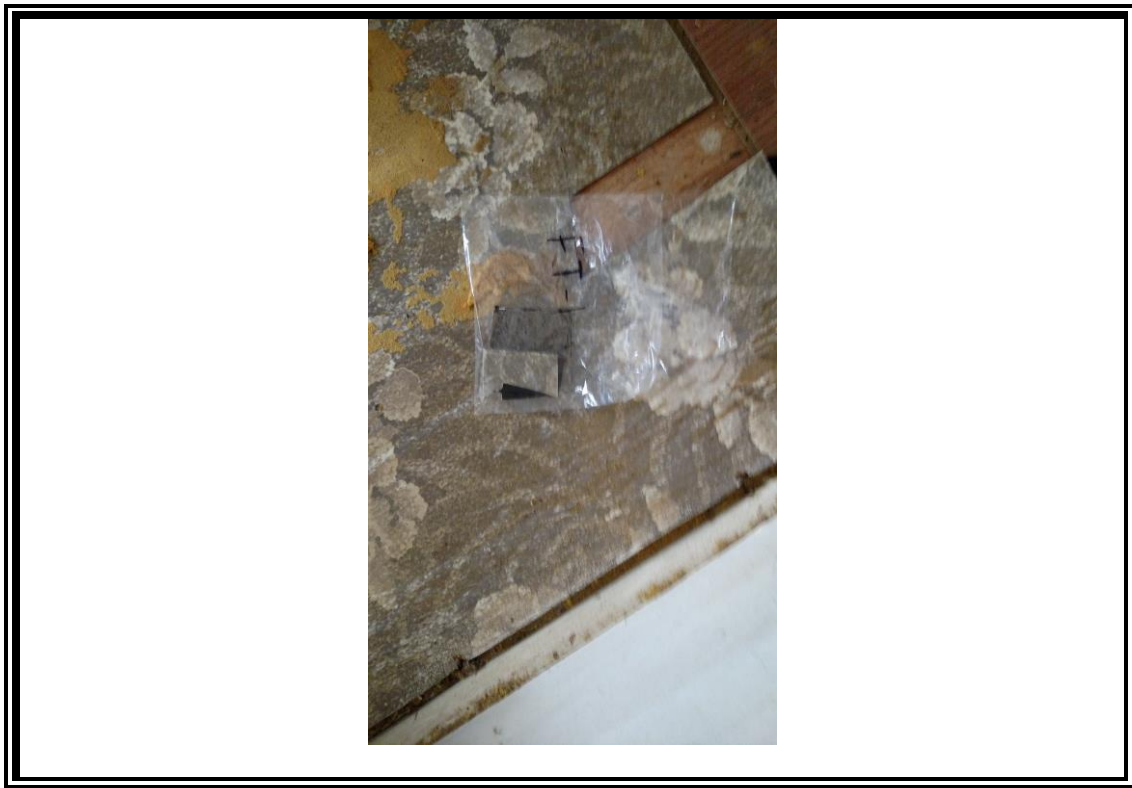
6. View of the floor tile sample in the living room at 650 California Blvd.

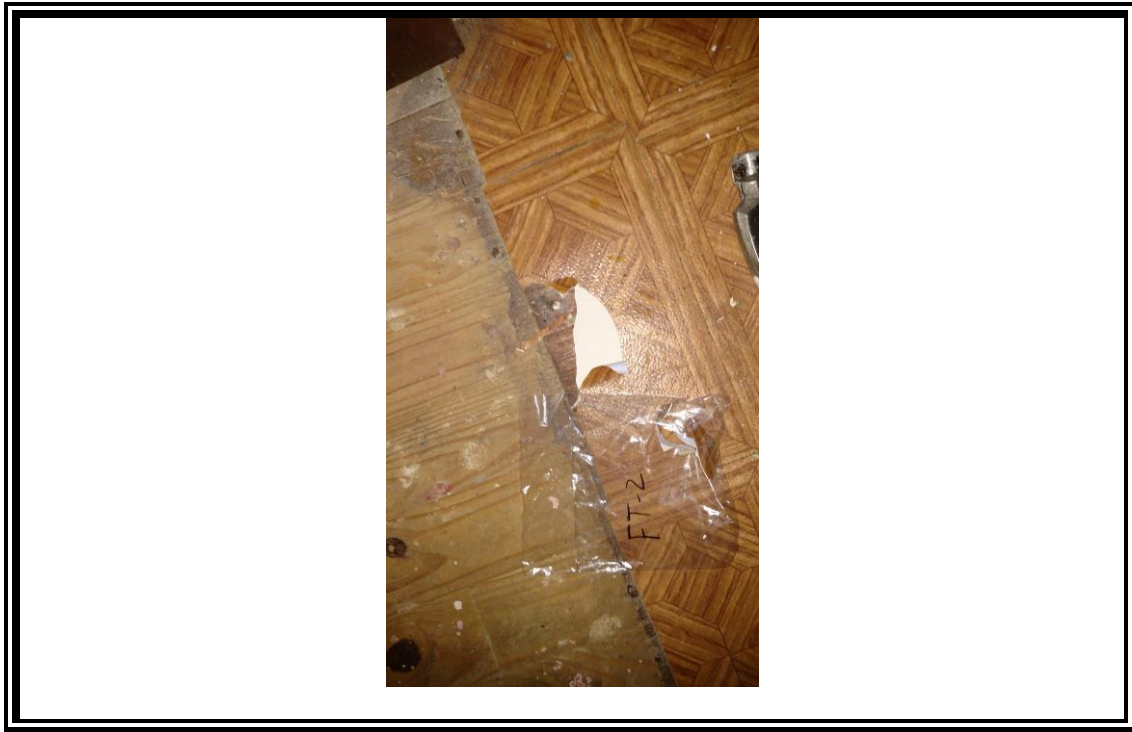
7. View of the floor tile sample in the bedroom at 650 California Blvd.

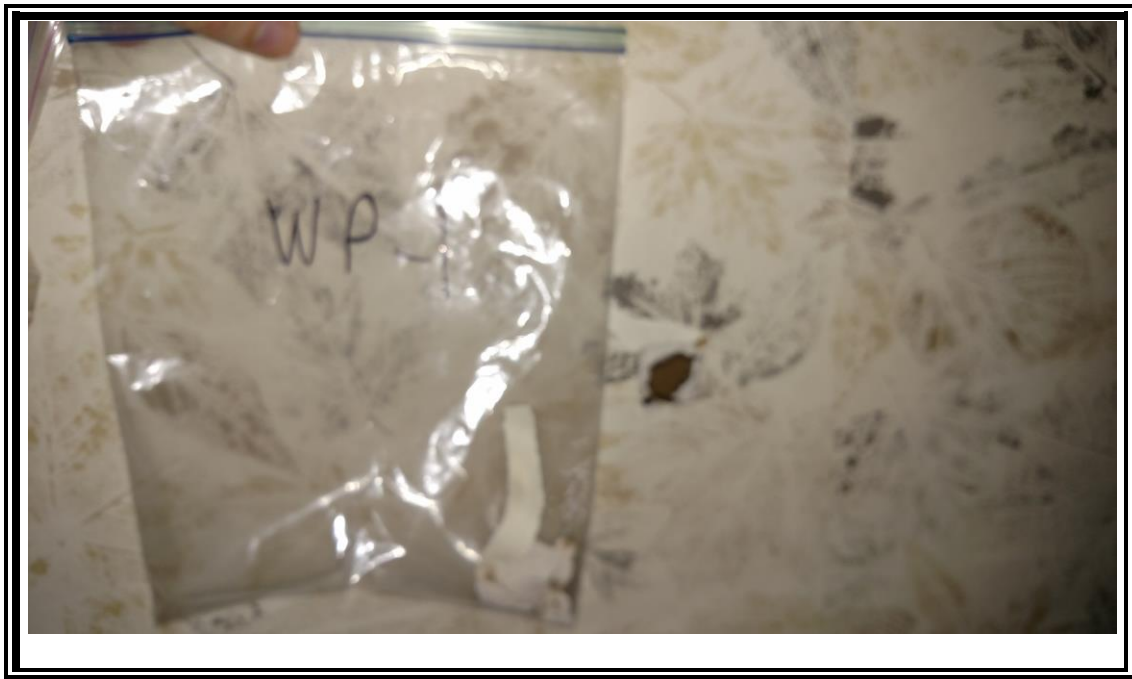
8. View of the wallpaper sample in the hallway at 650 California Blvd.

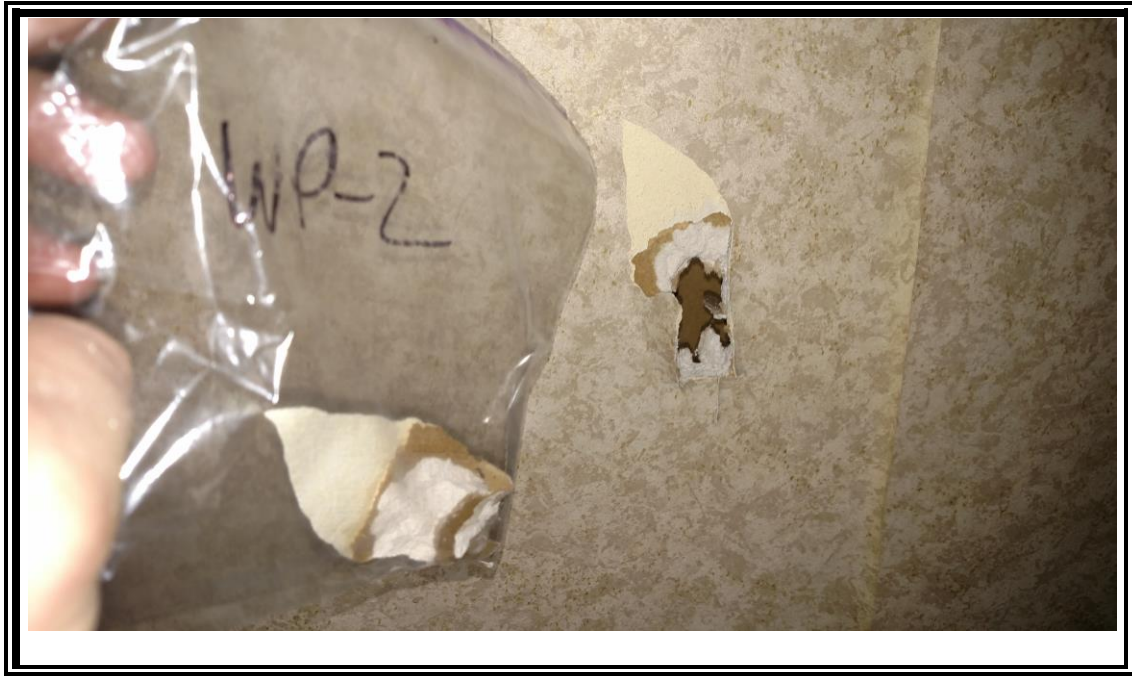
9. View of the wallpaper sample in the bedroom at 650 California Blvd.

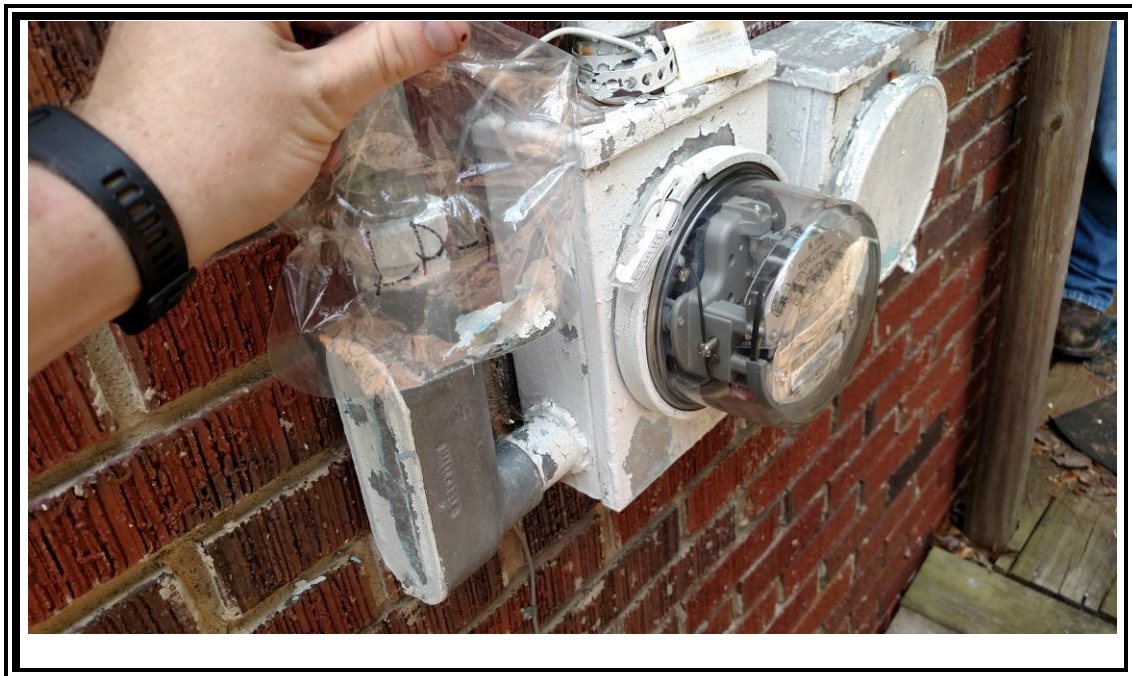
F&R personnel collected one sample from the electrical panel on the eastern side of the house. . Laboratory results indicate lead was detected at 0.26% by weight in the samples. This concentration does not constitute Lead-Based Paint; however, it can be considered lead-containing. The analytical report is included in Appendix II.

10. View of the lead-paint outside of 650 California Blvd.

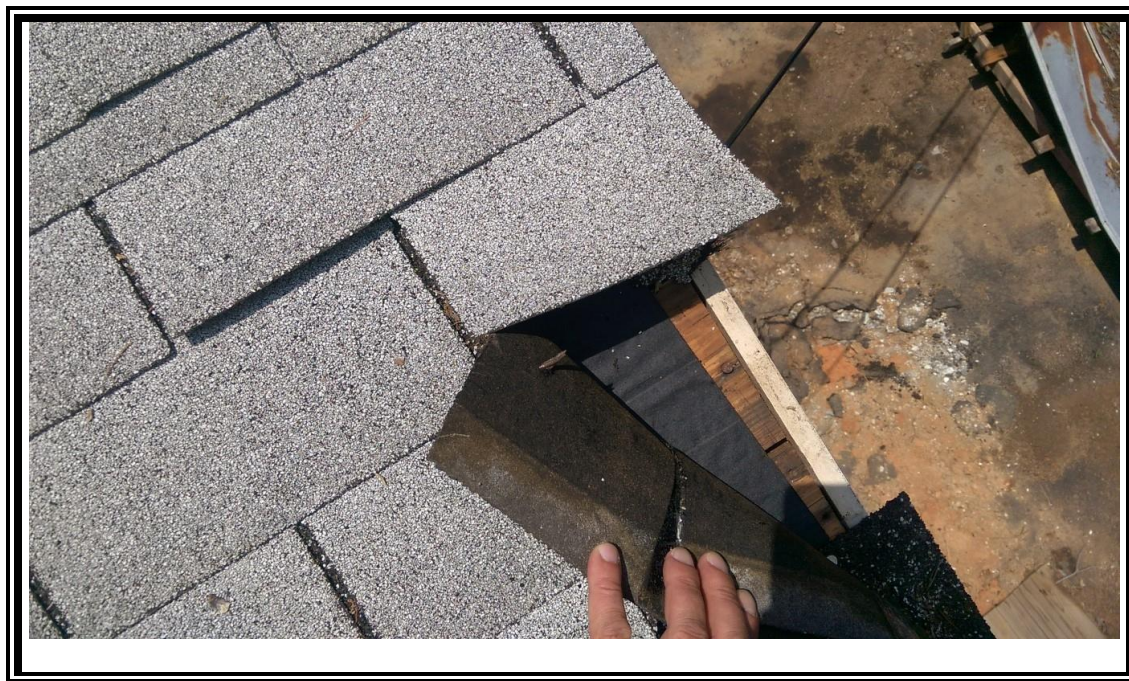
11. View of the roofing layers at 650 California Blvd.

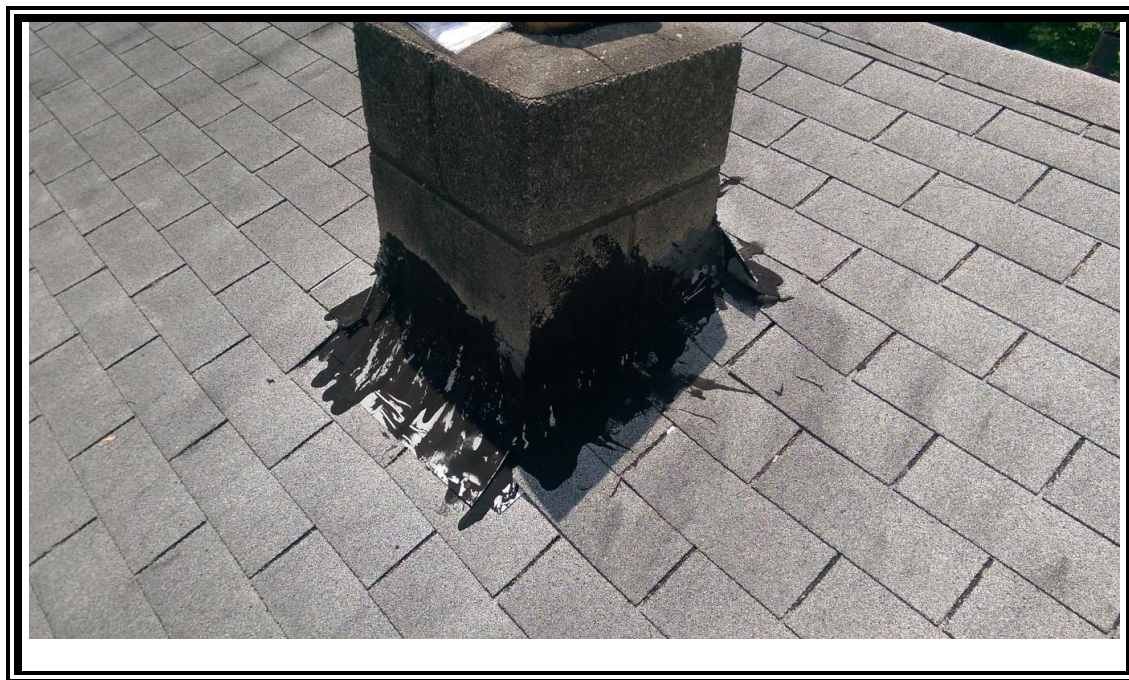
12. View of the chimney mastic at 650 California Blvd.
