# **PRE-DEMOLITION ASBESTOS & LEAD-BASED PAINT INSPECTION REPORT**

**F&R PROJECT NUMBER: 65U-0065**

SPARTANBURG AIRPORT ASBESTOS AND LEAD INSPECTIONS  
880 CALIFORNIA BOULEVARD, SPARTANBURG, SC 29304

Date of Report: June 9, 2016

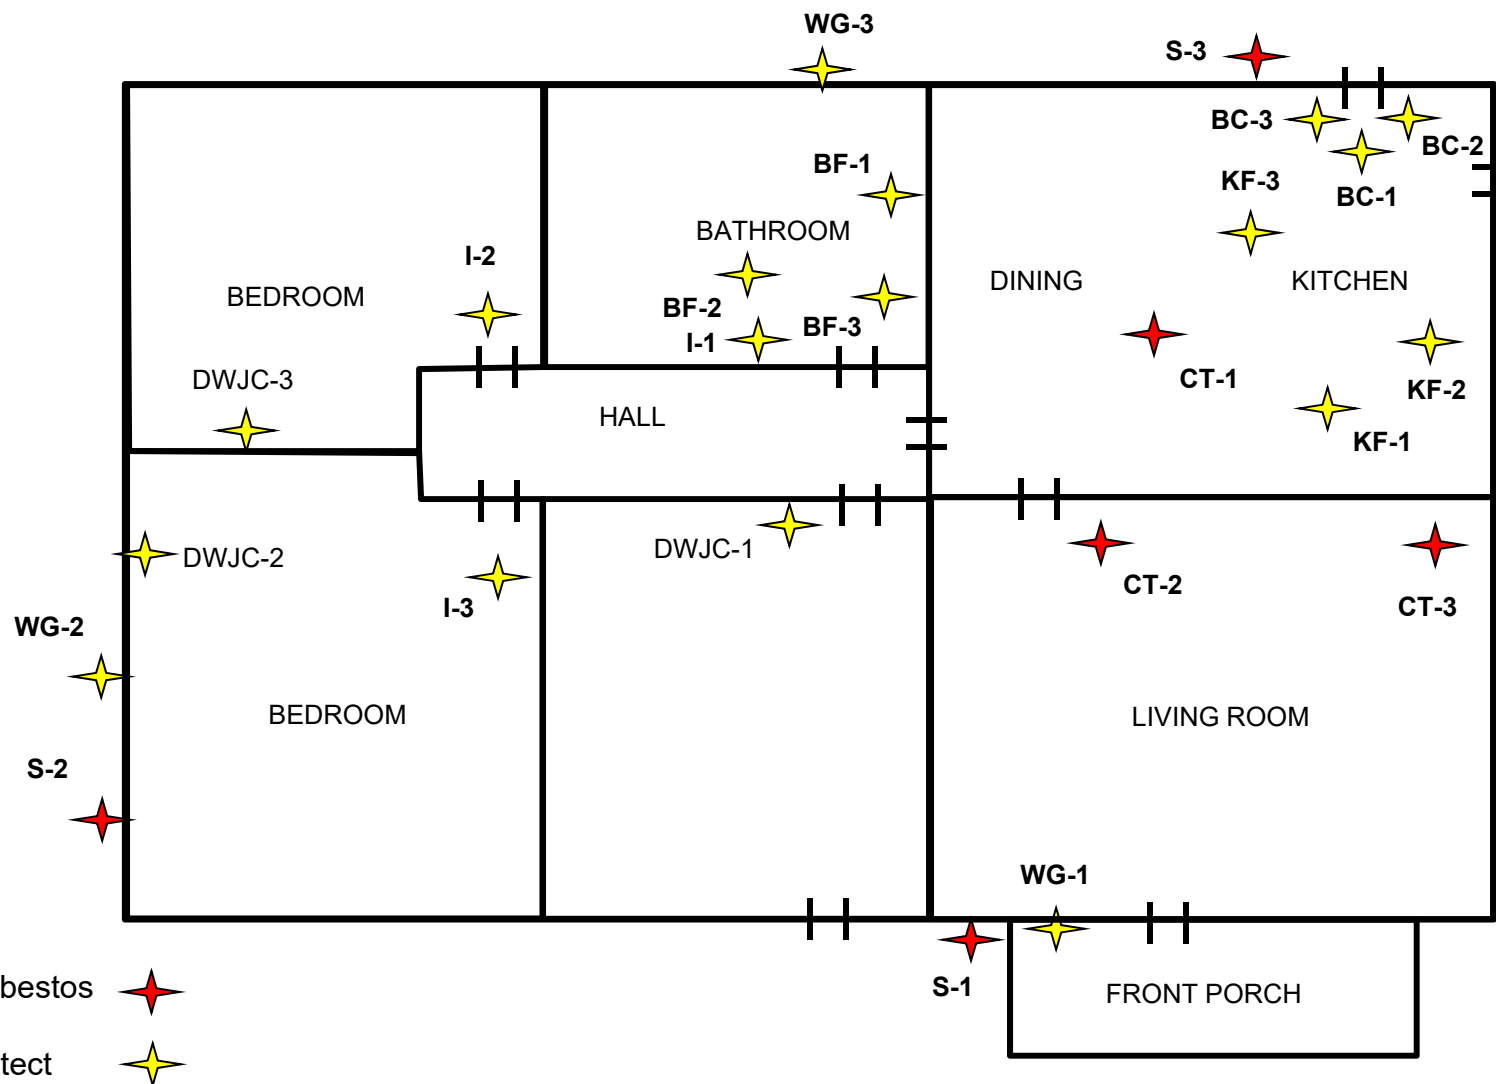
Based on the analytical results of F&R’s sampling, asbestos containing materials were identified as the **Transite panel** siding covering the facades and the **ceiling texture** located in the living room and kitchen.

<b>SUSPECT ACM SAMPLE LOCATIONS</b>

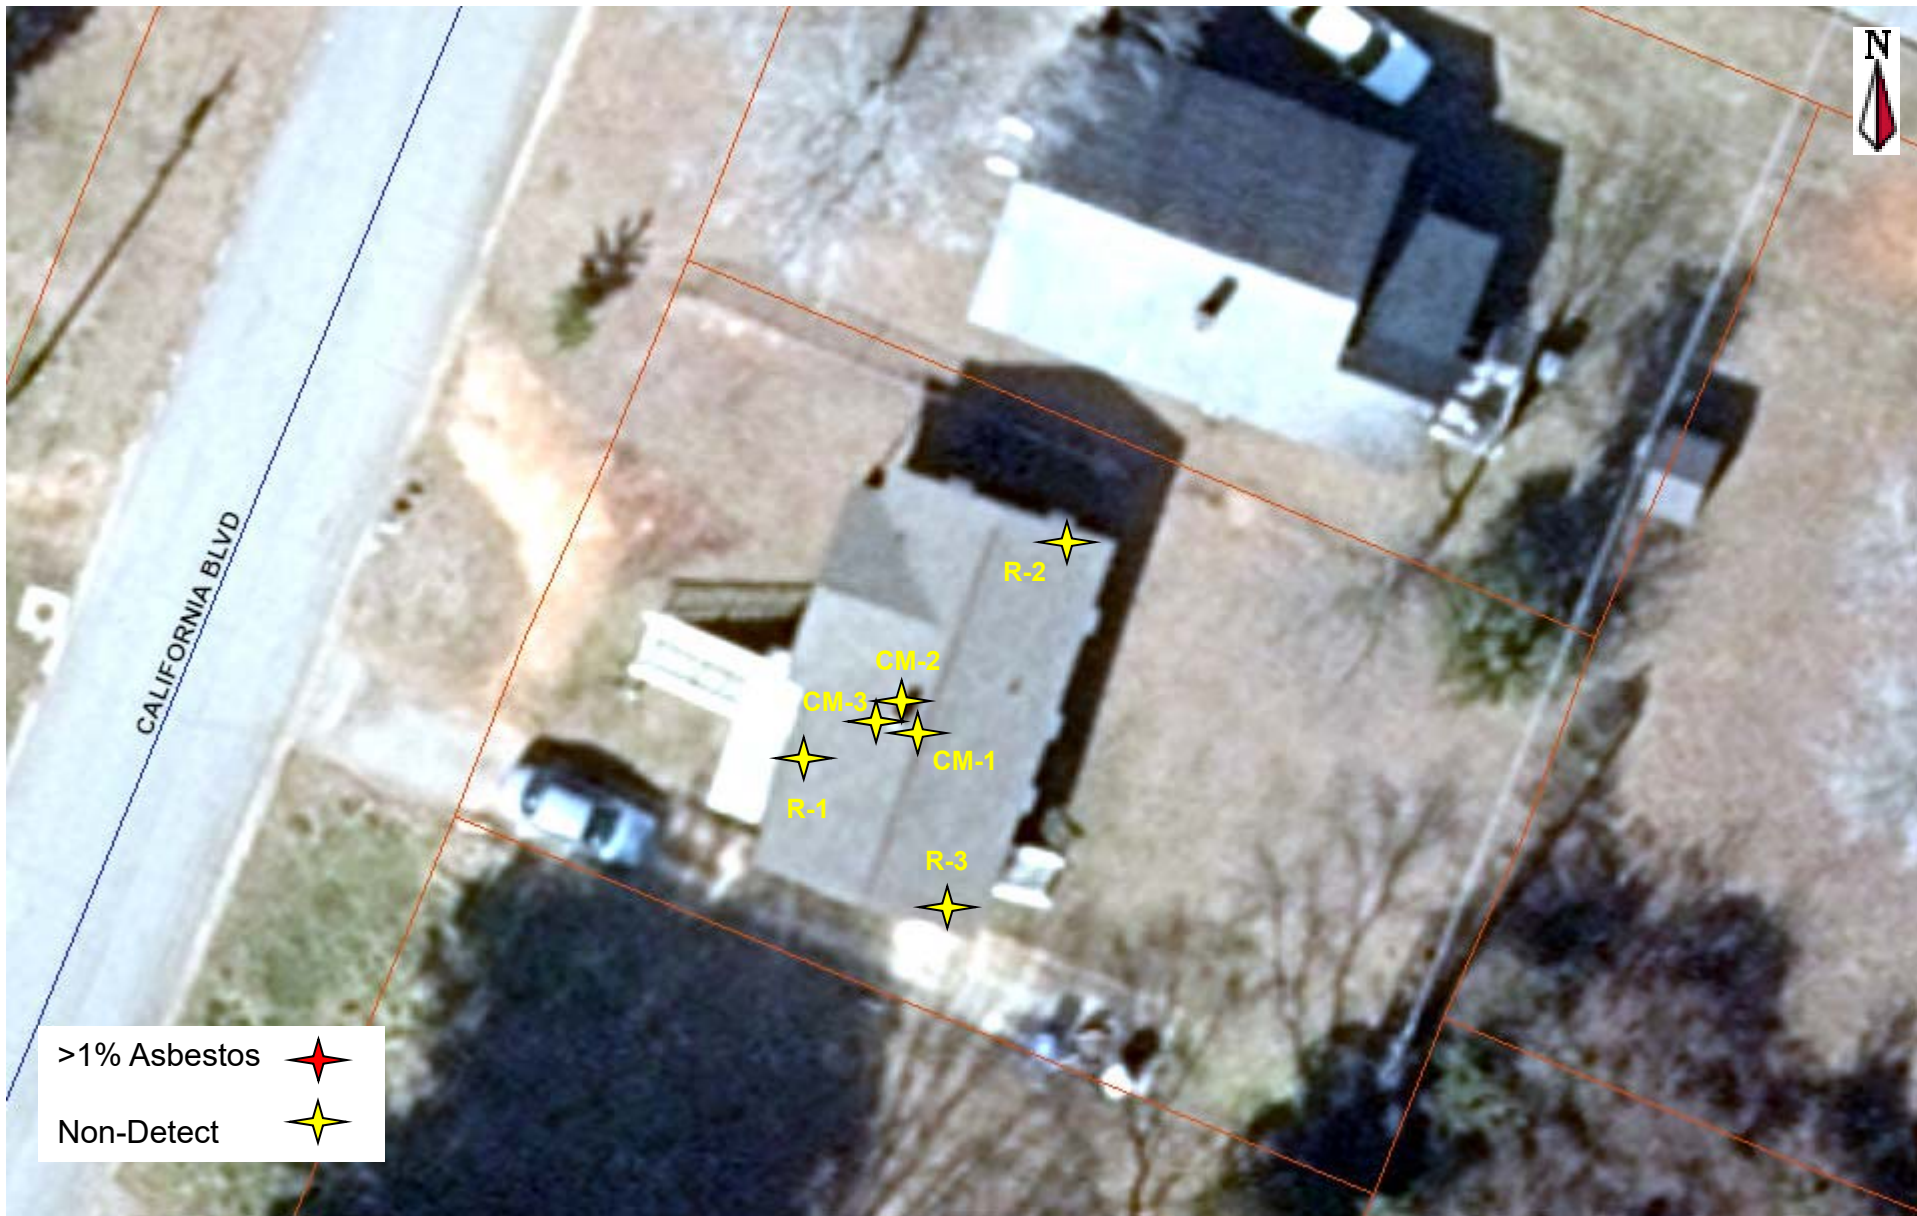
Figure 3

### SUSPECT ACM ROOFING SAMPLE LOCATIONS

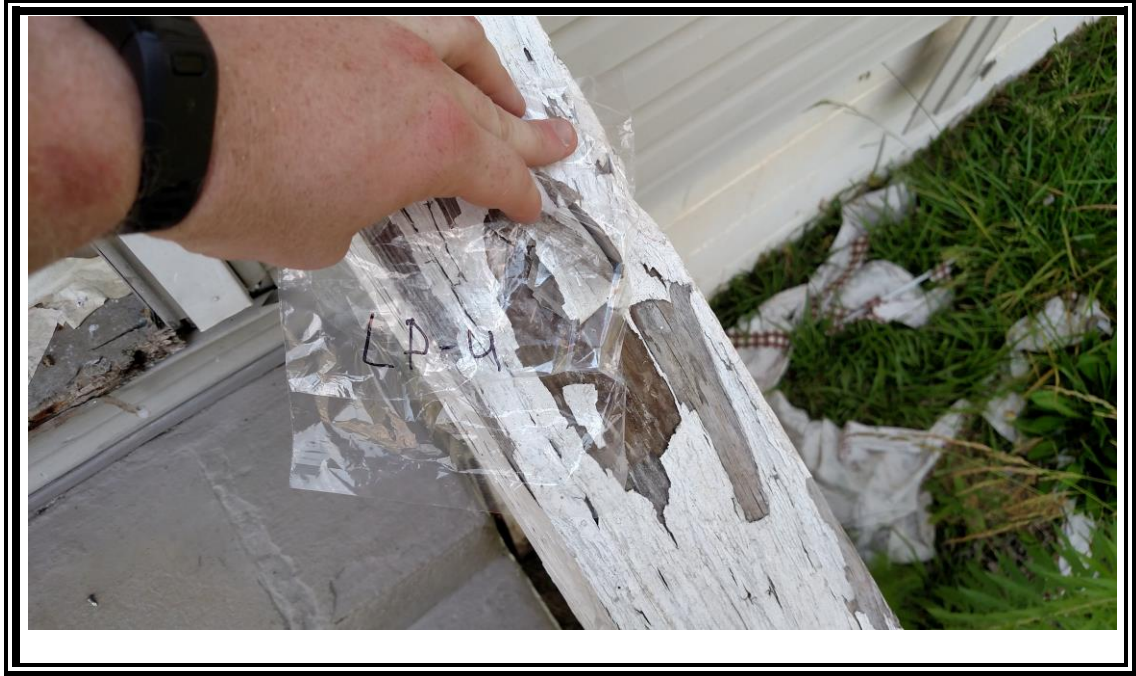
1. View of the lead-paint sample on the rear stair railing of 880 California Blvd.

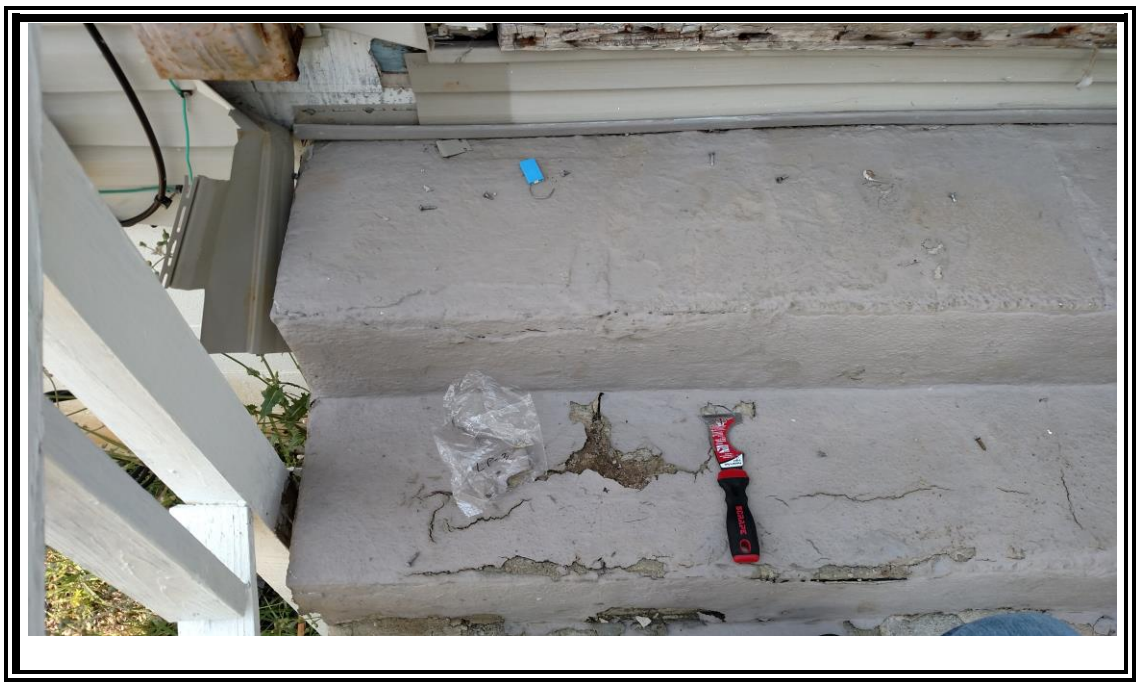
F&R personnel collected three samples from the rear entrance stairs and stair railings, and from the front entrance stairs. Laboratory results indicate lead was not detected above 0.010% by weight in any of the samples. The analytical report is included in Appendix II.

2. View of the lead-paint sample on the rear stairs of 880 California Blvd.

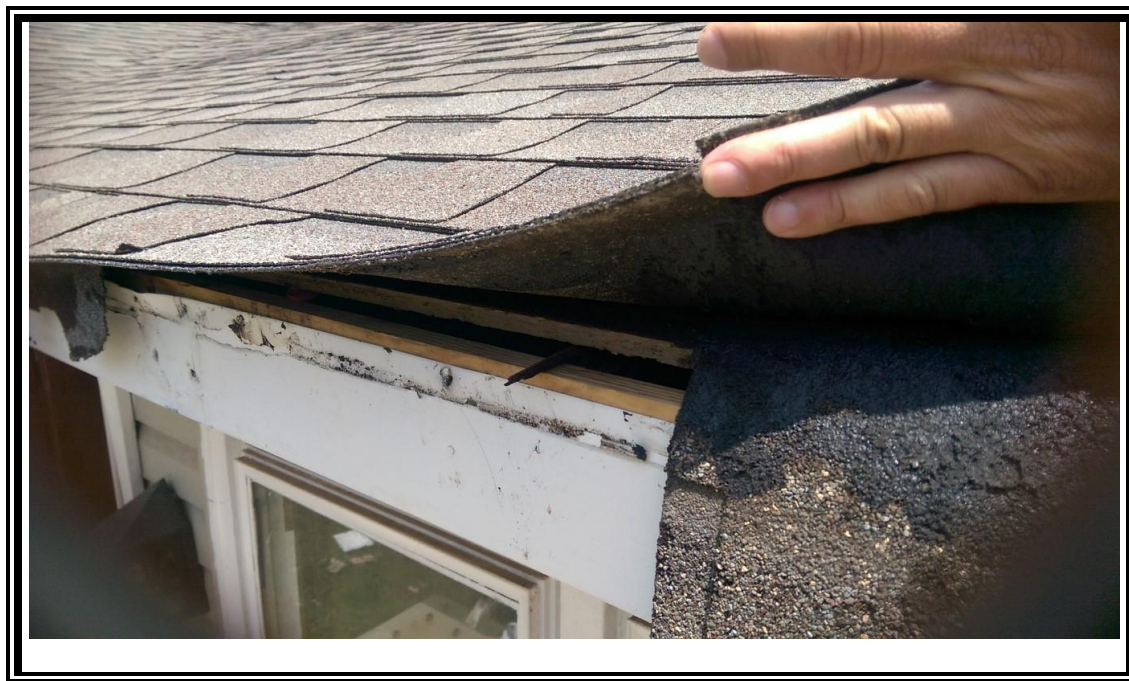
3. View of the shingle and felt paper on the roof of 880 California Blvd.

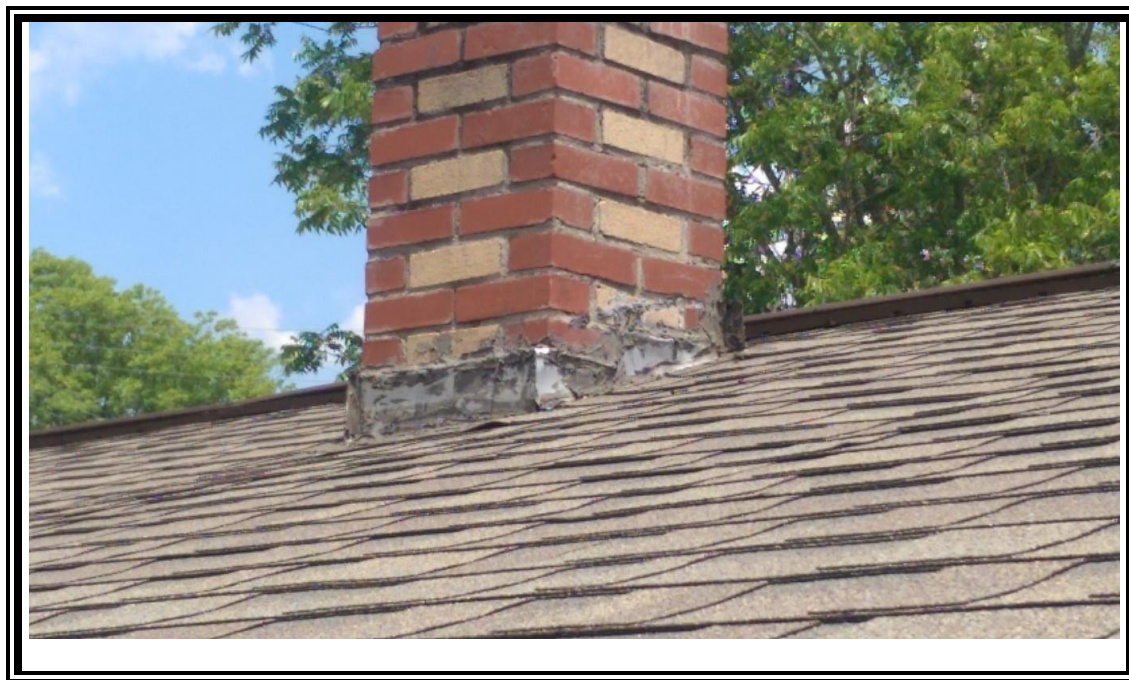
4. View of the chimney mastic at 880 California Blvd.

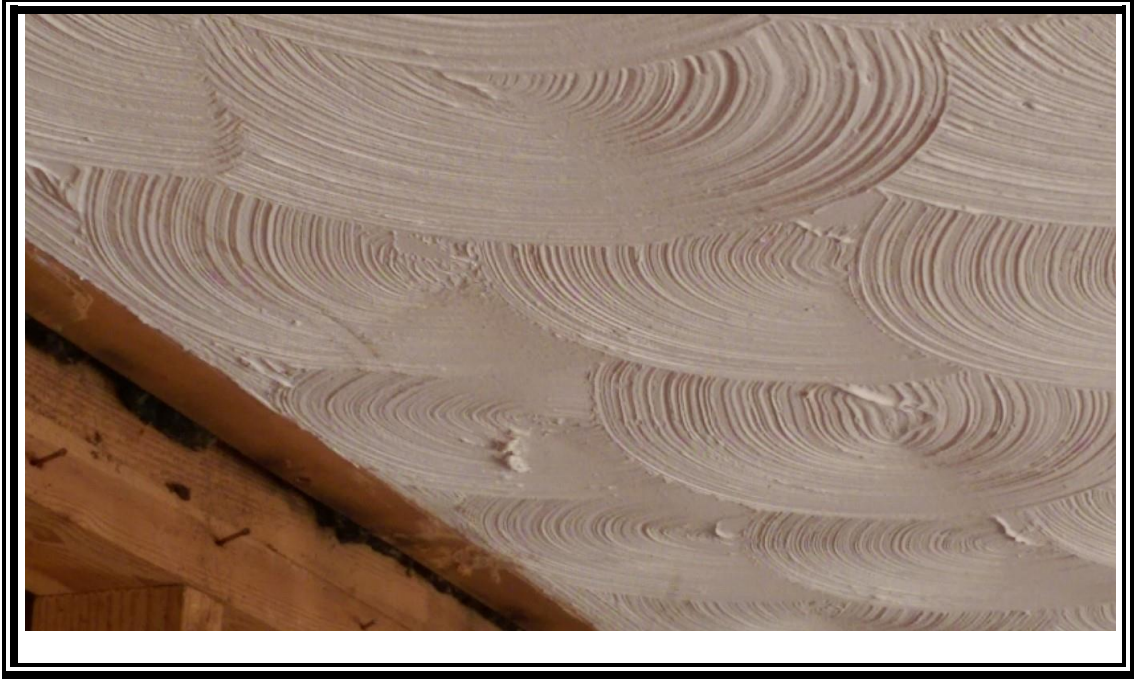
5. View of the ceiling texture in the living room and kitchen of 880 California Blvd.

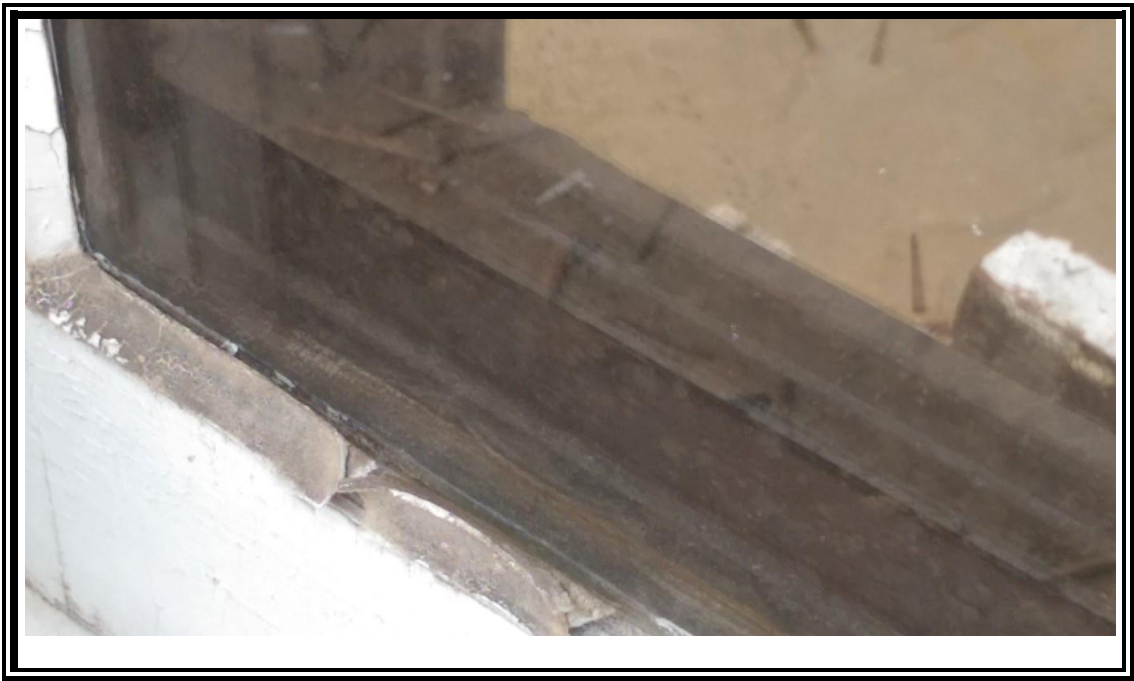
6. View of window glazing on the exterior of the 880 California Blvd. windows.

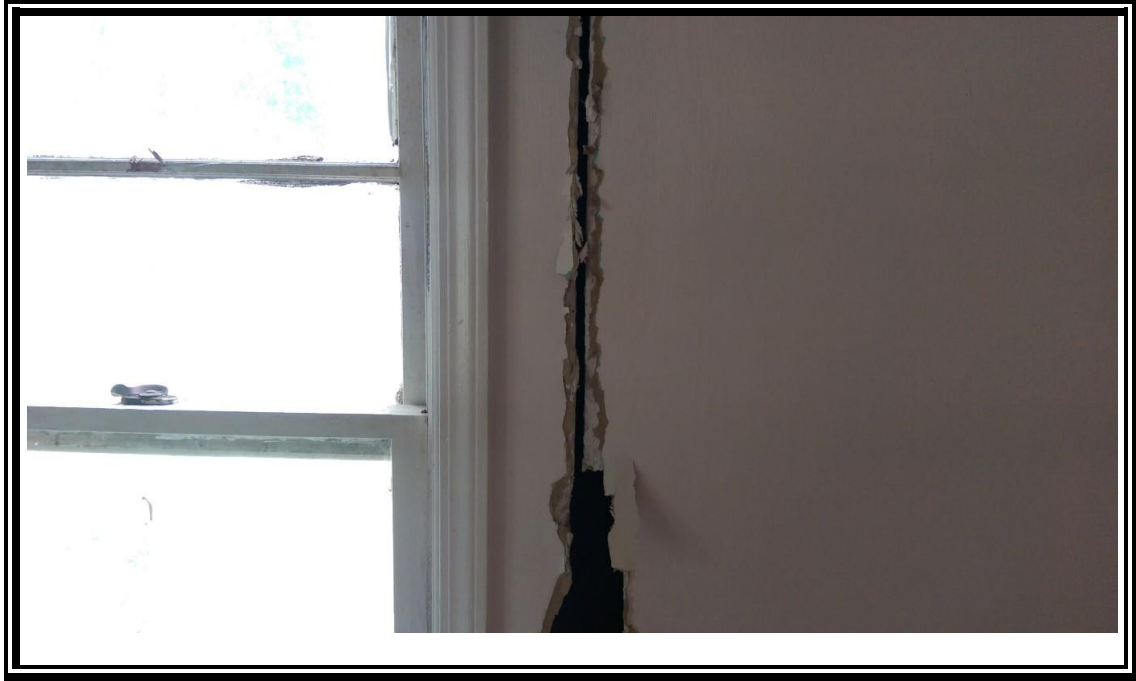
7. View of the drywall and joint compound located in 880 California Blvd.

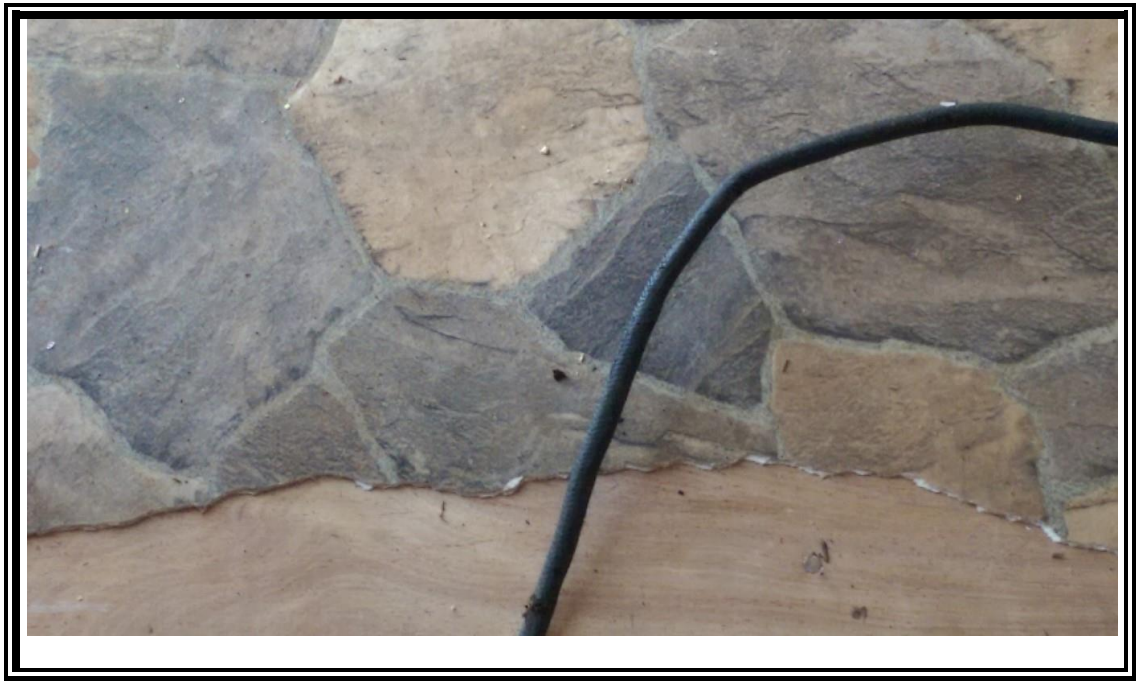
8. View of the kitchen flooring in 880 California Blvd.

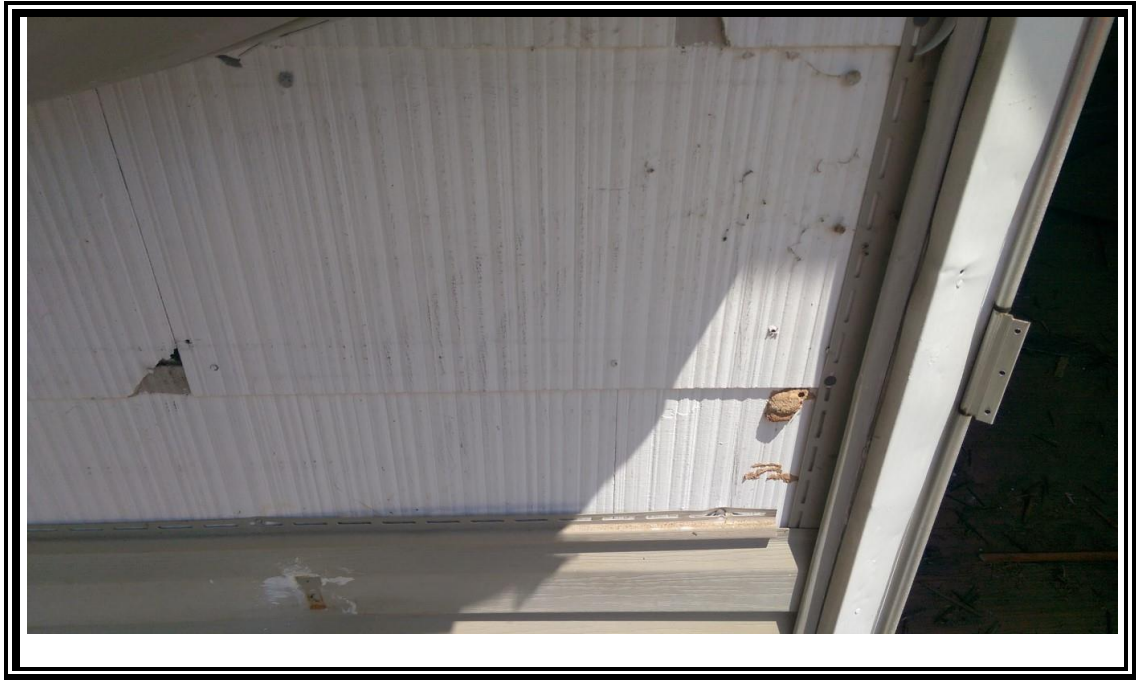
9. View of the Transite siding concealed by vinyl on 880 California Blvd.

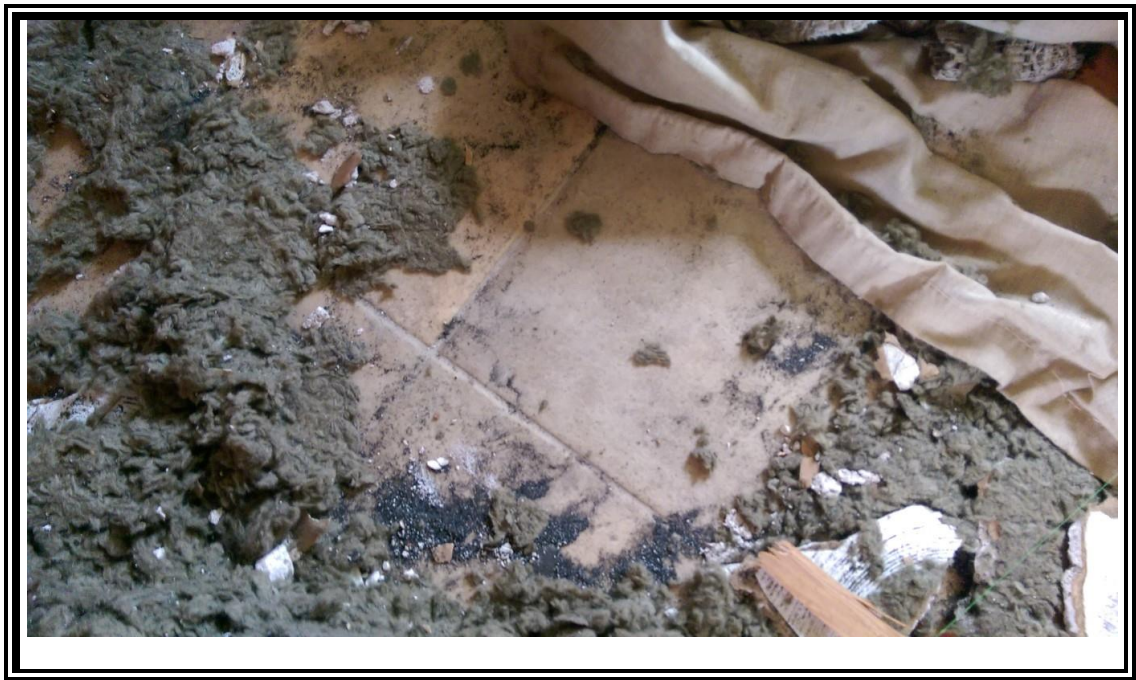
10. View of the bathroom flooring and insulation in 880 California Blvd.
