## **ADDENDUM NO. I**

SUBJECT: Addendum No. 1 – Sanitary Laundry Building: Roof Structure Repair and Reroofing

Subject: **Report of Limited Asbestos and Lead-Based Paint Survey**  
625 North Broadway Former Sanitary Laundry Facility  
750 Stone Street – Auto Repair Building  
760 Stone Street – Boiler House  
Knoxville, Tennessee  
EPA Cooperative Agreement Number BF-95443509-1  
S&ME Project No. 1434-11-392-007

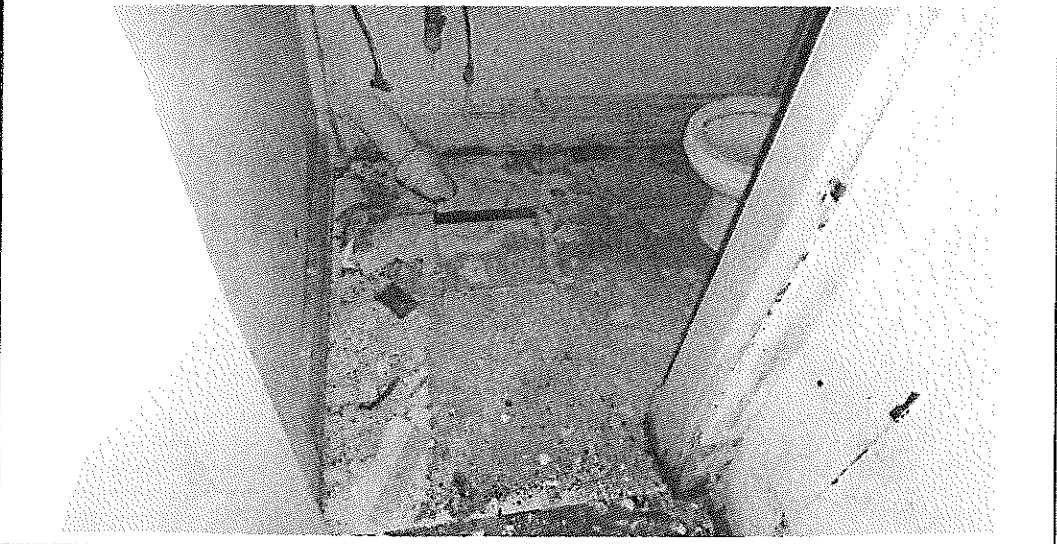
Photo 1

<b>Date:</b> 2/17/2014  <b>Photographer:</b> Emily Buckingham
<b>Sample # / Location</b>	SL-004 A/B / Sanitary laundry building - Ground floor bathroom room 103	
<b>Remarks</b>	Beige square patterned linoleum with black mastic Linoleum: ND; Mastic 3% Chrysotile

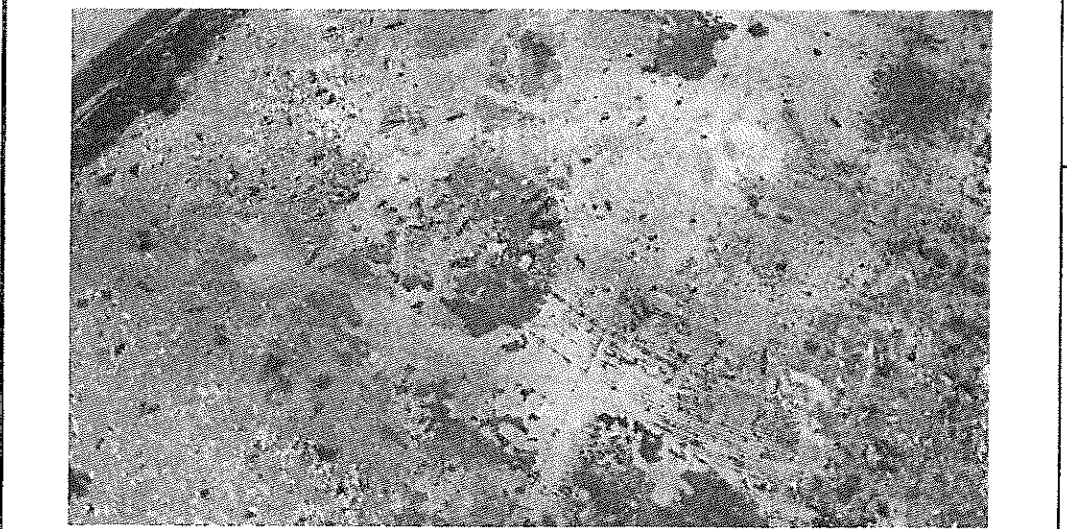
Photo 2

<b>Date:</b> 2/17/2014  <b>Photographer:</b> Emily Buckingham
<b>Sample # / Location</b>	SL-005 A/B / Sanitary laundry building - Ground floor room 101	
<b>Remarks</b>	Black mastic on concrete floor 7% Chrysotile

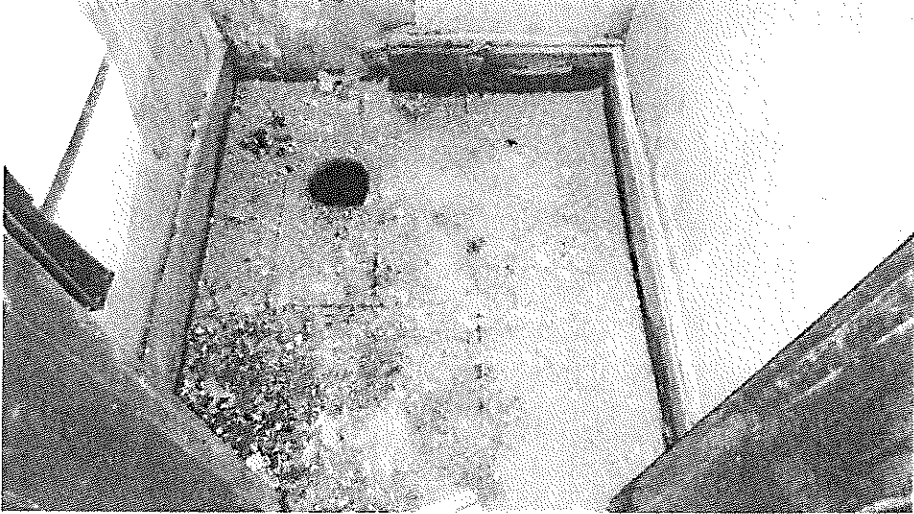
Photo 3

<div style="display: flex; justify-content: space-between;"> <div> <p><b>Sample # / Location</b> SL-008 A/B/ Sanitary laundry building - Ground floor bathroom 102</p> <p><b>Remarks</b> Beige 9" x 9" floor tile with black mastic            Tile: 5% Chrysotile, Mastic: 3% Chrysotile</p> </div> <div style="writing-mode: vertical-rl; transform: rotate(180deg);"> <p><b>Date:</b> 2/17/2014</p> <p><b>Photographer:</b> Emily Buckingham</p> </div> </div>

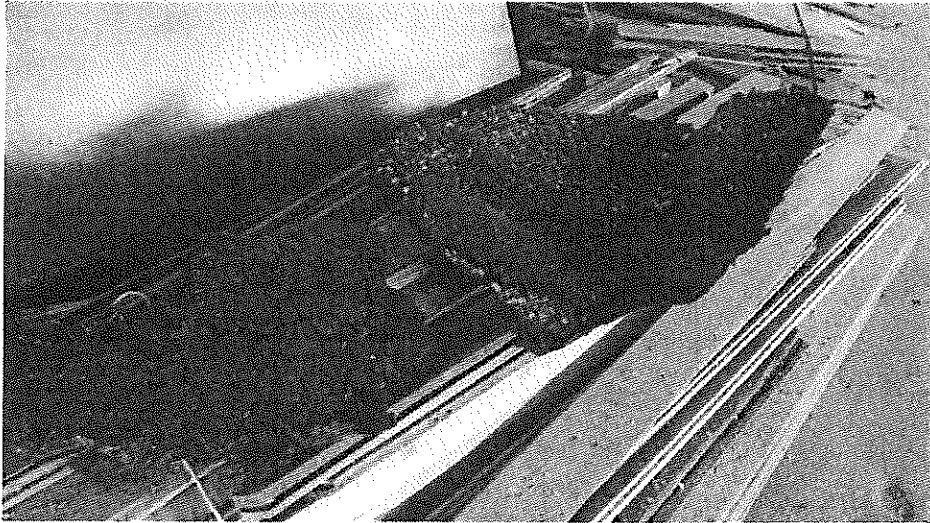
Photo 4

<div style="display: flex; justify-content: space-between;"> <div> <p><b>Sample # / Location</b> SL-011 A/B &amp; SL-012 A/B / Sanitary laundry building - Roof</p> <p><b>Remarks</b> Rocks over tar paper over roofing felt            Tar paper: 4% Chrysotile</p> </div> <div style="writing-mode: vertical-rl; transform: rotate(180deg);"> <p><b>Date:</b> 2/17/2014</p> <p><b>Photographer:</b> Emily Buckingham</p> </div> </div>

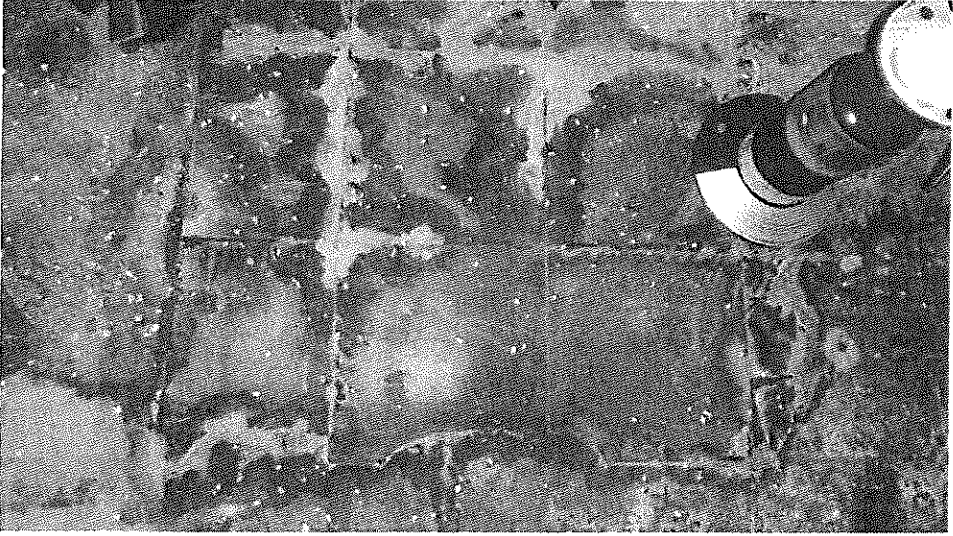
Photo 5

Date: 2/19/2014
	Photographer: Emily Buckingham
Sample # / Location	SL-018 A/B/ Sanitary laundry building - Basement room 010
Remarks	Blue 9" x 9" floor tile with black mastic Floor tile: 4% Chrysotile, Mastic 3% Chrysotile

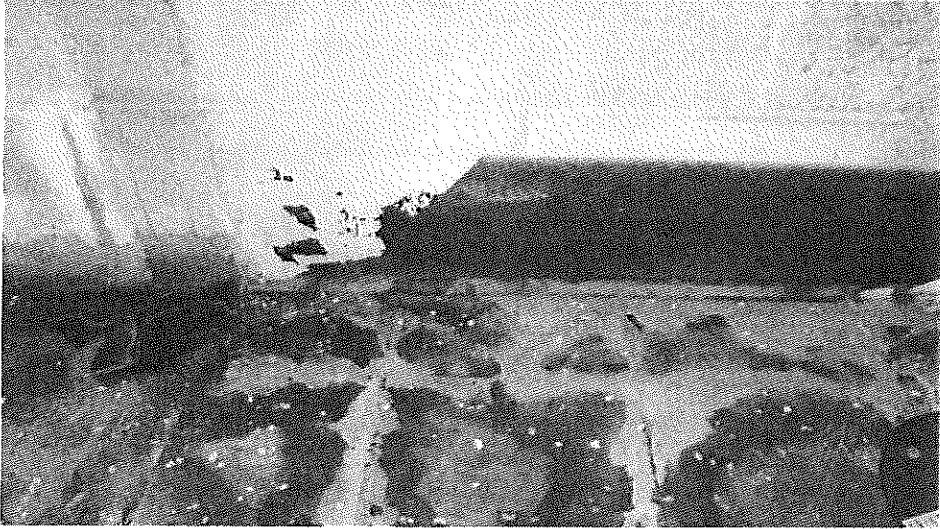
Photo 6

Date: 2/19/2014
	Photographer: Emily Buckingham
Sample # / Location	SL-019 A/B/ Sanitary laundry building - Basement room 010
Remarks	Black covebase with black mastic Covebase: 4% Chrysotile, Mastic: ND

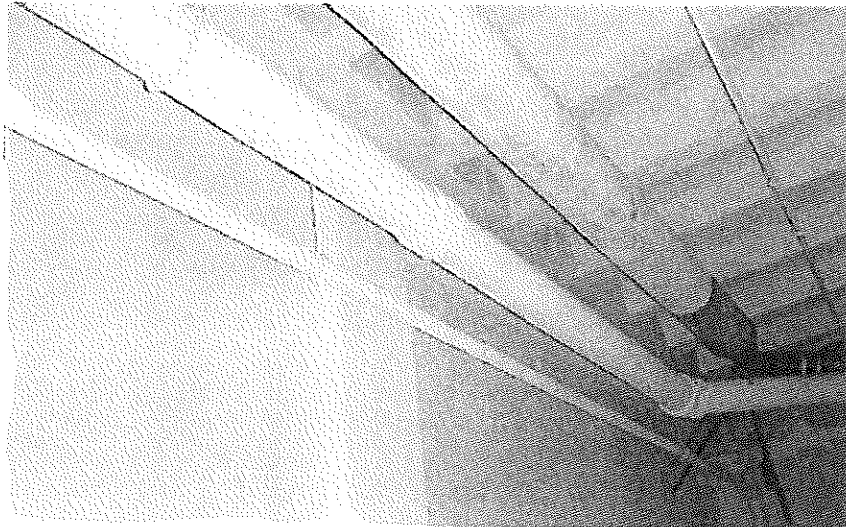
**Photo 7**

**Remarks** Brown paper and black tar layered thermal system insulation with paper wrap on water pipes  
Brown paper: 20% Chrysotile

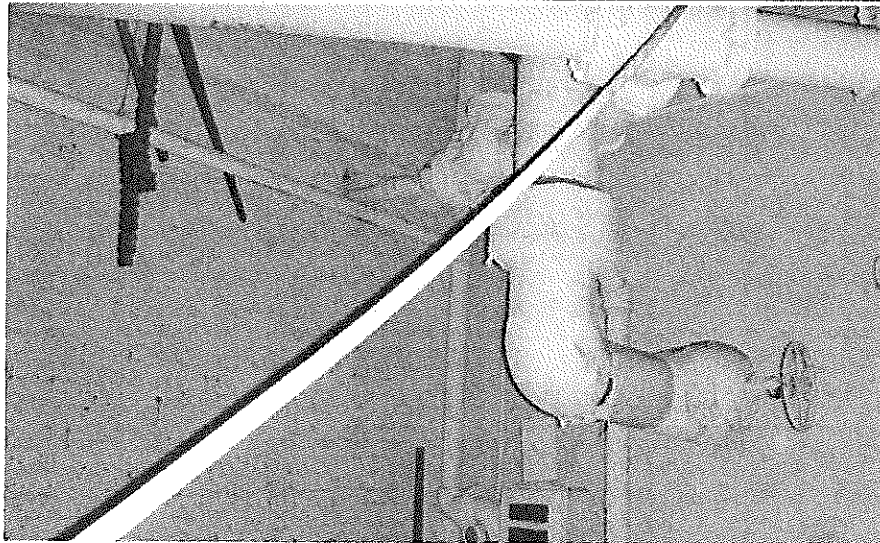
**Photo 8**

**Remarks** Hard, White mud on elbows of water pipes  
30% Chrysotile

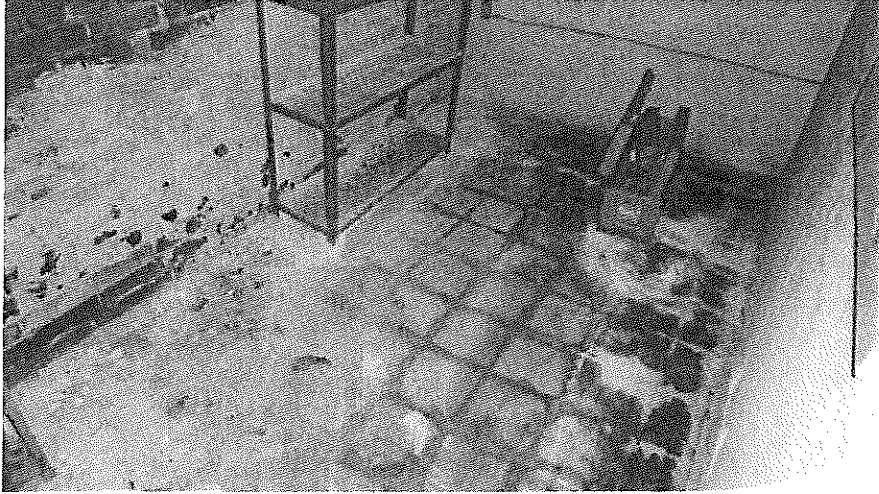
Photo 9

<div style="float: right; width: 150px;"> <b>Date:</b> 2/19/2014   <b>Photographer:</b> Emily Buckingham         </div>	
<b>Sample # / Location</b>	SL-022 A/B/Sanitary laundry building - Basement room 007
<b>Remarks</b>	Green 9" x 9" floor tile with black mastic Floor tile: 4% Chrysotile, Mastic 5% Chrysotile

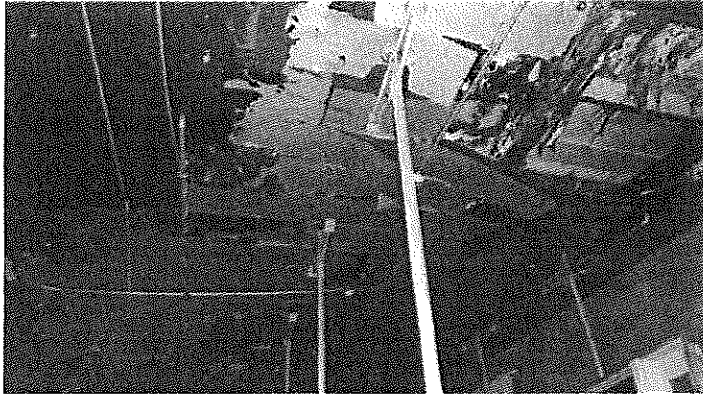
Photo 10

<div style="float: right; width: 150px;"> <b>Date:</b> 2/19/2014   <b>Photographer:</b> Emily Buckingham         </div>	
<b>Sample # / Location</b>	SL-024 A/B/ Saniary laundry building - Basement room 015
<b>Remarks</b>	Silver paint over black mastic on corkboard on ceiling Black mastic: 2% Chrysotile
