December 23, 2021

██████████
████████████████████
City of Griffin
100 S. Hill St.
Griffin GA 30223

Re: Final Engineering Inspection Report Project Number 21-0420
Existing Precast Concrete Parking Structure Next to City Hall
List of tasks that were not included in IMMEC's scope that still need to be addressed

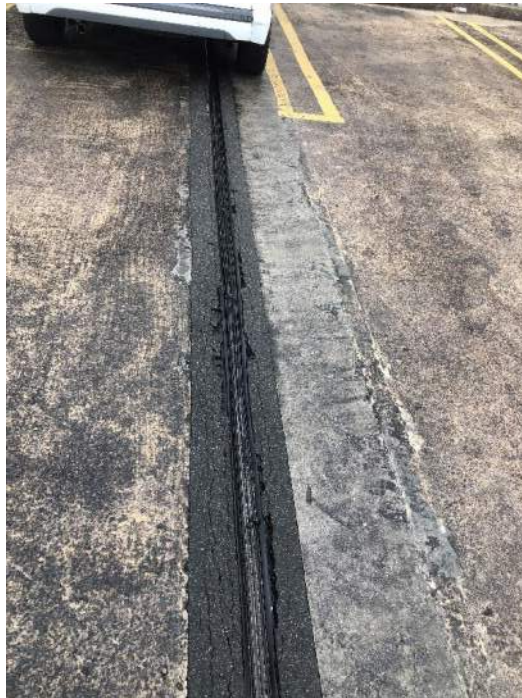
1. All of the expansion joints in the deck need to be replaced including addressing any damaged or cracked concrete on either side of the expansion joint. The expansion joints should be as waterproof as possible.

Photo 1 Existing Expansion Joints to be Completely Removed and Rebuilt

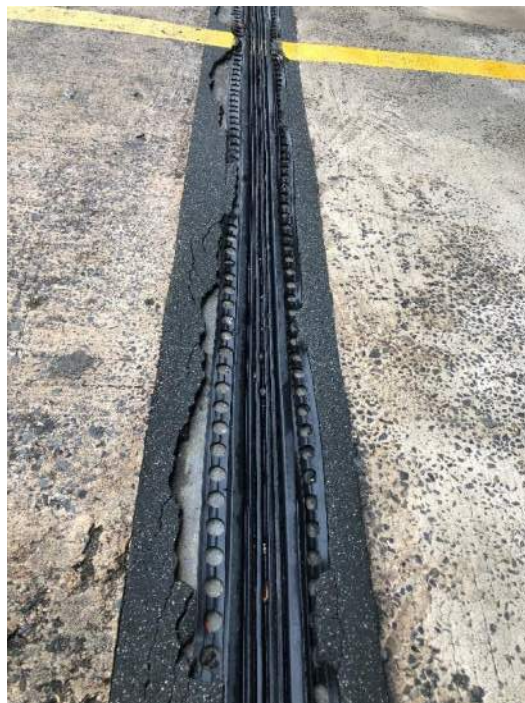
Photo 1A Closeup of Expansion Joint

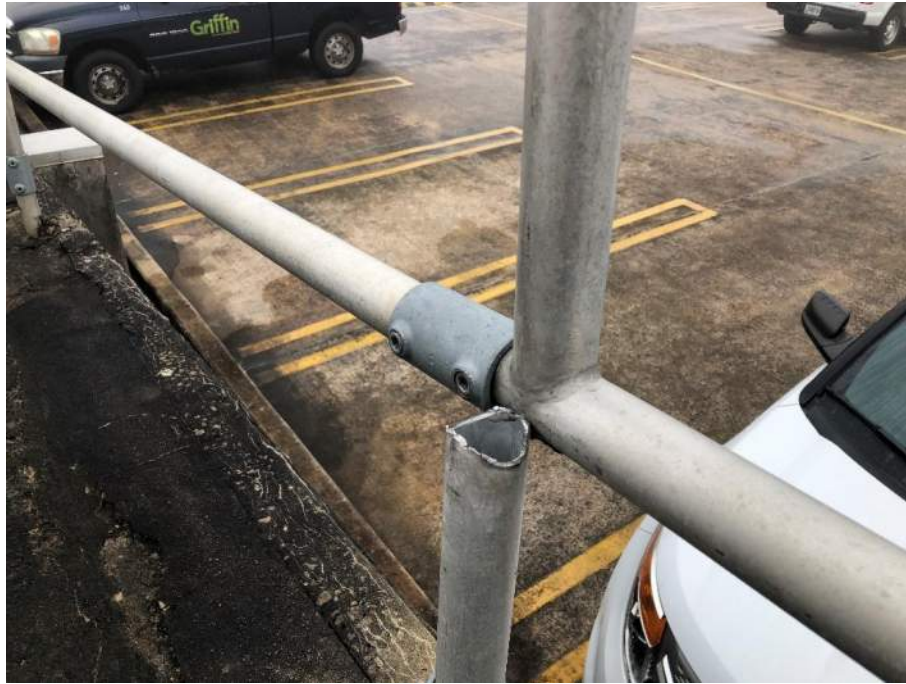
2. The existing aluminum handrail at the center of the parking deck at the ramps is cracked and loose. They will not hold the required pedestrian load per the building codes. The handrails can be welded back together and reattached to the existing columns.

Photo 2 Existing Aluminum Handrail to be Repaired

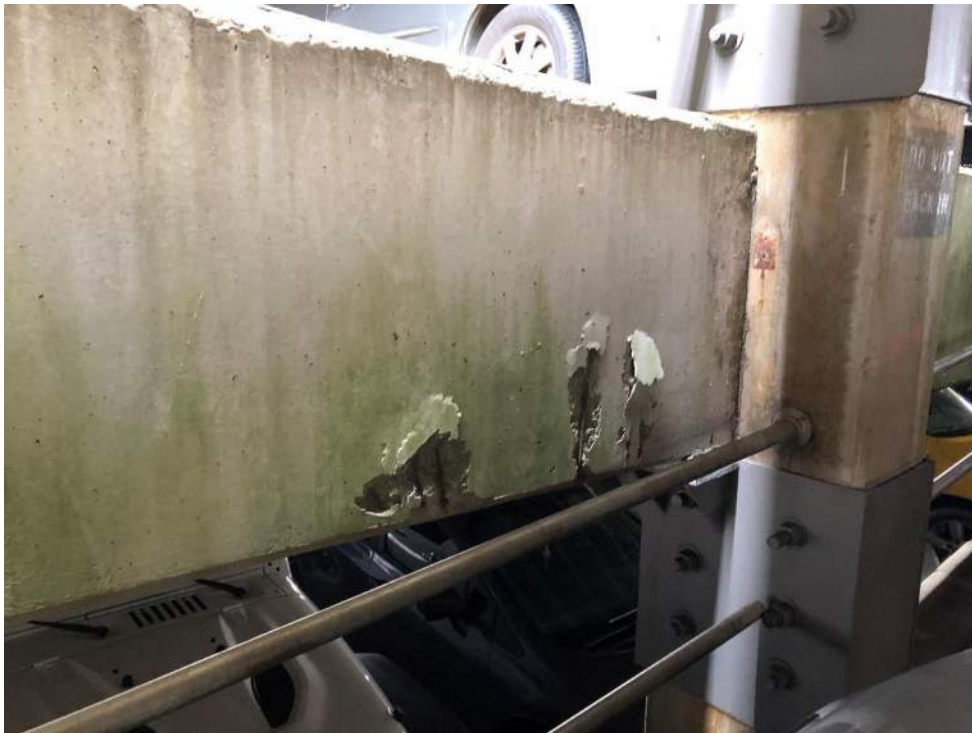
Photo 2A Aluminum Handrail and Spalling Concrete

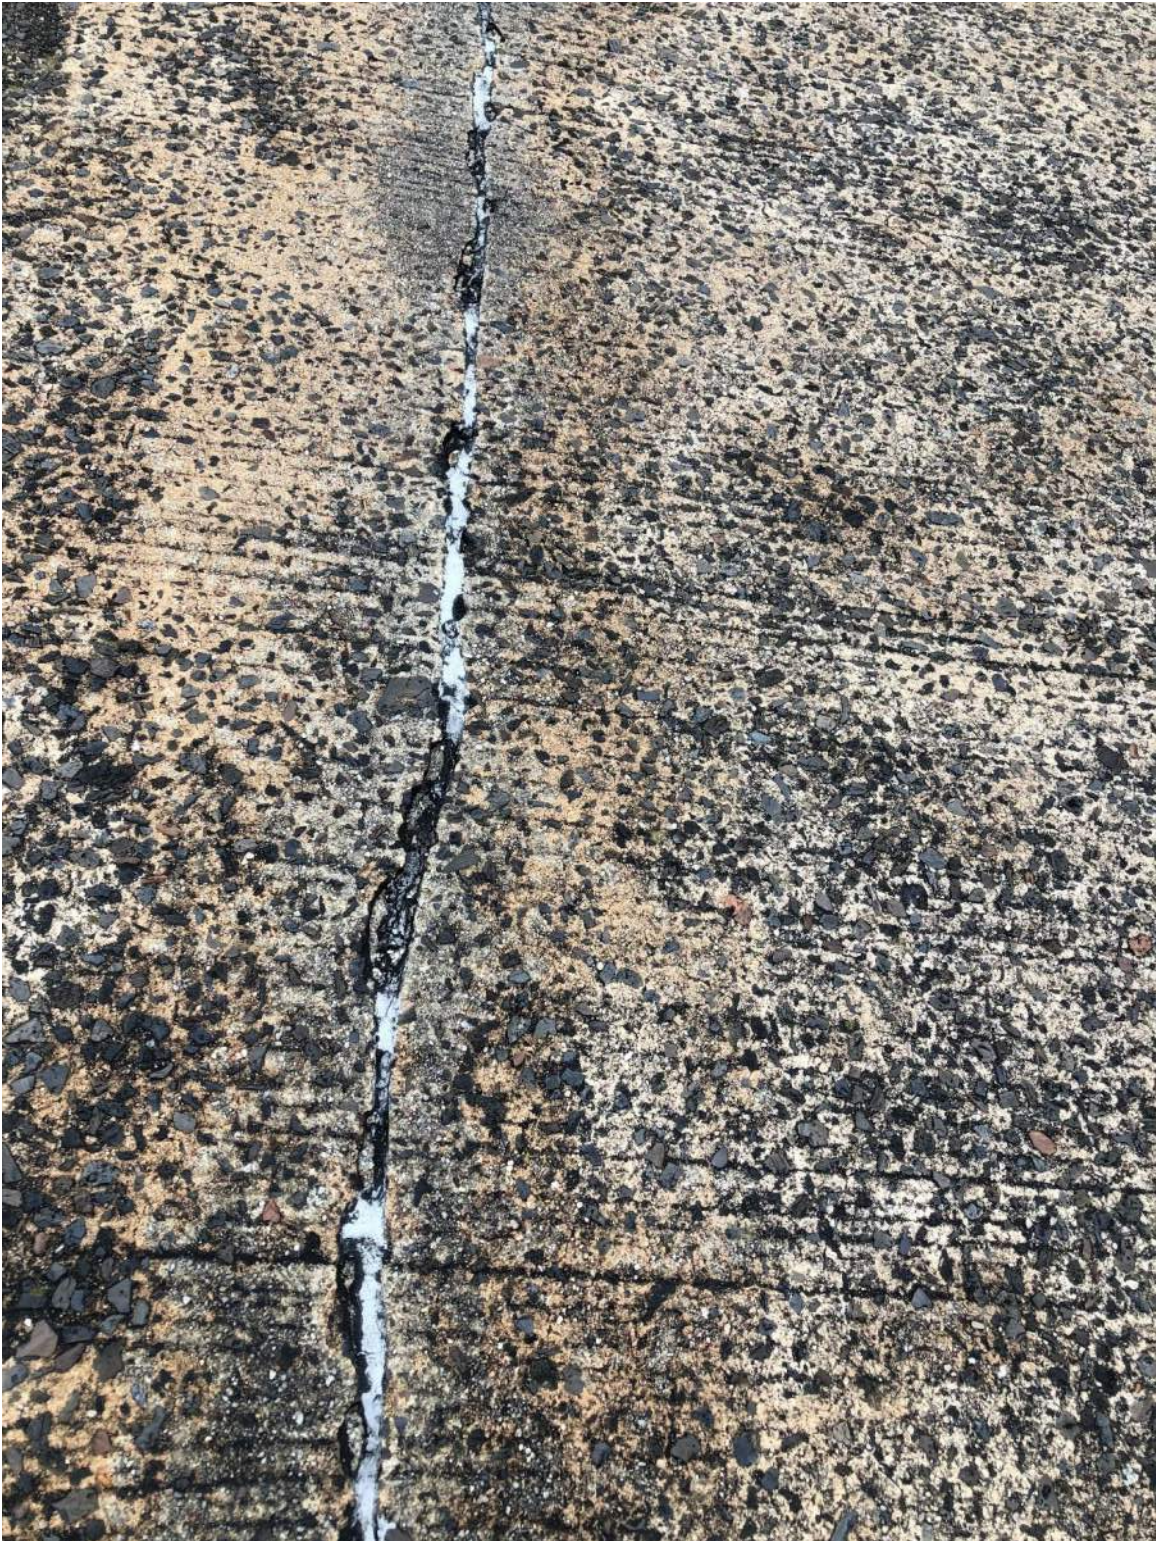
3. There are several cracks throughout the deck that need to be waterproofed. These are expansion related cracks which are expected in any concrete structure and these crack need to be sealed to keep out water and its damaging effects.

Photo 3 Crack in need of Recaulking

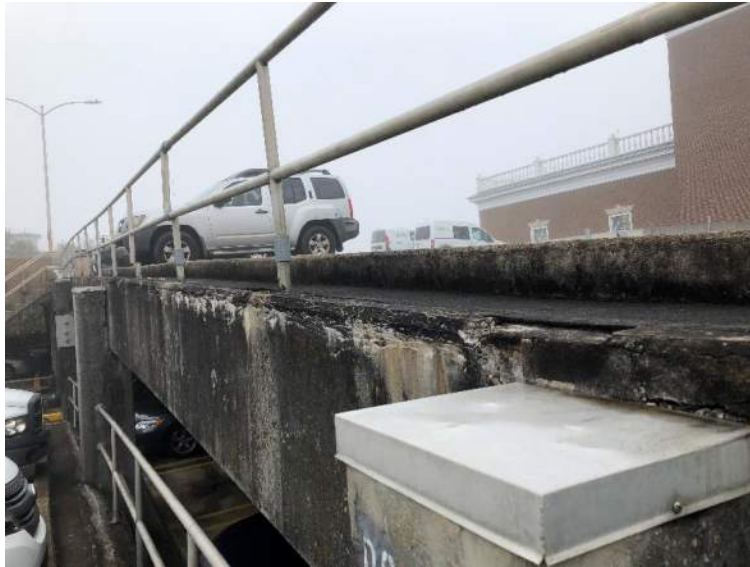
Photo 4 Top Concrete that need to be sealed

4. The exposed concrete at the top of the parking deck needs to be sealed/painted. This includes the tops of the columns and beams and the deck exposed to the weather.

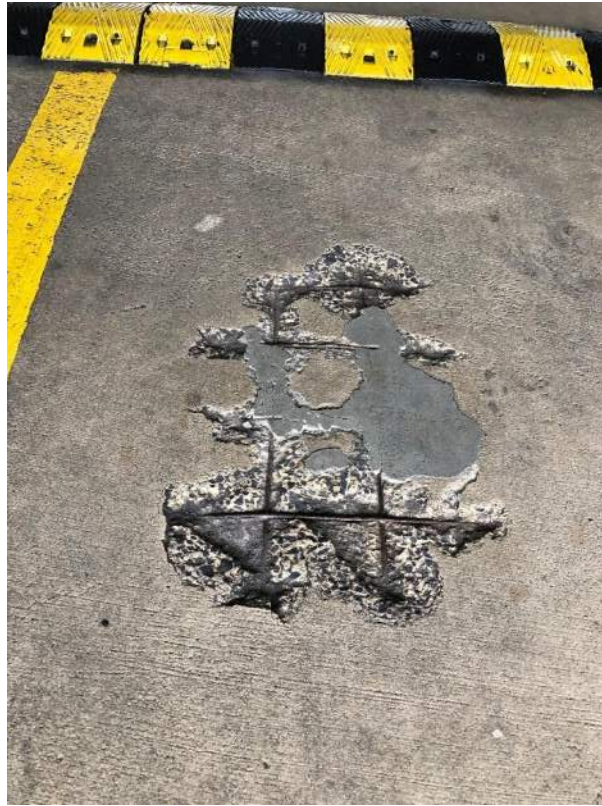
Photo 5 Deck Spalling Concrete

5. There are several places in the existing deck, beams, and columns where concrete has been spalled and rebar is exposed. These areas should be cleaned up, removing any loose concrete, coating with a corrosion inhibiting sealer and then shim coated with grout.

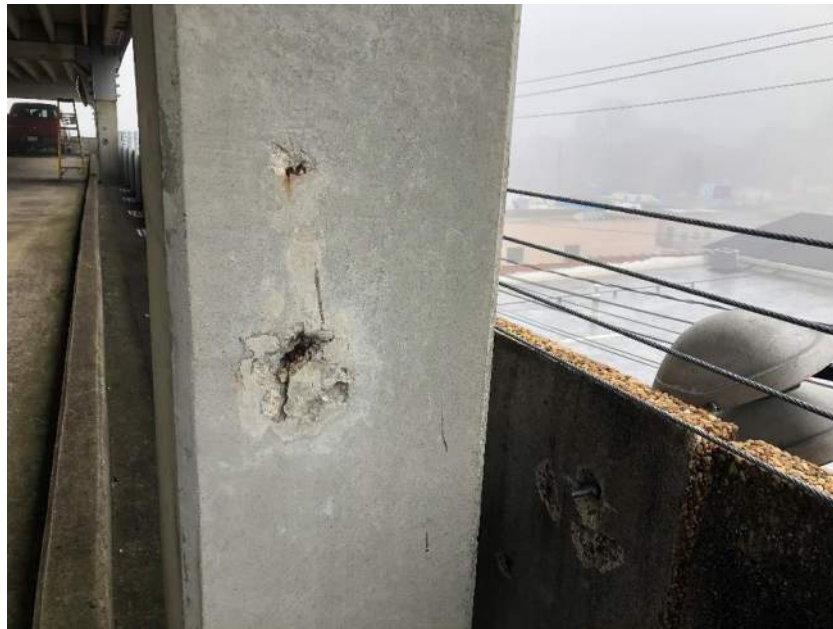
Photo 5A Column Spalling Concrete

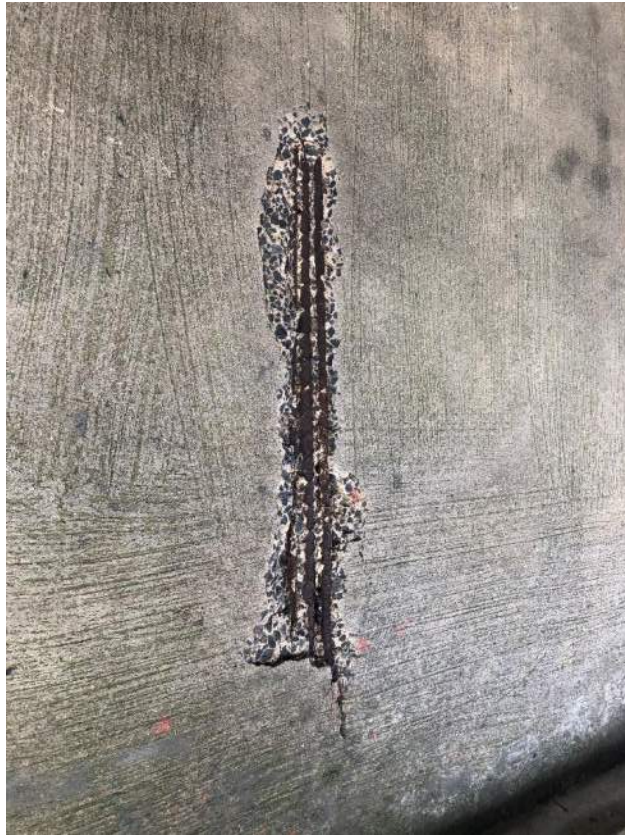
Photo 5B Spalling Deck

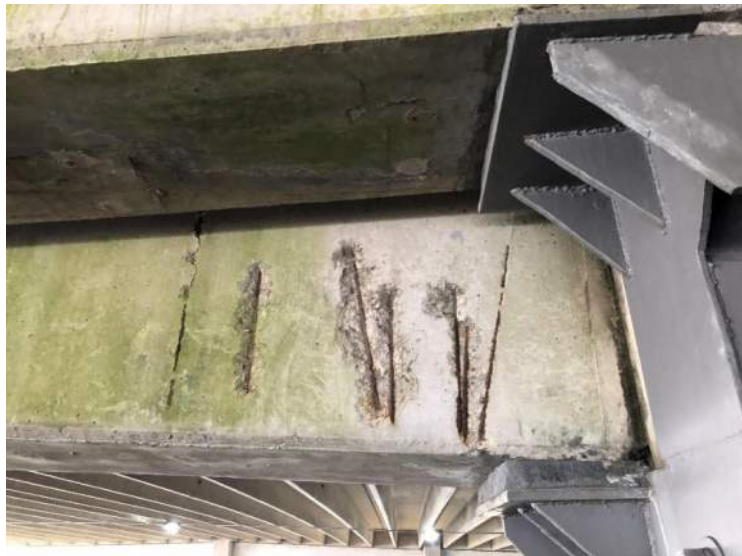
Photo 5C Beam Spalling

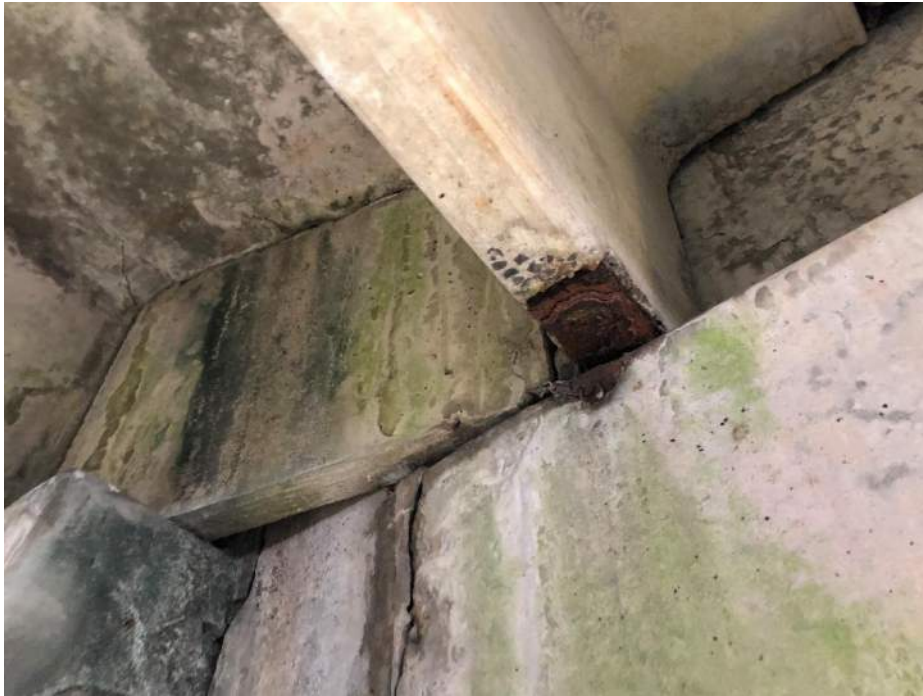
Photo 6 Paint Exposed Steel Shimes

6. All exposed steel that is rusting in the parking deck should be cleaned and painted.

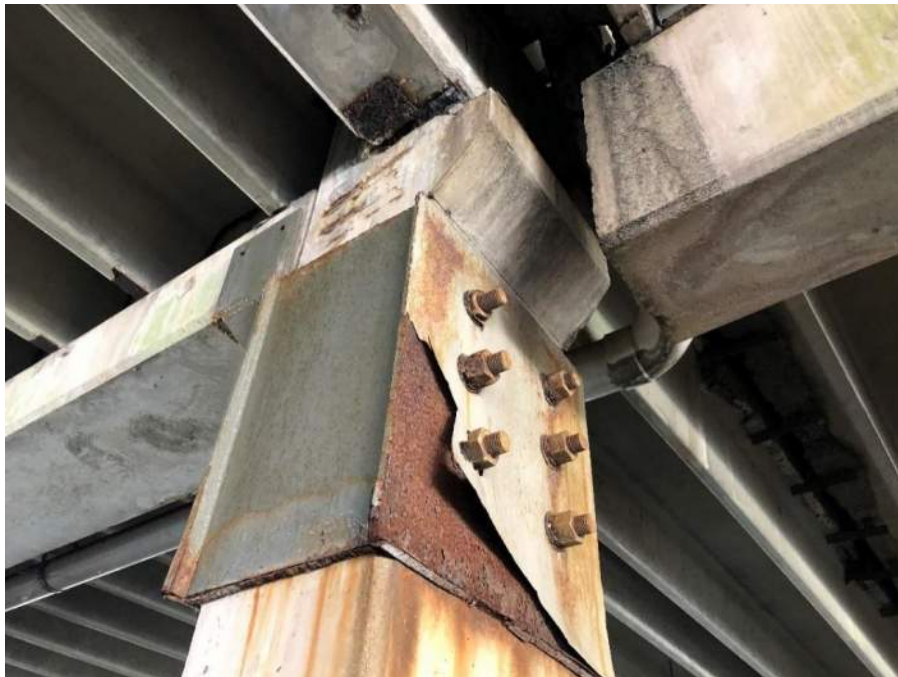
Photo 6A Paint Exposed Steel Reinforcements (Competed by Others)
