# SDVines, PE

April 15, 2022

RE: Griffin Parking Deck Assessment  
SDVPE Job No.: 22008

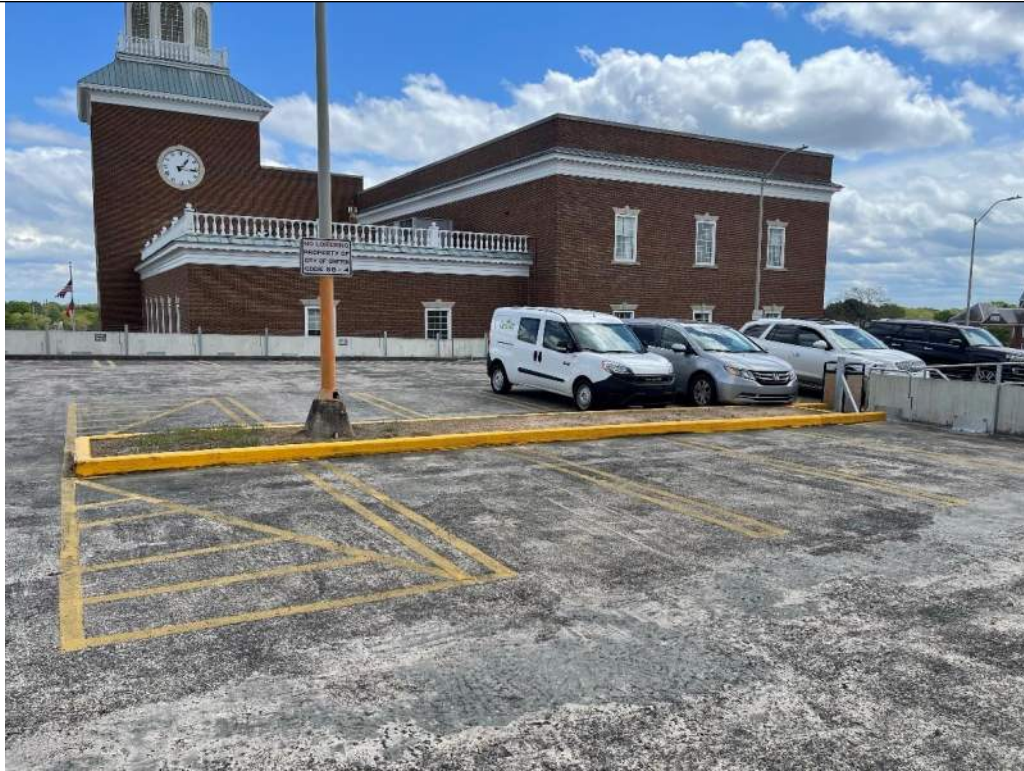
- Continuous concrete curbing has been installed on the deck slab surface in many locations, generally at the heads of parking spaces. It appears that this intended to act as wheel-stops to prevent vehicles from impacting the fascia panels or railings. In many areas, these curbs are trapping rainwater and runoff and/or redirecting it away from area drains. Without a proper outlet, much of the rainfall that impacts the deck is running off between the ramps or over the edges. This appears to be the source of much of the observed steel corrosion and concrete deterioration noted below.

Photo No. 1: Overview of Level 4A and north end of Level 3B – note concrete curbing and island

- 2) The existing concrete curbs/wheel-stops need to be reworked so as not to trap or redirect water away from area drains. This can be as simple as removing sections of the wheel-stops where they are not required as a vehicle barrier and providing relief cuts or penetrations along their length where they must remain in place. Additional observations of the behavior of runoff during a rain event would be required to provide guidance as to where modifications to the curbs will be most beneficial.

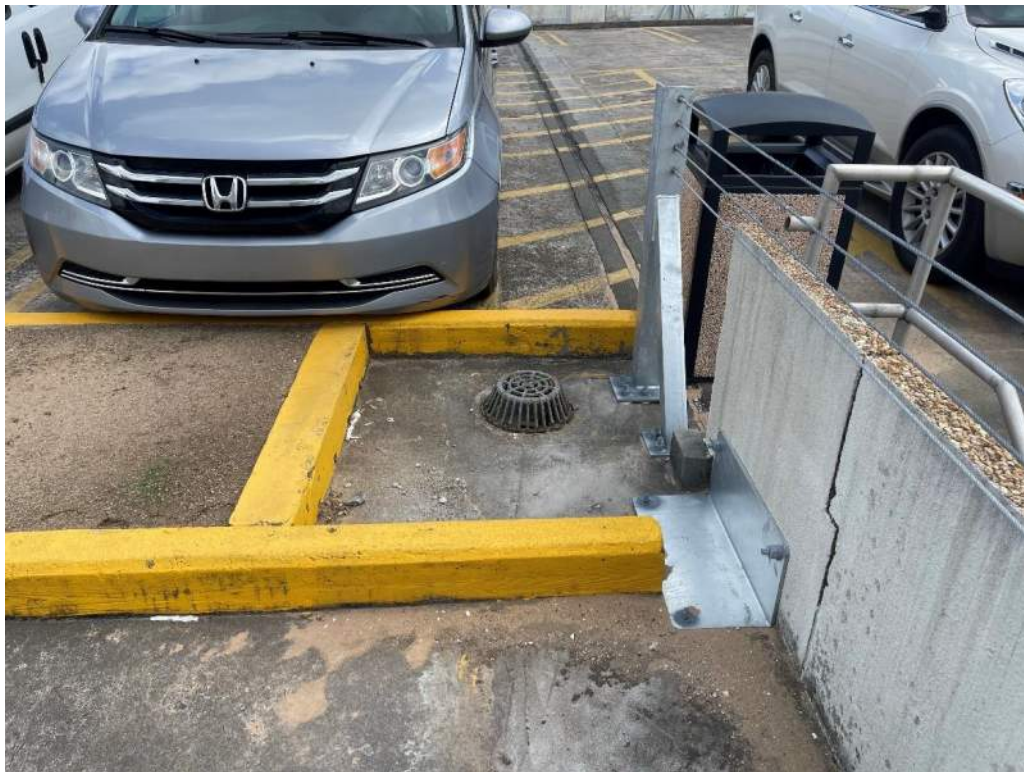
- Some area drains on the surface of the deck are currently, or have until very recently, been clogged with debris. During our initial inspection, [REDACTED] stated that city staff has been working recently to clear some of these drains and install new ones. One drain near the southeast corner of Level 3B appeared to have been clogged with "sandy" material from deterioration of the topping slab. Without adequate, functional drainage, rainwater runoff spills, uncontrolled, onto lower levels leading to steel corrosion and concrete deterioration.

Photo No. 2: Area drain isolated by concrete curbing at southeast corner of Level 4A

- 1) Existing area drains must be cleaned so that they flow freely and maintained in such a condition. Additional drains should be installed in locations where rainwater and runoff currently accumulate. Observation of the deck during a rain event will provide clues as to where additional drains may be effective. Additional observations of the behavior of runoff during a rain event would be required to provide guidance as to where additional drains will be most beneficial.

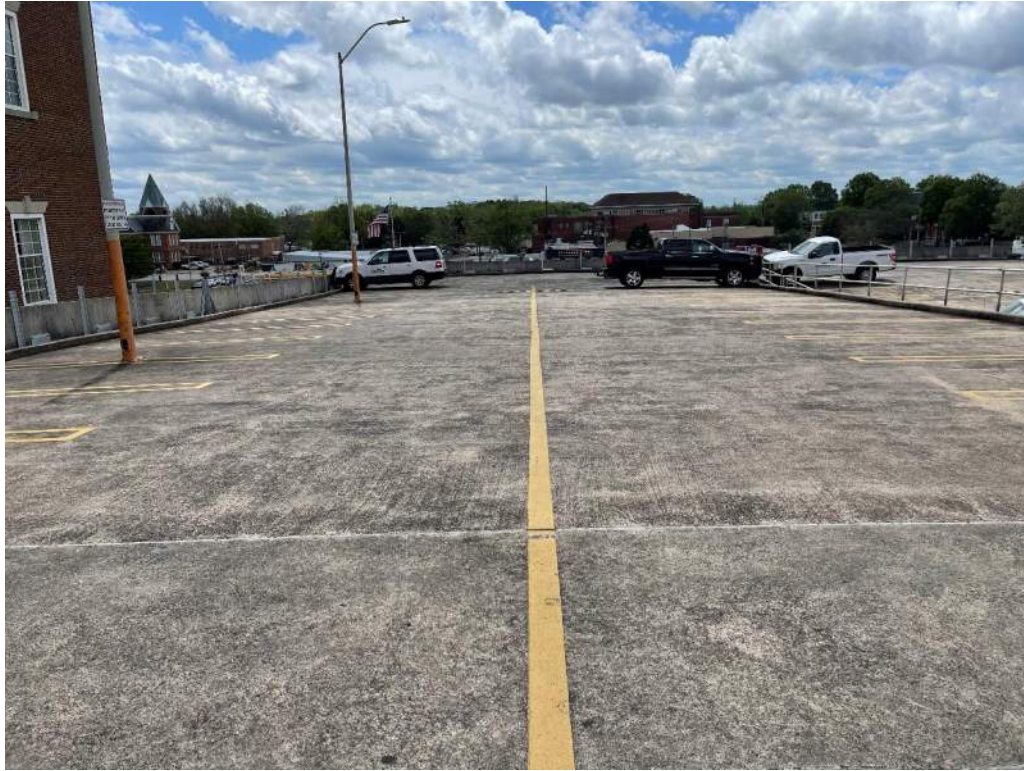
Photo No. 3: Overview of Level 3B (view facing south down ramp)

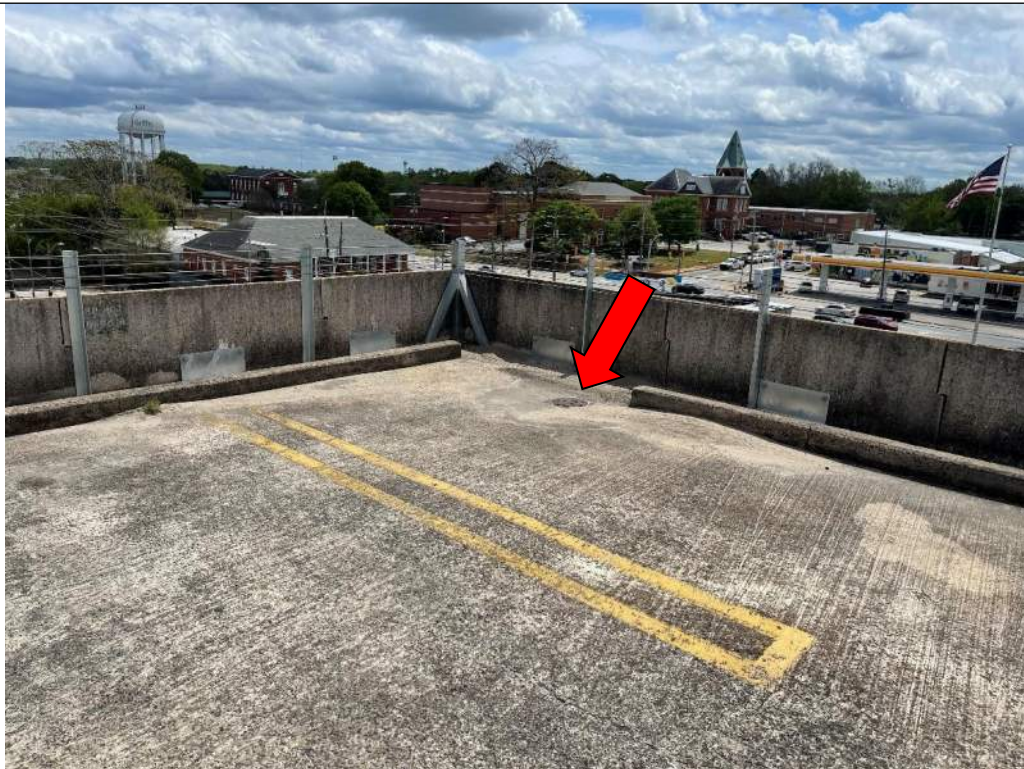
Photo No. 4: Area drain at southeast corner of Level 3B reported to have been recently cleared of sandy, granular debris

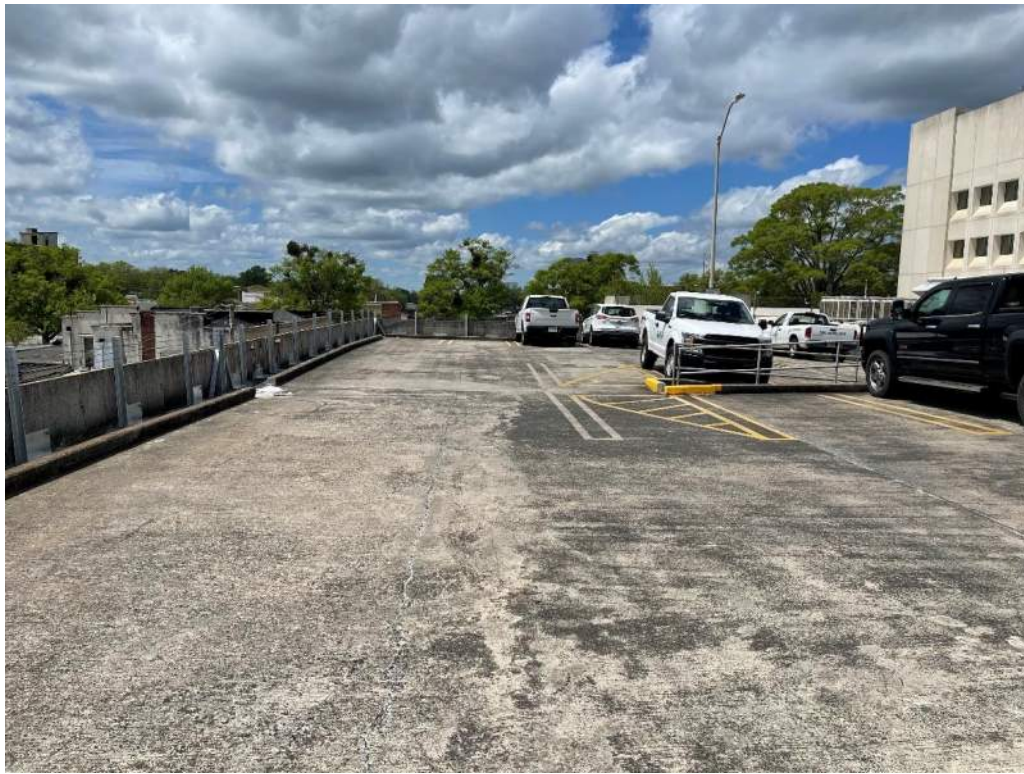
Photo No. 5: South end of Level 3 (view facing west)

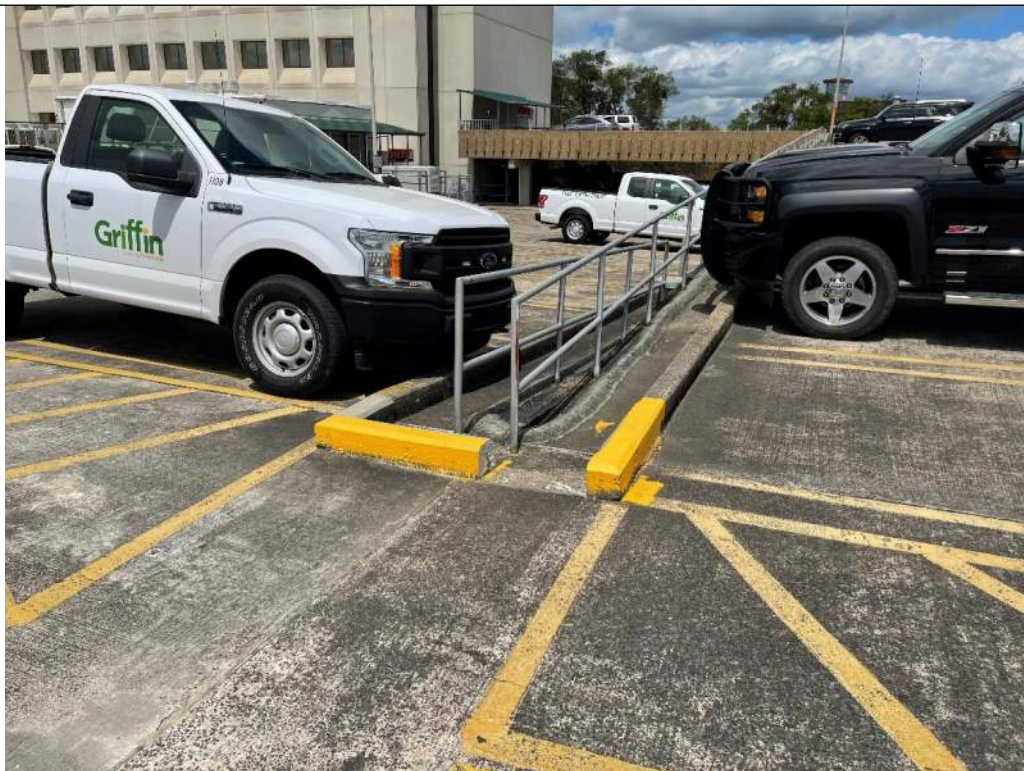
Photo No. 6: Concrete curbing/wheel stop at Level 3 near grid line J-2 – note section of curbing previously cut out and addition of concrete at edge of ramps

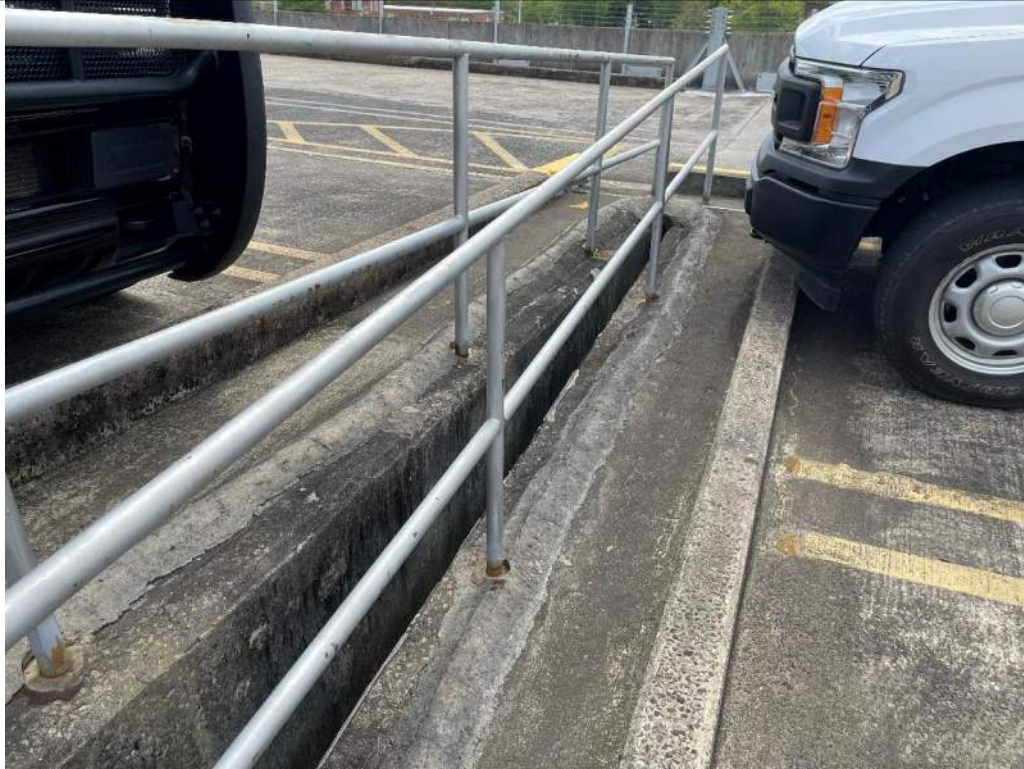
Photo No. 7: Alternate view of concrete added at edges of Level 3 ramps shown in Photo 6 above

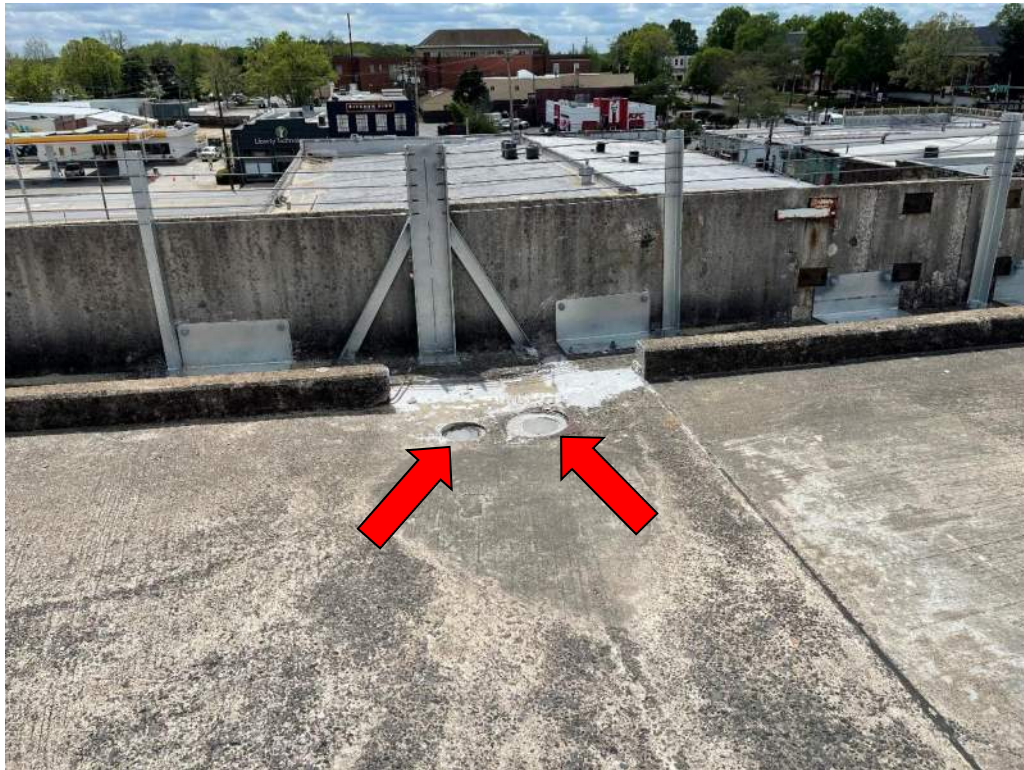
Photo No. 8: Existing (right) and newly installed drains at Level 3 near gridline K-2

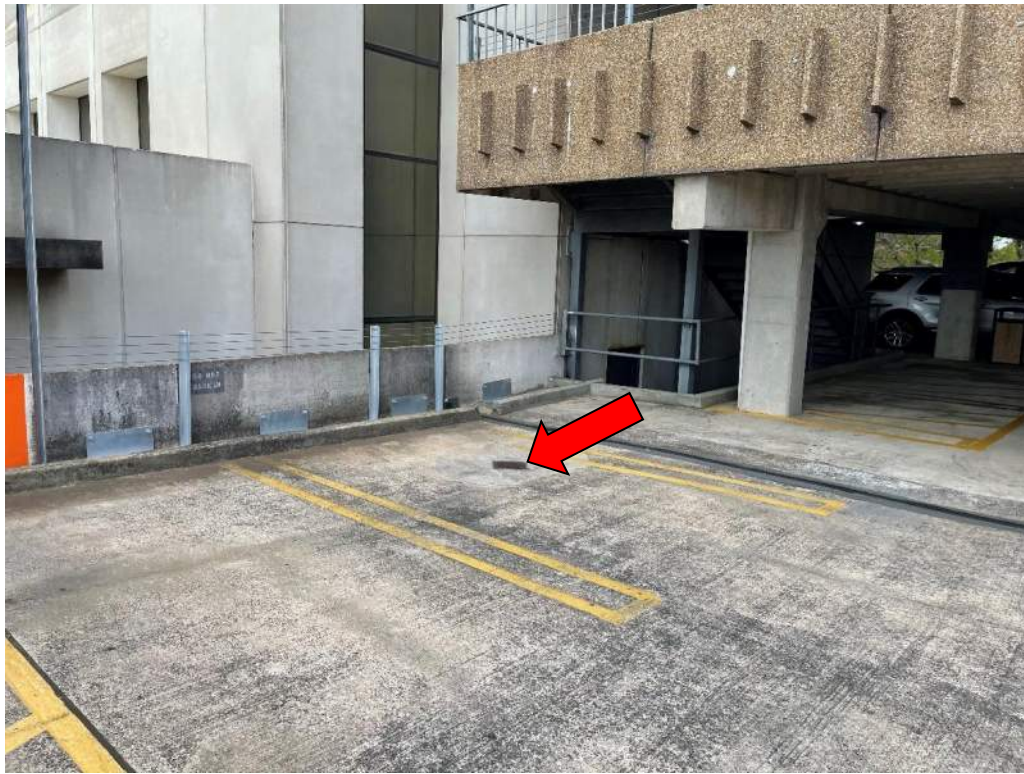
Photo No. 9: Area drain near northwest corner of ramp at Level 3A

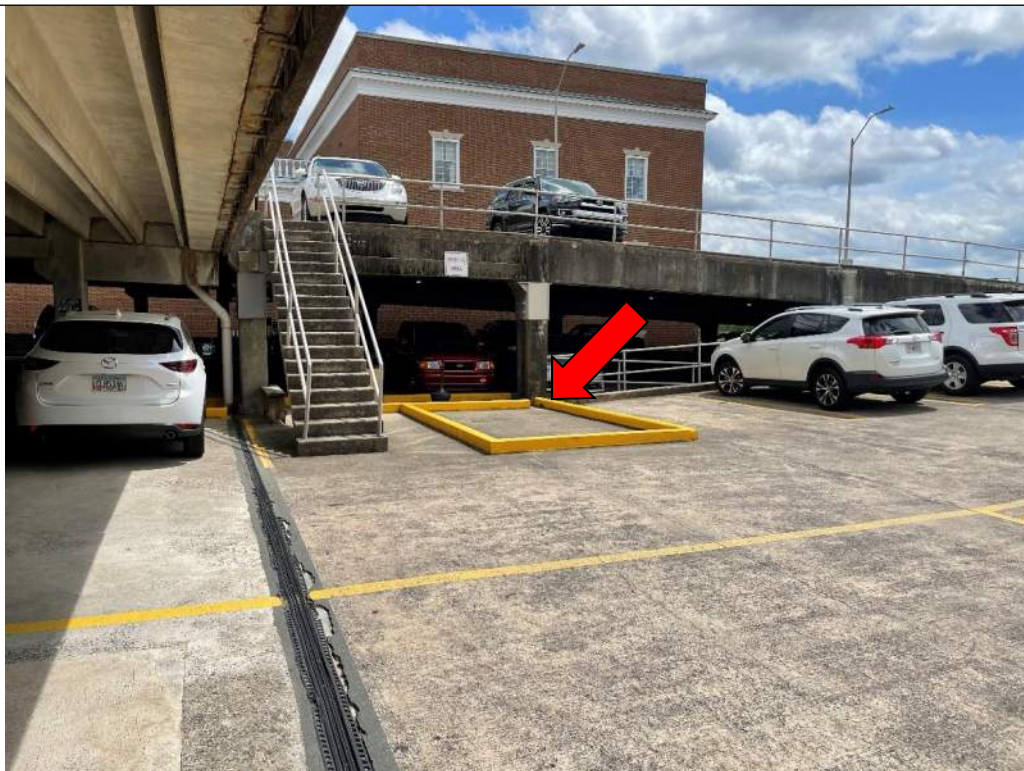
Photo No. 10: Concrete curbing installed near northeast corner of ramp at Level 3A – arrow indicates location of partially isolated drain shown in Photo 11 below

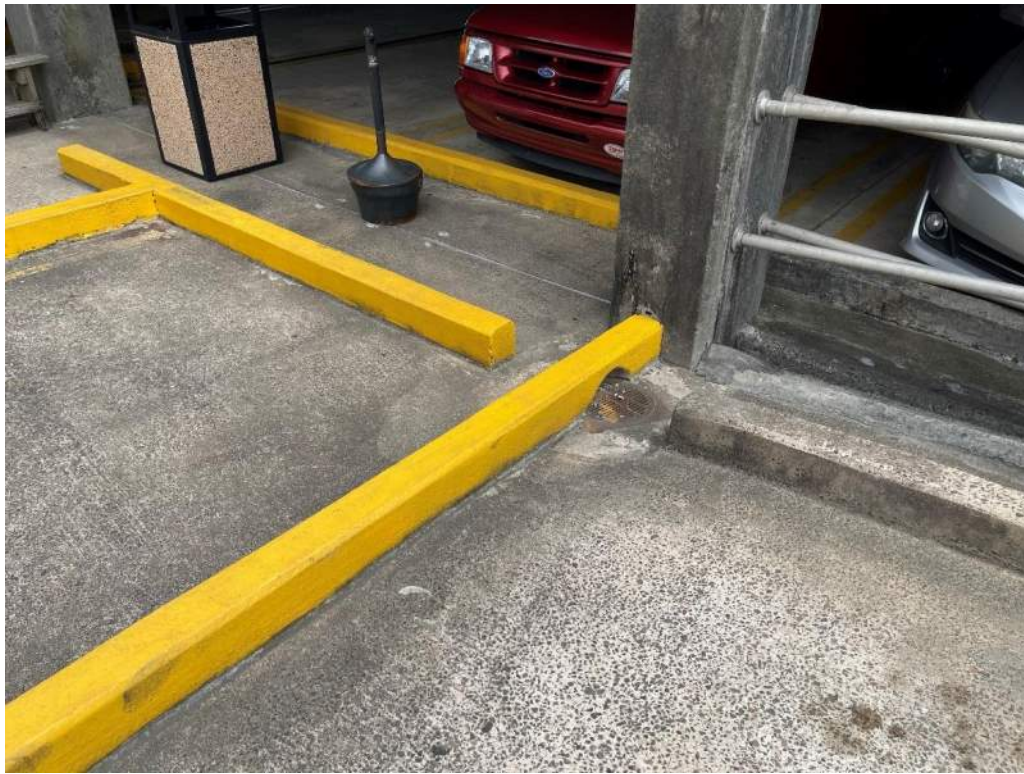
Photo No. 11: Partially isolated area drain at location shown in Photo 10 above

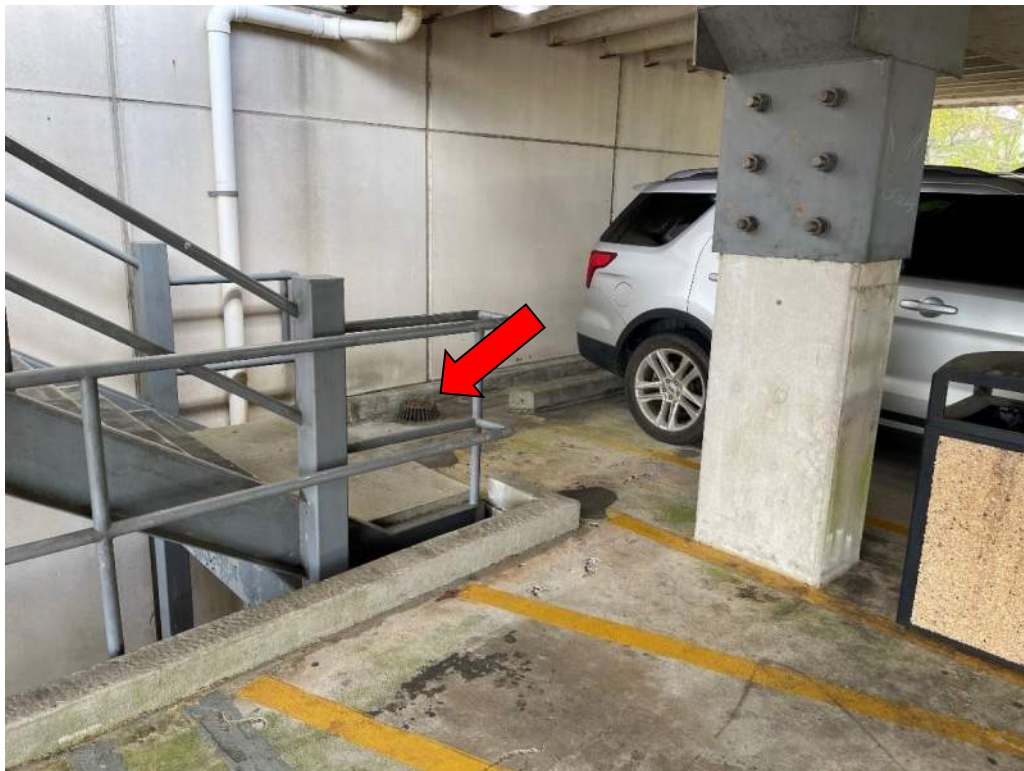
Photo No. 12: Partially isolated area drain at level 3A west of column at gridline B1

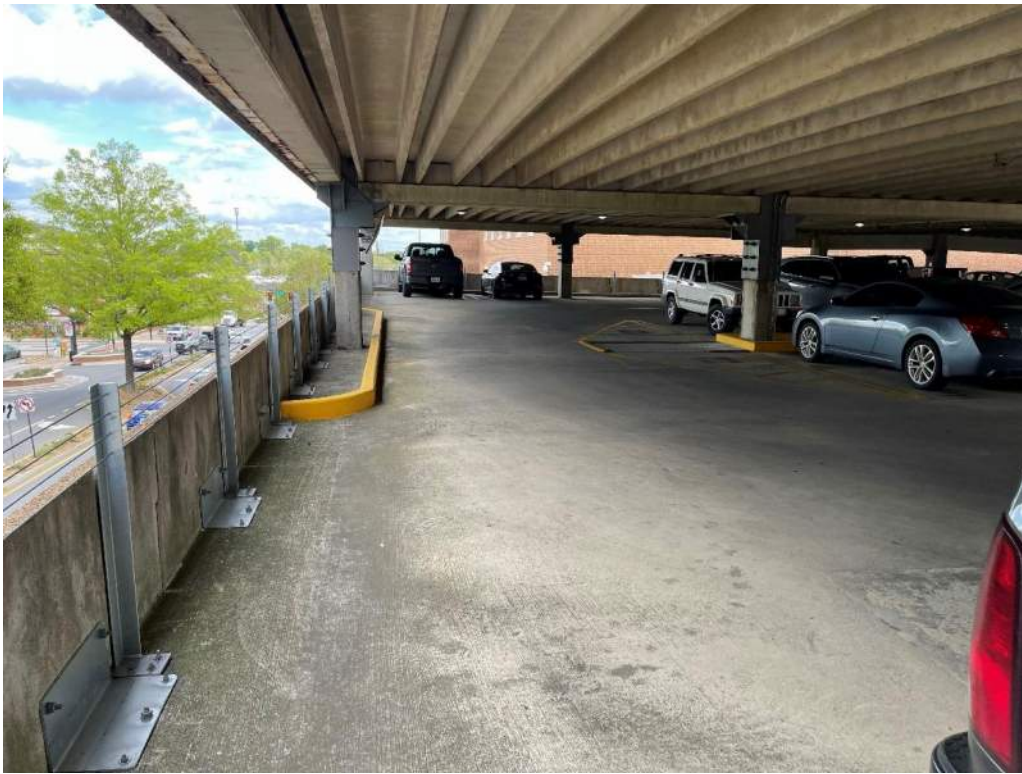
Photo No. 13: North end of Level 3A looking toward Level 2B

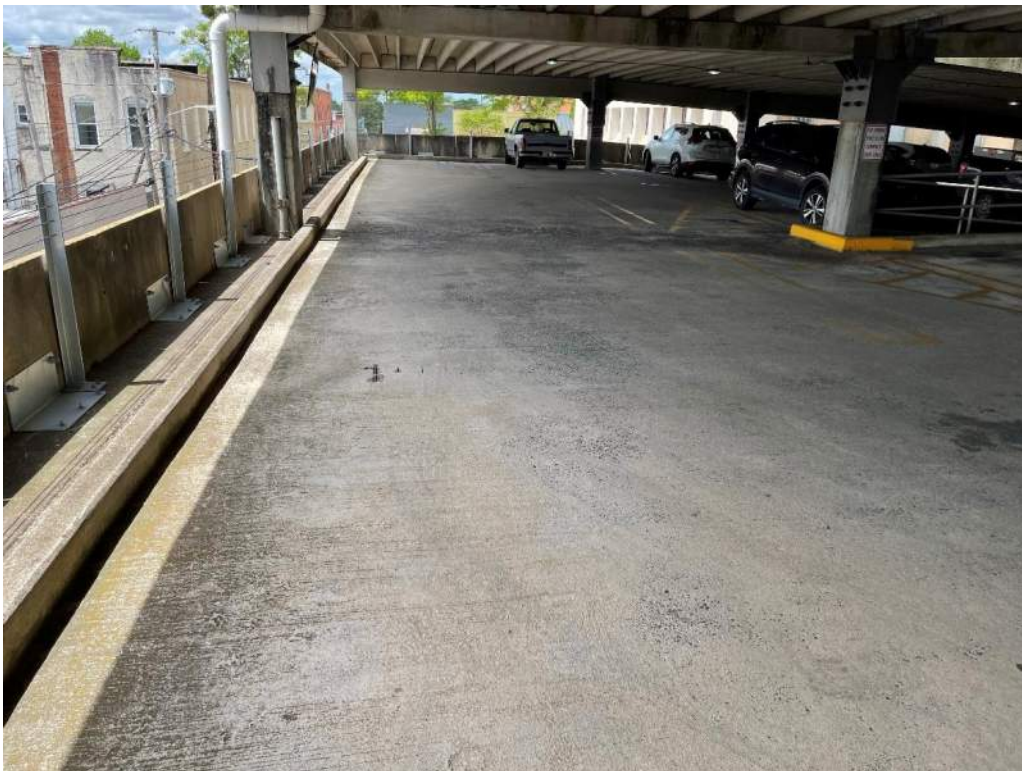
Photo No. 14: South end of Level 2B looking west toward Level 2A

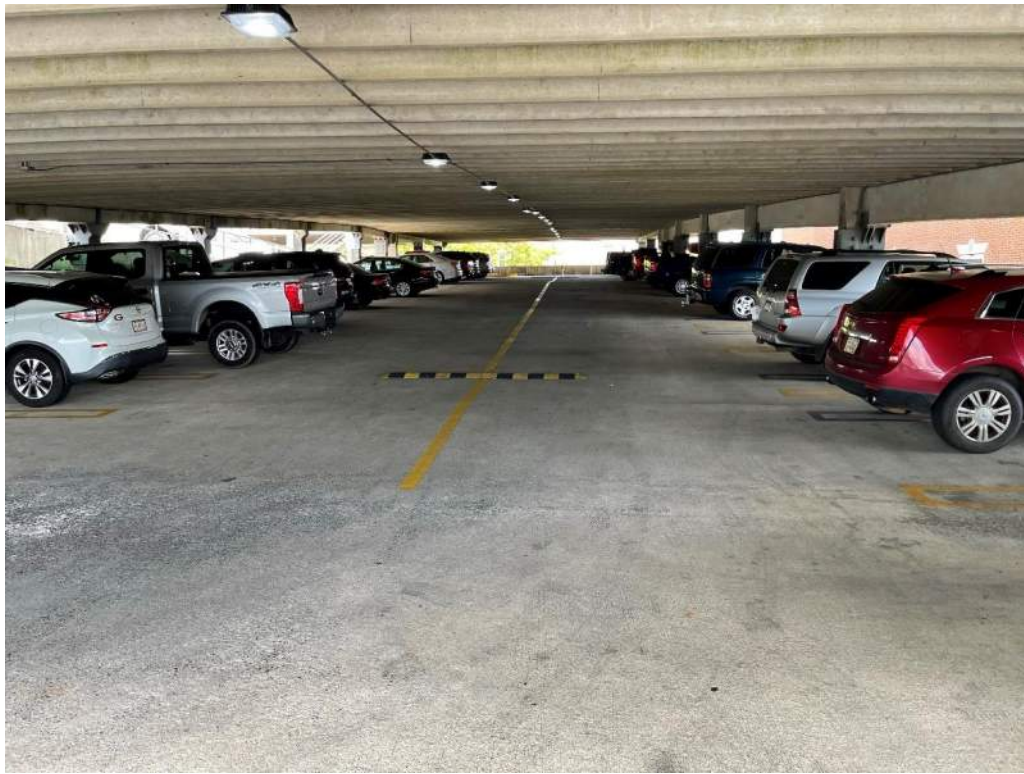
Photo No. 15: Level 2B ramp up – view facing north

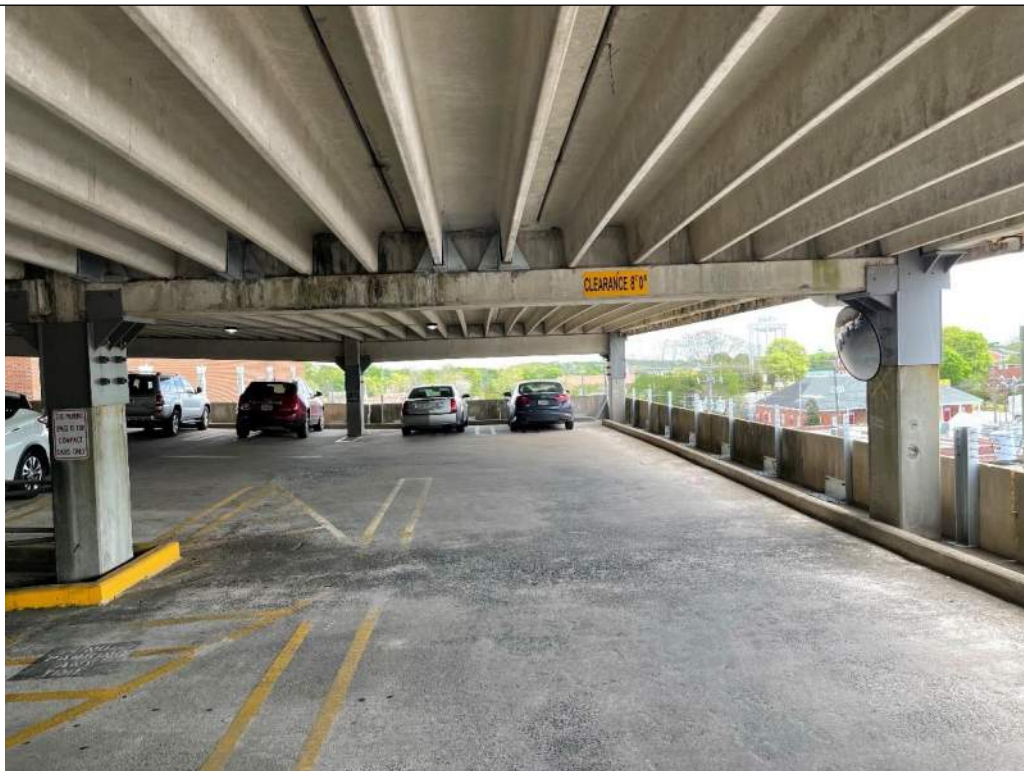
Photo No. 16: South end of Level 2A facing east toward Level 2B – note galvanized steel brackets supporting ends of double tees

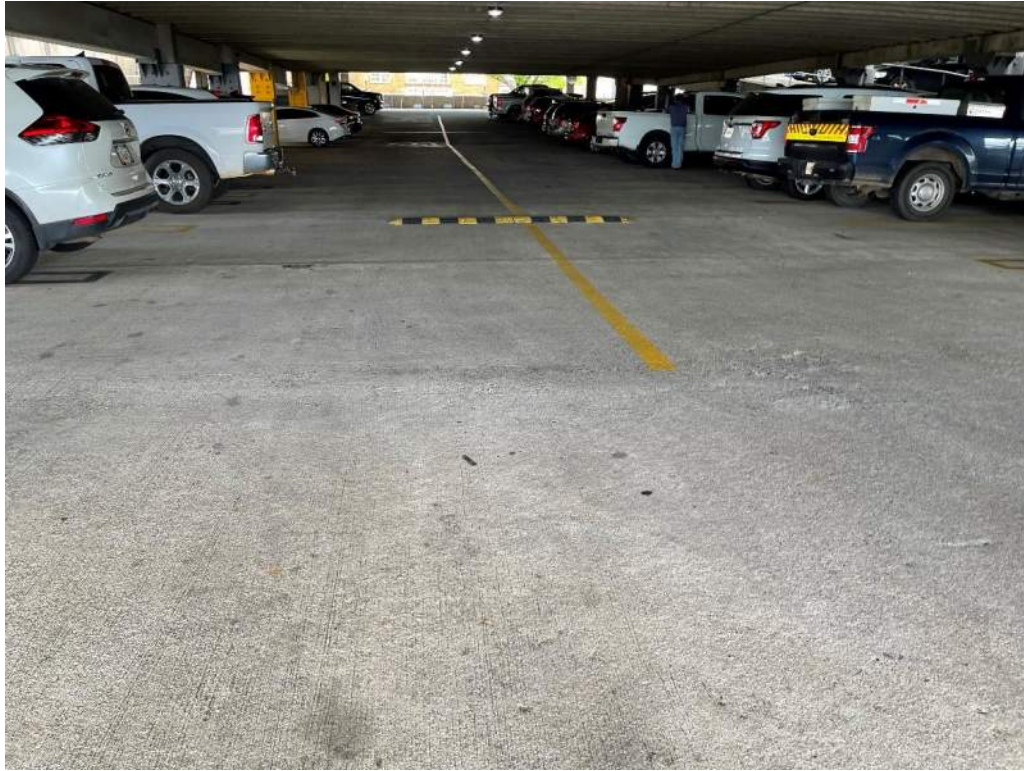
Photo No. 17: Level 2A ramp (view facing north)

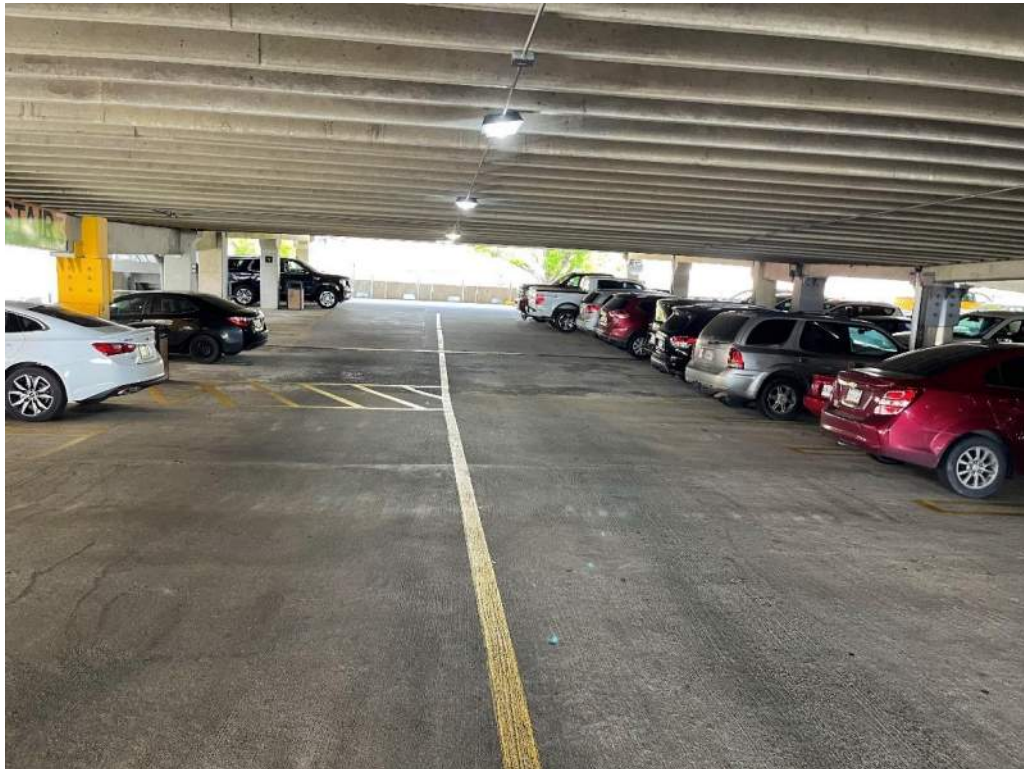
Photo No. 18: Level 2A ramp (view facing north)

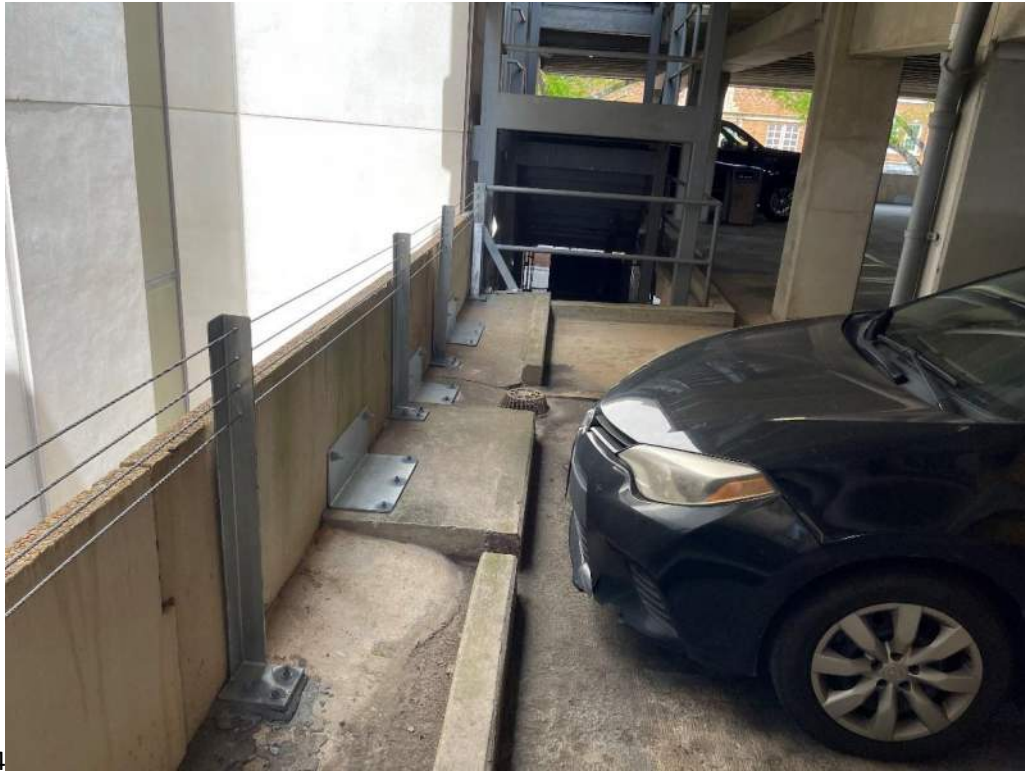
4  
Photo No. 19: Partially isolated area drain at Level 2A west of column at gridline D-1

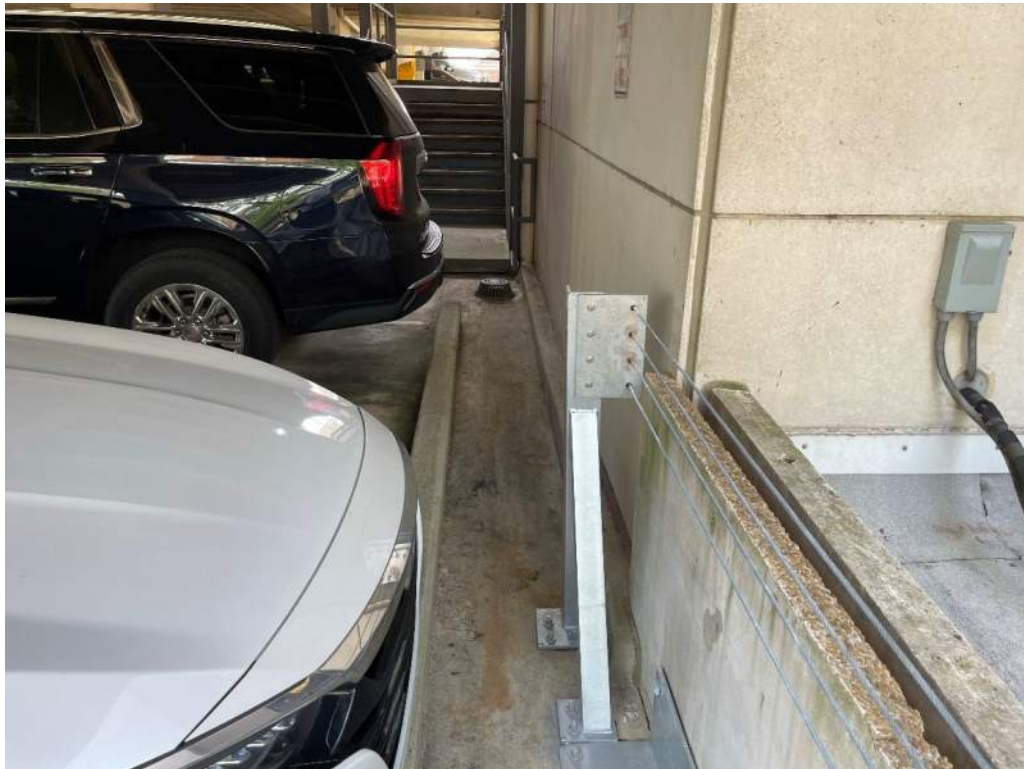
Photo No. 20: Partially isolated area drain at Level 2A west of column at gridline B-1

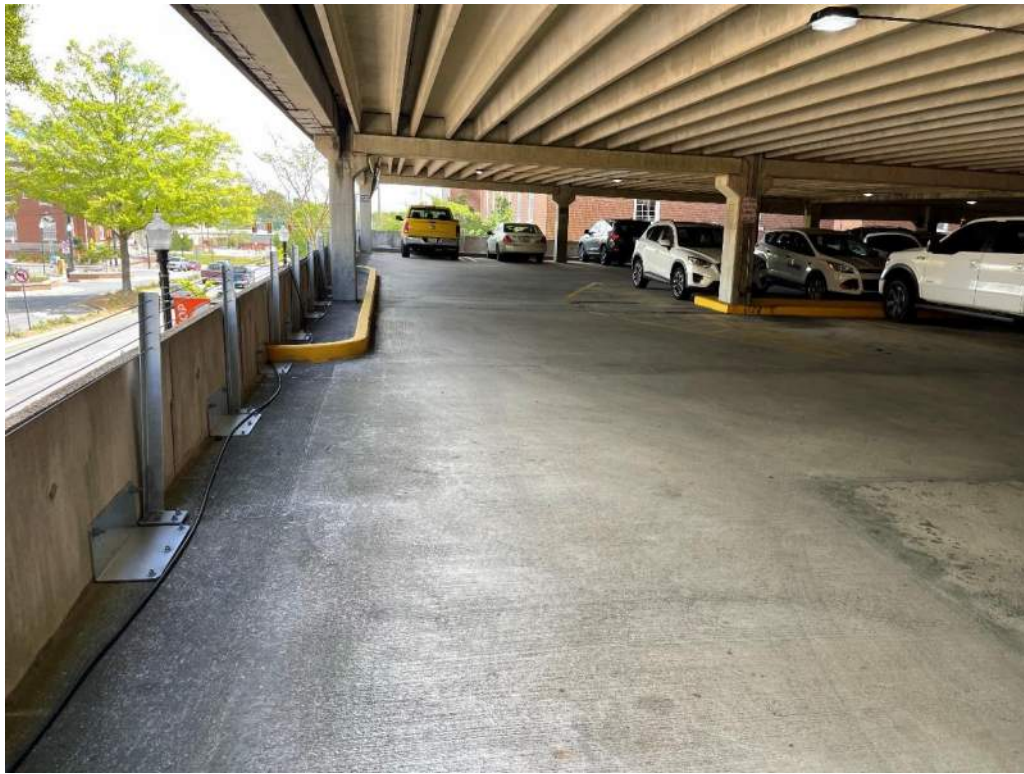
Photo No. 21: Level 2A facing east toward Level 1B

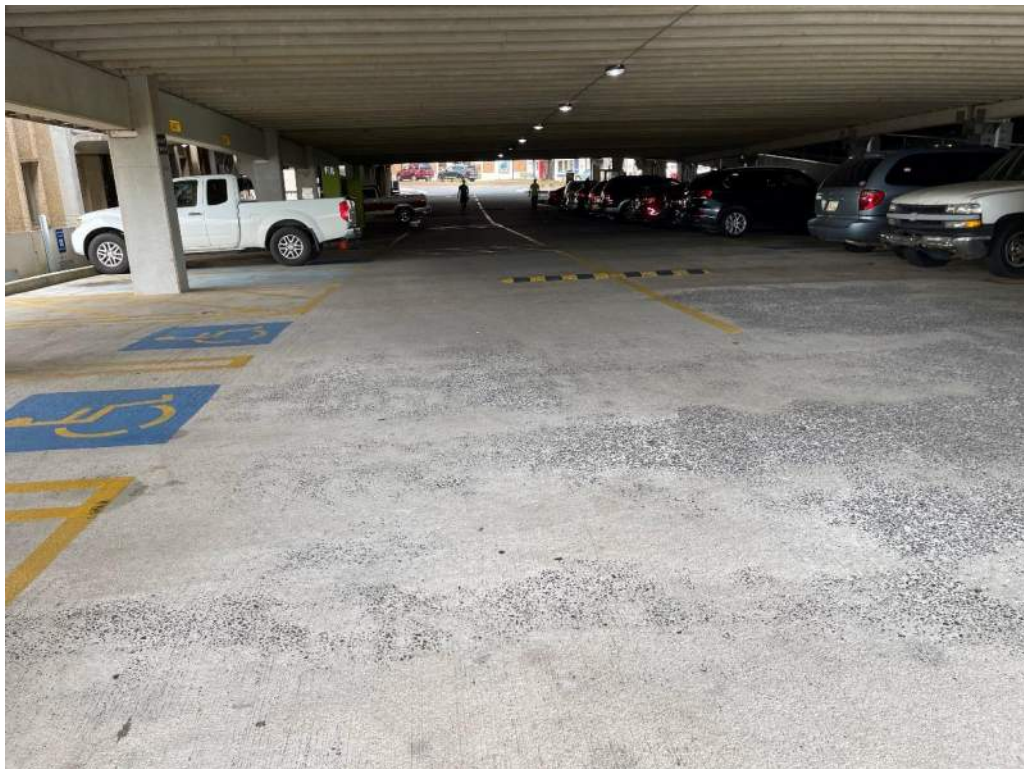
Photo No. 22: Level 1A ramp – view facing north toward on-grade portion of deck structure

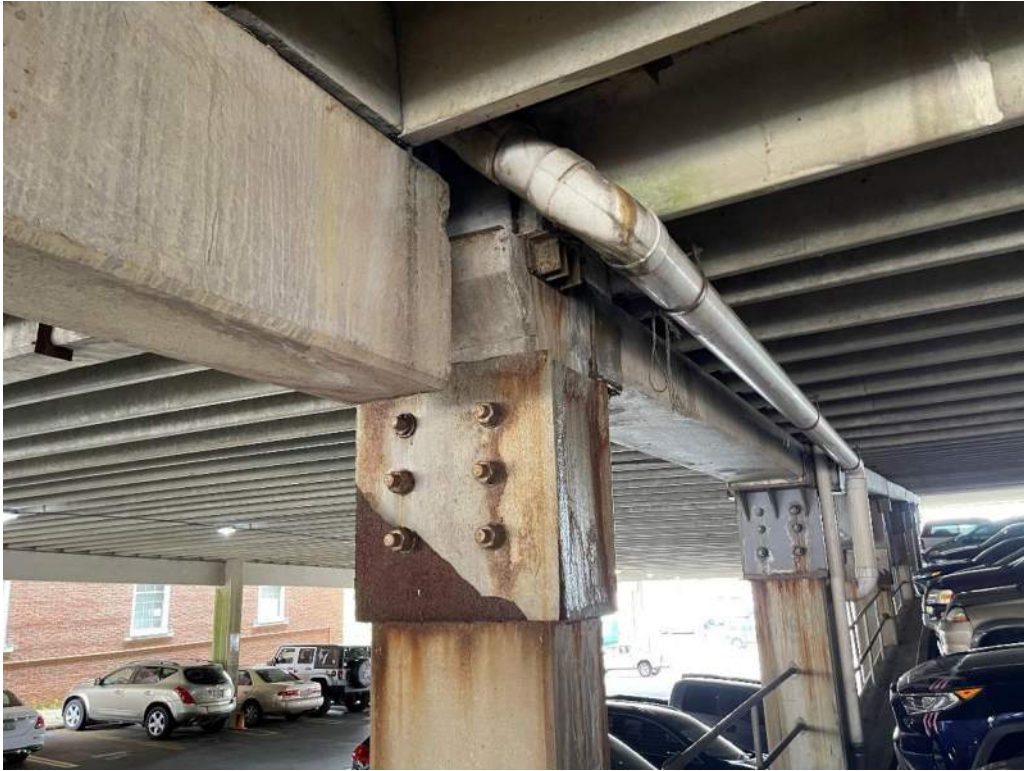
- Steel brackets were installed at numerous column-beam joints on all framed levels as noted above. Some of these brackets were of galvanized steel, while others were of painted, plain steel. Many of the plain steel brackets exhibited peeling paint and surface corrosion.
- A handful of the reportedly re-grouted connections by IMMEC have gaps between the grout and the supported member. It appears that the wrong grout mix or mix proportions may have been used leading to shrinkage. These locations should result in a call-back for IMMEC to re-grout.
- Aluminum guardrails between ramps along the centerline of the deck are loose or broken in places. At least one guardrail on Level 2 was reportedly damaged by a recent vehicle impact. Cable railing was recently added to the outer perimeter of the deck at all levels by IMMEC, but the interior guardrails were not addressed.

Photo No. 23: Corroded bracket supporting Level 2 framing at gridline 2-D

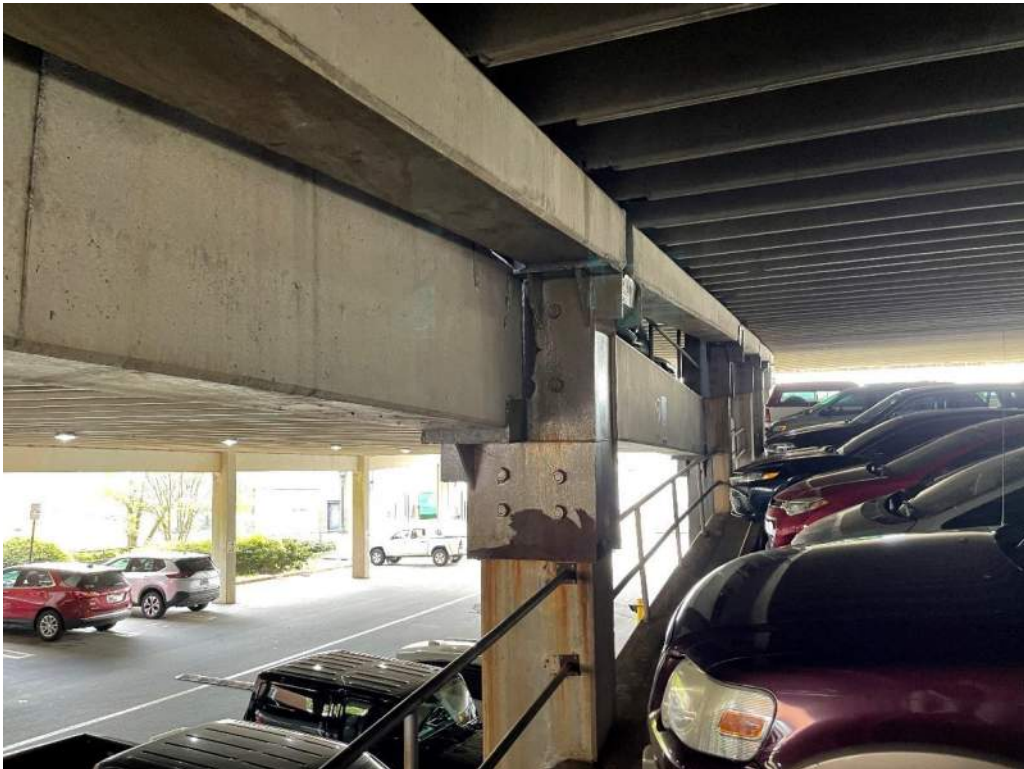
Photo No. 24: Corroded bracket supporting Level 2 framing at gridline 2-F

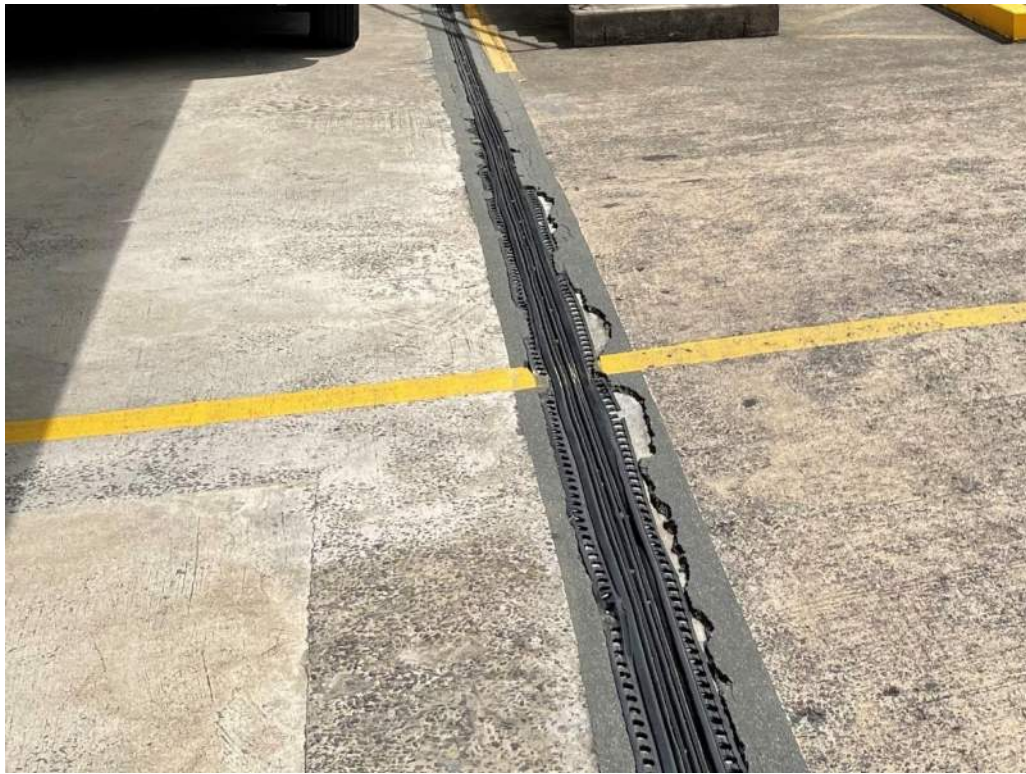
- The expansion joints on all levels have failed and are no longer watertight. This permits water from upper levels to impact lower levels.
- Spalled concrete at the surface of structural members is widespread throughout the parking deck. This type of damage is caused when water repeatedly penetrates the member and

Photo No. 25: Typical failed expansion joint – Level 3A shown

- 3) The expansion joints on all levels should be replaced.
- 4) The upper-level slabs which are directly impacted by rainwater should be coated with a waterproof traffic coating to prevent migration of water to the lower levels and supporting structure.

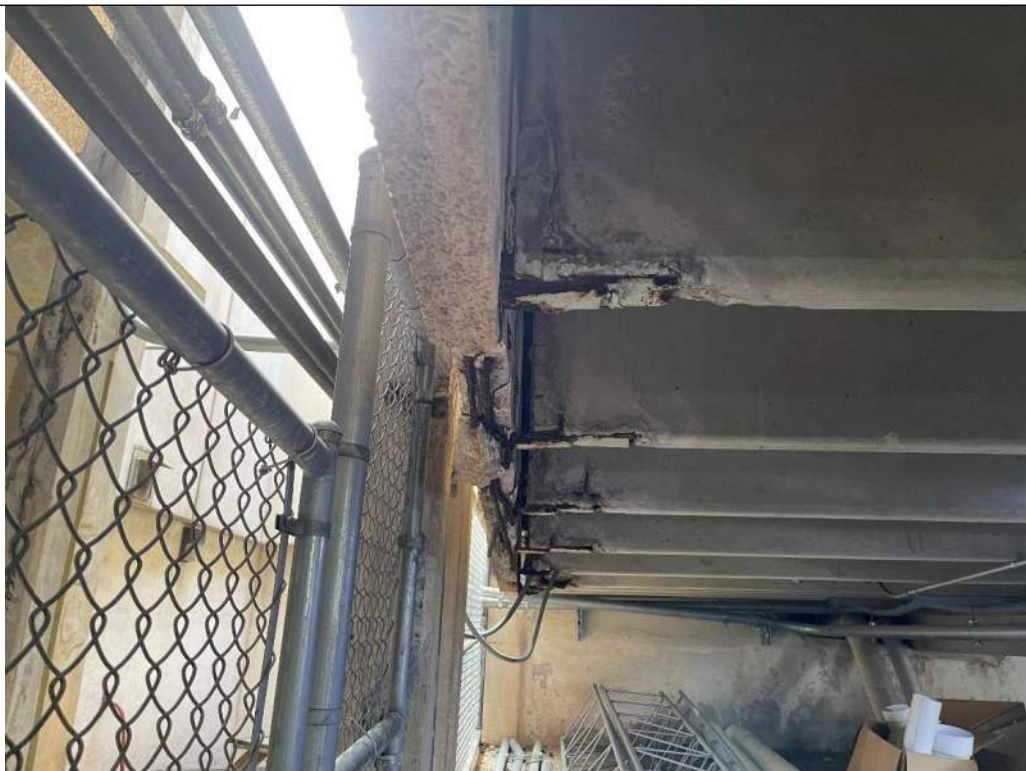
causes corrosion of the reinforcing steel. When steel rusts, it increases in volume leading to stresses which eventually cause the concrete cover to spall or break off. Spalling is generally more pronounced on lower levels. The worst area observed is at the underside of Level 1A along the western edge of the structure.

Photo No. 26: Spalling concrete and corroded reinforcing steel at underside of Level 1A along west edge of structure

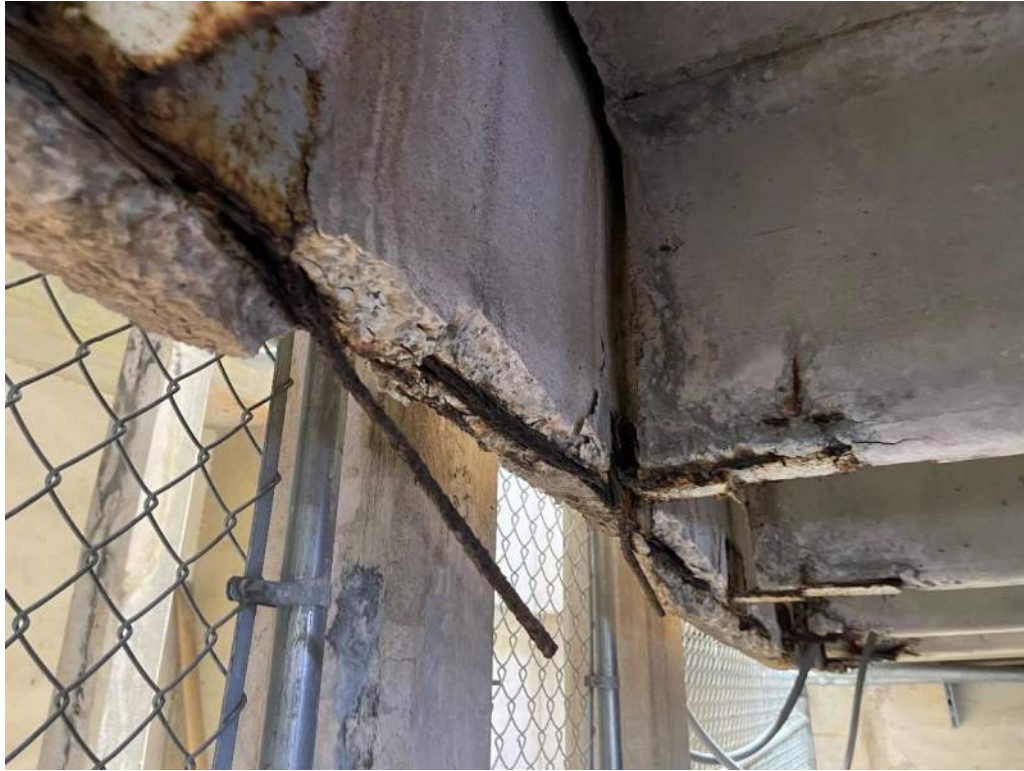
Photo No. 27: Enlarged view of area shown in Photo 26 above
