# SDVines, PE

April 15, 2022

RE: Griffin Parking Deck Assessment  
SDVPE Job No.: 22008

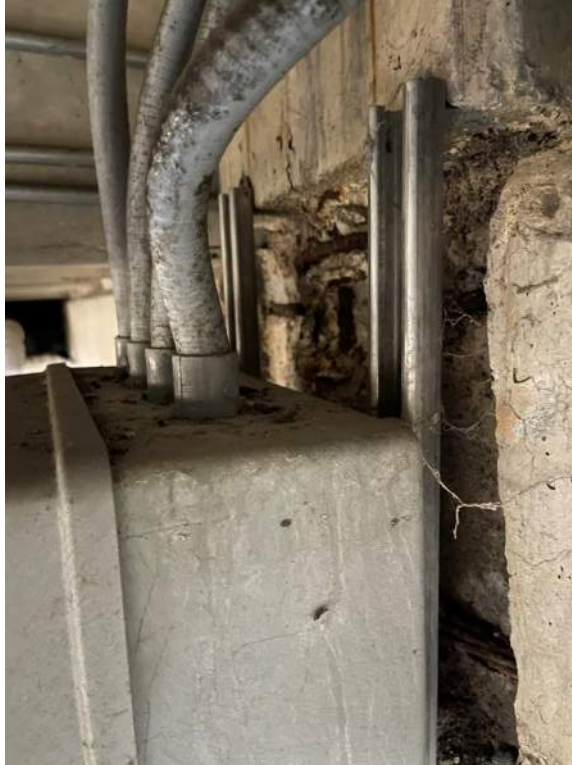
Photo No. 28: Spalled concrete on west face of concrete column at gridline 1-E below Level 1A

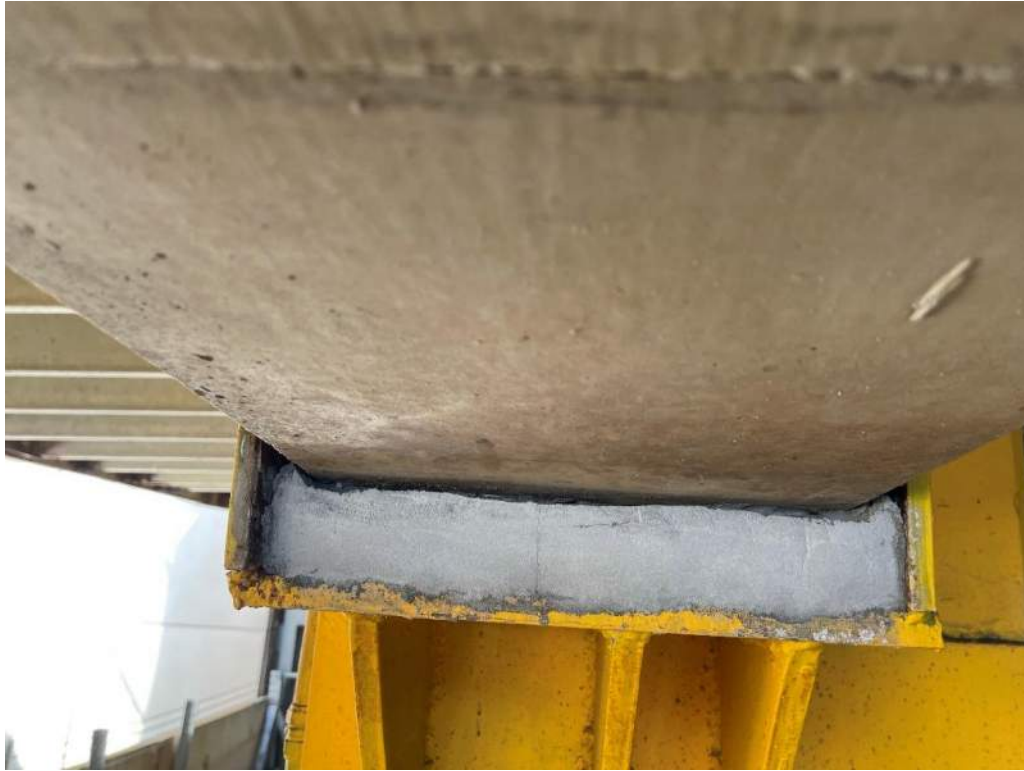
Photo No. 29: Gap at recently grouted steel bracket

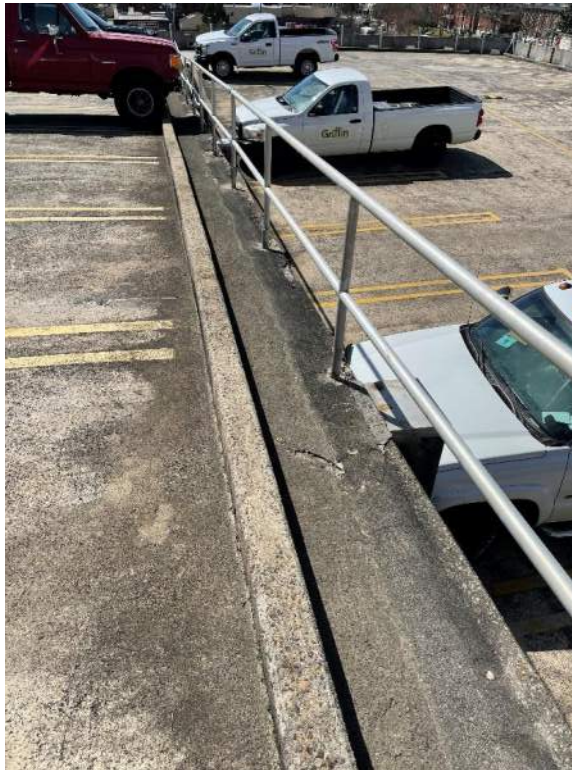
Photo No. 30: Aluminum guardrail along west edge of Level 3B

- 5) Guardrails along the interior edges of the ramps not addressed by IMMEC should be replaced. Cable railing attached to the concrete columns will be adequate for the lower levels. At the upper levels (Level 3B and Level 4A) standard steel pipe railing should be used.

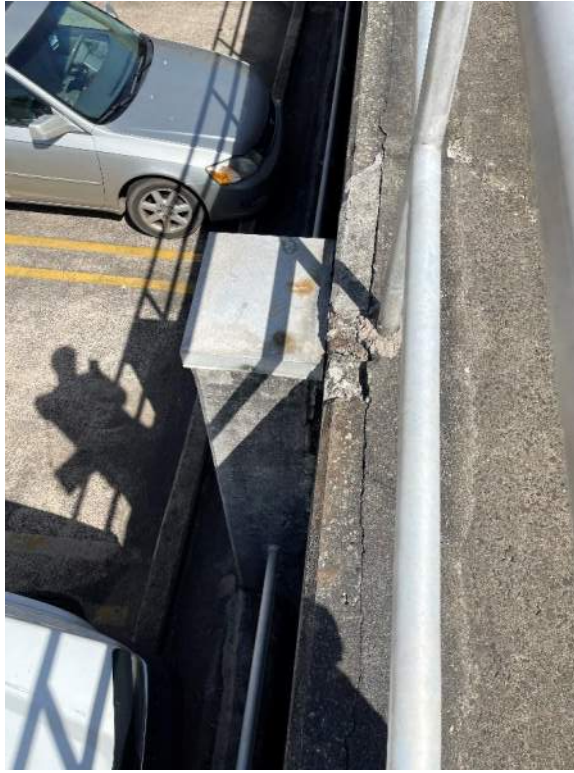
Photo No. 31: Spalled/failing concrete at guardrail post
