**EVALUATION OF THE
5,000,000 GALLON CONCRETE GROUND STORAGE TANK**

**“RESERVOIR NO. 2”
CARLSBAD, NEW MEXICO**

**SOUDER, MILLER & ASSOCIATES
ALBUQUERQUE, NEW MEXICO**

April 27 through May 5, 2016

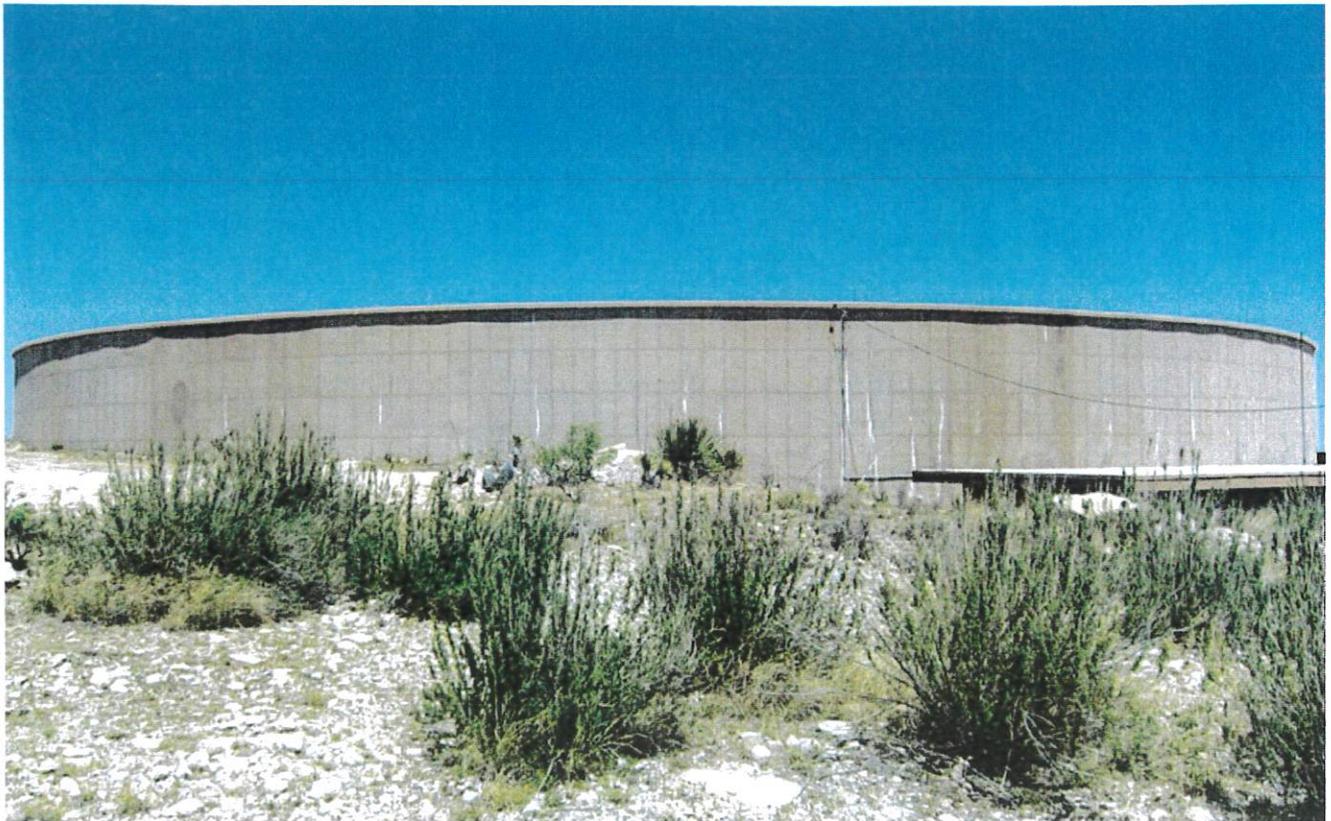
1. Tank and site.

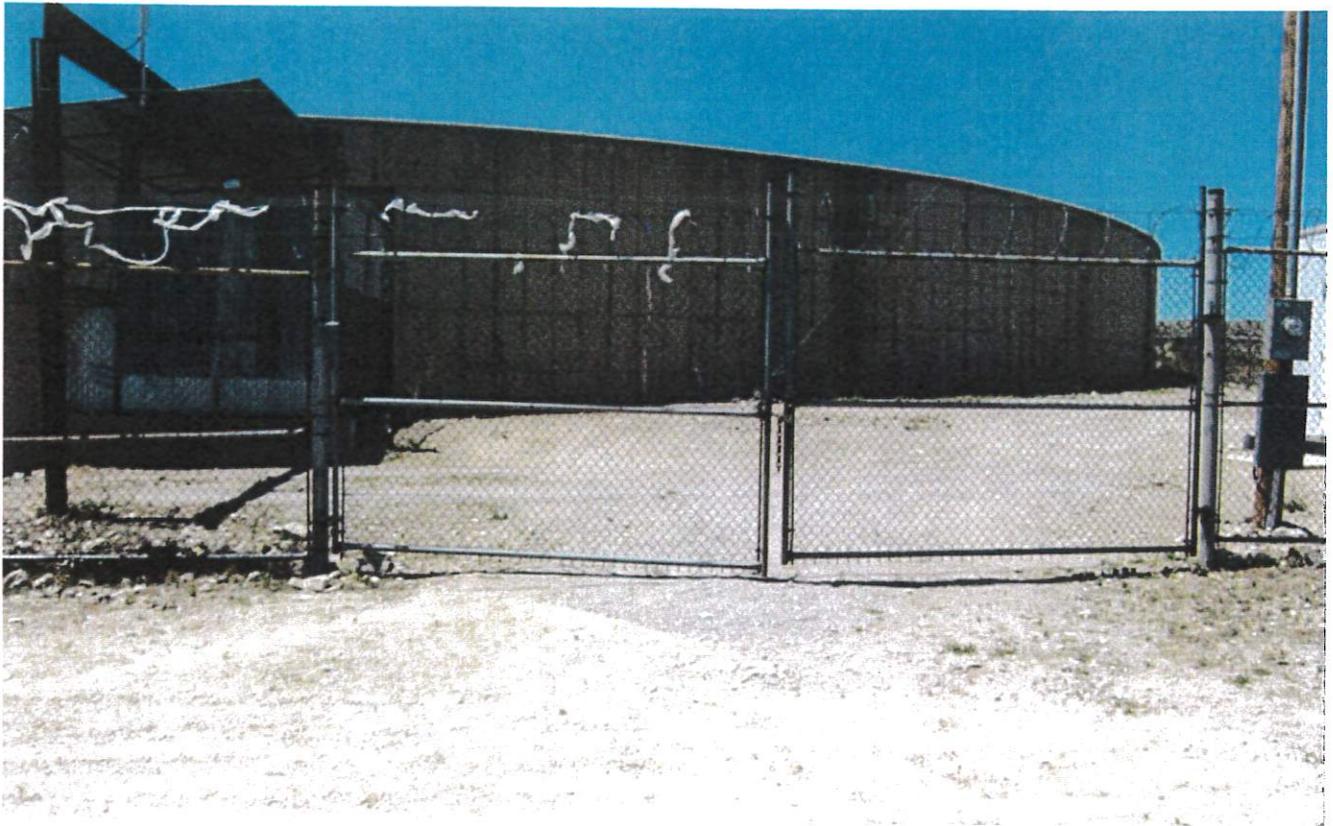
2. Tank and site.

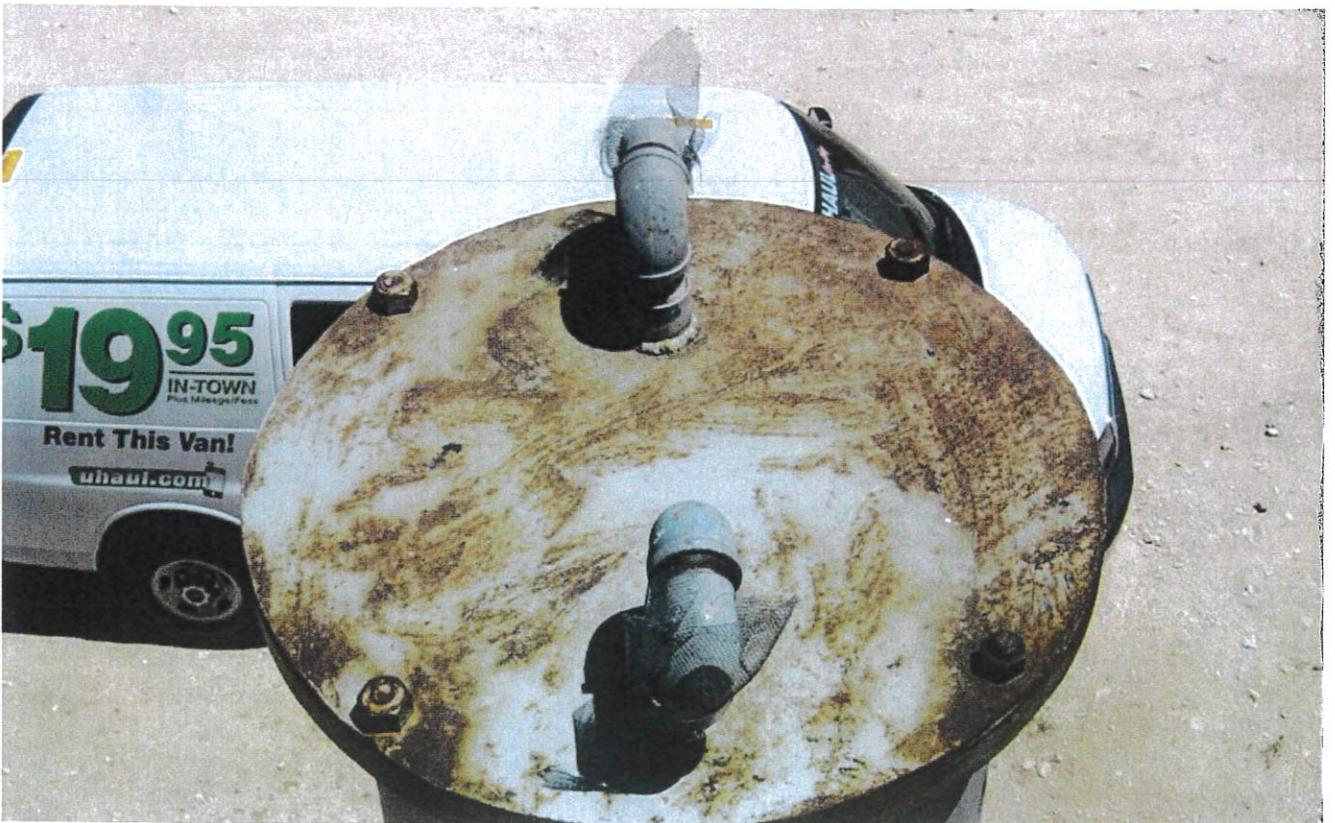
2. **Overflow Pipe and Drain Pipe:** The overflow pipe appeared to be an approximately 16 in. diameter pipe within an approximately 24 in. diameter standpipe located approximately 40 in. outside the tank shell. The top of the standpipe was equipped with two approximately 2 in. diameter gooseneck vents with 8 x 8 mesh screens which appeared to be in generally good condition. The coating on the exterior of the overflow standpipe appeared to consist of a coal tar primer and an aluminum finish coat. The coating exhibited fair adhesion to the steel. Approximately 1% coating failure to the underlying coating and less than 1/2% coating failure to rust were noted on the overflow standpipe. A flanged discharge section of pipe with a flap gate was located at the bottom of the standpipe for the overflow. This flanged discharge section had been temporarily removed by the Owner at the time of the evaluation in order to access the drain valve. The drain pipe opening appeared to be the same pipe opening as that for the overflow pipe inside the tank. The drain pipe extended below grade and discharged above grade adjacent to the tank. The discharge end of the drain pipe was equipped with a flap gate which appeared to be in good condition. (See photos 11-14)

11. Overflow standpipe adjacent to tank. Note section of overflow pipe temporarily removed in order to access drain valve.

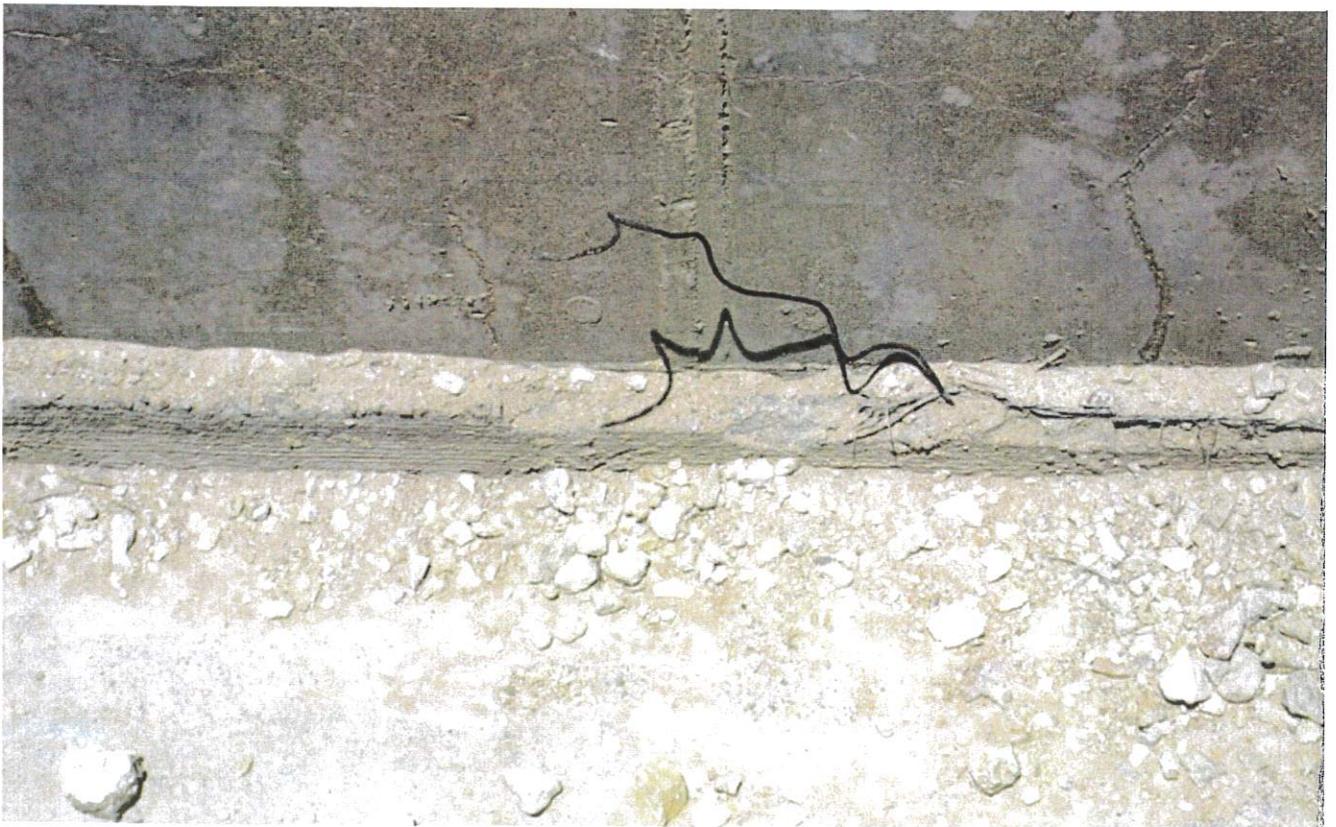
3. **Foundation:** The tank foundation appeared to be a concrete mat continued from the reinforced concrete floor of the tank. Except for hairline cracks and minor chipping, the exposed surface of the foundation appeared to be in nearly its original structural condition at the time of this field evaluation. The foundation was completely below grade on the north and west sides of the tank

15. Concrete tank foundation.

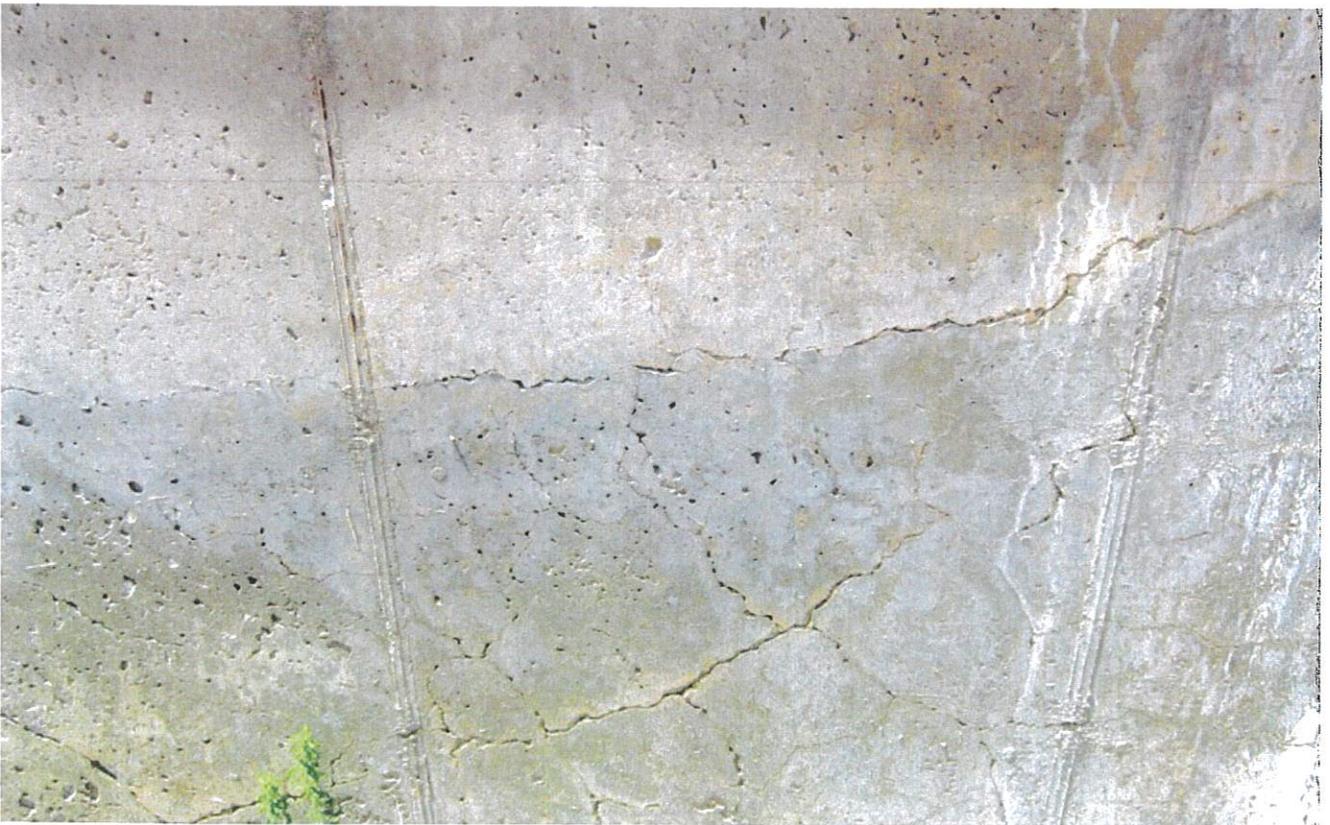
21. Cracks and efflorescence at bottom of shell.

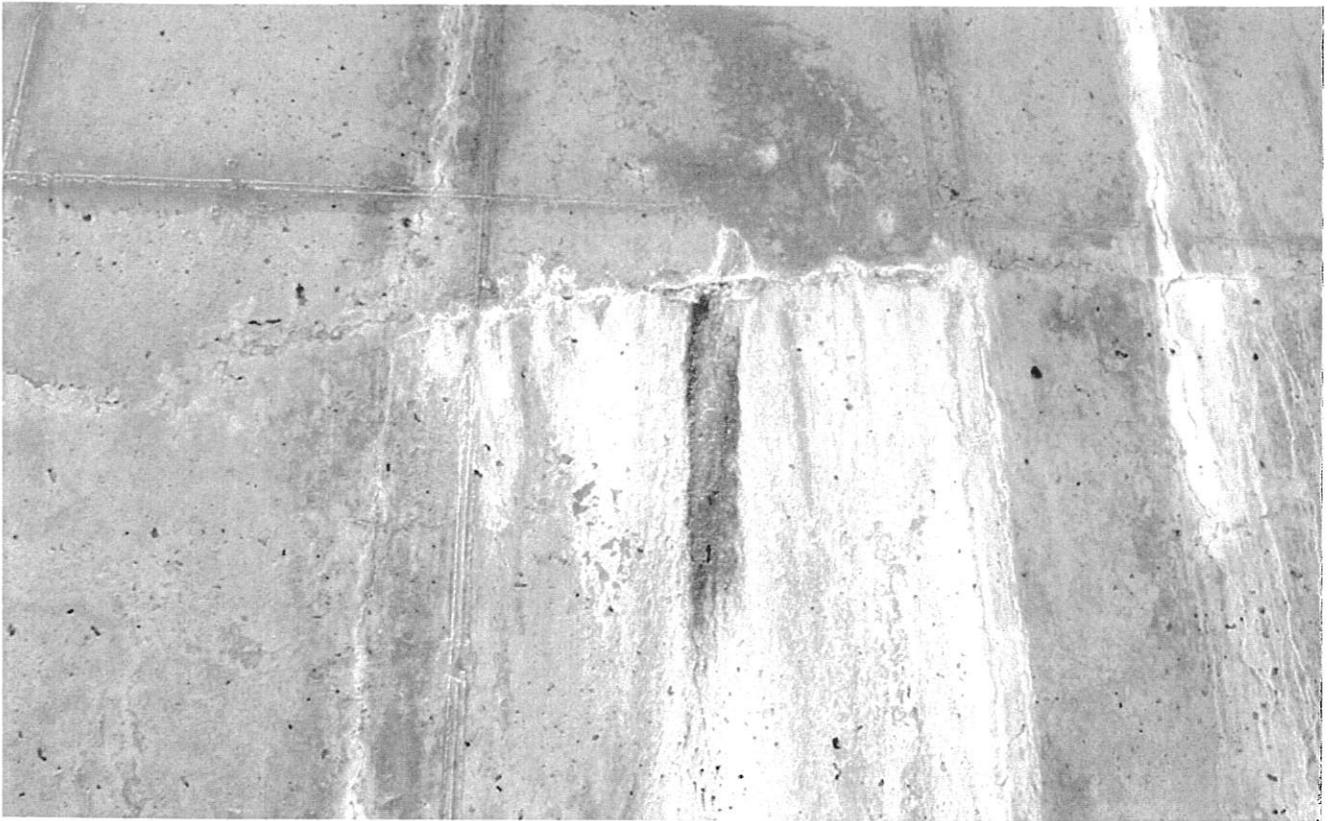
22. Cracking in shell.

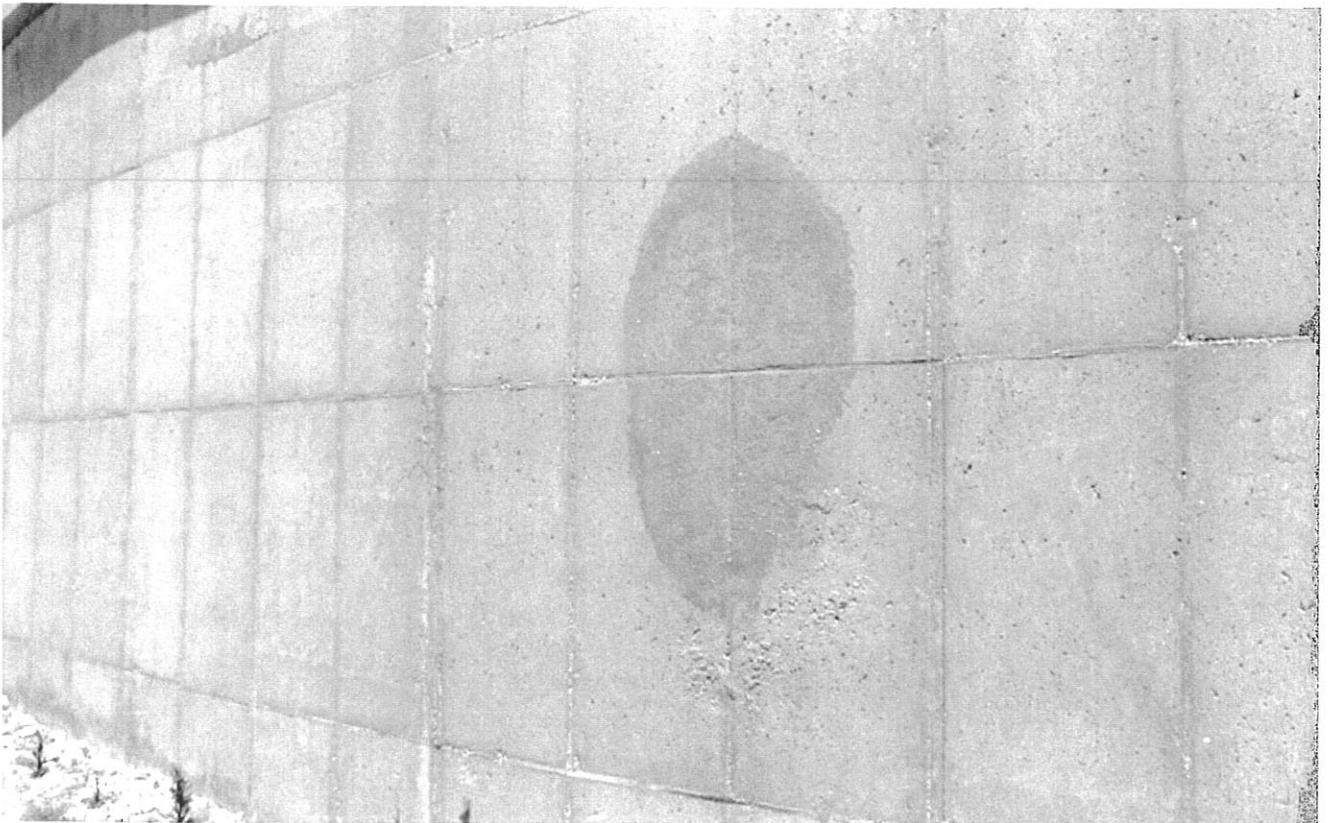
23. Crack in shell with efflorescence.

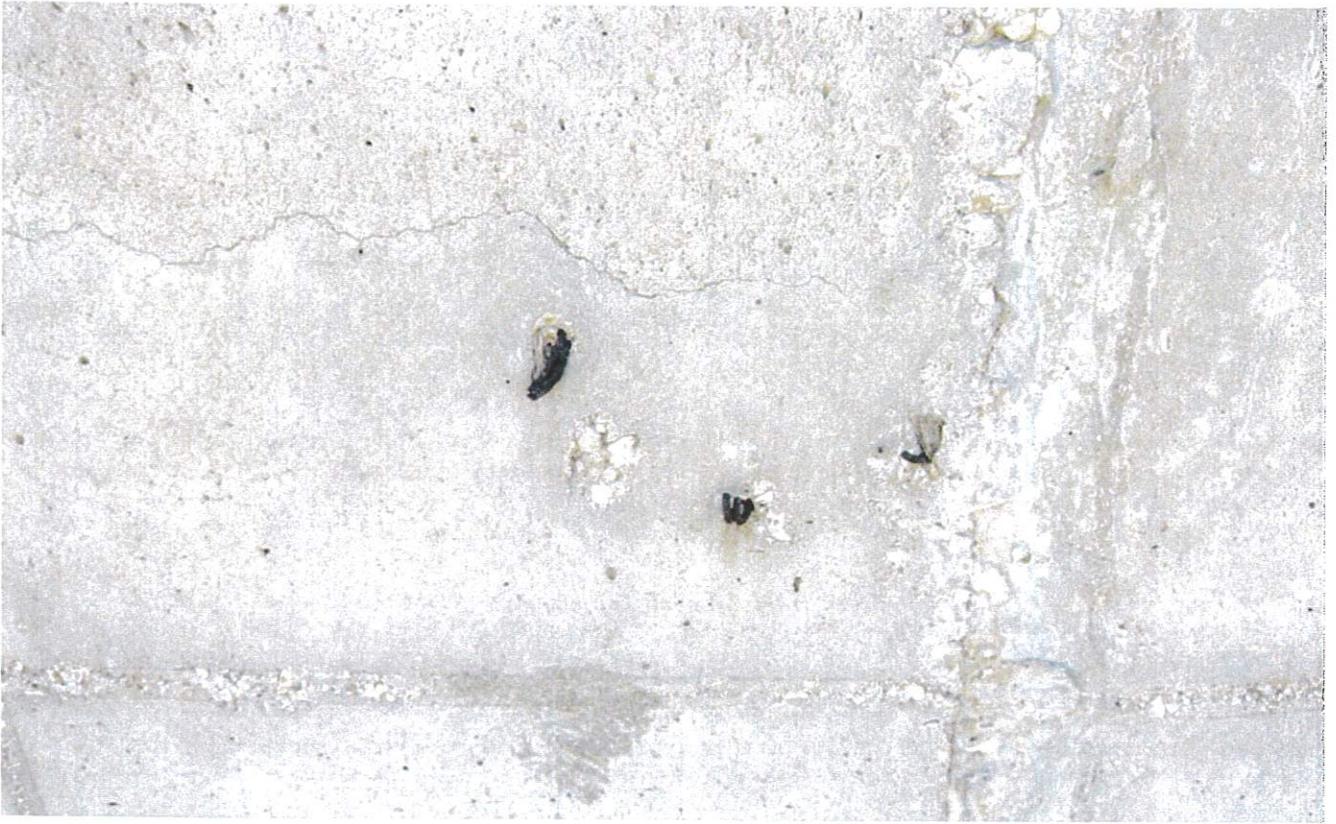
26. Exposed aggregate in shell.

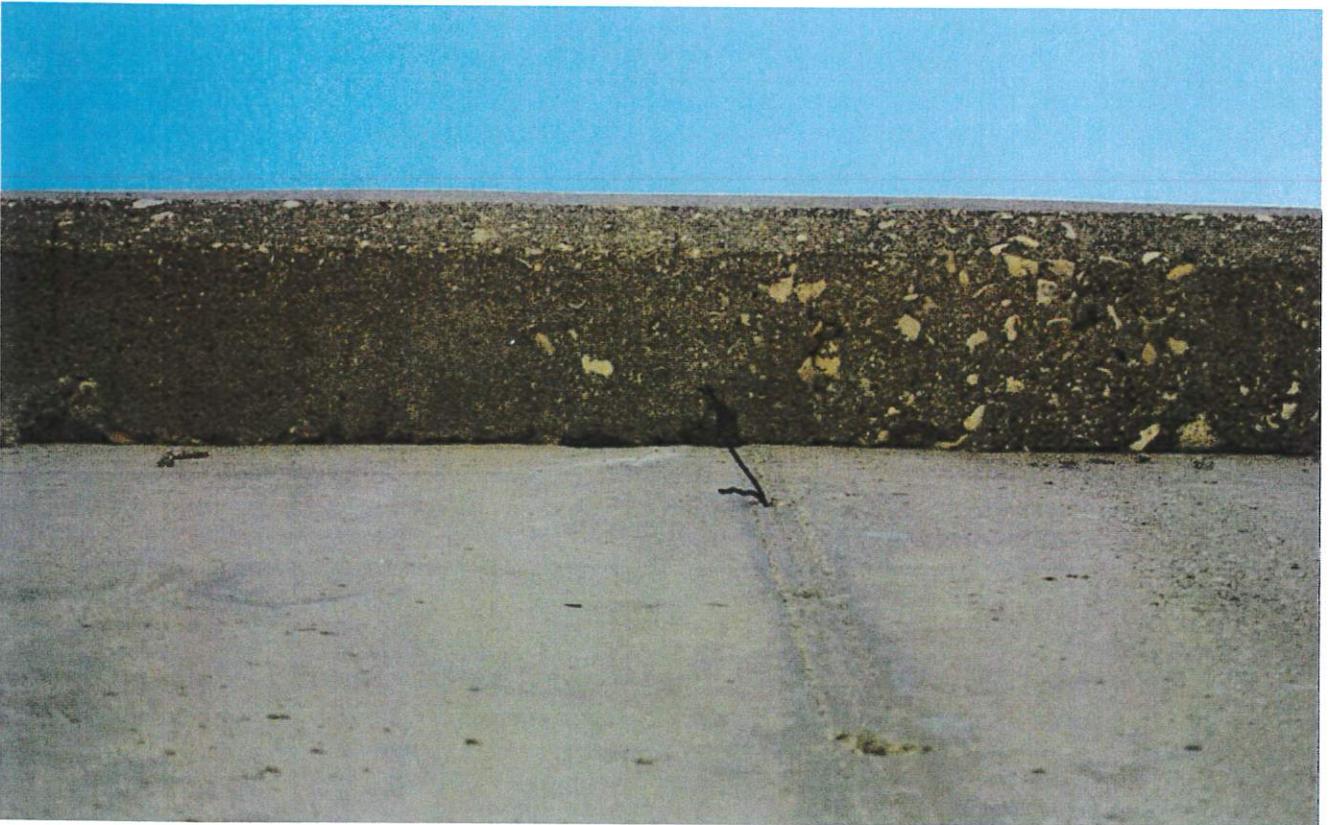
27. Tie wires in shell.

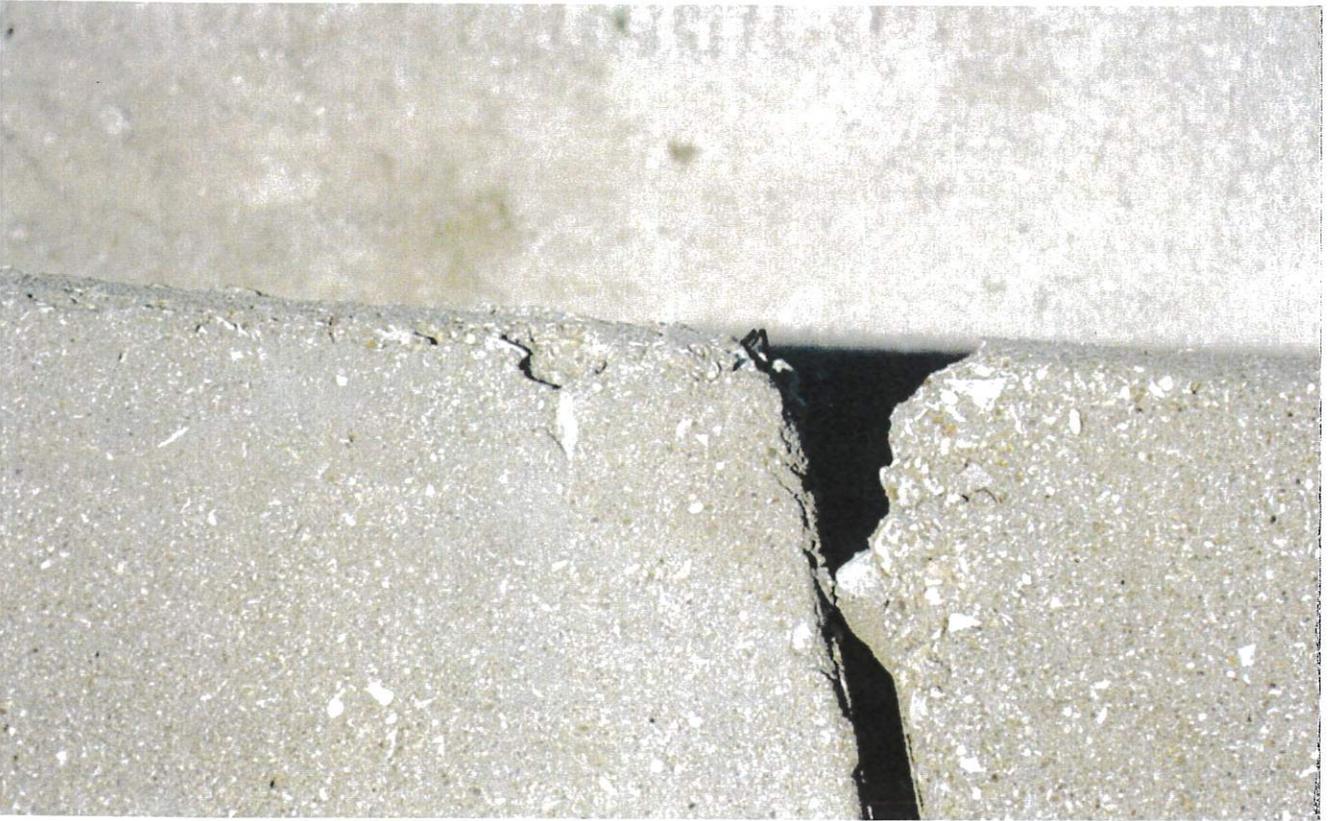
30. Chipped concrete at end of construction joint at roof perimeter.

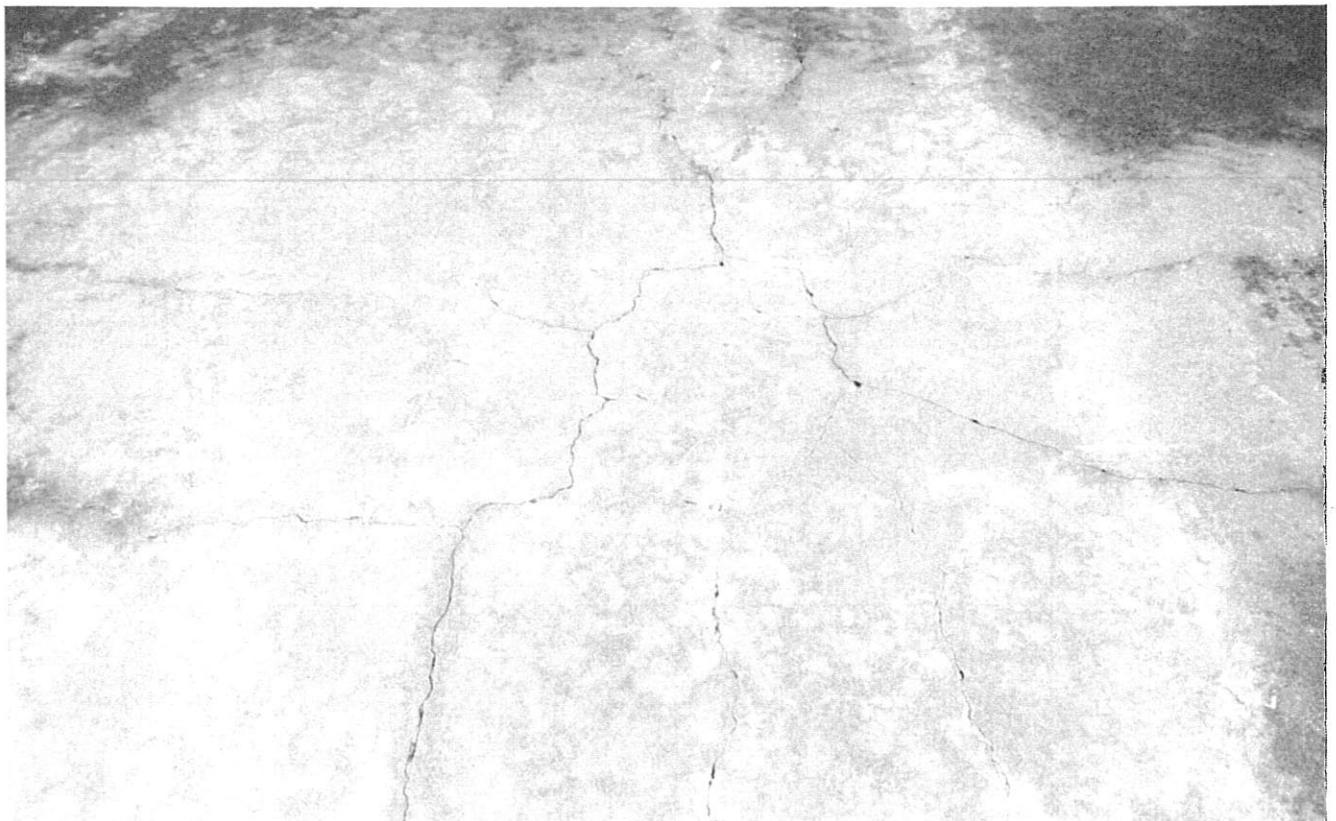
35. Cracks in exterior roof above apparent location of interior column.

2. **Roof Cracks at Columns:** The spider web looking cracking in the exterior roof at the apparent locations of the interior columns is of a potential structural concern and should be repaired. When the tank is regularly evaluated, the areas of the exterior roof above the apparent locations of the columns should continue to be monitored to verify the condition is not worsening.

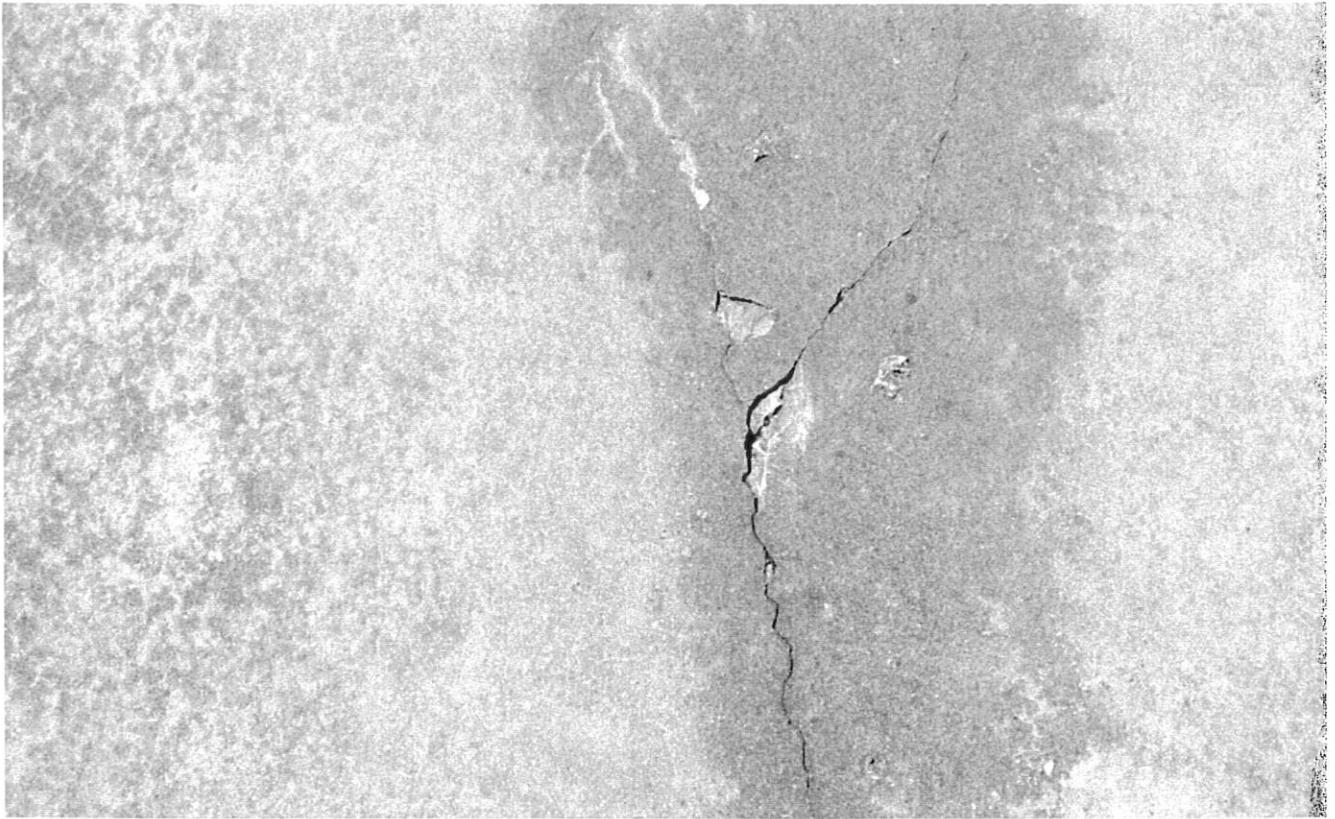
36. Cracks in exterior roof above apparent location of interior column.

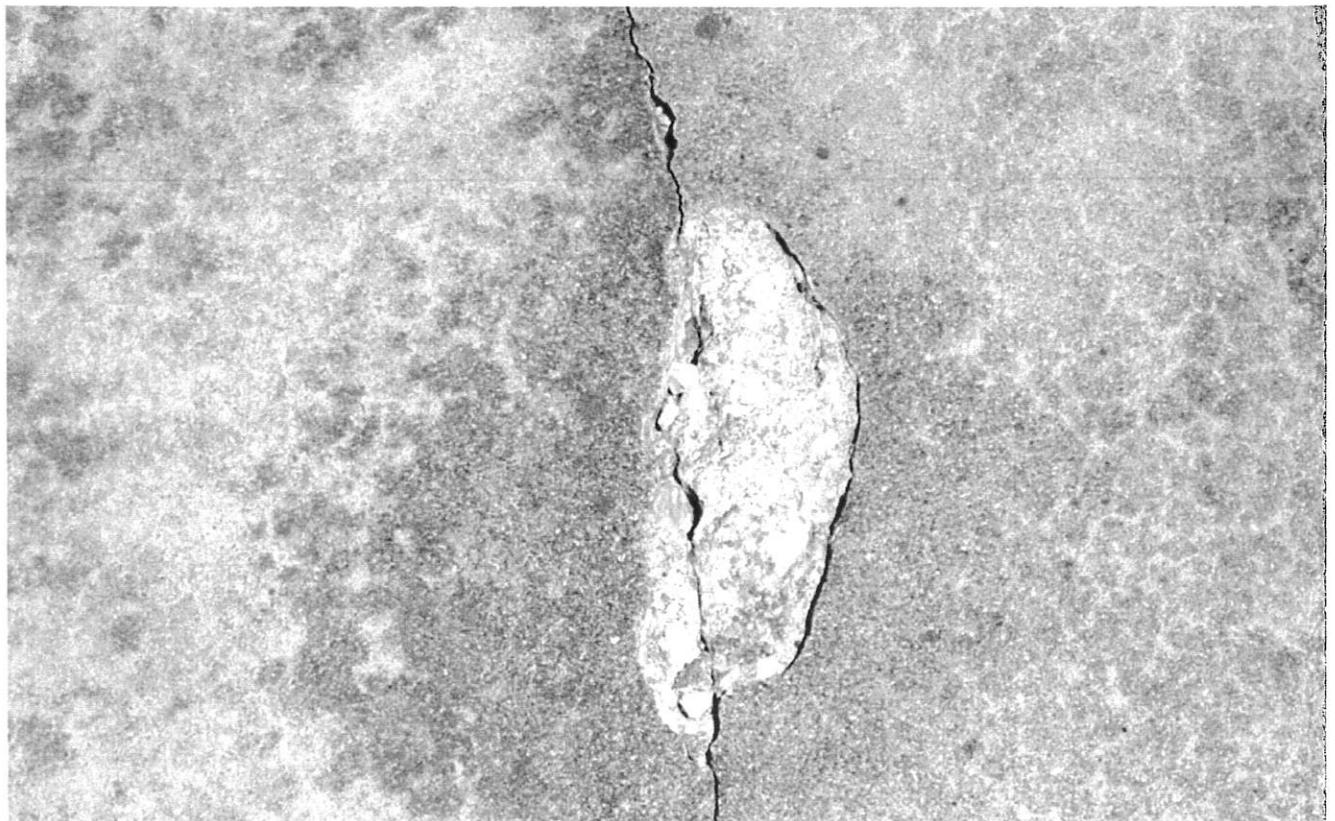
37. Crack in exterior roof.

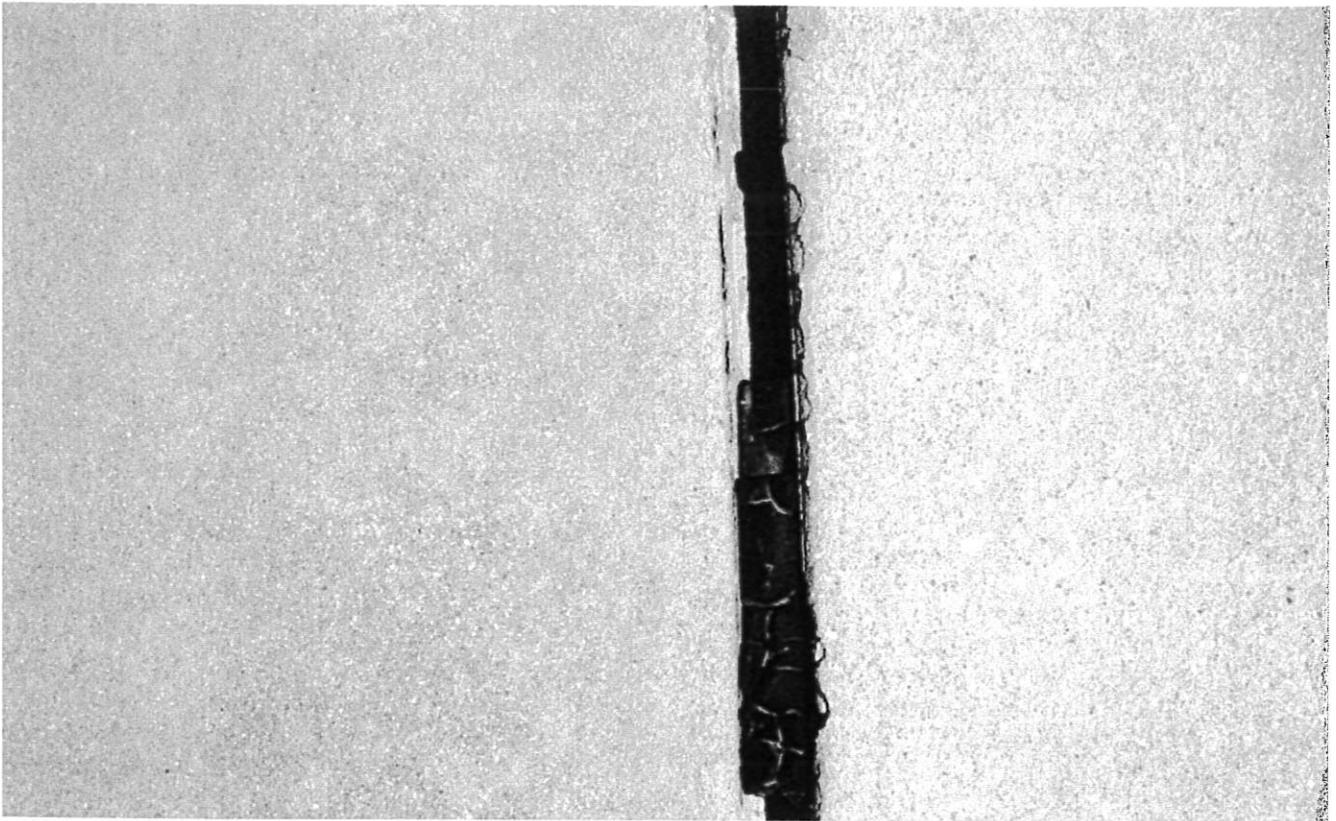
38. Cracks in exterior roof.

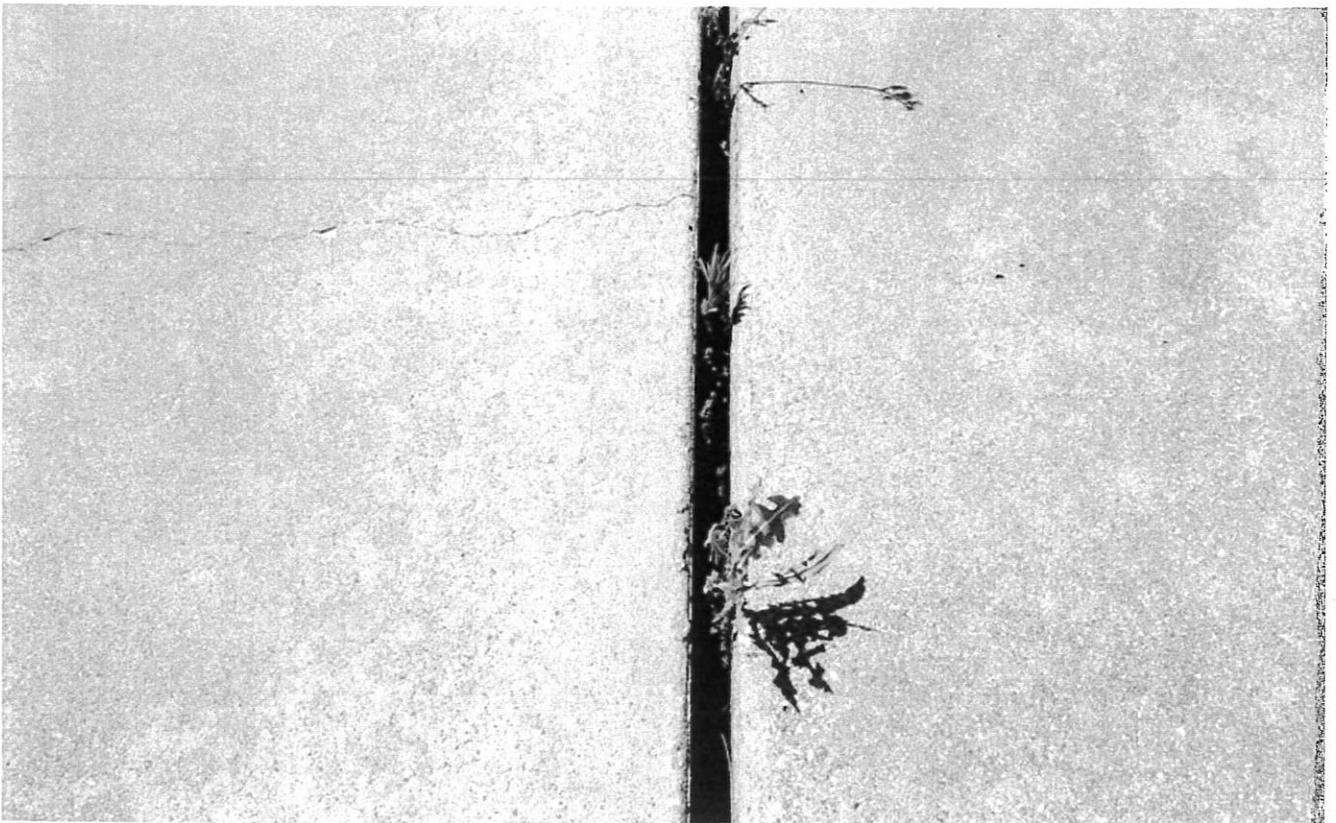
39. Sealant missing from construction joint in roof.

3. **Roof Construction Joints:** The existing bituminous sealant which appeared to be in poor condition and the vegetation should be removed from the roof construction joints and the joints resealed.

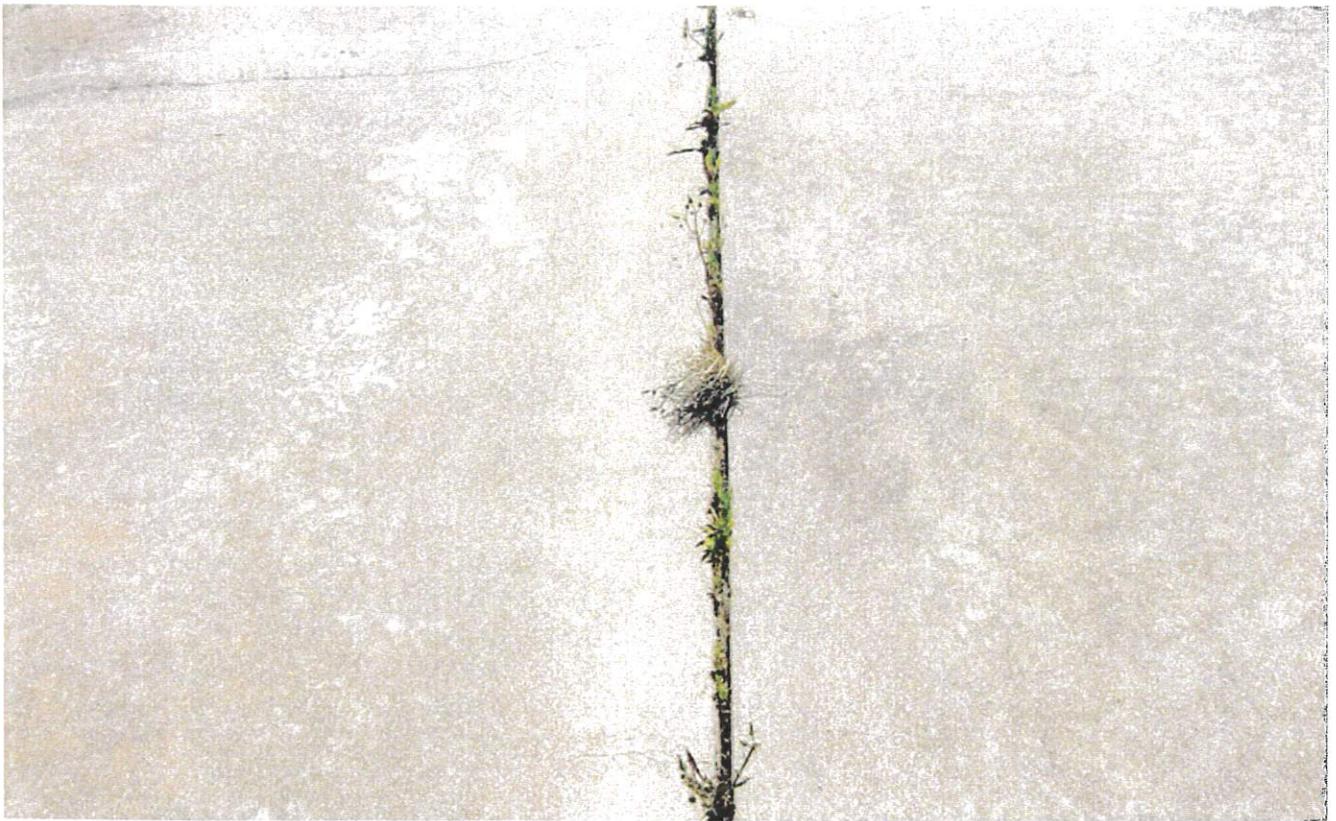
40. Vegetation in roof construction joint.

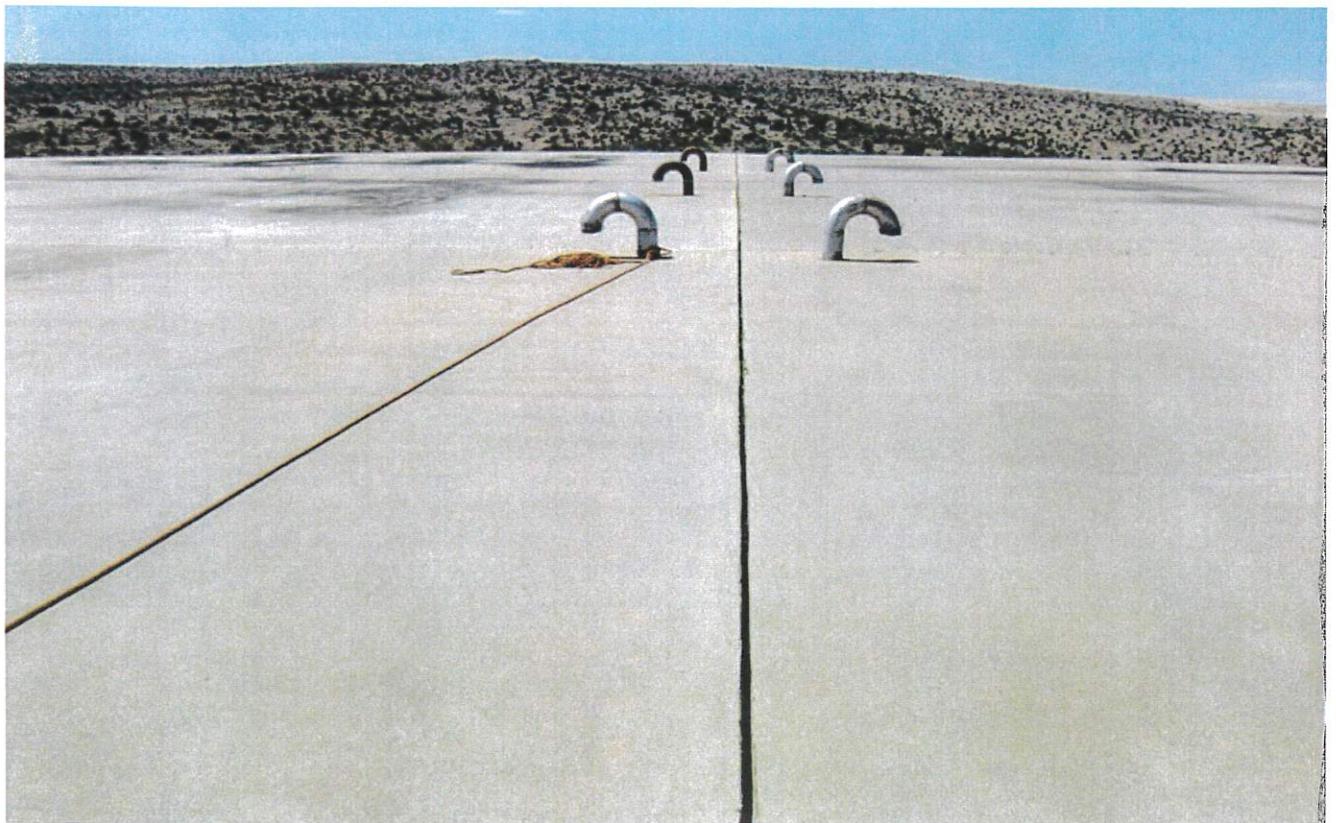
41. Vegetation in roof construction joint.

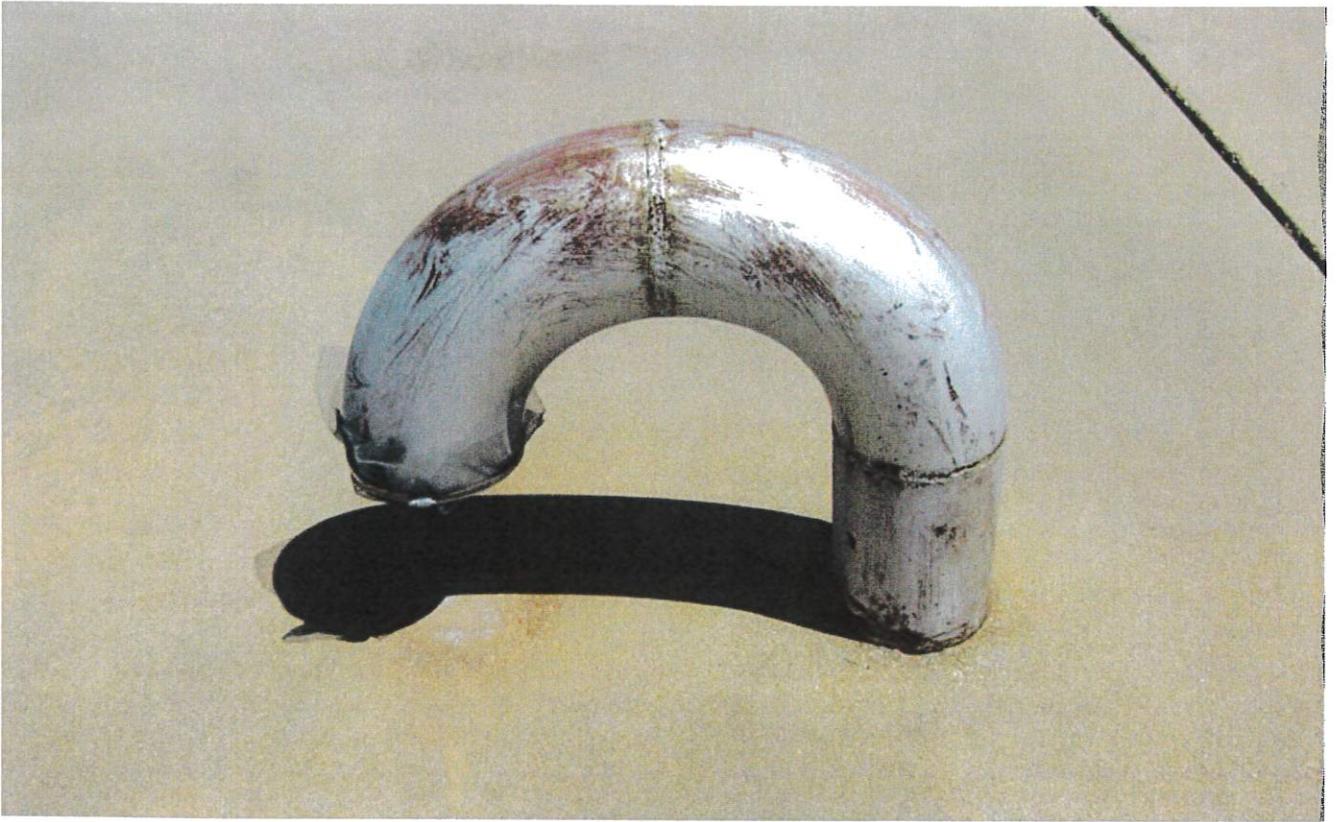
5. **Roof Vents:** **There was a potential sanitary deficiency noted: the protective screening on the gooseneck roof vents did not appear restrictive enough to prevent the ingress of insects into the tank.** The roof was equipped with six gooseneck roof vents. The end of each vent was equipped with a galvanized screen clamped to the vent. The coating on the steel vent pipes had weathered and wide spread coating failures to underlying coating and rust were observed on the vents. (See photos 42-50)

44. Gooseneck roof vent screen.

13. **Clog-Resistant Vent:** The AWWA D100 Standard (applicable for steel tanks) recommends that all vents with screening against insects be designed to ensure "fail-safe" operation if the insect screens become occluded. However, a concrete roof is typically capable of withstanding more pressure or vacuum than a steel roof. If the Owner desires to provide the utmost in safety, a clog-resistant vent should be installed.

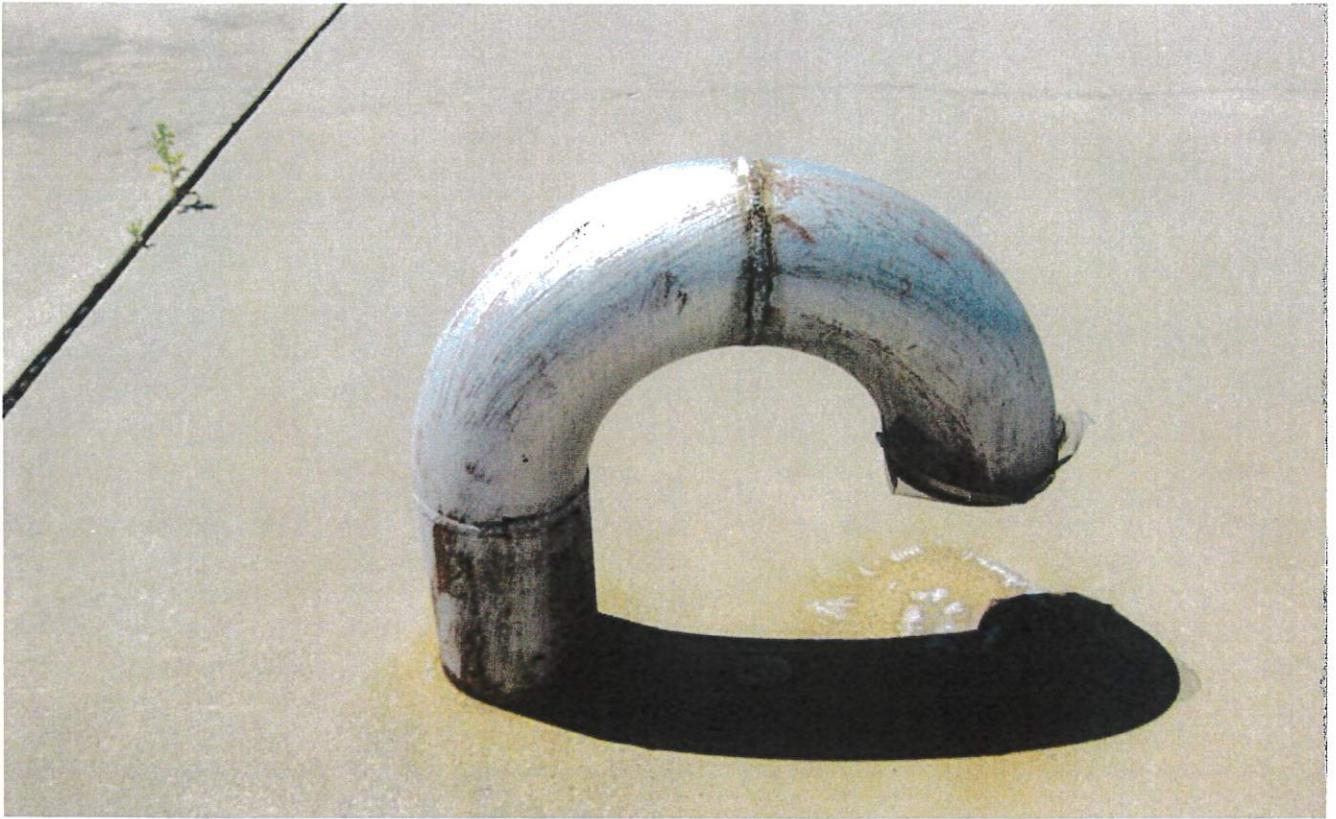
46. Gooseneck roof vent screen.

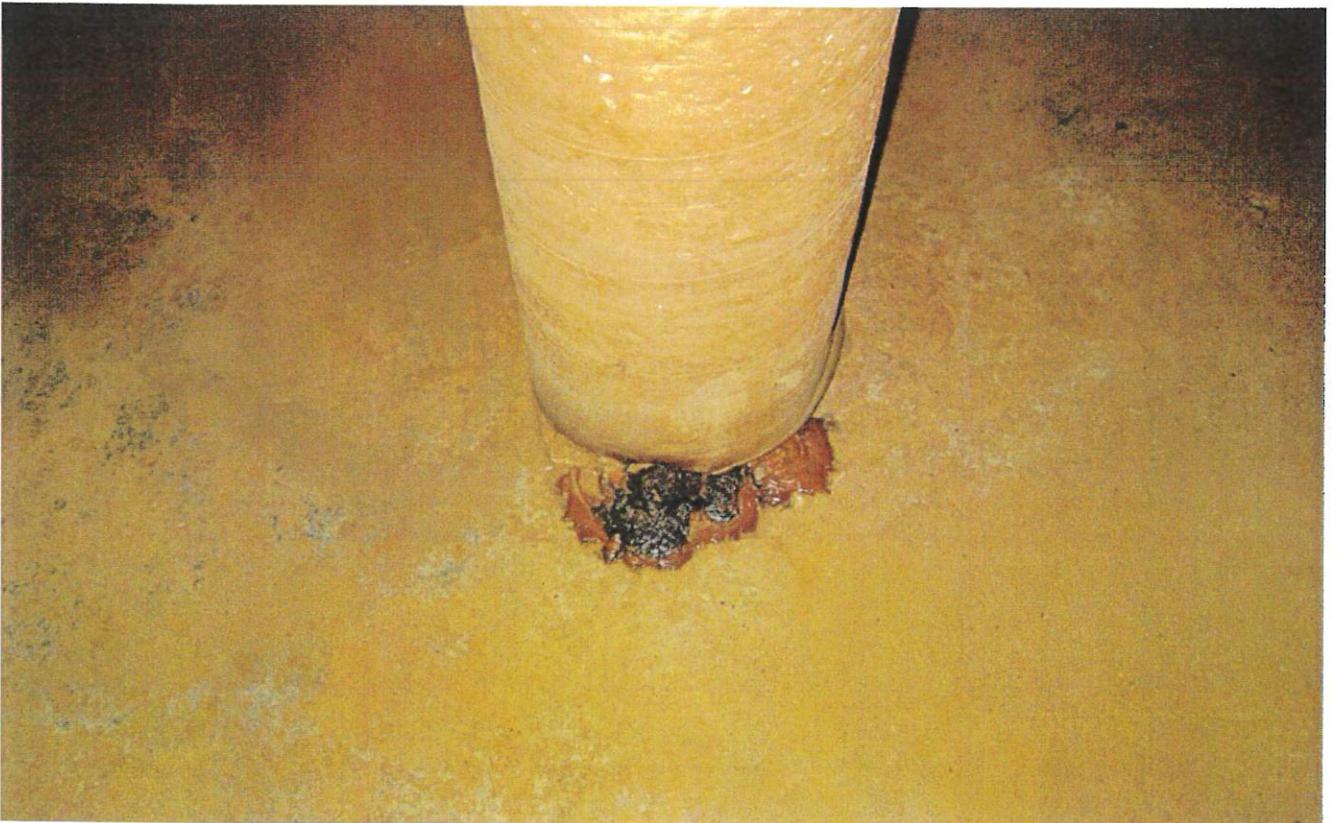
69. Interior floor and columns. Note cracking in floor.
