**EVALUATION OF THE
5,000,000 GALLON CONCRETE GROUND STORAGE TANK**

**“RESERVOIR NO. 2”
CARLSBAD, NEW MEXICO**

**SOUDER, MILLER & ASSOCIATES
ALBUQUERQUE, NEW MEXICO**

April 27 through May 5, 2016

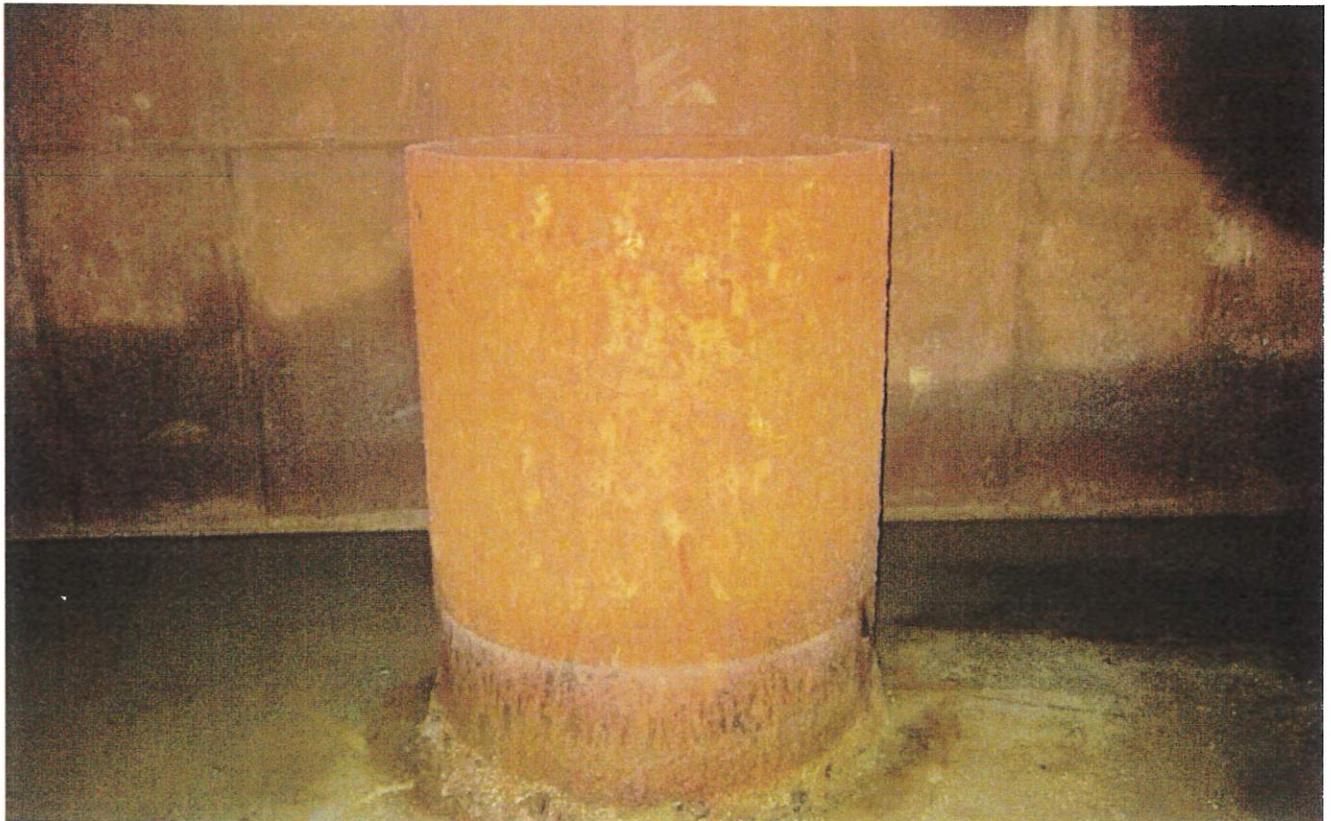
77. Abandoned tray located in tank.
