“City of Havelock
Request for Engineering Services: Woodhaven Drive”
Addendum 1
July 30, 2019

Addition to bid: Inspection report of storm culvert listed in project description.

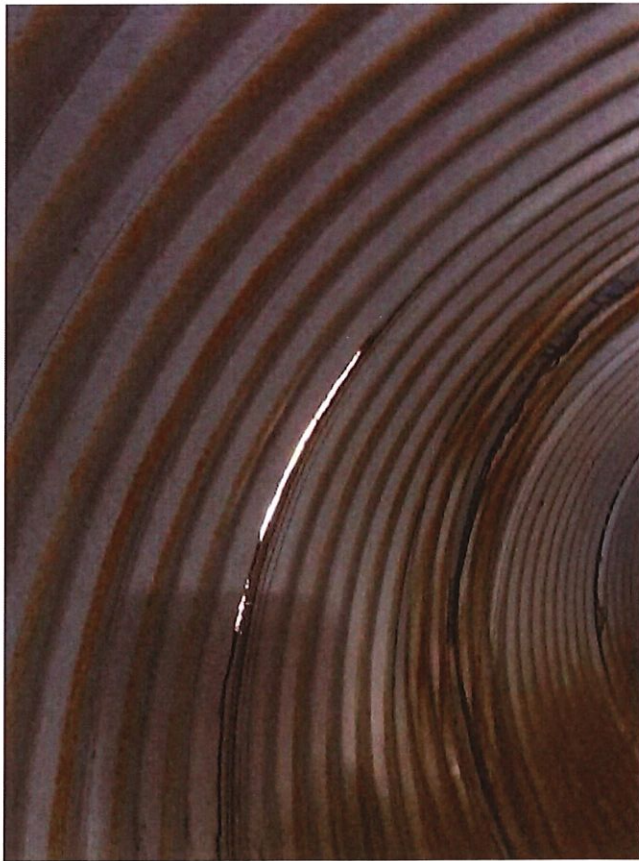
This pipe is 91' 9" long x 54" in diameter. Each joint has been photographed and all joints and bands/collars appear to be in good shape. There is some minor rusting, however, there are no signs of leaking or infiltration. There are two circumferential cracks in the pipe, as well as a hole in the invert towards the downstream end. They have been photographed and measured.

Photo 17
7' 10" from Joint
Circumferential Crack – 4' 6" Long from 1:00 – 5:00

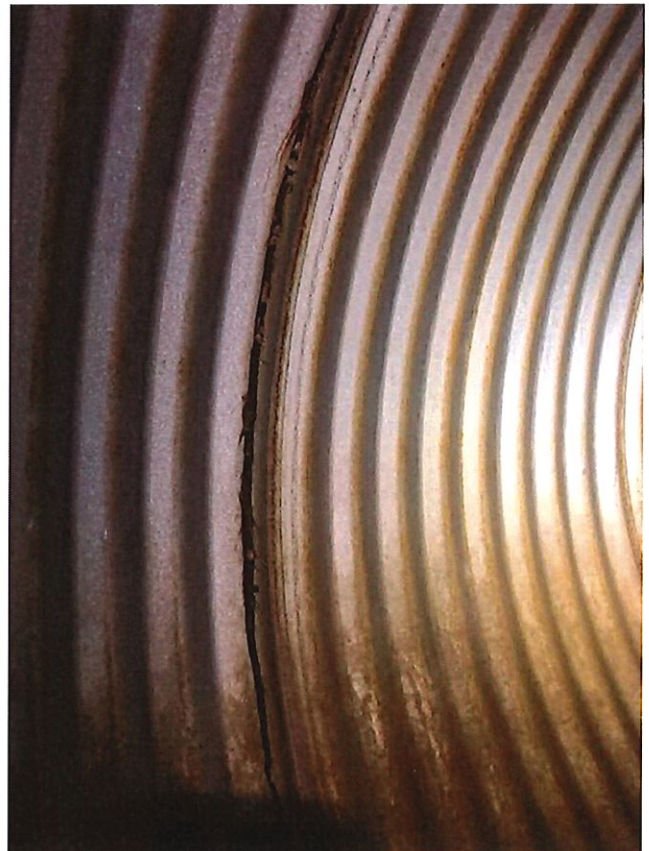
Photo 18
1' 10" from Joint
Circumference Crack – 2' 2" Long from 1:00 – 3:30

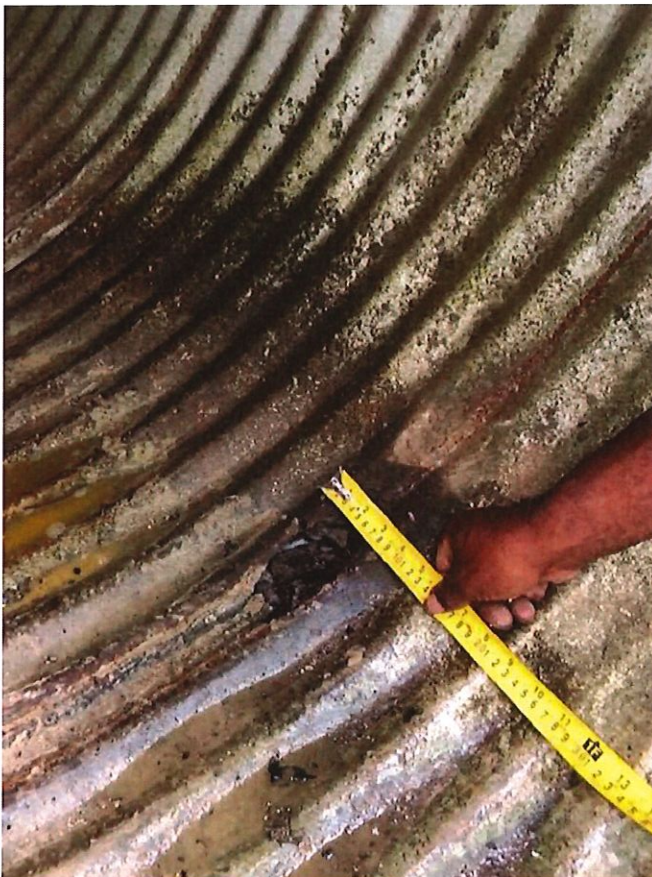
Photo 25
(Hole In invert 6" x 8")

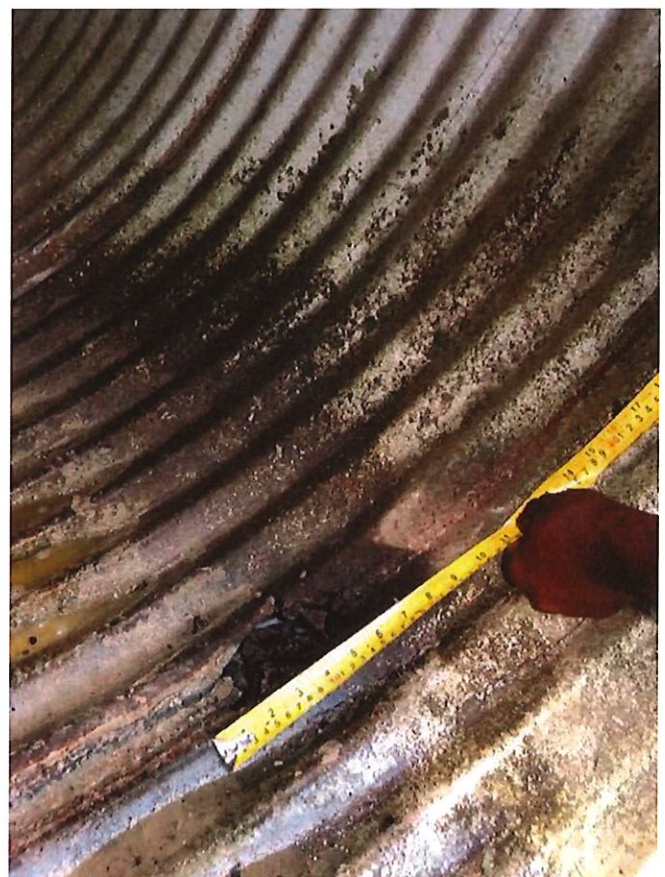
Photo 26
(Hole In invert 6" x 8")

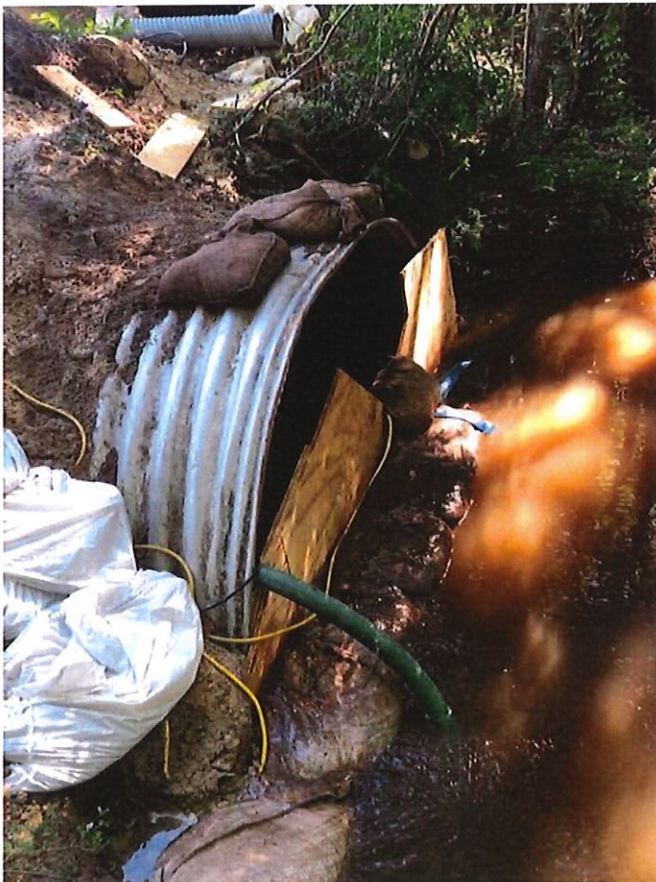
Photo 14
Downstream Dam

As you can see from the photos, upstream and downstream dams were constructed using sandbags and plywood; however, the I&I at the joints did not allow the water level to decrease. We were able to incorporate a Super Max 6" hydraulic pump (rented from United Rentals). It included 50' of 8" discharge hose and 100' of suction hose. Even with this equipment, the I&I was greater than the discharge and we were only able to reduce the water level to about 1.5'. This did show the rusting, which was more severe at higher levels on the pipe - this is due to the fluctuating water level. Typically, the pipe will rust faster if there is intermittent flow. It exposes the pipe to the elements, which accelerates the rusting.
