**ADDENDUM FOUR
GLENWOOD YFD CENTER AND OTHER CITY FACILITY FOUNDATION REPAIRS
CONTRACT NO. Y-19-009-202
CITY OF CHATTANOOGA, TENNESSEE**

The following changes shall be made to the Contract Documents, Specifications, and Drawings:

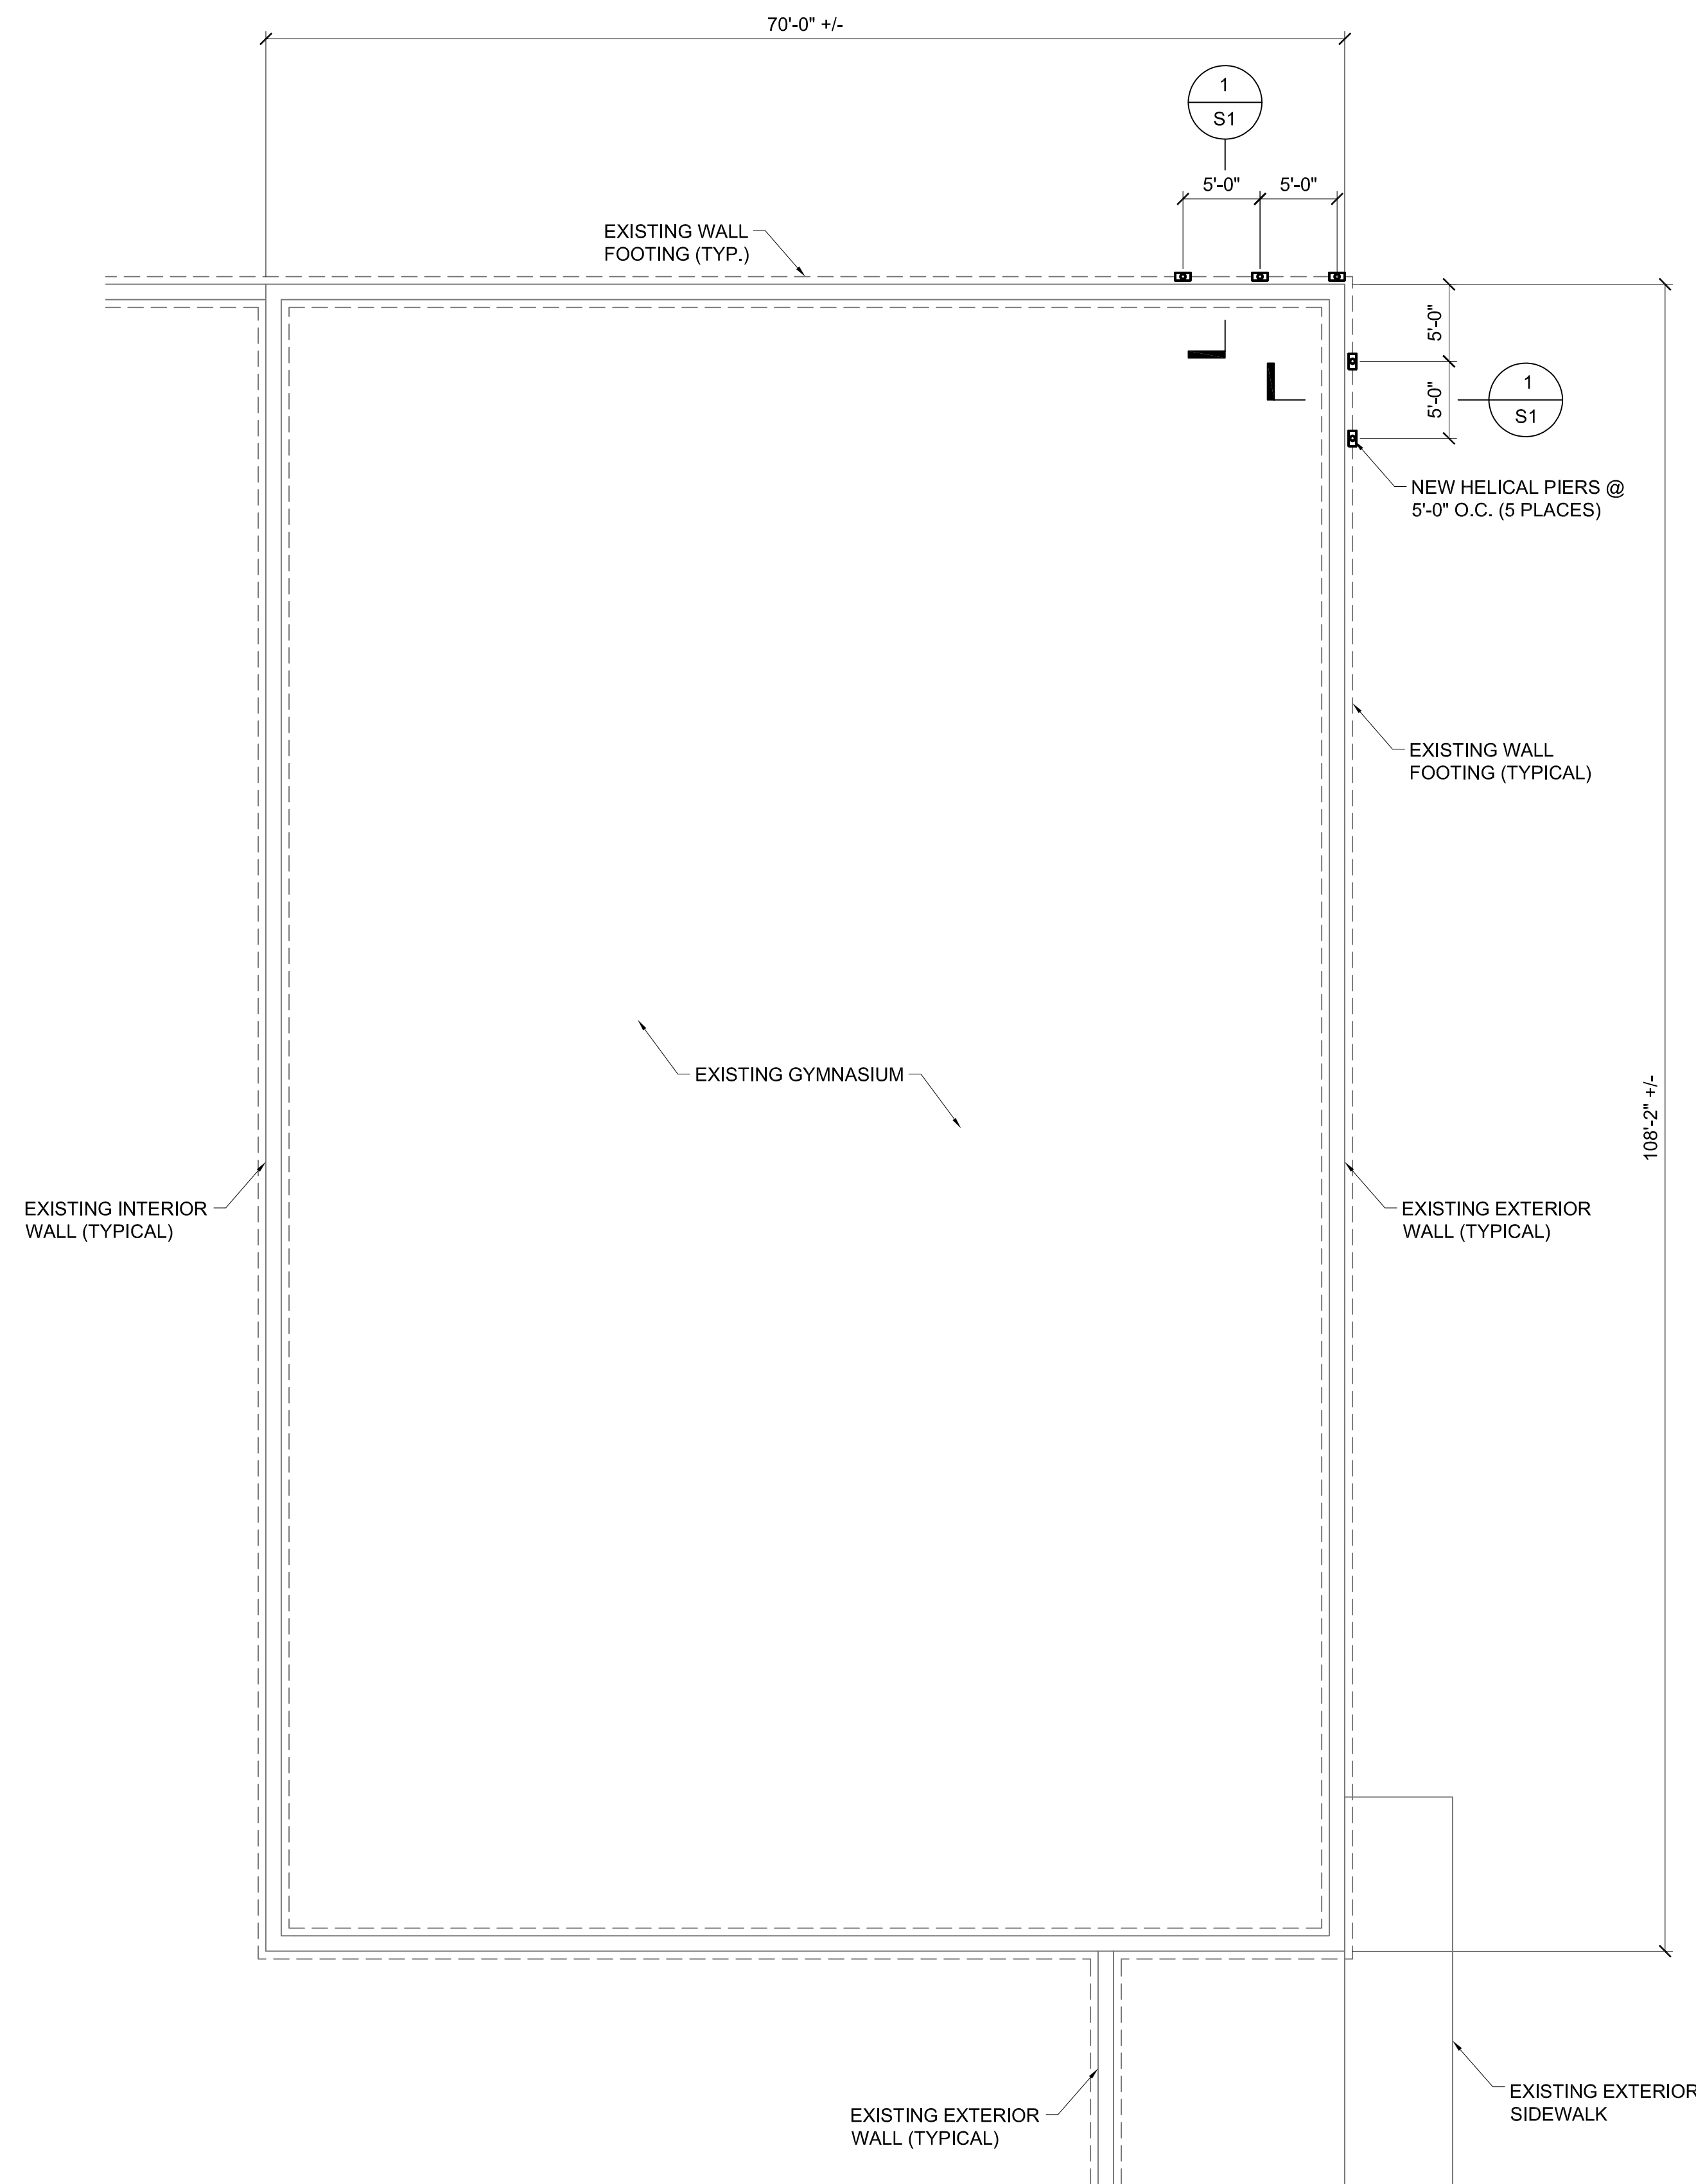
FOUNDATION REPAIR PLAN
SCALE: 3/8" = 1'-0" 1
S1

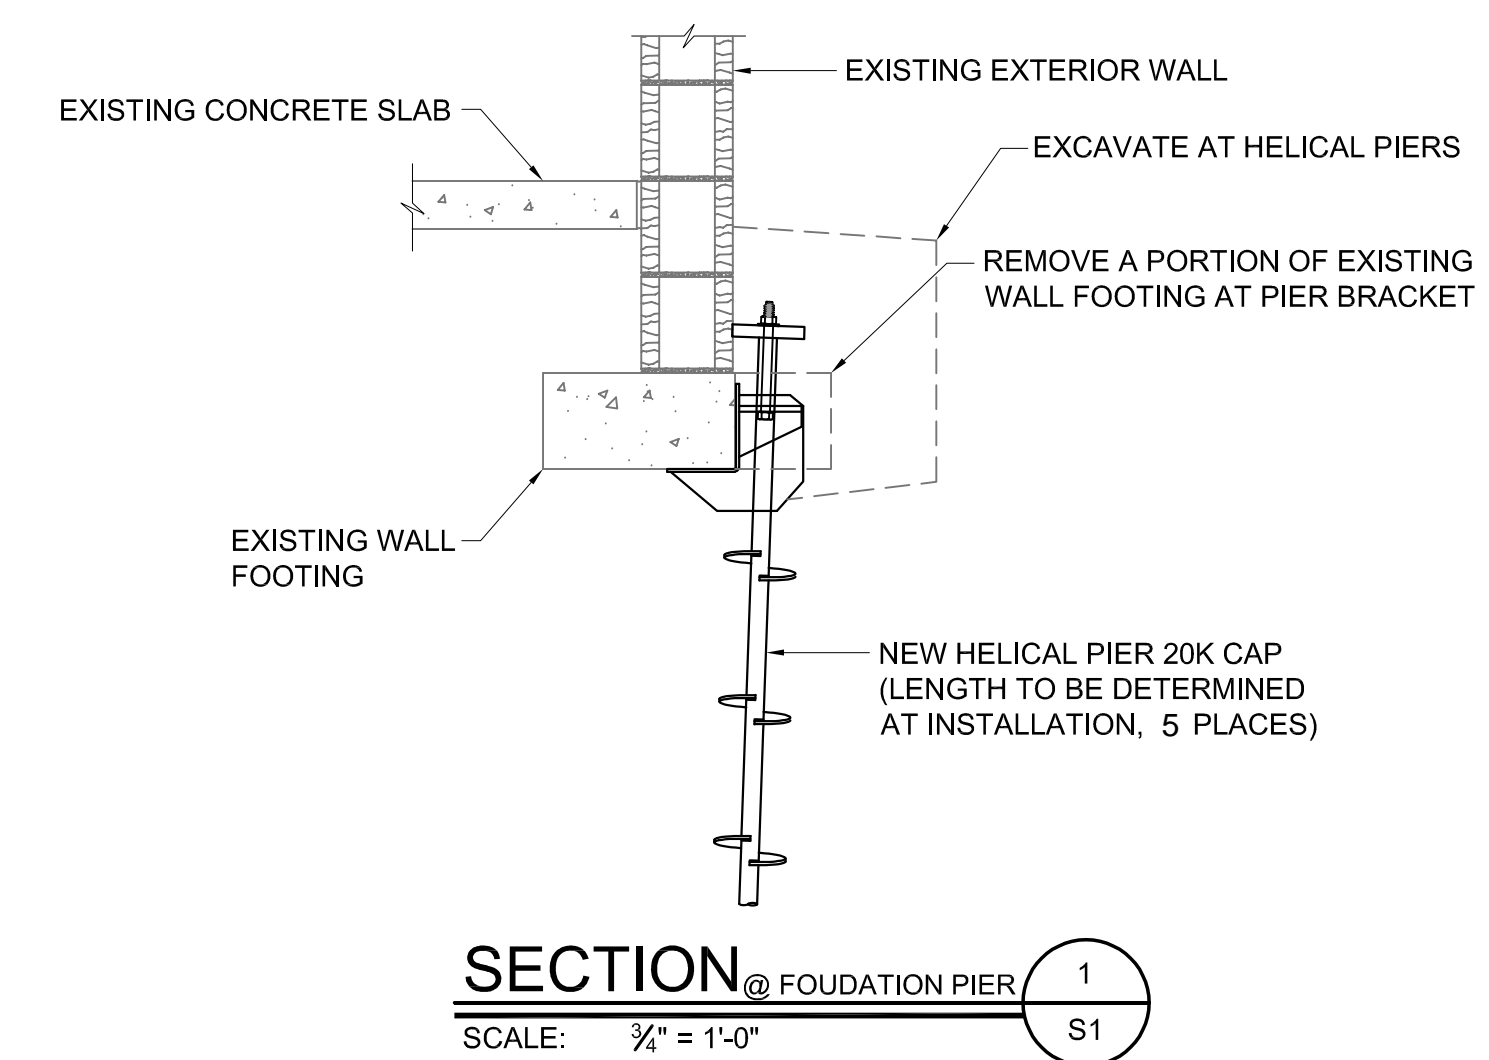
SECTION @ FOUNDATION PIER
SCALE: 3/8" = 1'-0" 1
S1

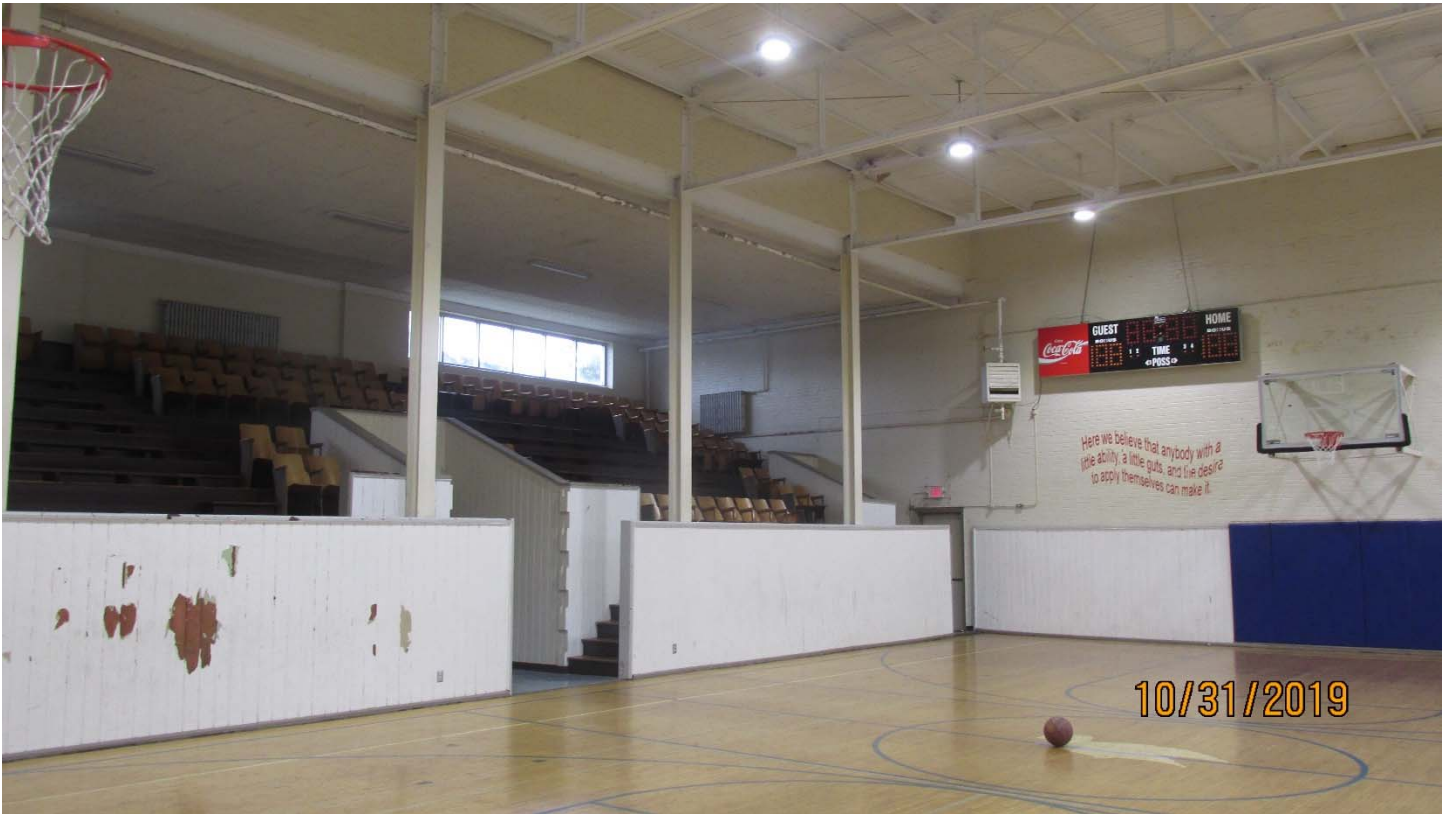
Picture #05: Interior Elevation – South End – Gymnasium

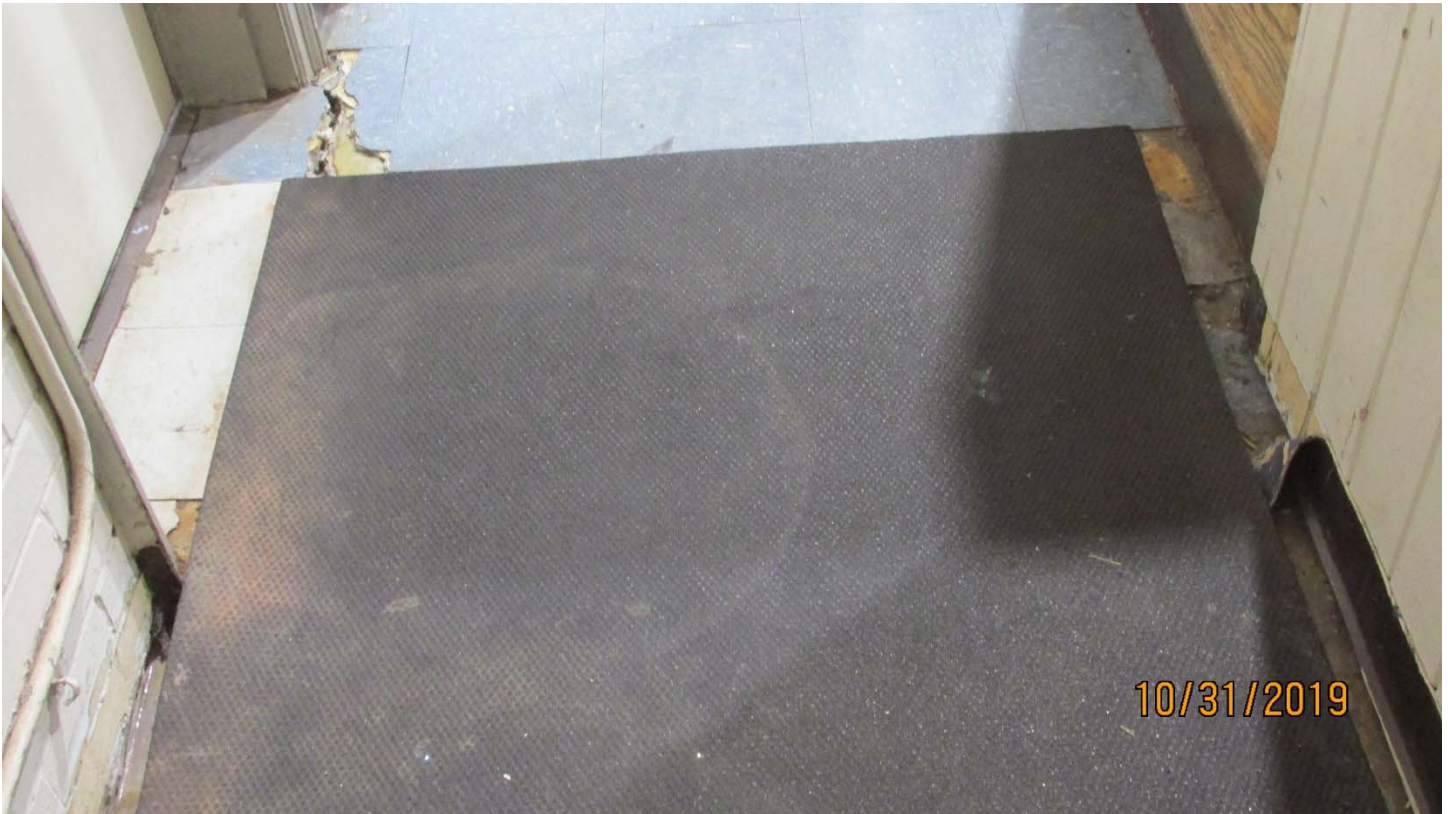
Picture #09: Concrete floor in bleacher area subsidence **(DL-3)**

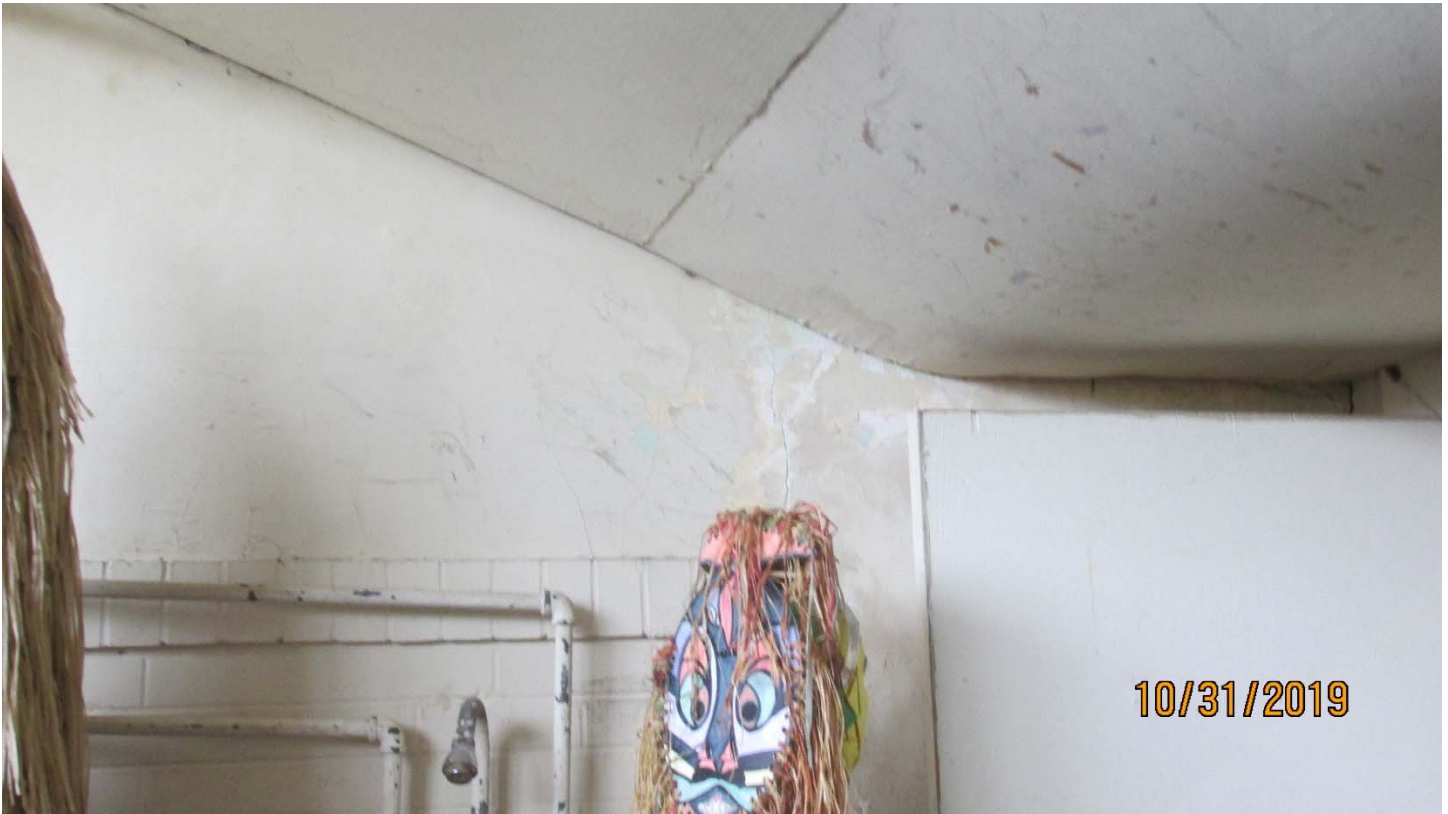
Picture #14: Cracks in Exterior Brick Wall – South End of Gymnasium underneath bleachers (DL-3)

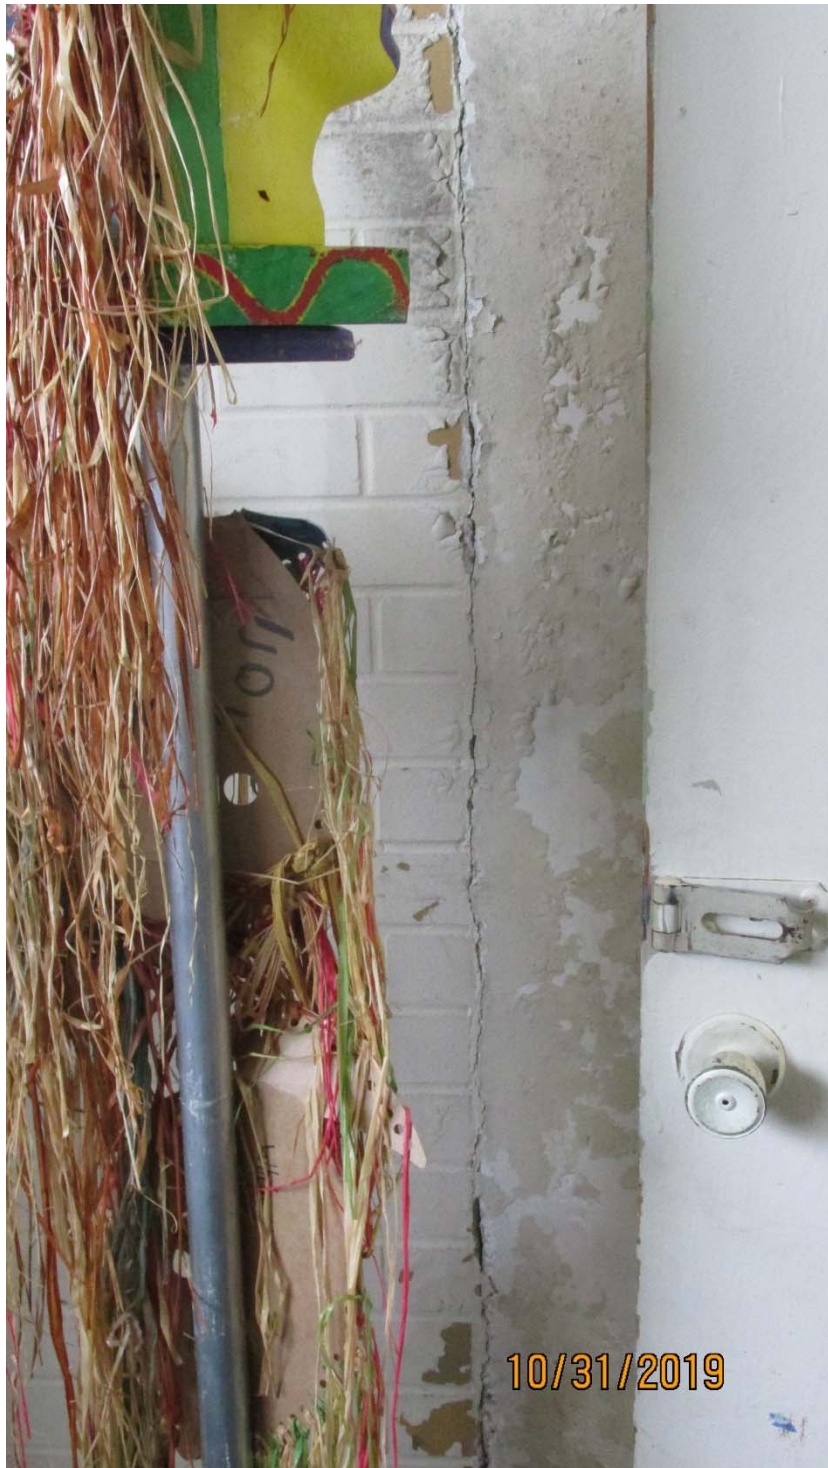
Picture #15: Cracks in Exterior Brick Wall – South End of Gymnasium underneath bleachers **(DL-3)**

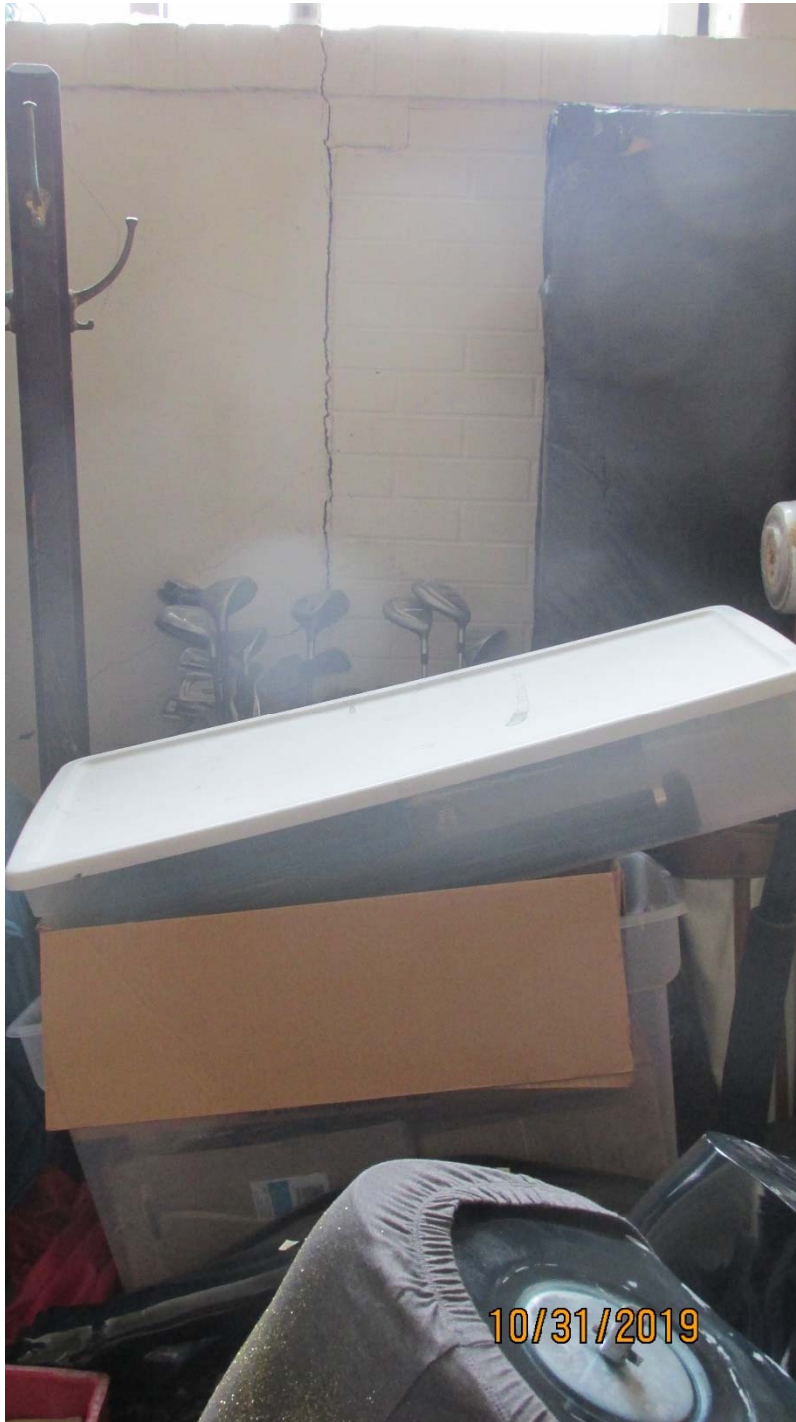
Picture #16: Cracks in Exterior Brick Wall – South End of Gymnasium underneath bleachers (DL-3)

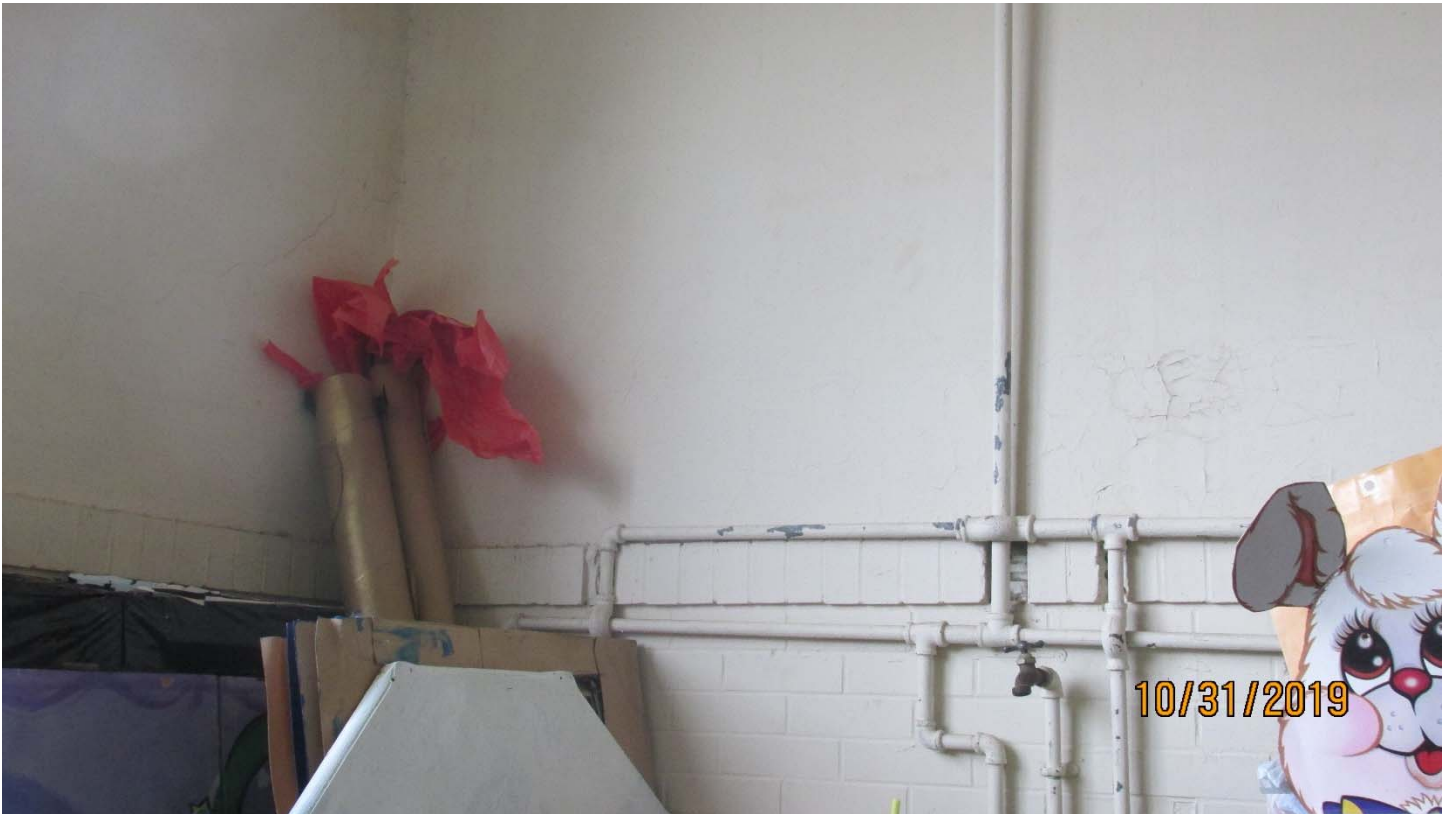
Picture #18: Cracks in Exterior Brick Wall – South End of Gymnasium underneath bleachers (DL-3)

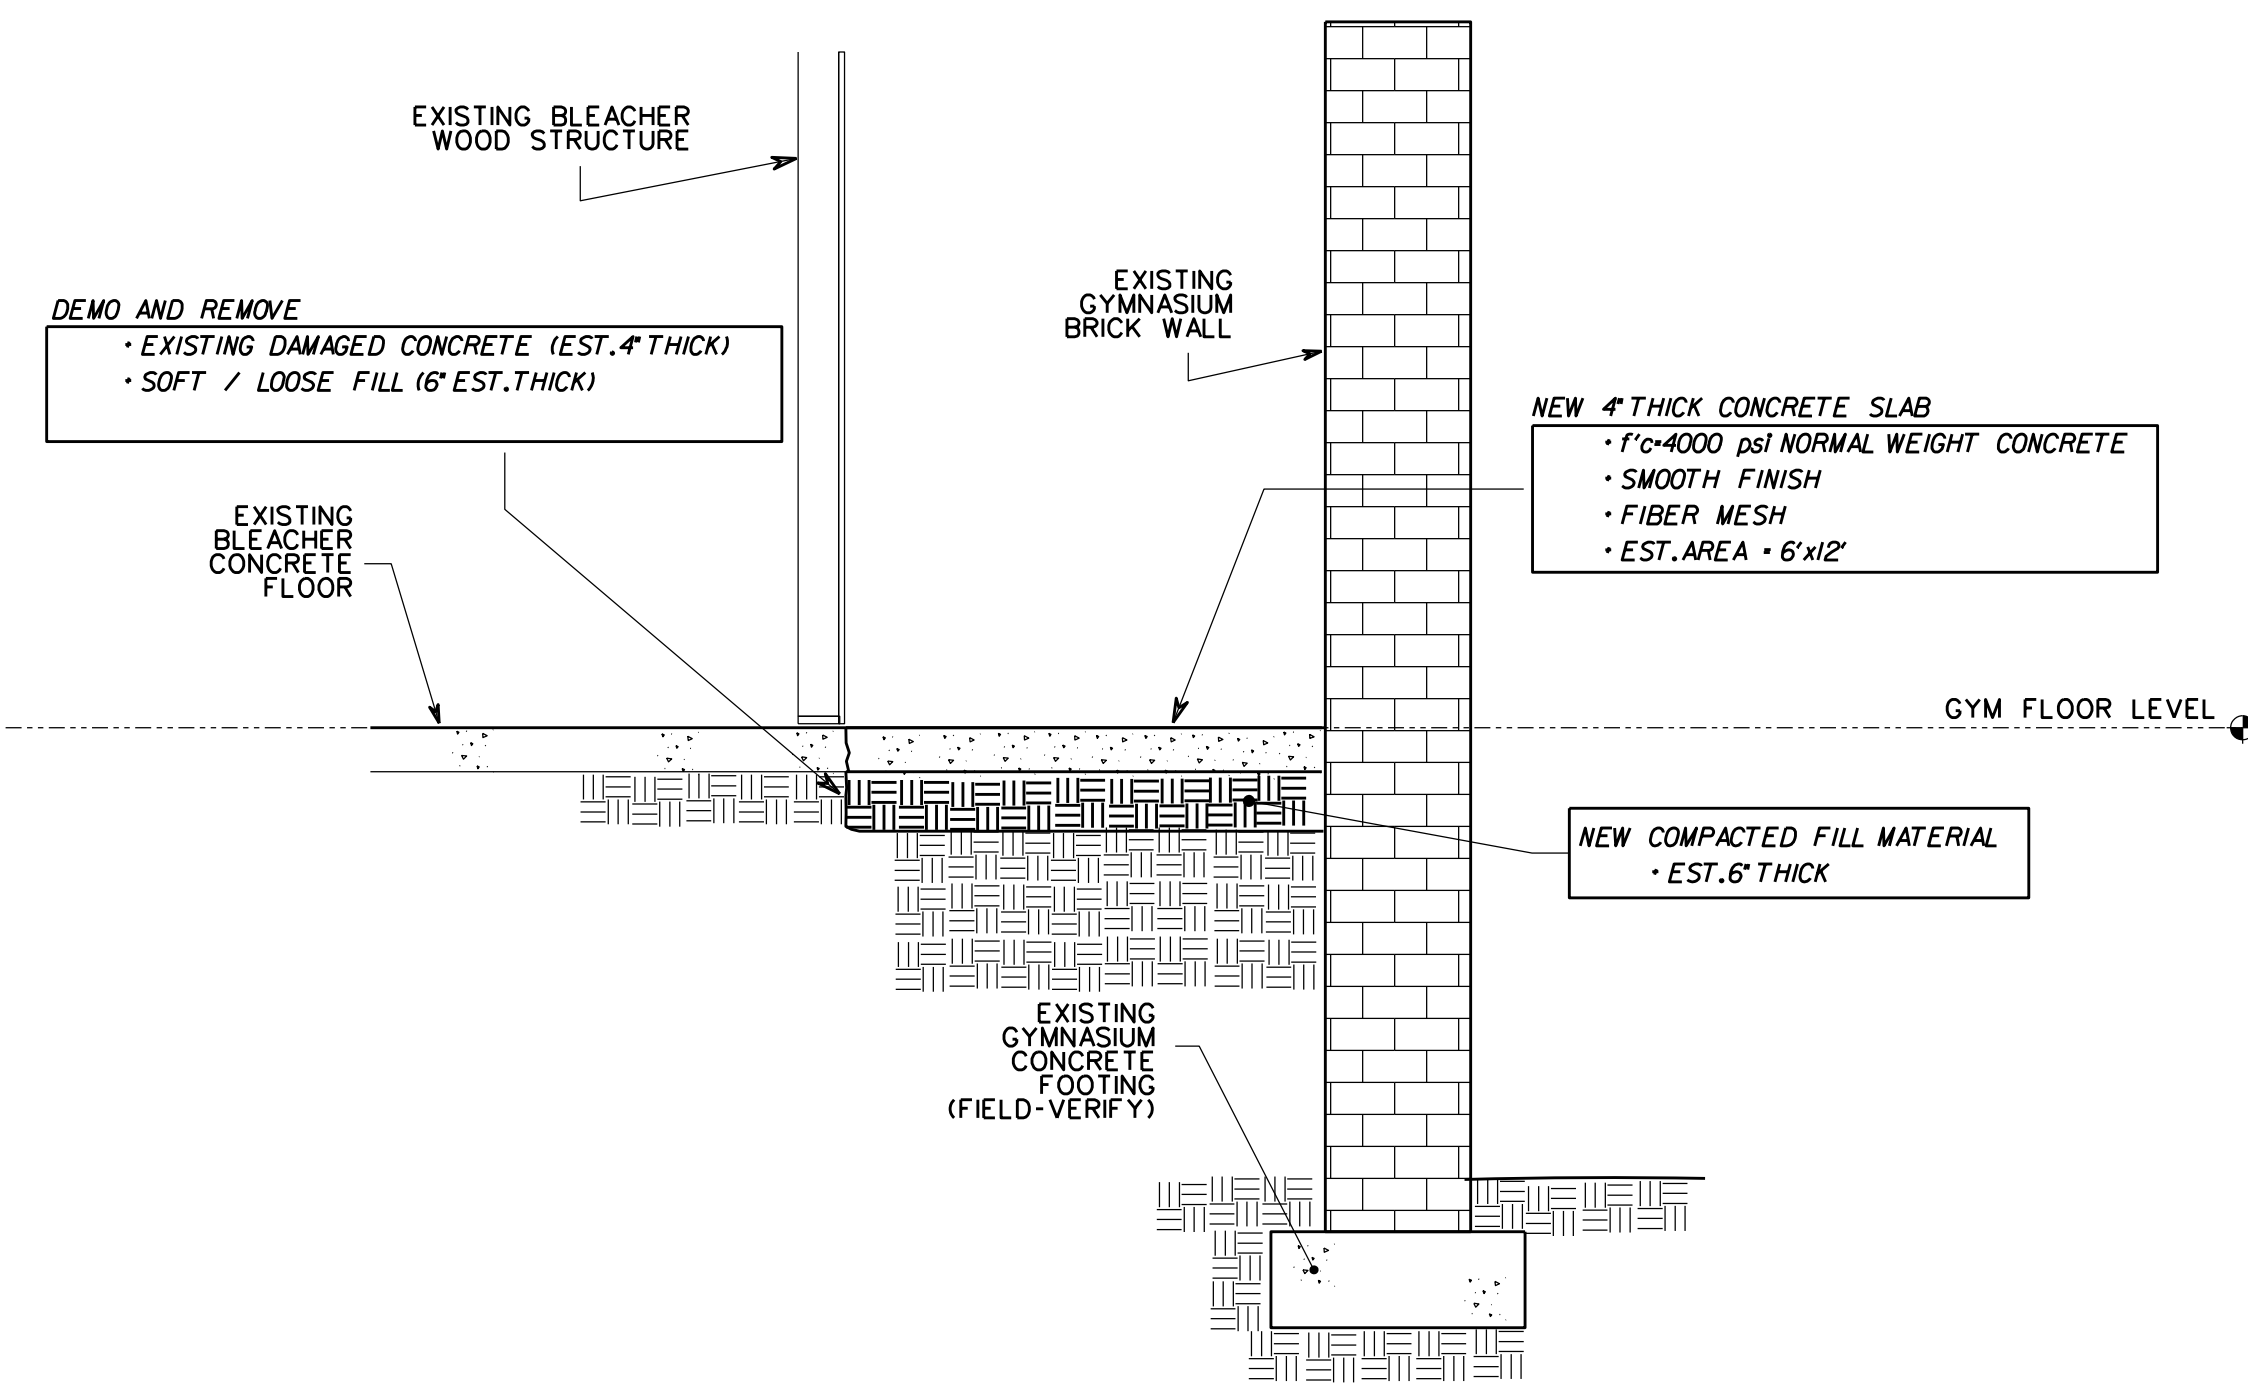
NEW SLAB REPAIR AT BLEACHERS (B)

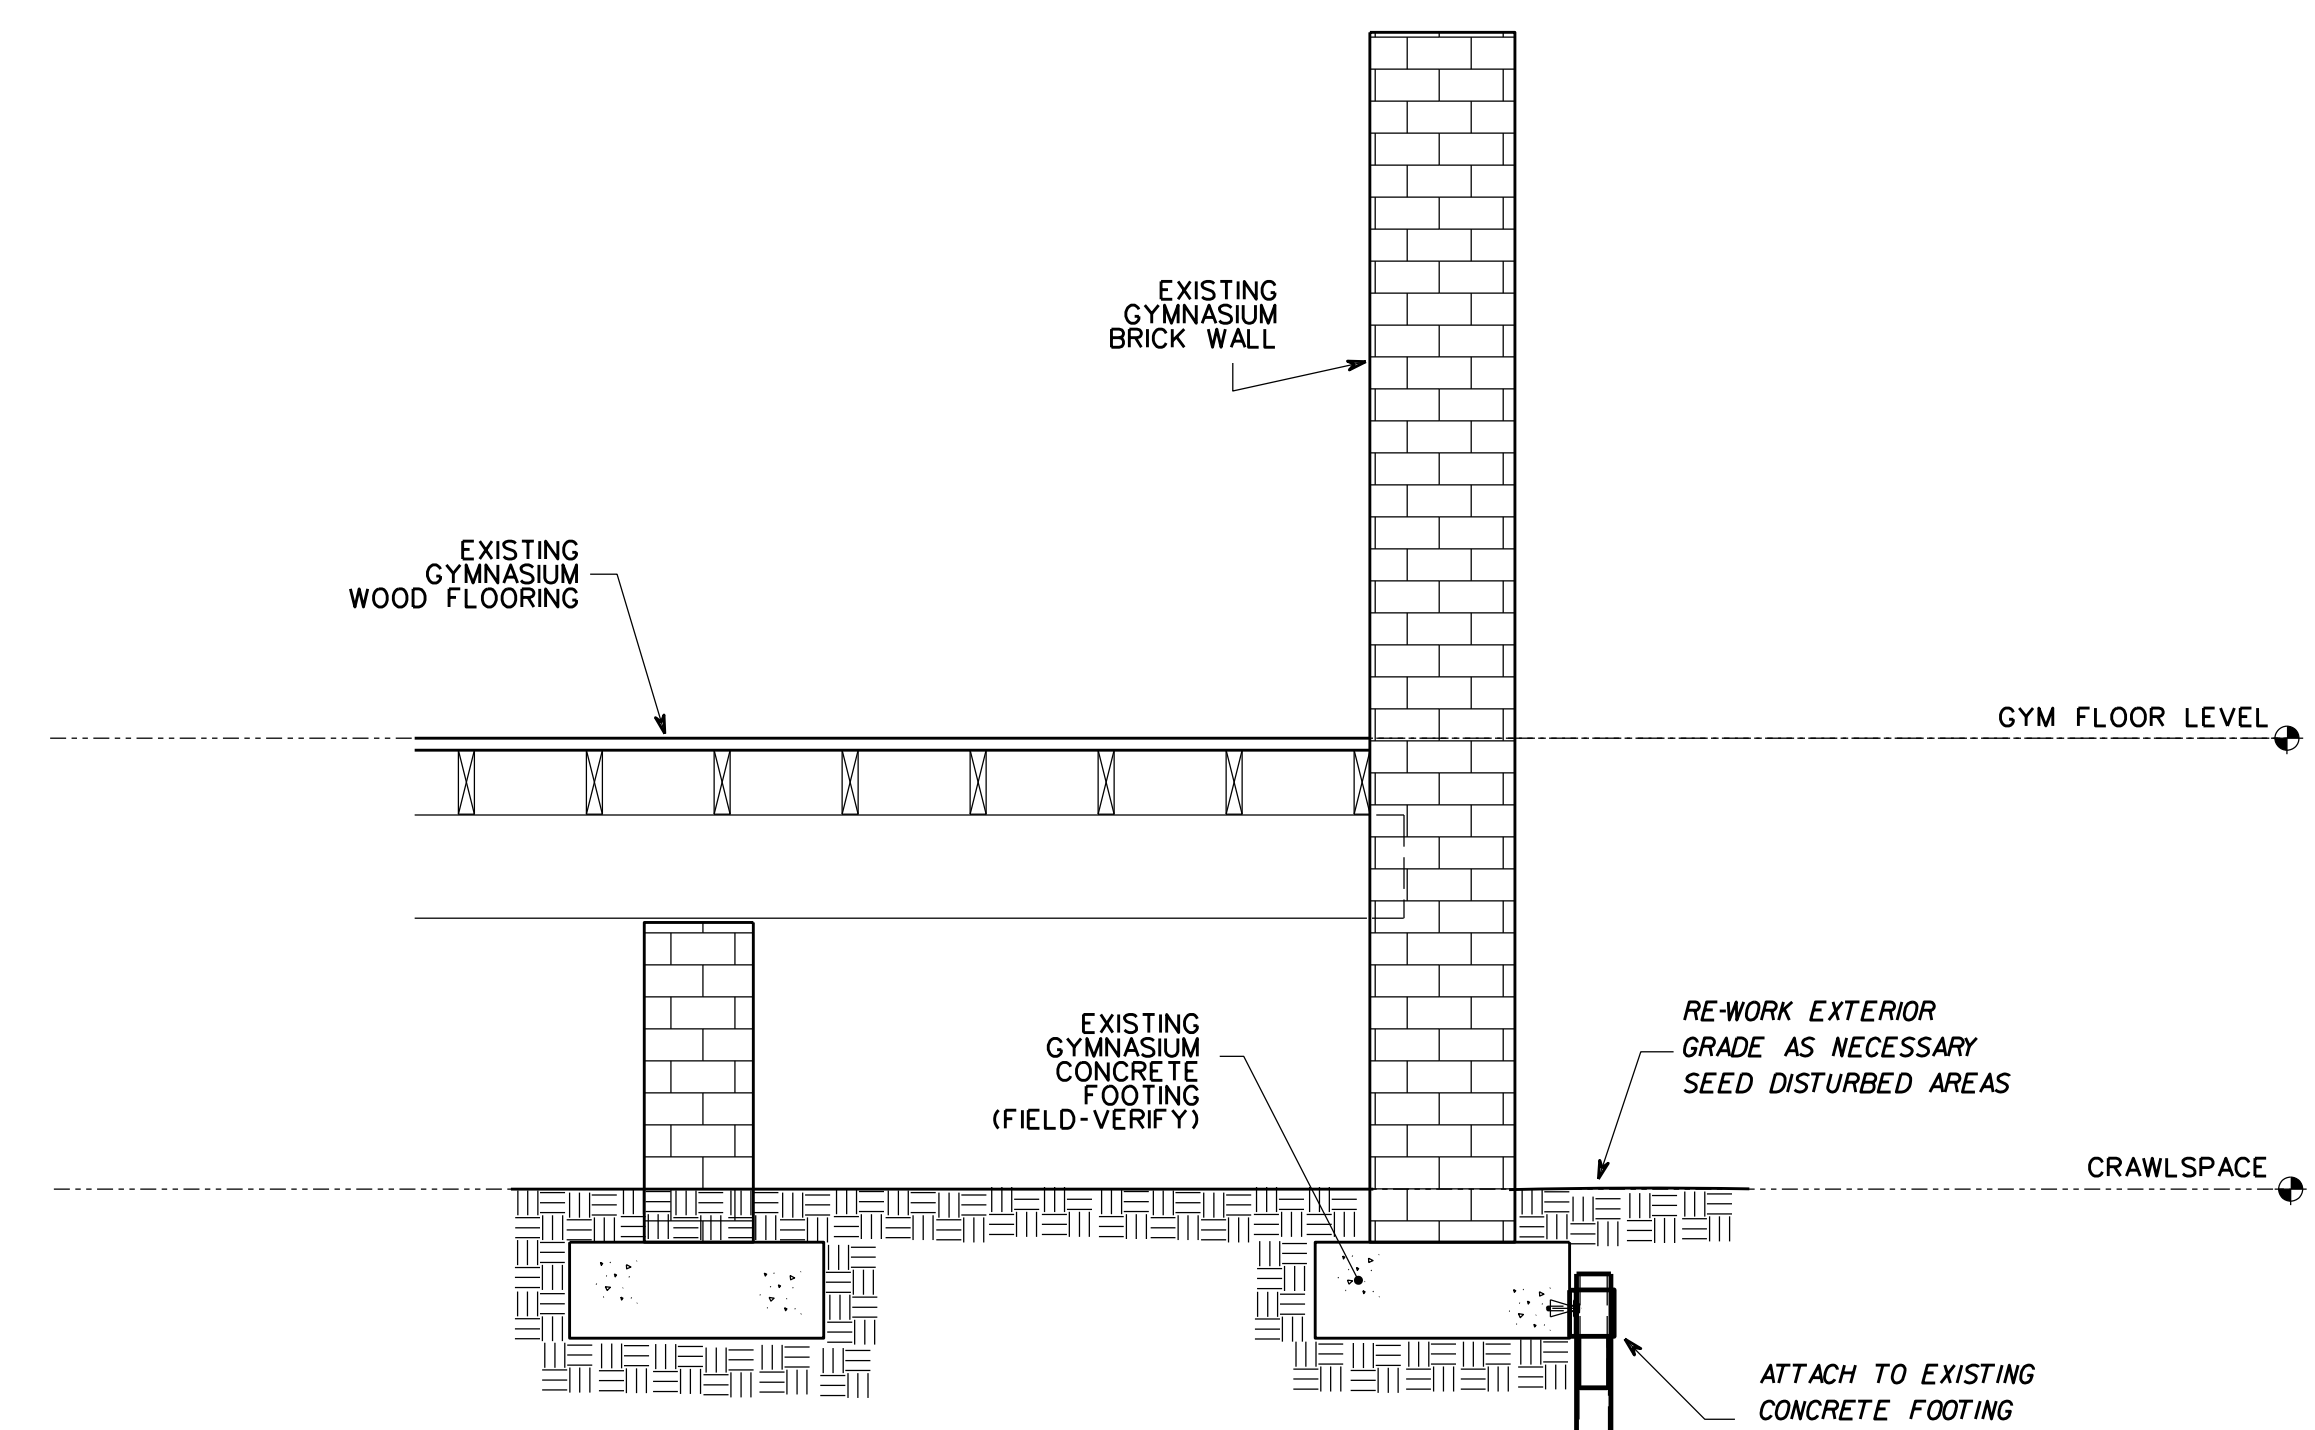
FOUNDATION REPAIR OF EXISTING EXTERIOR MASONRY WALL (A)

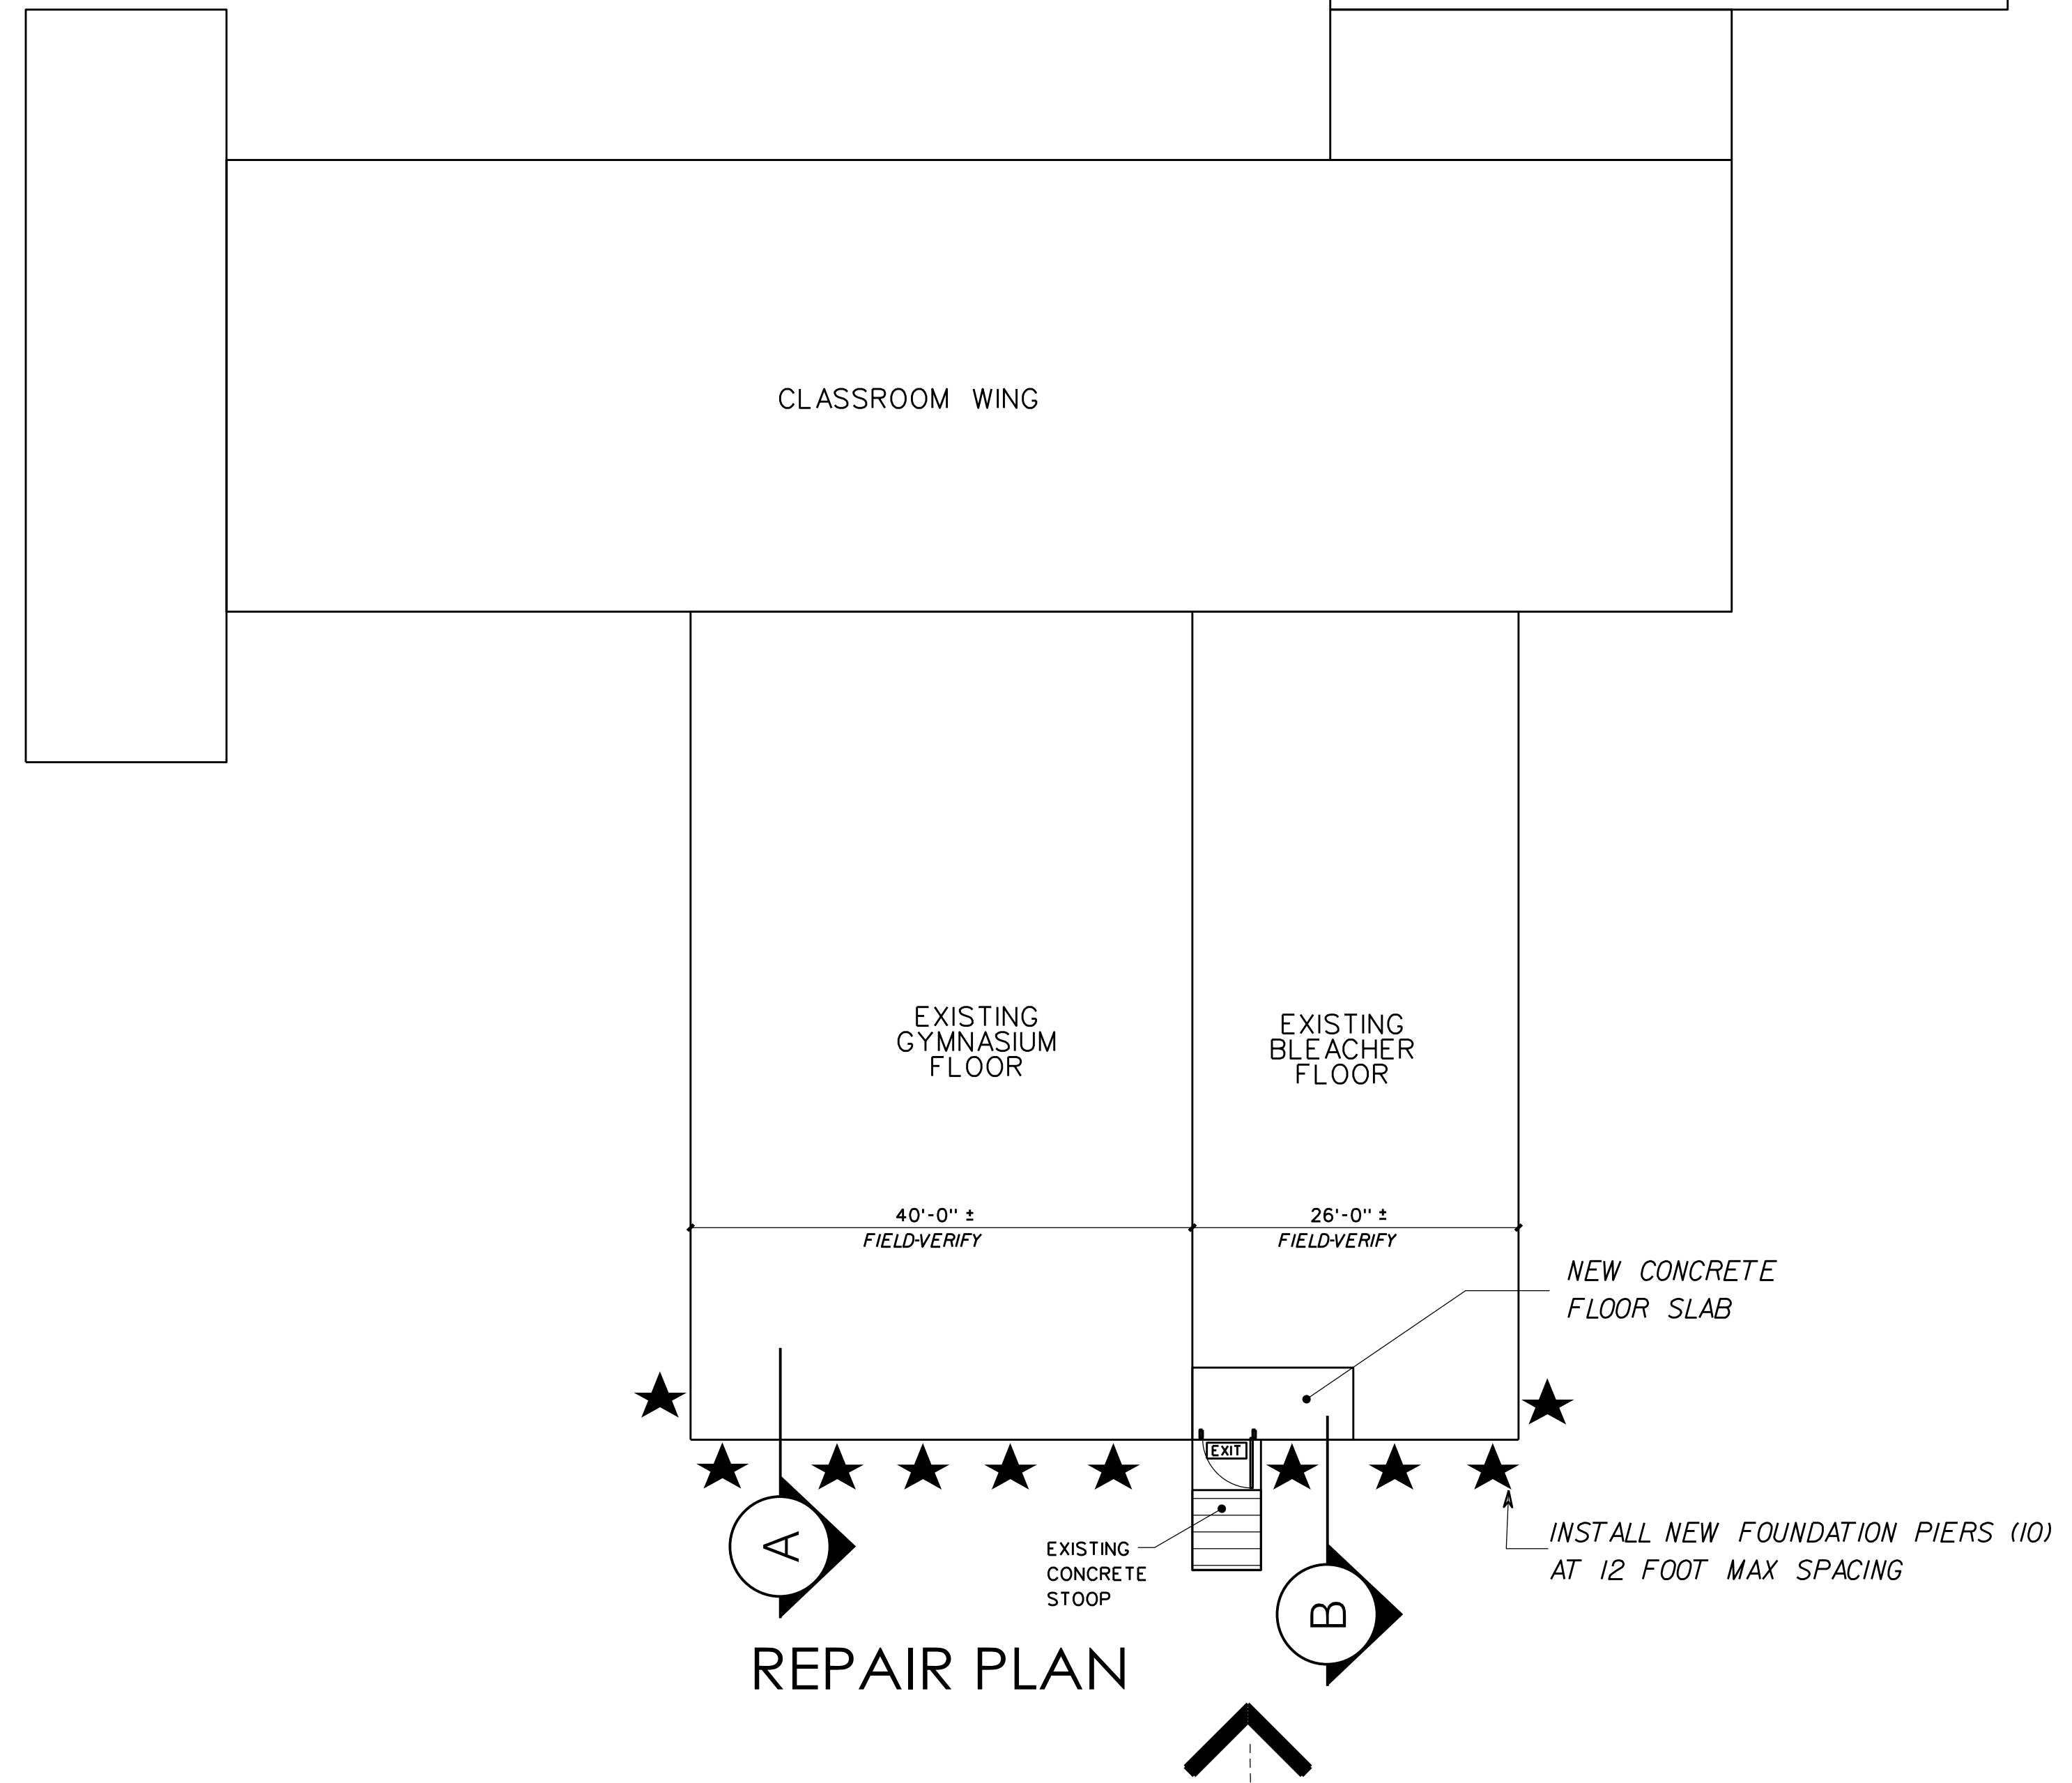
- FOUNDATION REPAIR NOTES:**
1. HELICAL PIERS (SOIL BEARING) OR STEEL PIERS (ROCK BEARING)
 - a. GALVANIZED OR SHOP-COATED WITH WEATHERPROOF ENAMEL PAINT
 - b. DESIGN LOADS (SERVICE):
 - DEAD LOAD - 6.4 kips
 - LIVE LOAD - 2.0 kips
 - c. MAXIMUM SPACING - 12'-0" c/c
 - d. ESTIMATED DEPTH - 16' FT FROM BOTTOM OF FOOTING (OR TO AUGER REFUSAL)
 - e. ACCEPTABLE MANUFACTURERS:
 - RAMJACK
 - DWYER
 - CHANCE
 - approved equal
 - f. 30 year MANUFACTURERS WARRANTY
