ADDENDUM NO. 3

SUBJECT: Addendum No. 3 – South Knoxville Community Center Roof

PROJECT NO.: 17G-V-0641

Inspection Report

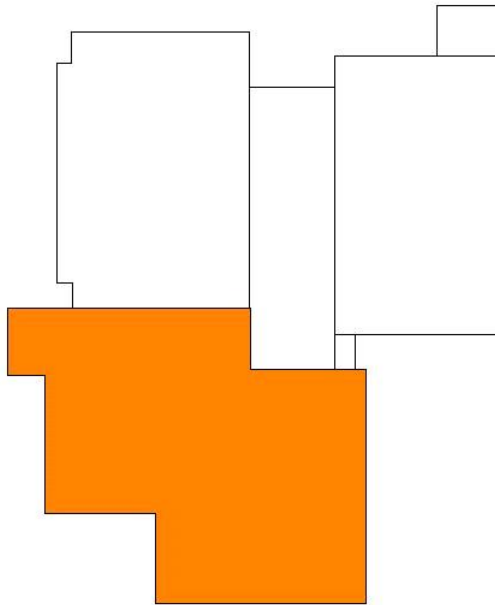
Roof: Roof A

Roof System: Modified Bitumen
Install Date: - Unknown
Roof Deck: Concrete- Lightweight
Roof SF: 10,317
Elevation: 0
Interior Sensitivity: 2 - Medium
Warranty:

Condition Assessment: 75 - Fair

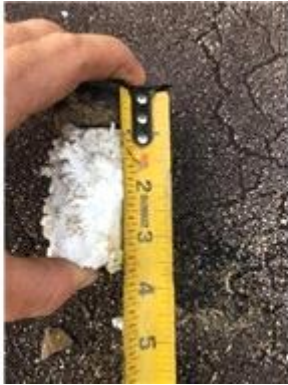
Condition: Core Sample #1
Severity: 3 - High
Qty: SF: 1 LF: 4 EA: 1

Core sample #1 on Roof A: 1/2" Modified bitumen, 1/2" wood fiber insulation, 2 3/4" EPS insulation over a lightweight concrete decking.

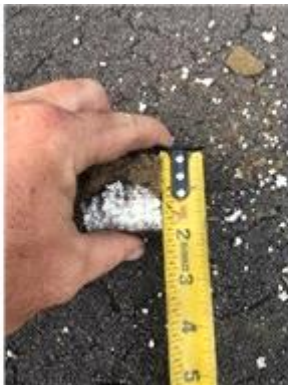
Condition: Core Sample #2
Severity: 3 - High
Qty: SF: 1 LF: 4 EA: 1

Core sample #2 on Roof A: 1/2" Modified bitumen, 1/2" wood fiber insulation, 1" EPS insulation over a lightweight concrete decking.

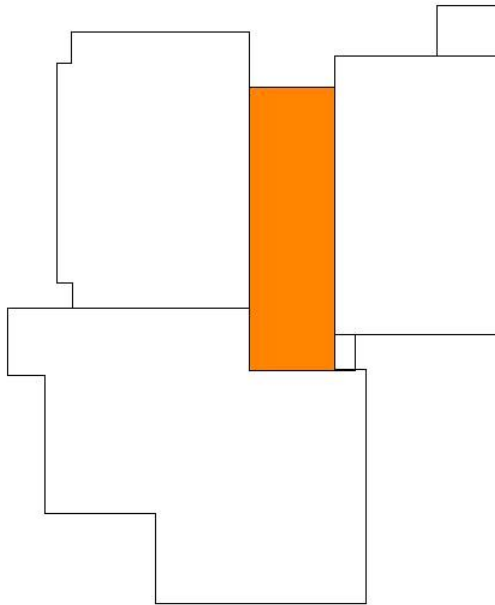
Roof: Roof B

Roof System: Modified Bitumen
Install Date: - Unknown
Roof Deck: Concrete- Lightweight
Roof SF: 3,111
Elevation: 0
Interior Sensitivity: 2 - Medium
Warranty:

Condition Assessment: 75 - Fair

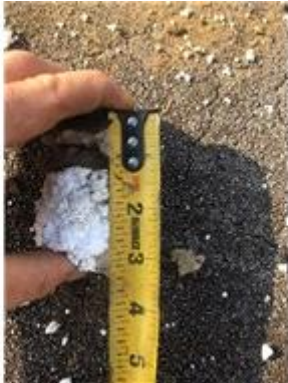
Condition: Core Sample #1
Severity: 3 - High
Qty: SF: 1 LF: 4 EA: 1

Core sample #1 on Roof B: 1/2" Modified bitumen, 1/2" wood fiber insulation, 2" EPS insulation over a lightweight concrete decking.

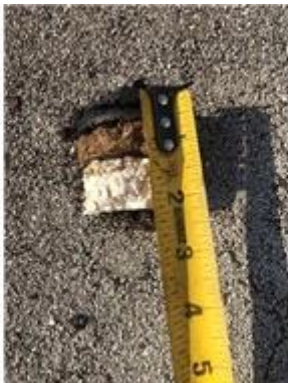
Condition: Core Sample #2
Severity: 3 - High
Qty: SF: 1 LF: 4 EA: 1

Core sample #2 on Roof B: 1/2" Modified bitumen, 1/2" wood fiber insulation, 1" EPS insulation over a lightweight concrete decking.

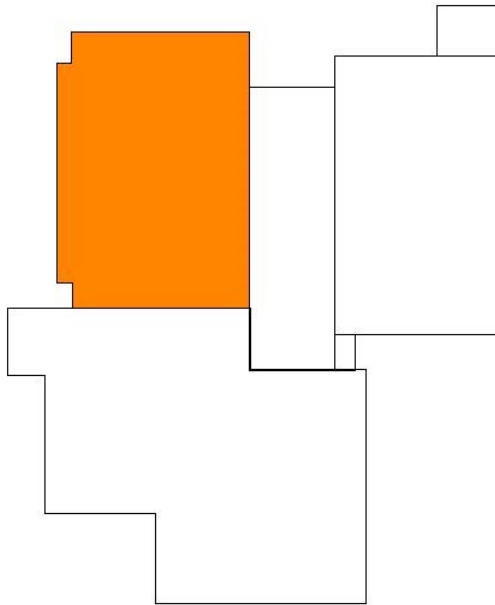
Roof: Roof C

Roof System: Modified Bitumen
Install Date: - Unknown
Roof Deck: Tectum
Roof SF: 6,759
Elevation: 0
Interior Sensitivity: 2 - Medium
Warranty:

Condition Assessment: 75 - Fair

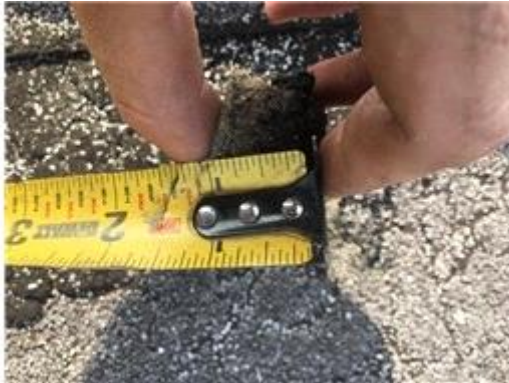
Condition: Core Sample #1 & #2

Core sample #1 and #2 on Roof C: 1/2" Modified bitumen, 1/2" wood fiber insulation, over a tectum decking.

This indicates the slope in the roof is created by the decking.

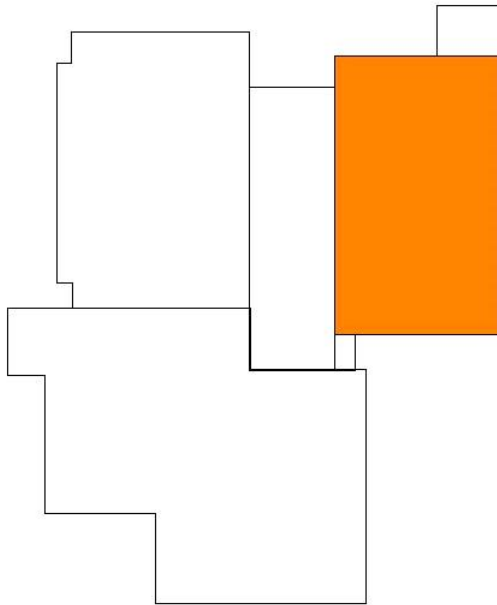
Roof: Roof D

Roof System: Modified Bitumen
Install Date: - Unknown
Roof Deck: Concrete- Lightweight
Roof SF: 5,900
Elevation: 0
Interior Sensitivity: 2 - Medium
Warranty:

Condition Assessment: 75 - Fair

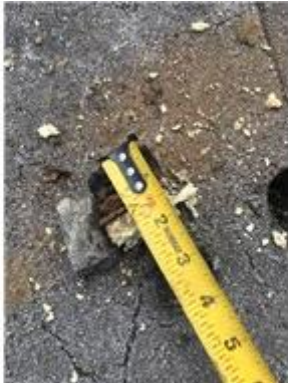
Condition: Debris on roof
Severity: 3 - High
Qty: SF: 1 LF: 4 EA: 1

Core sample #1 and #2 on Roof D: 1/2" Modified bitumen, 1/2" wood fiber insulation, 1" ISO insulation over a lightweight concrete decking.

This indicates the slope is in the roof is created by the decking.

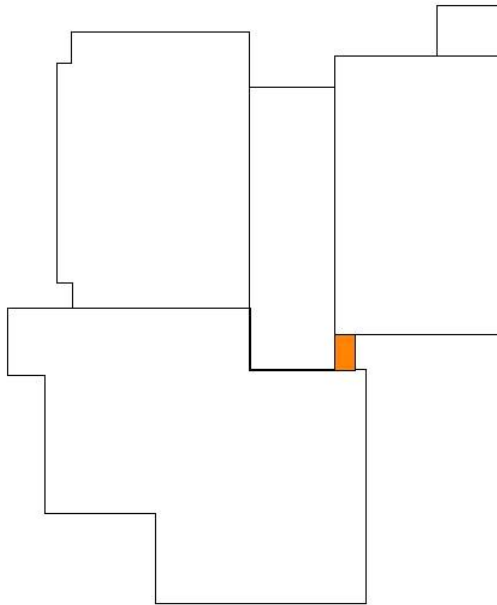
Roof: Roof E

Roof System: Modified Bitumen
Install Date: - Unknown
Roof Deck: Concrete- Lightweight
Roof SF: 98
Elevation: 0
Interior Sensitivity: 2 - Medium
Warranty:

Condition Assessment: 75 - Fair

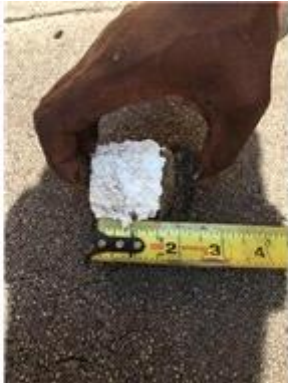
Condition: Core Sample #1 & #2

Core sample #1 and #2 on Roof E: 1/2" Modified bitumen, 1/2" wood fiber insulation, 1" EPS insulation over a lightweight concrete decking.

This indicates the slope in the roof is created by the decking.

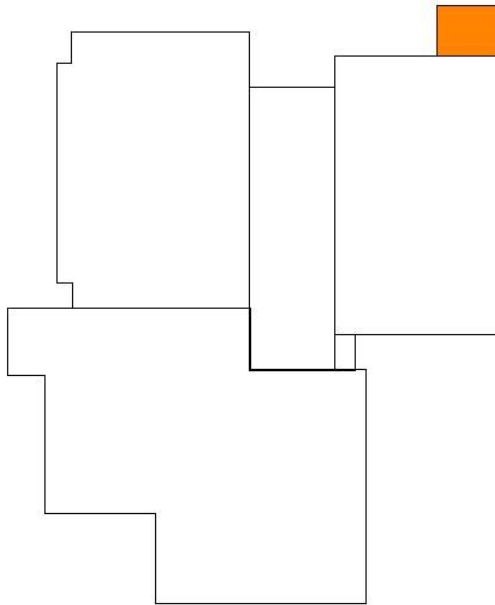
Roof: Roof F

Roof System: Modified Bitumen
Install Date: - Unknown
Roof Deck: Concrete- Lightweight
Roof SF: 405
Elevation: 0
Interior Sensitivity: 2 - Medium
Warranty:

Condition Assessment: 75 - Fair

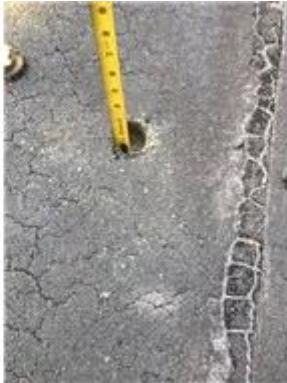
Condition: Core Sample #1 & #2

Core sample #1 on Roof F: 1/2" Modified bitumen, 1/2" wood fiber insulation, 1" ISO insulation over a lightweight concrete decking.

This indicates the slope in the roof is created by the decking.
