GEOTECHNICAL ENGINEERING REPORT

Pine Valley Estates Roadway and Drainage Improvement Project Escambia County, Florida

NOVA Project Number: 10116-2020120

August 5, 2020

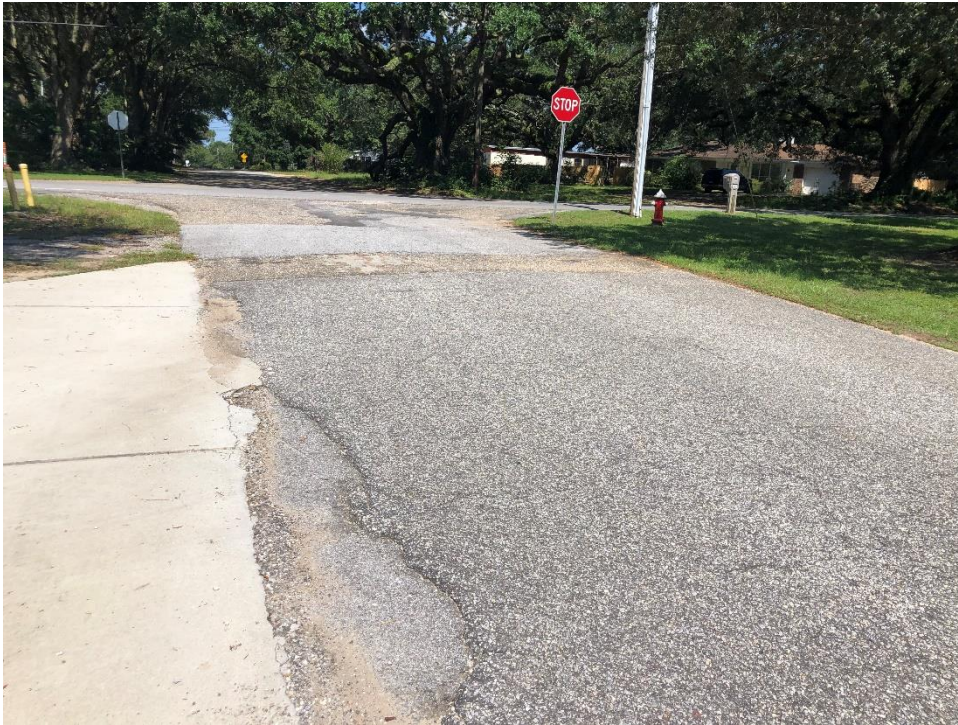
PHOTO 1

The above photo depicts the typical pavement conditions at the entrance to Dunaway Lane from Eight Mile Creek Road. The pavement conditions were noted to consist of several patches, loss of pavement along the shoulders, raveling and polishing of the pavement surface, and longitudinal cracks.

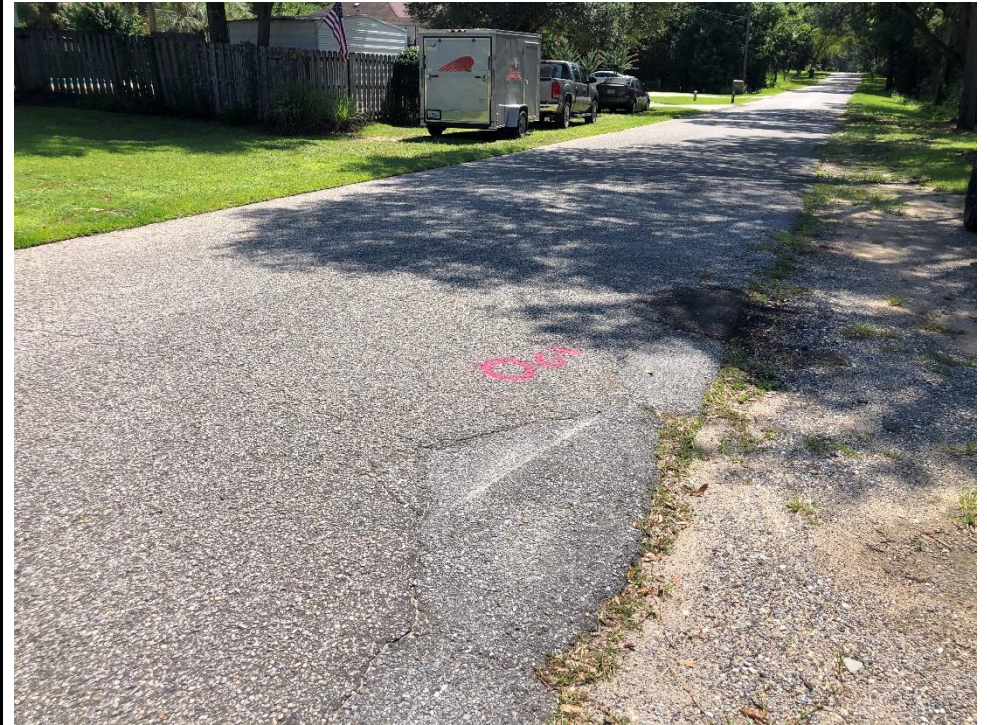
PHOTO 2

The above photo depicts the typical pavement conditions along Dunaway Lane from Eight Mile Creek Road. In addition to previously mentioned distresses, the roadway was noted to have minor rutting within the wheel paths.

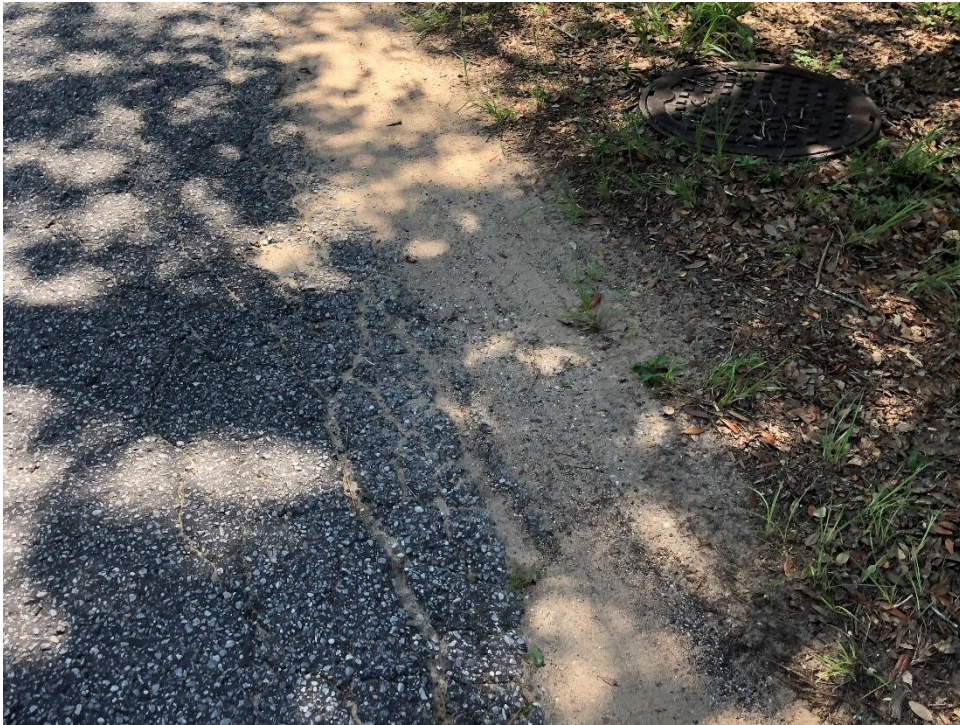
PHOTO 3

Photo of the loss of pavement in the shoulder (Dunaway Lane)

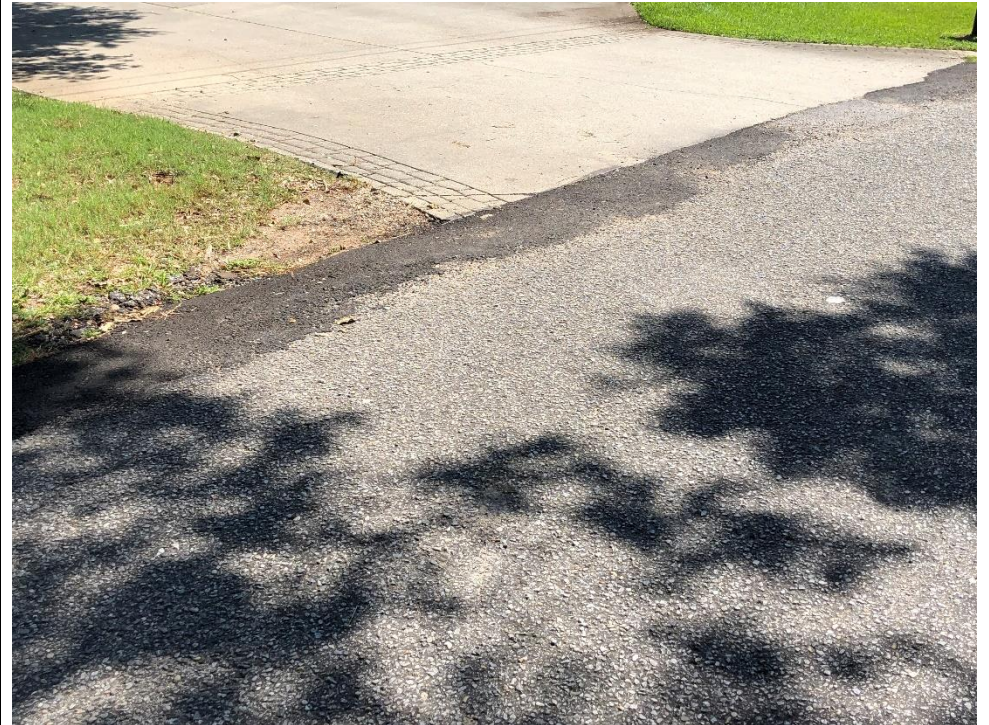
PHOTO 4

Previously patched area along driveway.

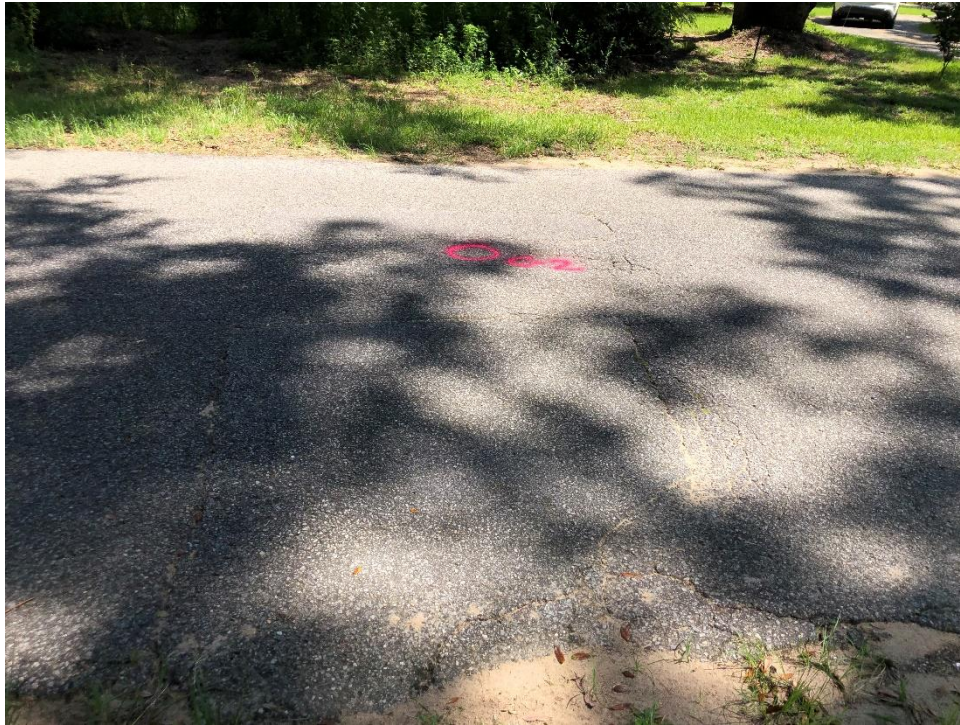
PHOTO 5

The above photo depicts block cracking along Dunaway Lane, as well as other pavement distresses consistent with previously mentioned conditions.

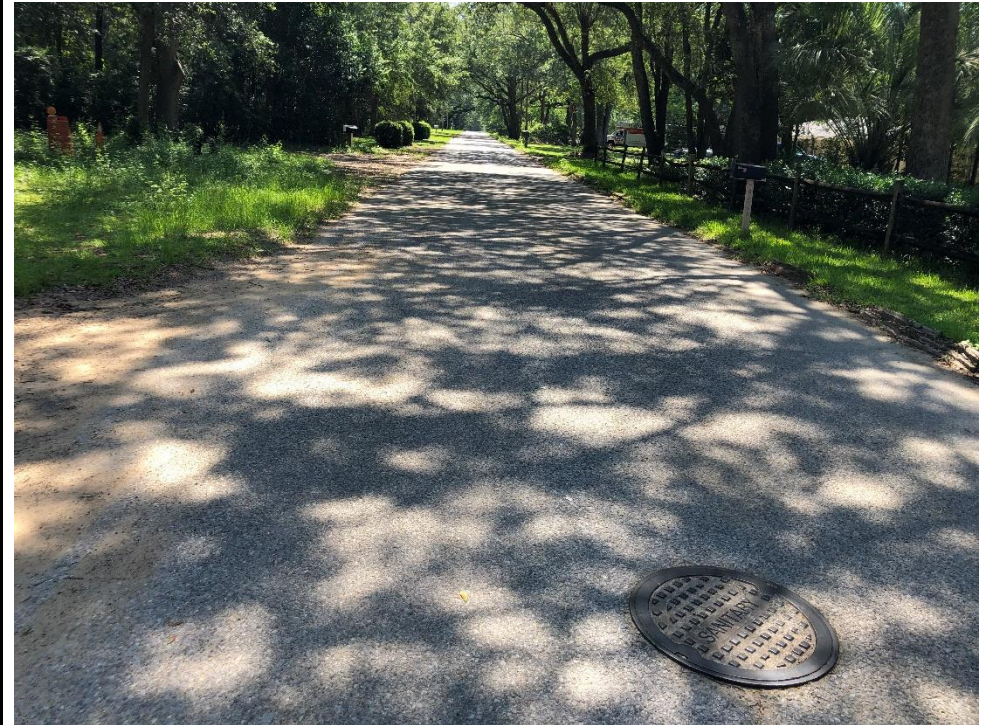
PHOTO 6

A sanitary sewer was observed to be within the approximate centerline of the roadway.

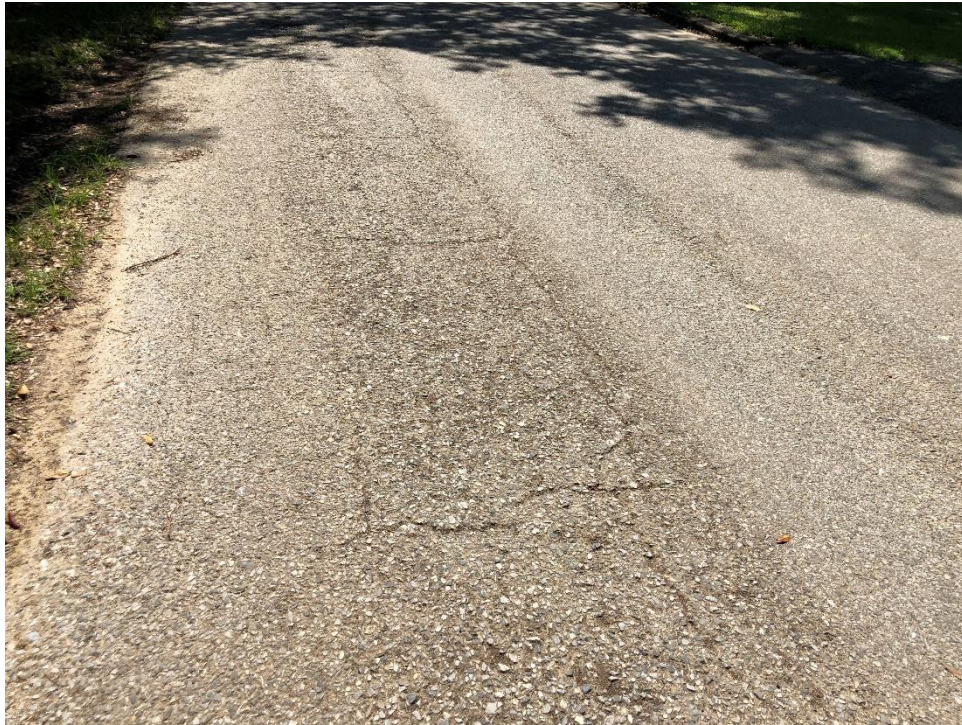
PHOTO 7

The above photo depicts traveling and “alligator” cracking and surface raveling along the Dunaway Lane alignment.

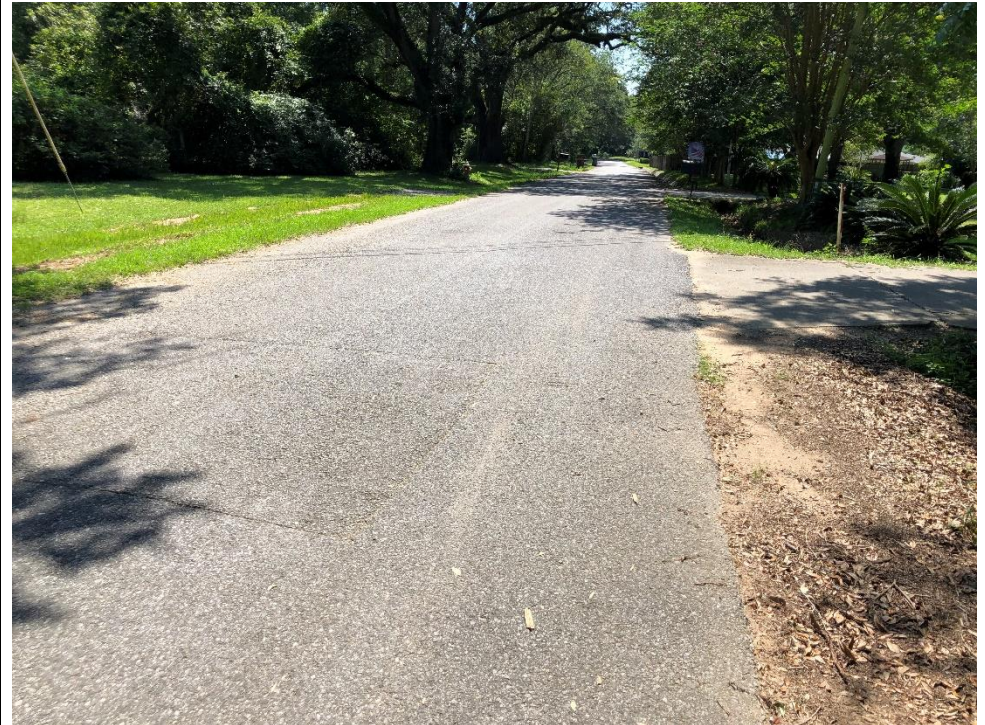
PHOTO 8

Photo of the approximate east-west center of Dunaway Lane where a previously patched area was observed.

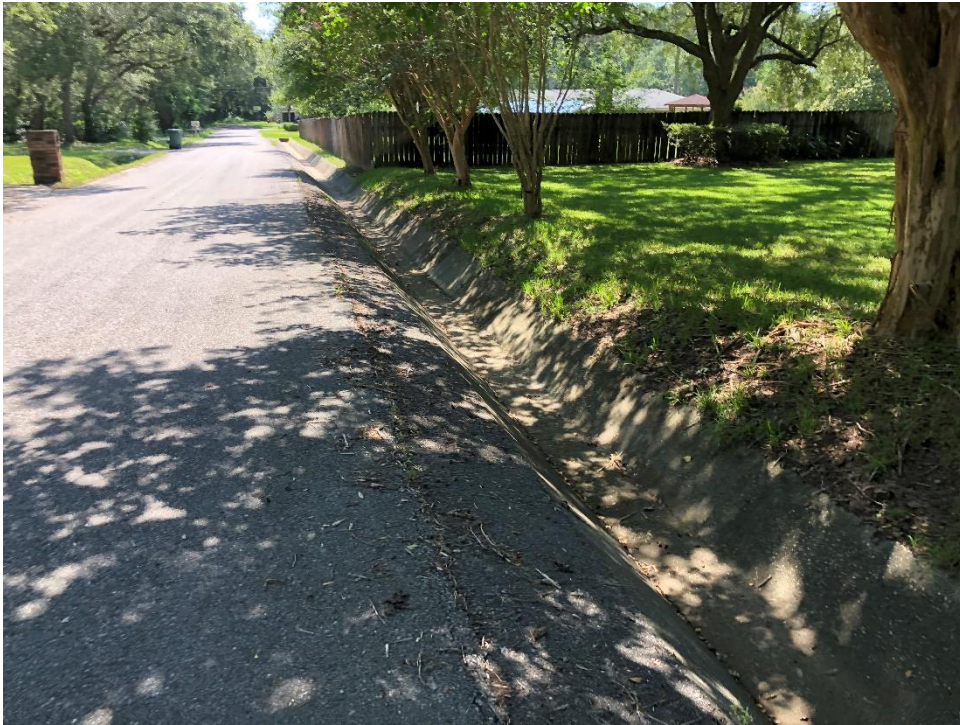
PHOTO 9

Photo of a concrete-lined ditch along the south side of Dunaway Lane.

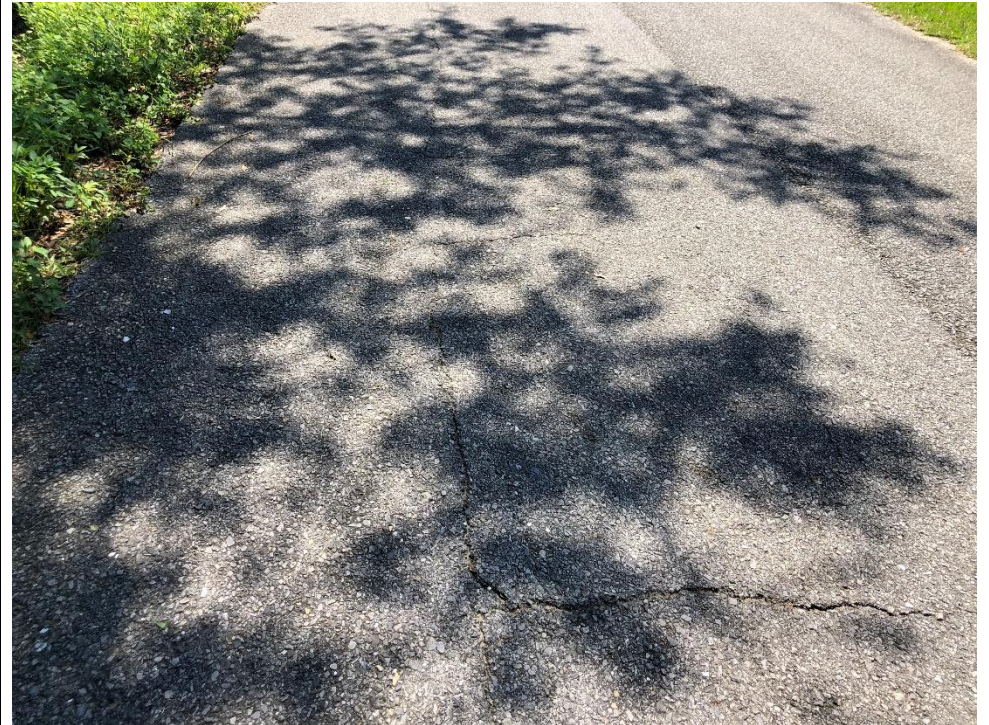
PHOTO 10

The above photo depicts raveling and block cracking along the Dunaway Lane alignment.

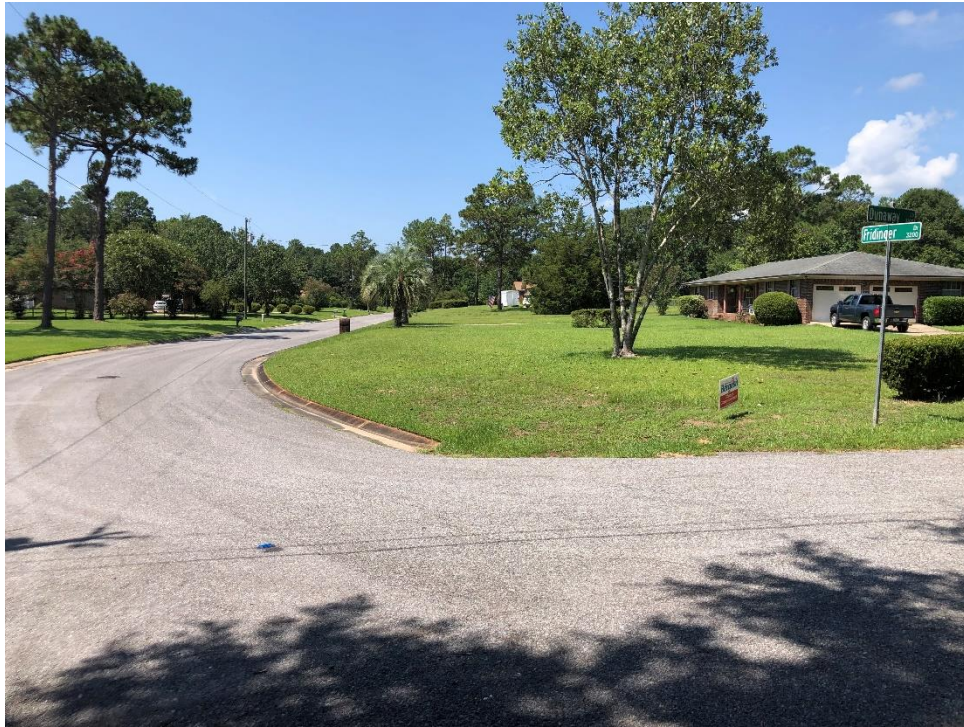
PHOTO 11

Photo of the intersection of Dunaway Lane and Fridinger Drive.

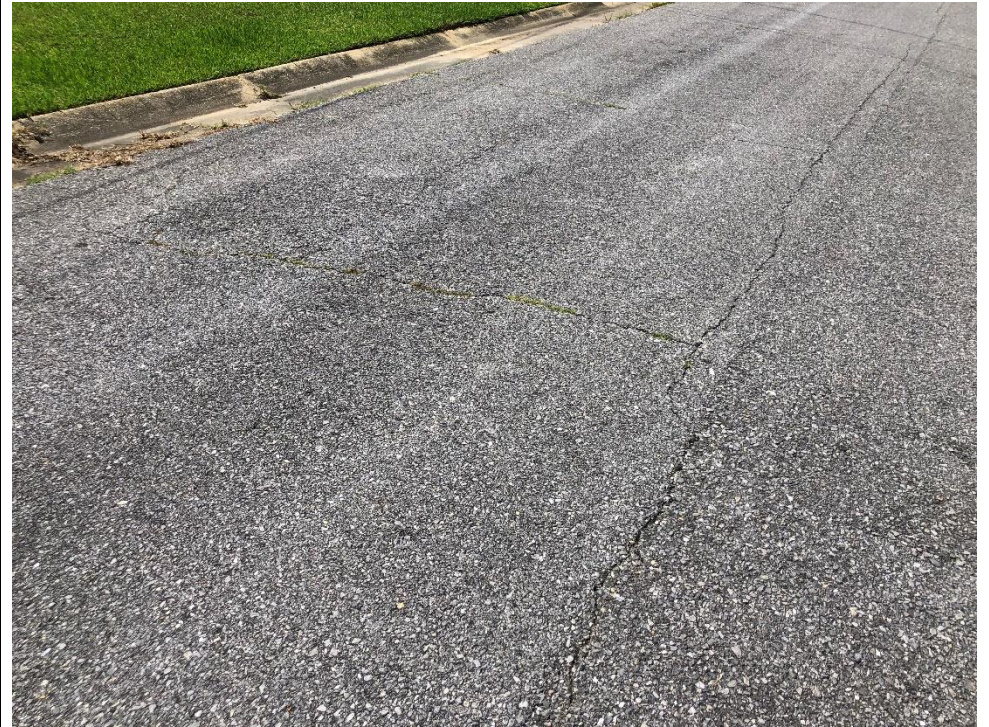
PHOTO 12

The above photo depicts block cracking (measured to be between 1/4 to 3/4 inch in width) along Fridinger Drive. Some cracks did have established vegetation and were observed to extend the full depth of the existing pavement section.

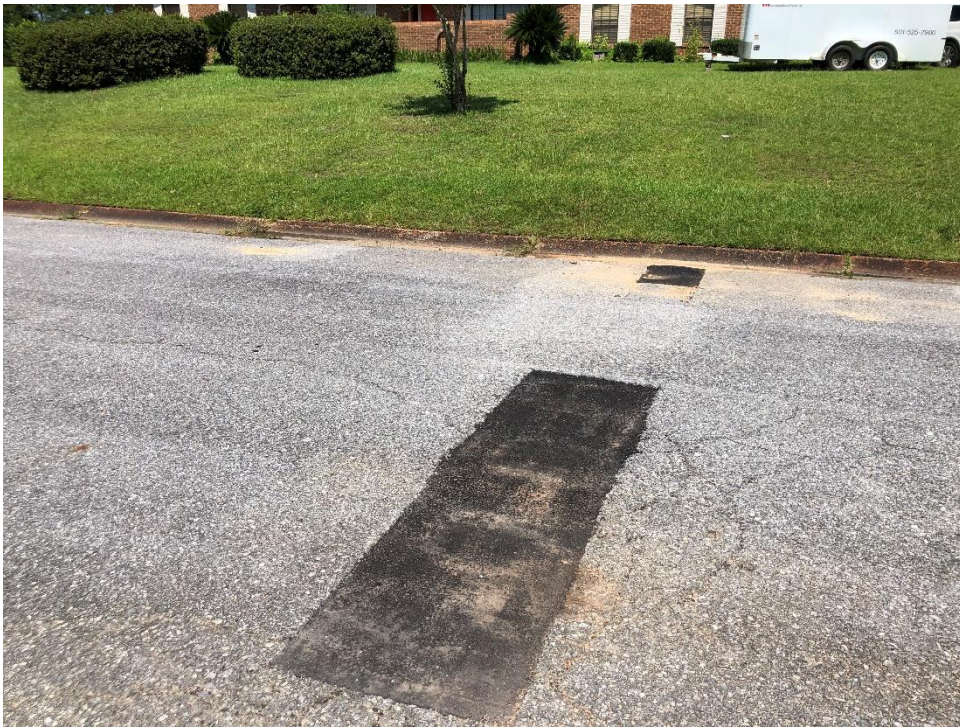
PHOTO 13

The above photo depicts a recent utility patch along Fridinger Drive. This patch was observed to have excessive rutting.

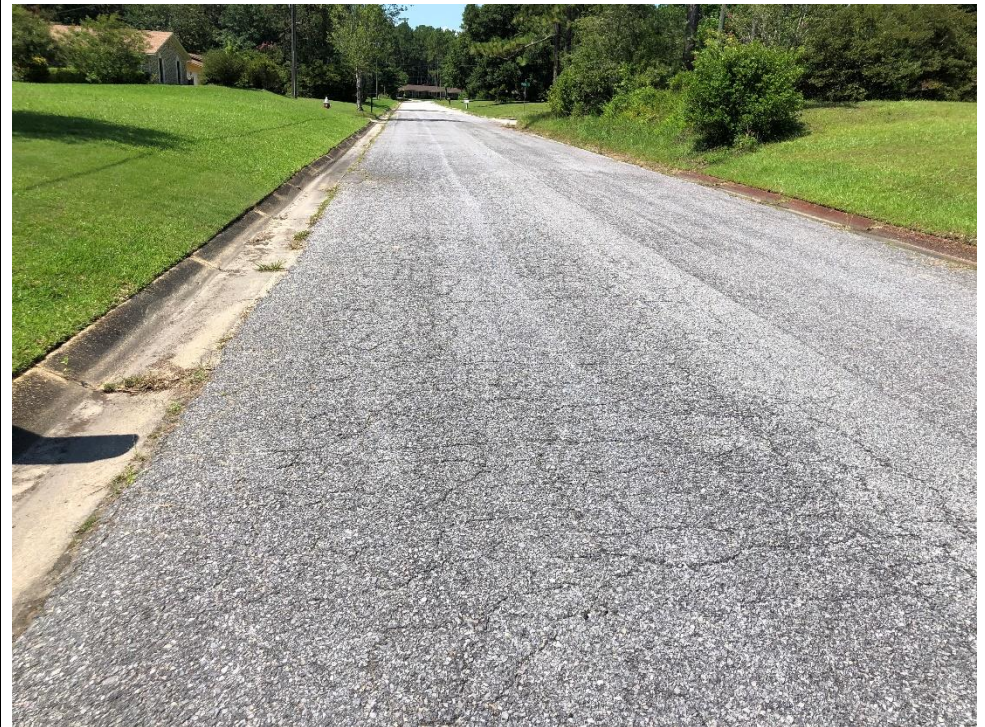
PHOTO 14

The above photo depicts “alligator” cracking, rutting, and raveling within the Fridinger Drive alignment.

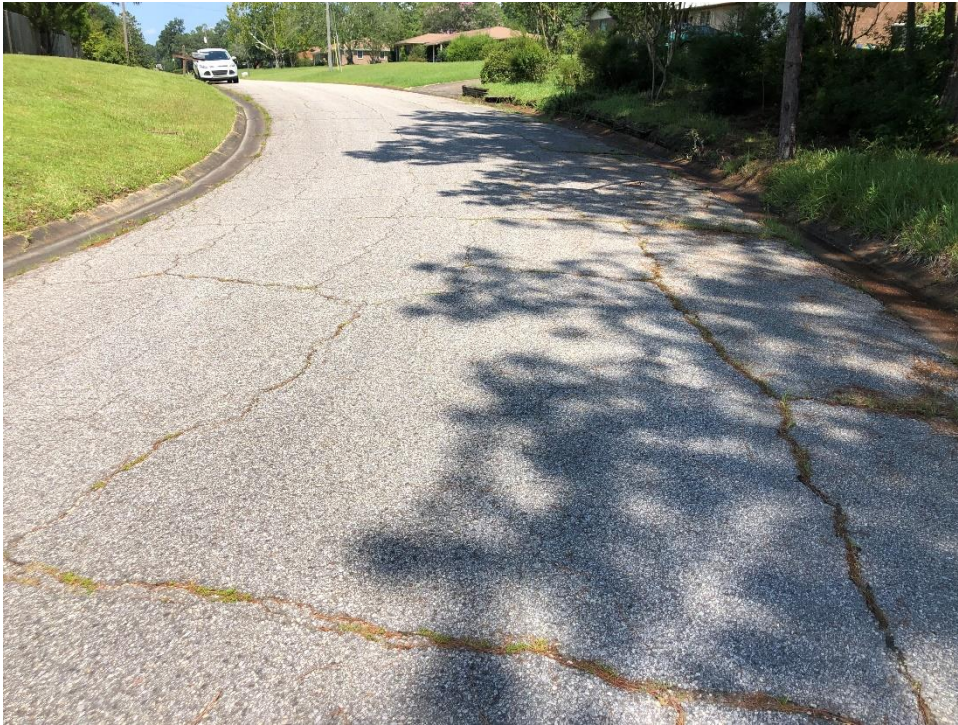
PHOTO 15

The above photo depicts extensive block cracking (some in excess of ¾ inch) along the eastern terminus of Pursell Lane.

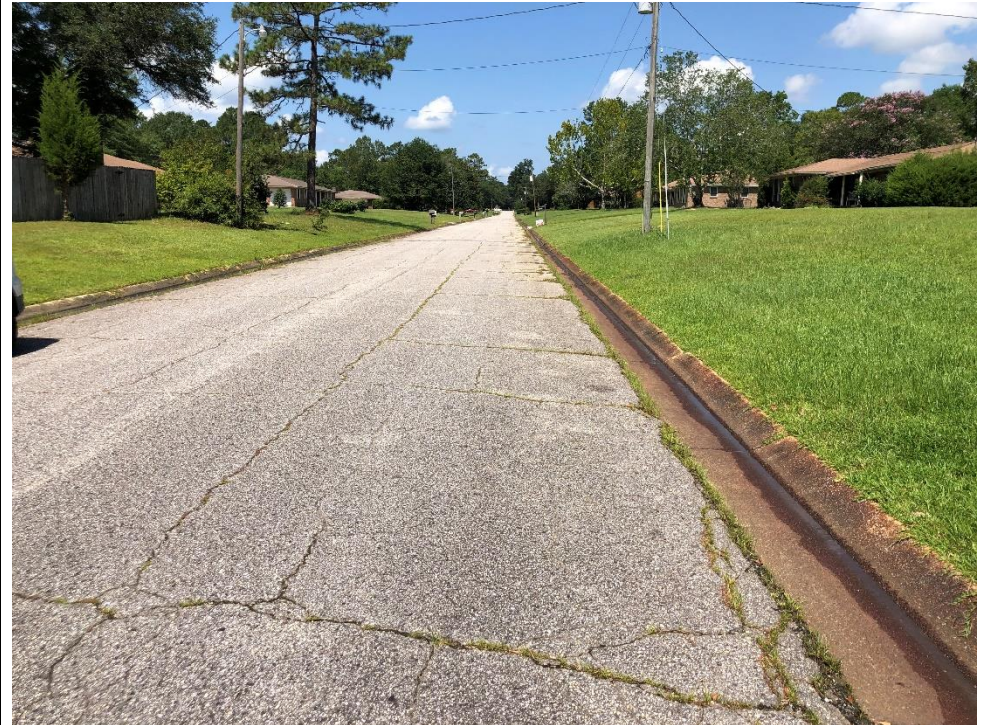
PHOTO 16

The above photo depicts the typical pavement conditions along Pursell Lane which consisted of severe block cracking, rutting, raveling and polishing of the pavement surfaces, and isolated areas of “alligator” cracking.

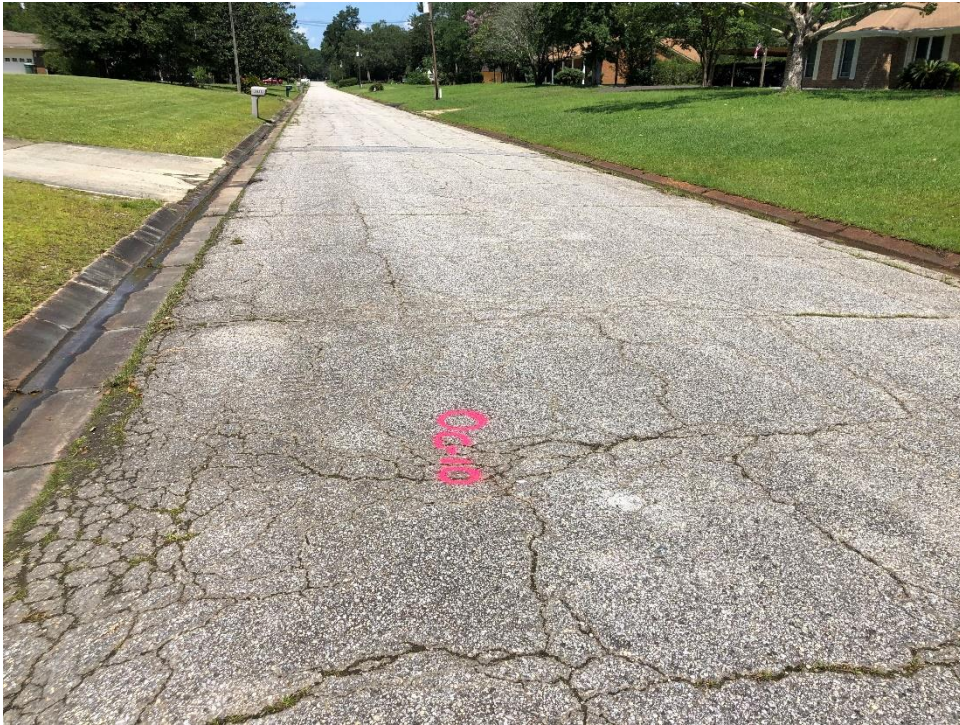
PHOTO 17

Area of “alligator” cracking and raveling along Pursell Lane.

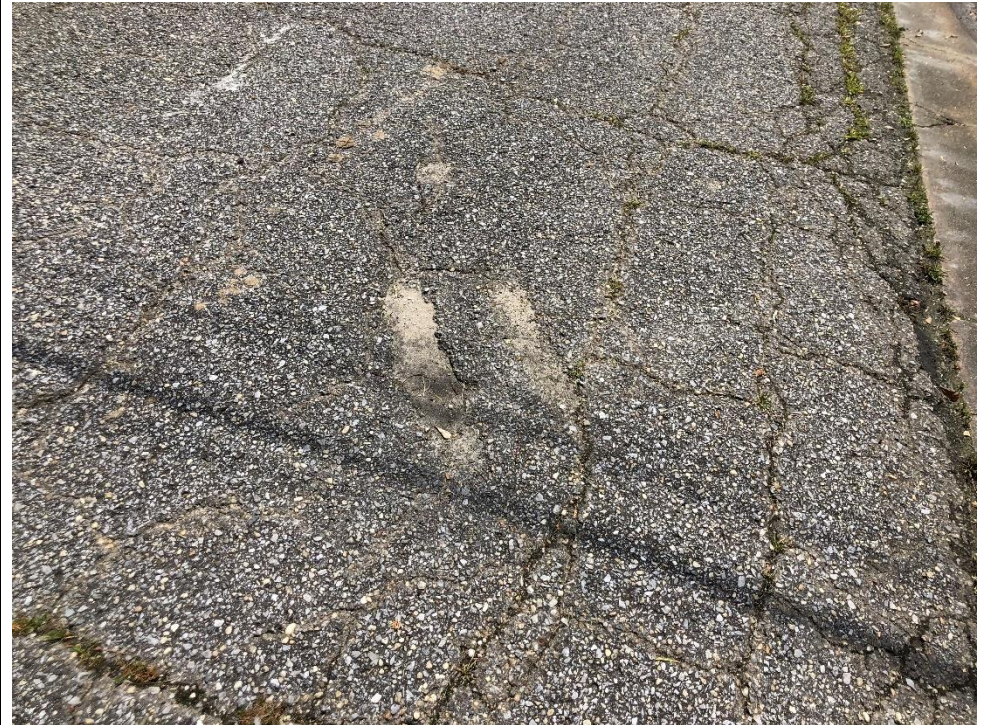
PHOTO 18

The above photo depicts an isolated area along Pursell Lane which was observed to be shoving towards the shoulder from the centerline.

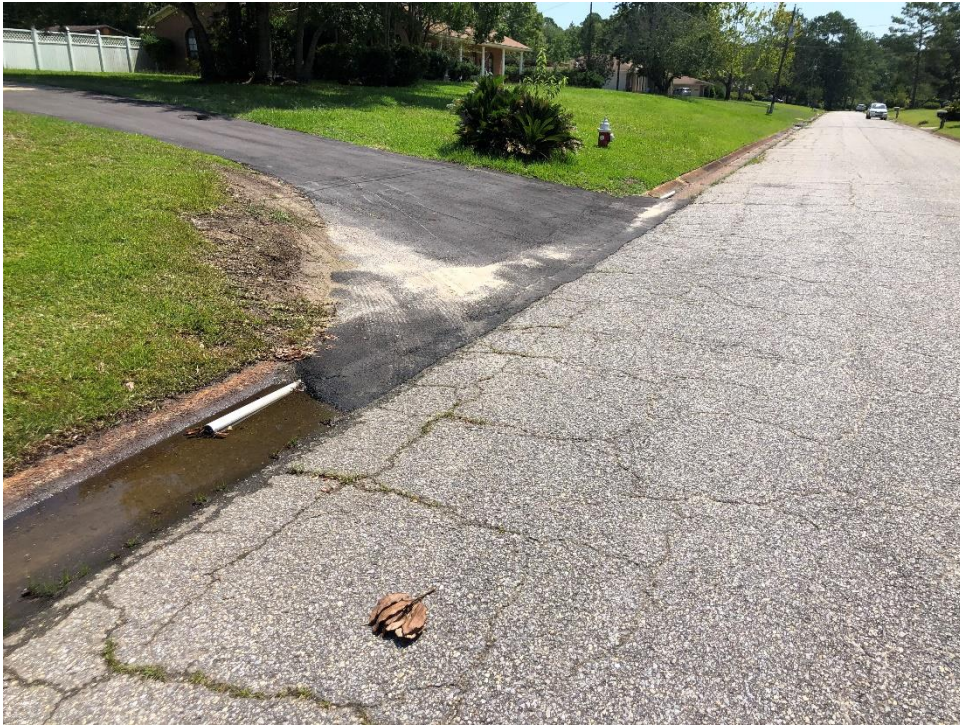
PHOTO 19

Area of compromised curbing along Pursell Lane.

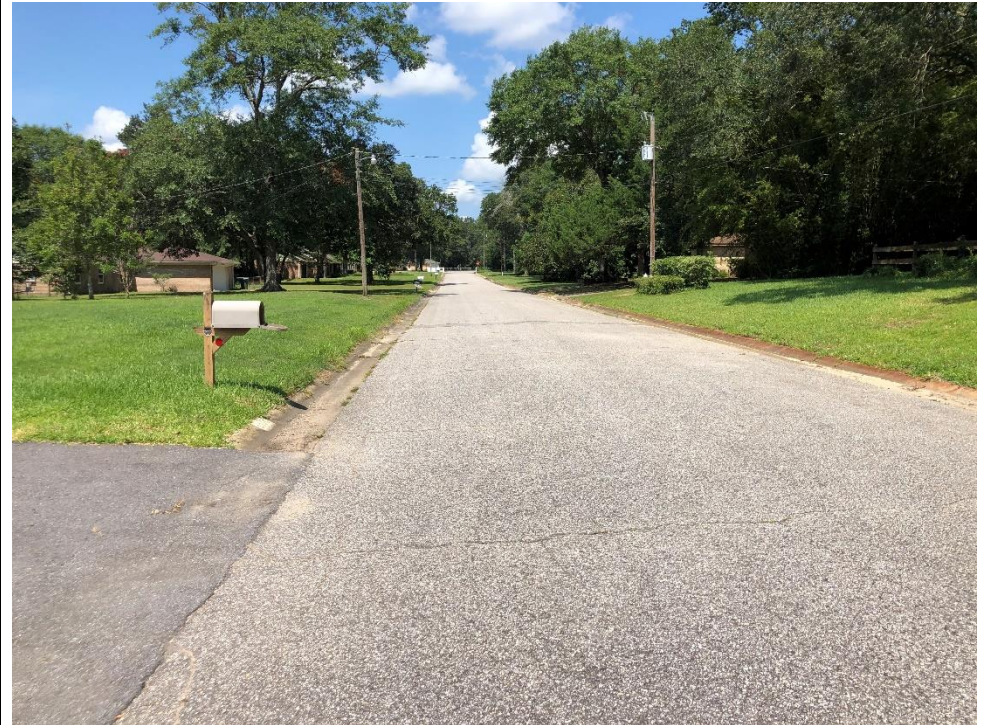
PHOTO 20

The above photo further depicts the typical pavement conditions along Pursell Lane.

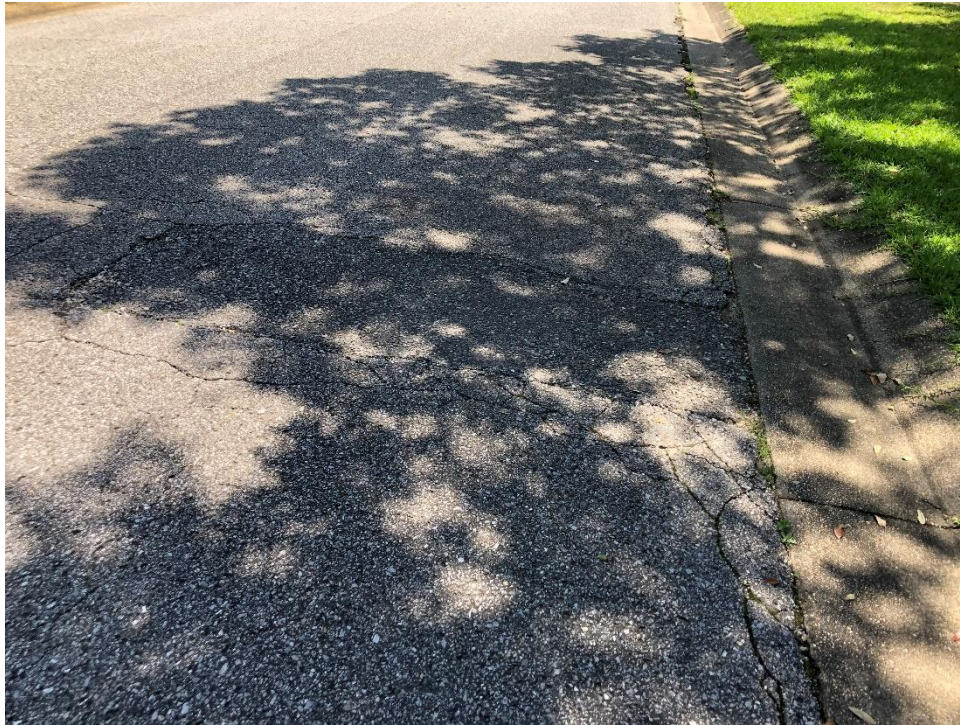
PHOTO 21

This photo depicts an area of pothole formation along Pursell Lane.

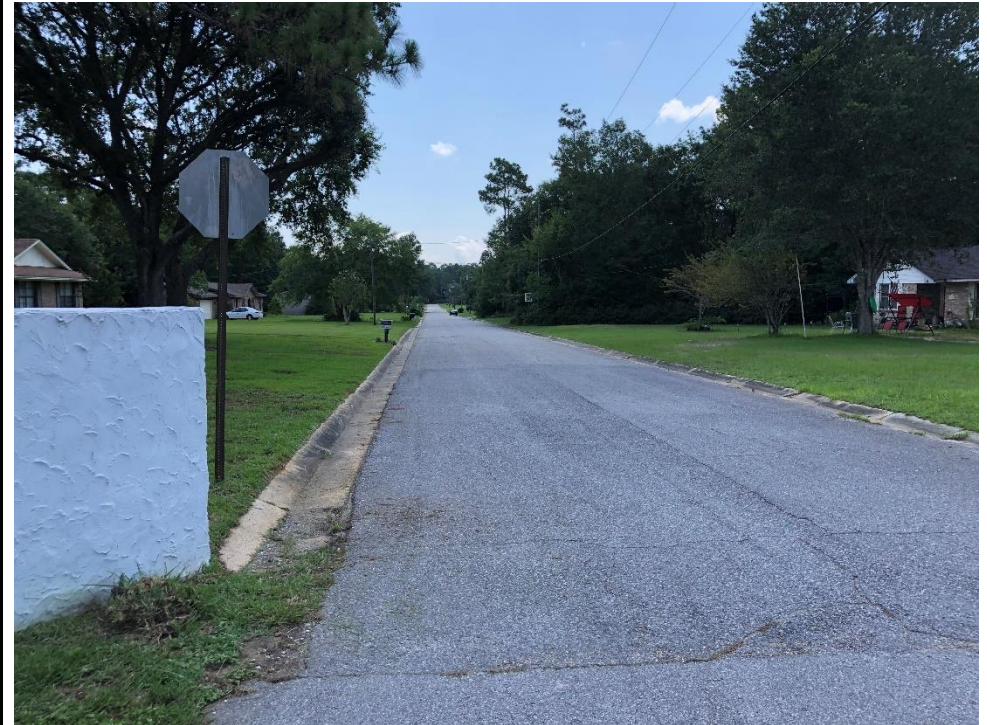
PHOTO 22

The above photo depicts the typical pavement conditions at the western terminus of Fridinger Lane adjacent to Eight Mile Creek Road. The pavements along this alignment were consistent with others within the development.

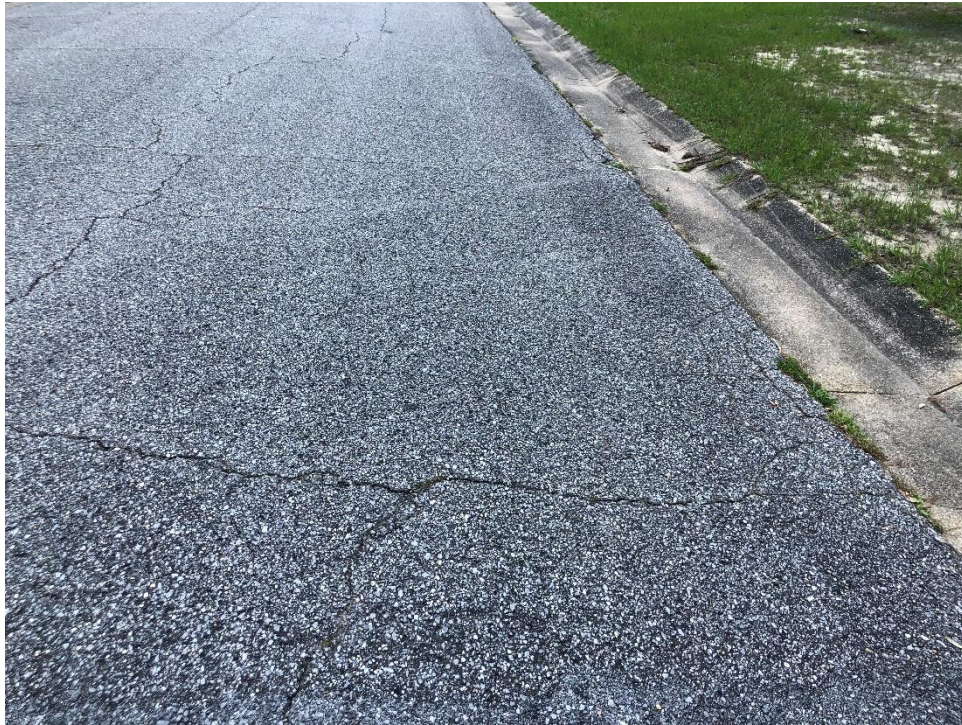
PHOTO 23

Branch and block cracking (observed to be less than ½ inch in width) along Fridinger Drive.

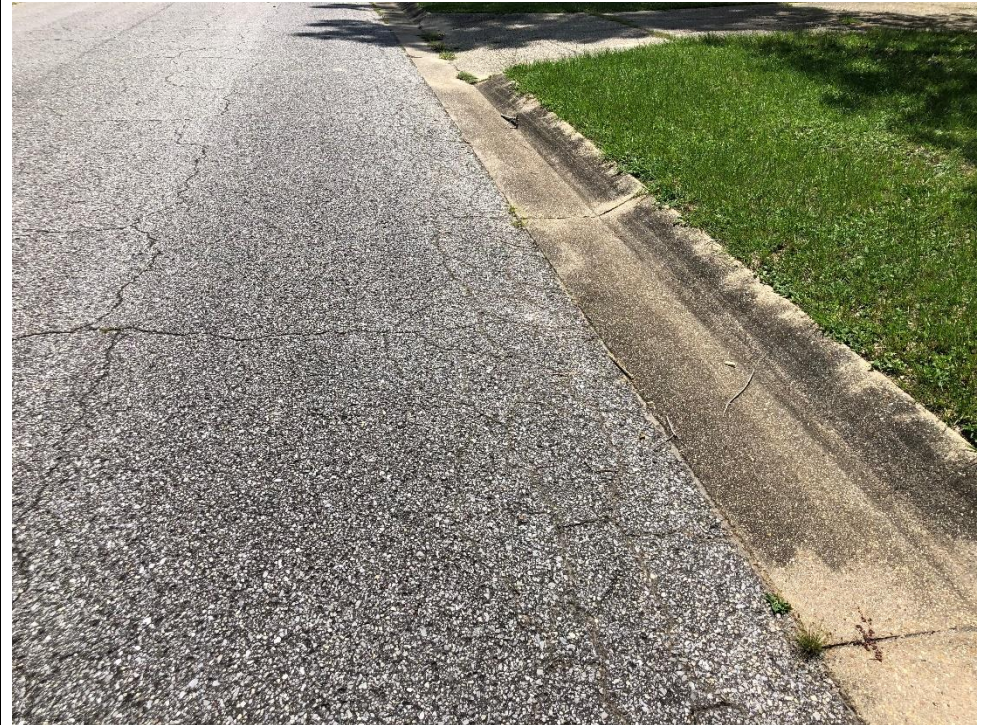
PHOTO 24

Area of extensive block cracking and raveling along Fridinger Drive.

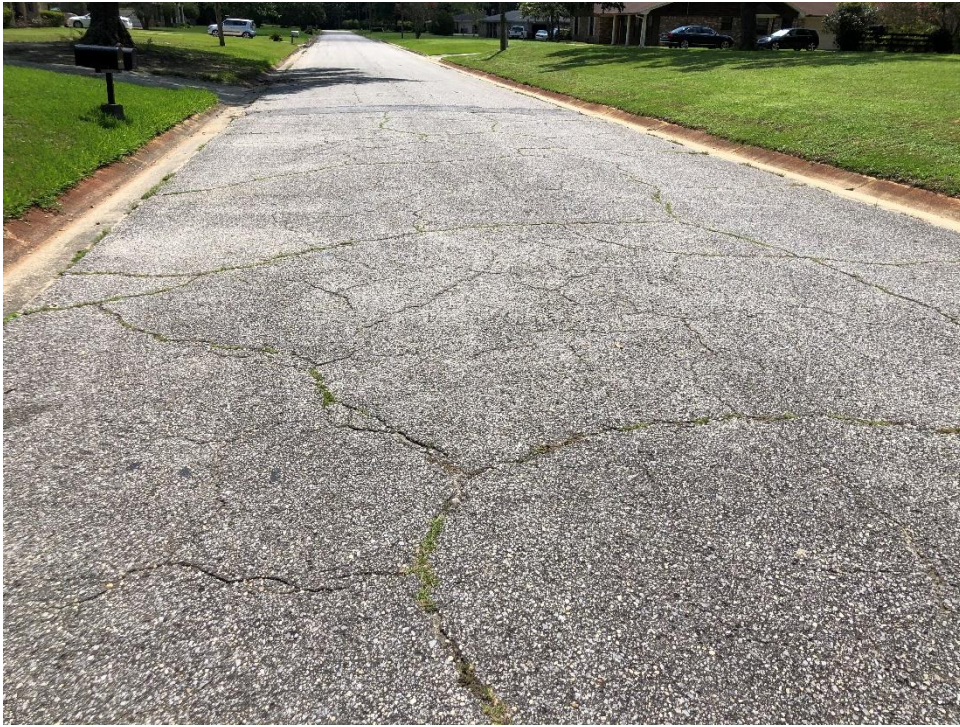
PHOTO 25

The above photo depicts branch cracking (observed to be between ¼ inch to 1 inch in width) along Fridinger Drive. Some cracks had extensive vegetative growth.

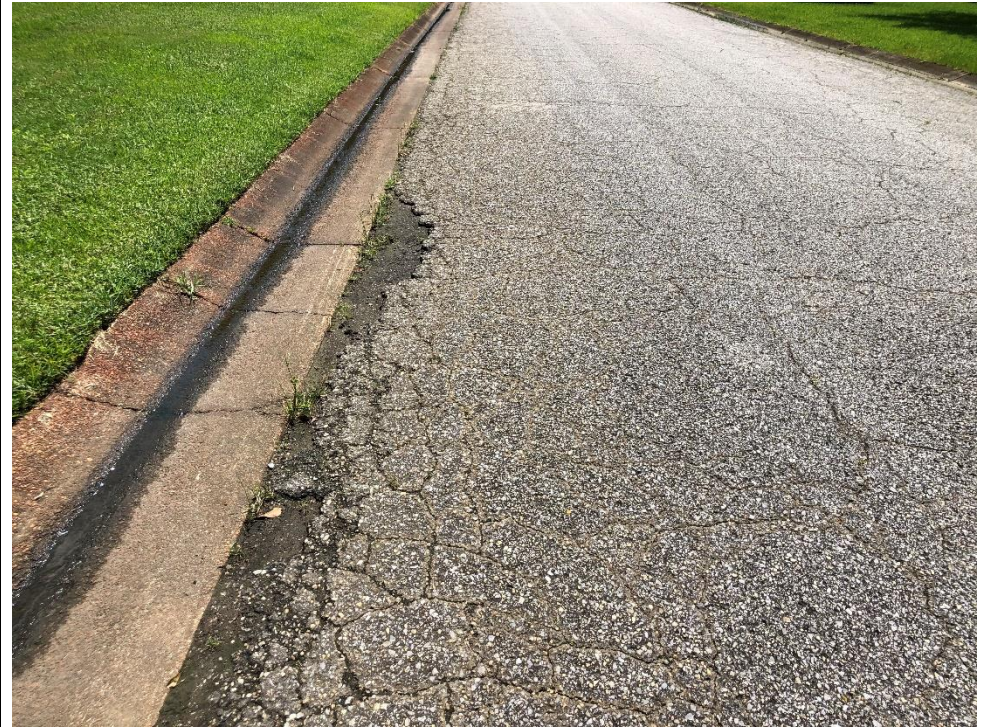
PHOTO 26

Photo of loss of pavement surface and extensive “alligator” cracking and raveling along Fridinger Drive. .

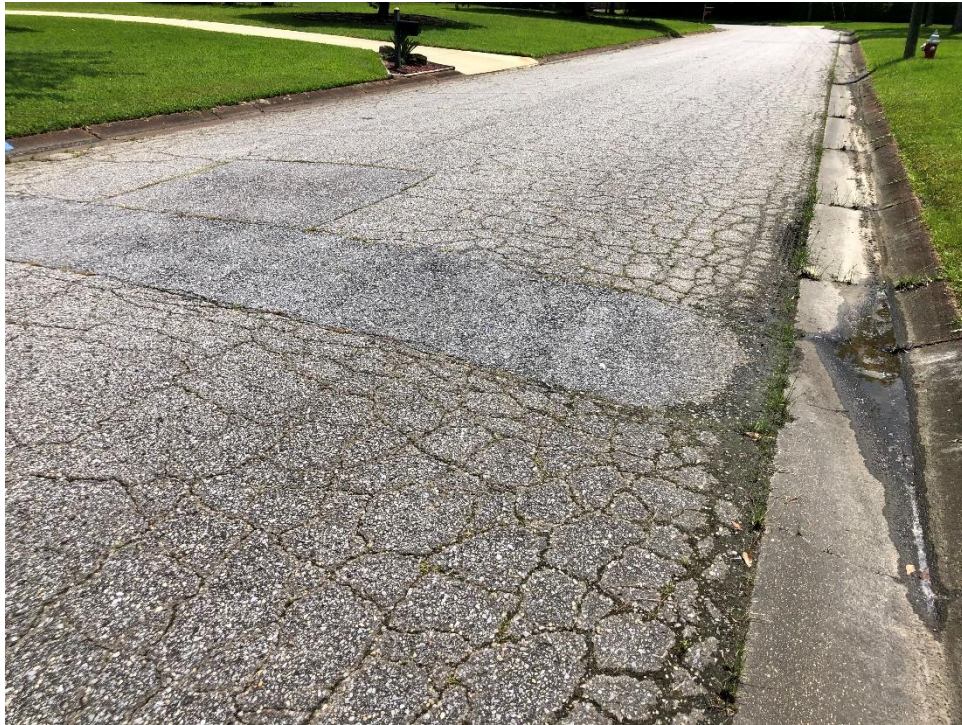
PHOTO 27

Utility patch surrounded with excessively distressed pavements.

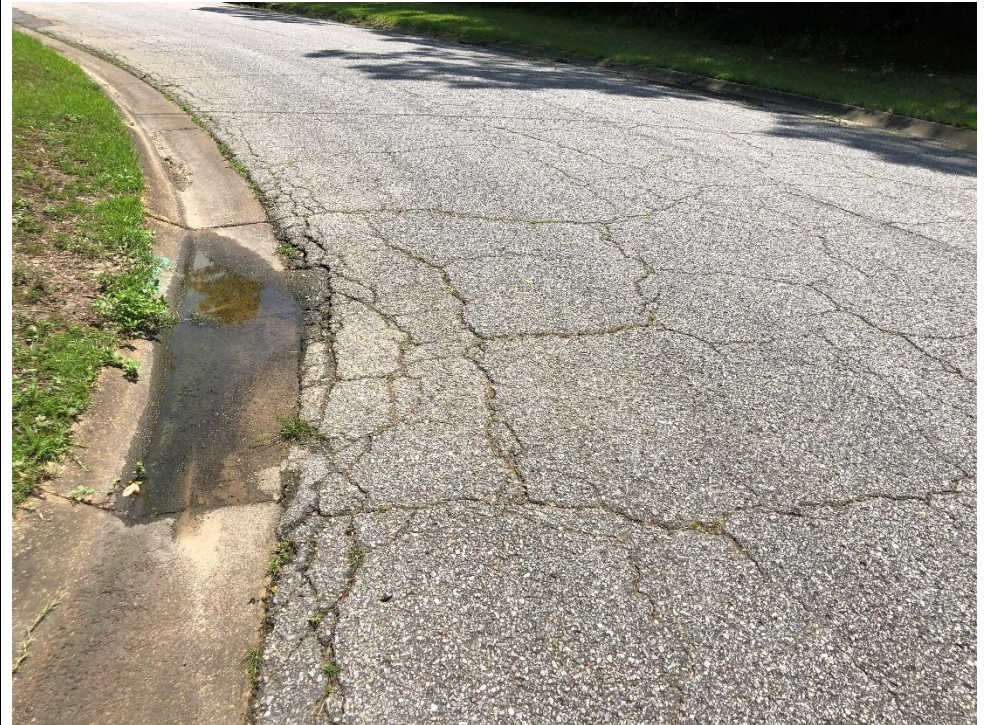
PHOTO 28

The above photo depicts the east to north turn of Fridinger Drive where the pavement has begun pothole formation due to excessive cracking and raveling.

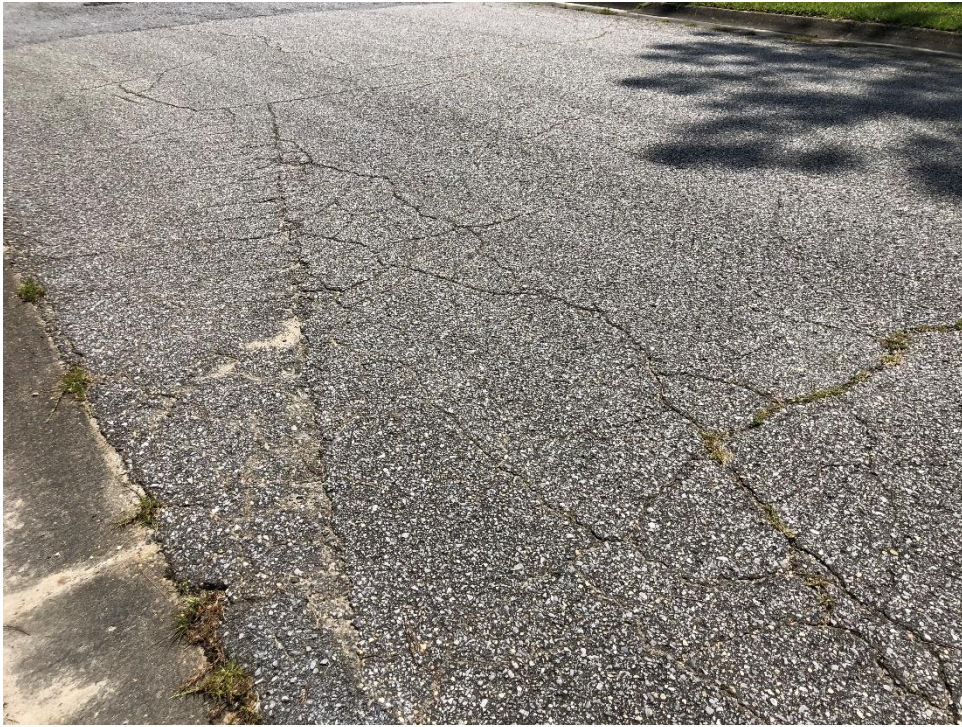
PHOTO 29

The above photo depicts another area of extensive “alligator” cracking along Fridinger Drive.
