Asbestos & Lead Based Paint Assessment

City of Spartanburg
592 Farley Avenue
Spartanburg, South Carolina

Project Number: 0815-163

January 4, 2017

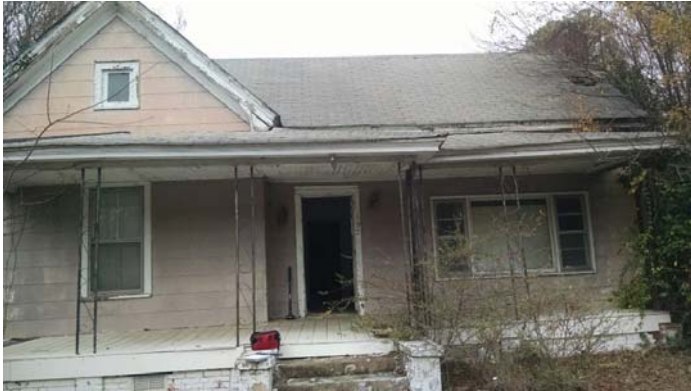
| Sample No. | Location | Sample Description | Analytical Results | Friable/Non Friable | Condition | Quantity |
|---|---|--|---|---|---|---|
| 1 | Roof | Roof shingles (2 layers) and no felt | PLM - NAD | Non-Friable | Good | 1,600 SF |

Photo 1 – 592 Farley Avenue with two layers of shingles and no felt on the roof.

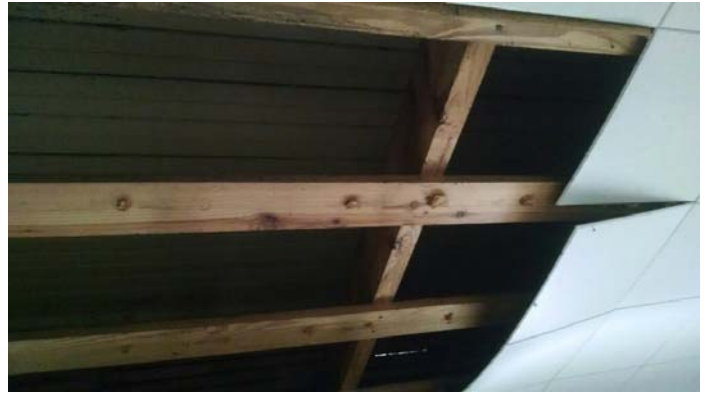
| Sample No. | Location | Sample Description | Analytical Results | Friable/Non Friable | Condition | Quantity |
|---|--|--|---|---|---|---|
| 34 | Living room | 1'x1' ceiling tiles with composite | PLM - NAD | Friable | Good | 1,000 SF |

Photo 2 – 1'x1' ceiling tile in the living room.

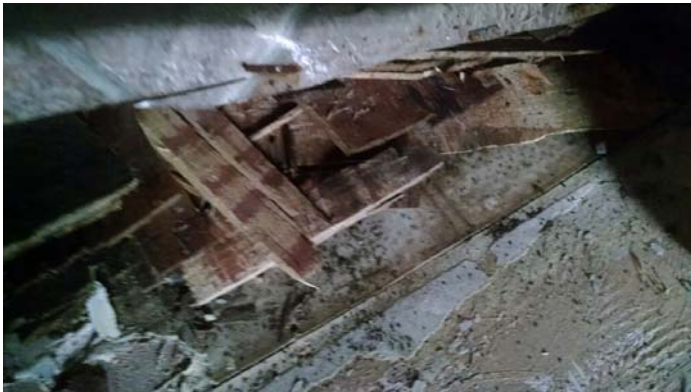
Photo 3 – Flooring under layer of sub-floor at kitchen entrance.

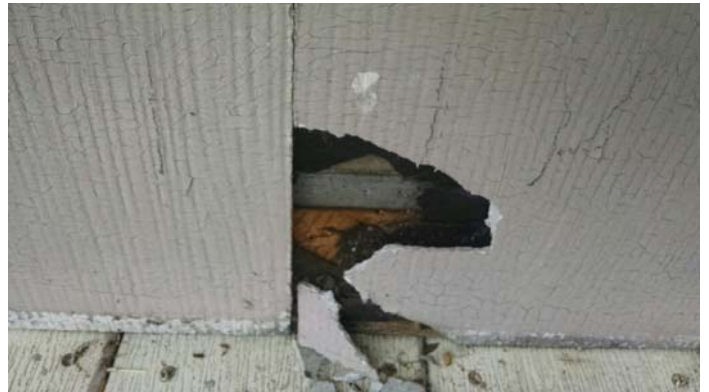
- Approximately 3,800 SF of exterior cement board siding and felt.

| Sample No. | Location | Sample Description | Analytical Results | Friable/Non Friable | Condition | Quantity |
|---|---|--|---|---|---|---|
| 22 | Exterior siding | Cement board siding with felt | PLM - Cement board - 15% Chry | Non-Friable | Good | 3,800 SF |
| 23 | | | PLM - Felt - 2% Chry | | | |

| Client ID Lab ID | Lab Description | Lab Attributes | NON-ASBESTOS COMPONENTS | | | | ASBESTOS % |
|---|---|---|---|---|---|---|---|
| Lab Notes: Chrysotile found in felt likely contamination from transite. | | | | | | | |

Photo 4 – Cement board siding with felt behind.

1. Abate the asbestos containing materials in the structure prior to renovation or demolition.
2. Follow applicable asbestos regulations during renovation or demolition of the structure. You should be aware that stringent requirements are imposed upon anyone renovating or demolishing a structure in which ACM will be disturbed. This work must be performed in accordance with OSHA asbestos regulations, 29 CFR 1910 & 1926, and NESHAP asbestos regulations 40 CFR 61, subpart M. South Carolina regulations require the accreditation of personnel who work in the asbestos field and notification and permitting fees for asbestos removal projects. There is a 10 working day notification period required prior to abatement of asbestos in a facility. Failure to take proper precautions and actions to protect human health and the environment can result in penalties, danger to personnel, and construction delays.

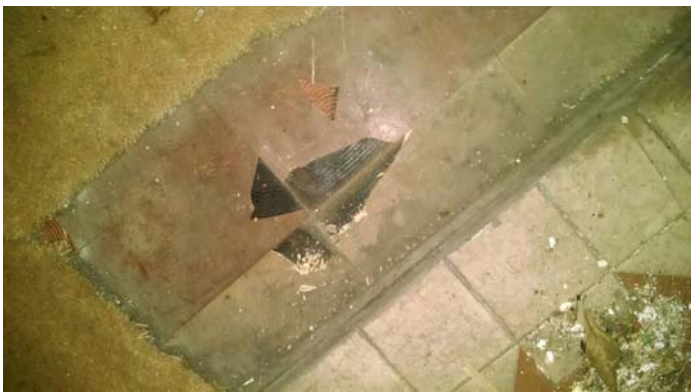
| Sample No. | Location | Sample Description | Analytical Results | Friable/Non Friable | Condition | Quantity |
|---|---|--|---|---|---|---|
| 19 | Bedroom | 9"x9" tan floor tile & mastic over 9"x9" brown floor tile with mastic and tar paper | PLM - NAD | Non-Friable | Good | 150 SF |
| 20 | | | TEM - Black tar paper - <1% Chry | | | |

Photo 5 – 9"x9" floor tile and mastic in bedroom.

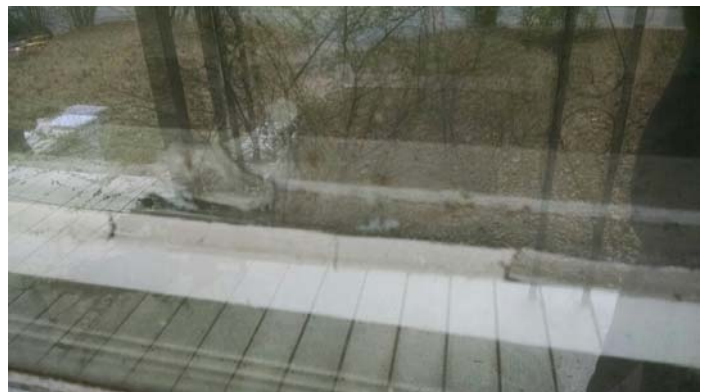
| Sample No. | Location | Sample Description | Analytical Results | Friable/Non Friable | Condition | Quantity |
|---|--|--|---|---|---|---|
| 25 | Exterior windows | Window glazing | PLM - NAD | Non-Friable | Damaged | 12 EA |

Photo 6 – Exterior window glazing.

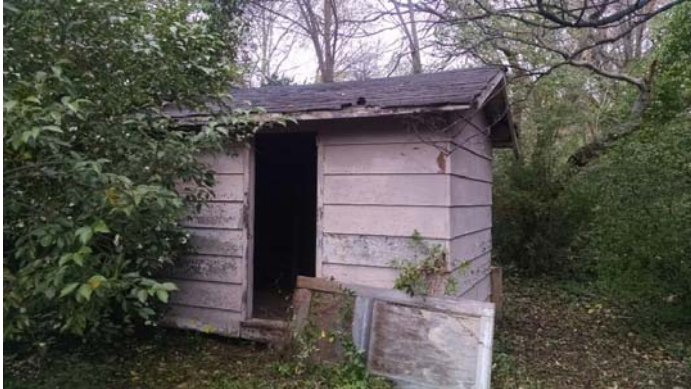
| Sample No. | Location | Sample Description | Analytical Results | Friable/Non Friable | Condition | Quantity |
|---|---|--|---|---|---|---|
| 4 | Shed roof | Roof shingles (2 layers) and felt | PLM - NAD | Non-Friable | Good | 250 SF |

Photo 7 – Exterior shed with two layers of shingles and one layer of felt.

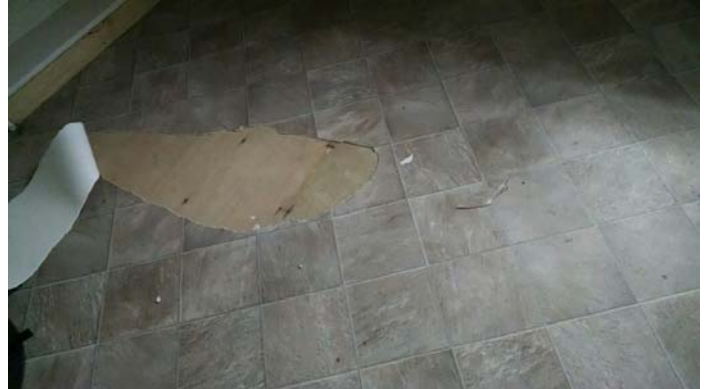
| Sample No. | Location | Sample Description | Analytical Results | Friable/Non Friable | Condition | Quantity |
|---|---|--|---|---|---|---|
| 13 | Hall outside kitchen | Grey rolled vinyl flooring with mastic | PLM - NAD | Non-Friable | Good | 100 SF |

Photo 8 – Grey roll vinyl flooring in the hall outside of the kitchen.

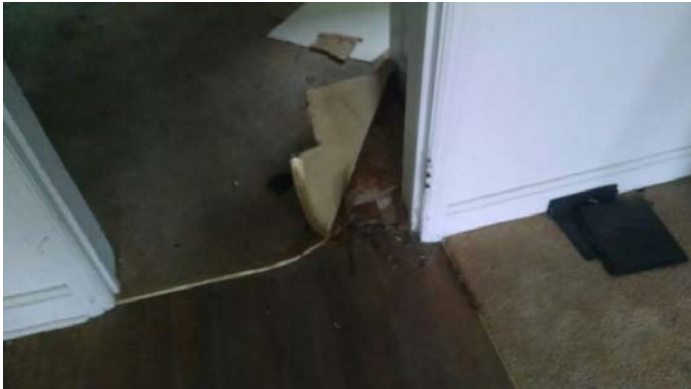
Photo 9 – Flooring and mastic under carpet and layer of subfloor between living room and hall outside bathroom.

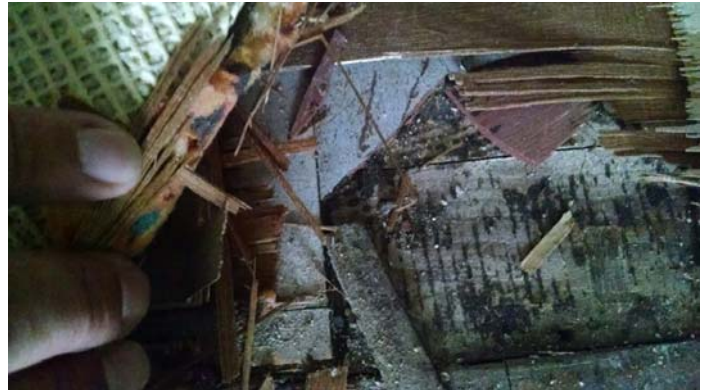
Photo 10 – Flooring and mastic under carpet and layer of subfloor between living room and hall outside bathroom.

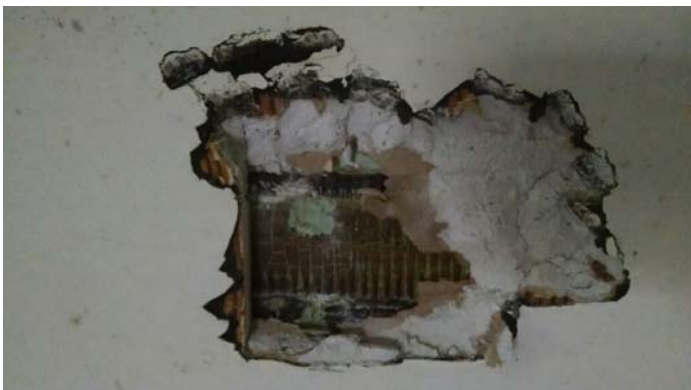
| Sample No. | Location | Sample Description | Analytical Results | Friable/Non Friable | Condition | Quantity |
|---|--|--|---|---|---|---|
| 28 | Kitchen | Drywall with mastic and tarpaper (no joint compound) | PLM - NAD | Friable | Good | 500 SF |

Photo 11 – Kitchen drywall with mastic.

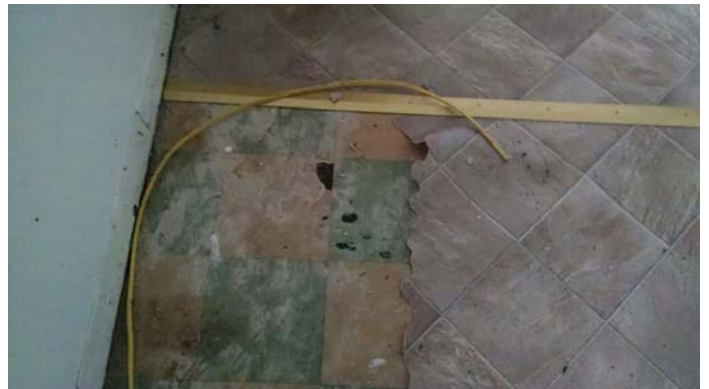
| Sample No. | Location | Sample Description | Analytical Results | Friable/Non Friable | Condition | Quantity |
|---|---|--|---|---|---|---|
| 16 | Bathroom | Tan roll vinyl floor over 9"x9" green floor tile with tarpaper with 9"x9" yellow floor tile and tarpaper beneath | PLM - NAD | Non-Friable | Good | 100 SF |

Photo 12 – Tan roll vinyl over 9"x9" green and yellow pattern flooring in the bathroom
