Asbestos & Lead Based Paint Assessment

City of Spartanburg
328 Brown Avenue
Spartanburg, South Carolina

Project Number: 0815-163

October 4, 2016

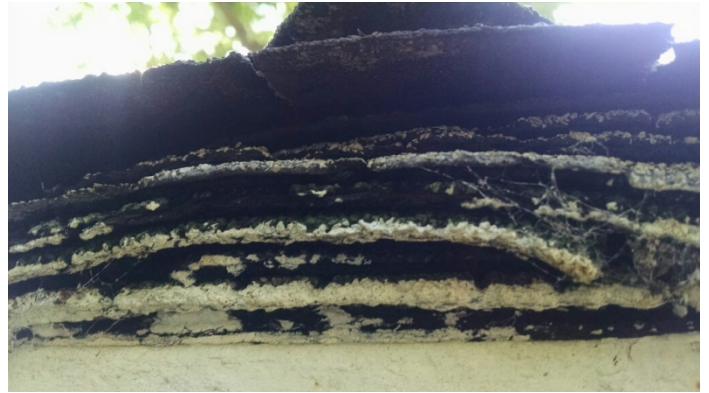
Photo 2 – 6 layers of roof shingles with no felt.

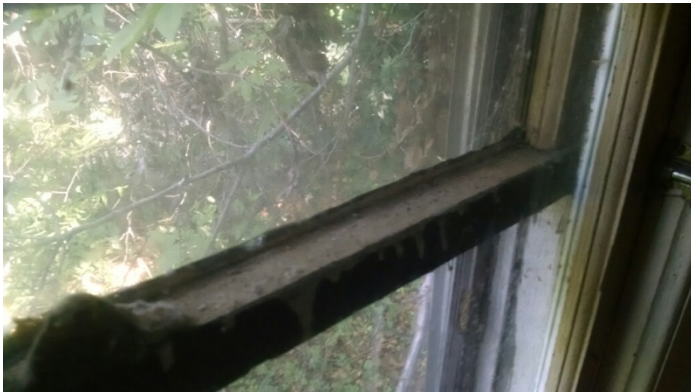
Photo 3 – Window glazing.

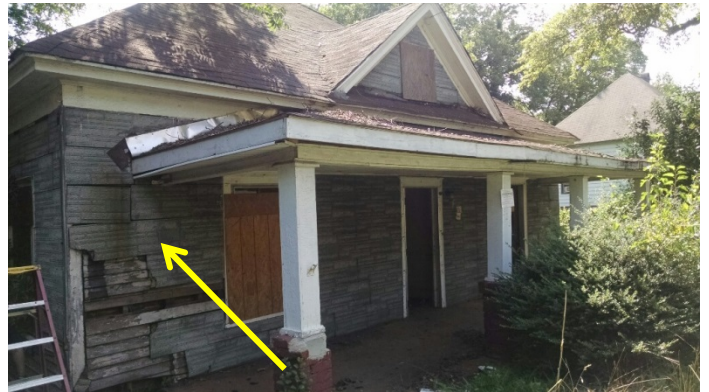
- Approximately 500 SF of drywall with joint compound in the pantry & living room.
- Approximately 4,500 SF of exterior asphalt siding.
- Approximately 6 LF of chimney tar/mastic – assumed.

Photo 4 – Asphalt siding over wooden siding.

1. Abate the asbestos containing materials in the structure prior to renovation or demolition.

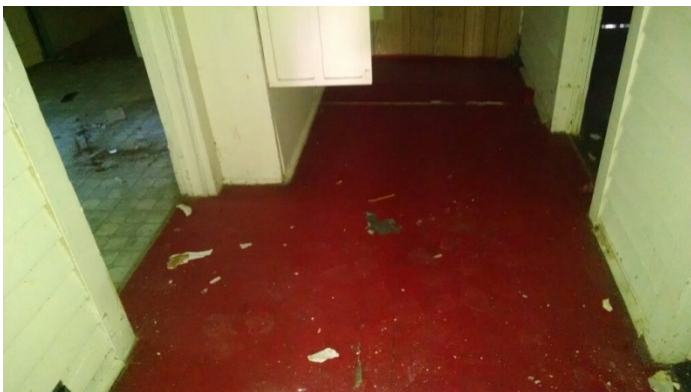
Photo 5 – Red sheet vinyl flooring with no mastic in the pantry.

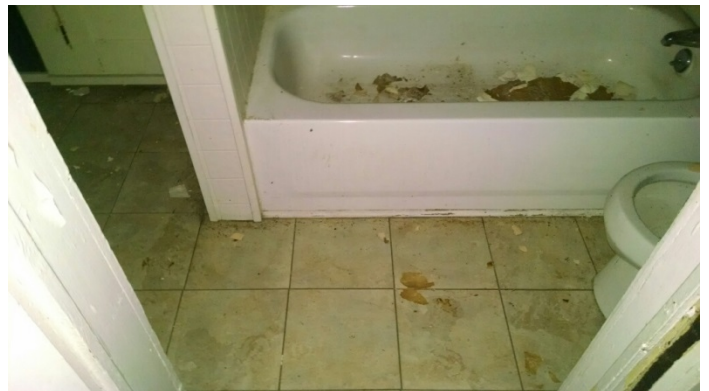
Photo 6 – 12" x 12" gray self-stick vinyl floor tile in the bathroom.

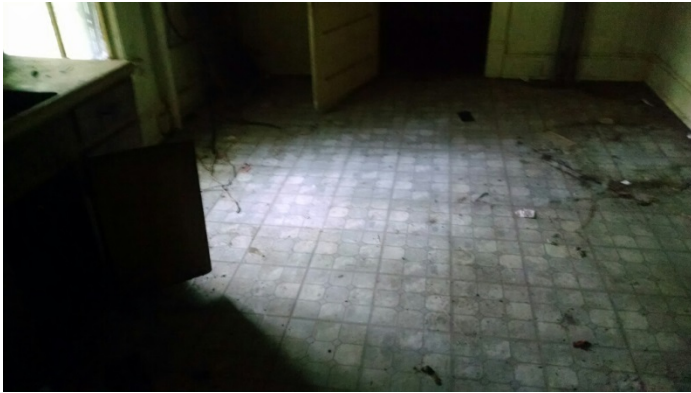
Photo 7 – 12" x 12" tan self-stick vinyl floor tiles in the kitchen.

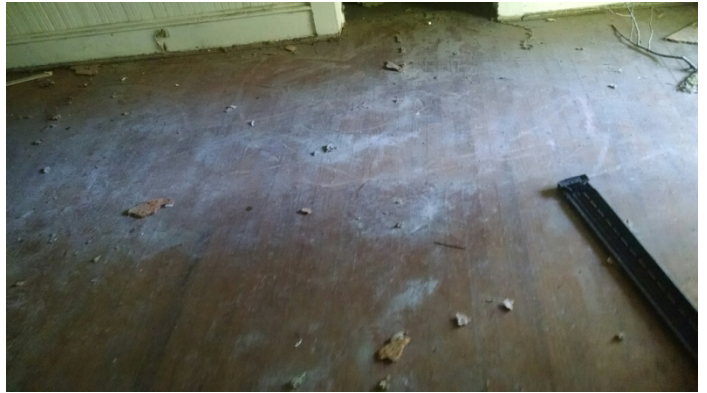
Photo 8 – Wooden floors.

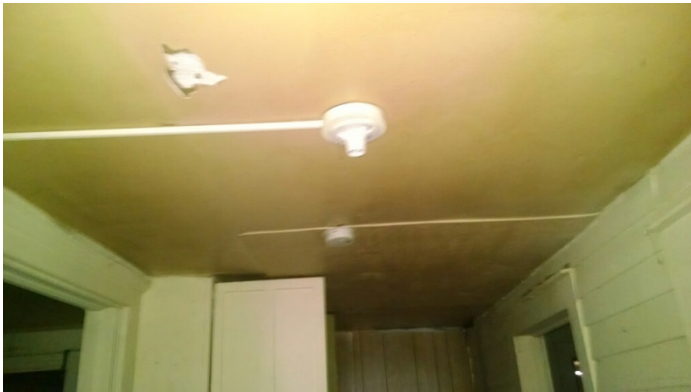
Photo 9 – Drywall with joint compound & no tape in the pantry & living room.

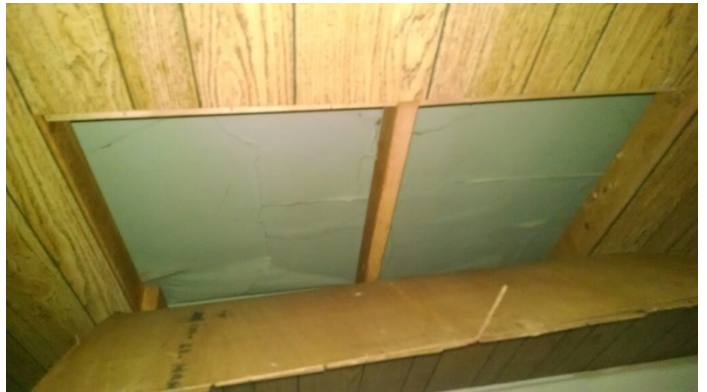
Photo 10 – Plaster with finish.
