ASBESTOS INSPECTION REPORT

Holloman Elementary School
Holloman Air Force Base
Alamogordo, NM

Alamogordo Public Schools
1211 Hawaii Ave.
Alamogordo, NM 88310

Date of Inspection: June 9th and 23rd, 2021

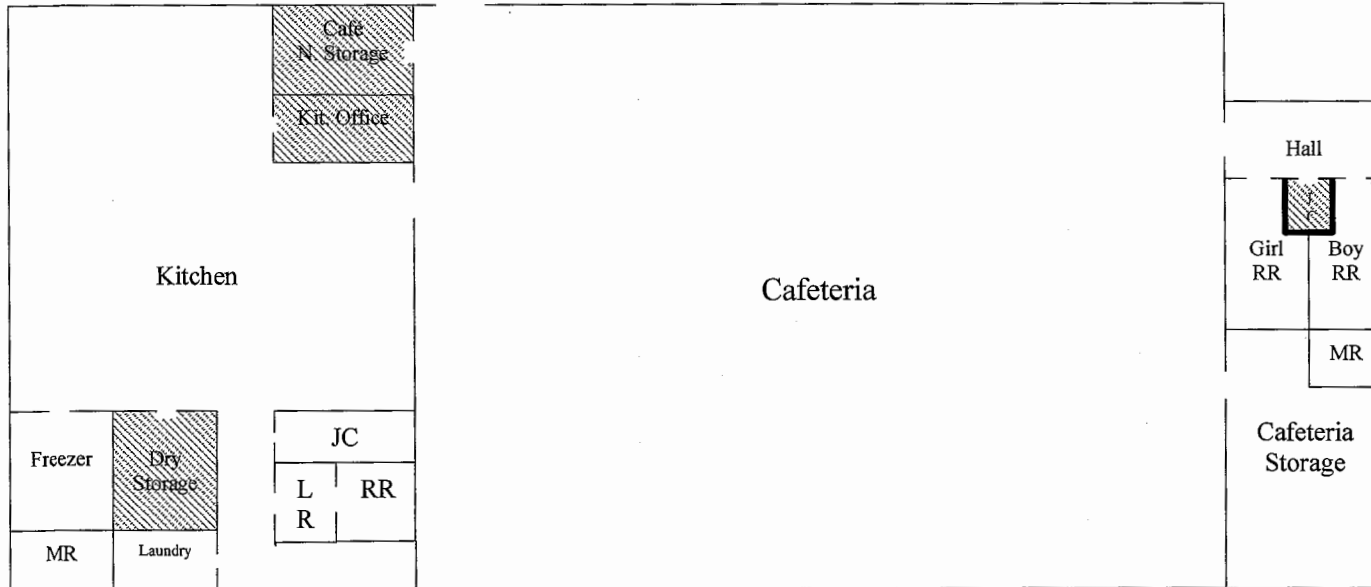
FUNCTIONAL SPACE AND ACM LOCATION DIAGRAM

*Cove Base Mastic (Cafeteria, Hall, Hall Janitor's Closet)
