## **Asbestos & Lead Based Paint Assessment**

City of Spartanburg  
356 Saint Andrews Street  
Spartanburg, South Carolina

Project Number: 0417-66

July 3, 2017

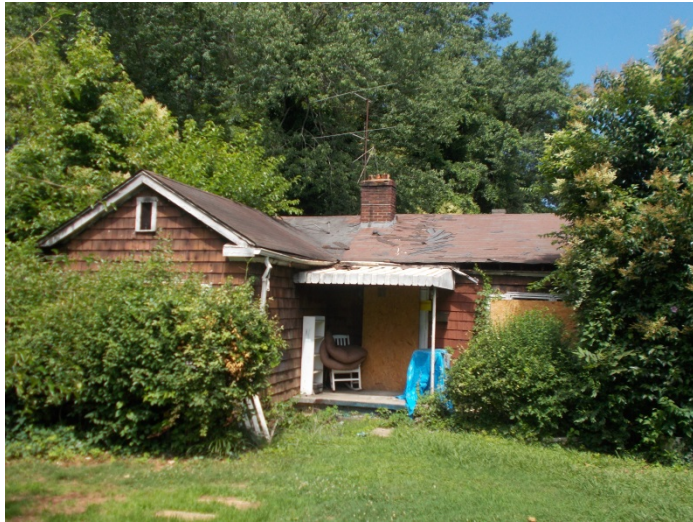
Photo 1 – 356 Saint Andrews Street in Spartanburg, South Carolina.

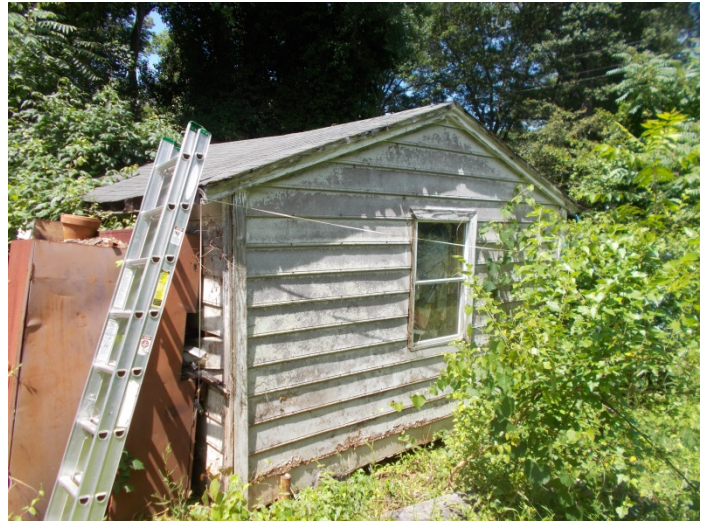
Photo 2 – Exterior shed in back yard.

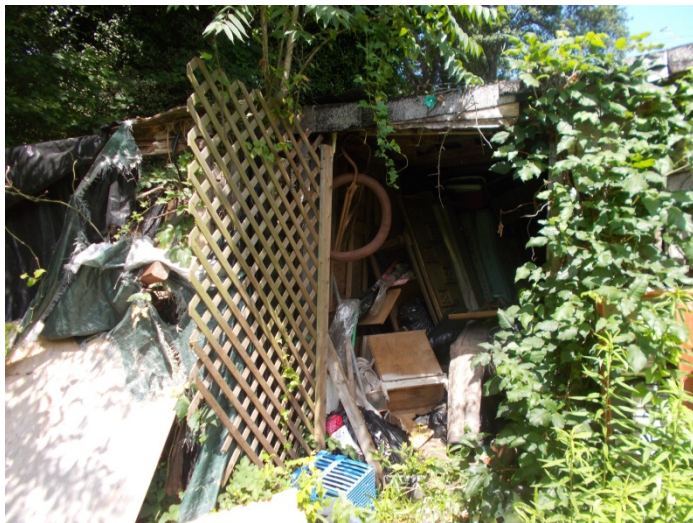
Photo 3 – Large amount of debris stacked in and around shed.

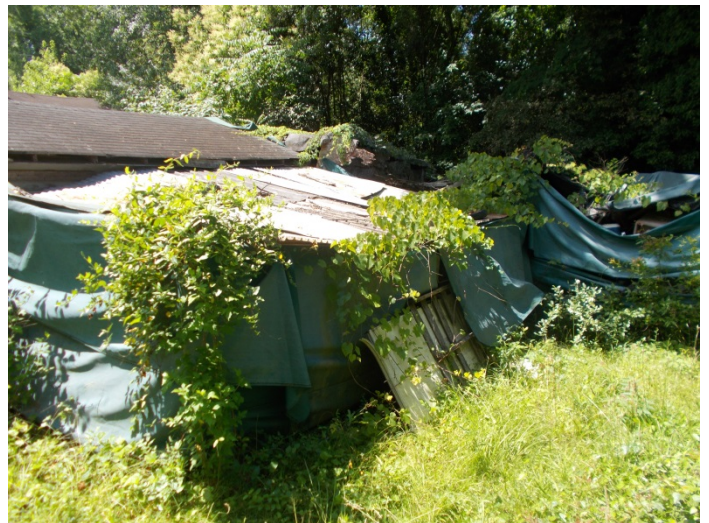
Photo 4 – Debris stacked behind shed.

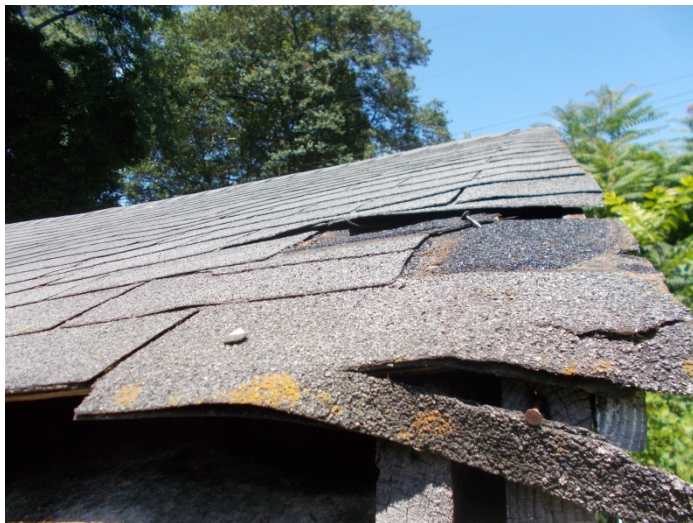
Photo 5 – Roofing shingles (2 layers) and no felt on main exterior shed roof.

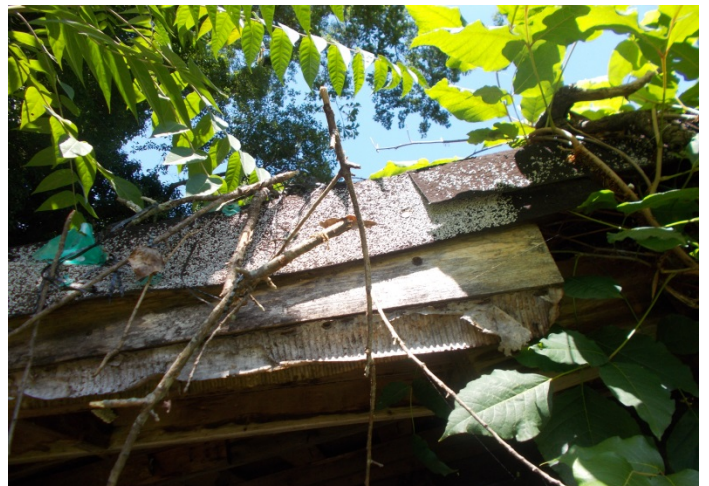
Photo 6 – Roll roofing (1 layer) and no felt on exterior shed roof addition.

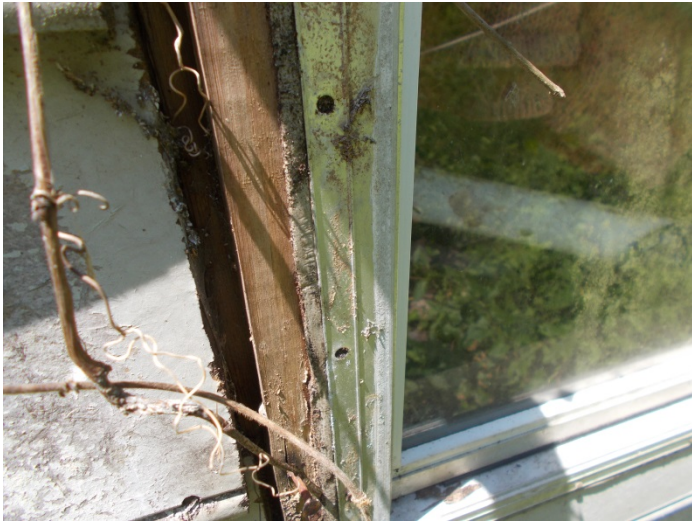
Photo 7 – Putty/Caulk on exterior shed window casing.

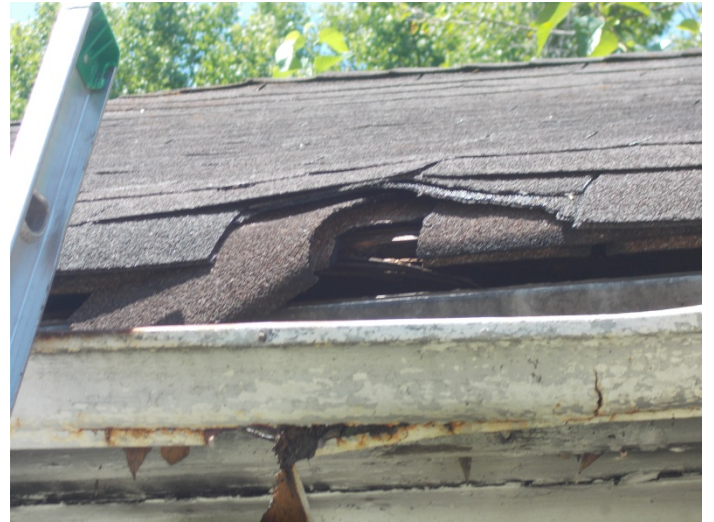
Photo 8 – Roofing shingles (5 layers) and no felt on main house roof.

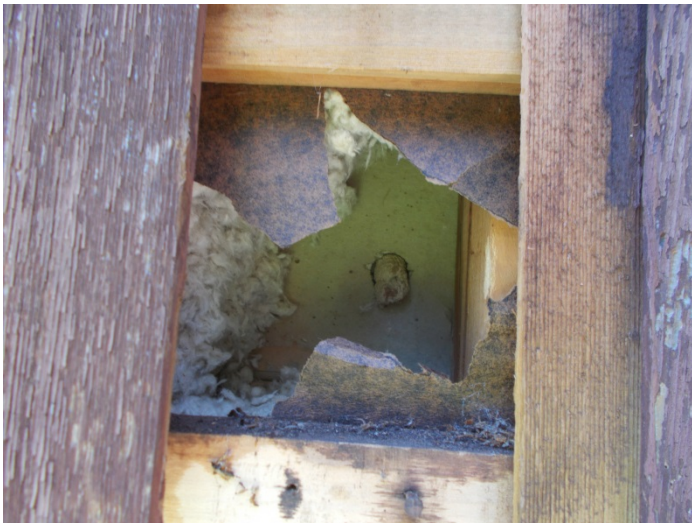
Photo 9 – Siding paper beneath framing studs.

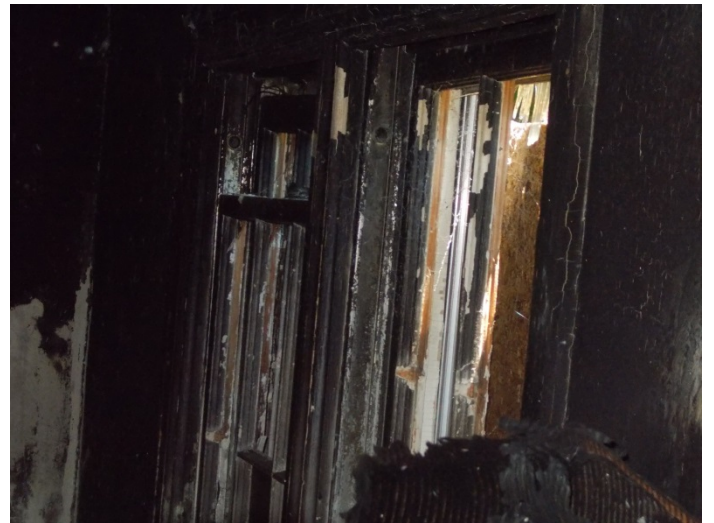
- Approximately 15 wooden windows with glazing.
- Approximately 1,400 SF of assumed potential suspect ACM and contaminated debris within the structure that was inaccessible during the survey.

Photo 10 – Glazing on exterior wooden windows.

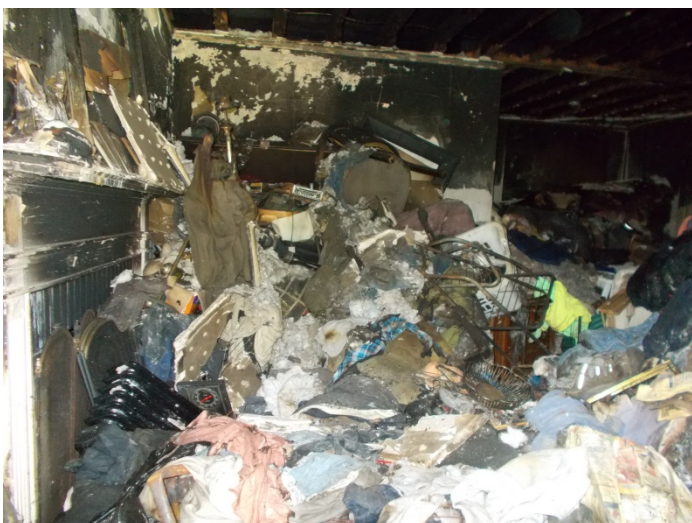
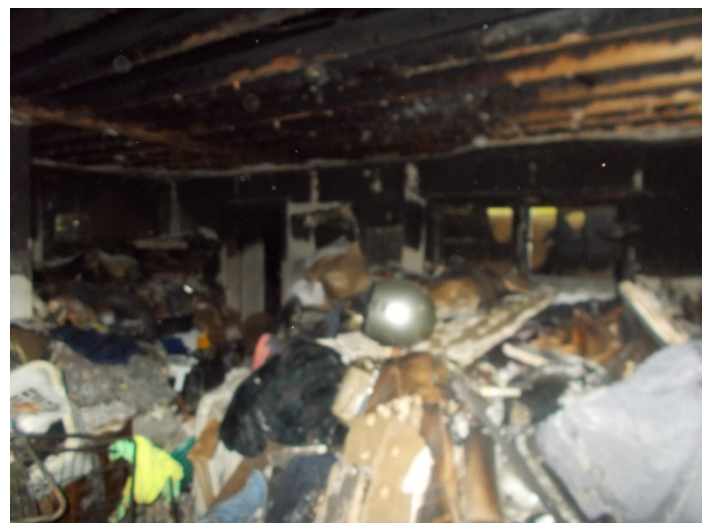
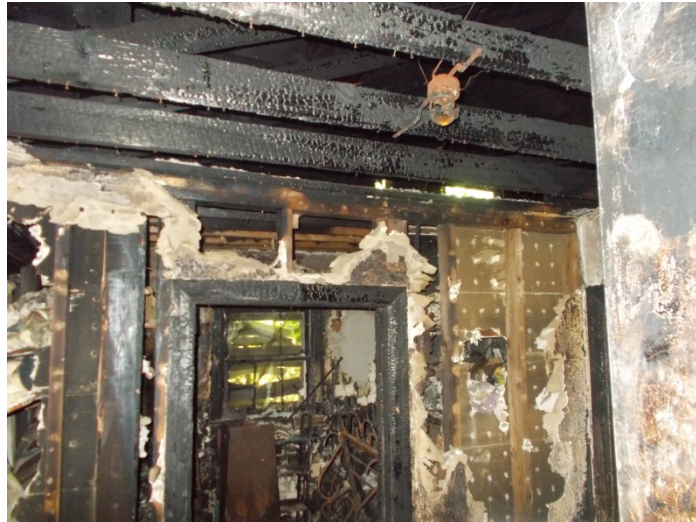
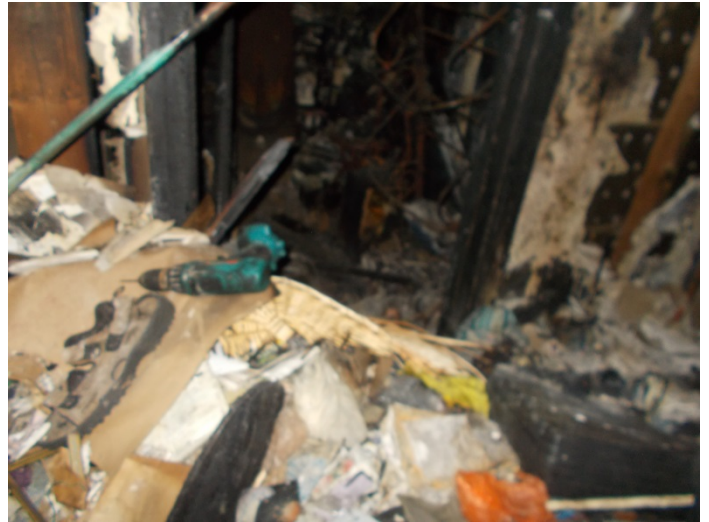
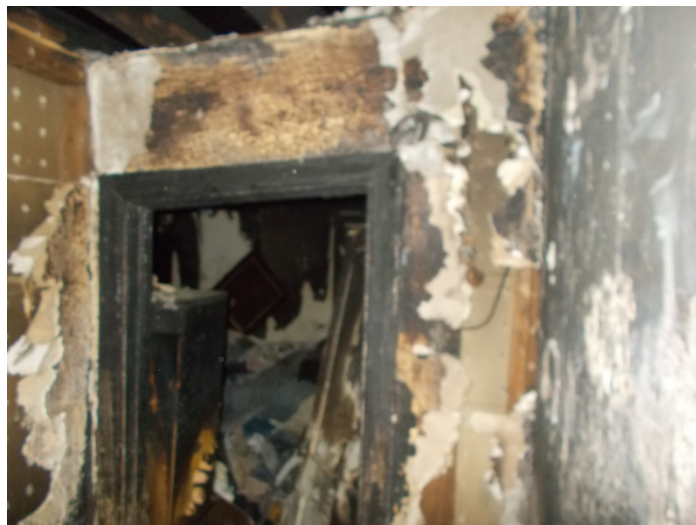
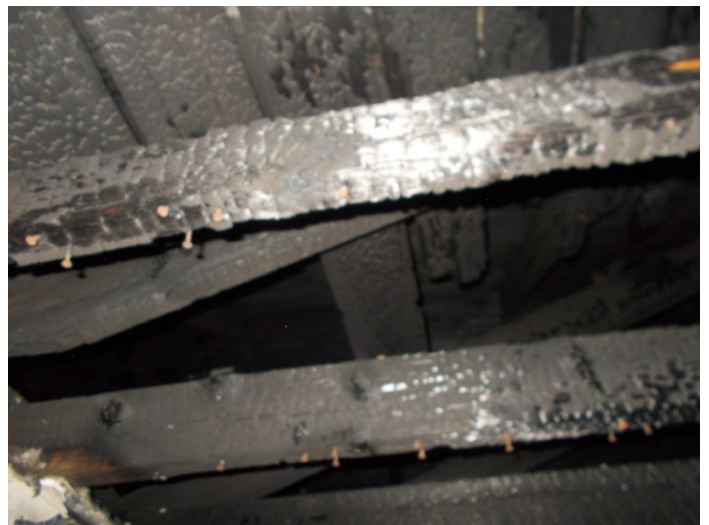
- Interior building materials were not observed due to fire & structural damage within the residence.
- Due to safety concerns no asbestos samples were collected from within the residence.
- Structure/debris pile is assumed to be positive for ACM (1,400 SF).
- No interior sampling was performed due to safety concerns.

The residence was inaccessible due to fire and structural damage and debris throughout the interior. Due to the inaccessible nature of the residence, the building materials and finishes not sampled during the survey should be assumed to be ACM. The remaining debris should be considered contaminated material. Apex recommends that the building be demolished in place

and materials be treated and disposed of as friable ACM.

Photo 11 – Fire/structural damaged interior of house and debris piles.

1. Demolish the residence with assumed ACM in place and dispose of the waste stream as friable Regulated Asbestos Containing Materials (RACM) and delivered to an asbestos approved hazardous waste landfill for disposal.
