## **Asbestos & Lead Based Paint Assessment**

City of Spartanburg  
312 East Park Avenue  
Spartanburg, South Carolina 29306

Project Number: 0120-17

September 22, 2020

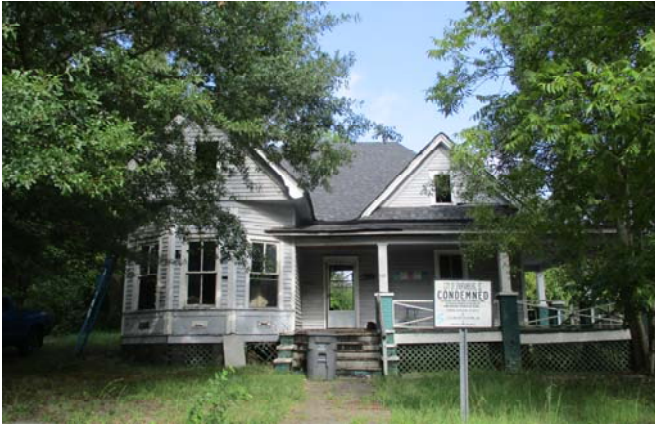
Photo 1 – 312 East Park Avenue in Spartanburg, South Carolina.

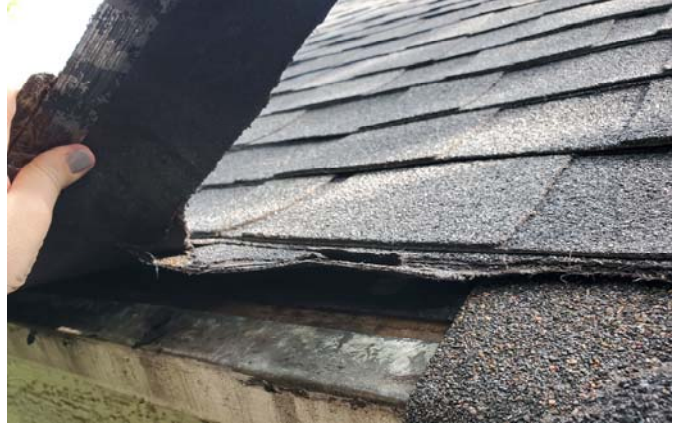
Photo 2 – Vinyl paper under shingles.

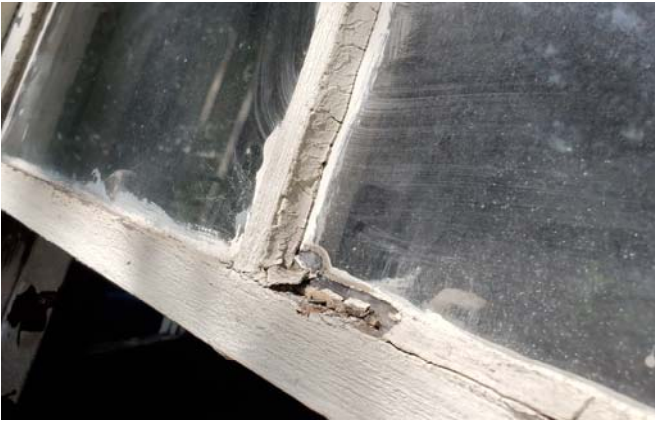
Photo 3 – Exterior window glazing.

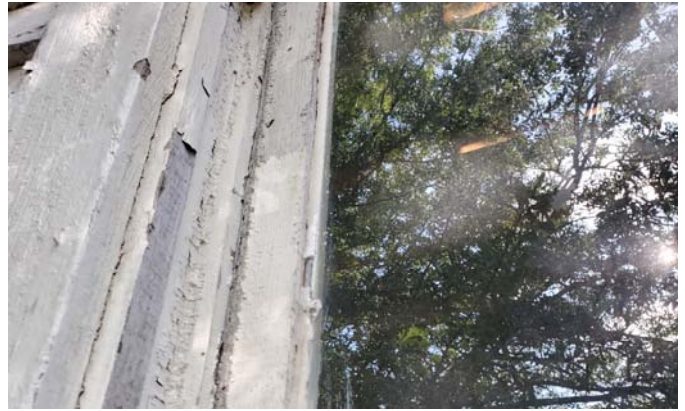
Photo 4 – Exterior window caulk.

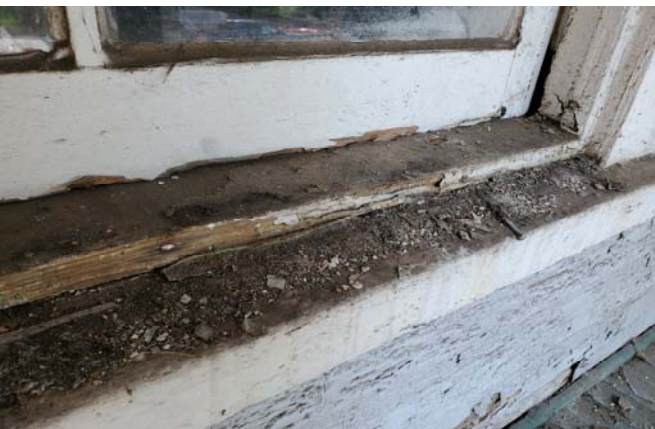
Photo 5 – Remnants of glazing between sill and sub sill of window.

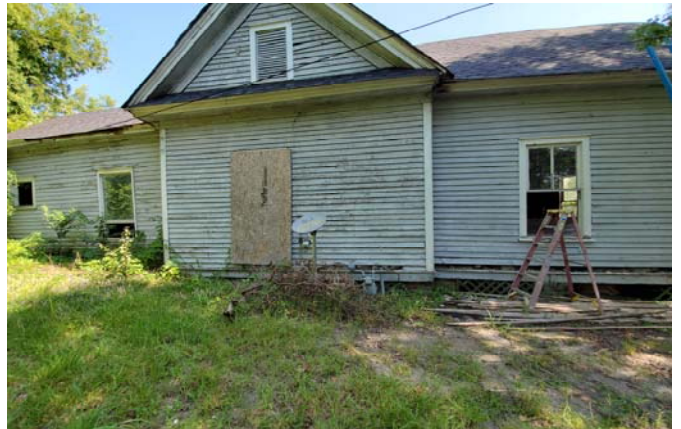
Photo 6 – Side view of structure.

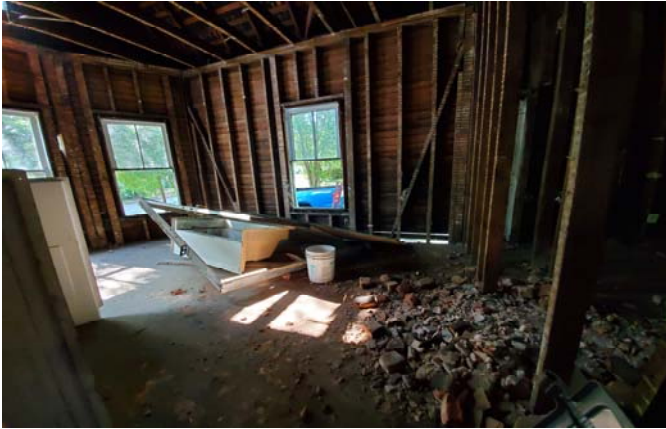
Photo 7 – Debris scattered throughout structure.

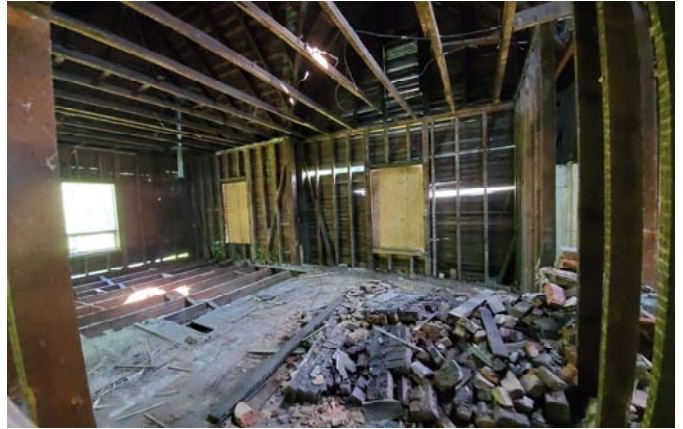
Photo 8 – Remnants of fireplace and missing floor back right area of structure.

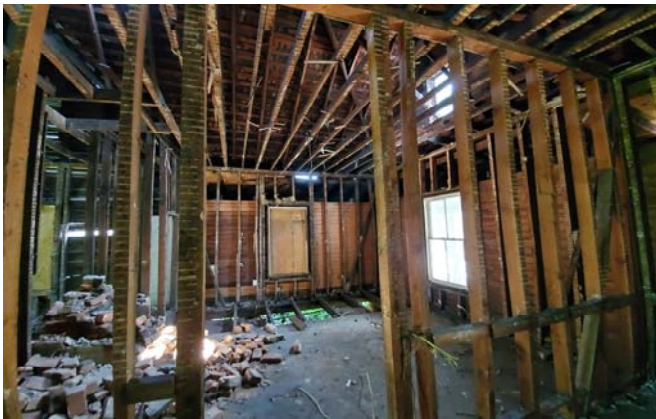
Photo 9 – Remnants of fireplace and missing floor front right area of structure.

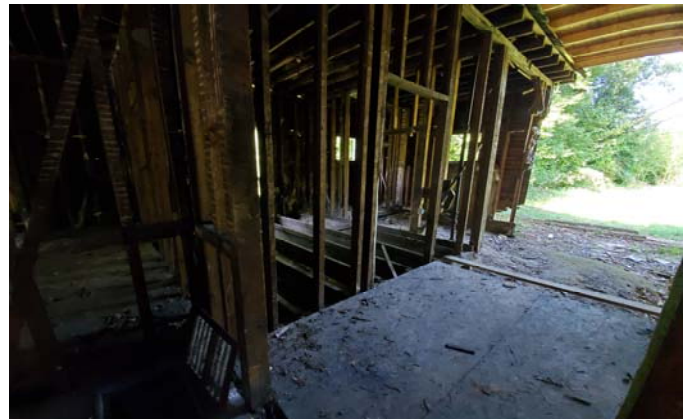
Photo 10 – Missing floor back left area of structure.

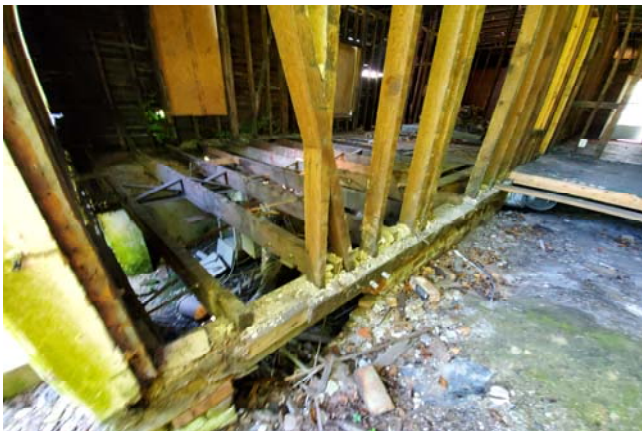
Photo 11 – Debris scattered back area.

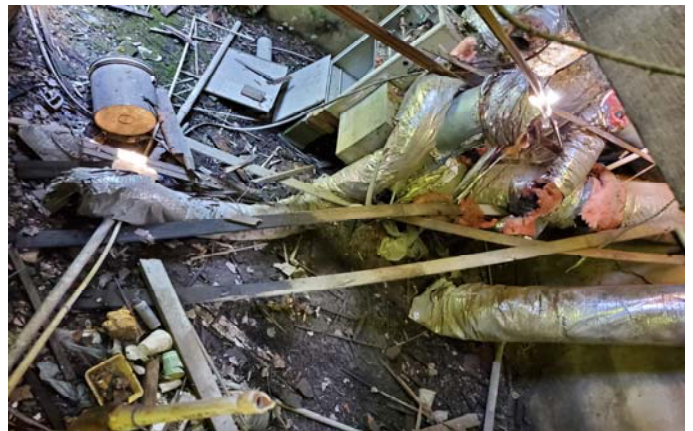
Photo 12 – Debris scattered in back crawl space.
