Asbestos & Lead Based Paint Assessment

City of Spartanburg
310 Hydrick Street
Spartanburg, South Carolina 29306

Project Number: 0120-17

October 21, 2020

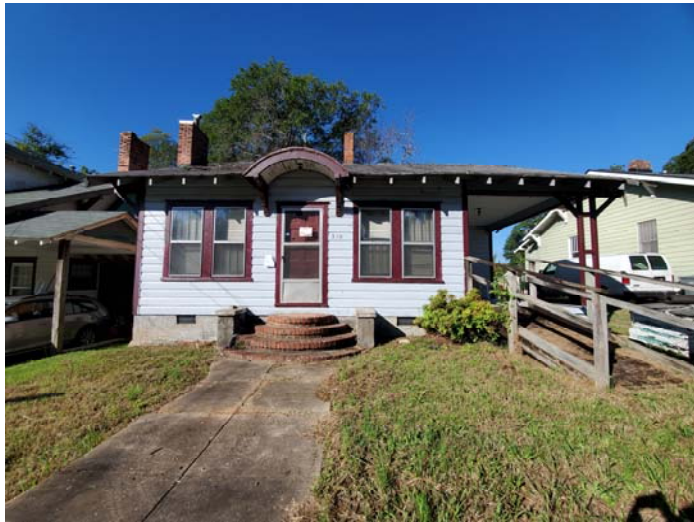
Photo 1 – 310 Hydrick Street in Spartanburg, South Carolina 29306

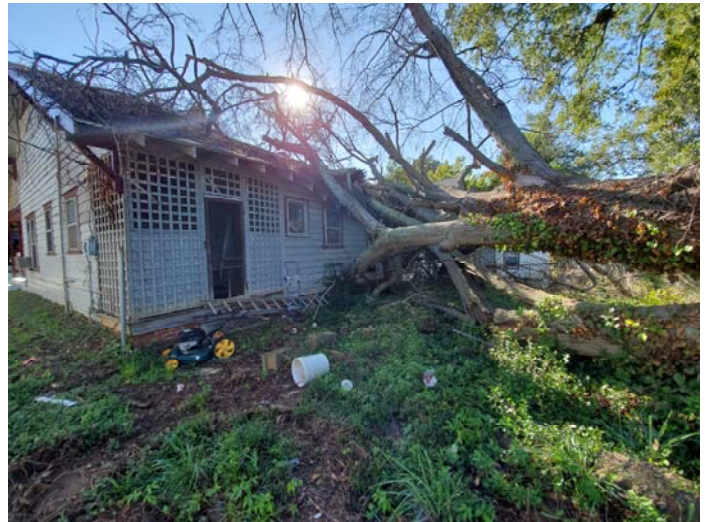
Photo 2 – Damage to back portion of house.

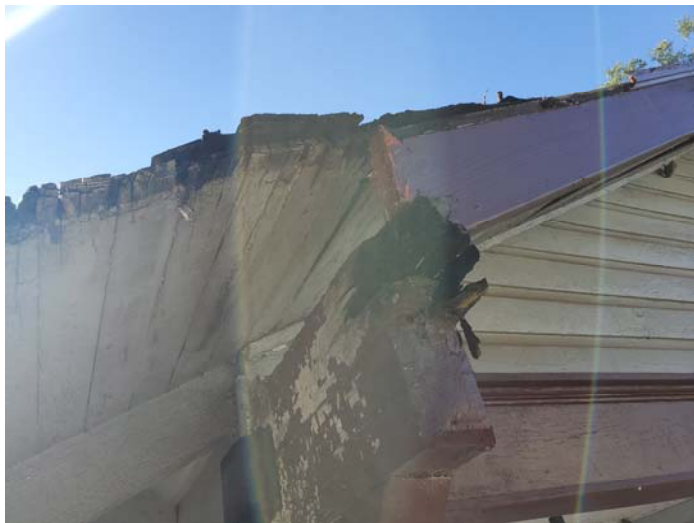
Photo 3 – Shingles with no felt.

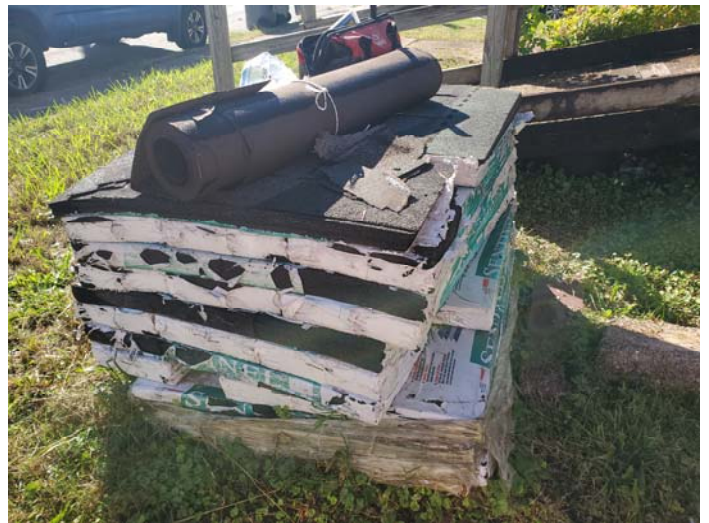
Photo 4 – Pallet of shingles with roll of felt paper located in front yard.

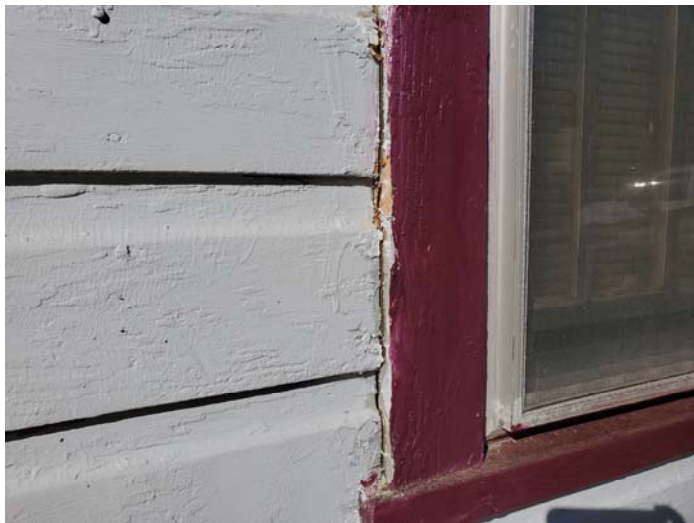
Photo 5 – Casing caulk on doors and windows.

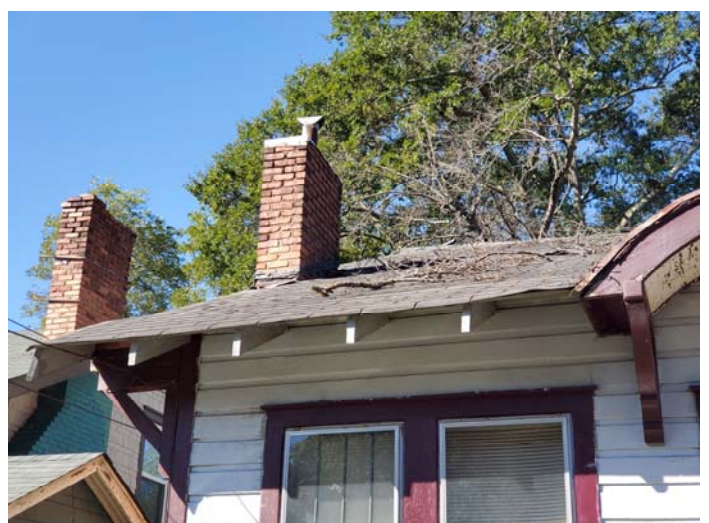
- Approximately 265 SF of brown square pattern flooring and associated mastic beneath the 12"x12" adhesive white pattern flooring in the kitchen, pantry and hallway.
- Approximately 36 LF of tar located on three chimneys – assumed positive.

Photo 6 – Assumed ACM on chimney.

1. Abate the asbestos containing materials in the structure prior to renovation or demolition.
2. Follow applicable asbestos regulations during renovation or demolition of the structure. You

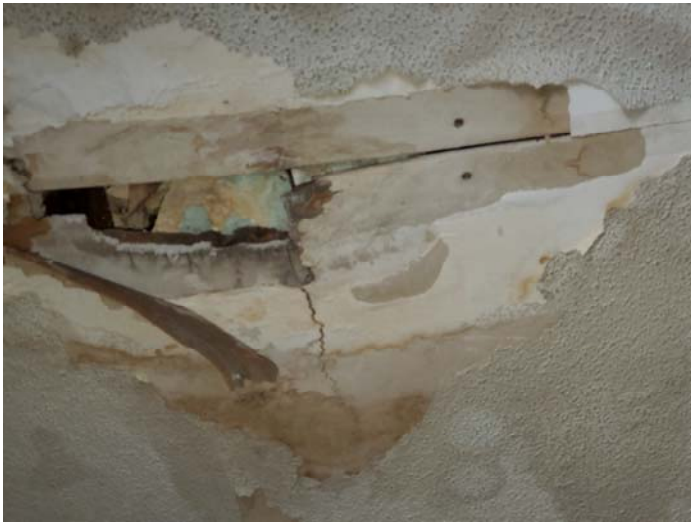
Photo 7 – Ceiling texture, drywall, joint compound & tape throughout ceilings.

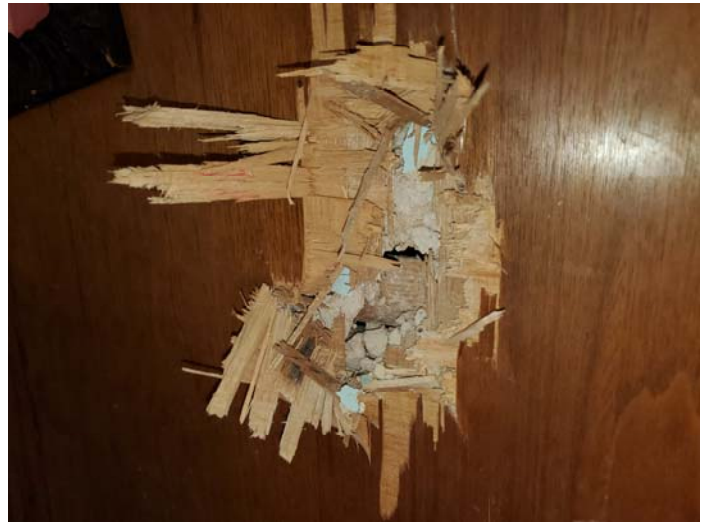
Photo 8 – Plaster with finish under wood paneling on walls throughout.

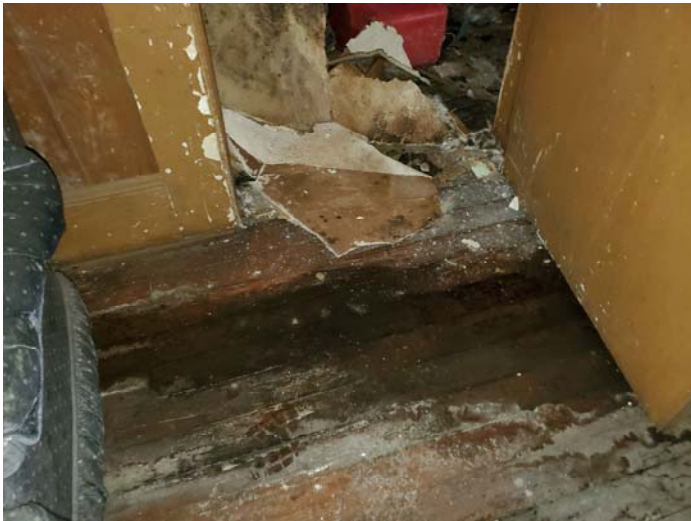
Photo 9 – Wood floors throughout.

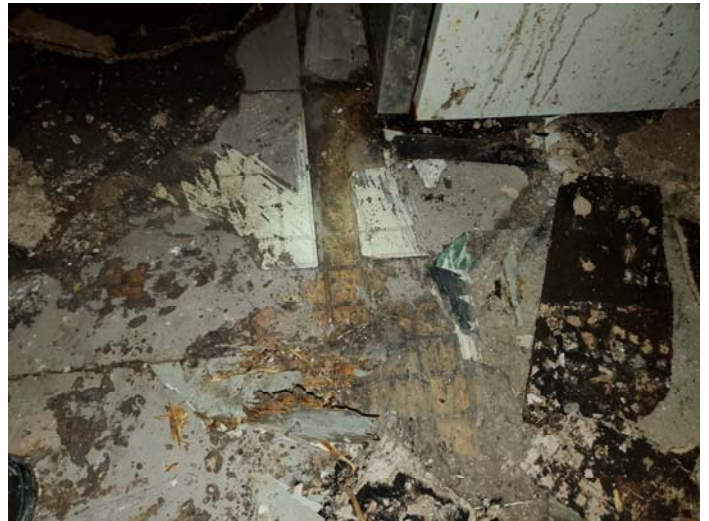
Photo 10 – 12"x12" brown square pattern flooring and associated mastic in kitchen, pantry and hallway is ACM.

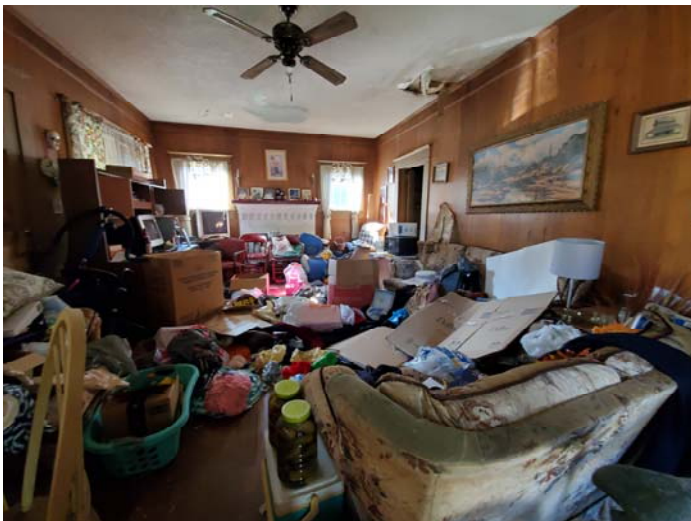
Photo 11 – Household debris throughout house.

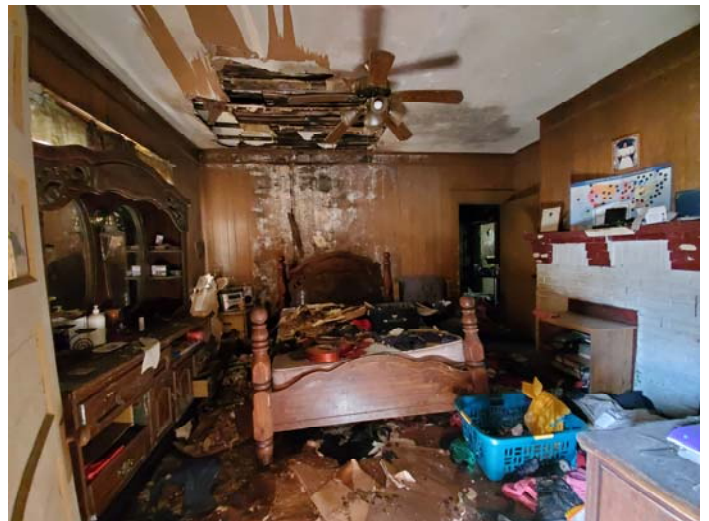
Portions of the residence have collapsed ceilings or floors that are collapsing. These areas were fully assessed, however, if additional suspect ACM should be discovered during demolition

Photo 12 – Damage to ceiling throughout the house.

activities, Apex recommends that work activities stop until the suspect building materials may be sampled and analyzed.
