**FLORIDA DEPARTMENT OF TRANSPORTATION
BRIDGE MANAGEMENT SYSTEM
Inspection/CIDR/Bridge Profile Report
Inspection**

Structure ID: 884036

TYPE OF INSPECTION: Regular NBI

STRUCTURE NAME: Not recorded
 YEAR BUILT: 1965
 SECTION NO.: 88 000 407
 MP: 0.006
 ROUTE: 00000
 FACILITY CARRIED: 53RD STREET
 FEATURE INTERSECTED: LATERAL A CANAL

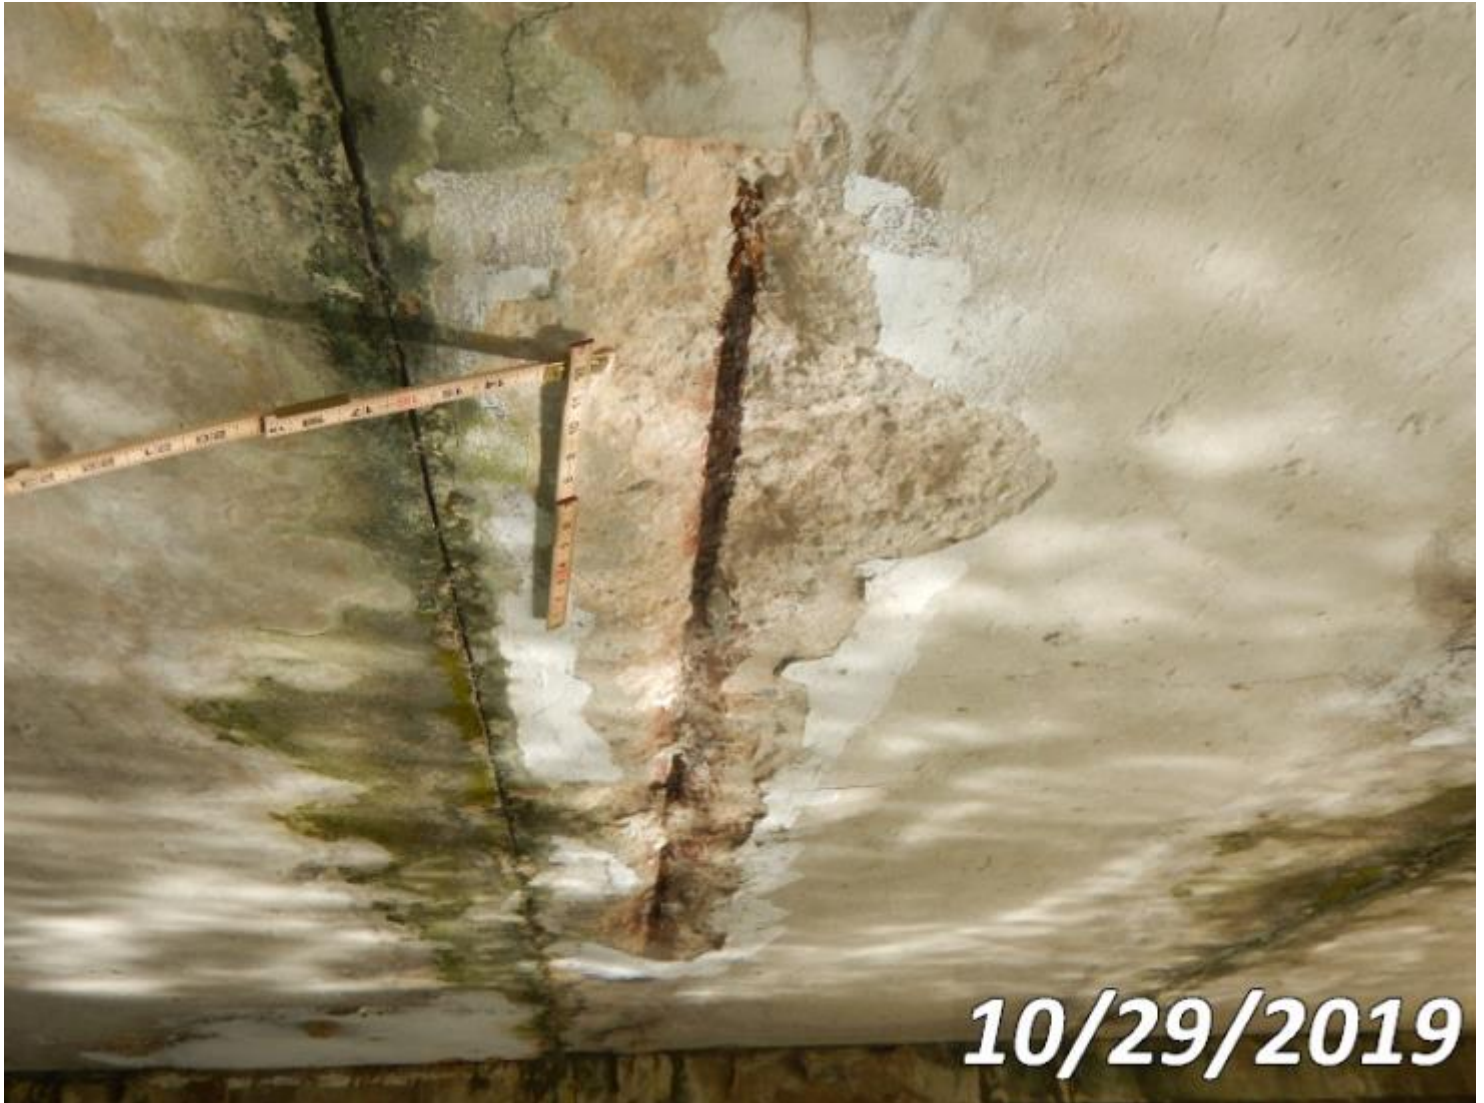
Photo 38-S01 (Unit 0: Re Concrete Slab)

1) Slab Unit 2-3 in the deck underside at the west edge has a spall/failed patch 5ft. L x 1ft. W x 2in. D with corroded exposed steel, at midspan (total 5sf.). NO CHANGE. See Photo 38-S01.

Spall/failed patch with exposed corroded steel in the deck underside at the west edge of Slab Unit 2-3 at midspan.

Repair spalls and delaminations in the deck underside of Slab Units 2-3 3-3 and 3-4.

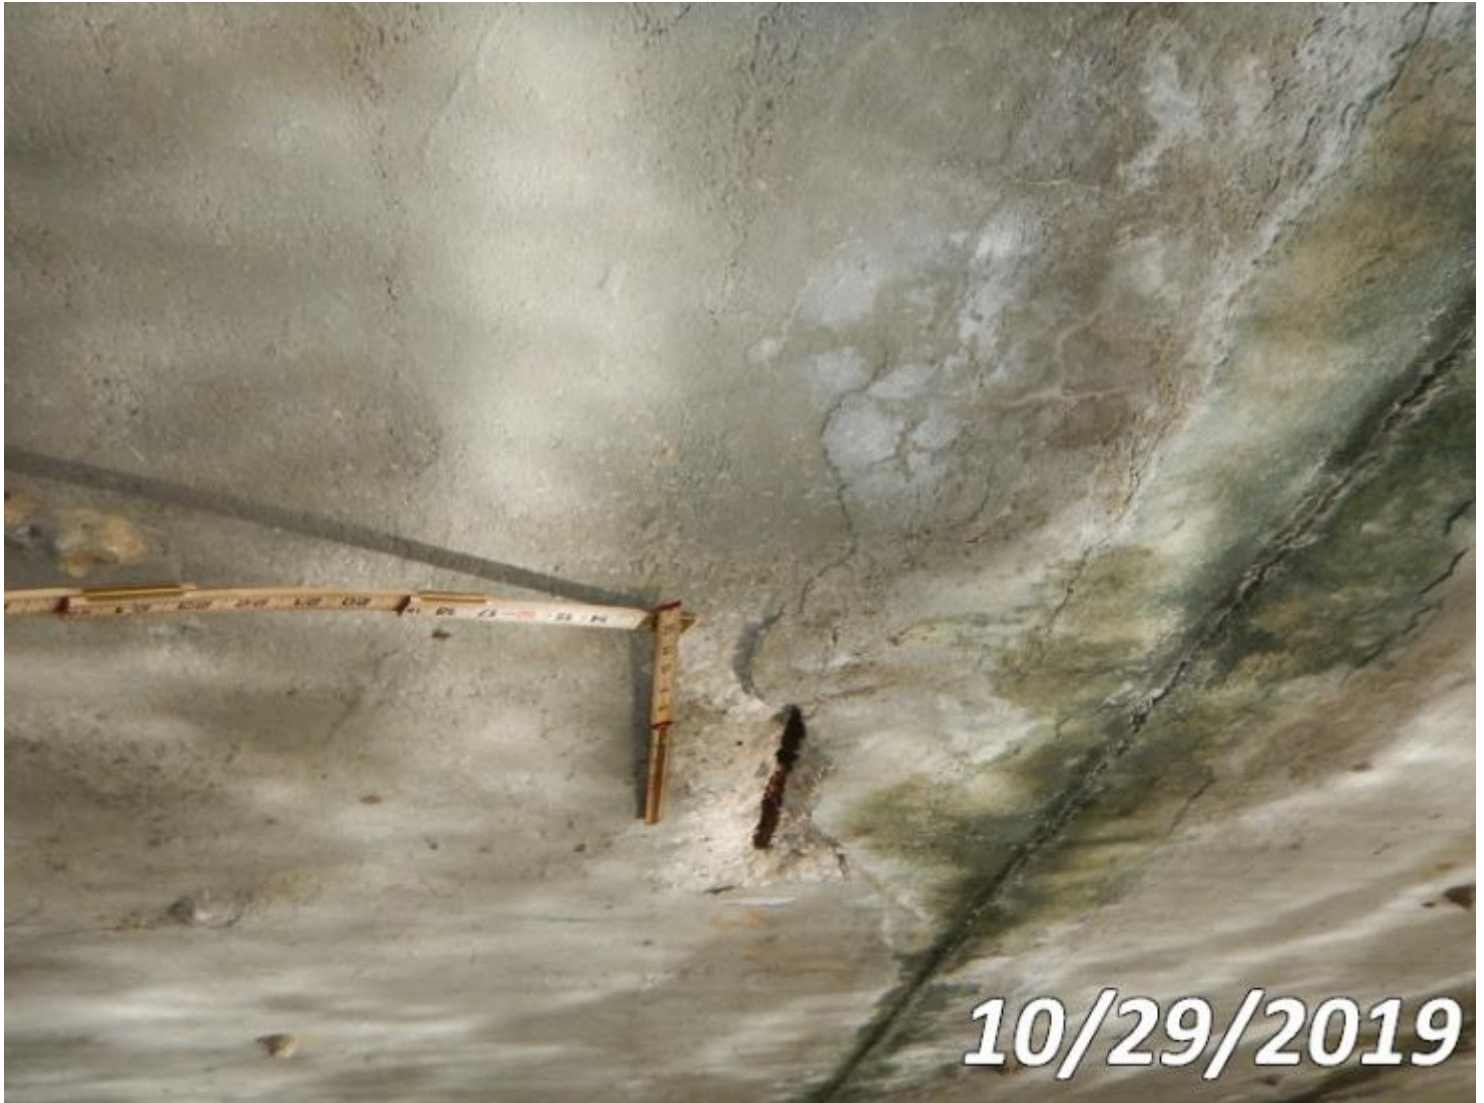
Photo 38-S02 (Unit 0: Re Concrete Slab)

2) Slab Unit 3-3 in the deck underside at mid-span exhibits a spall/delamination over 30in. L x 8in. W x 1in. D with corroded exposed rebar (total 3sf.). NEW. See Photo 38-S02.

Spall/delamination with exposed corroded rebar in the deck underside of Slab Unit 3-3 at midspan.

Repair spalls and delaminations in the deck underside of Slab Units 2-3 3-3 and 3-4.

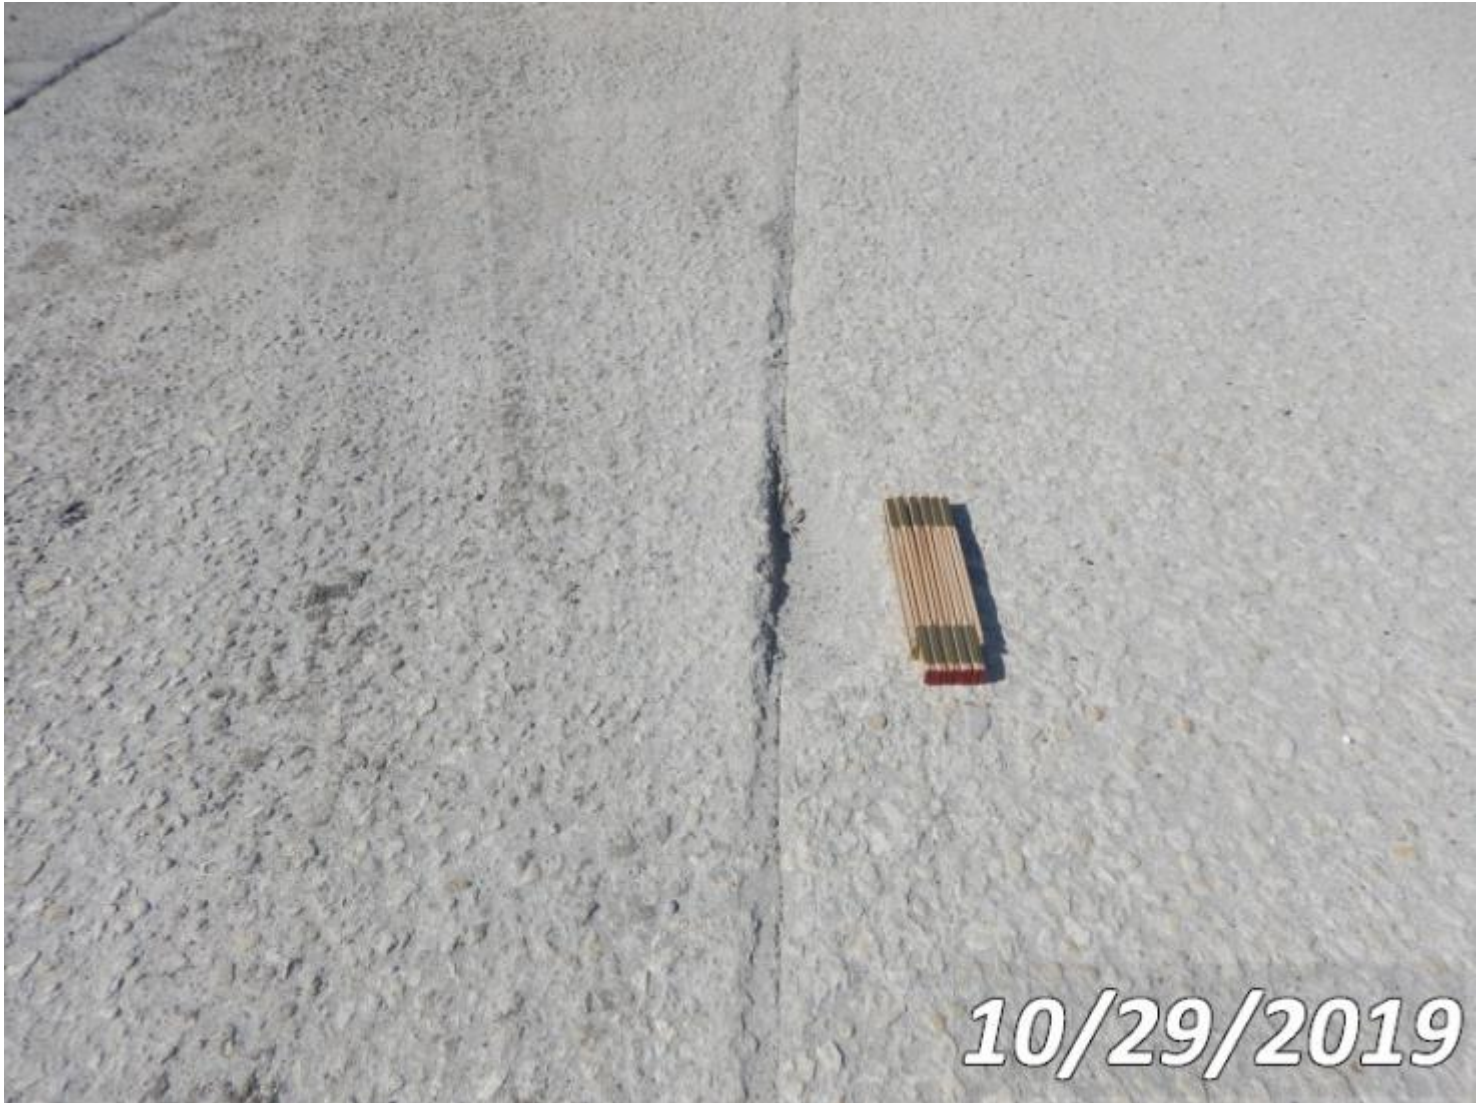
Photo 38-S03 (Unit 0: Re Concrete Slab)

3) The top of the slab units exhibit several edge spalls up to 8in. L x 3in. W x 1in. D with no exposed steel (total 20sf.). NO CHANGE. See Photo 38-S03.

Spalls with no exposed steel in the top of Slab Unit 1-3.

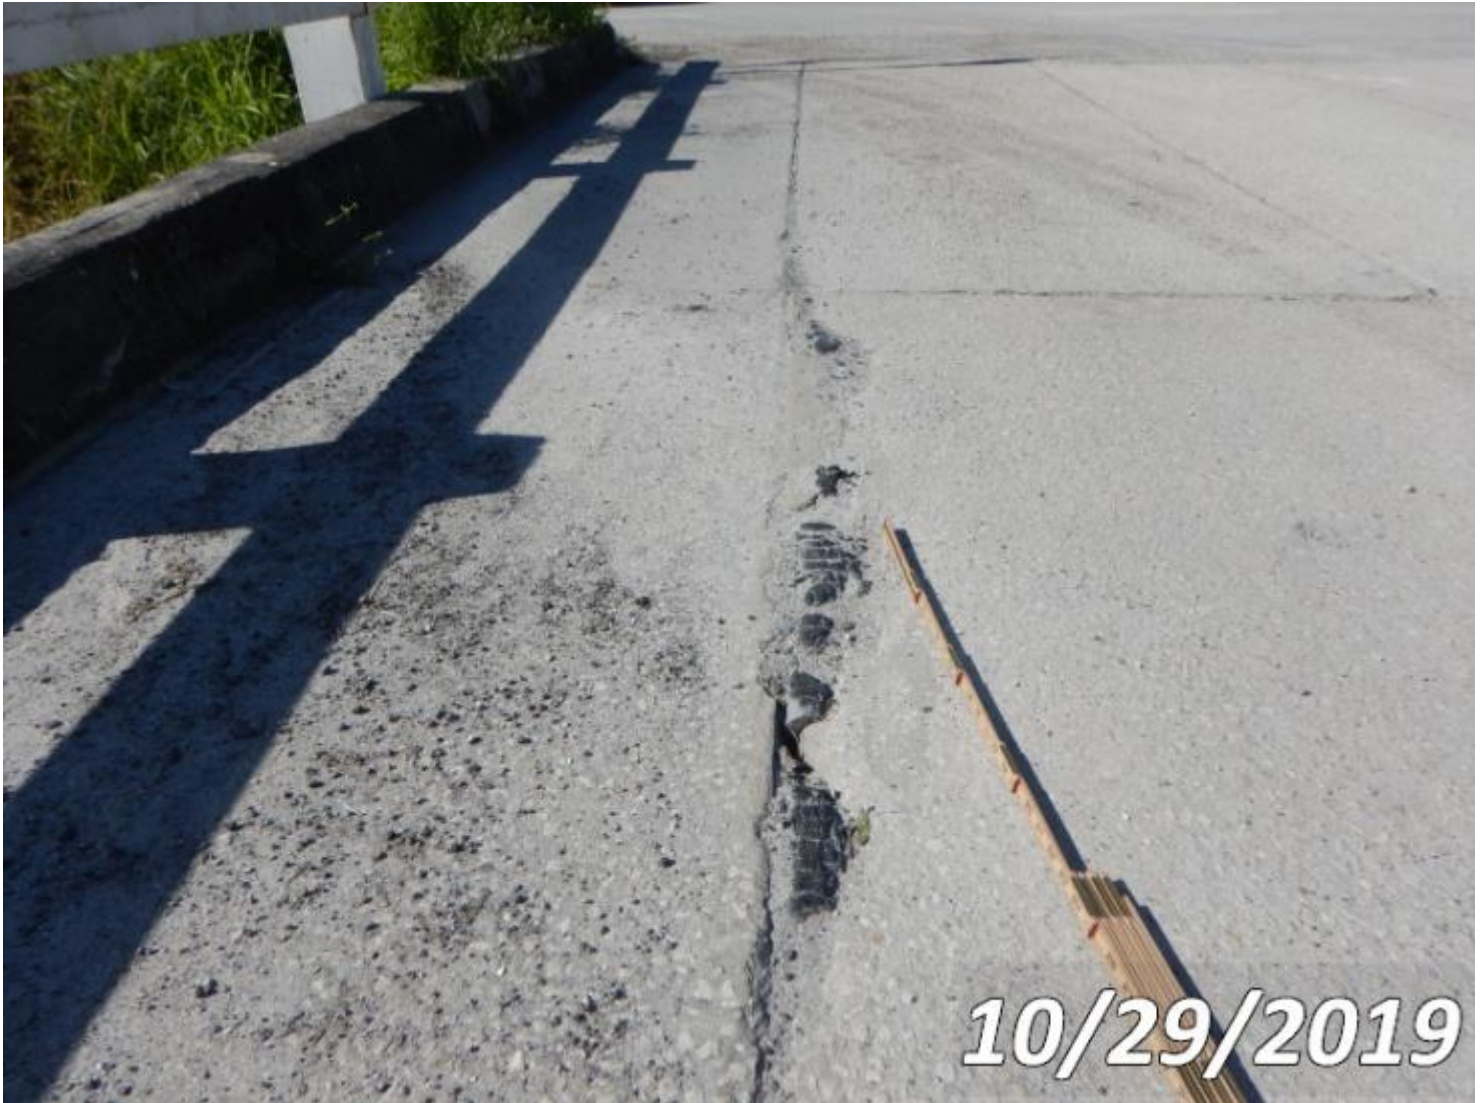
Photo 38-S04 (Unit 0: Re Concrete Slab)

4) The deck top along the longitudinal joints and in the edges are deteriorated sealant repair areas throughout the structure filled in spalls up to 7ft. L x 5in. W x 1in. D (total 195sf.). NO CHANGE. See Photo 38-S04.

Deteriorated joint seal in the deck top between Slab Units 2-4 and 2-5.

Repair deteriorated joint seals in the deck top between the slab units.

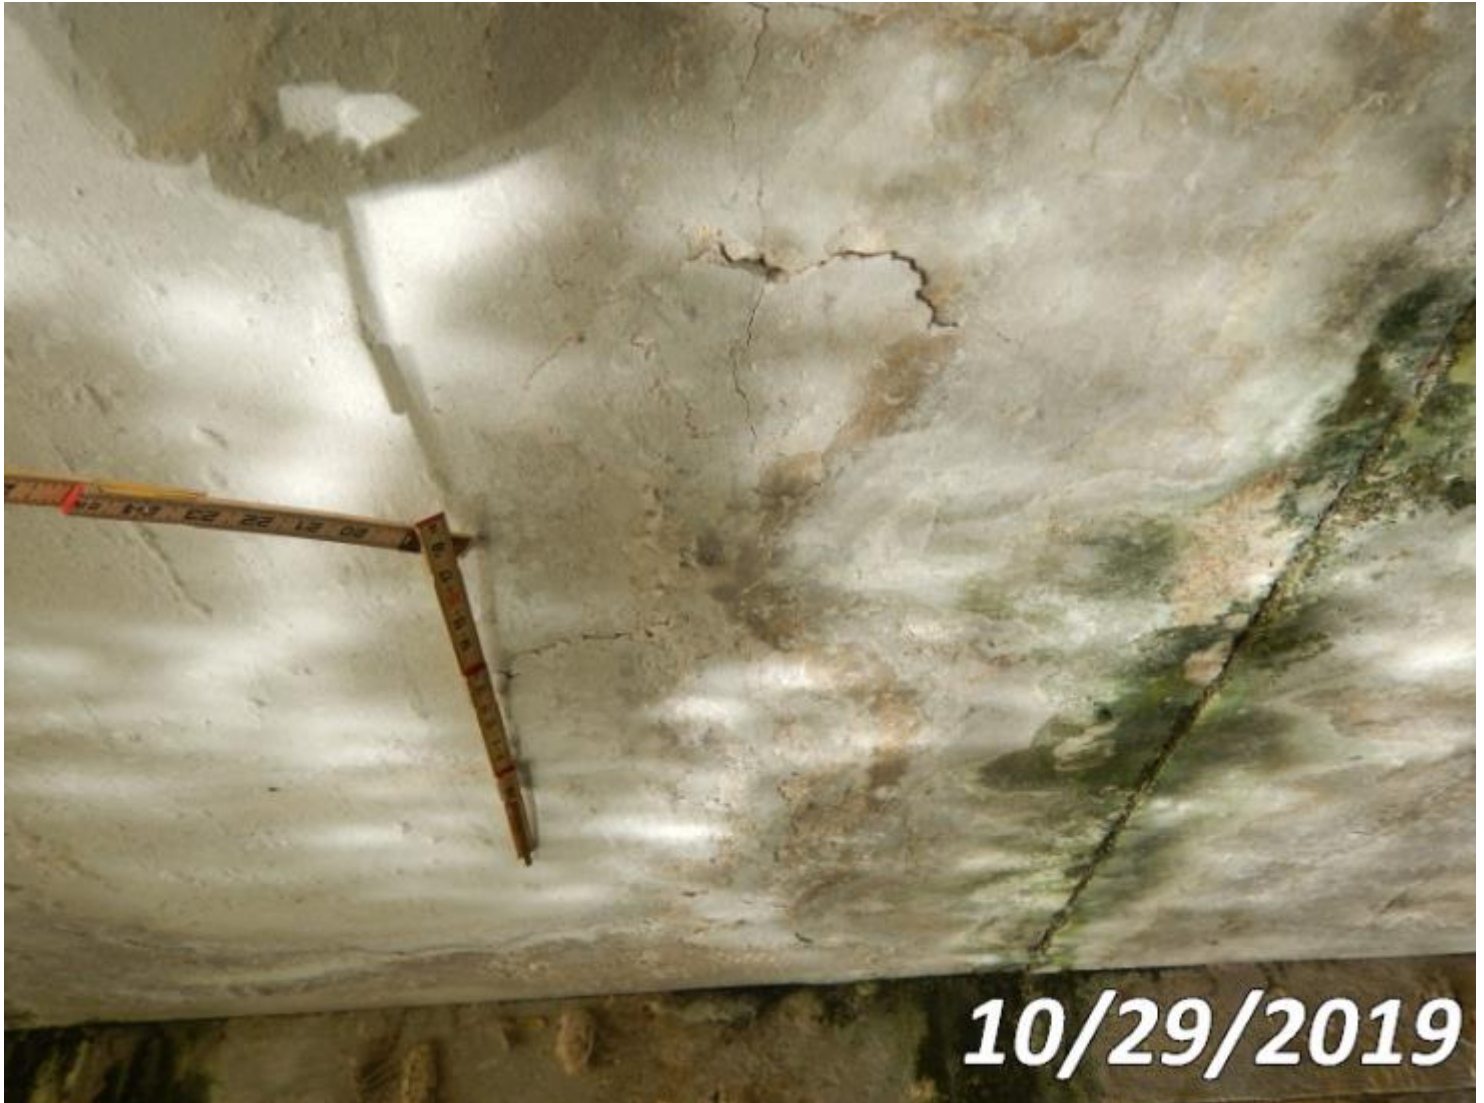
Photo 38-S05 (Unit 0: Re Concrete Slab)

5) Slab Unit 2-3 in the deck underside exhibits a delamination 5ft. L x 6ft. W adjacent to Bent 2 (total 5sf.). NO CHANGE. See Photo 38-S05.

Delamination in the deck underside of Slab Unit 2-3 adjacent to Bent 2.

Repair spalls and delaminations in the deck underside of Slab Units 2-3 3-3 and 3-4.

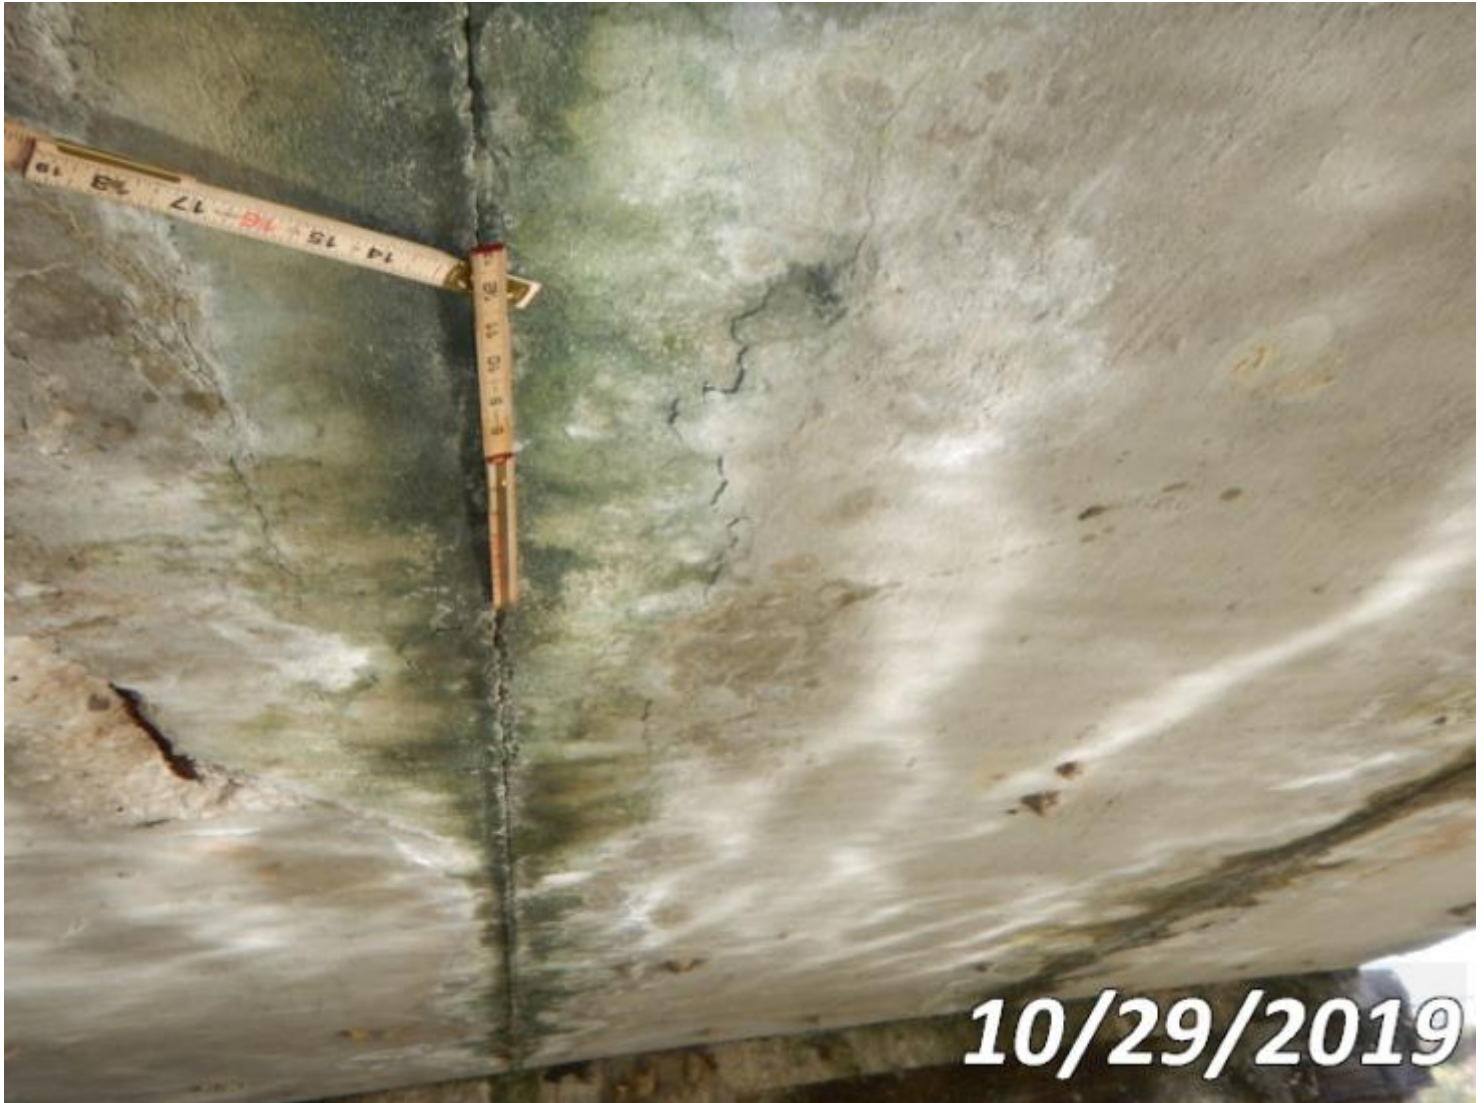
Photo 38-S06 (Unit 0: Re Concrete Slab)

6) Slab Unit 3-4 in the deck underside at mid-span exhibits a delamination over 30in. L x 8in. W (total 3sf.). NEW. See Photo 38-S06.

Delamination in the deck underside of Slab Unit 3-4.

Repair spalls and delaminations in the deck underside of Slab Units 2-3 3-3 and 3-4.

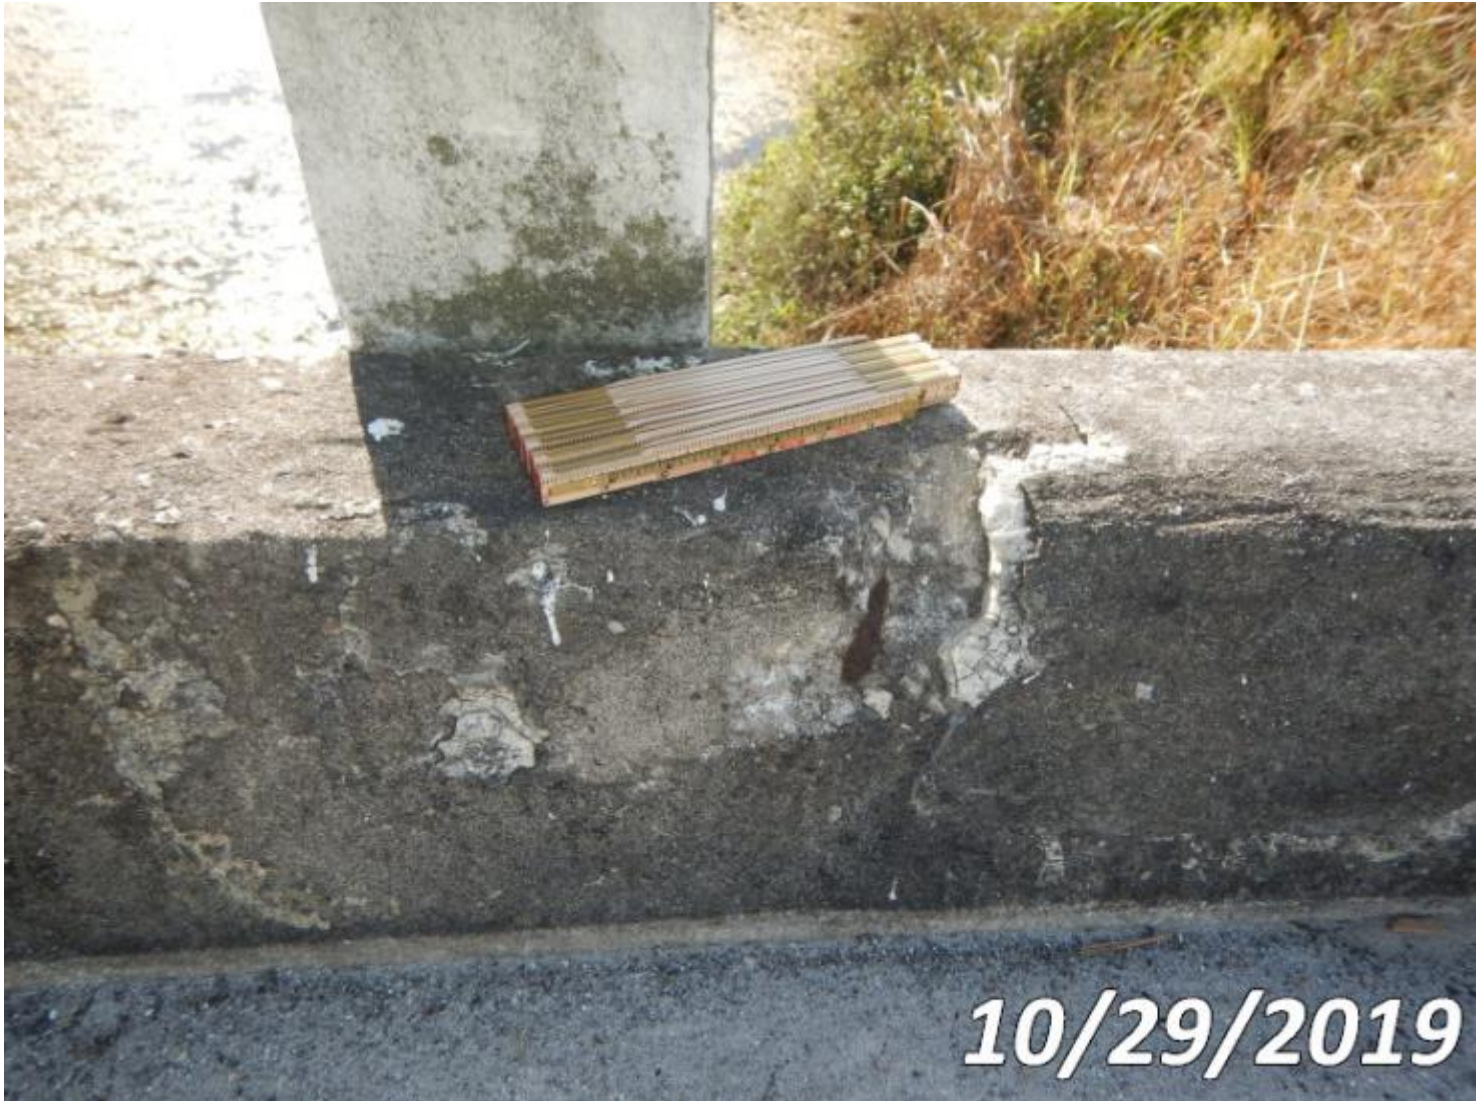
Photo 38-S07 (Unit 0: Re Concrete Slab)

8) The curbs have vehicle impact-related edge spalls up to 9in. L x 4in. W x 1in. D with exposed corroded steel throughout (total 7sf.). NO CHANGE. See Photo 38-S07.

Spall with exposed corroded steel in the right curb due to impact damage.

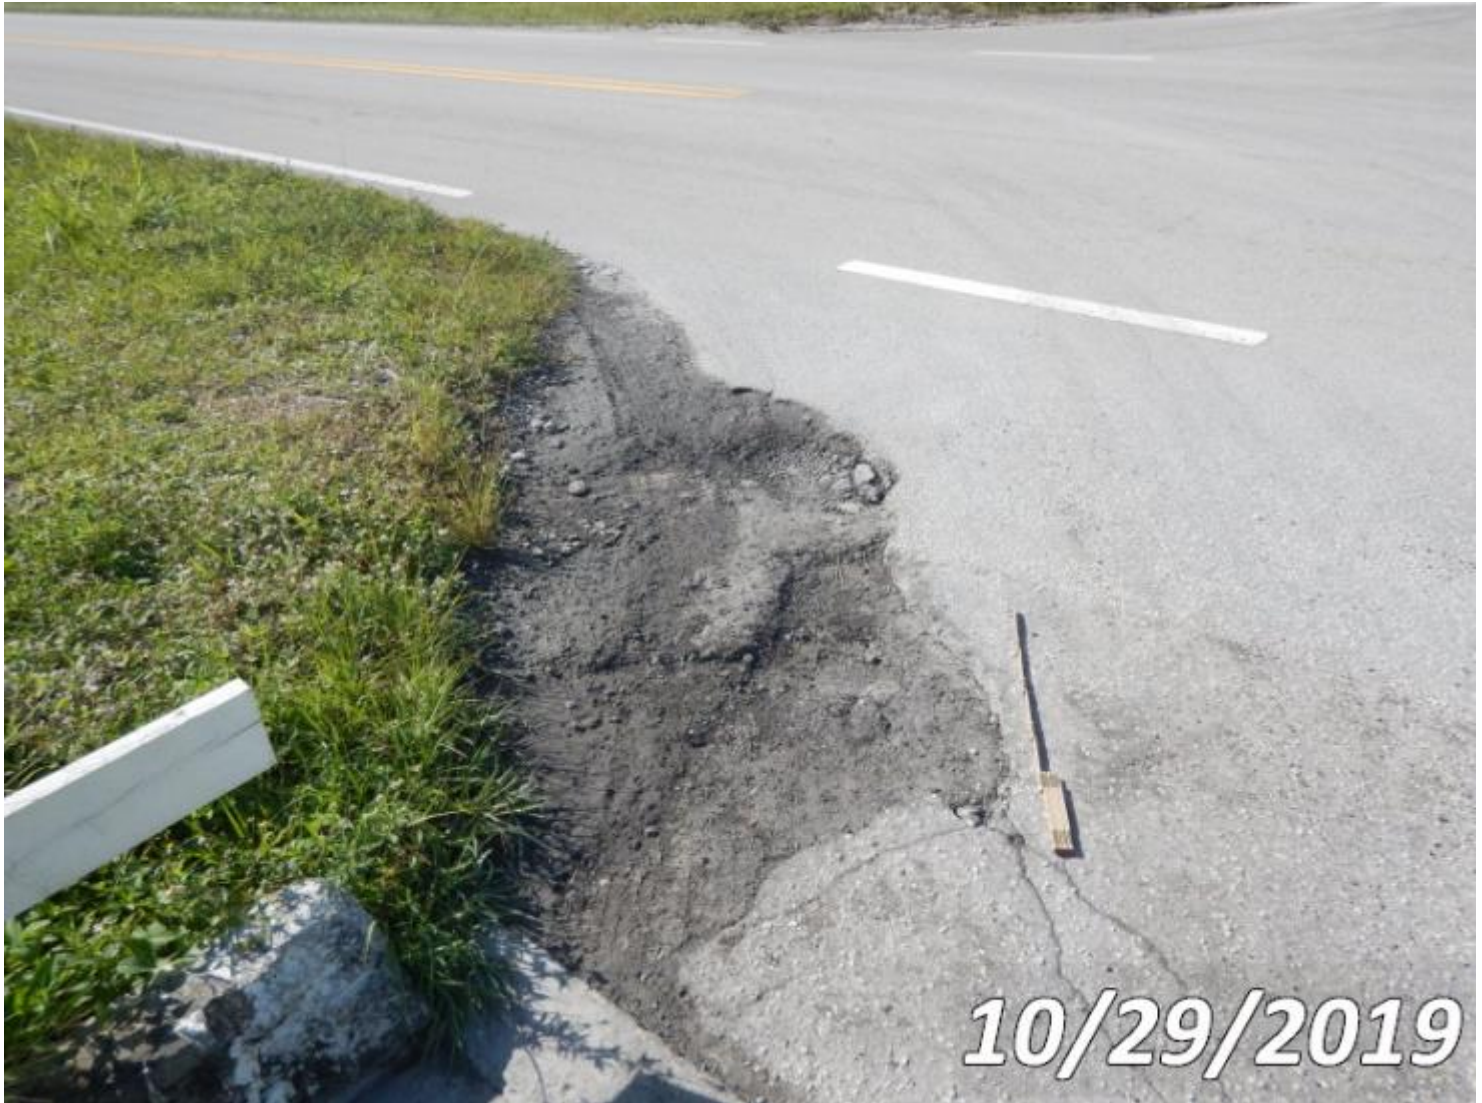
Photo 38-S08 (Unit 0: Re Concrete Slab)

12) There is an area of missing asphalt at the southwest corner of the approach roadway over 8ft. L x 4ft. W. NEW. See Photo 38-S08.

Missing asphalt at the southwest corner of the approach roadway.

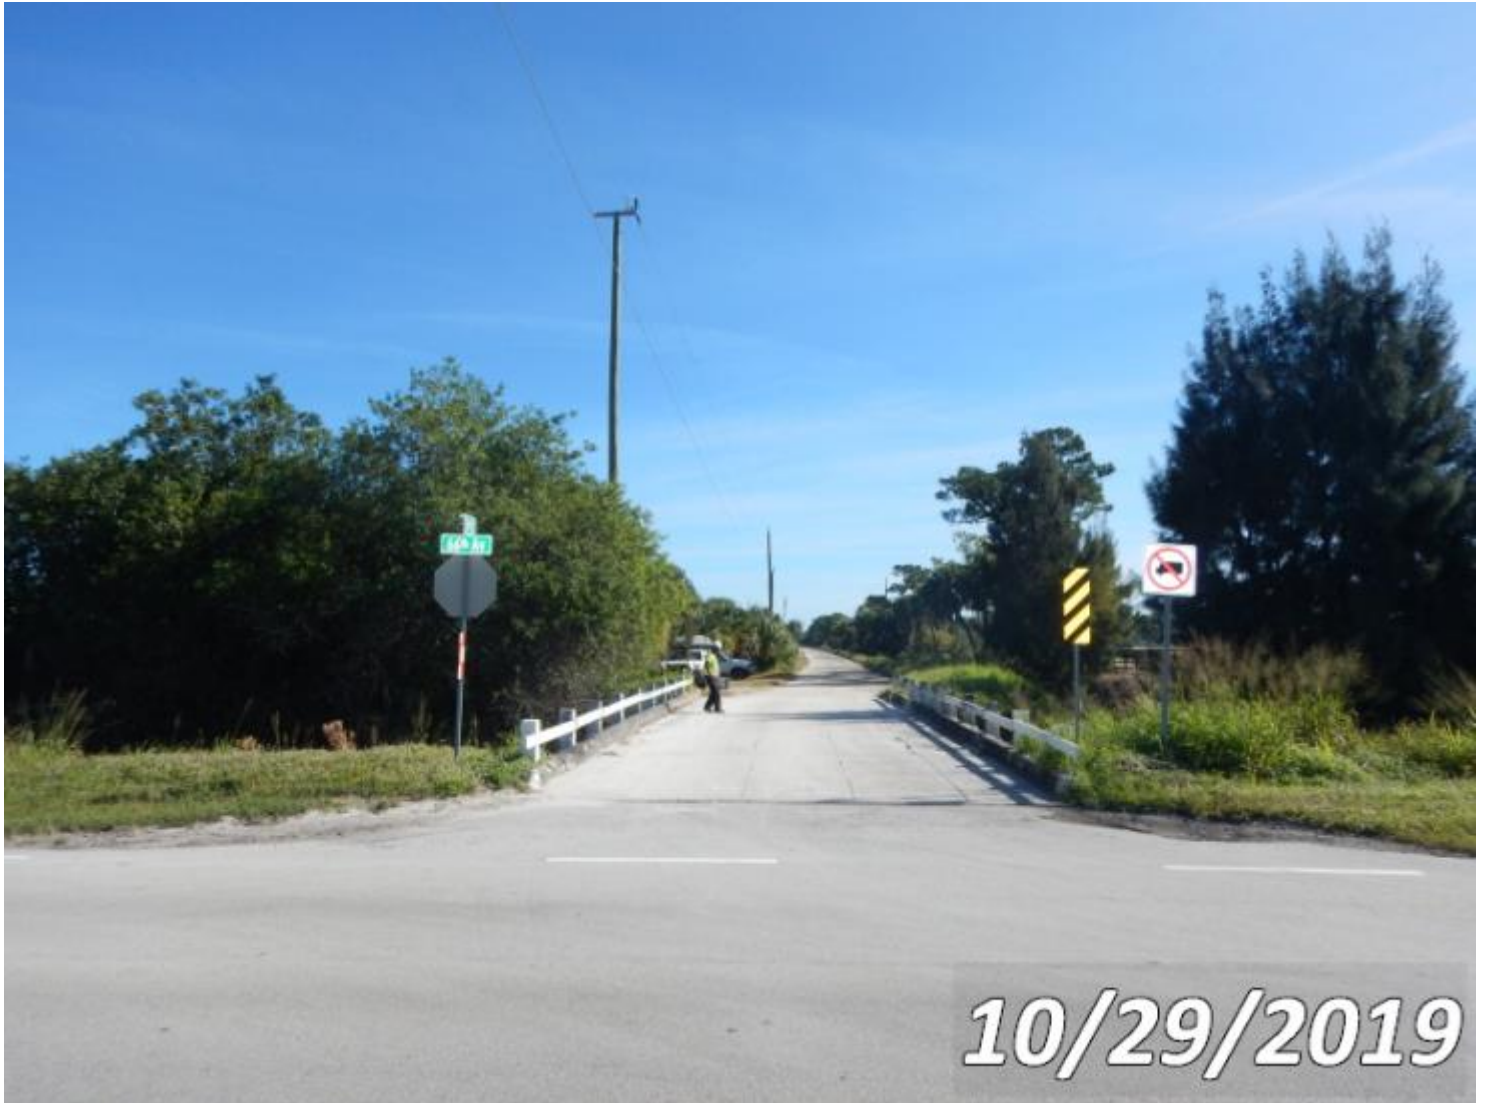
Photo 38-S09 (Unit 0: Re Concrete Slab)

13) There is no object marker at the northwest (off-going), northeast and southeast corner of the structure. NO CHANGE. See Photo 38-S09.

No object marker at the northwest corner of the structure.

CONDITION STATE		PRIORITY
1	MMS Quantity: 1 lf Element Estimated Quantity: 1 ft WORK ORDER RECOMMENDATION: Install approach guardrails at all four corners of the bridge.	3
1	MMS Quantity: 1 lf Element Estimated Quantity: 2 ft WORK ORDER RECOMMENDATION: Repair spalls in the west face of Post 1-2 right and Post 2-1 left.	3

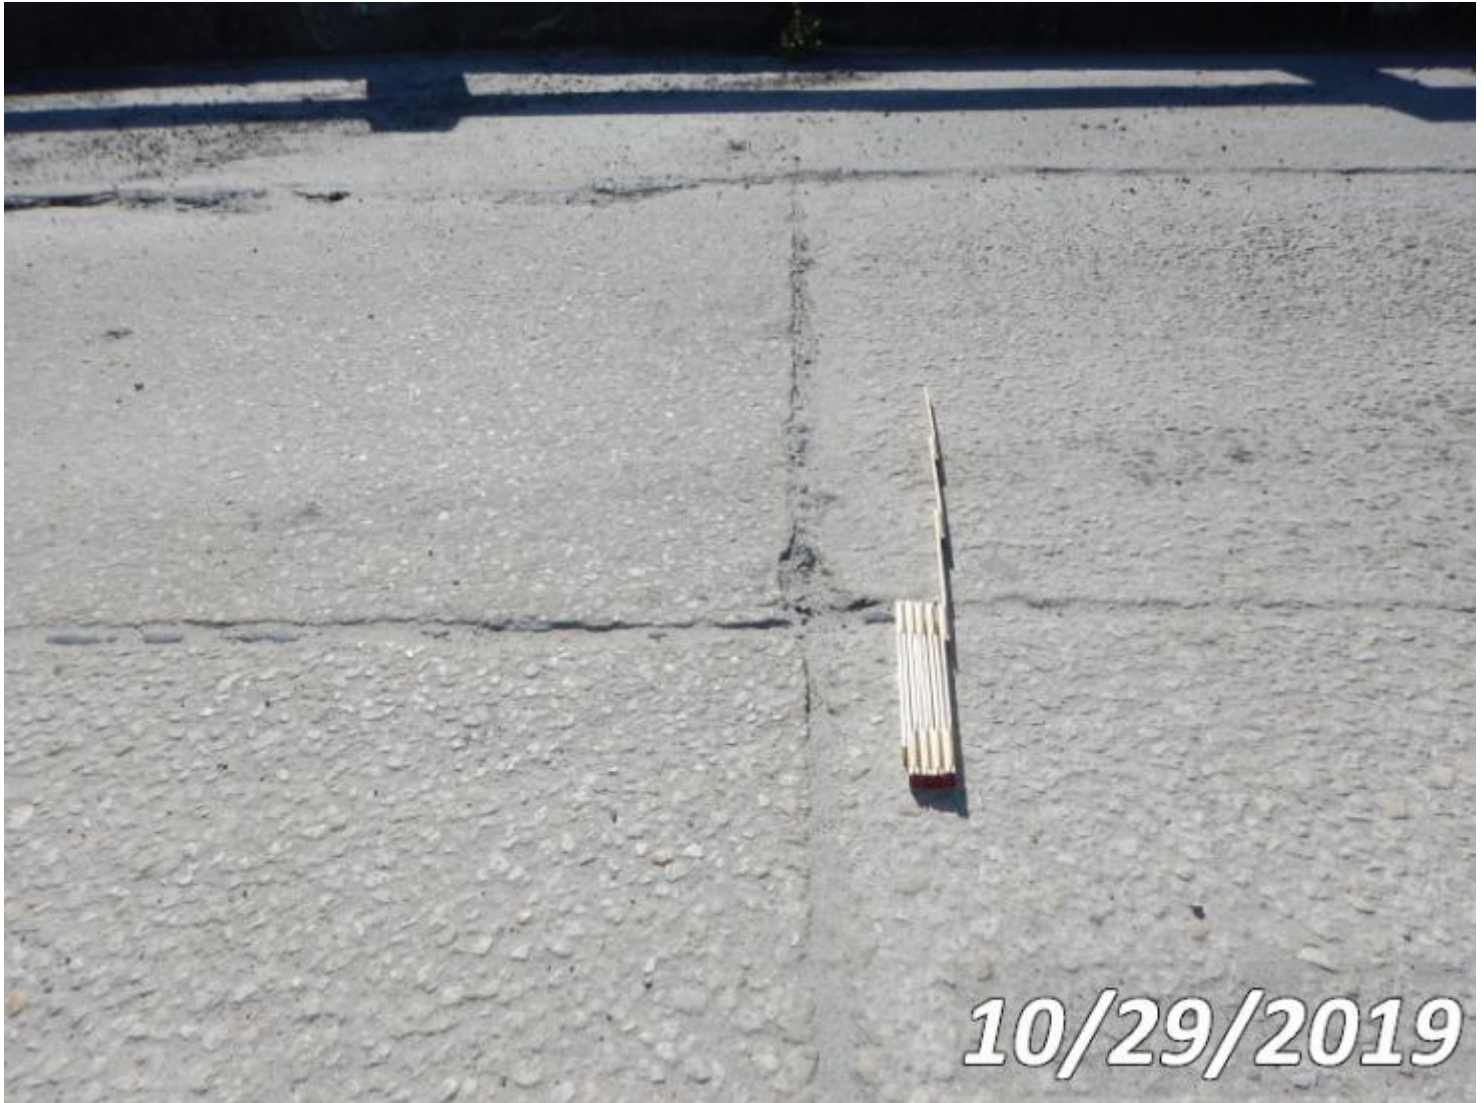
Photo 301-S01 (Unit 0: Pourable Joint Seal)

301/3 CS3:
1) The hot poured sealant within the joints exhibits deterioration up to 16ft. L throughout (total 126ft.). Previously noted as 6ft. L. INCREASE. See Photo 301-S01.

Deteriorated joint seal along Bent 2.

Repair deteriorated joint seals throughout the bridge.

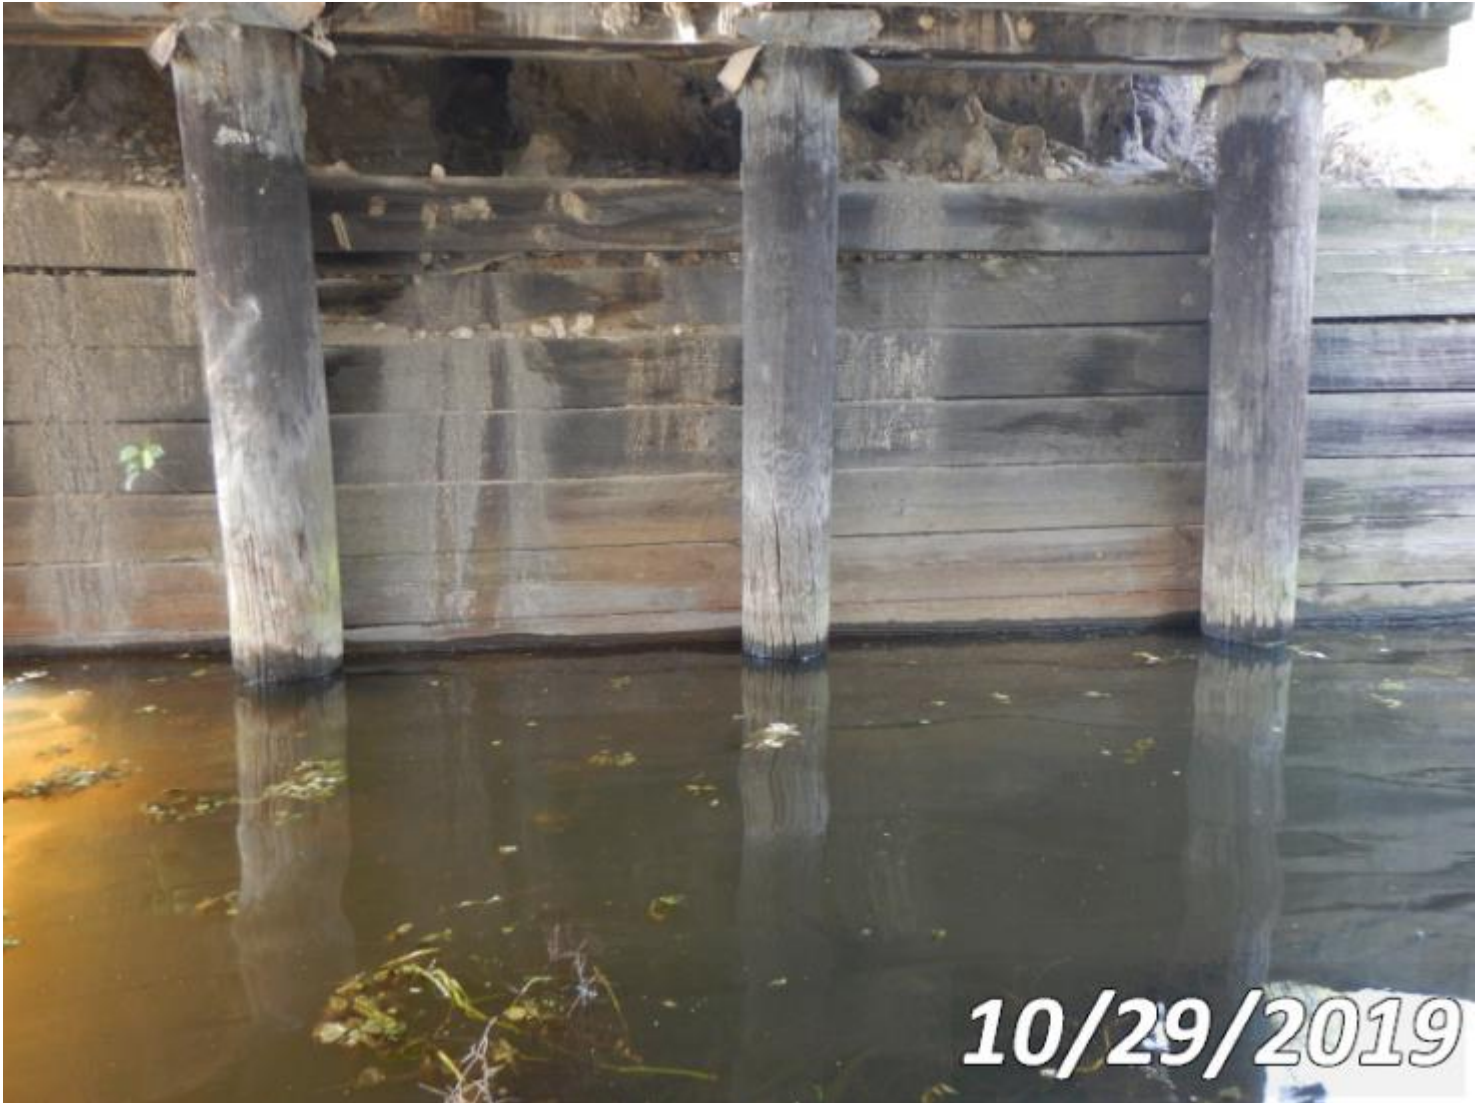
Photo 228-S01 (Unit 0: Timber Pile)

2) Four piles at Bent 2 have weathering splits up to 2ft. L x 1/8in. W (total 4ea.). NO CHANGE. See Photo 228-S01.

Splits in the Piles 2-1 thru 2-3.

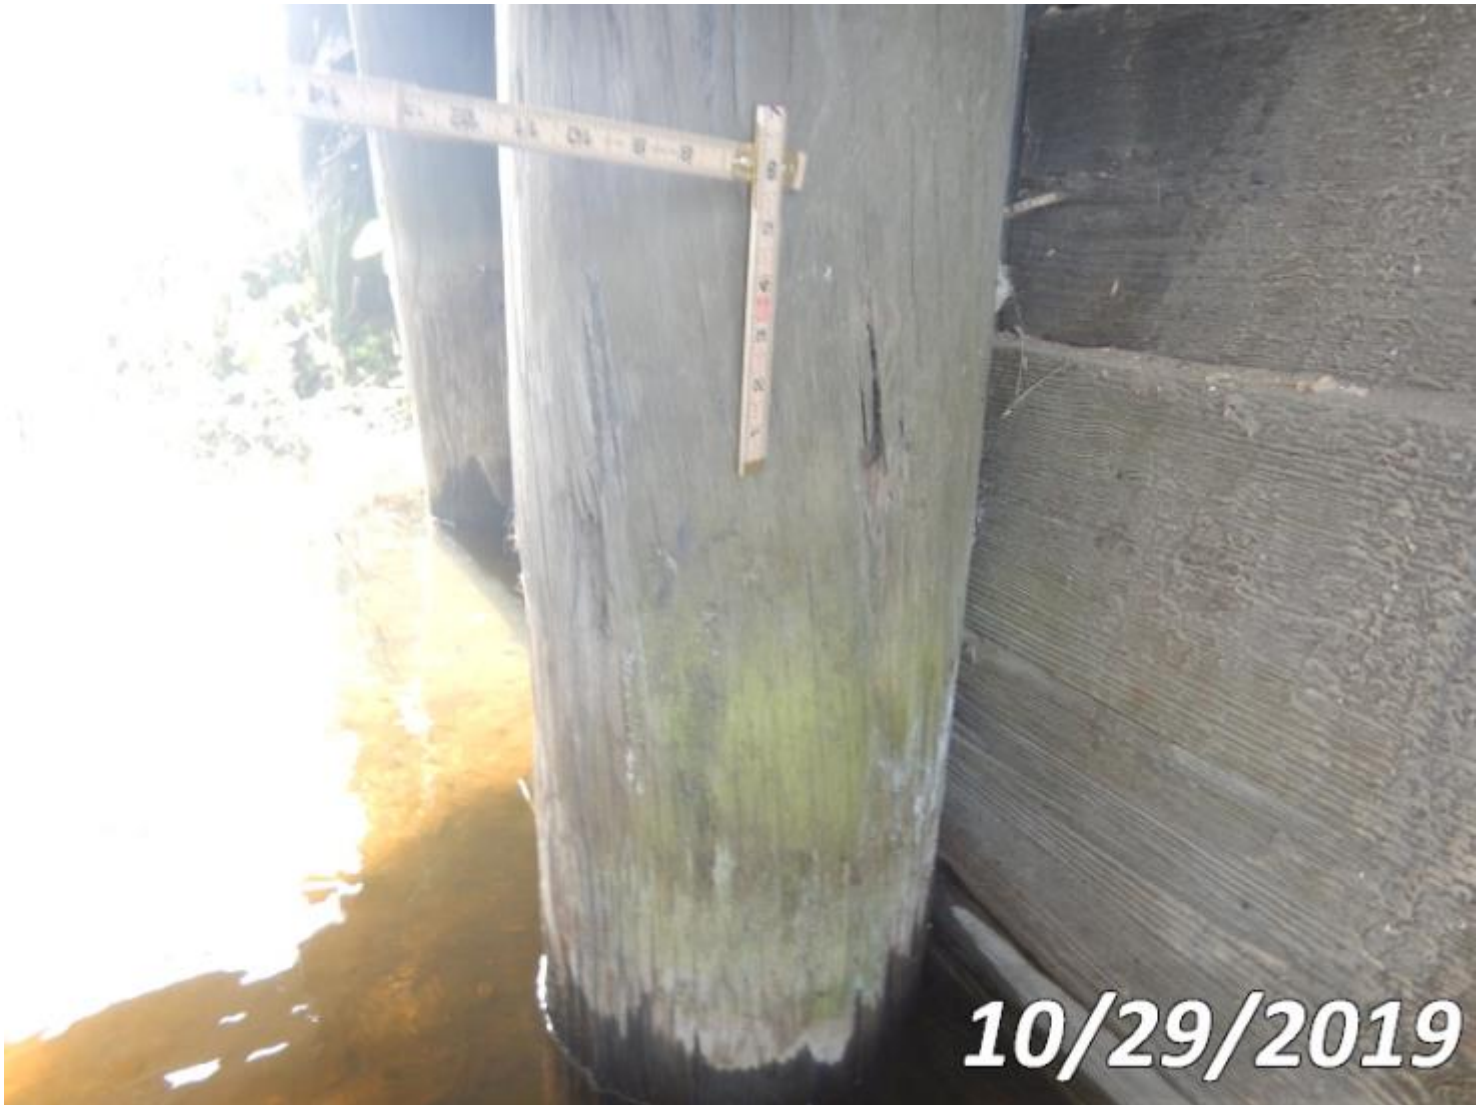
Photo 228-S02 (Unit 0: Timber Pile)

3) Pile 2-3 north and east quadrants have splintered areas up to 1ft. L x 6in. W x 1in. D, starting at the waterline (total 1ea.). NO CHANGE. See Photo 228-S02.

Splintered area in the north quadrant of Pile 2-3, starting at the waterline.

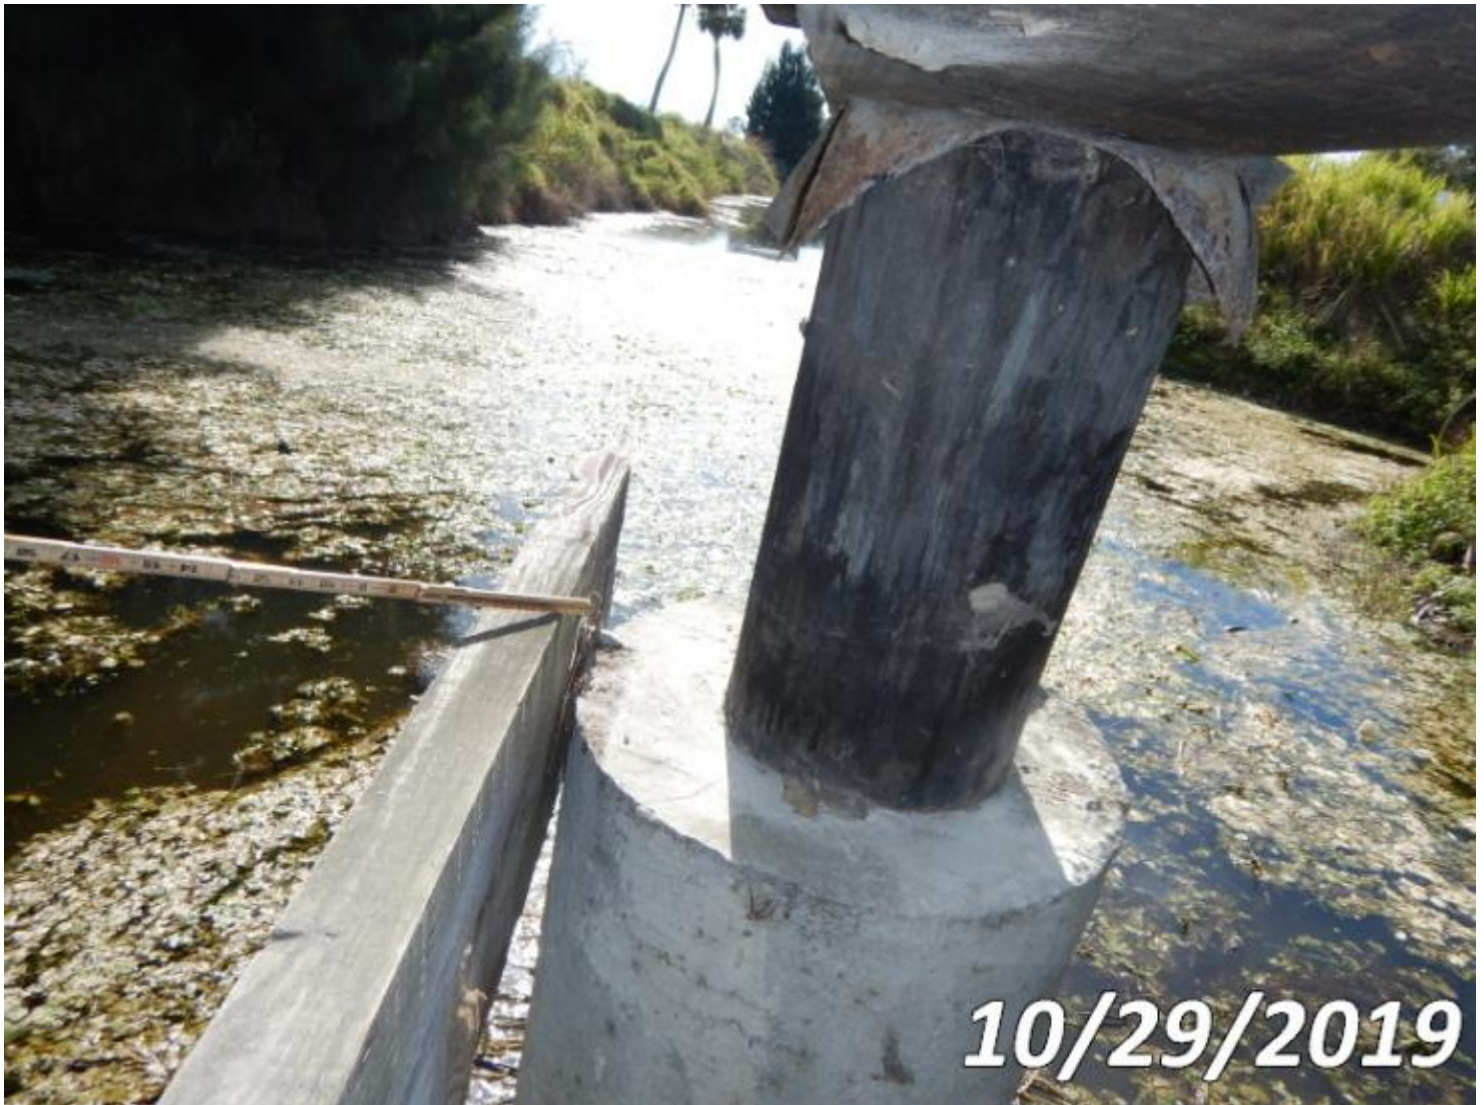
Photo 228-S03 (Unit 0: Timber Pile)

6) The cross brace at Bent 3 is disconnected at Pile 3-5. NEW. See Photo 228-S03.

Disconnected cross brace from Pile 3-5 at Bent 3.

CONDITION STATE		PRIORITY
2, 3, 4	MMS Quantity: 1 mh Element Estimated Quantity: 1 (EA)	3
WORK ORDER RECOMMENDATION: Reconnect the cross brace to Pile 3-5 at Bent 3.
