**FLORIDA DEPARTMENT OF TRANSPORTATION
BRIDGE MANAGEMENT SYSTEM
Inspection/CIDR/Bridge Profile Report
Inspection**

Structure ID: 884036

TYPE OF INSPECTION: Regular NBI

STRUCTURE NAME: Not recorded
 YEAR BUILT: 1965
 SECTION NO.: 88 000 407
 MP: 0.006
 ROUTE: 00000
 FACILITY CARRIED: 53RD STREET
 FEATURE INTERSECTED: LATERAL A CANAL

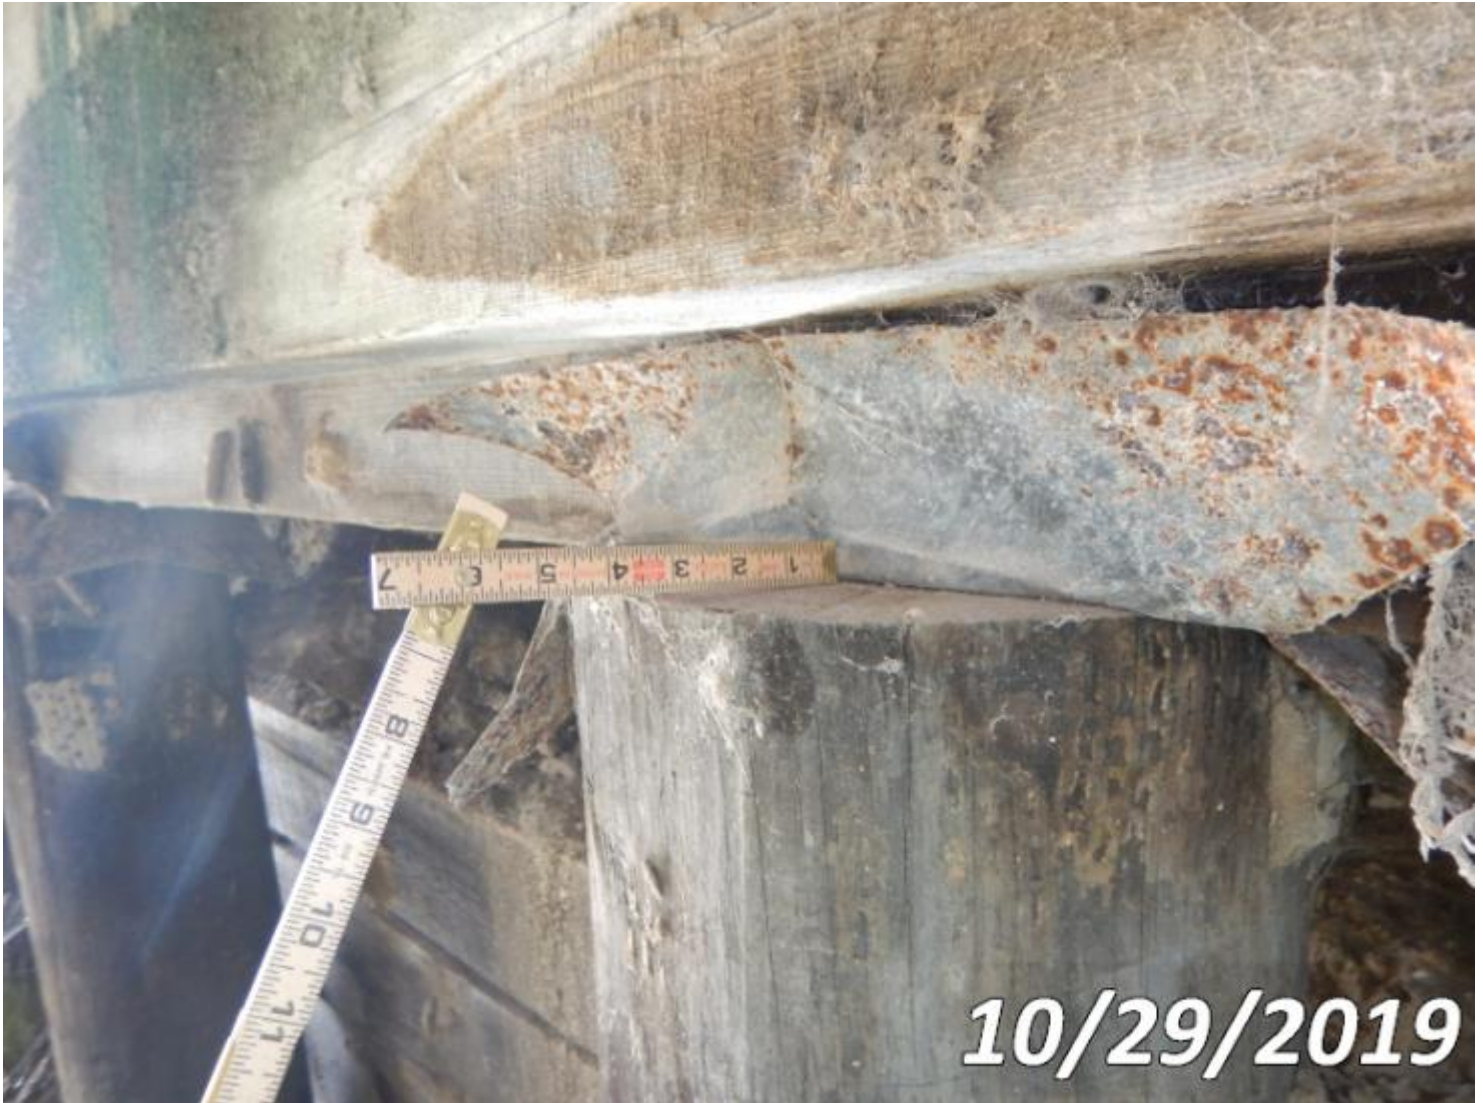
Photo 228-S04 (Unit 0: Timber Pile)

7) All five piles at Bent 2 have reduced bearing with the cap and it appears the piles have leaned/rotated to the east. NO CHANGE. This condition was first noted in the

11/02/05 report and may be due to pressure exerted by the timber backwall.

Pile 2-3 = 3in. (56%) - NO CHANGE SINCE 2005. See Photo 228-S04.

Measurement of the distance of the cap at Bent 2 to the east edge of Pile 2-3.

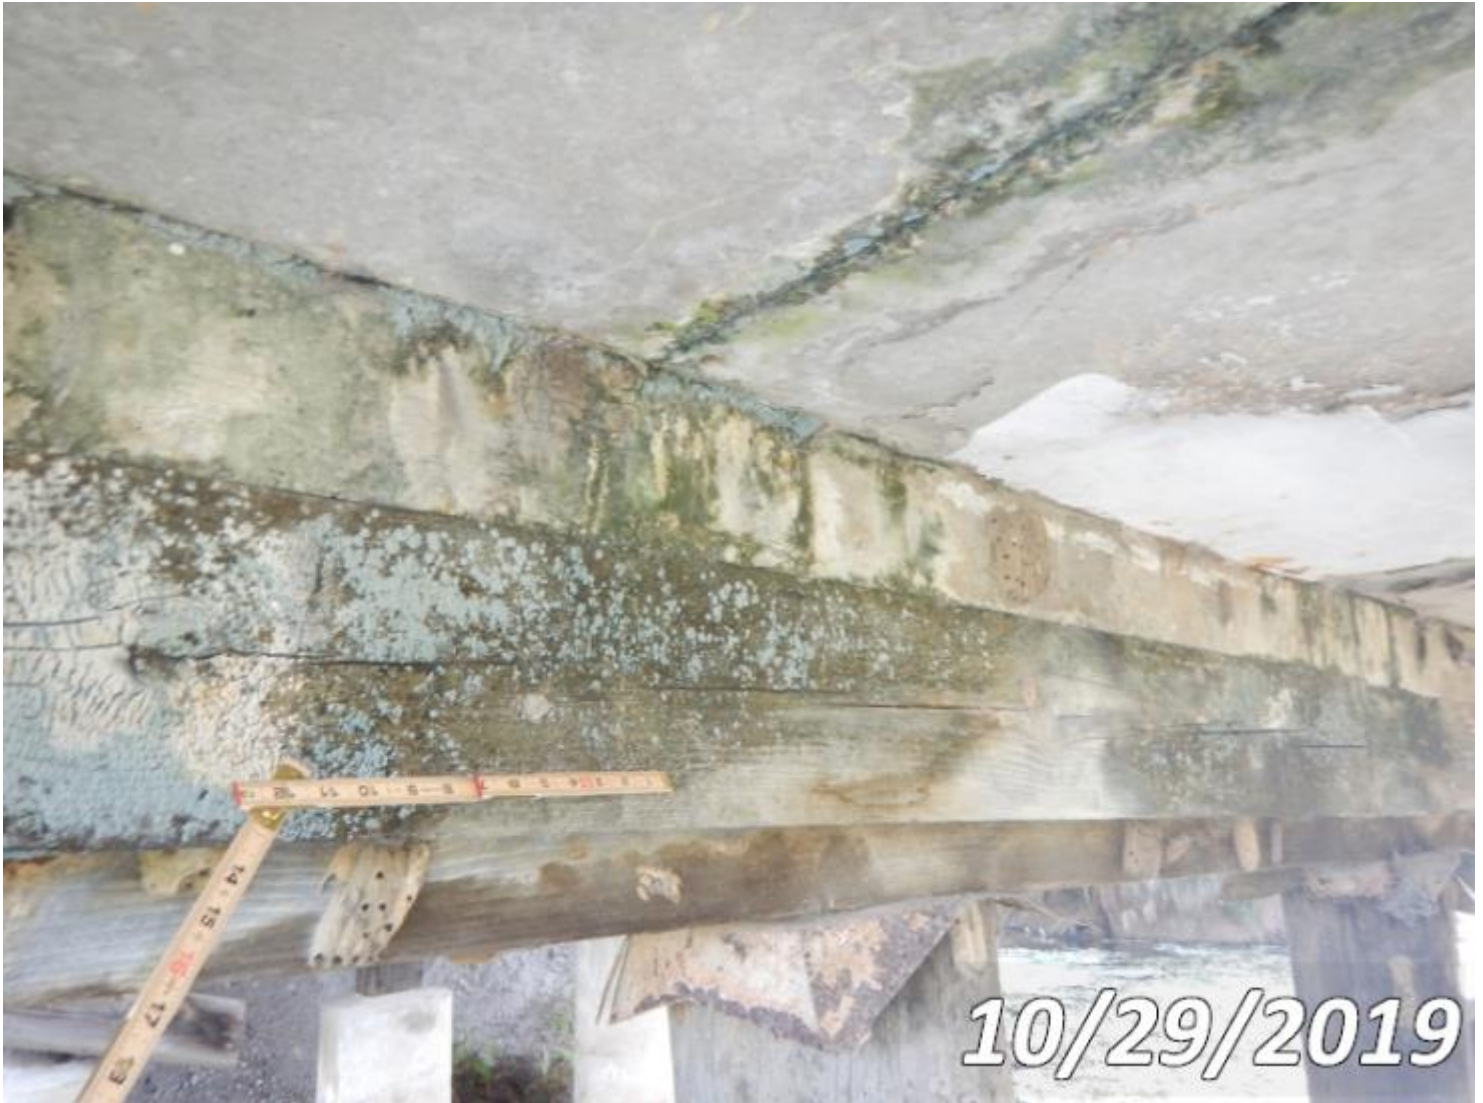
Photo 235-S01 (Unit 0: Timber Pier Cap)

2) The extension boards on the east face at the north end of the cap at Bent 2 has splitting up to 4ft. L x 1/8in. W (total 6ft.). NO CHANGE. See Photo 235-S01.

Splitting in the extension board on the east face north end of the cap at Bent 2.

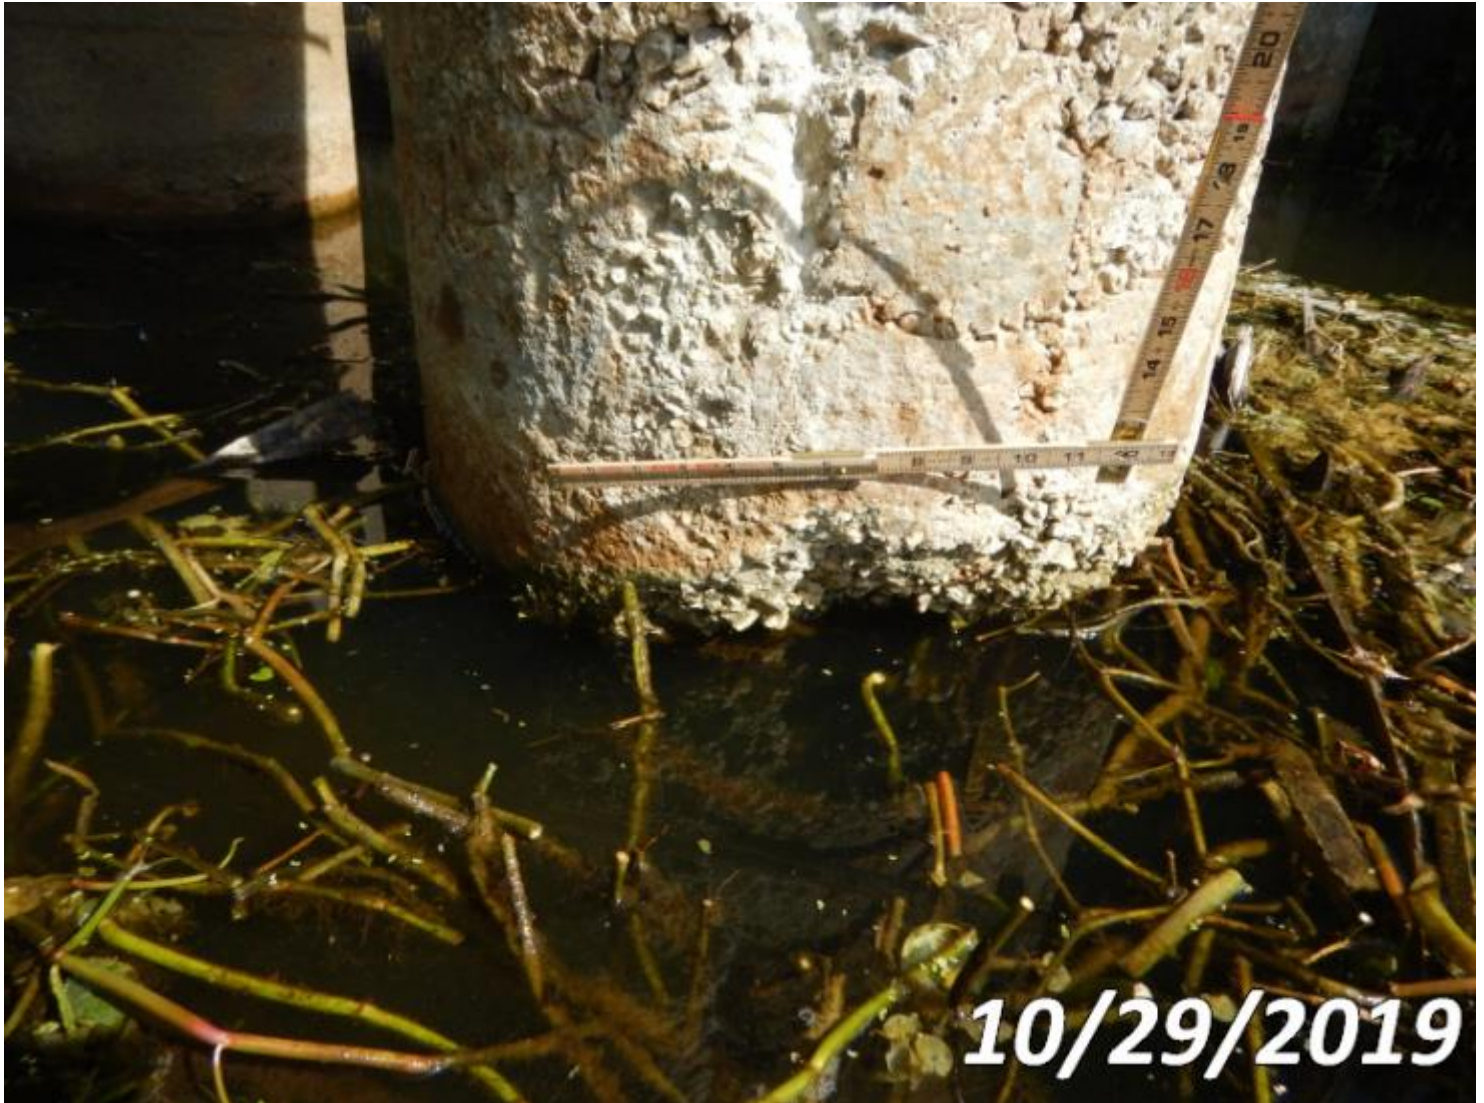
Photo 8298-S01 (Unit 0: Pile Jacket Bare)

1) The jackets for Piles 3-1, 3-3, 3-4 and 3-5 have spalling and honeycombing in the bottom 2ft. resulting in exposure of the wire mesh and rebar reinforcing (total 4ea.). NO CHANGE. See Photo 8298-S01.

Spalled in the lower portion of Pile Jacket 3-5.

Clean and repair spalls and honeycombing in Piles 3-1 3-3 3-4 and 3-5.

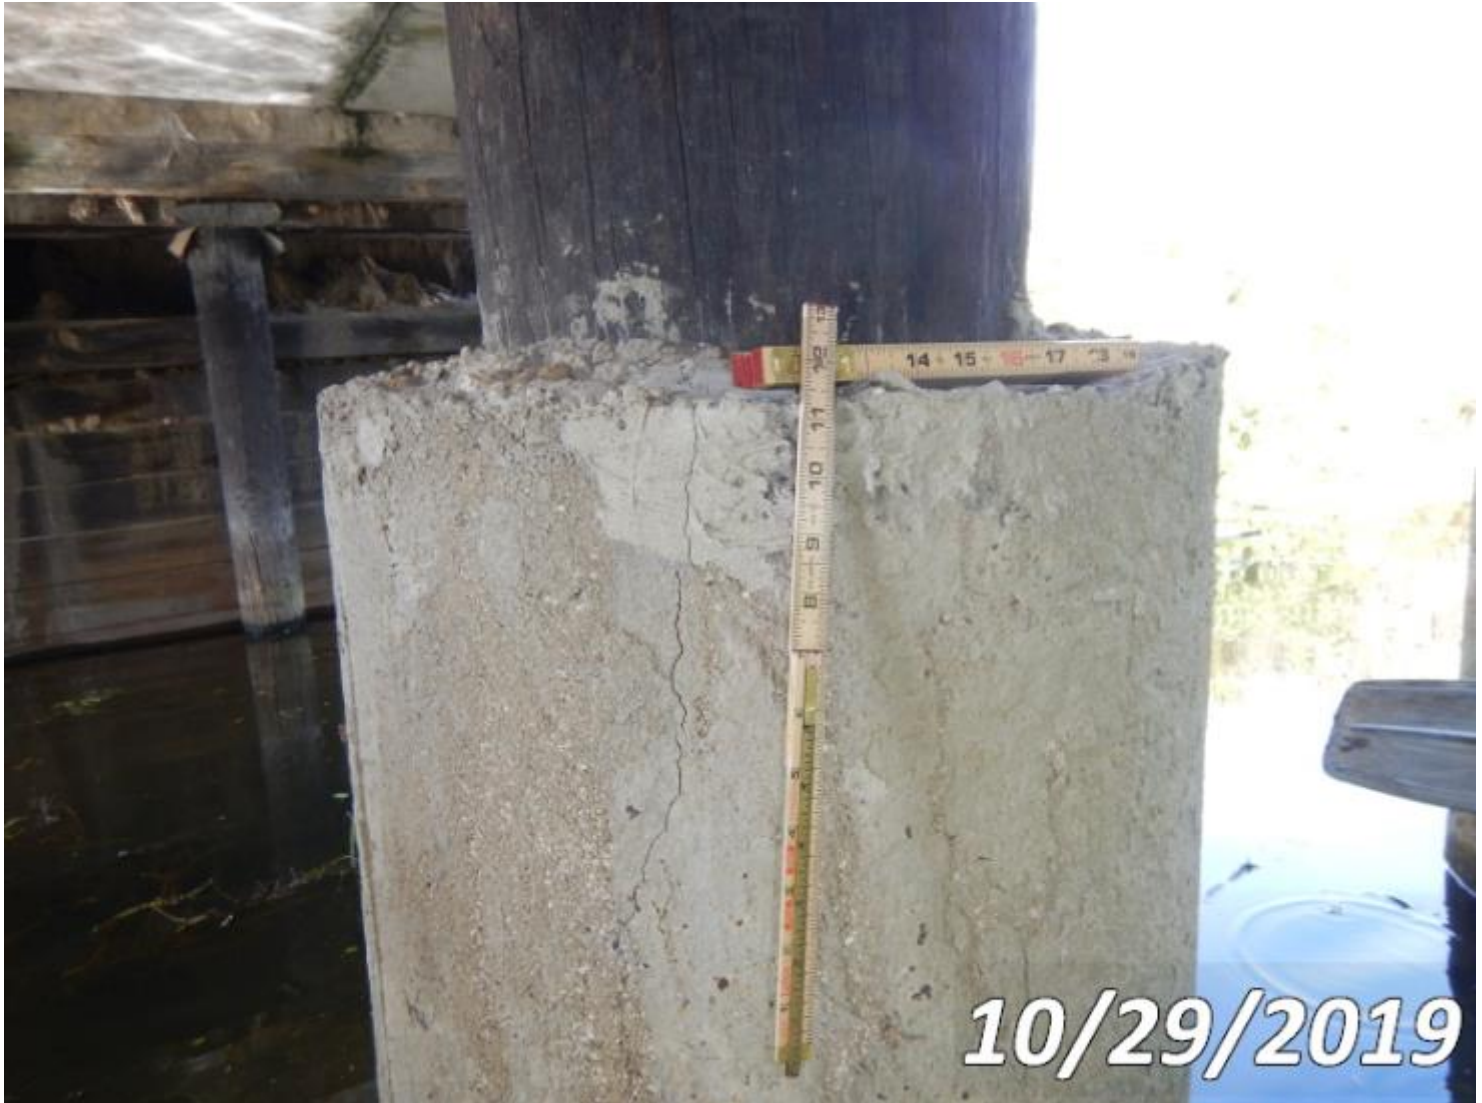
Photo 8298-S02 (Unit 0: Pile Jacket Bare)

3) The jackets have vertical shrinkage cracks up to 3ft. H x 1/64in. W. NO CHANGE. See Photo 8298-S02.

Vertical cracks in the Pile Jacket 3-2.

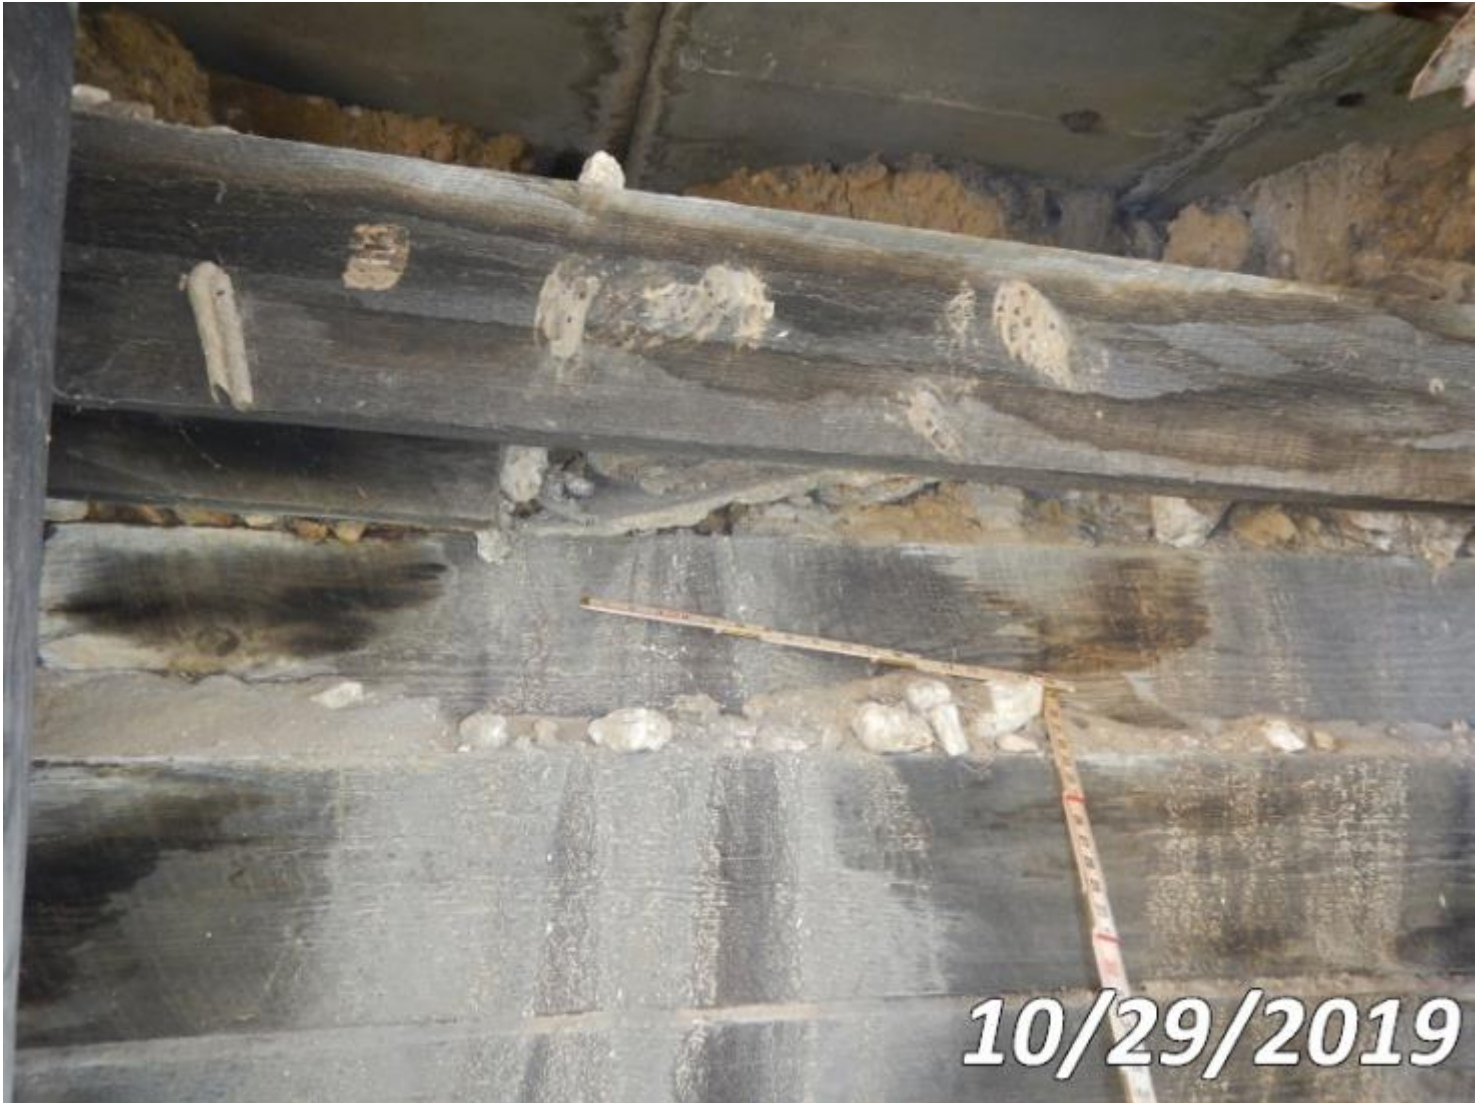
Photo 8395-S01 (Unit 0: Timber Abutment Slope Protection)

2) There are gaps between the boards are also allowing some fill leakage to occur. NO CHANGE. See Photo 8395-S01.

Gaps between the boards at the timber retaining wall at Bent 2.

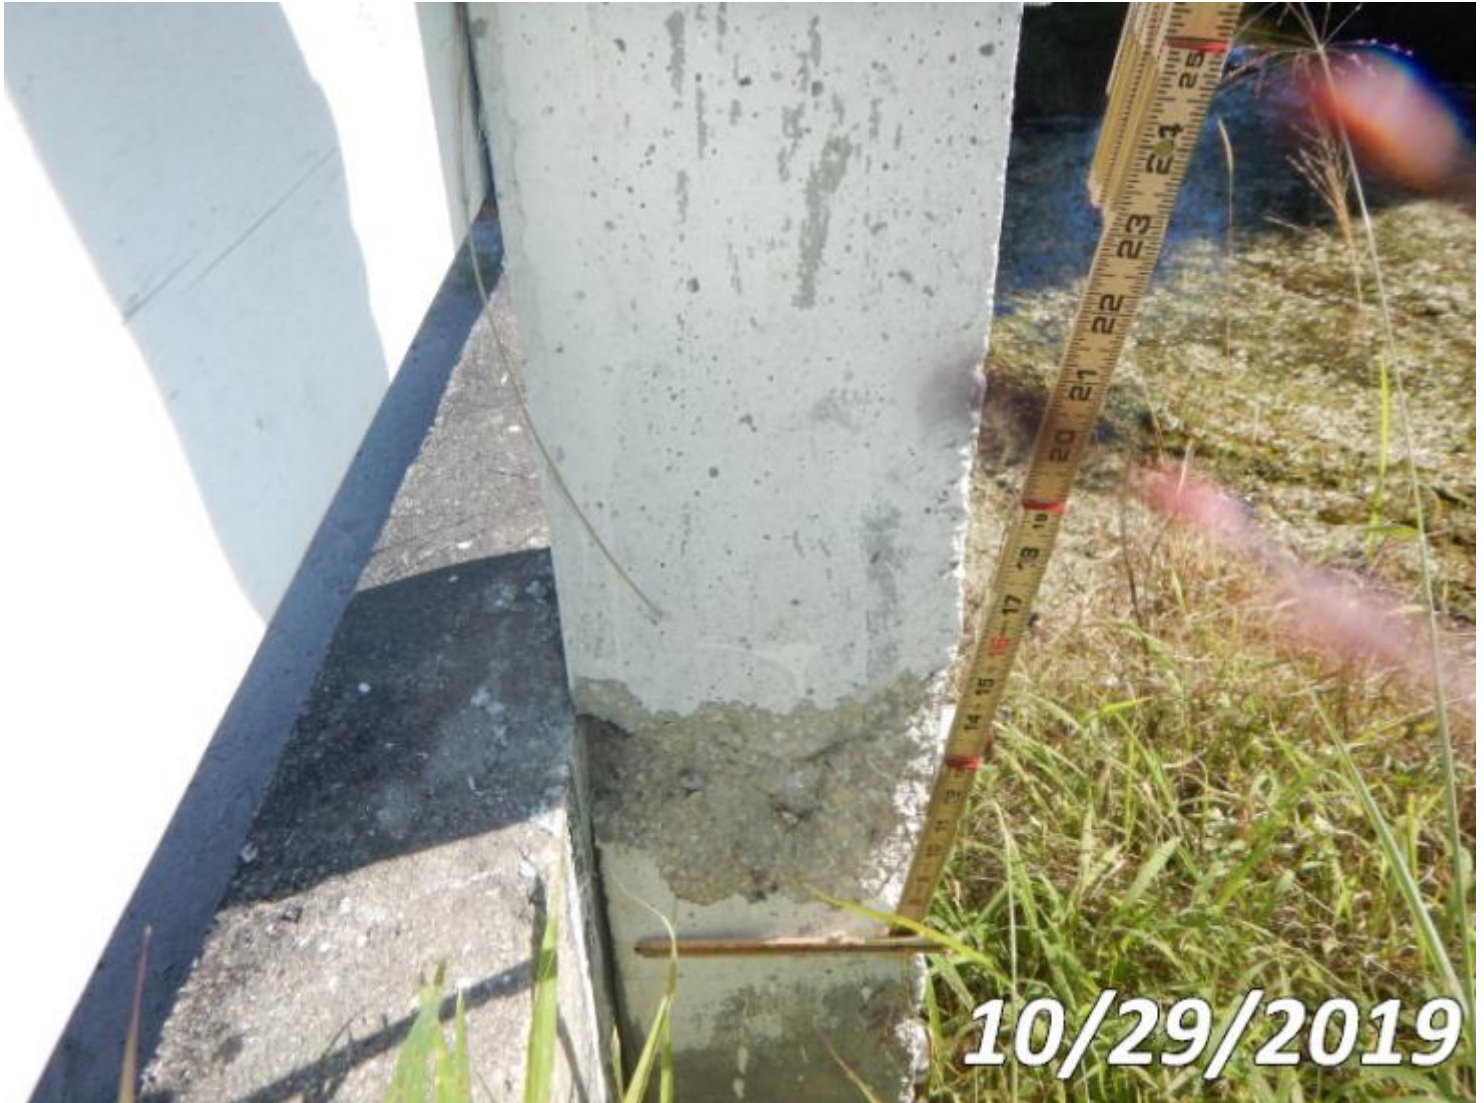
Photo 333-S01 (Unit 0: Other Bridge Railing)

1) Post 1-2 right in the west face exhibits a spall over 7in. L x 10in. H x 1in. D with no exposed steel. NEW. See Photo 333-S01.

Spall with no exposed steel in the west face of Post 1-2 right.

Repair spalls in the west face of Post 1-2 right and Post 2-1 left.

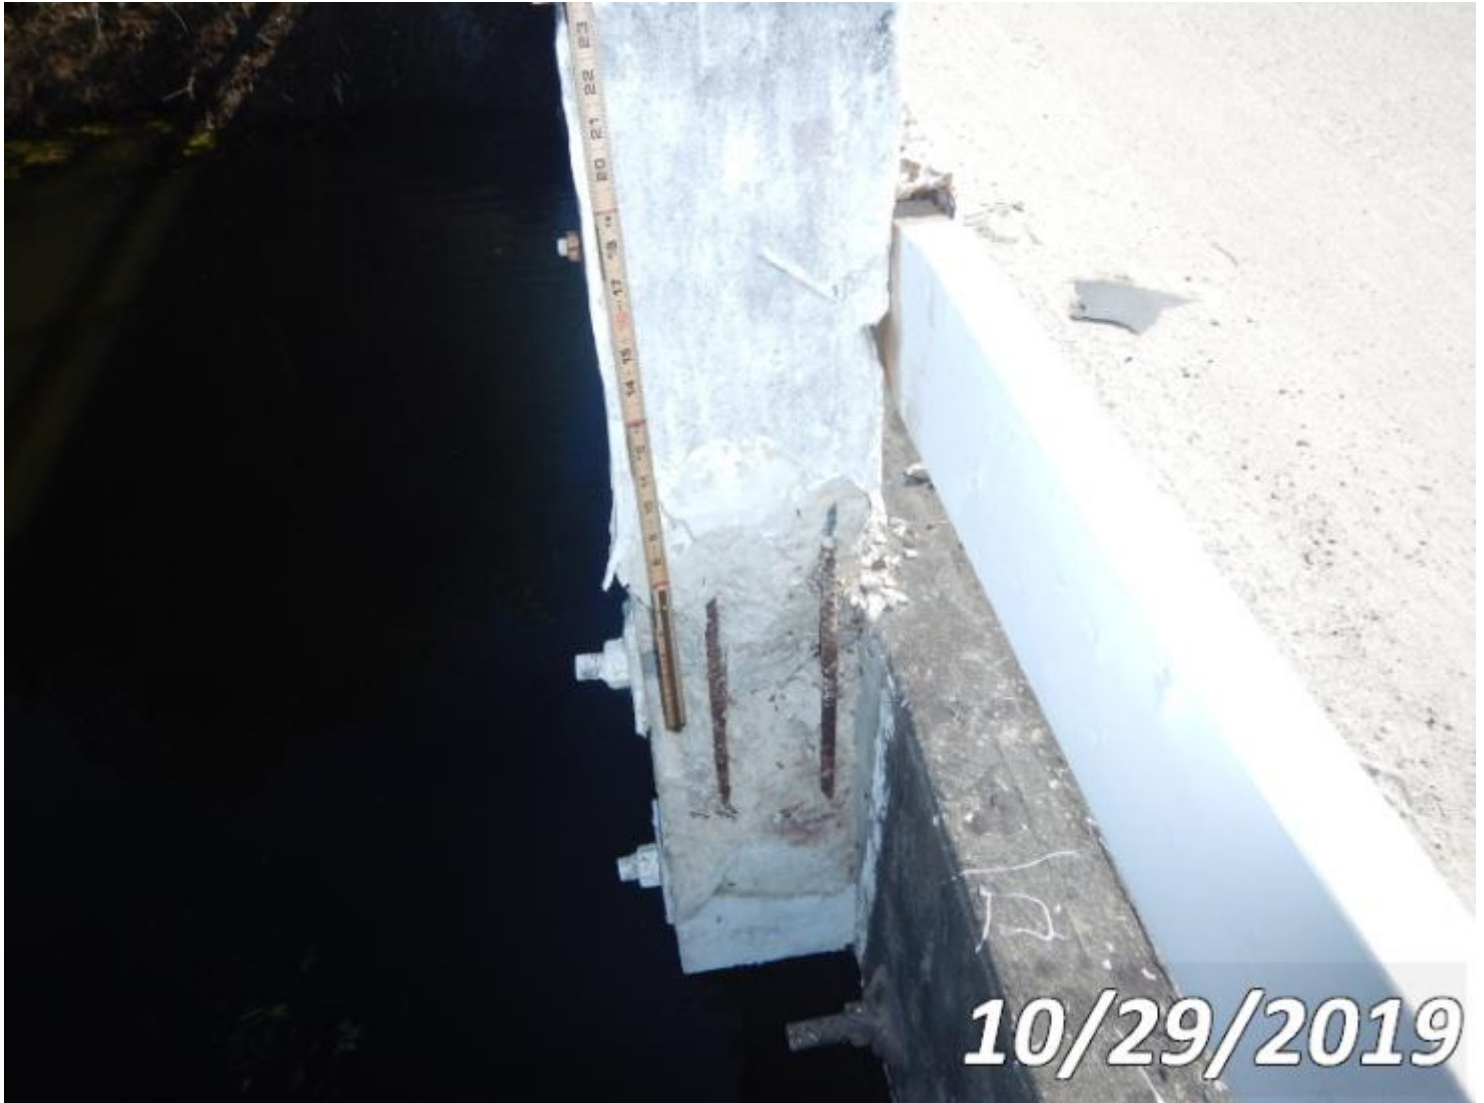
Photo 333-S02 (Unit 0: Other Bridge Railing)

2) Post 2-1 left in the west face exhibits a spall over 8in. L x 24in. H x 3in. D with 2 corroded exposed rebar. NEW. See Photo 333-S02.

Spall with corroded exposed rebar in the west face of Post 2-1 left.

Repair spalls in the west face of Post 1-2 right and Post 2-1 left.

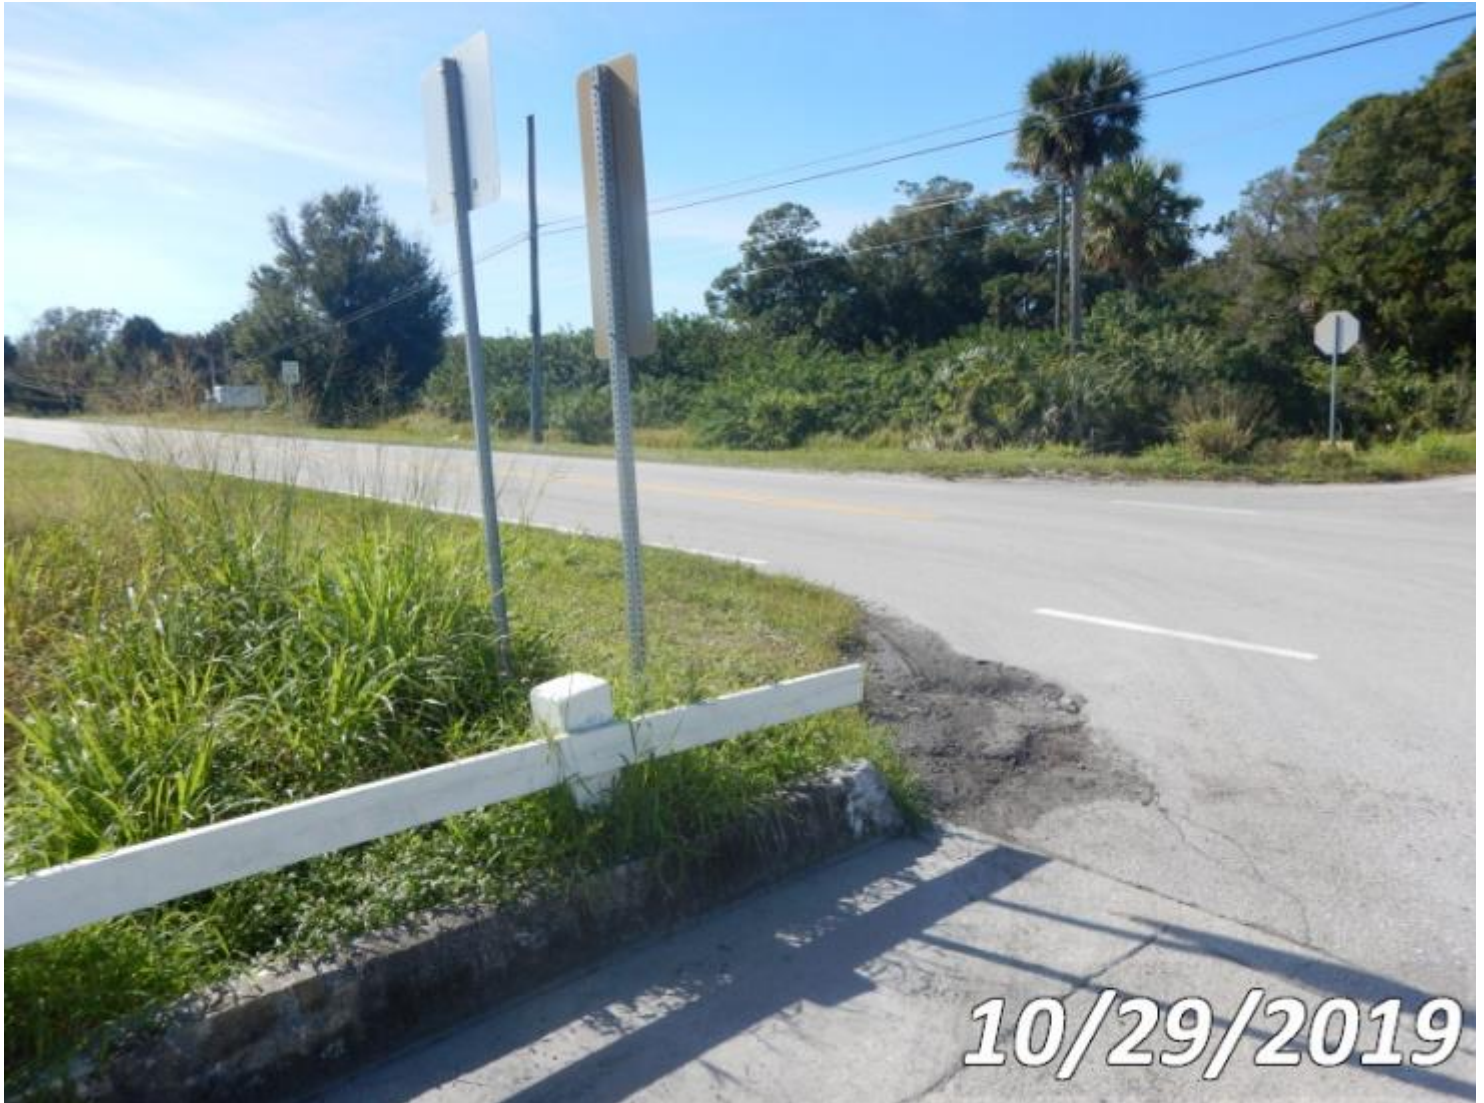
Photo 333-S03 (Unit 0: Other Bridge Railing)

No guardrail at the southwest approach.

CONDITION STATE		PRIORITY
1	MMS Quantity: 1 lf Element Estimated Quantity: 1 ft WORK ORDER RECOMMENDATION: Install approach guardrails at all four corners of the bridge.	3
1	MMS Quantity: 1 lf Element Estimated Quantity: 2 ft WORK ORDER RECOMMENDATION: Repair spalls in the west face of Post 1-2 right and Post 2-1 left.	3
