**FLORIDA DEPARTMENT OF TRANSPORTATION
BRIDGE MANAGEMENT SYSTEM
Inspection/CIDR/Bridge Profile Report
Inspection**

Structure ID: 880006

STRUCTURE NAME: Not recorded
YEAR BUILT: 1951
SECTION NO.: 88 530 000
MP: 3.747
ROUTE: 00615
FACILITY CARRIED: CR-615 (66TH AVE)
FEATURE INTERSECTED: NORTH RELIEF CANAL

TYPE OF INSPECTION: Regular NBI

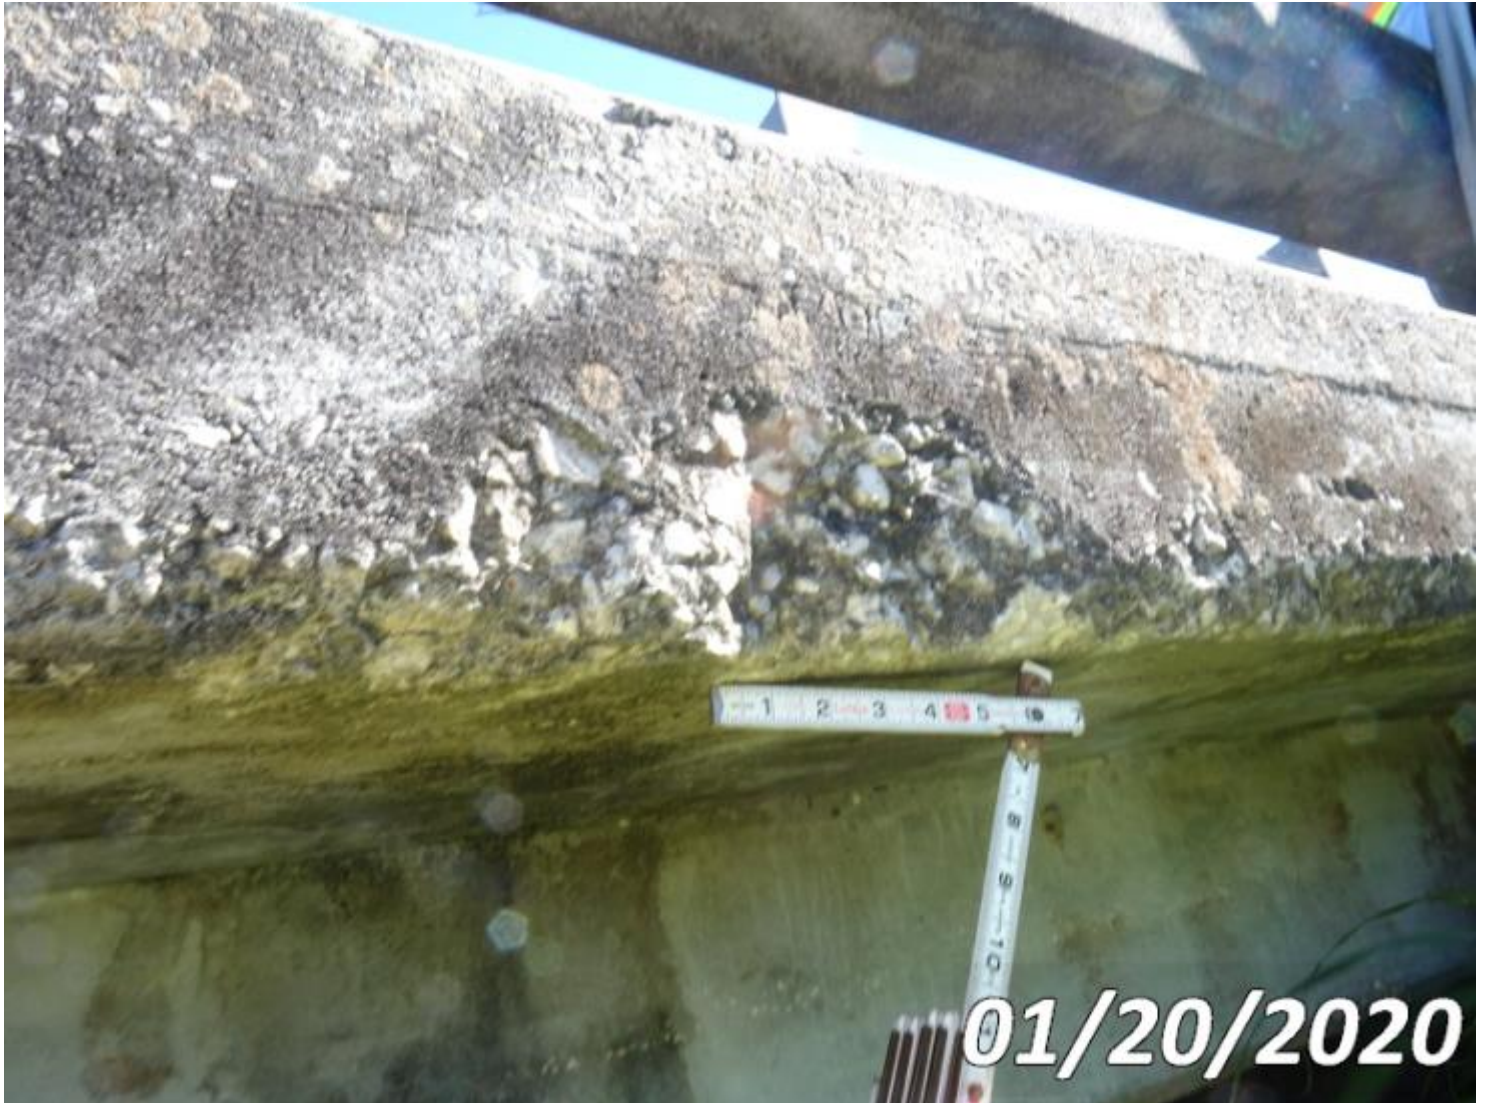
Photo 38-S01 (Unit 0: Re Concrete Slab)

2) Span 1 left (west) curb exhibits an edge spall 2ft. L x 4in. H x 1in. D, along the bottom west edge. NO CHANGE. See Photo 38-S01.

Spall in Span 1 left (west) curb along the bottom west edge.

REPAIR RECOMMENDATION:
Repair spall in Span 1 left west curb.

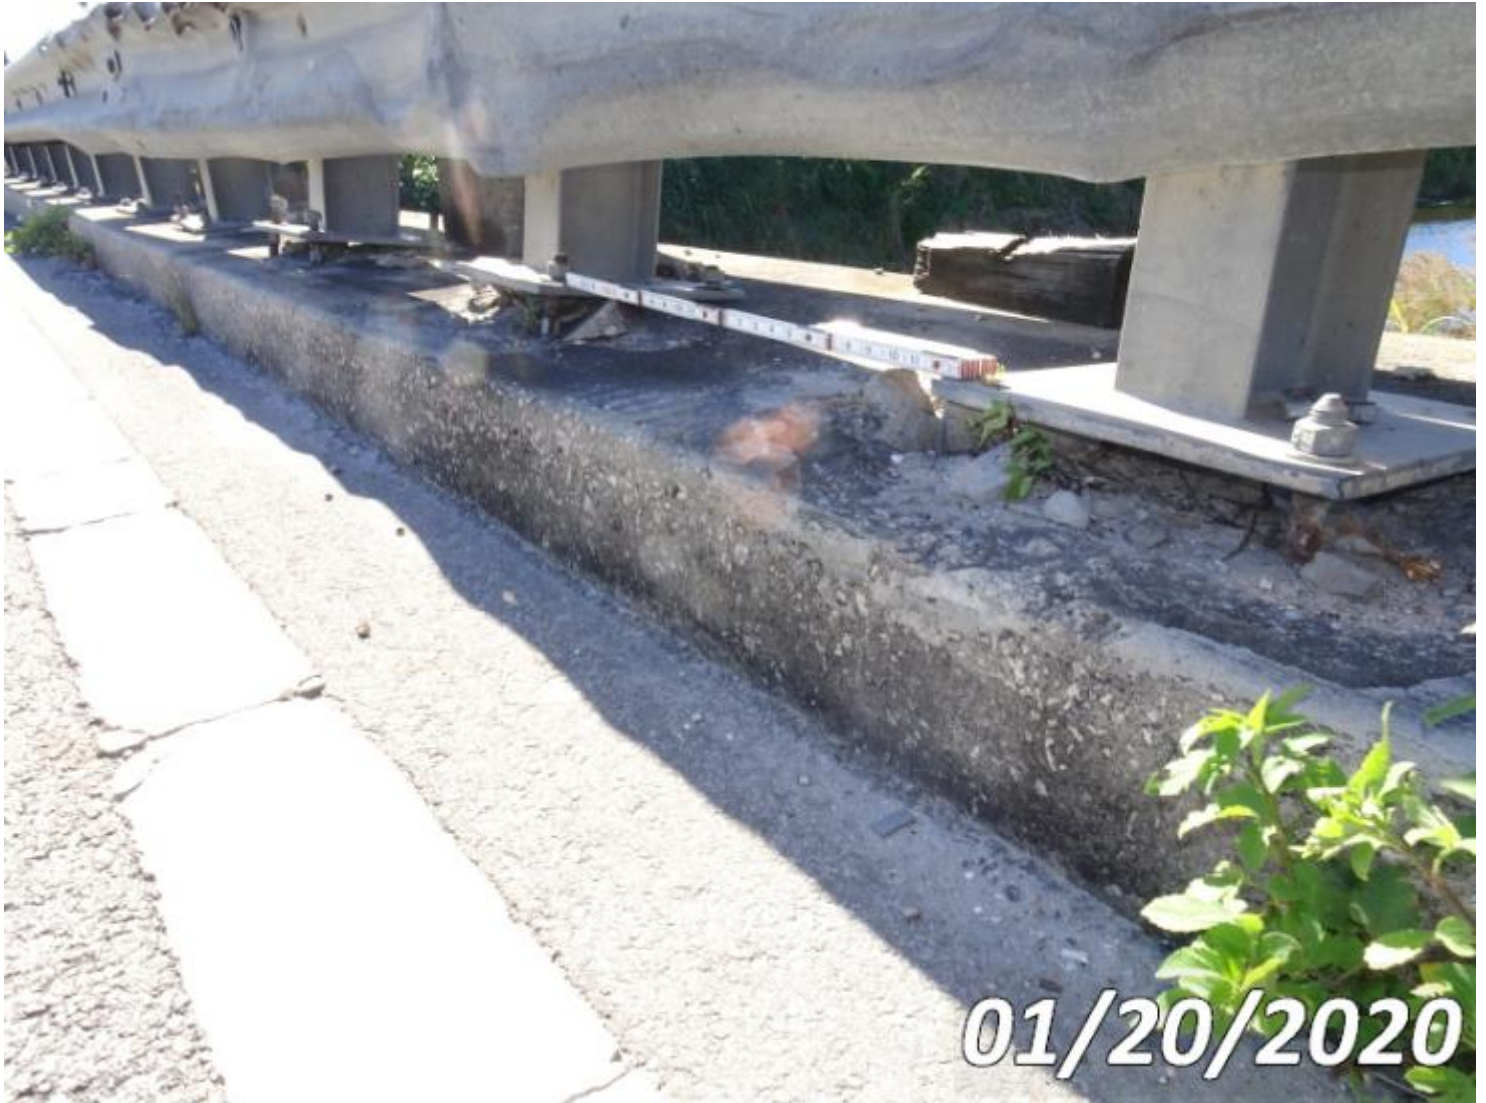
Photo 38-S02 (Unit 0: Re Concrete Slab)

4) Span 4 left (west) curb at the last 3 steel bridge rail post connections exhibits spalled/delaminated areas up to 2ft. L x 1ft. W x 1in. D, due to impact damage. Previously noted as steel bridge rail post connection. INCREASE. See Photo 38-S02.

Spall/delamination on the left curb of Span 4 due to impact damage.

Repair spalls delaminations in the left curb in Span 4.

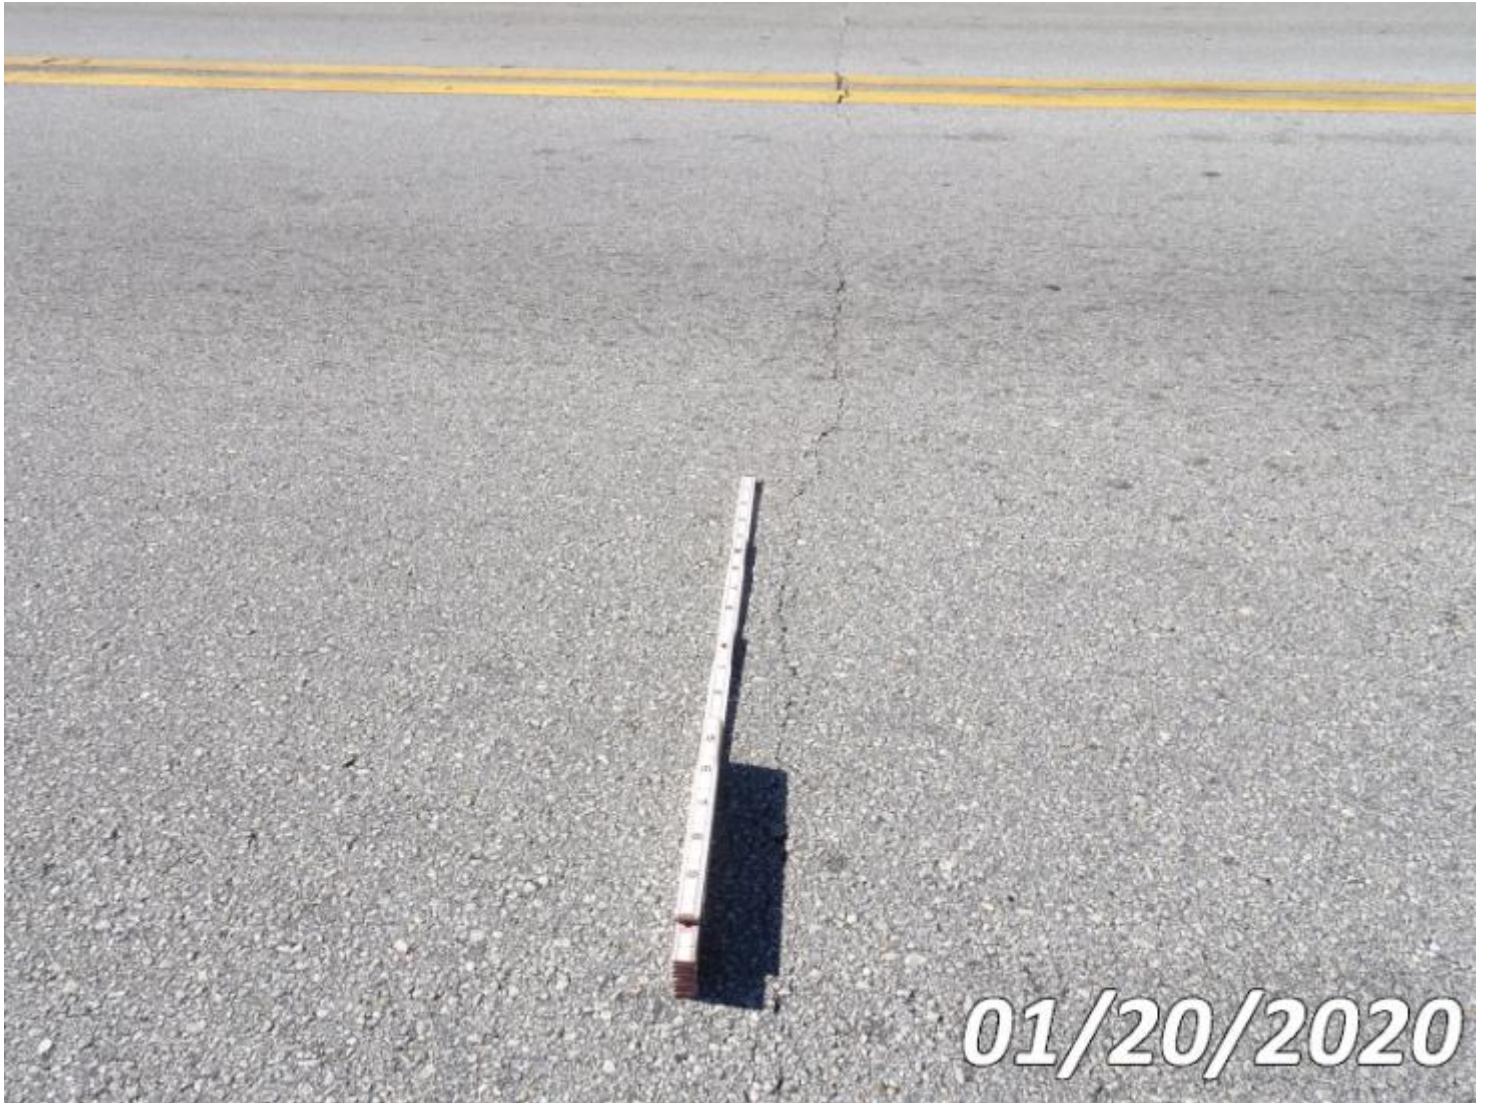
Photo 38-S03 (Unit 0: Re Concrete Slab)

5) The asphalt overlay over End Bents 1 and 5 joints are cracked up to 50ft. L x 1/8in. W (total 50sf.). Previously noted incorrectly with 1/2in. W. NO CHANGE. See Photo 38-S03.

Transverse crack in the asphalt overlay over End Bent 1.

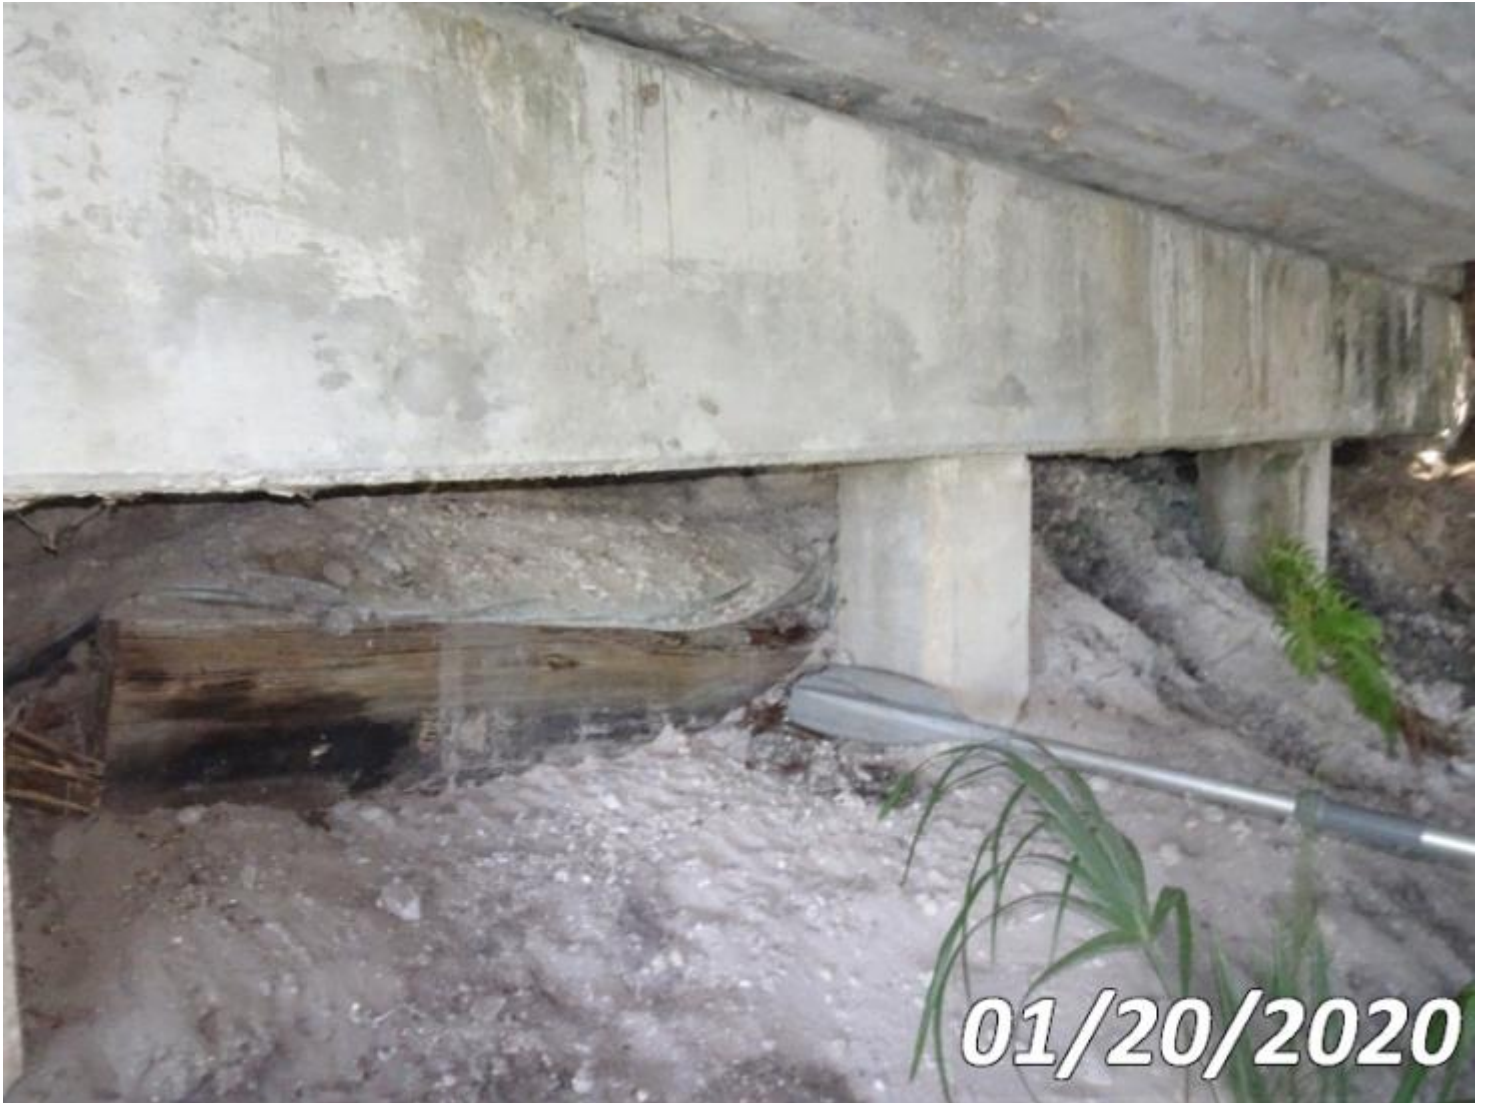
Photo 8290-S01 (Unit 0: Channel) & (Unit 0: Timber Walls)

1) End Bent 5 timber backwall between Piles 5-3 and 5-4 has heavy decay and the top 1ft. is missing (total 11ft.) NO CHANGE. See Photo 8290-S01.

Rutted and eroded area at End Bent 5. Note missing and decay on timber walls.

Repair eroded area at End Bent 5 between Piles 5-3 and 5-4 and Piles 5-4 and 5-5.

Repair or replace timber walls at End Bent 5.

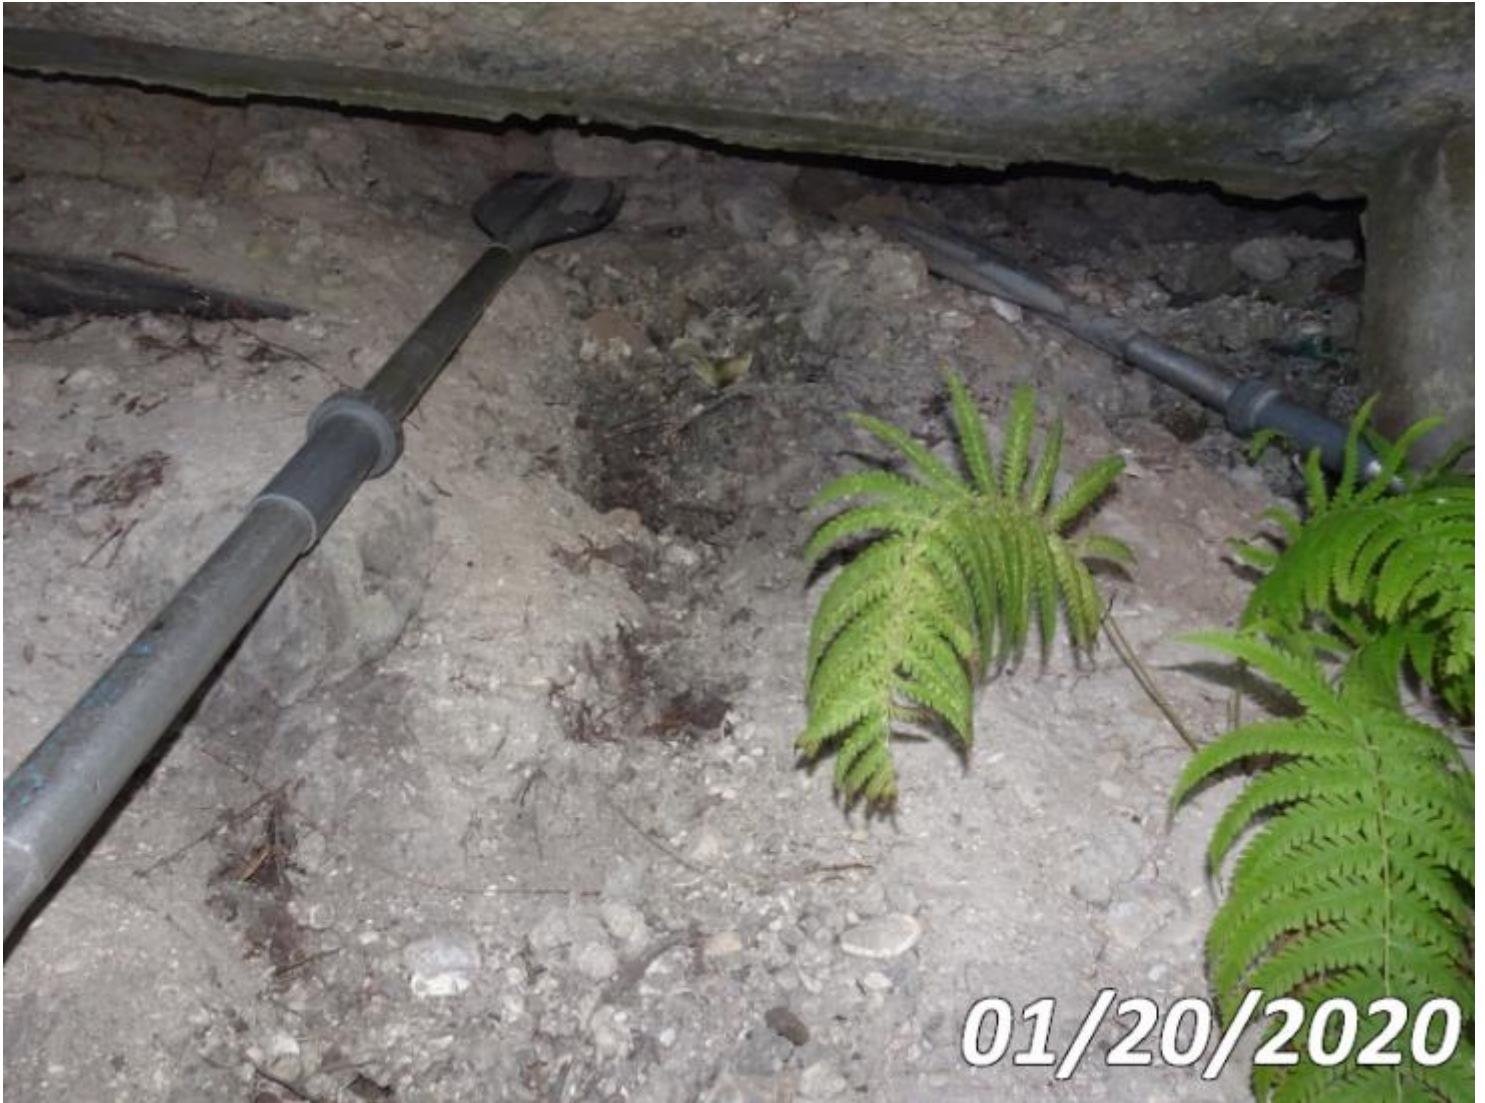
Photo 8290-S02 (Unit 0: Channel) & (Unit 0: Re Conc Approach Slab)

2) Between Piles 5-4 and 5-5, the End Bent 5 backwall is completely deteriorated/missing which has allowed backfill to leak out and undermined End Bent 5 and the north approach slab (total 11ft.). NO CHANGE.

Undermining at End Bent 5 cap between Piles 5-4 and 5-5 and undermining at the north approach slab behind End Bent 5.

Repair undermined north approach slab behind End Bent 5 cap between Piles 5-4 and 5-5.

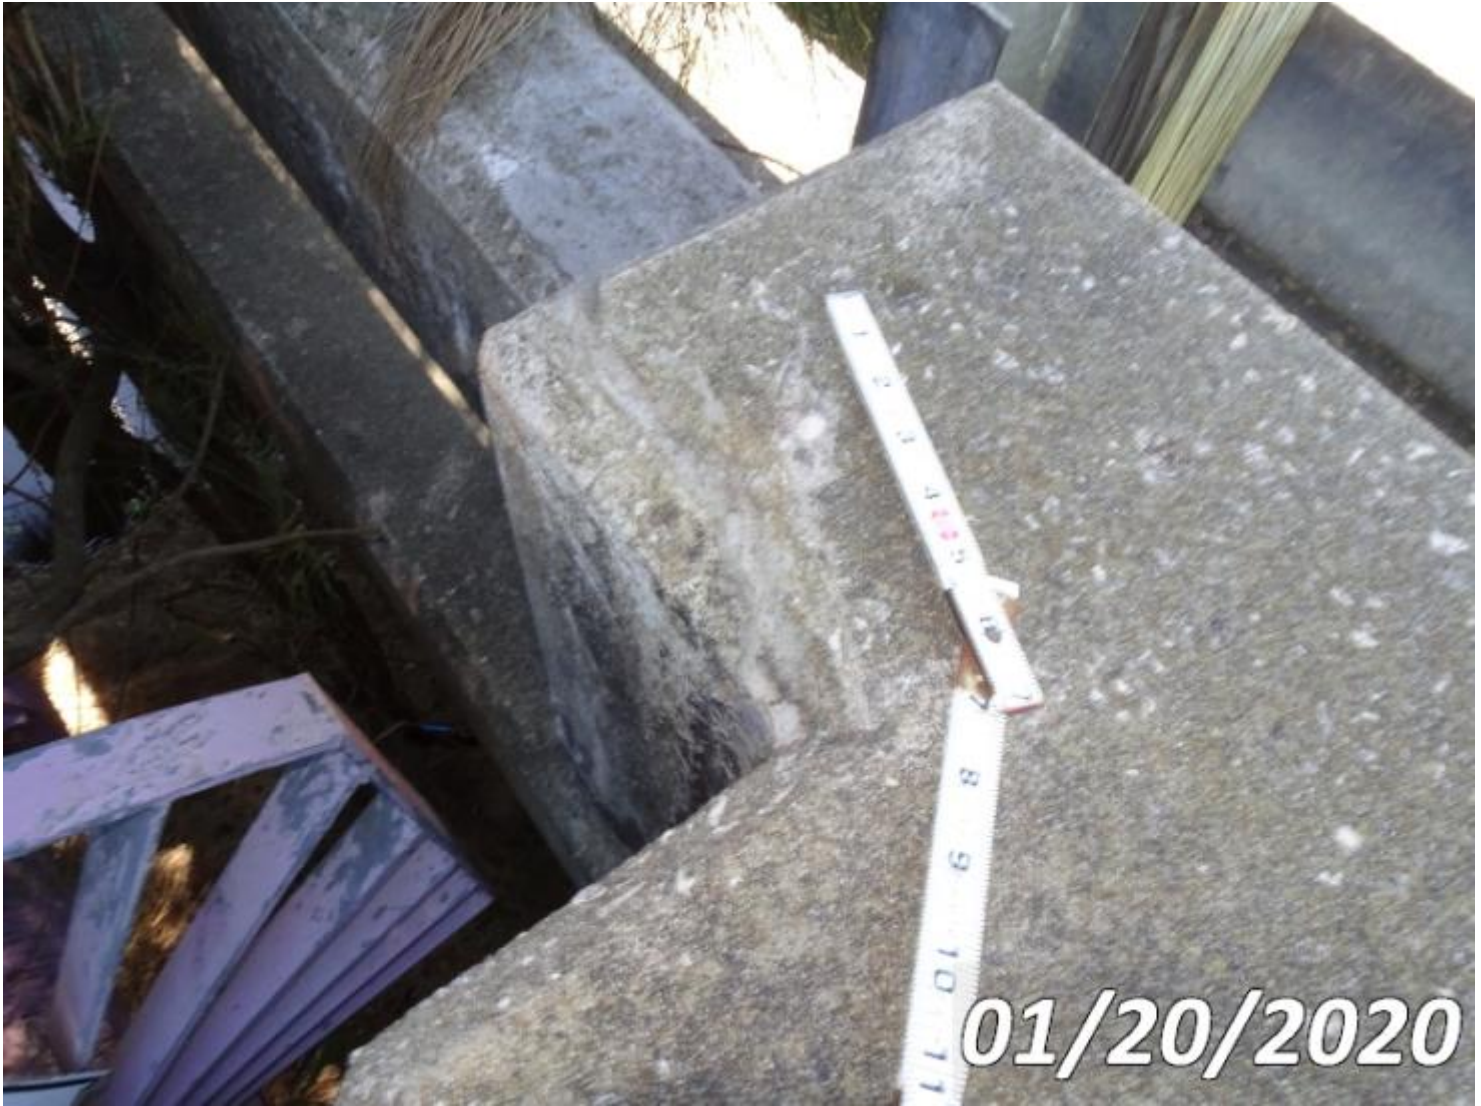
Photo 321-S01 (Unit 0: Re Conc Approach Slab)

1) The northeast end post of the bridge rail exhibits a delamination 30in. H x 6in. W with associated cracking up to 1/32in. W (total 3ft.). Previously noted under Element 331. NO CHANGE. See Photo 321-S01.

Delamination on the northeast end post.

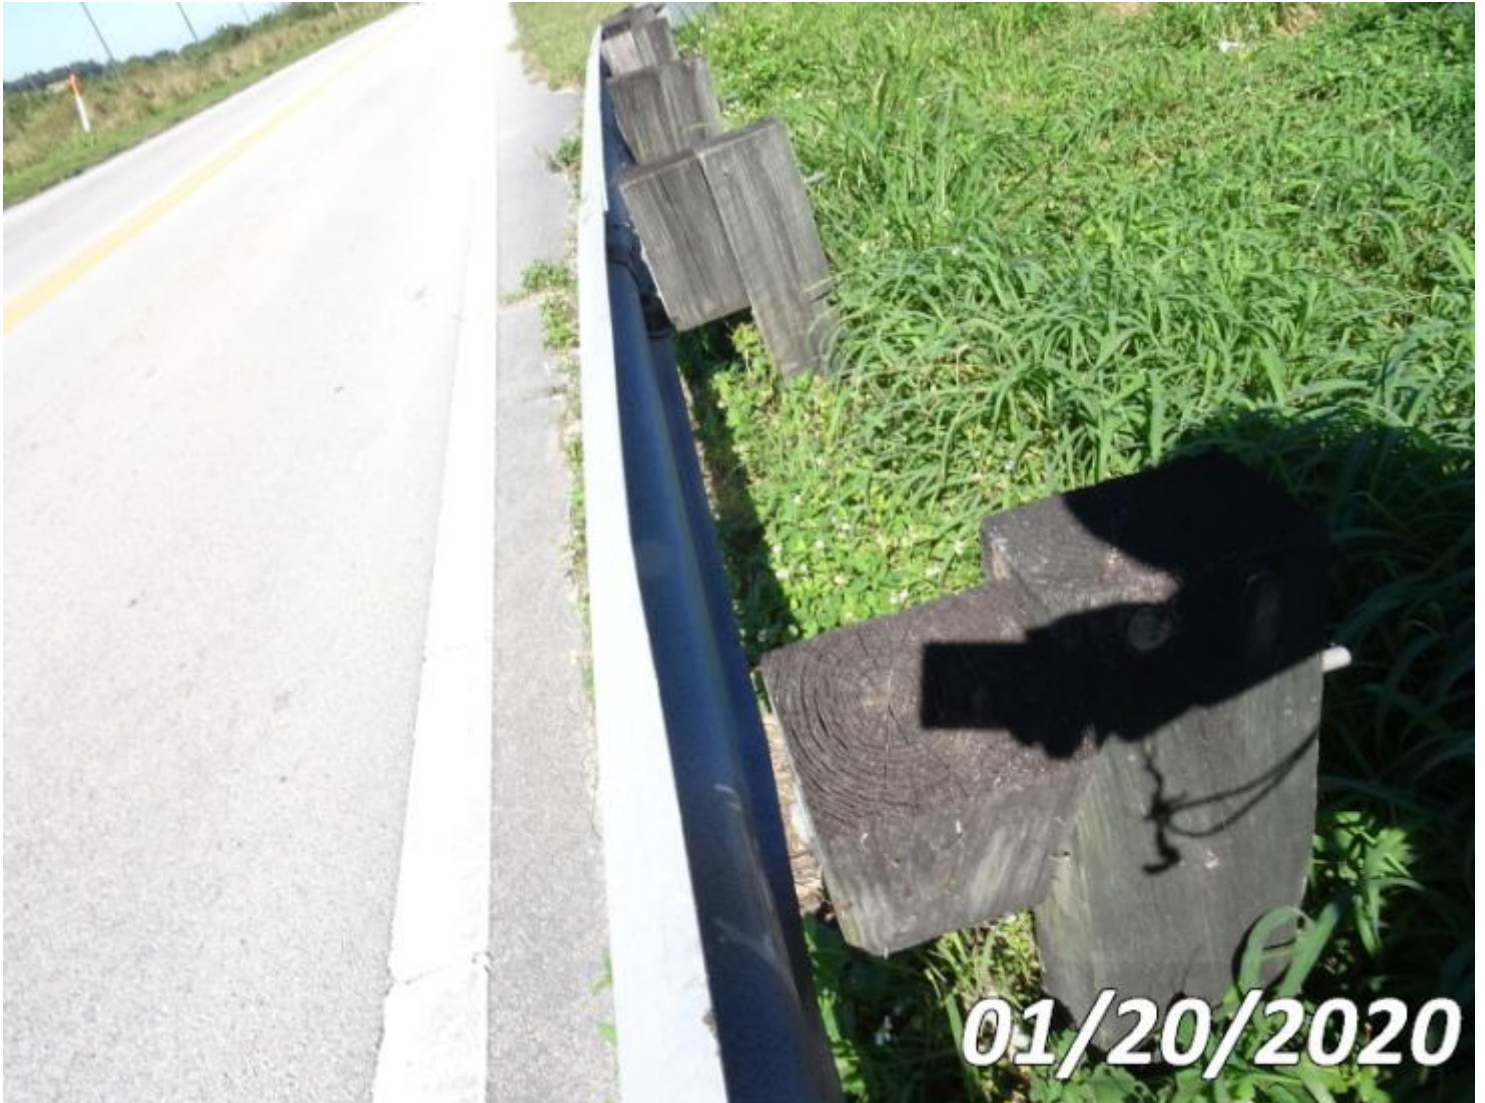
Photo 321-S02 (Unit 0: Re Conc Approach Slab)

5) The northeast guardrail, 2nd post from the bridge exhibits a cushion block that is unattached to the guardrail. Previously noted under Element 330. NO CHANGE. See Photo 321-S02.

Unattached cushion block on the northeast guardrail, 2nd post from the bride to the guardrail.

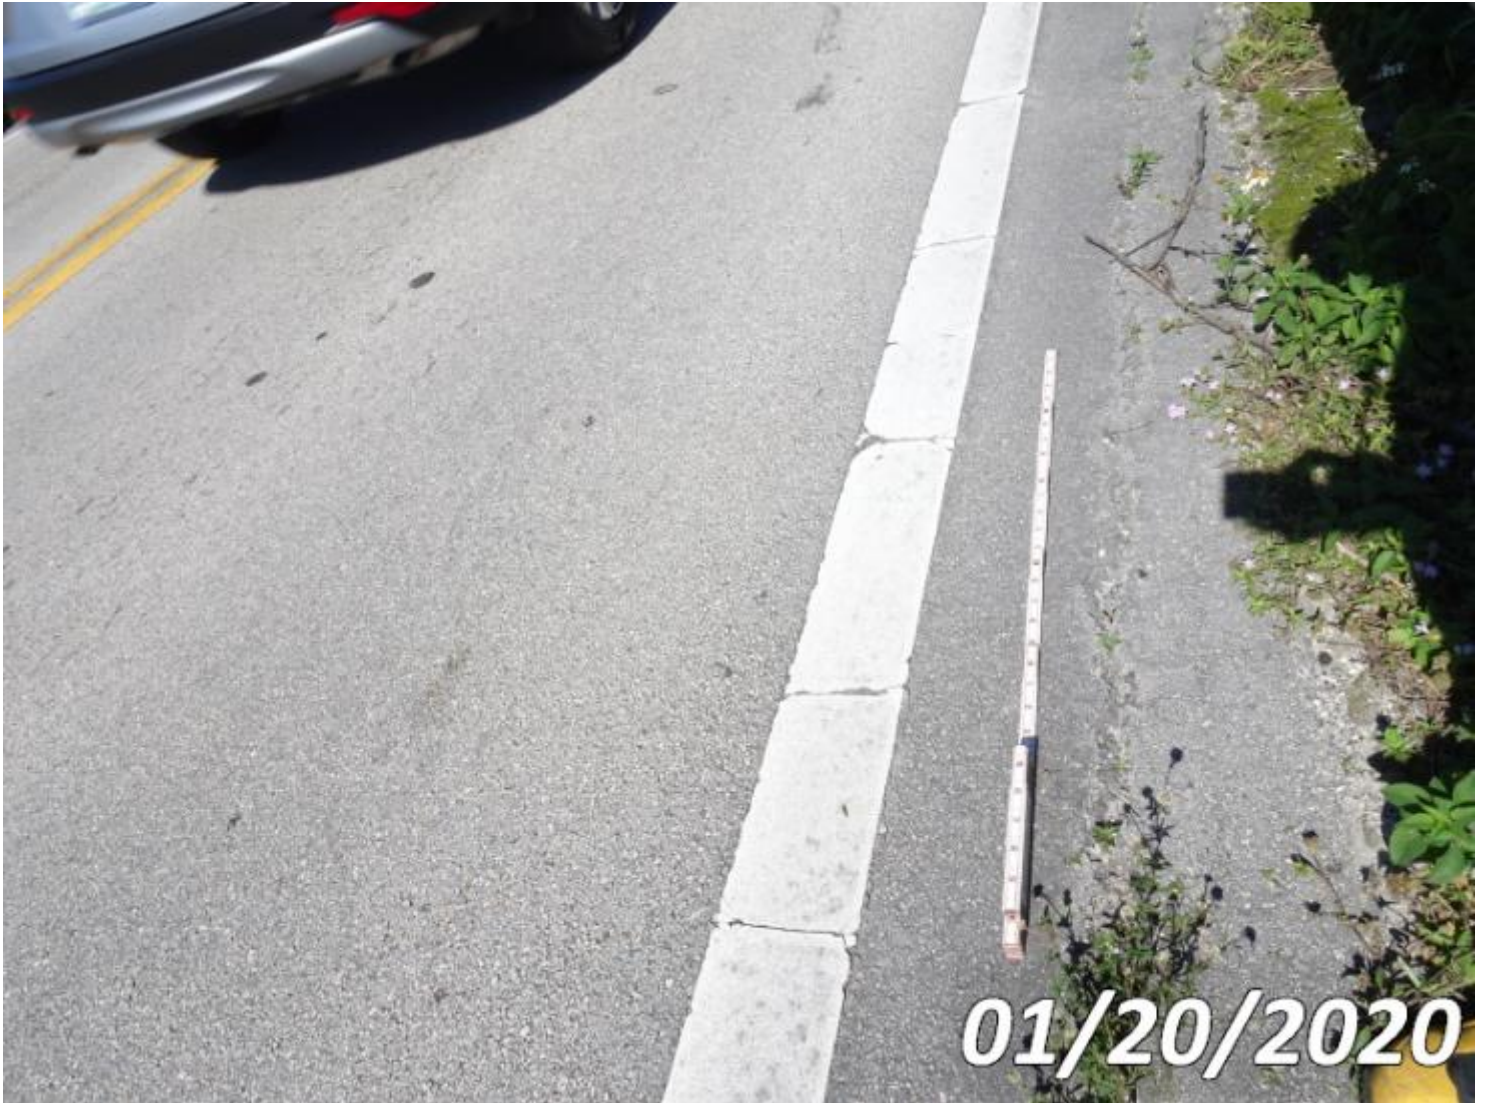
Photo 321-S03 (Unit 0: Re Conc Approach Slab)

8) There is up to 1/2in. wide cracks and minor crumbling asphalt outlining all four sides of both approach slabs (total 176sf.). NO CHANGE. See Photo 321-S03.

Cracks in the east side of the asphalt outlining at the south approach slab.

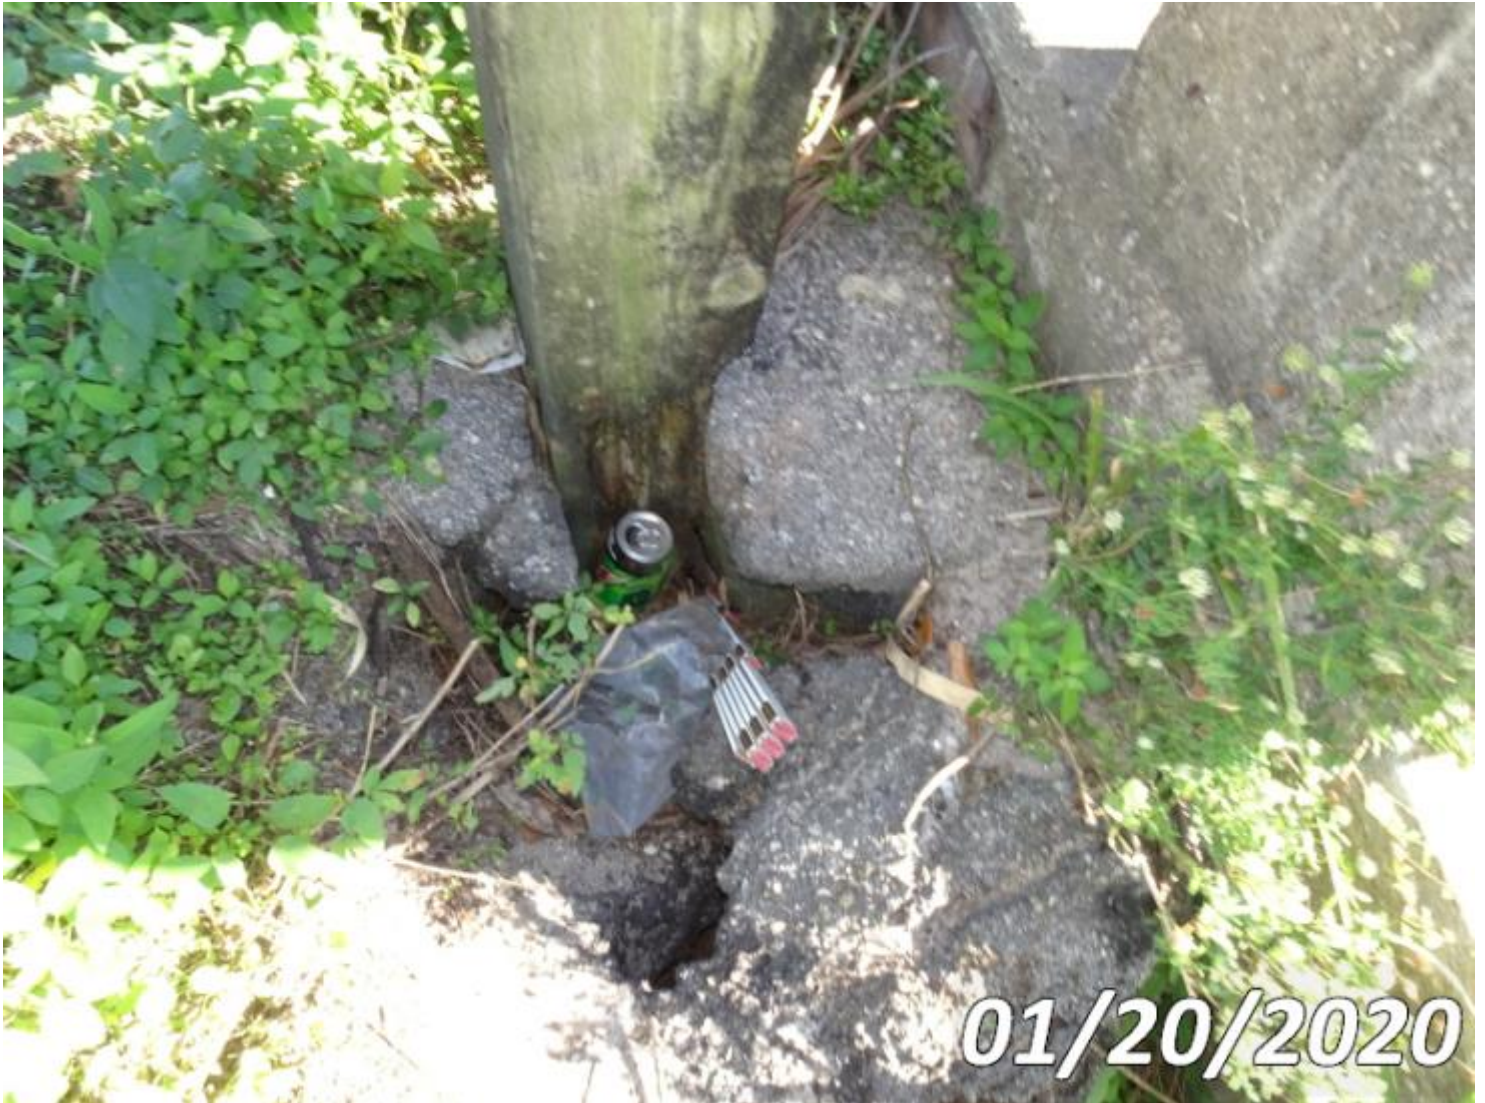
Photo 8476-S01 (Unit 0: Timber Walls)

4) The northwest end of the bridge rail, 1st timber post exhibits a washout area and water leaking behind End Bent 5 and maybe causing the erosion at End Bent 5. NO CHANGE. See Photo 8476-S01.

Washout at the 1st timber post at the northwest end of the bridge rail.

Repair washout areas on the northwest end of bridge rail 1st timber post.

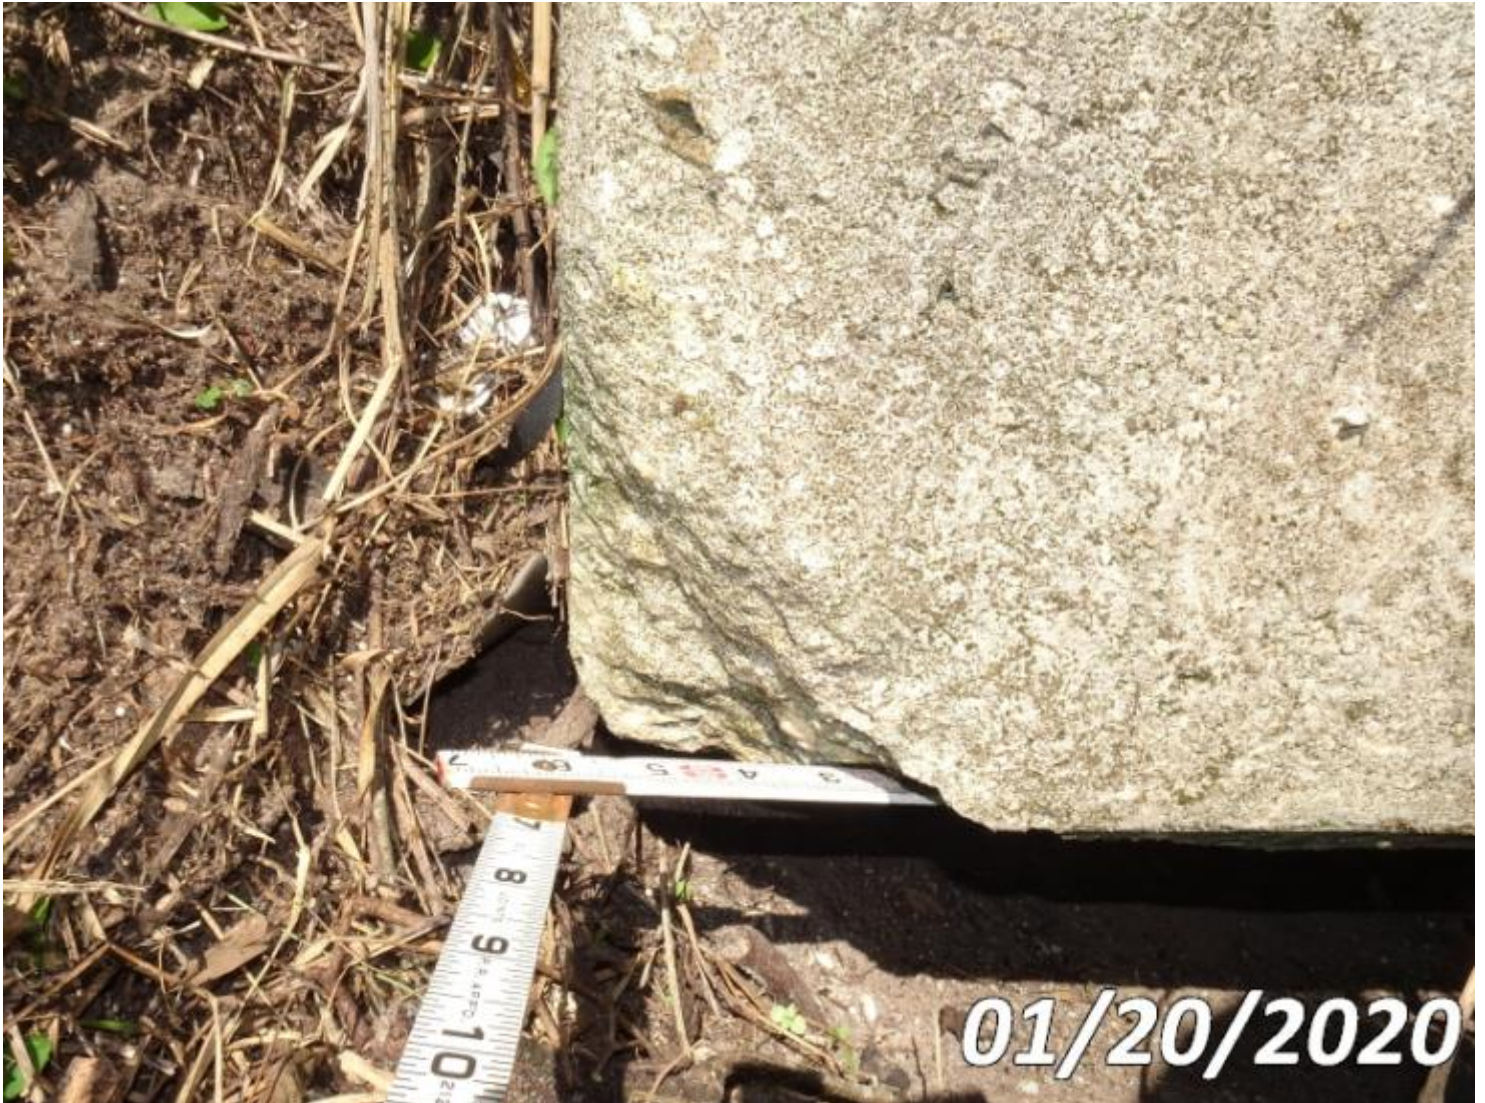
Photo 215-S01 (Unit 0: Re Conc Abutment)

1) End Bent 5 cap exhibits a spall 3in. L x 1in. W x 1/2in. D, in the bottom southwest corner (total 1ft.). NO CHANGE. See Photo 215-S01.

Spall in the bottom southwest corner of End Bent 5 cap.

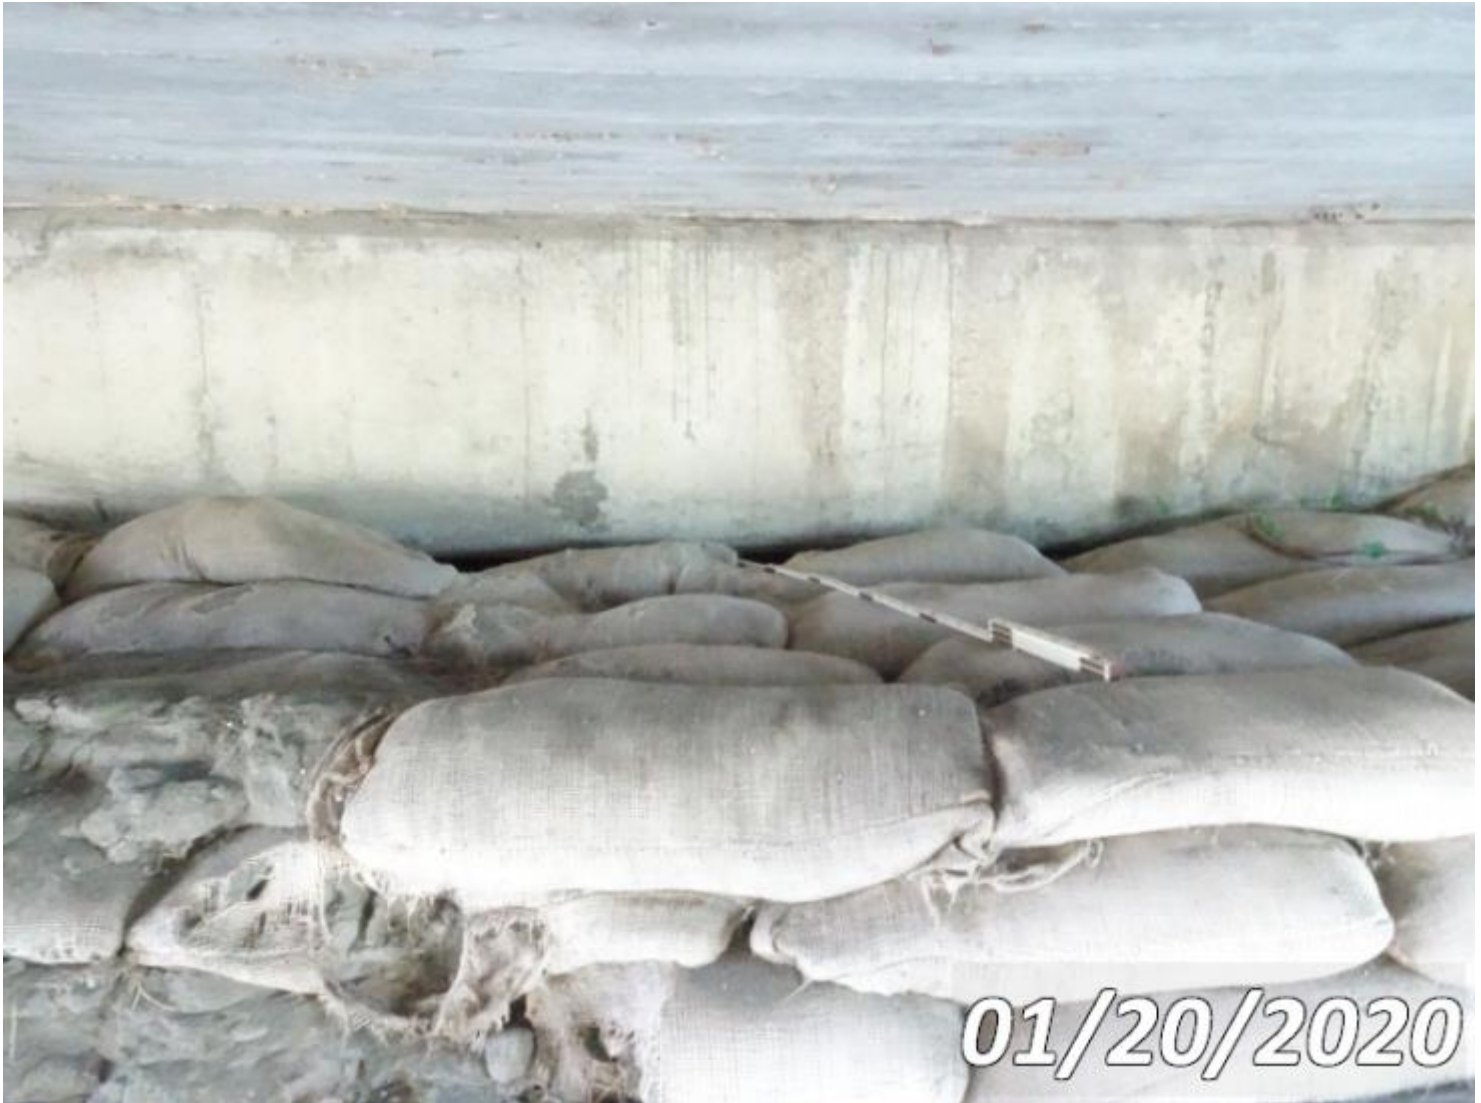
Photo 215-S02 (Unit 0: Re Conc Abutment)

Undermining at End Bent 1 cap.

Repair undermining at End Bents 1 and 5 cap.

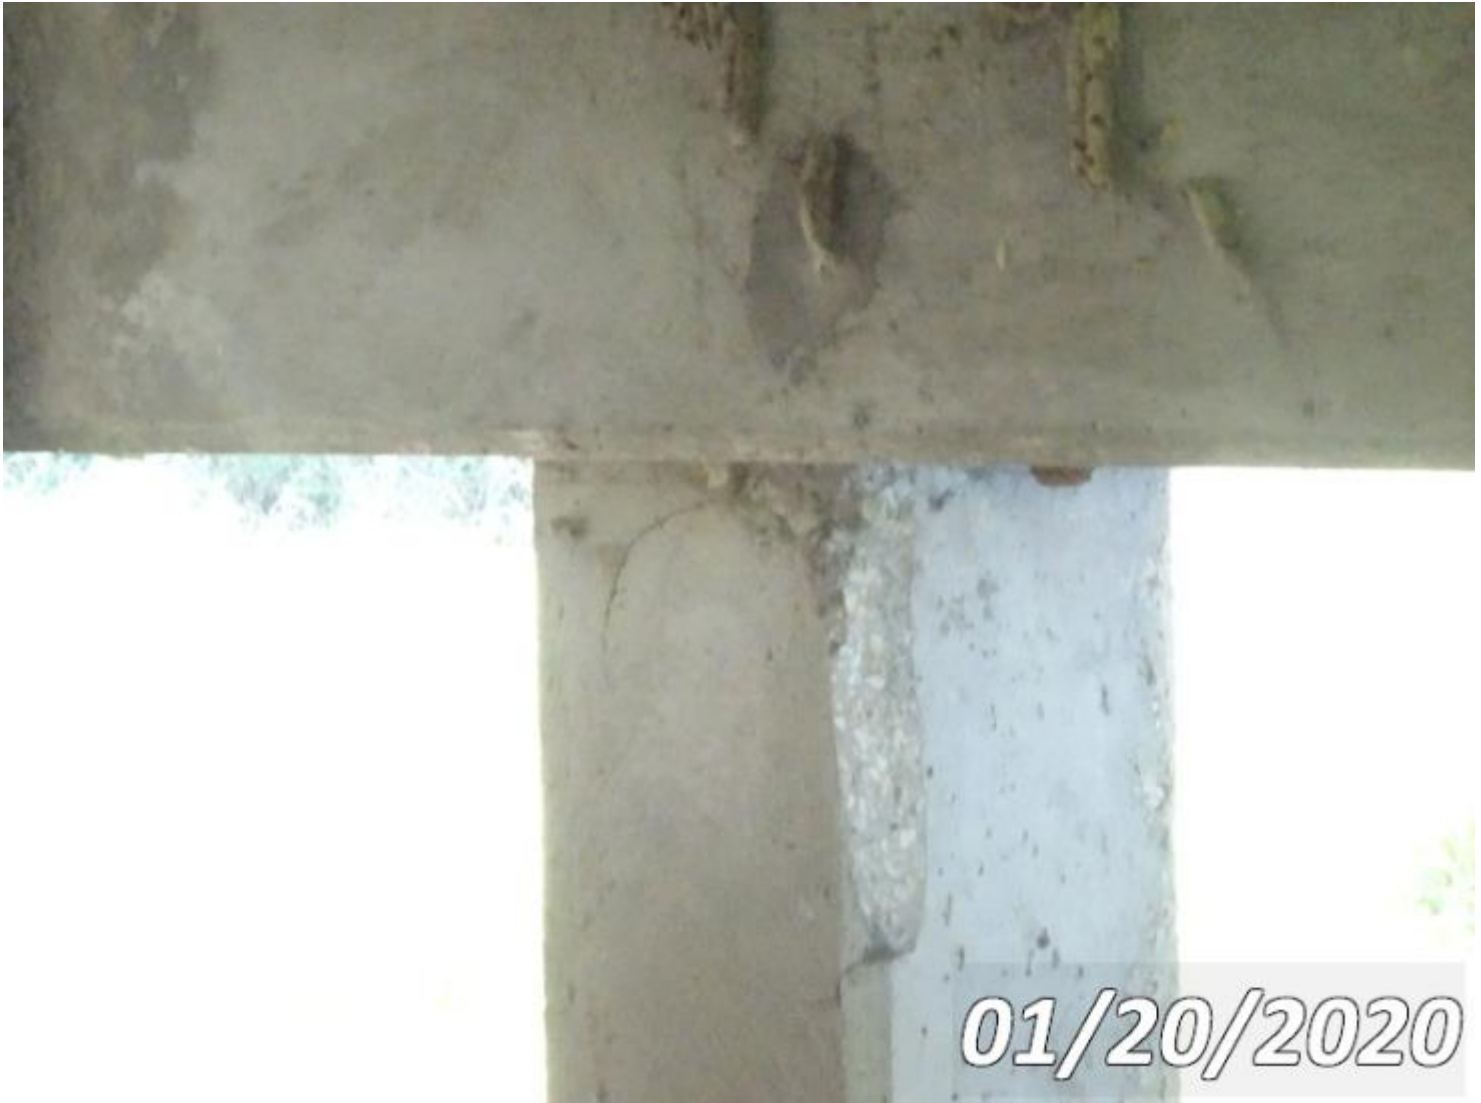
Photo 227-S01 (Unit 0: Re Conc Pile)

1) Pile 4-4 northeast corner exhibits a spall 11in. H x 3in. W x 1/2in. D, above the waterline (total 1ea.). NO CHANGE. See Photo 227-S01.

Spall in the northwest corner of Pile 4-4.

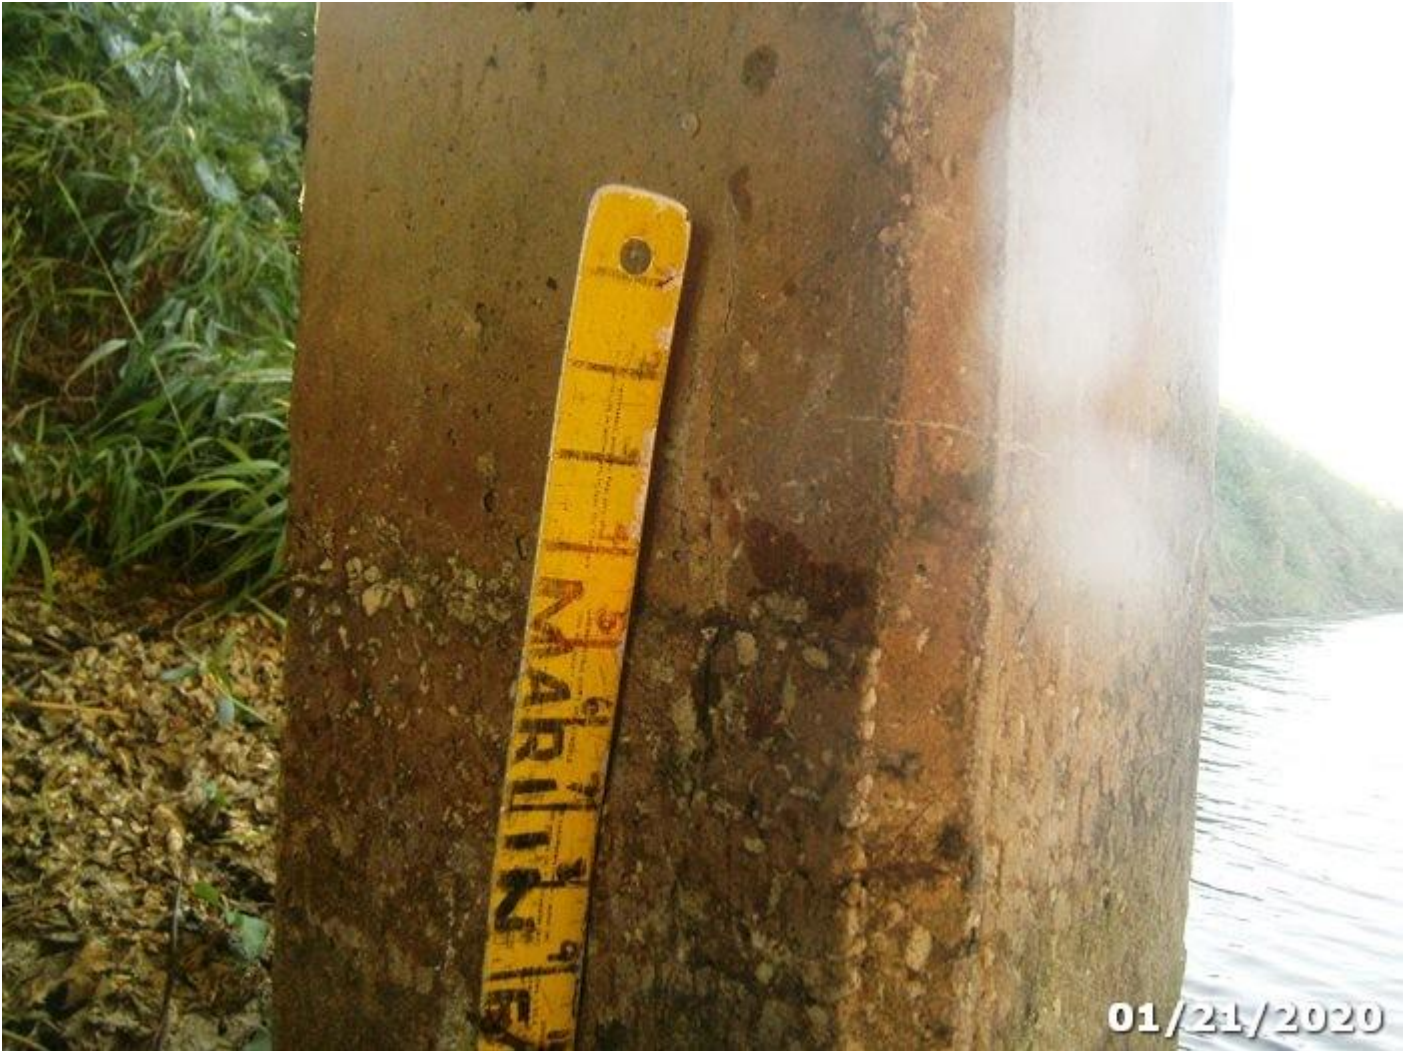
Photo 227-U01 (Unit 0: Re Conc Pile)

3) Pile 2-1, east face exhibits a vertical crack 12in. L x 1/64in. W with corrosion bleed-out, 3ft. 2in. below the cap (total 1ea.). NO CHANGE. See Photo 227-U01.

Crack with corrosion on the east face of Pile 2-1.

REPAIR RECOMMENDATION:
Repair cracking in all piles.
