**FLORIDA DEPARTMENT OF TRANSPORTATION
BRIDGE MANAGEMENT SYSTEM
Inspection/CIDR/Bridge Profile Report
Inspection**

Structure ID: 880006

STRUCTURE NAME: Not recorded
YEAR BUILT: 1951
SECTION NO.: 88 530 000
MP: 3.747
ROUTE: 00615
FACILITY CARRIED: CR-615 (66TH AVE)
FEATURE INTERSECTED: NORTH RELIEF CANAL

TYPE OF INSPECTION: Regular NBI

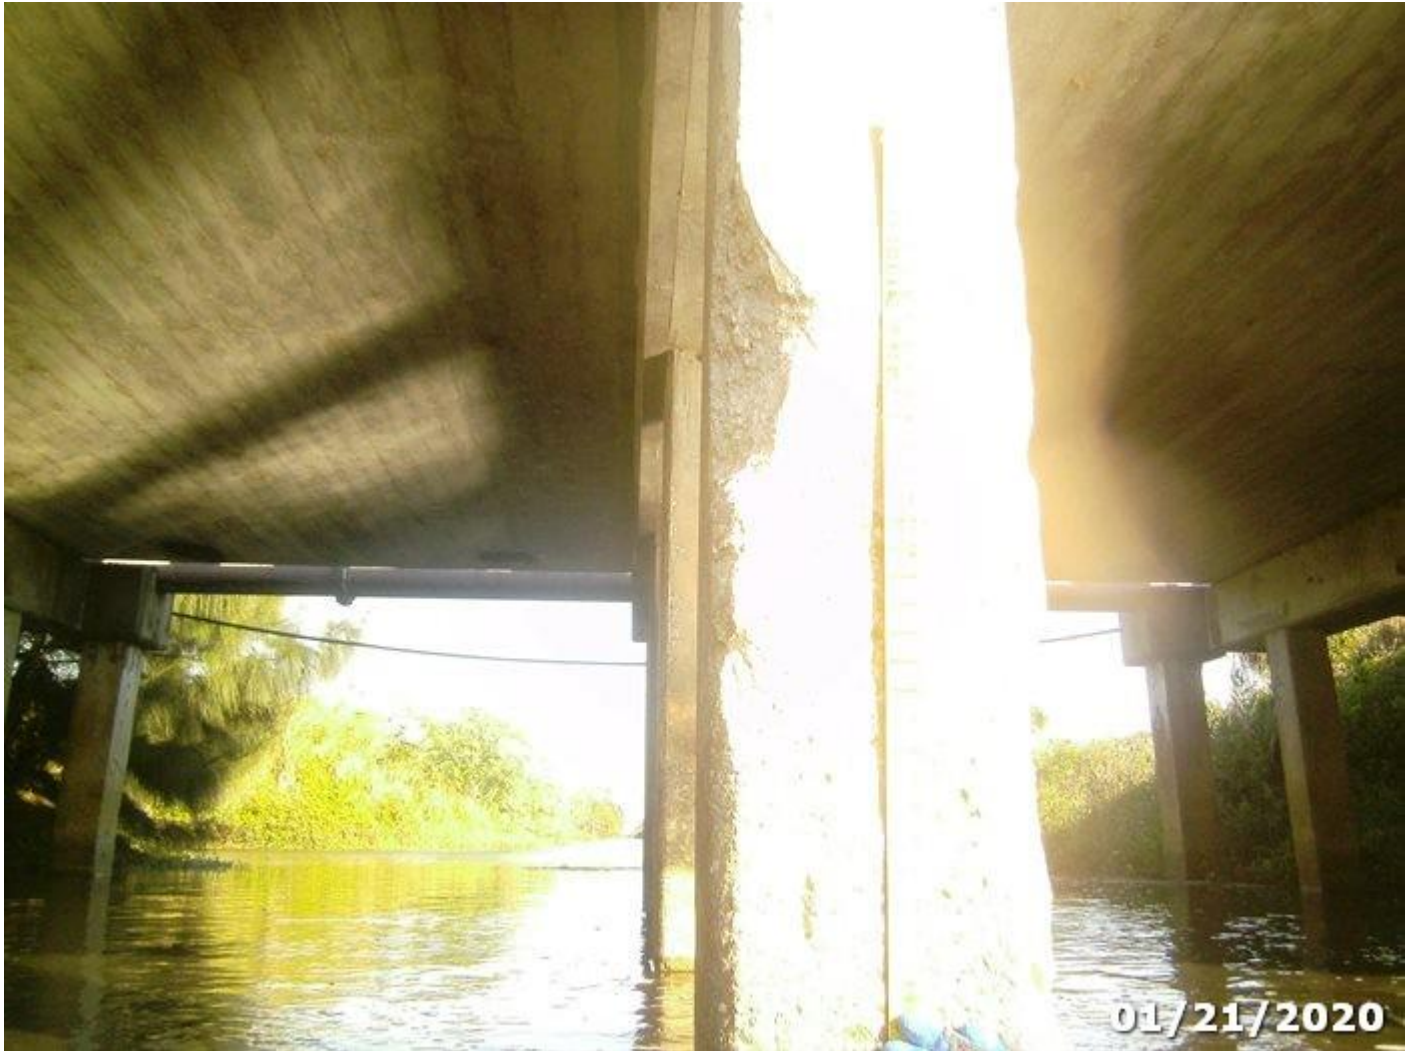
Photo 227-U02 (Unit 0: Re Conc Pile)

4) Pile 3-1, southwest corner exhibits a spall 12in. H x 4in. W x 1in. D, 4ft. below the cap. The northwest corner exhibits intermittent spalls up to 18in. H x 6in. W x 3in. D, 3ft. below the cap (total 1ea.) NO CHANGE. See Photo 227-U02.

Spalls in the southwest and northwest corners of Pile 3-1.

REPAIR RECOMMENDATION:
Repair cracking in all piles.

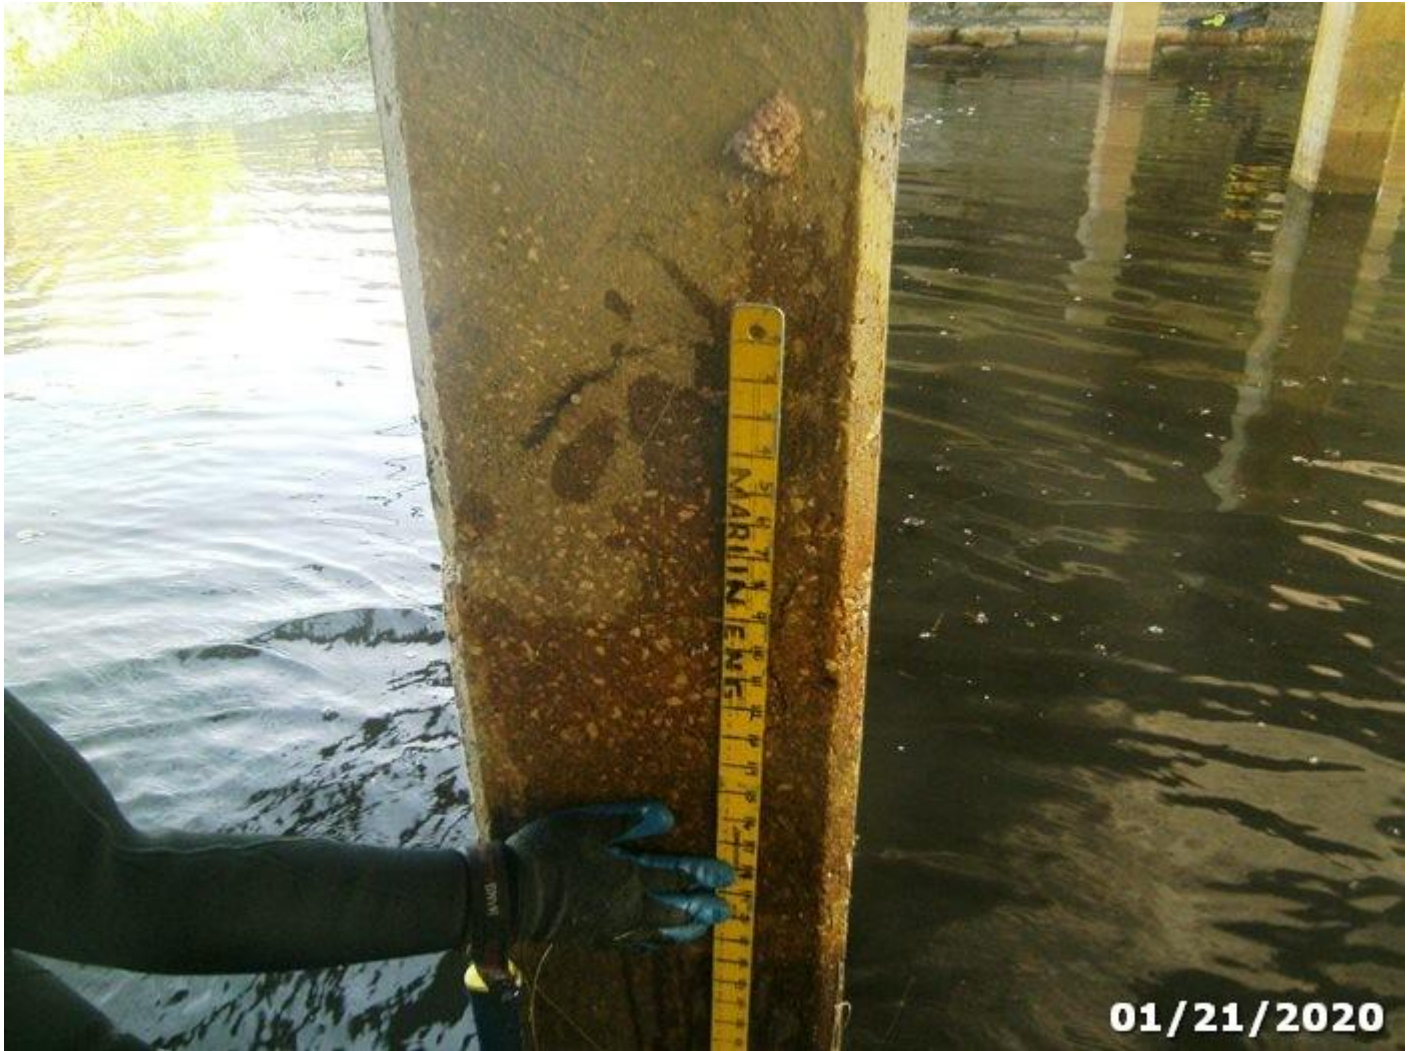
Photo 227-U03 (Unit 0: Re Conc Pile)

5) Pile 3-4, south, north, and west faces exhibit delaminations, with associated cracks up to 1/32in. W, up to 14in. H x 7in. W with corrosion bleed-out, 3ft. below the cap (total 1ea.). NO CHANGE. See Photo 227-U03.

Cracks with corrosion at the north, south and west faces of Pile 3-4.

REPAIR RECOMMENDATION:
Repair cracking in all piles.

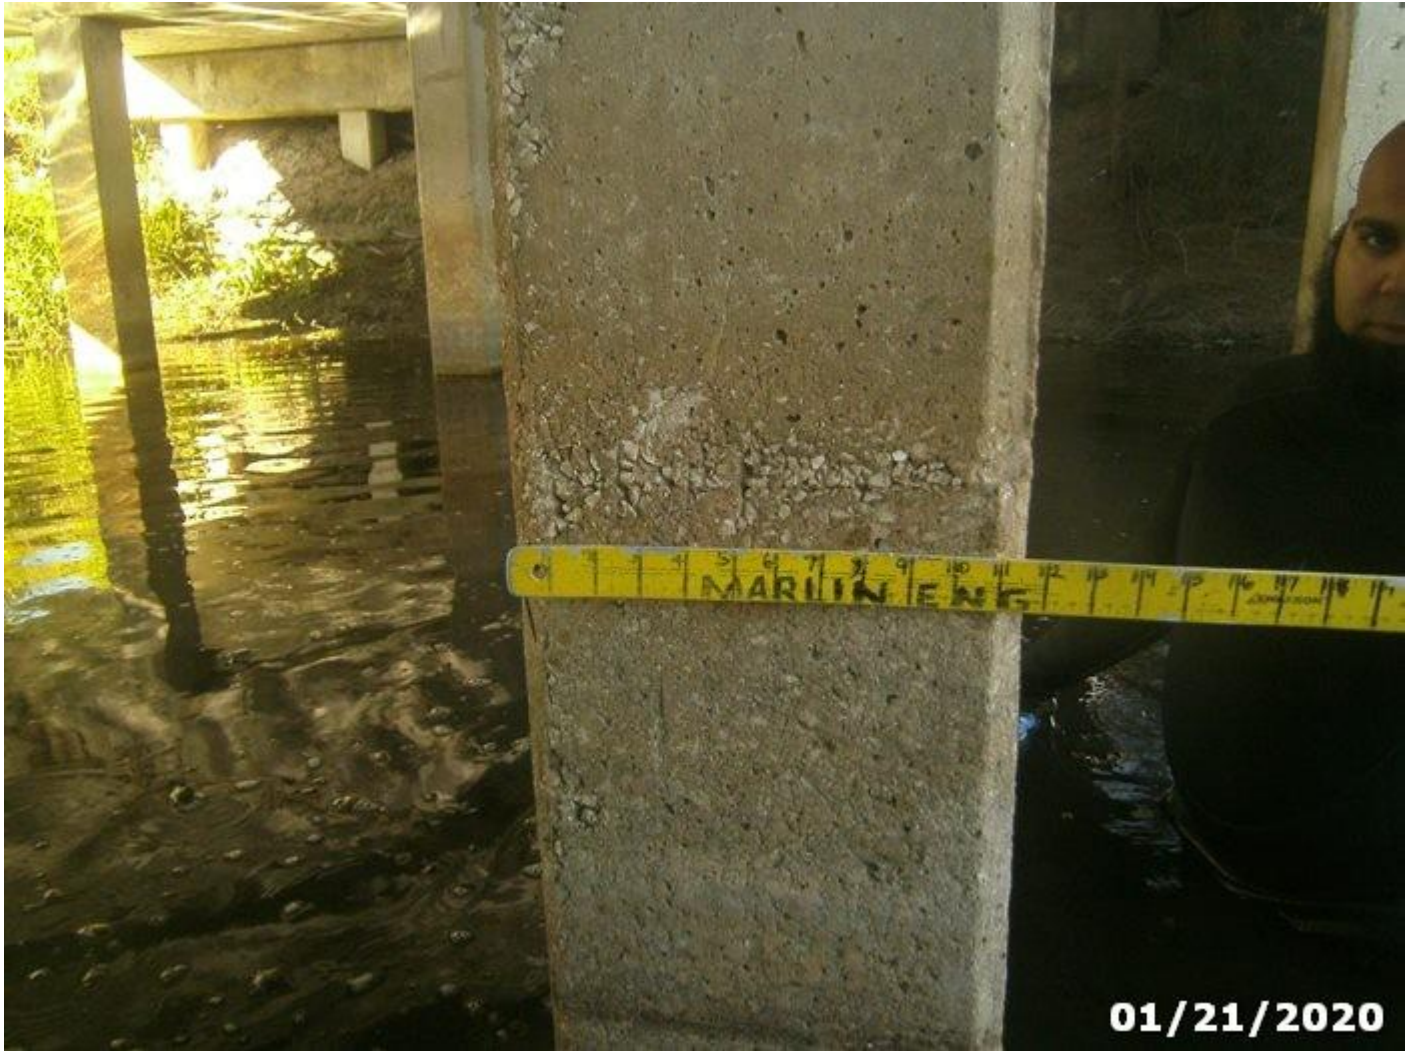
Photo 227-U04 (Unit 0: Re Conc Pile)

9) The intermediate bent piles exhibit scale damage up to 1/8in. D from the high watermark down (total 7ea.). NO CHANGE. See Photo 227-U04.

Typical scale damage on piles at Bents 2, 3 and 4.

REPAIR RECOMMENDATION:
Repair cracking in all piles.

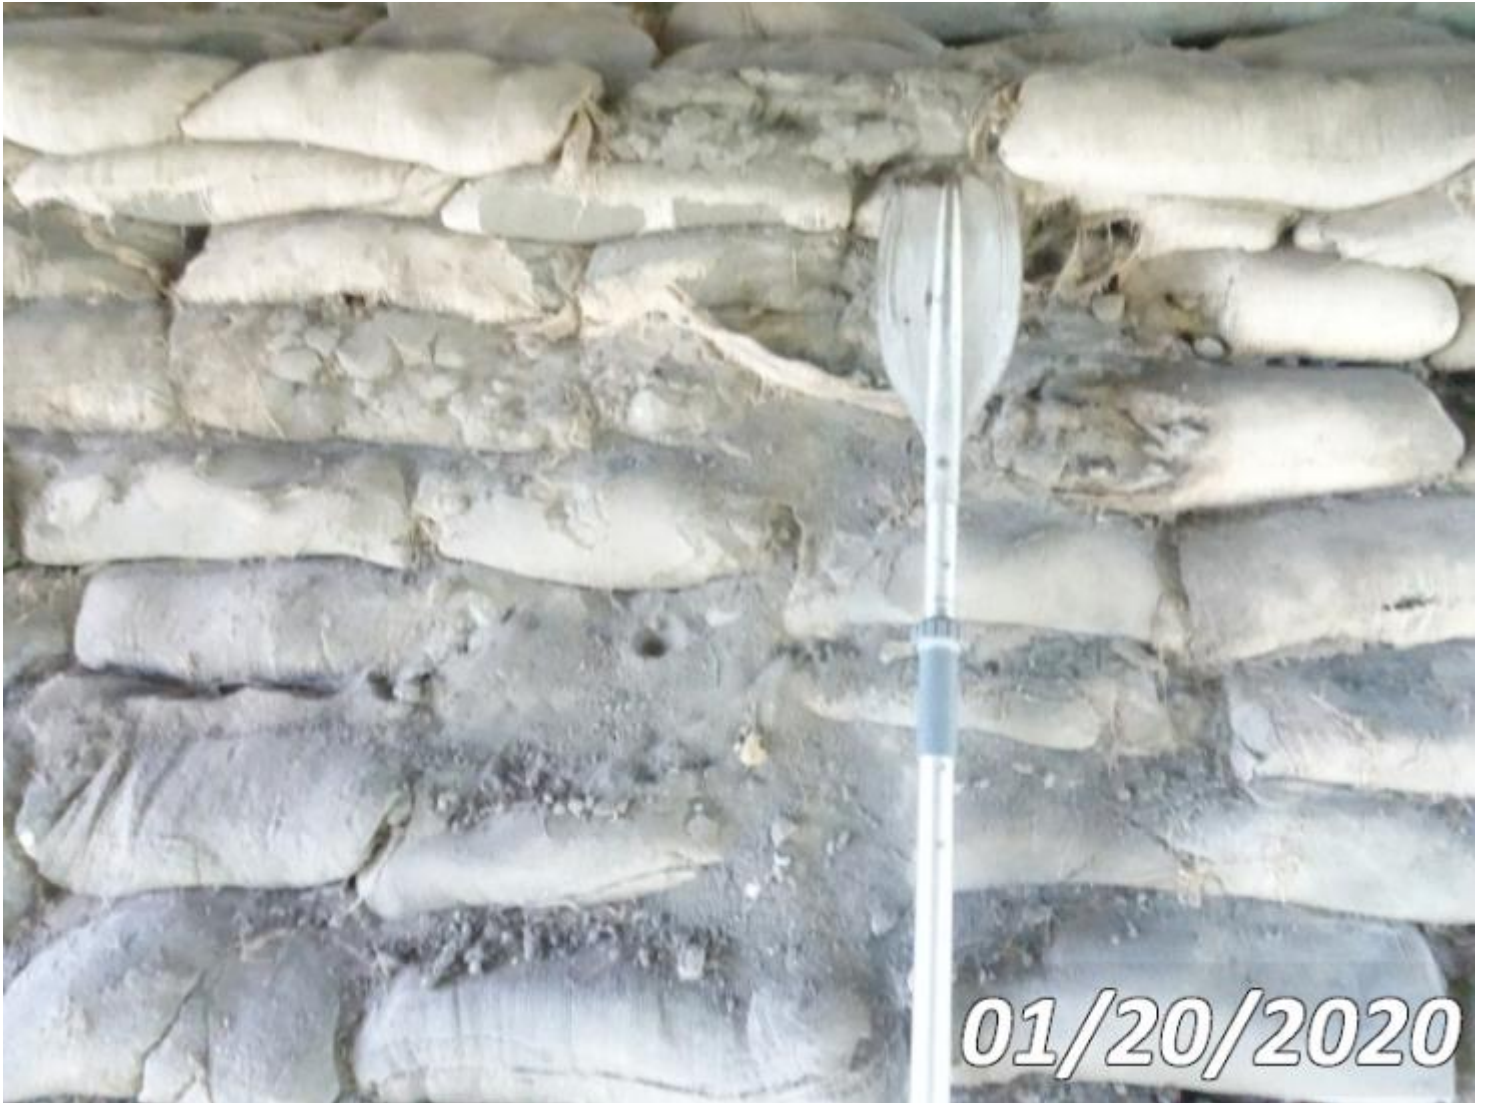
Photo 8396-S01 (Unit 0: Other Abutment Slope Protection)

Settlement at End Bent 1 slope protection near the centerline.

Repair settled area at End Bent 1 slope protection.

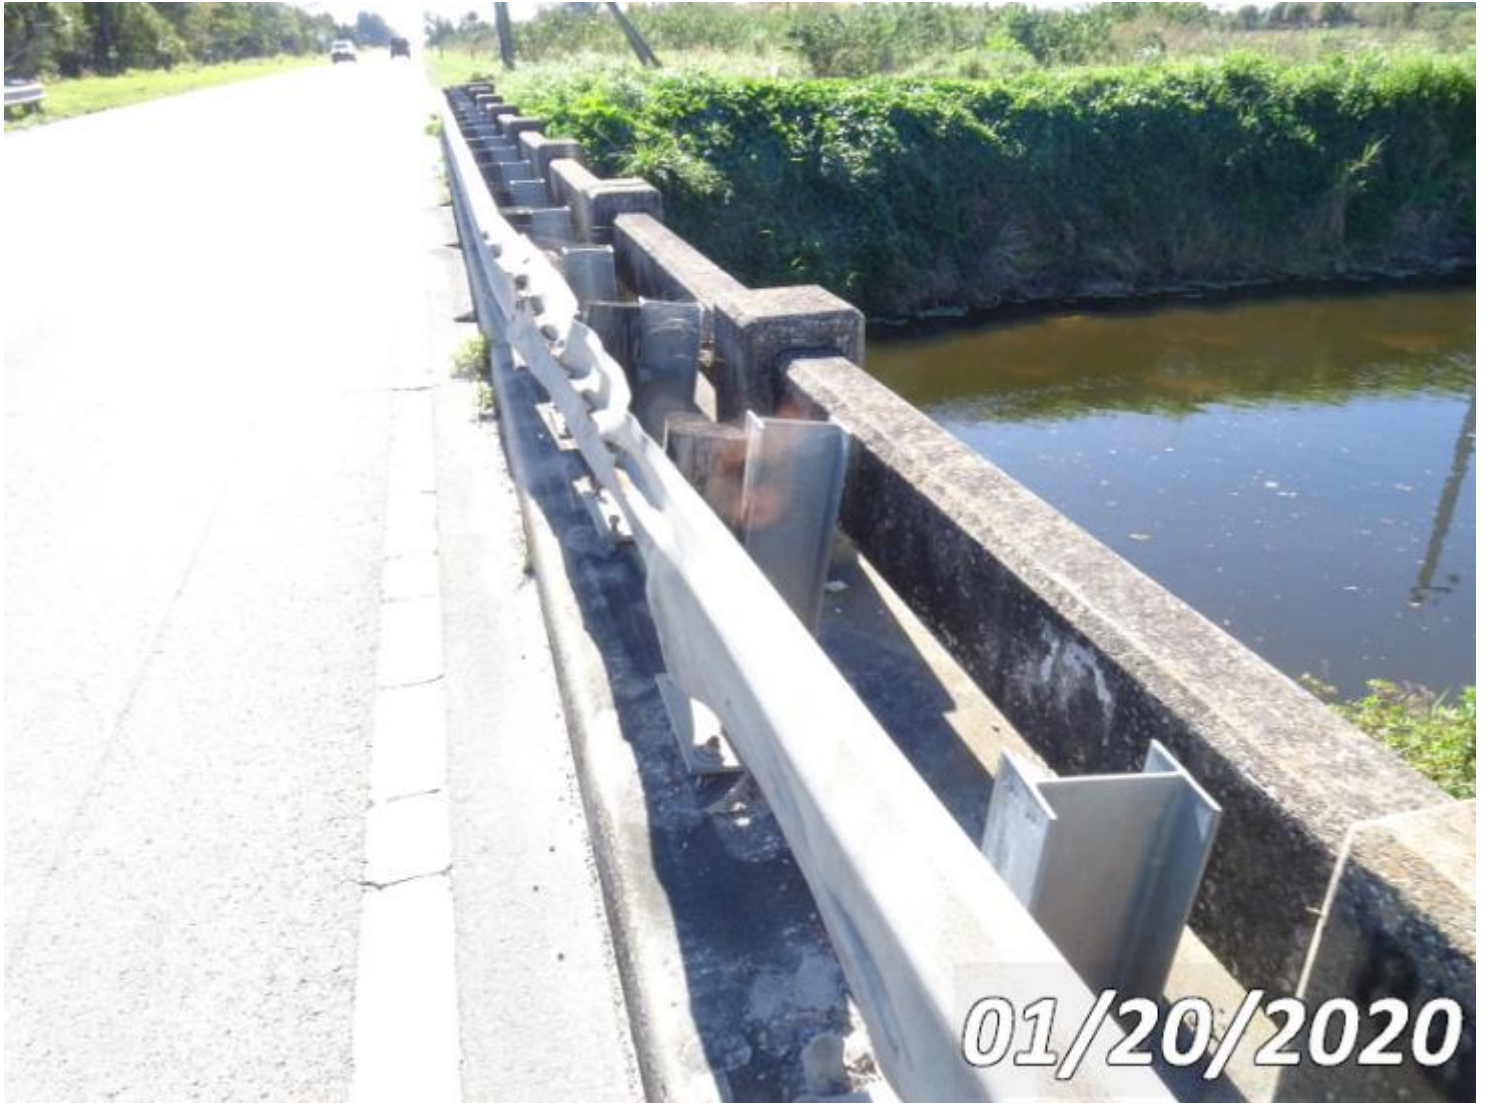
Photo 330-S01 (Unit 0: Metal Bridge Railing)

2) The left bridge rail in Span 4 has impact damage (total 10ft.). NO CHANGE. See Photo 330-01.

Impact damage to the left rail in Span 4. Failed galvanized coating.

Repair or replace damaged guardrails in Spans 1, 3 and 4.
