**FLORIDA DEPARTMENT OF TRANSPORTATION
BRIDGE MANAGEMENT SYSTEM
Inspection/CIDR/Bridge Profile Report
Inspection**

Structure ID: 880049

INSPECTION DATE: 1/20/2020 PUNW

BY: TranSystems Corporation Consultants	STRUCTURE NAME: Not recorded
OWNER: 2 County Hwy Agency	YEAR BUILT: 1956
MAINTAINED BY: 2 County Hwy Agency	SECTION NO.: 88 590 000
STRUCTURE TYPE: 1 Reinforced Concrete - 01 Slab	MP: 0.010
LOCATION: 25FT. EAST OF 66TH AVE.	ROUTE: 00632
SERV. TYPE ON: 1 Highway	FACILITY CARRIED: 65TH ST.
SERV. TYPE UNDER: 5 Waterway	FEATURE INTERSECTED: LATERAL A CANAL

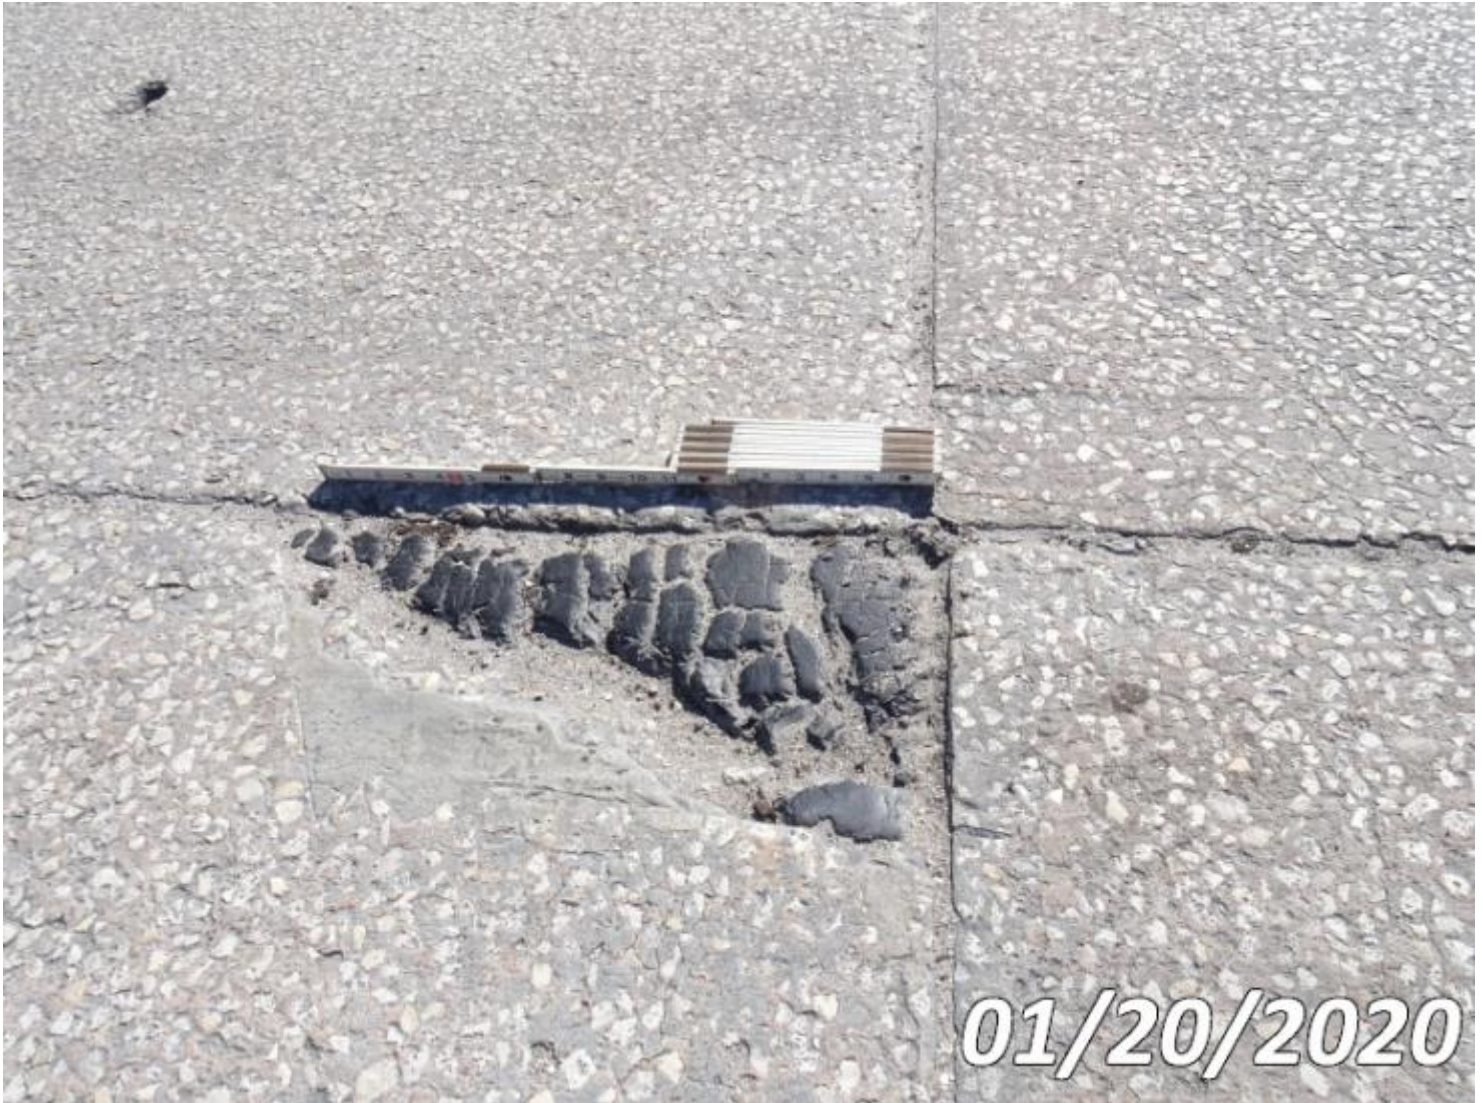
Photo 38-S01 (Unit 0: Re Concrete Slab)

1) The top of Slab Units 1-2, 2-2, 2-3 and 3-3, southwest corners, each has a spalled/delaminated patch up to 17in. L x 10in. W x 1/4in. D; however, this patch has been repaired with hot poured sealant and the sealant is deteriorated (total 8sf.). NO CHANGE. See Photo 38-S01.

Spall/delaminated patch in Slab Unit 2-3 at the top side of the slab in the southwest corner.

Repair spall and delaminated patch at the top of Slab Units 1-2 2-2 2-3 and 3-3.

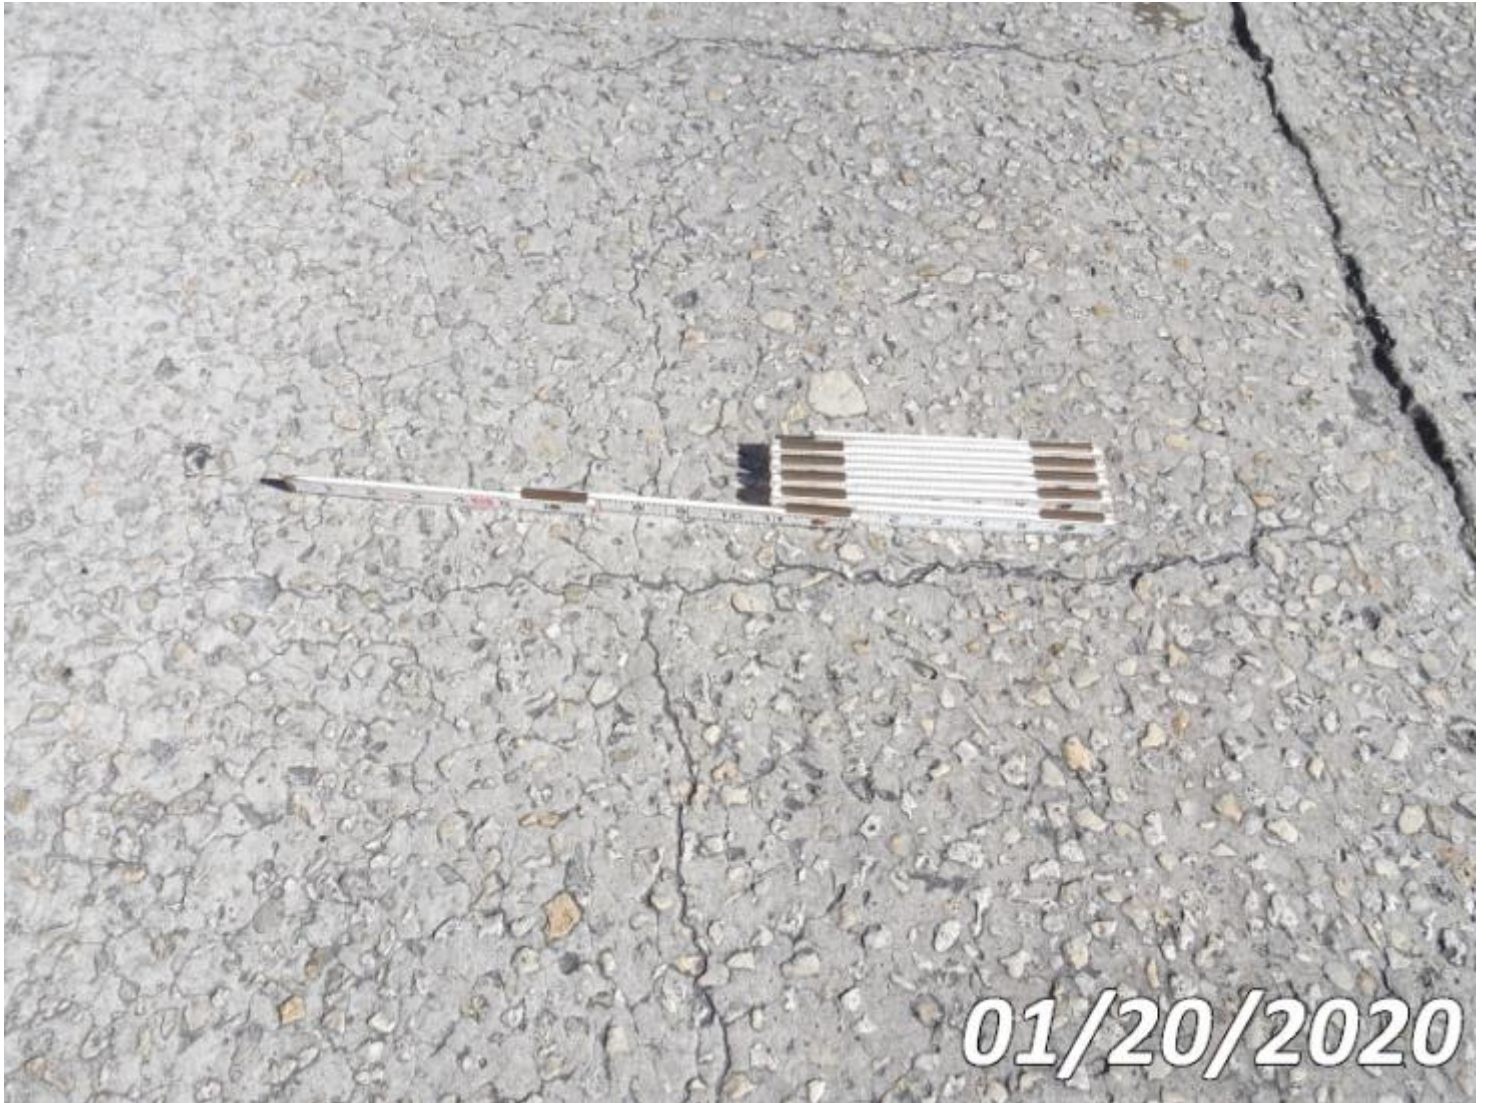
Photo 38-S02 (Unit 0: Re Concrete Slab)

4) The top face of Slab Units 3-1 and 3-4 have up to 4ft. L x 1/8in. W transverse cracks in 12in. to 24in. intervals, starting at Bent 3 and extending to End Bent 4 (total 16sf.). NO CHANGE. See Photo 38-S02.

Transverse cracks in Slab Unit 3-1.

REPAIR RECOMMENDATION:
None.

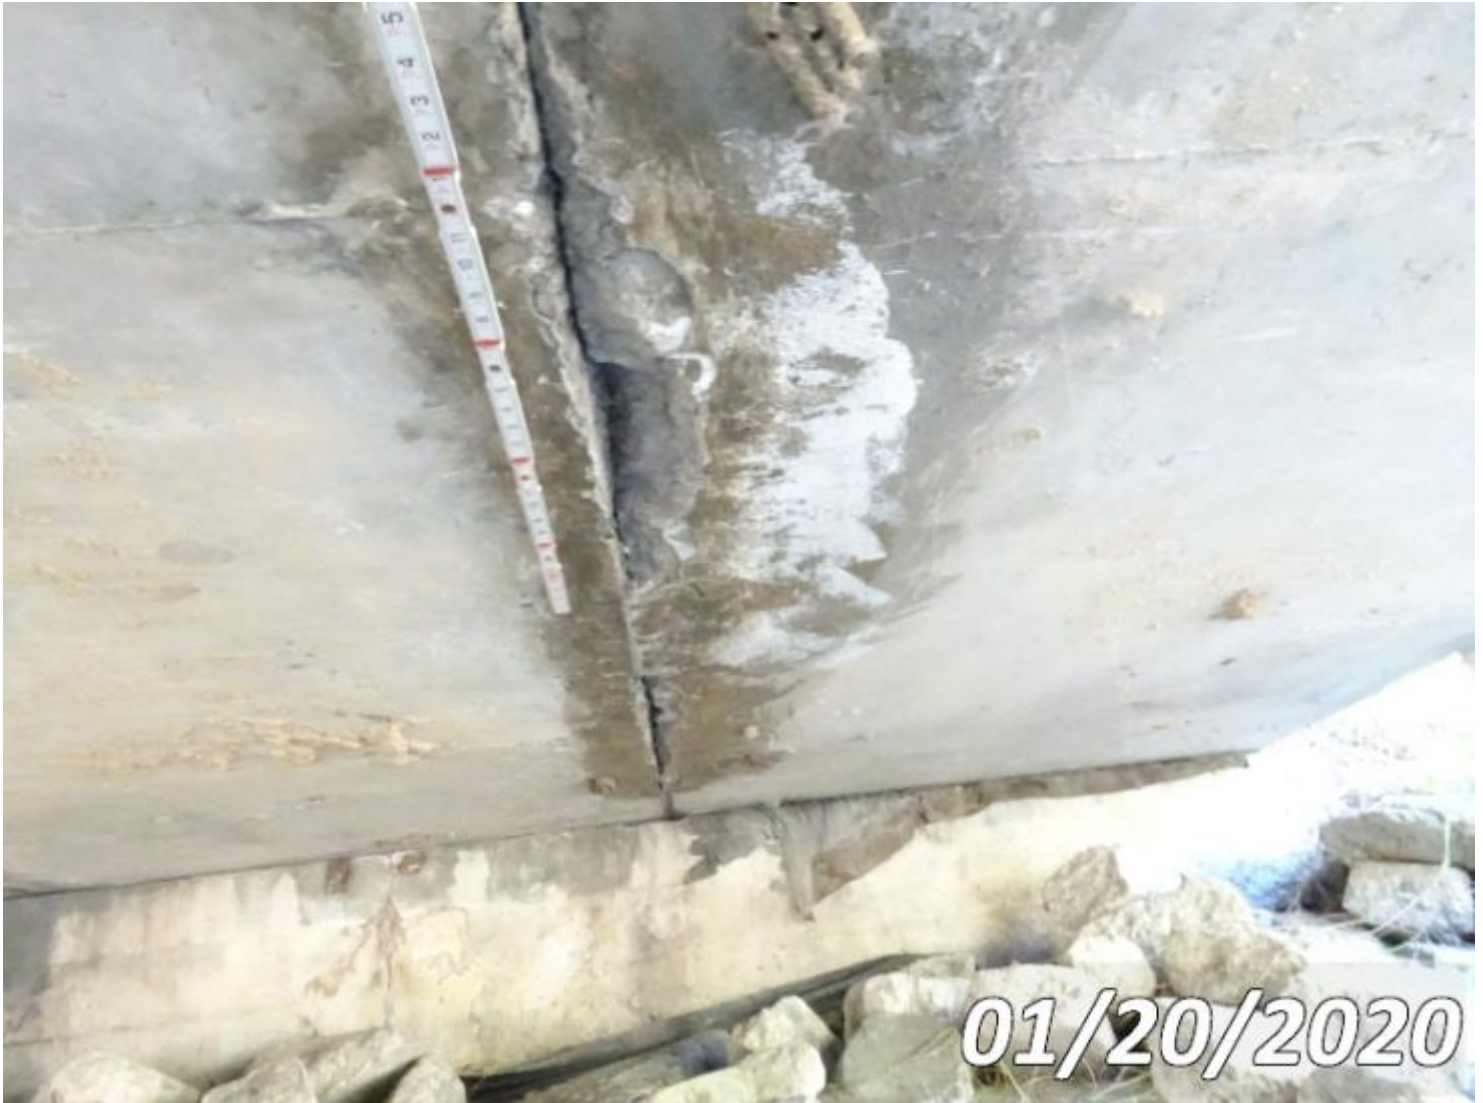
Photo 38-S03 (Unit 0: Re Concrete Slab)

6) The south edge of Slab Unit 1-1 exhibits a spall/delamination 48in. L x 6in. W x 3in. D, 3ft. from End Bent 1, (total 4sf.). NO CHANGE. See Photo 38-S03.

Spall in the south edge of Slab Unit 1-1, 3ft. from End Bent 1.

Repair spalls and delaminations in Slab Units 1-1 1-2 2-2 3-1 3-2 and 3-4.

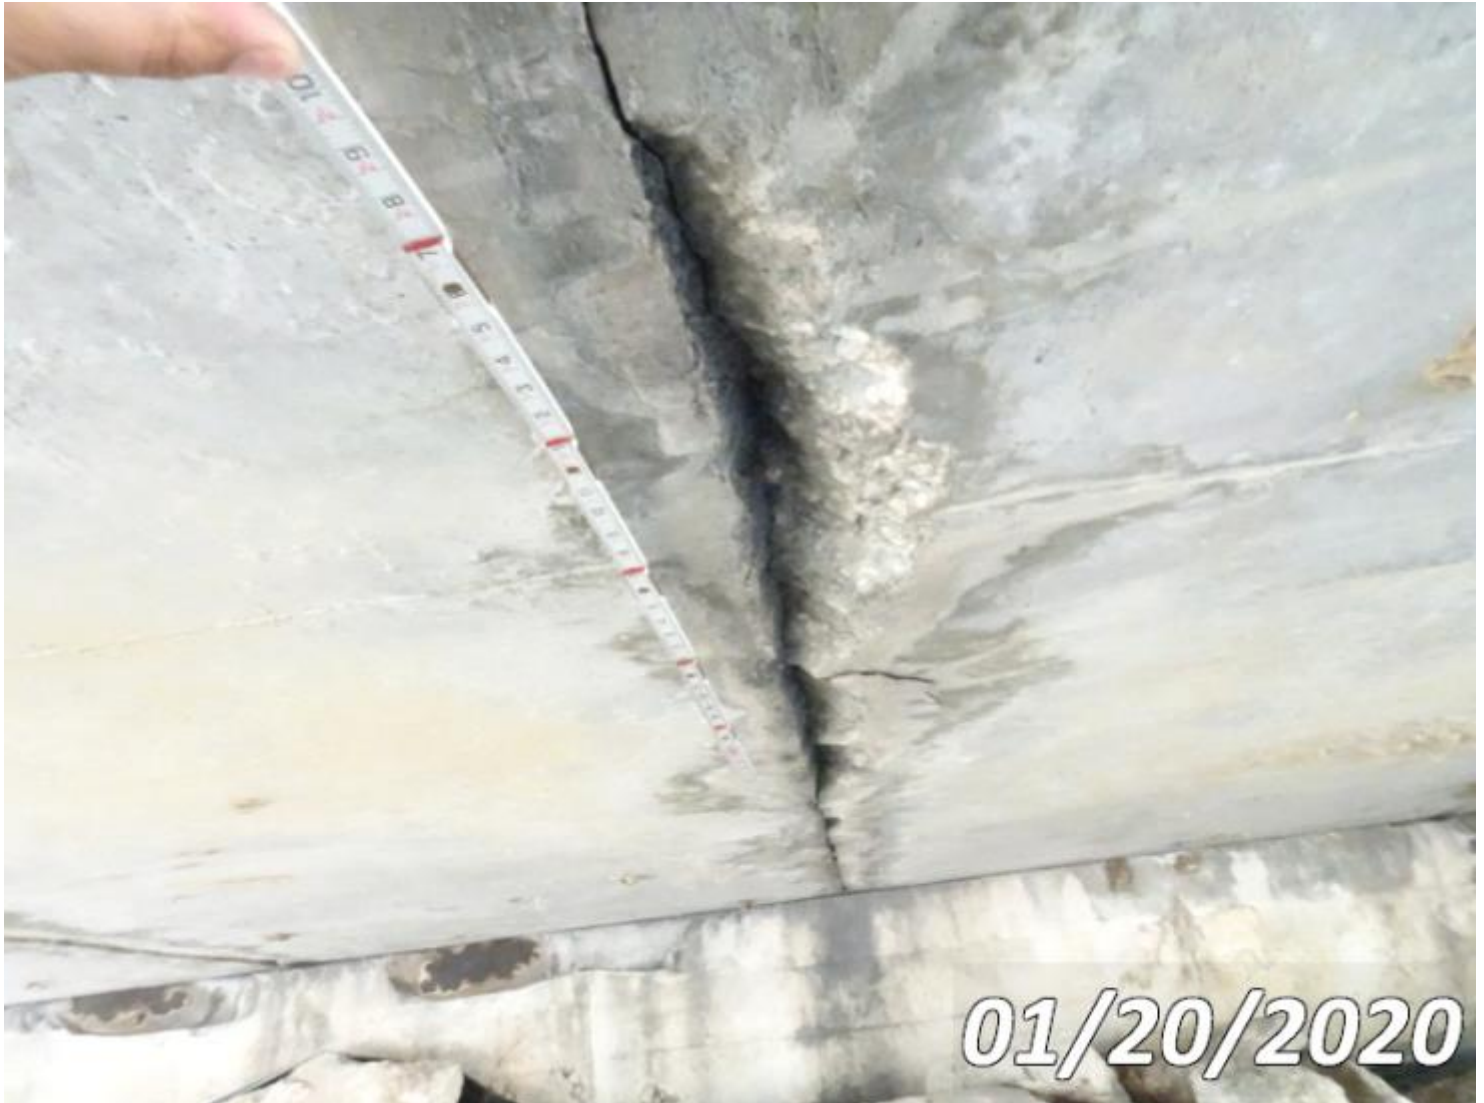
Photo 38-S04 (Unit 0: Re Concrete Slab)

7) The south edge of Slab Unit 1-2 exhibits a spall 4ft. L x 4in. W x 3in. D, 3ft. from End Bent 1 (total 3sf.). Previously noted as 3ft. L. INCREASE. See Photo 38-S04.

Spall in the south edge of Slab Unit 1-2, 3ft. from End Bent 1.

Repair spalls and delaminations in Slab Units 1-1 1-2 2-2 3-1 3-2 and 3-4.

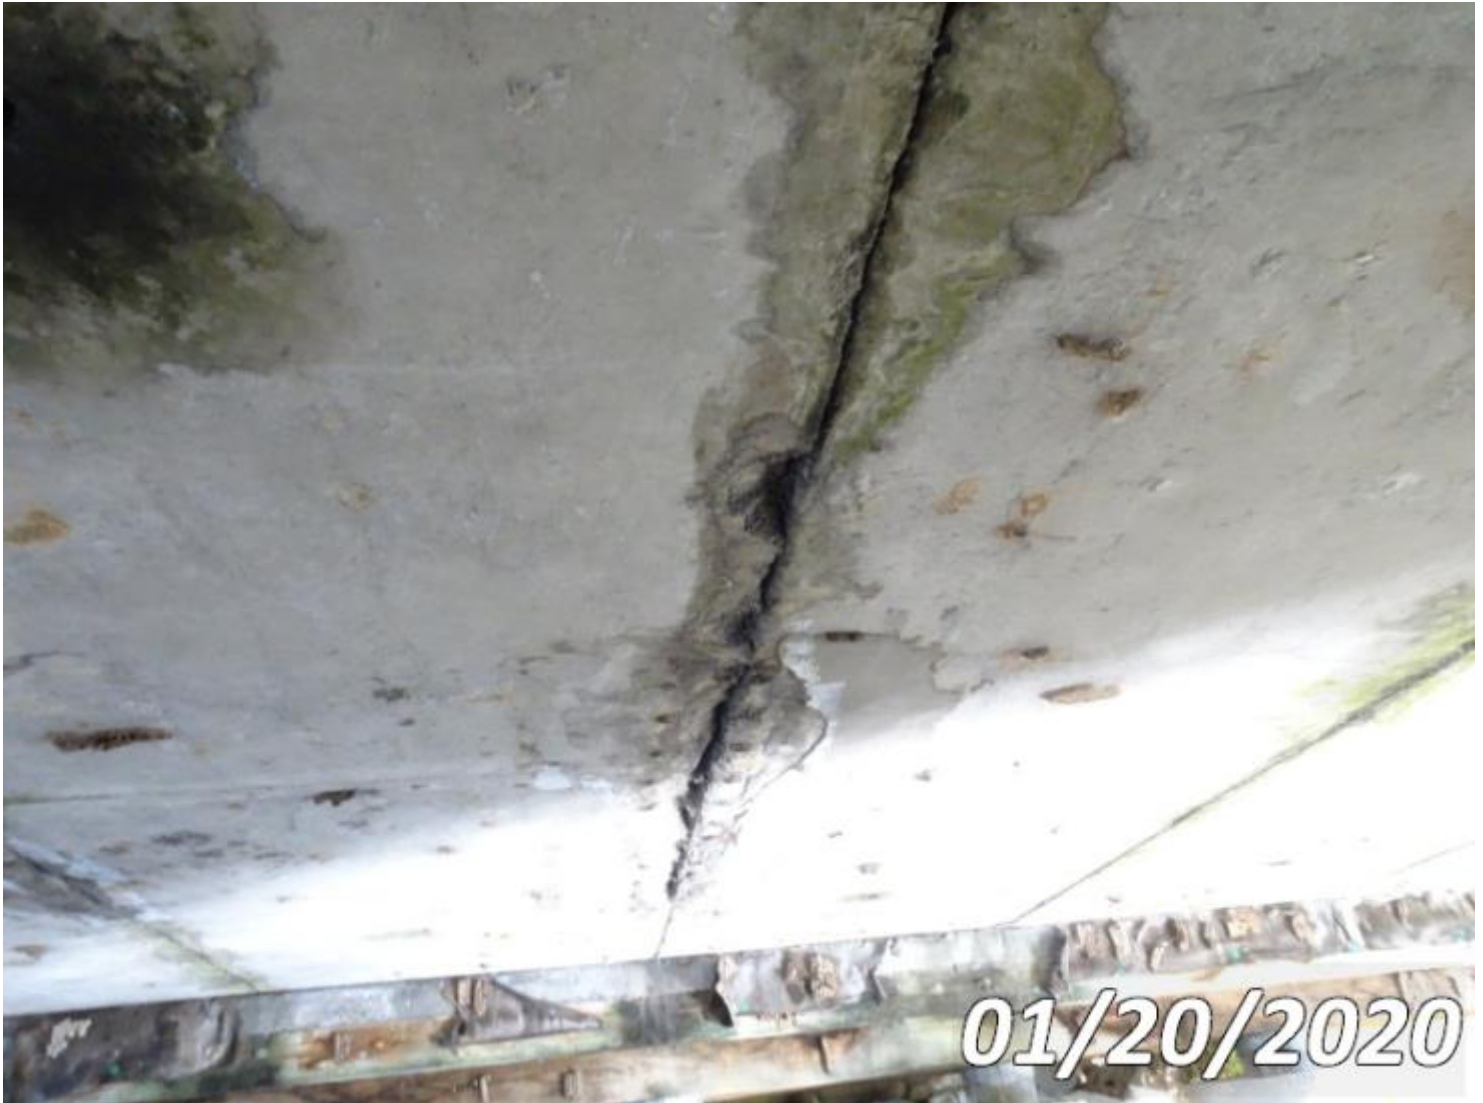
Photo 38-S05 (Unit 0: Re Concrete Slab)

8) The south edge of Slab Unit 2-2 exhibits four spalls up to 5ft. L x 6in. W x 3in. D, 4ft east of Bent 2 (total 20sf.). NO CHANGE. See Photo 38-S05.

Spalls in the south edge of Slab Unit 2-2, 4ft. east of Bent 2.

Repair spalls and delaminations in Slab Units 1-1 1-2 2-2 3-1 3-2 and 3-4.

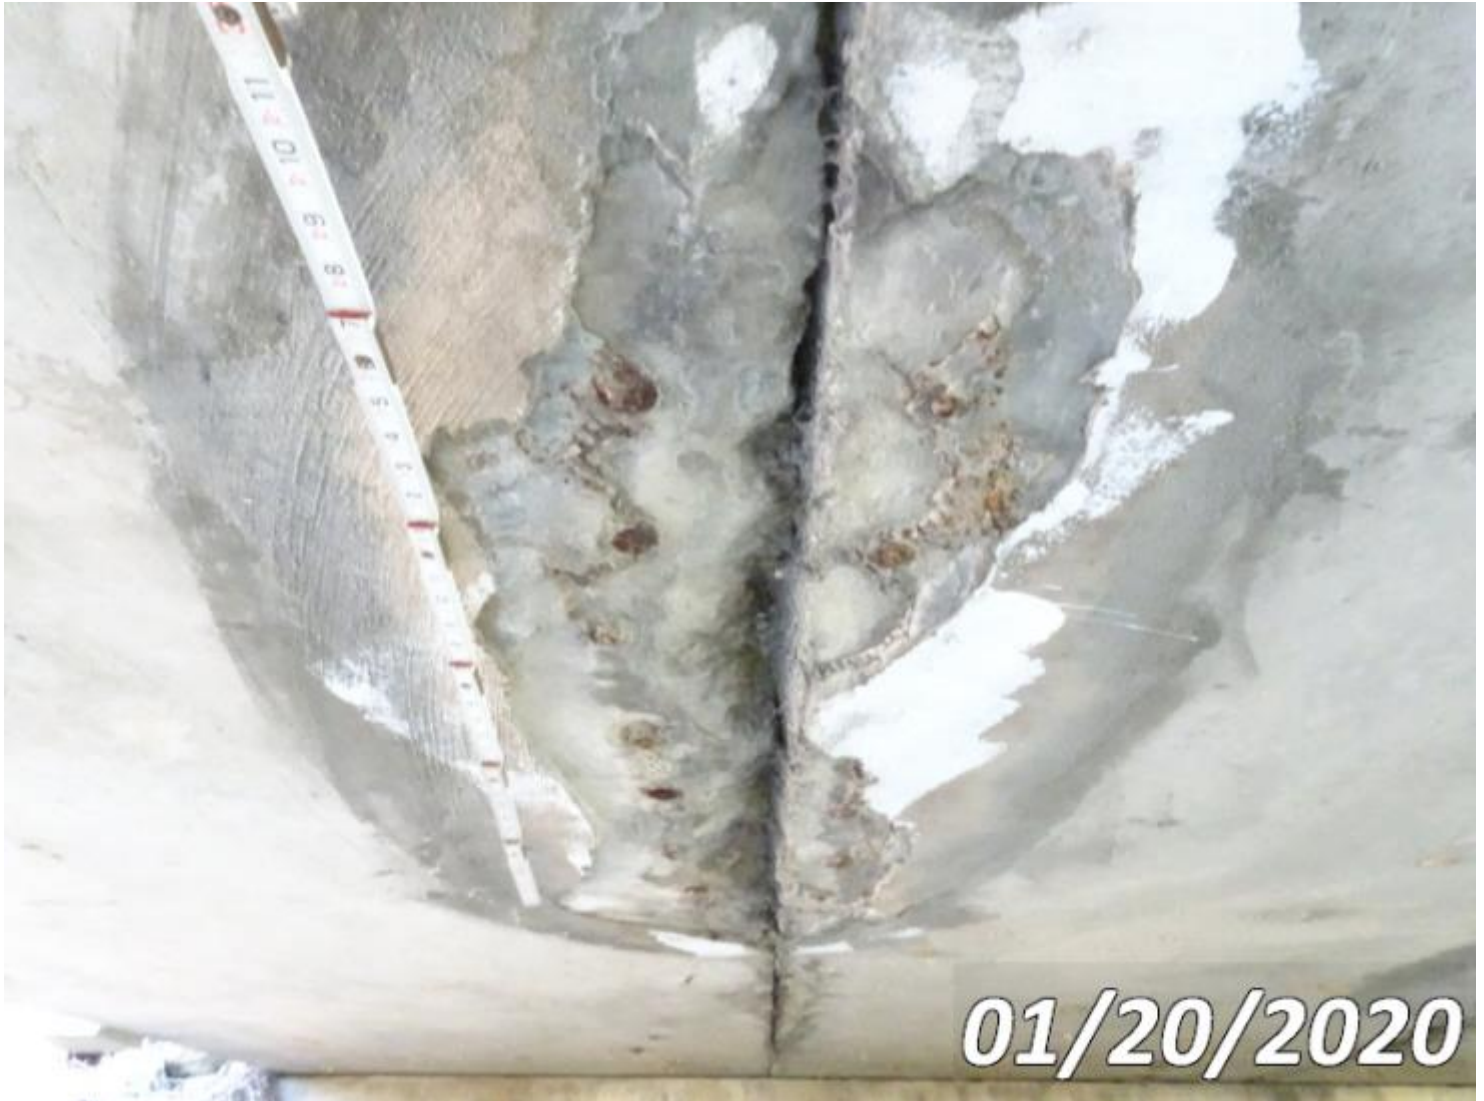
Photo 38-S06 (Unit 0: Re Concrete Slab)

9) The north edge of Slab Unit 3-1 exhibits a spalled patch 4ft. L x 4in. W x 1in. D with no exposed steel at midspan (total 4sf.). NEW. See Photo 38-S06.

Spalled patch with no exposed steel in the midspan of Slab Unit 3-1.

Repair spalls and delaminations in Slab Units 1-1 1-2 2-2 3-1 3-2 and 3-4.

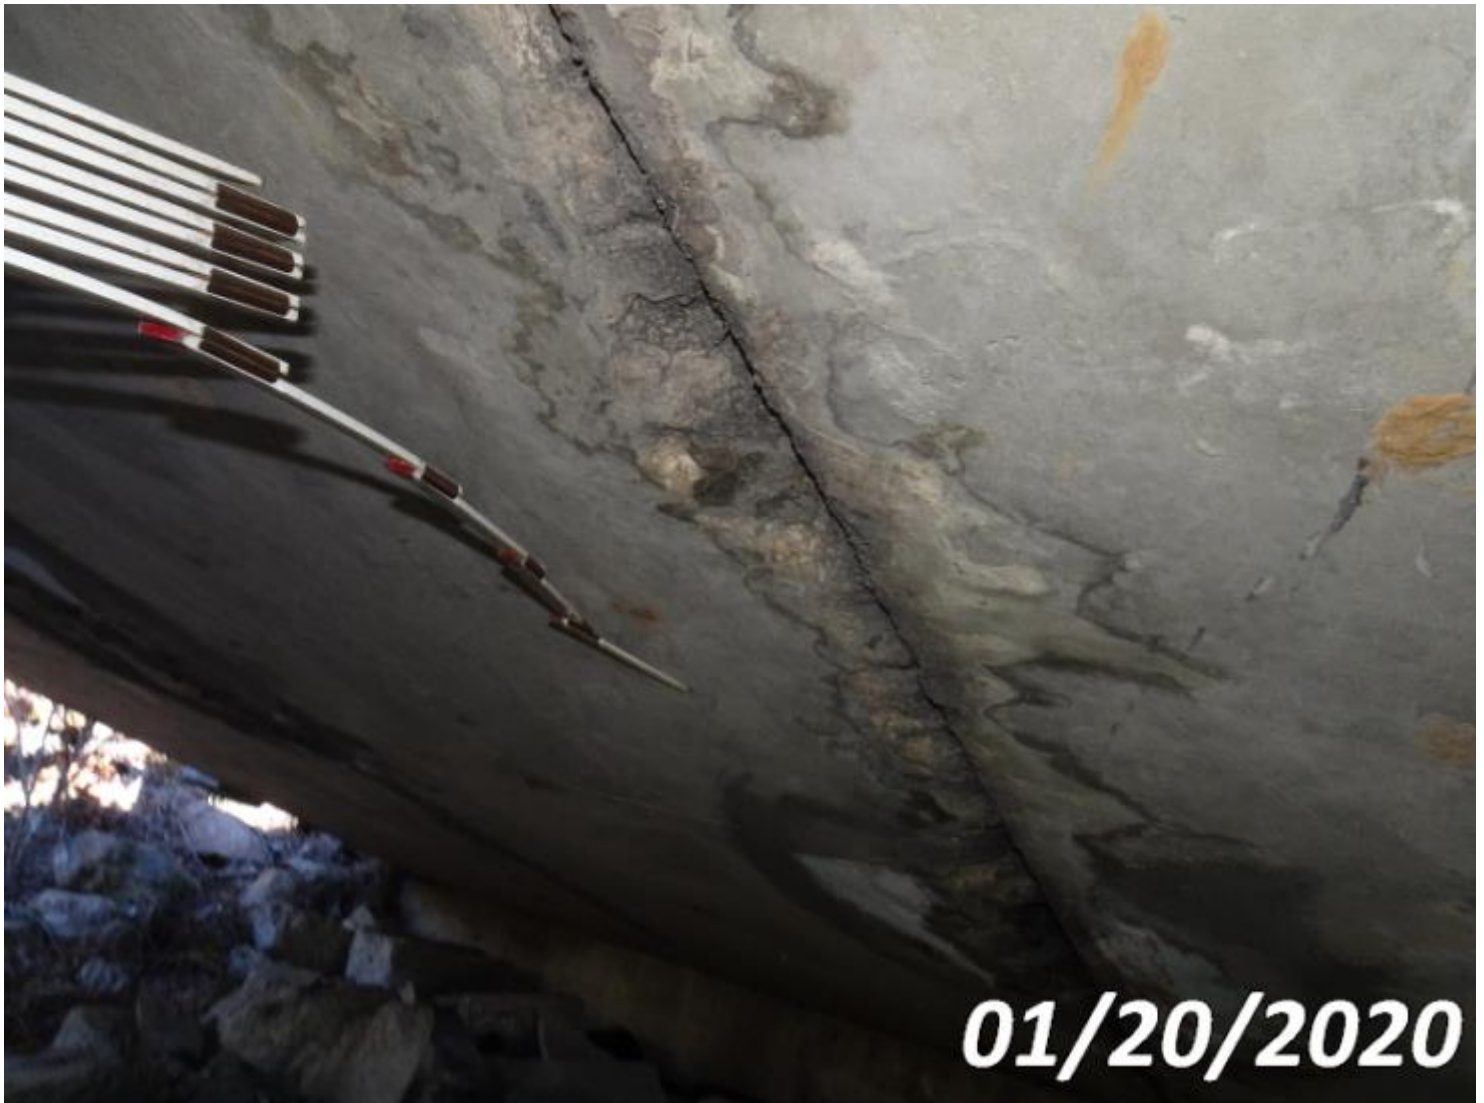
Photo 38-S07 (Unit 0: Re Concrete Slab)

10) Slab Unit 3-2 south edge near 3/4 point exhibits a spall 6ft. L x 6in. W x 4in. D in a failed patch with exposed corroded rebar with 7/8in. remaining thickness (1in. Original)(total 6sf.). NO CHANGE. See Photo 38-S07.

Spall in the south edge of Slab Unit 3-2.

Repair spalls and delaminations in Slab Units 1-1 1-2 2-2 3-1 3-2 and 3-4.

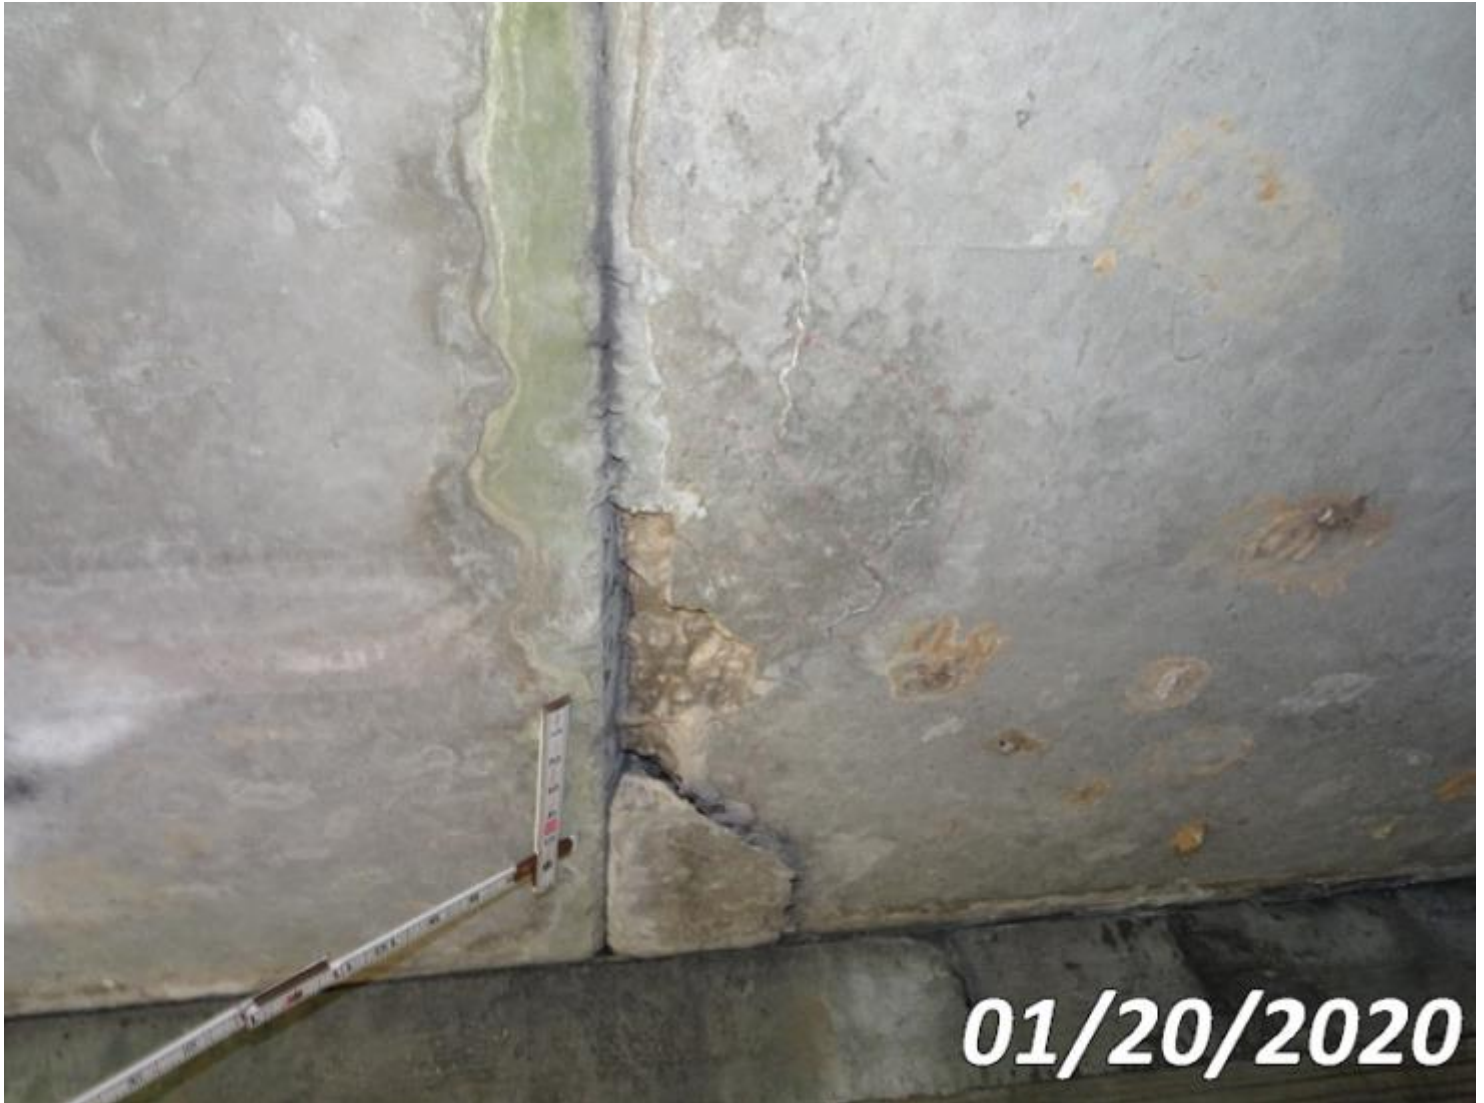
Photo 38-S08 (Unit 0: Re Concrete Slab)

11) Slab Unit 3-4 south edge at Bent 3 exhibits a spall/delamination 2ft. L x 5in. W x 1in. D (total 2sf.). Spall not previously noted. INCREASE. See Photo 38-S08.

Spall in the south edge of Slab Unit 3-4.

Repair spalls and delaminations in Slab Units 1-1 1-2 2-2 3-1 3-2 and 3-4.

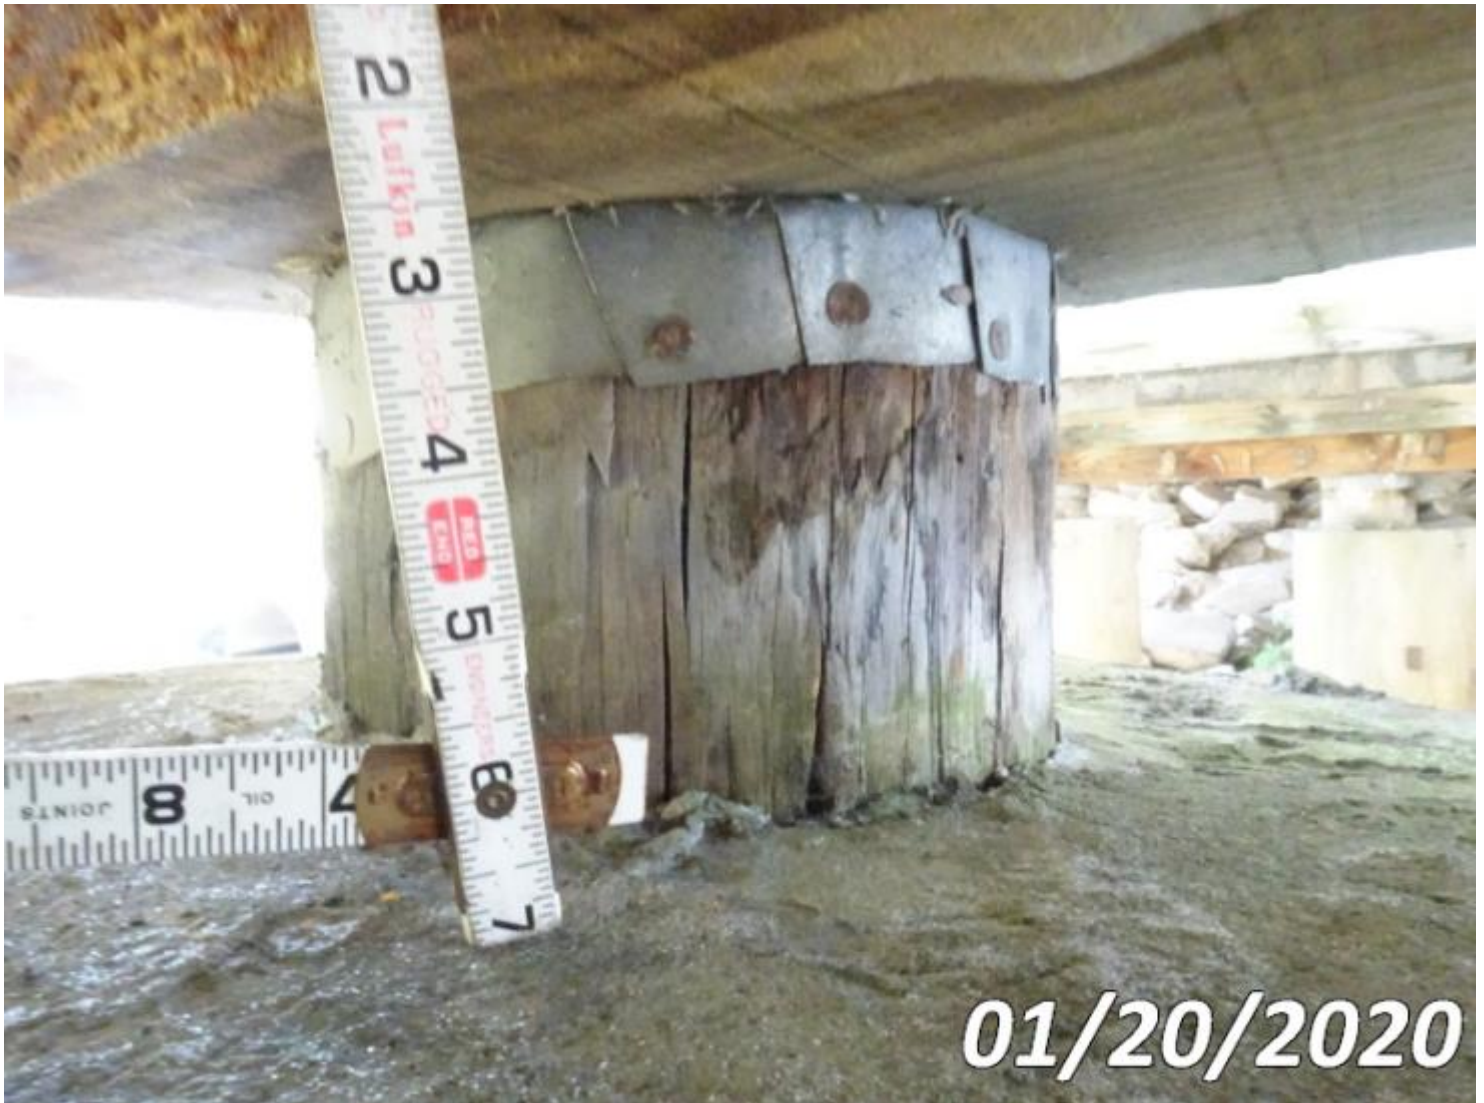
Photo 228-S01 (unit 0: Timber Pile)

1) The visible portions of the piles have weathering splits up to 1/8in. W above the jackets (total 12ea.). NO CHANGE. See Photo 228-S01.

Split in the visible portion of Pile 3-4 above the jacket.

REPAIR RECOMMENDATION:
None.

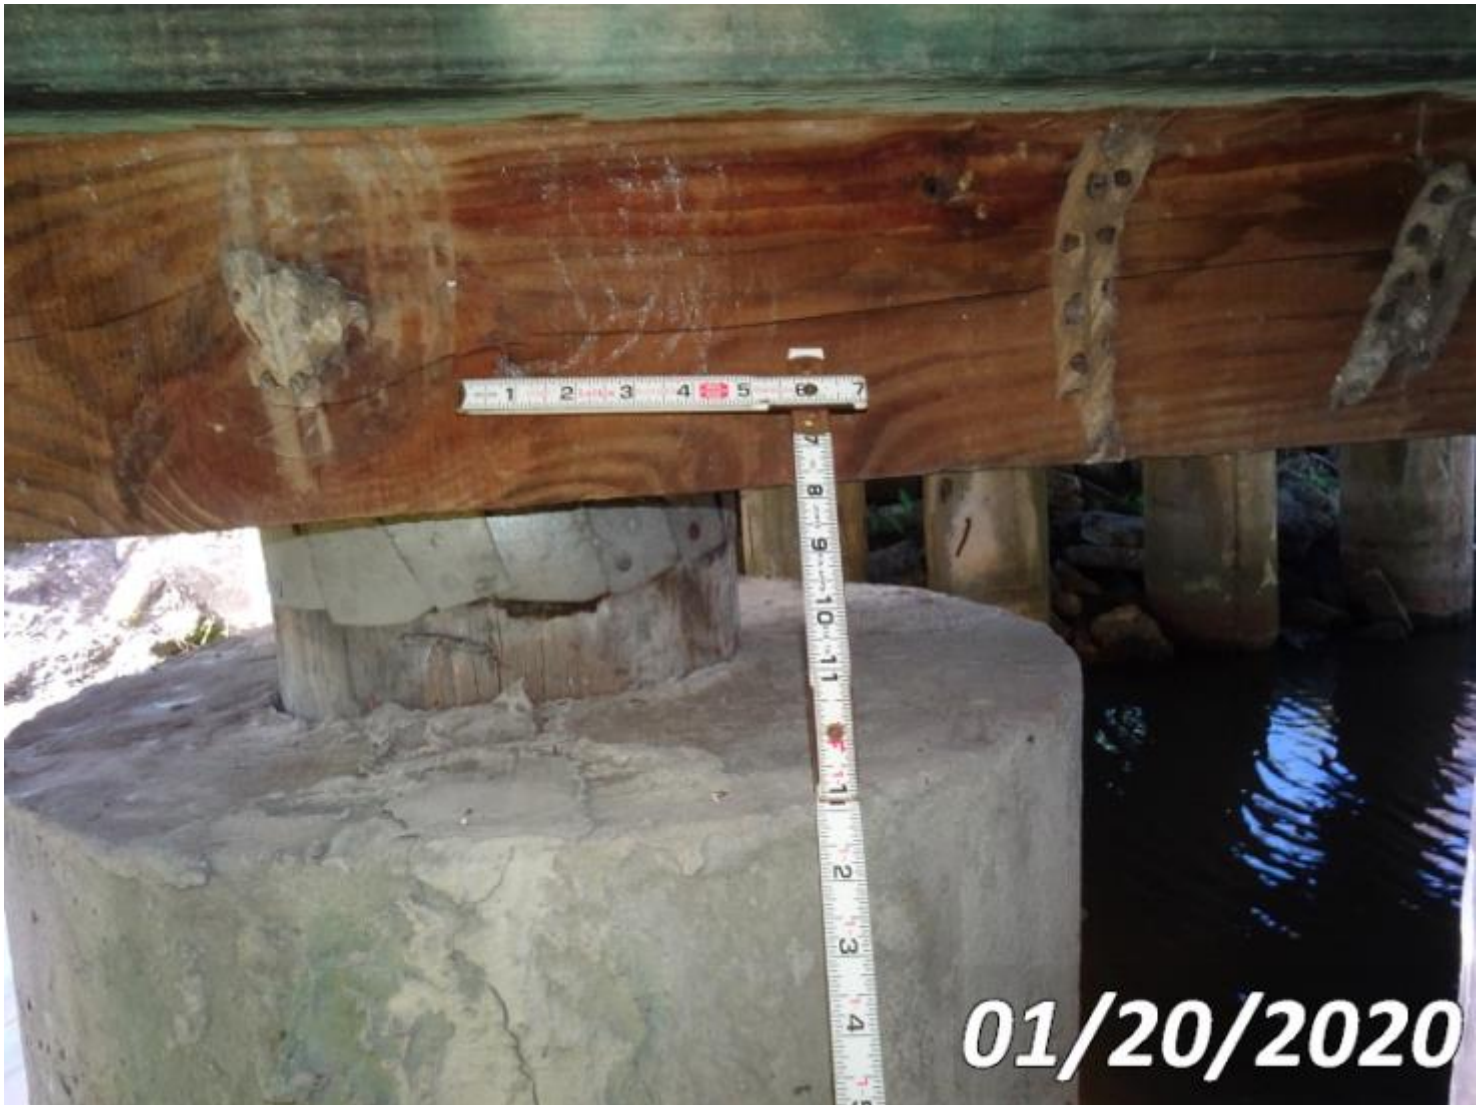
Photo 235-S01 (Unit 0: Timber Pier Cap)

1) The timber caps and fascia boards have weathering splits up to 1/16in. W (total 10ft.). NO CHANGE. See Photo 235-S01.

Horizontal split in the east face of Bent 3 cap.

REPAIR RECOMMENDATION:
Repair horizontal split in the timber caps.

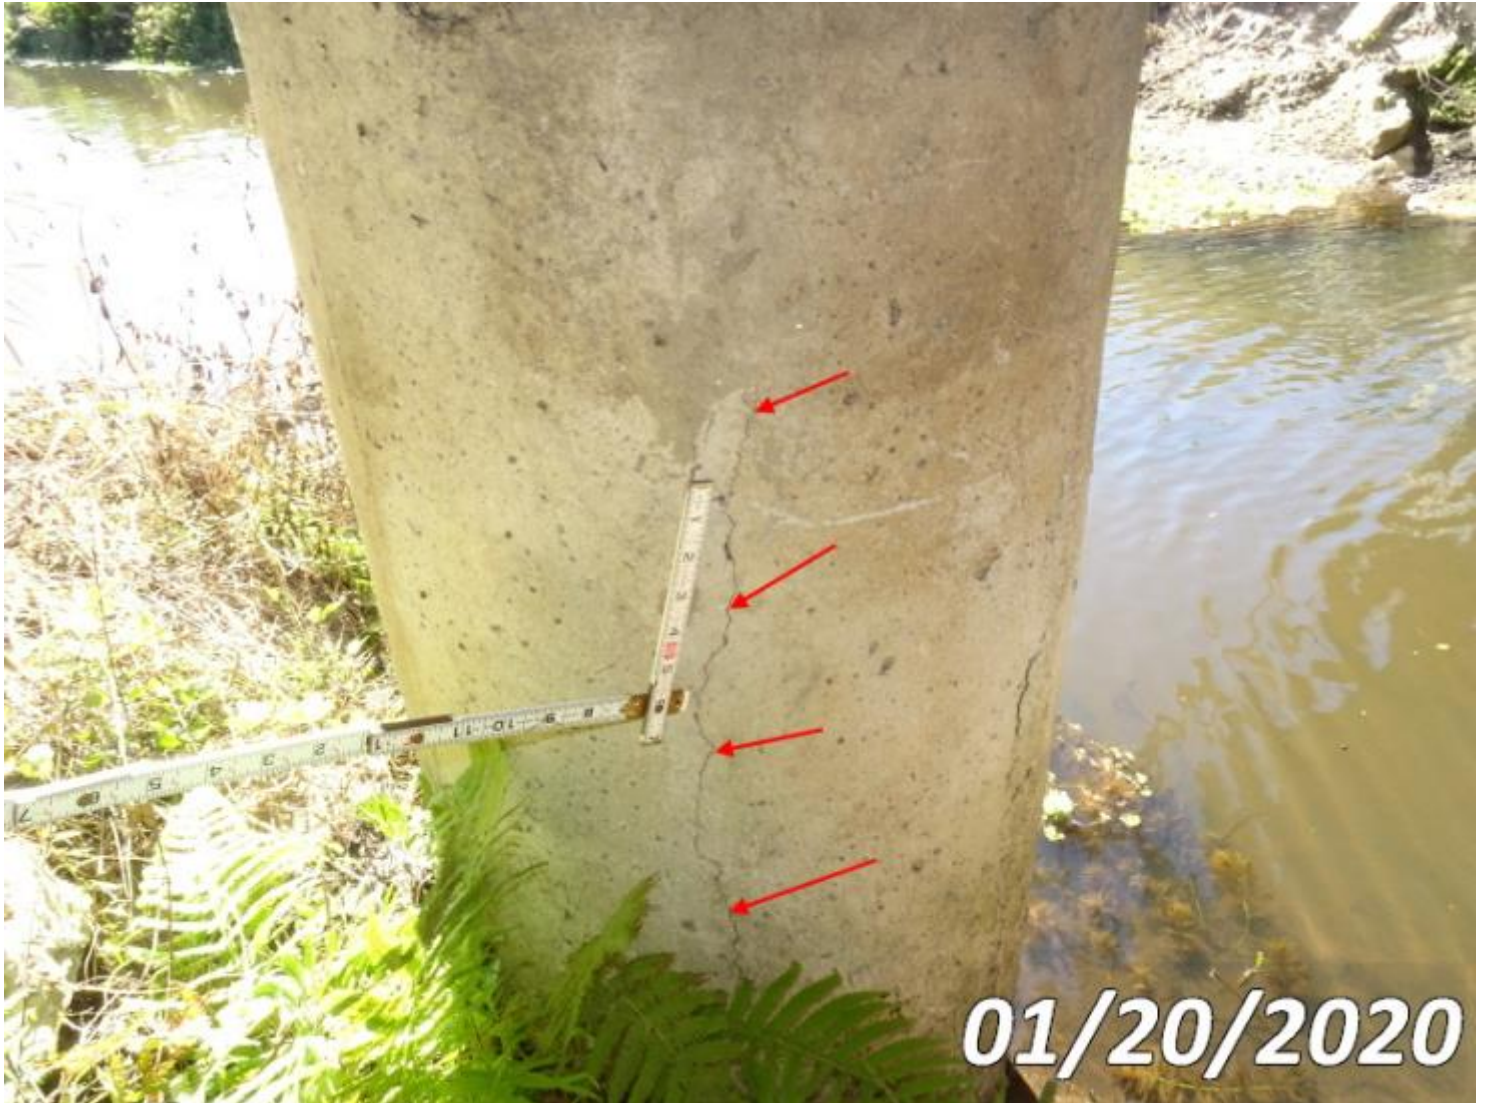
Photo 8298-S01 (Unit 0: Pile Jacket Bare)

1) Numerous jackets have vertical cracks up to 4ft. L x 1/8in. W, primarily in the previously patched areas (total 12ea.). NO CHANGE. See Photo 8298-S01.

Vertical crack in Pile Jacket 3-6.

REPAIR RECOMMENDATION:
None.

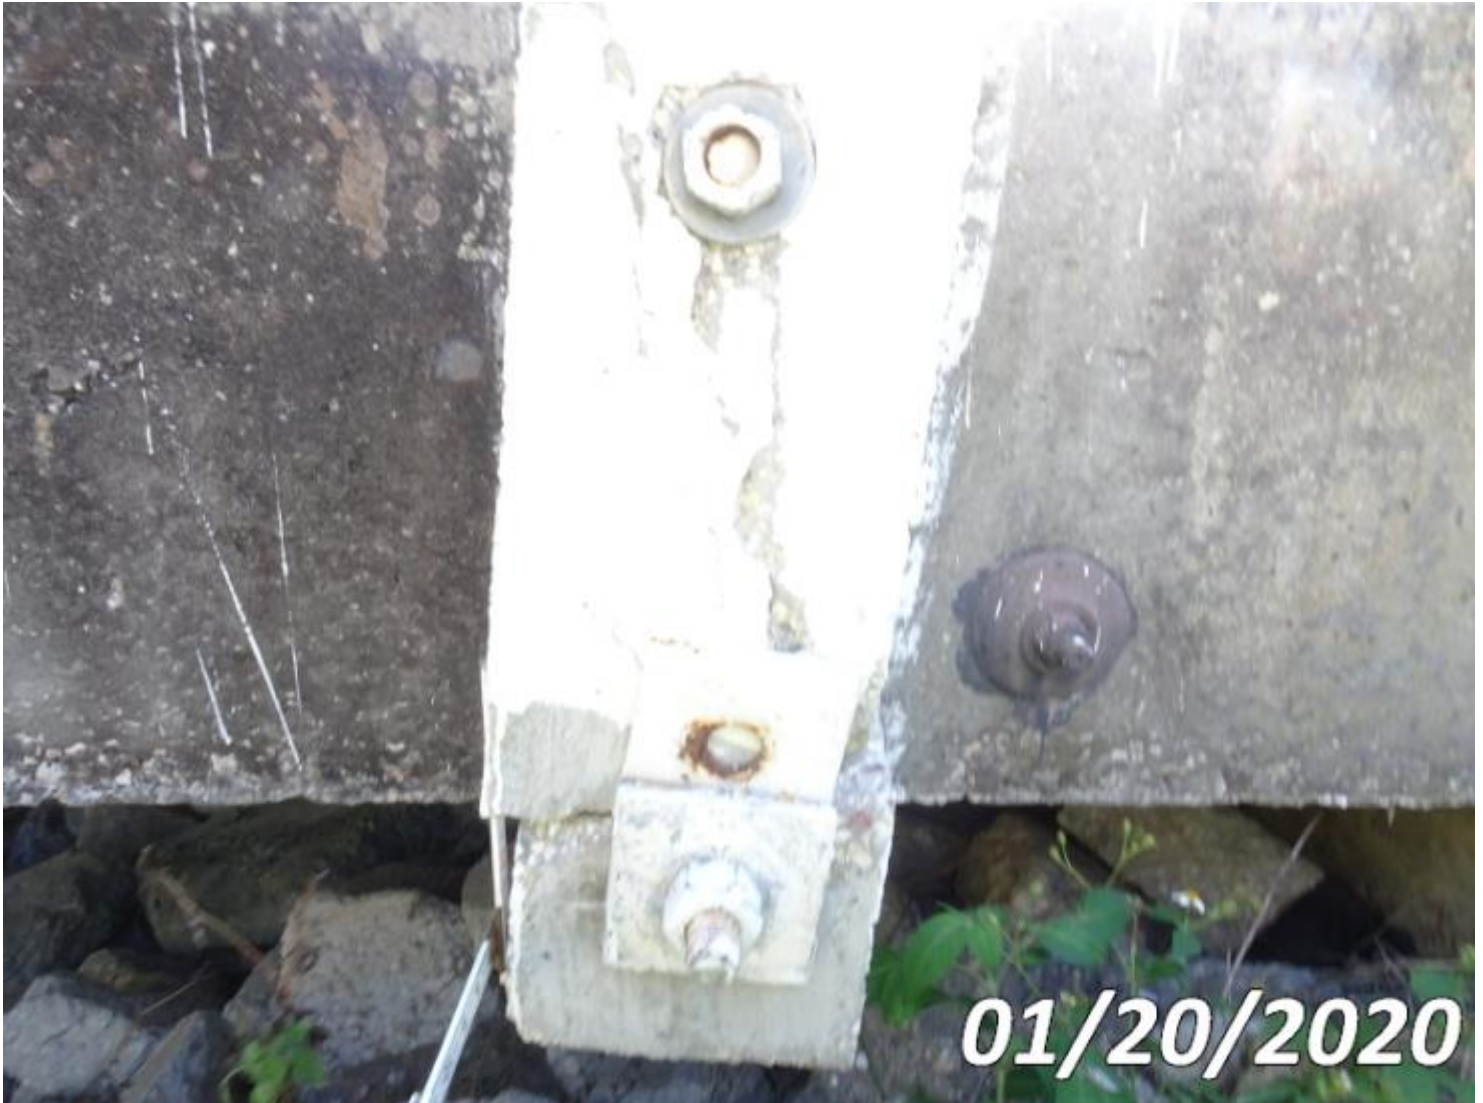
Photo 333-S01 (Unit 0: Other Bridge Railing)

1) Railing Post 1-1L is completely fractured with efflorescence and is loose (total 1ft.). NEW. See Photo 333-S01.

Loose and fractured Post 1-1L.

Replace loose and fractured Posts 1-1L and 1-2L.

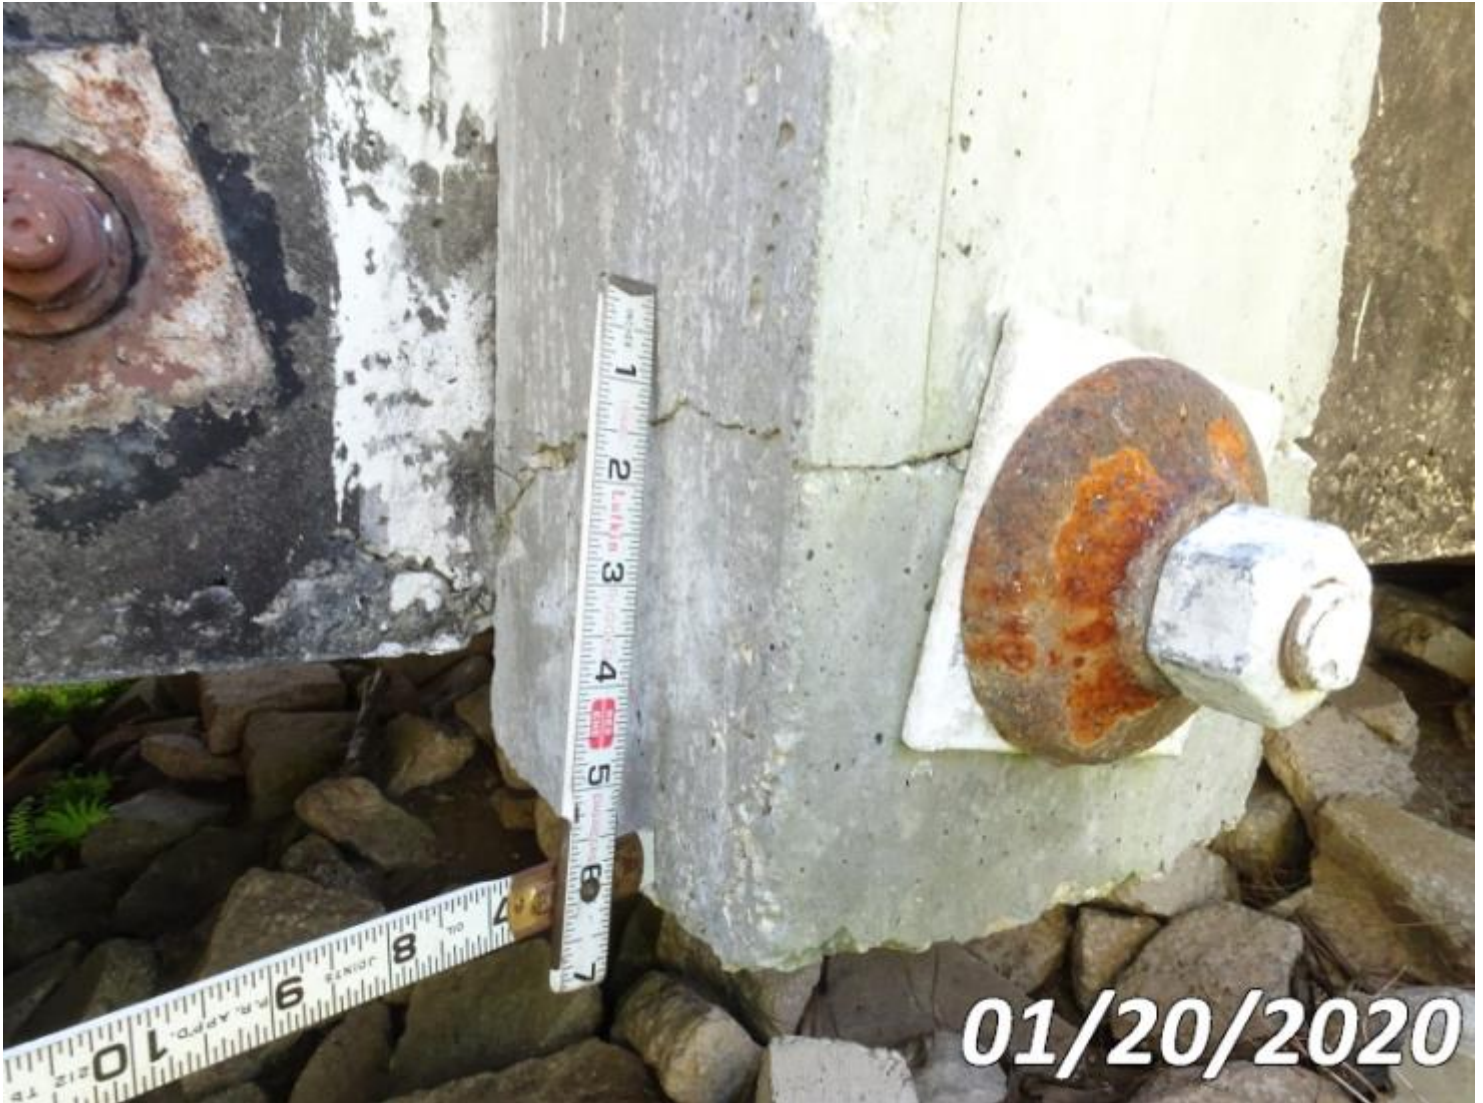
Photo 333-S02 (Unit 0: Other Bridge Railing)

2) Railing Post 1-2L is fractured around the post and loose at the bottom edge (total

1ft.). Previously noted with delamination. INCREASE. See Photo 333-S02.

Fractured and loose Railing Post 1-2L.

Replace loose and fractured Posts 1-1L and 1-2L.
