**FLORIDA DEPARTMENT OF TRANSPORTATION
BRIDGE MANAGEMENT SYSTEM
Inspection/CIDR/Bridge Profile Report
Inspection**

Structure ID: 880049

INSPECTION DATE: 1/20/2020 PUNW

BY: TranSystems Corporation Consultants	STRUCTURE NAME: Not recorded
OWNER: 2 County Hwy Agency	YEAR BUILT: 1956
MAINTAINED BY: 2 County Hwy Agency	SECTION NO.: 88 590 000
STRUCTURE TYPE: 1 Reinforced Concrete - 01 Slab	MP: 0.010
LOCATION: 25FT. EAST OF 66TH AVE.	ROUTE: 00632
SERV. TYPE ON: 1 Highway	FACILITY CARRIED: 65TH ST.
SERV. TYPE UNDER: 5 Waterway	FEATURE INTERSECTED: LATERAL A CANAL

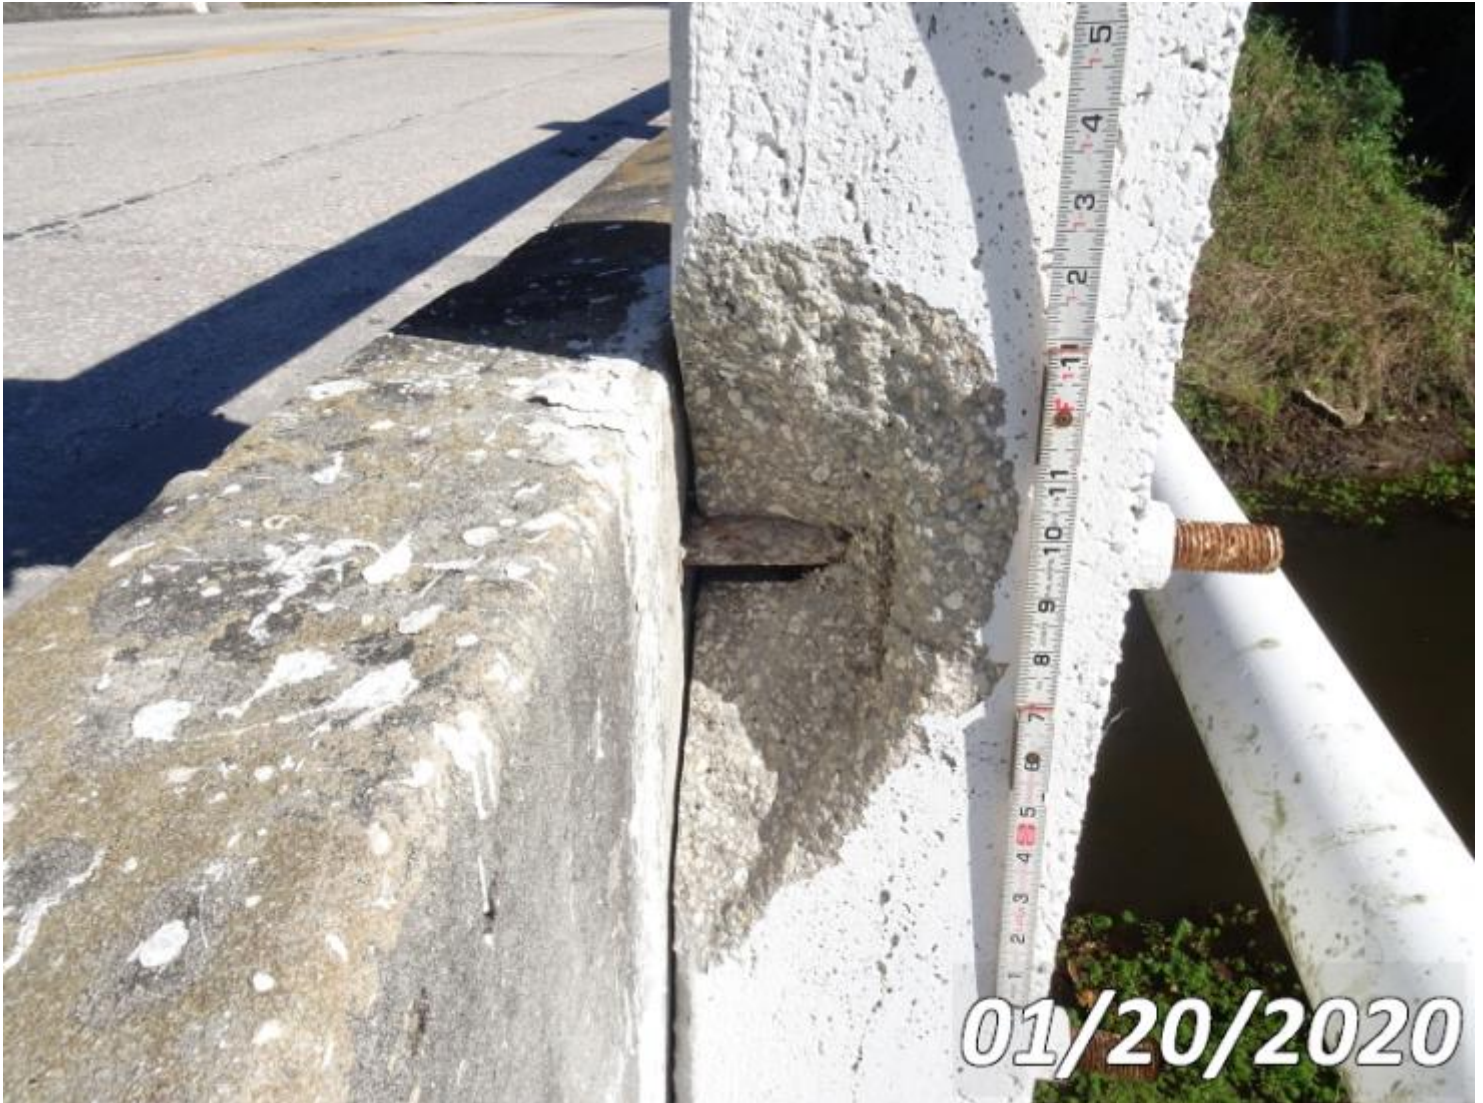
Photo 333-S03 (Unit 0: Other Bridge Railing)

3) Railing Post 1-2R exhibits a spall 14in. H x 5in. W x 2in. D with exposed rebar in the west face (total 1ft.). NEW. See Photo 333-S03.

Spall in Railing Post 1-2R, in the west face.

Repair spalls and delaminations in Railing Posts 1-2R 2-1R 2-2R and 3-2L.

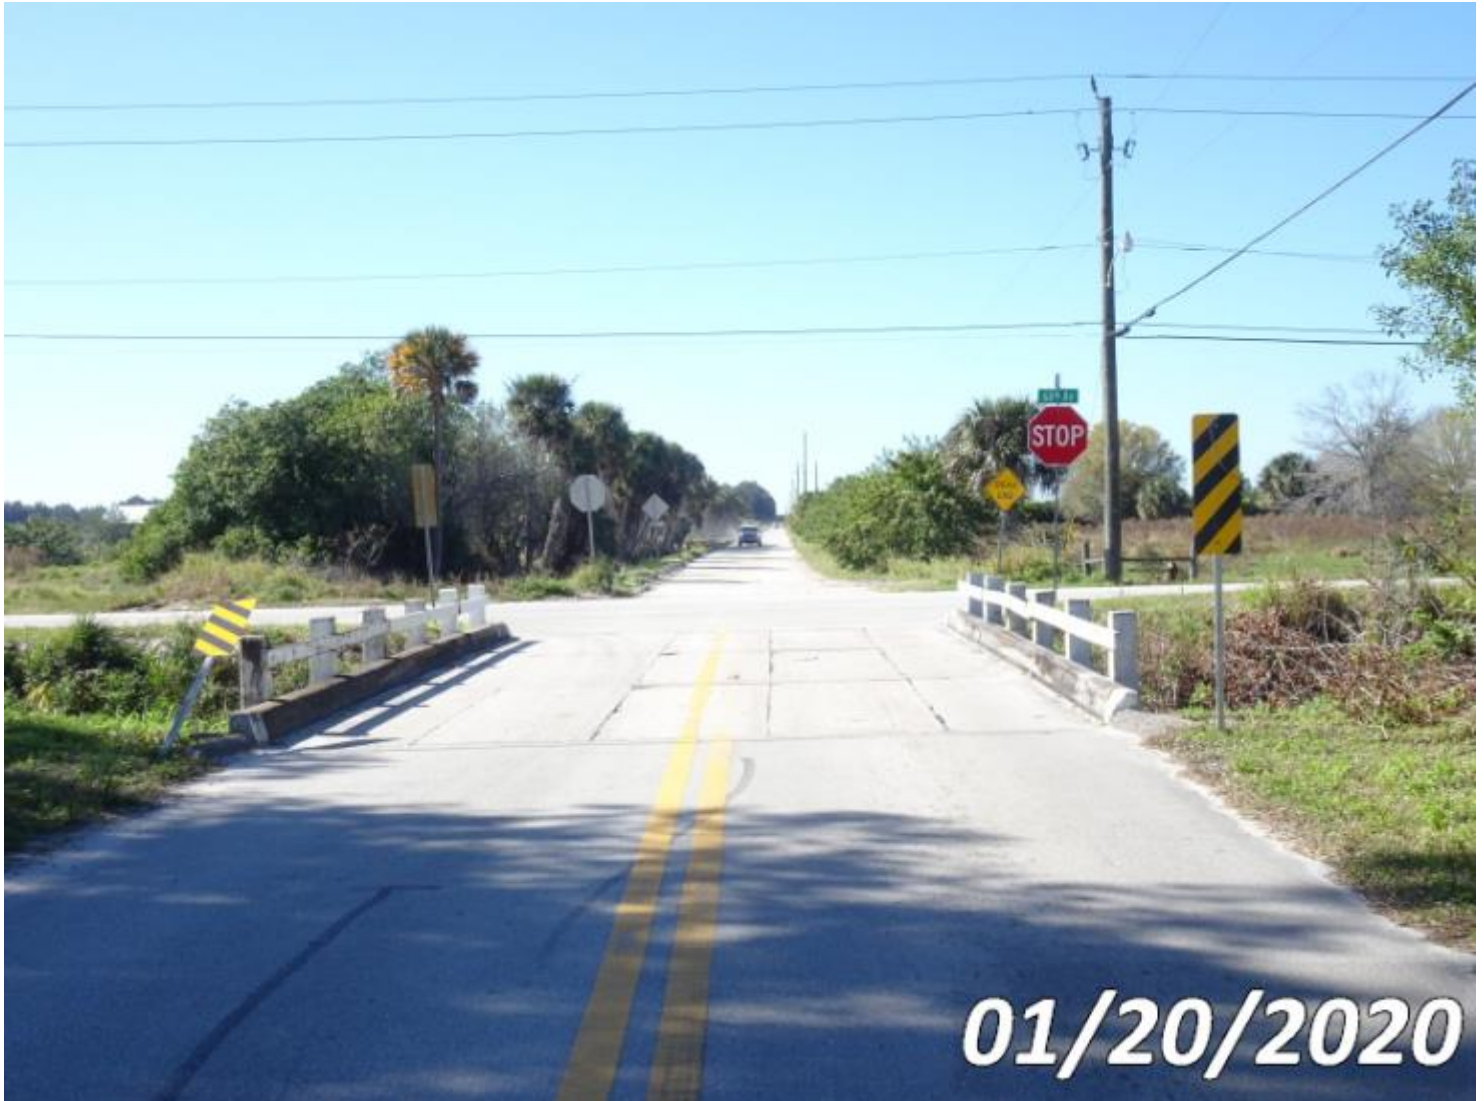
Photo 333-S04 (Unit 0: Other Bridge Railing)

6) There are no bridge rail mounted reflectors provided. NO CHANGE. See Photo 333-S03.

7) There is no object marker at the northwest corner (off-going) of the structure. NO CHANGE. See Photo 333-S04.

8) There is no approach guardrail system at the four corners of the structure. NO CHANGE. See Photo 333-S04.

No guardrail system at the west approach. Note no reflectors on the bridge railings and no object marker at the northwest corner.

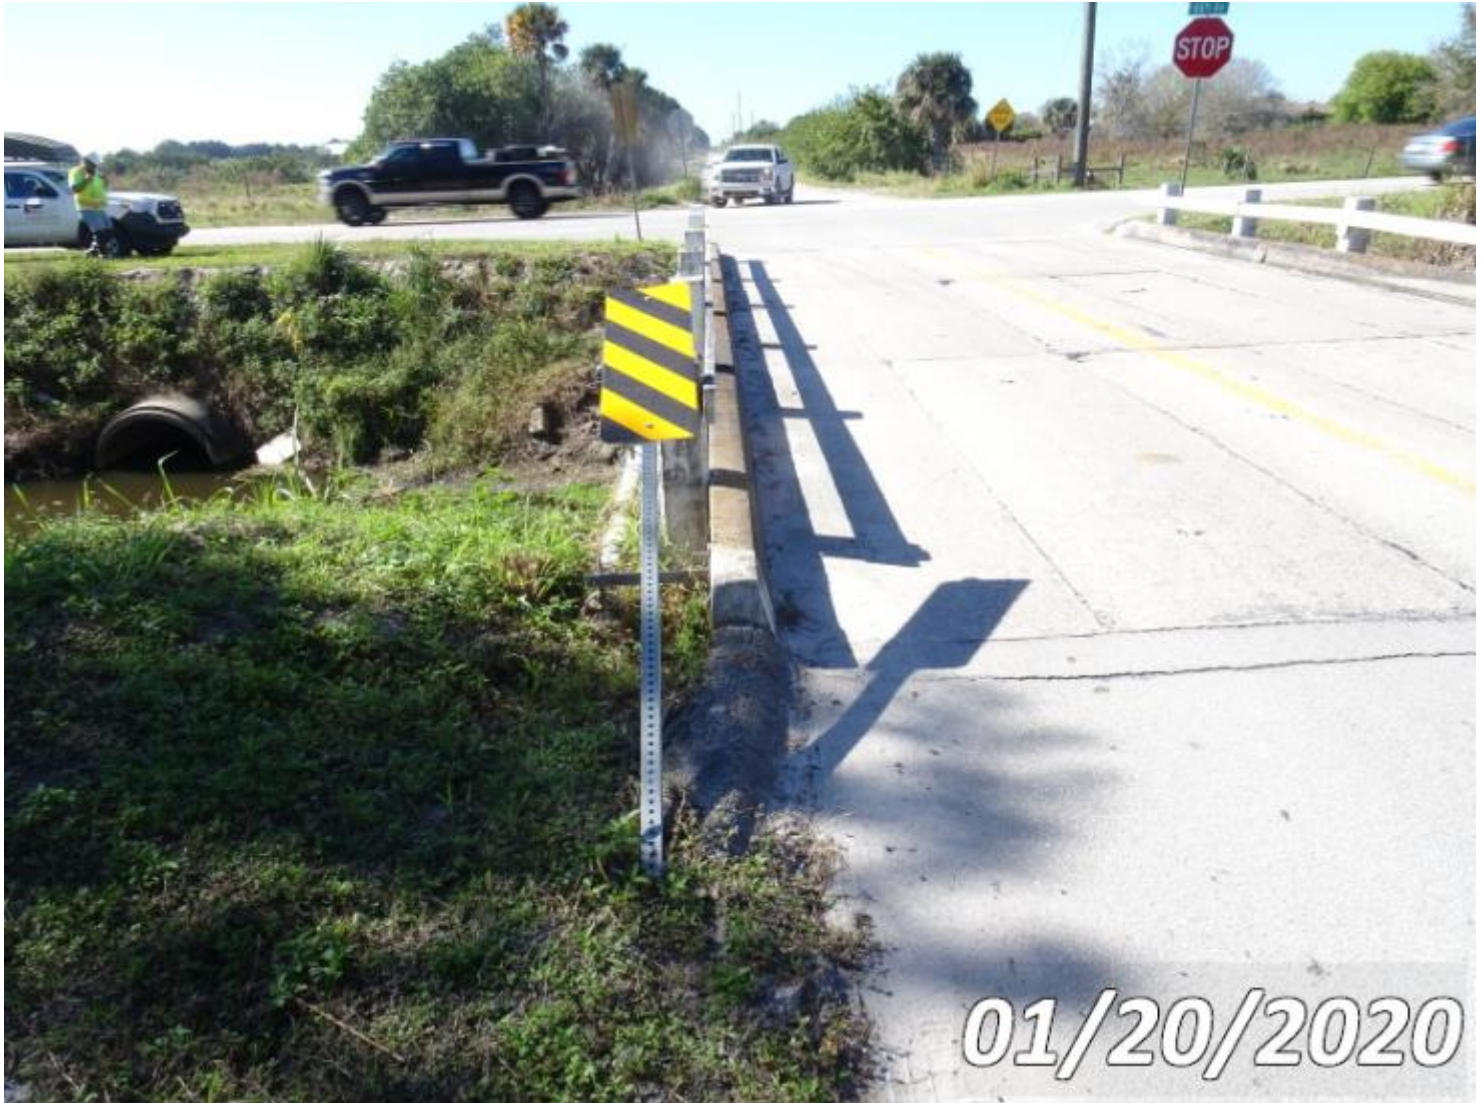
Photo 333-S05 (Unit 0: Other Bridge Railing)

9) The southeast object marker is leaning towards the west. NEW. See Photo 333-S04.

Southeast object marker leaning towards the west.

Repair the leaning southeast object marker.
