**FLORIDA DEPARTMENT OF TRANSPORTATION
BRIDGE MANAGEMENT SYSTEM
Inspection/CIDR/Bridge Profile Report
Inspection**

Structure ID: 884038

TYPE OF INSPECTION: Regular NBI

STRUCTURE NAME: Not recorded
 YEAR BUILT: 1964
 SECTION NO.: 88 000 000
 MP: 0.000
 ROUTE: 00000
 FACILITY CARRIED: 61ST./PECAN GROVE
 FEATURE INTERSECTED: LATERAL A CANAL

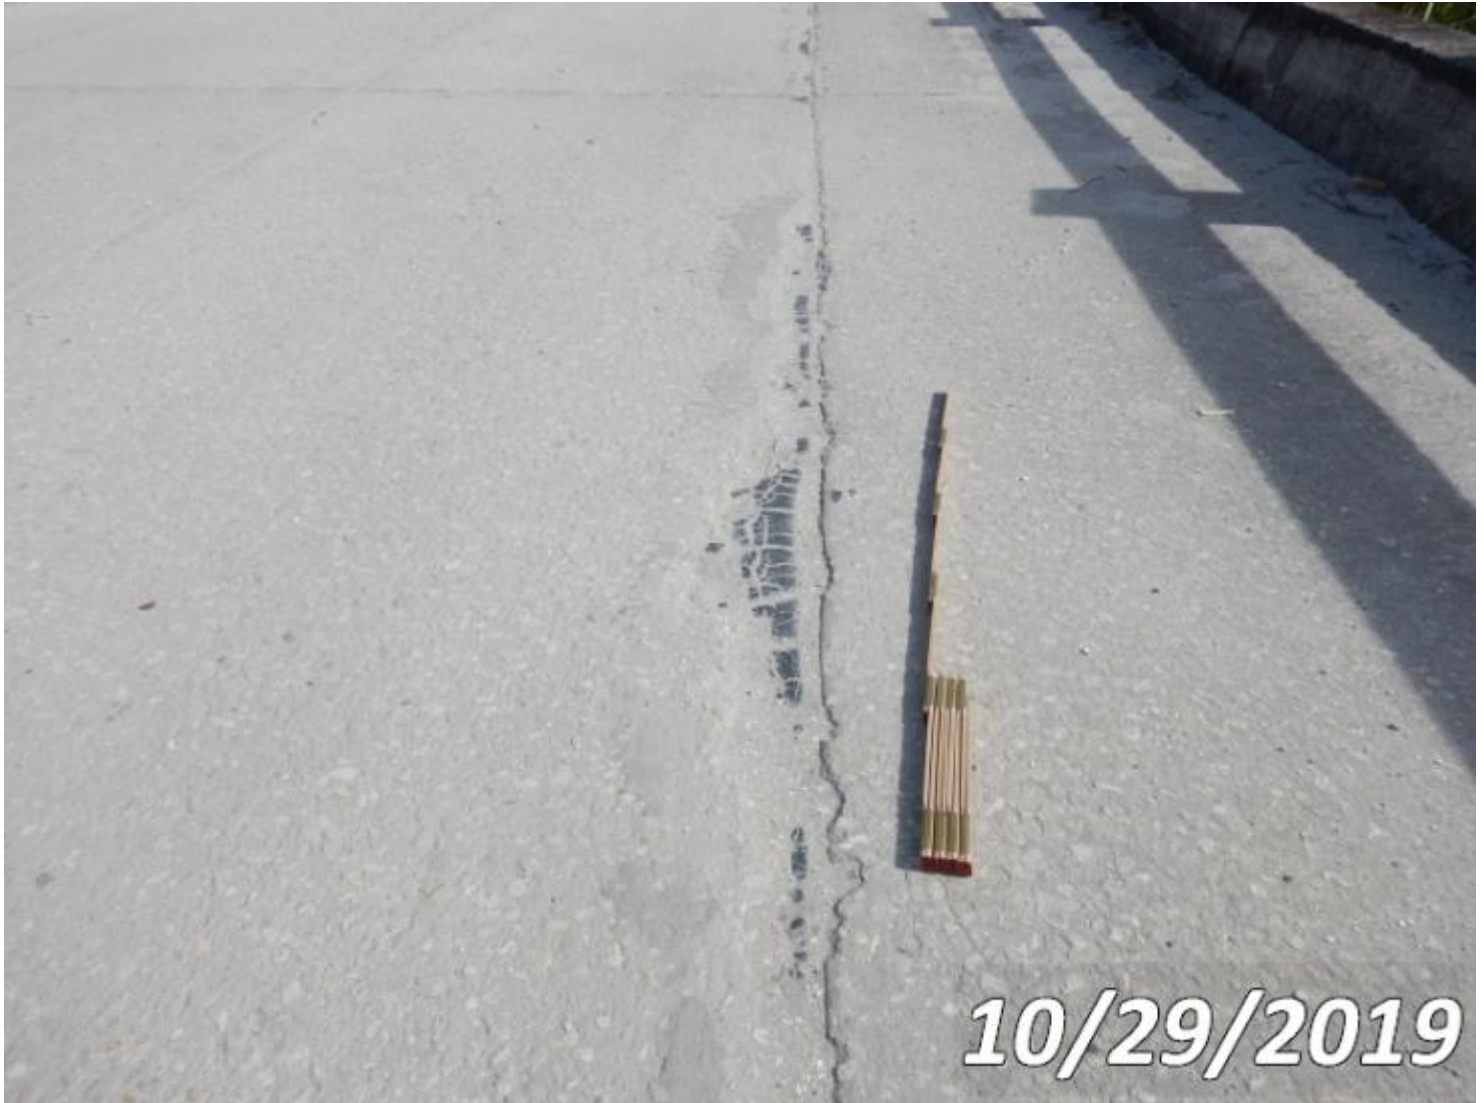
Photo 38-S01 (Unit 0: Re Concrete Slab)

1) The deck top along the top side of the longitudinal joints between the slab units has random edge spalls up to 1ft. L x 3in. W x 1in. D with no exposed steel. Most of the edge spalls have been sealed with hot poured sealant in conjunction with the sealing of the longitudinal joints. The sealant is brittle and deteriorated in the spalls up to 1ft. L x 3in. W x 1in. D throughout (total 25sf.). NO CHANGE. See Photo 38-S01.

Spalls filled with sealant in the deck top along the top side of the longitudinal joints between Slab Unit 2-3 and 2-4. Joint sealant is deteriorated at random locations.

Repair spalls and deteriorated joint sealant in the deck top along the top side of the longitudinal joints between the slab units.

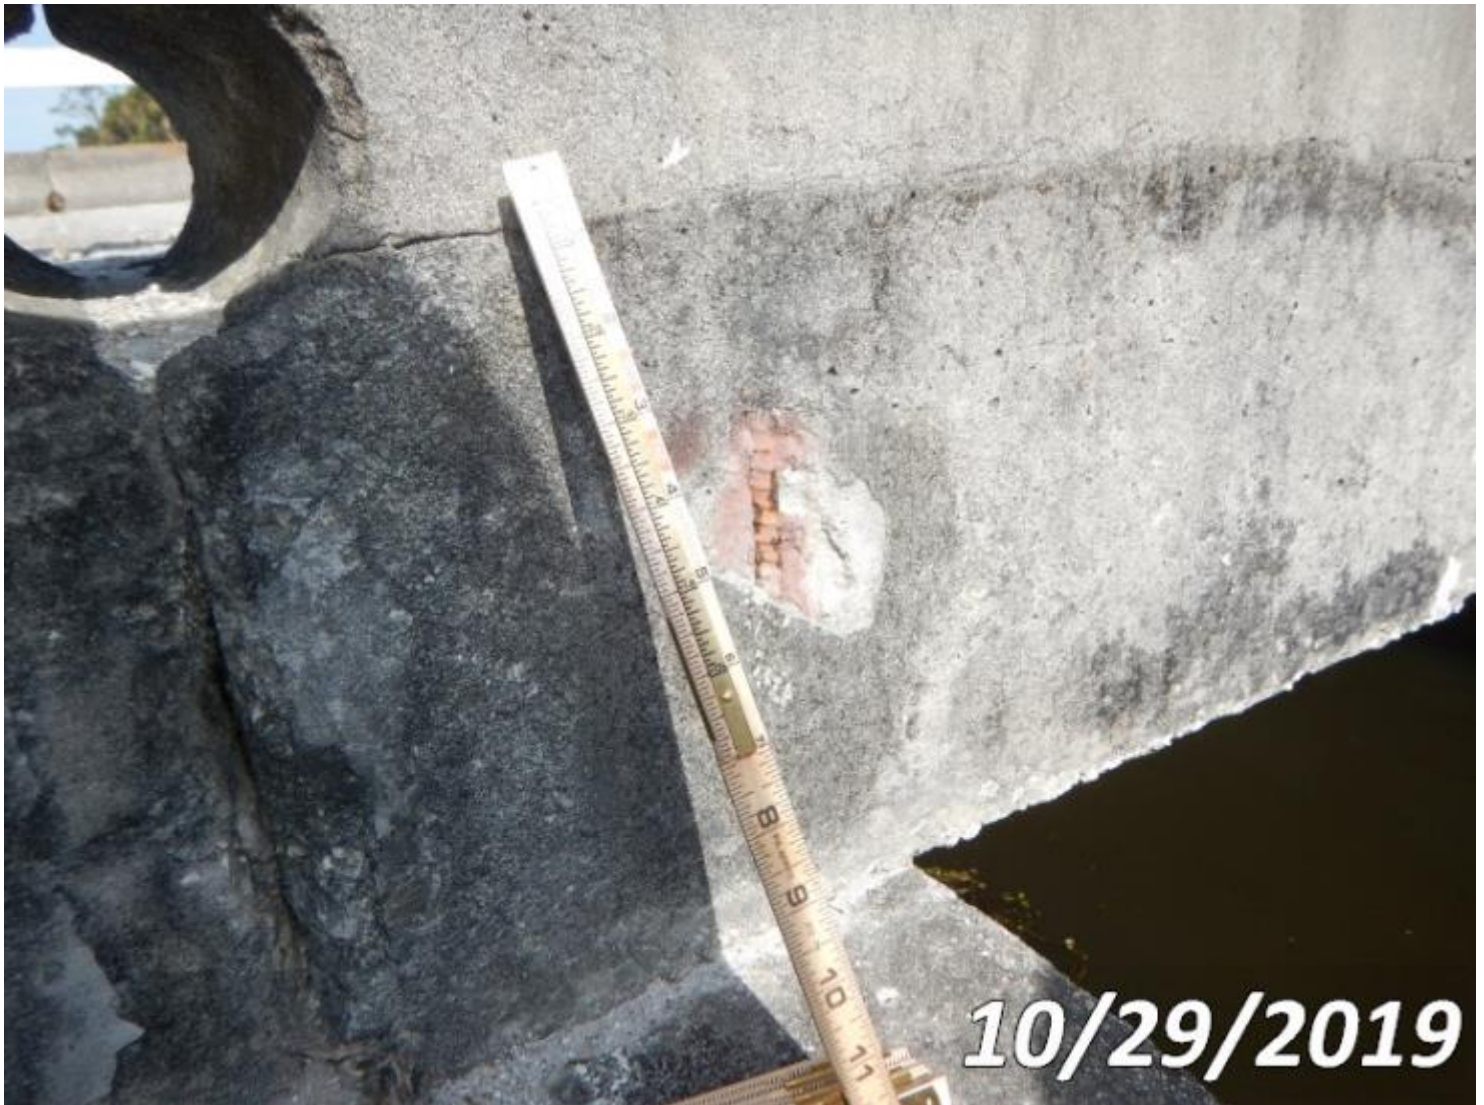
Photo 38-S02 (Unit 0: Re Concrete Slab)

5) Slab Unit 2-4 in the south face exhibits a spall 4in. H x 4in. W x 1/2in. D with exposed corroded steel, over Bent 2 (total 1sf.). NO CHANGE. See Photo 38-S02.

Spall with exposed corroded rebar in the south face of Slab Unit 2-4 over Bent 2.

Repair spall in the south face of Slab Unit 2-4 over Bent 2.

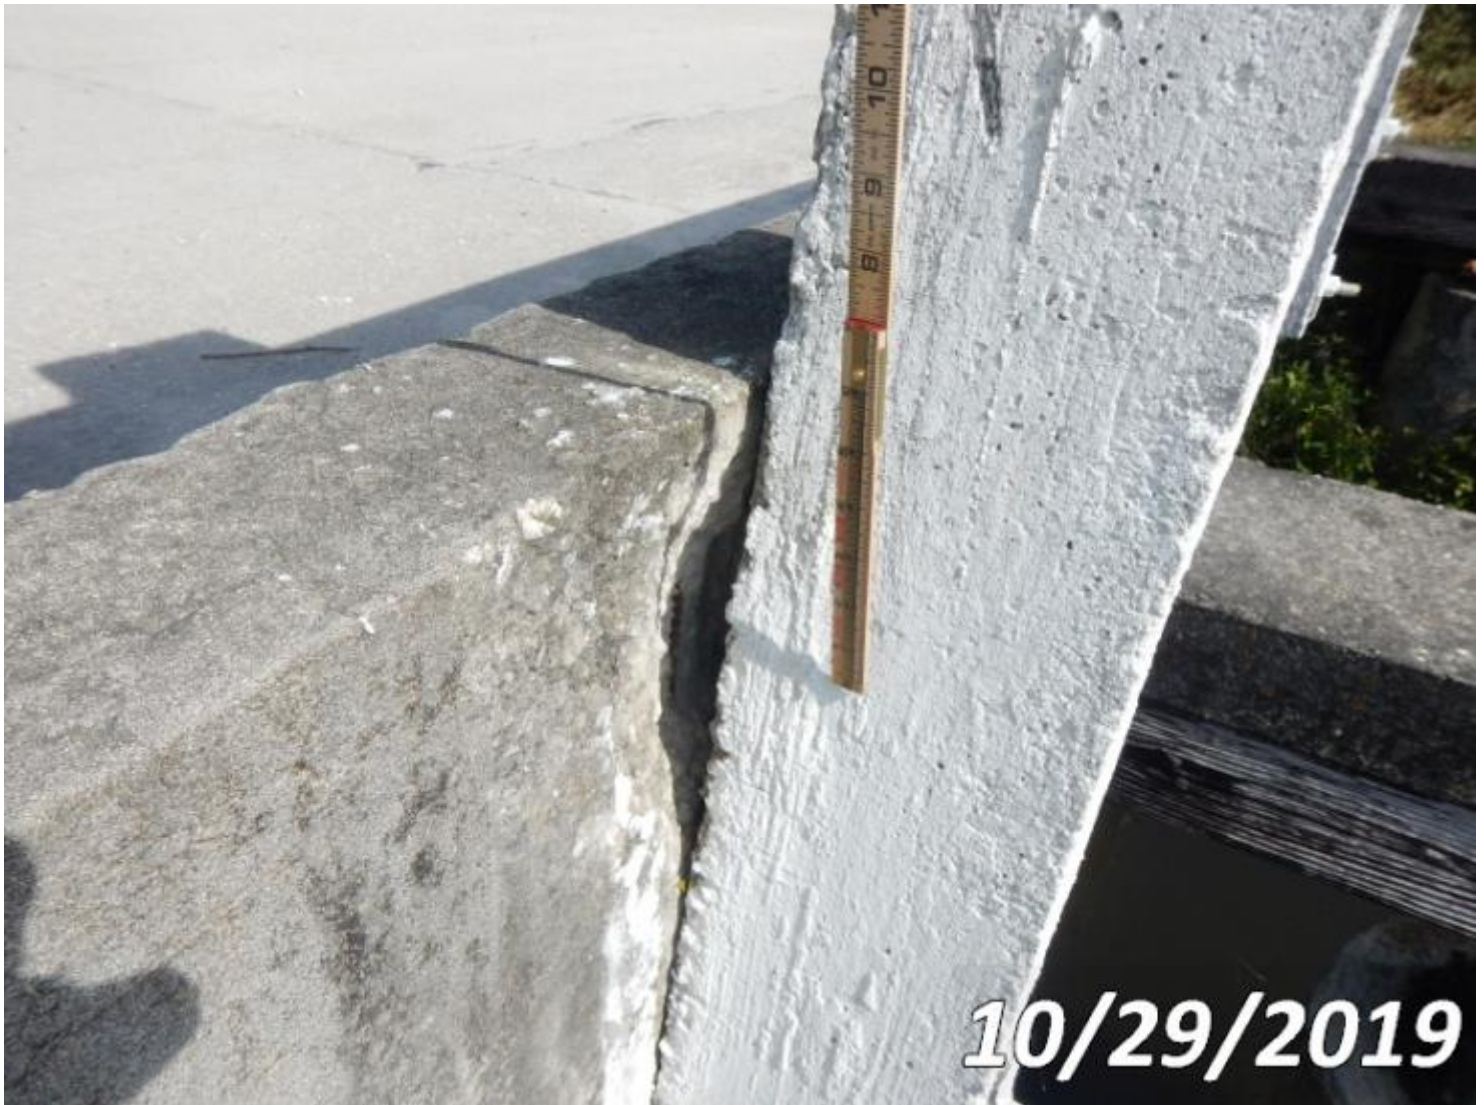
Photo 38-S03 (Unit 0: Re Concrete Slab)

7) The south curb over Slab Unit 2-4 exhibits a spall 9in. H x 7in. W x 1in. D with exposed corroded steel, adjacent to Railing Post 2-2R. NEW. See Photo 38-S03.

Spall with exposed corroded steel in the south curb over Slab Unit 2-4, adjacent to Railing Post 2-2R.

Repair spall in the south curb over Slab Unit 2-4 adjacent to Railing Post 2-2R.

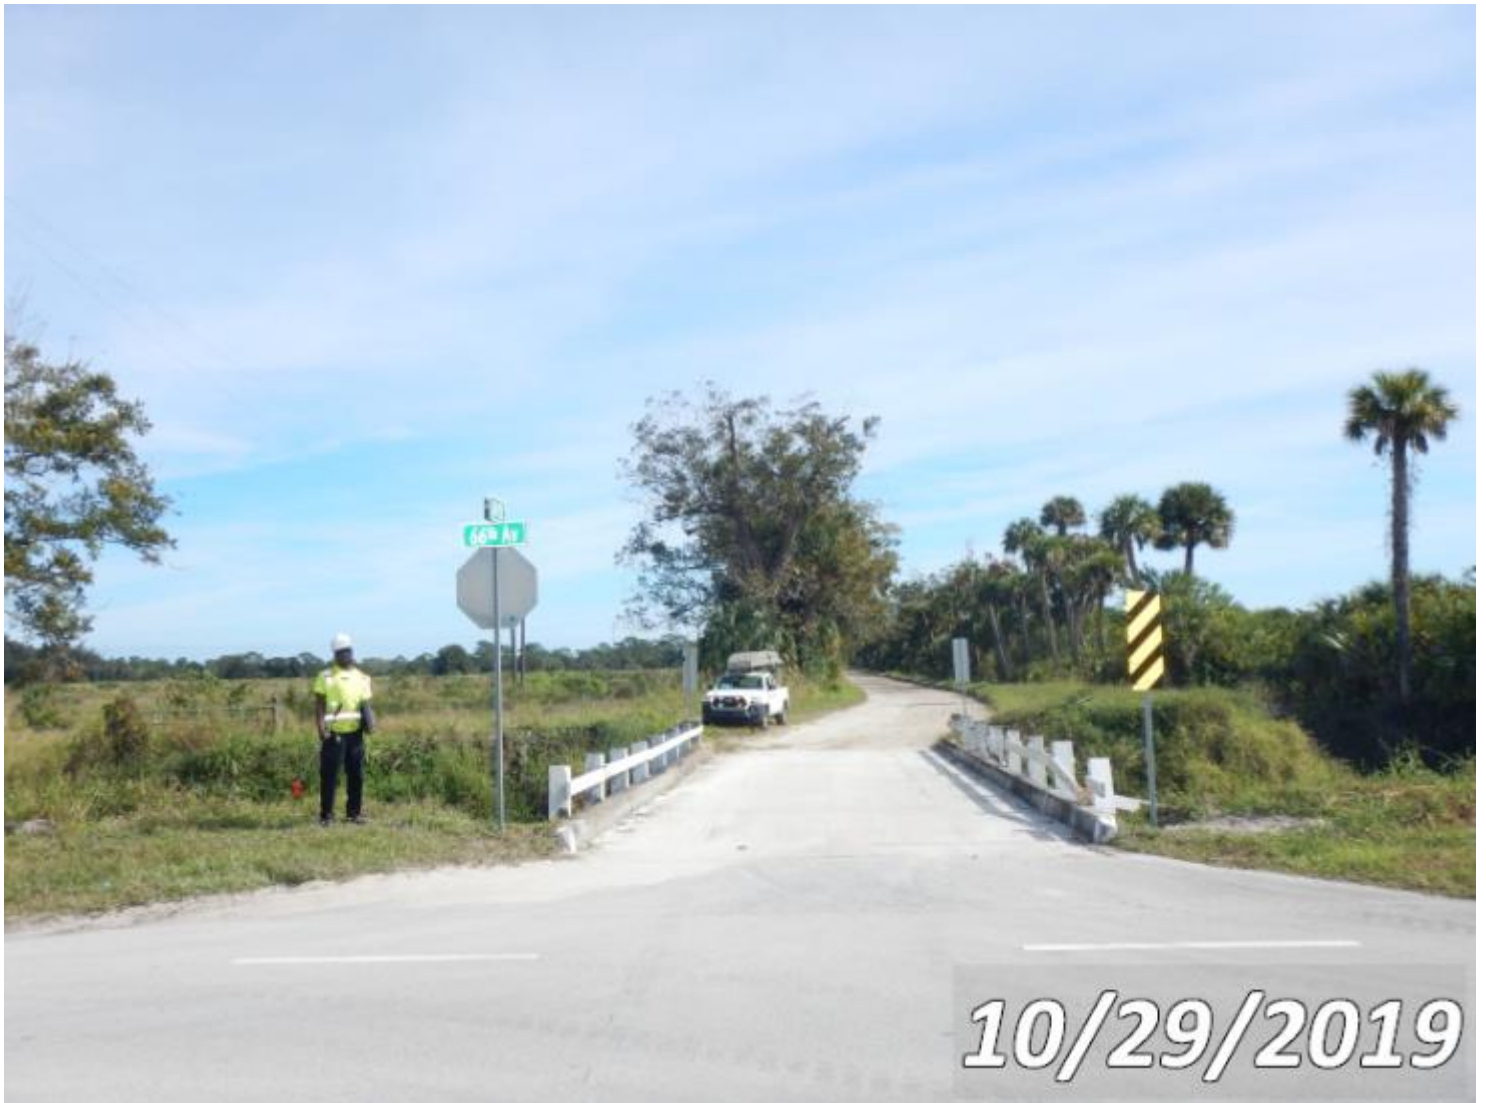
Photo 38-S04 (Unit 0: Re Concrete Slab)

8) There is no object marker at the northwest corner of the structure. NO CHANGE. See Photo 38-S04.

No object marker at the northwest corner of the structure.

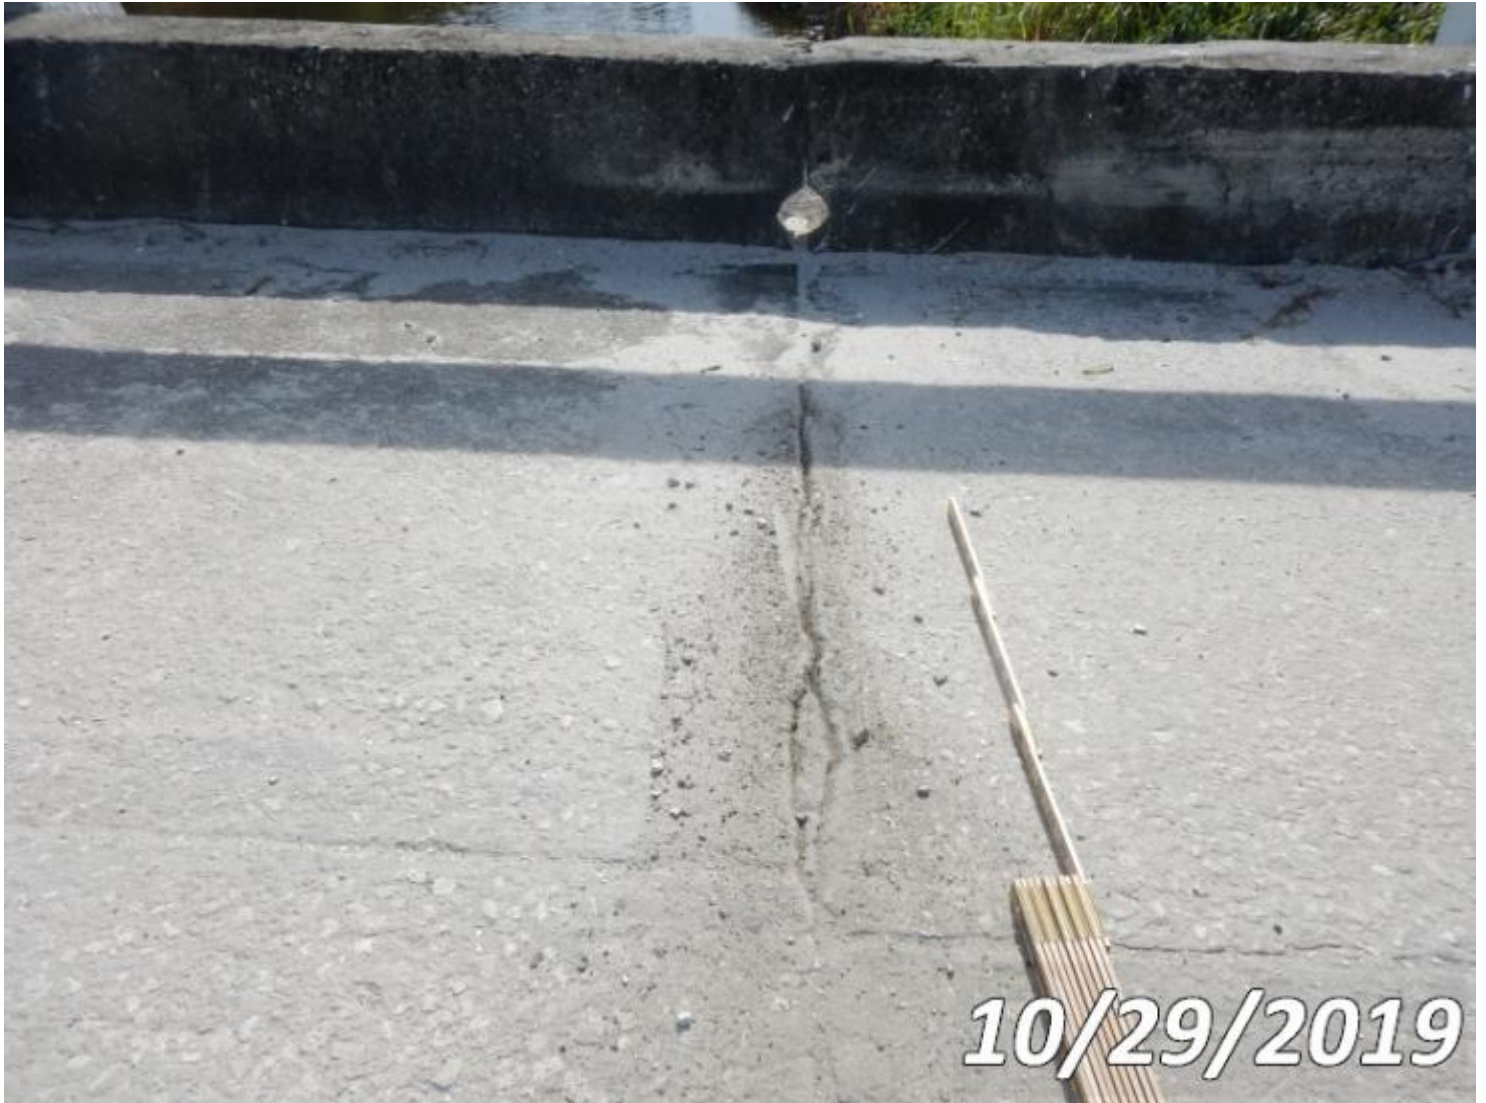
Photo 301-S01 (Unit 0: Pourable Joint Seal)

1) The pourable sealant is cracked and deteriorated up to 15ft. L at random locations (total 45ft.). NO CHANGE.

Cracked and deteriorated joint seal at the right end at Bent 2.

Repair cracked and deteriorated joint seals throughout the bridge.

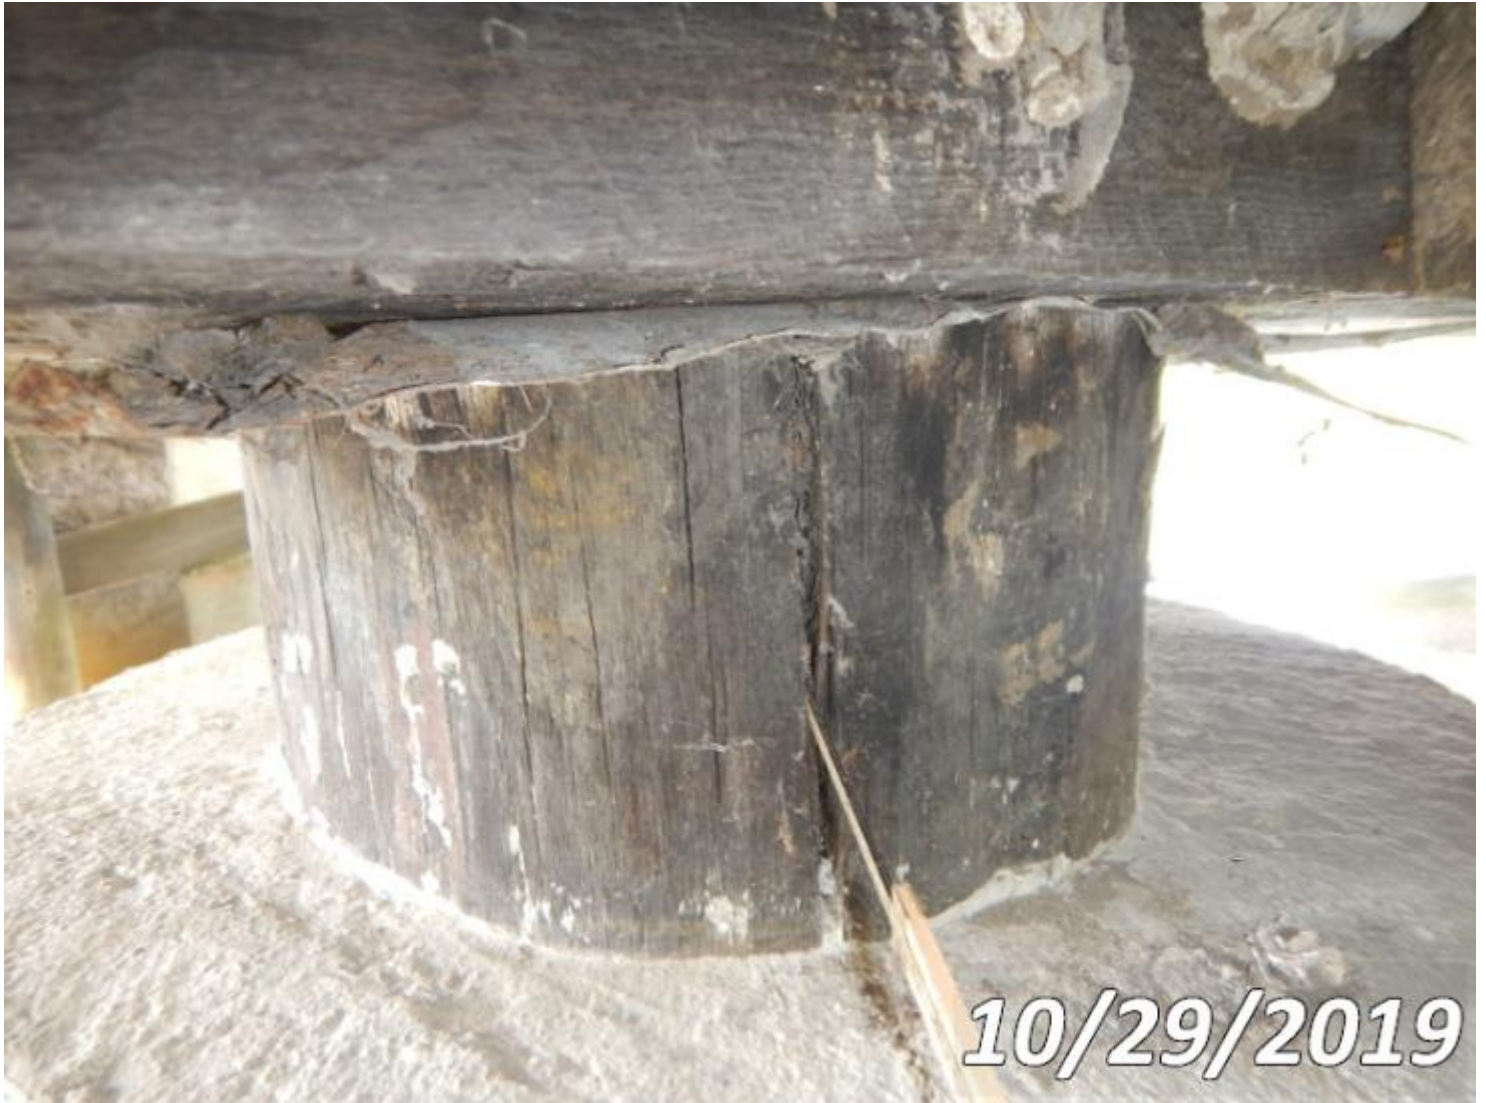
Photo 228-S01 (Unit 0: Timber Pile)

1) Piles 2-1, 2-2, 2-4 and 4-3 exhibit a split up to 8ft. Hx 1/4in. W, which can be probed up to 4in. D in the northeast quadrant total (total 4 ea.). Previously noted at Piles 2-1, 2-2 and 2-4 only. See Photo 228-S01.

Split in the northeast quadrant of Pile 4-3.

Repair splits and checks in the exposed portions of the timber piles.

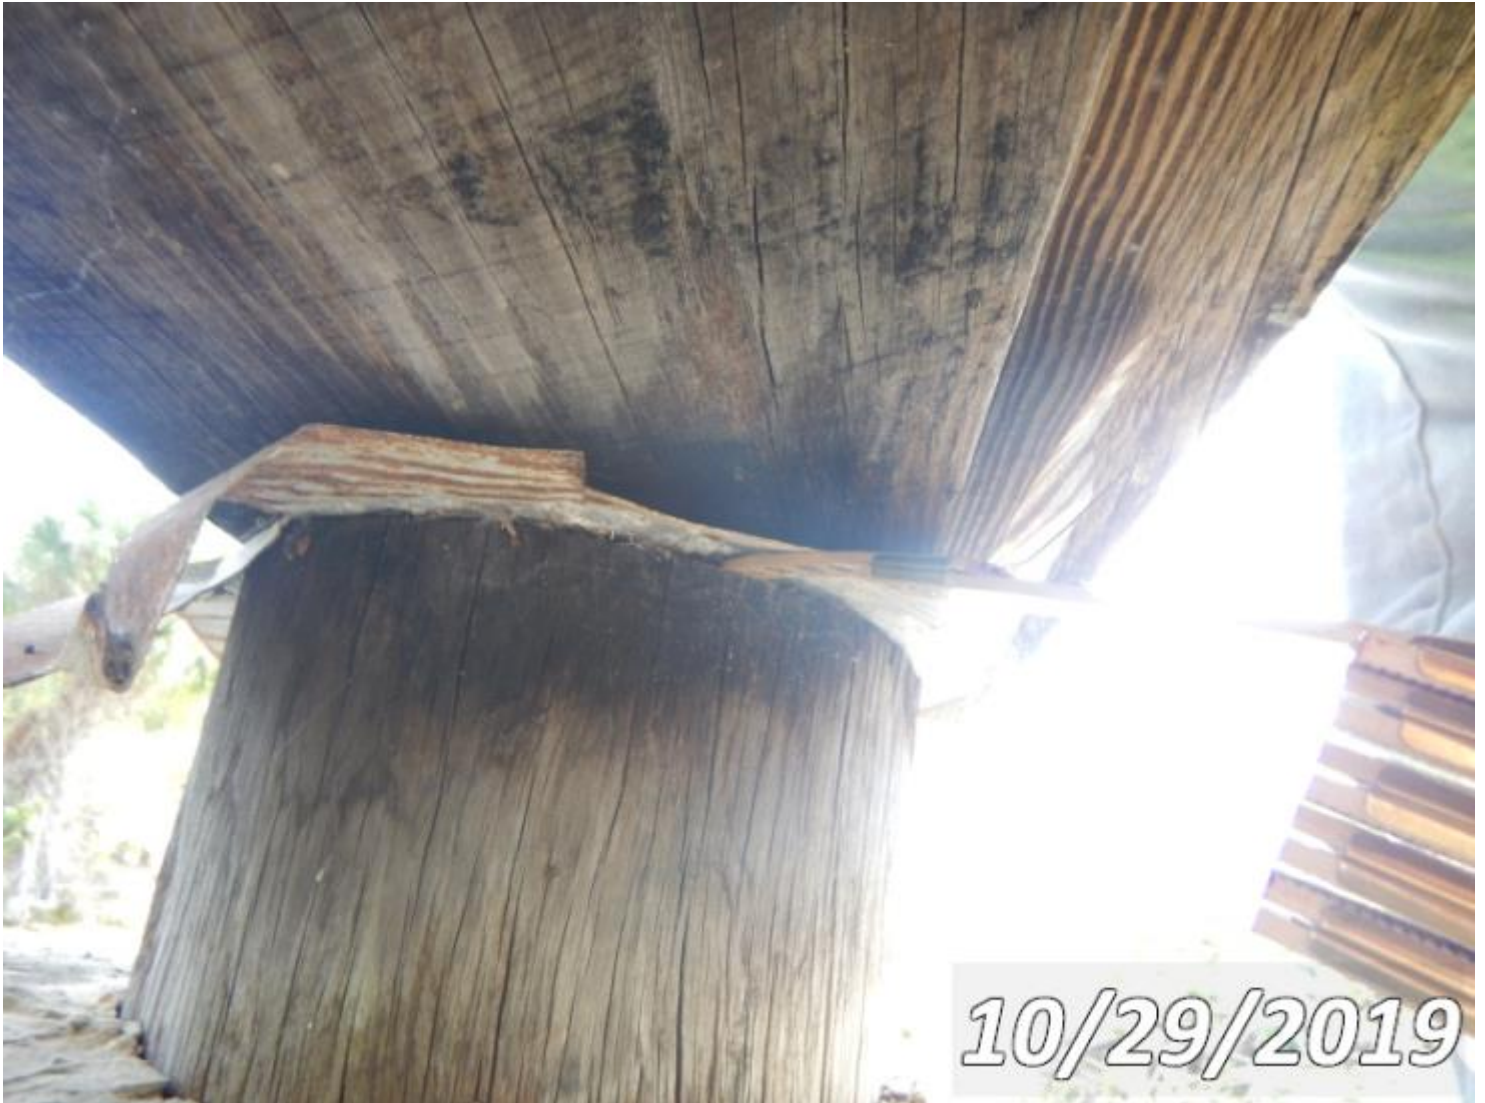
Photo 228-S02 (Unit 0: Timber Pile)

4) Pile 2-5 has a 1/8in. W gap between the top of the piles and the cap. The cap is not

bearing on the pile at this location (total 1 ea.). NO CHANGE. See Photo 228-S02.

Gap between the top of Pile 2-5 and the cap.

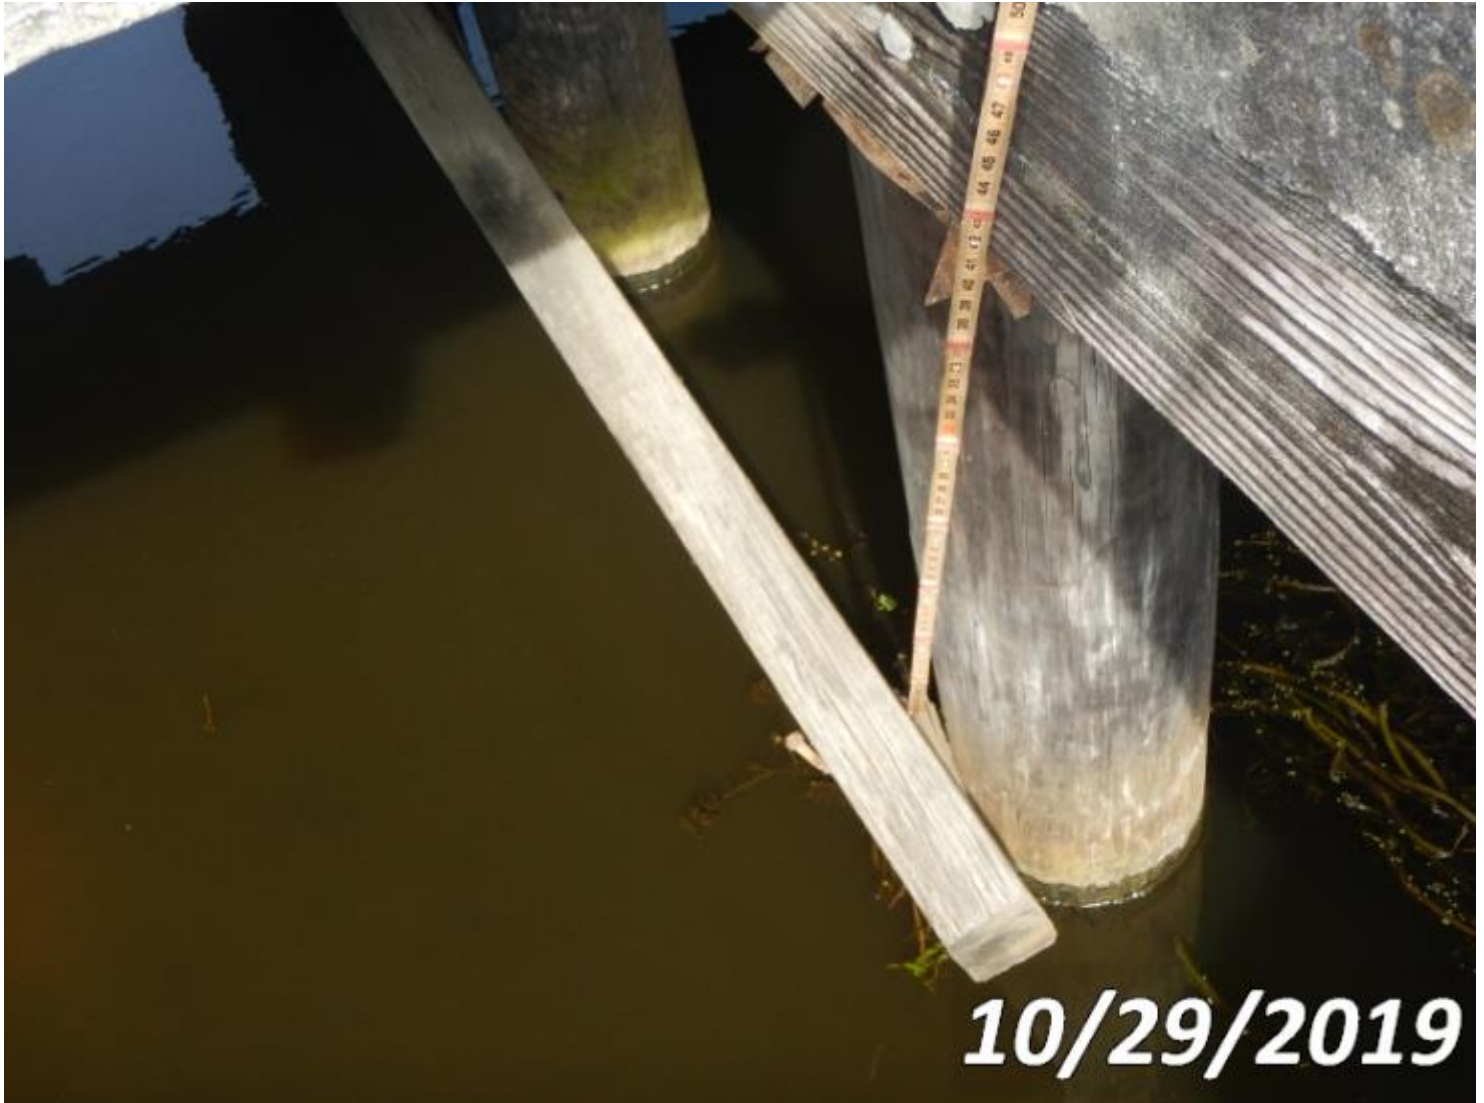
Photo 228-S03 (Unit 0: Timber Pile)

7) The timber brace attached to the west face of Bent 3 has pulled away from the piles up to 5in. and is detached from Pile 3-4. NO CHANGE. See Photo 228-S03.

Pulled away timber brace attached to the west face of Bent 3 from the piles is detached from Pile 3-4.

Repair the timber brace attached to the west face of Bent 3.

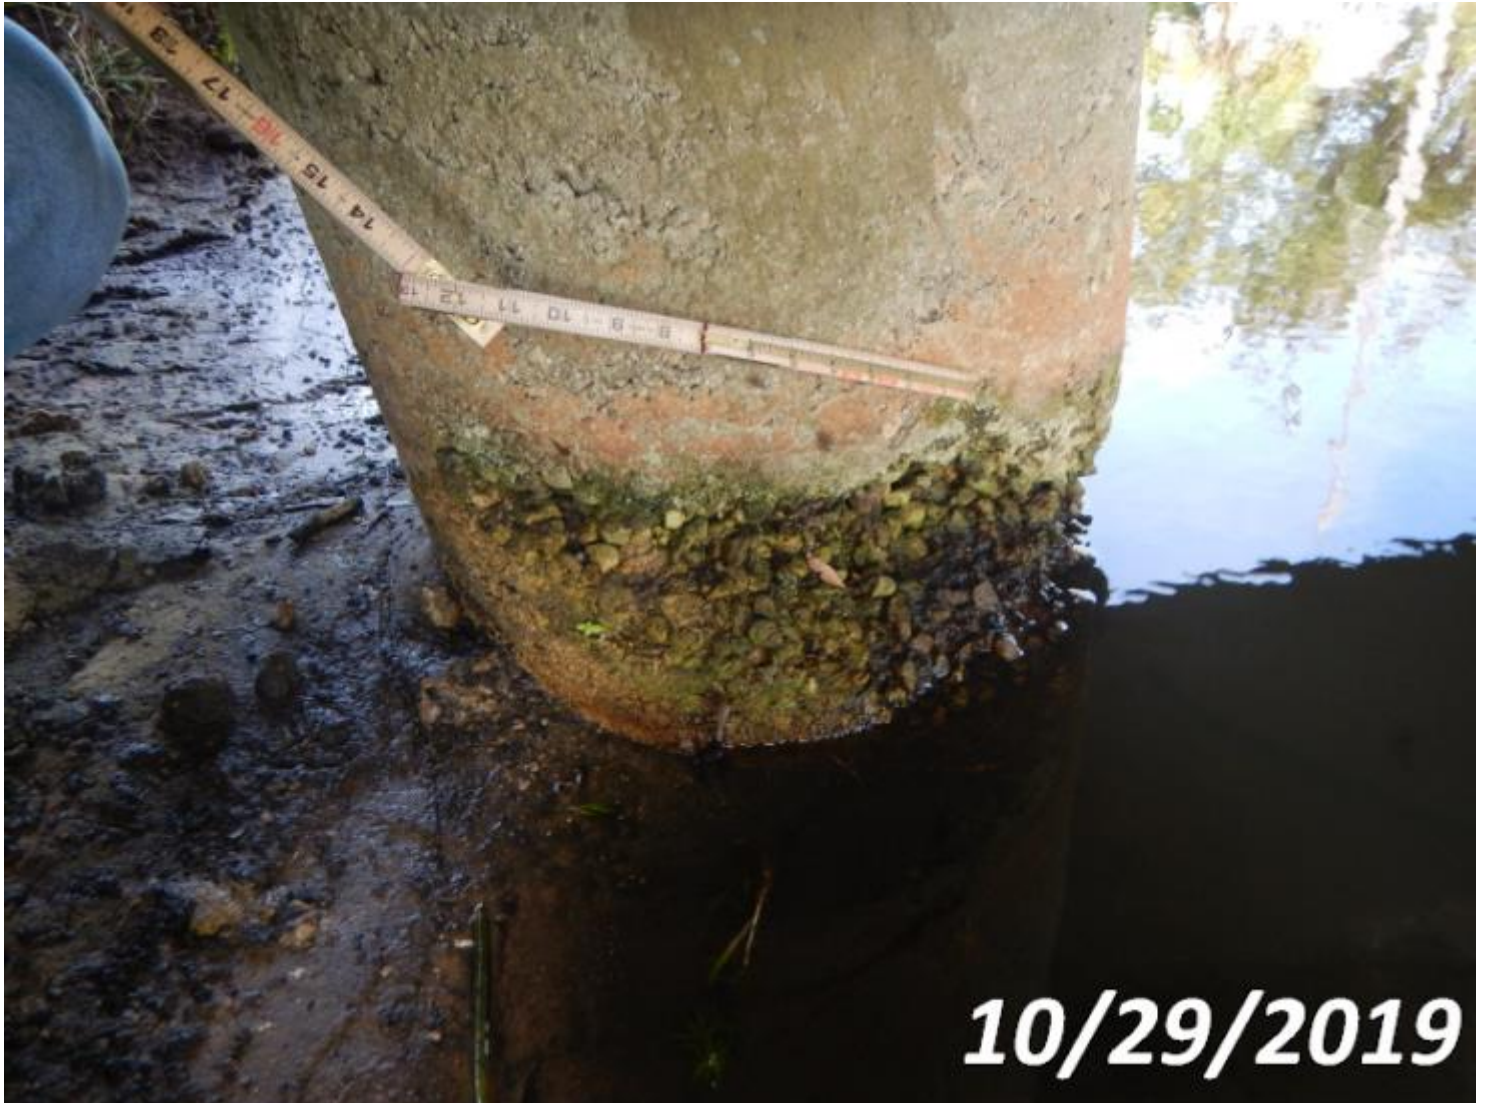
Photo 8298-S01 (Unit 0: Pile Jacket Bare)

Void/spall with exposed rebar and section loss in the south quadrant at the pile jacket of Pile 2-2 at the mudline.

Repair voids in the pile jackets at Piles 2-2 and 4-4 in the west and south faces at the mudline.

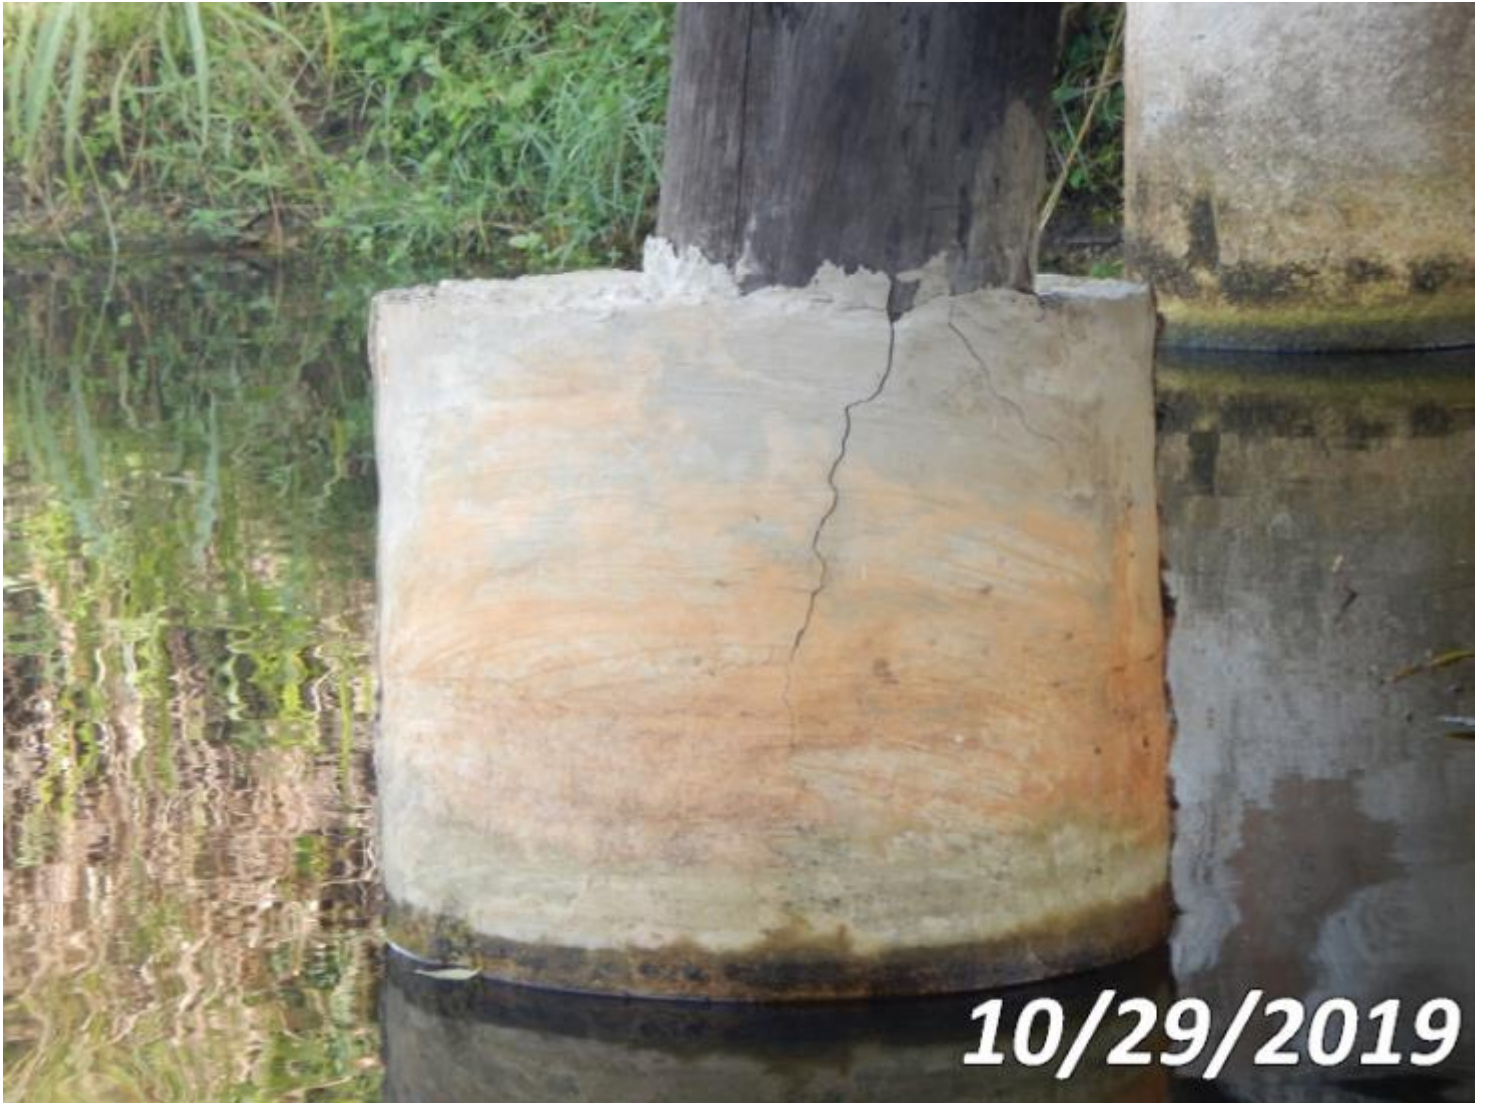
Photo 8298-S02 (Unit 0: Pile Jacket Bare)

3) The west quadrant of the pile jacket at Pile 3-1 exhibits vertical cracks up to 3ft. H x 1/4in. W (total 1 ea.). NEW. See Photo 8298-S02.

Vertical crack in the west quadrant at the pile jacket of Pile 3-1.

REPAIR RECOMMENDATION:
None.

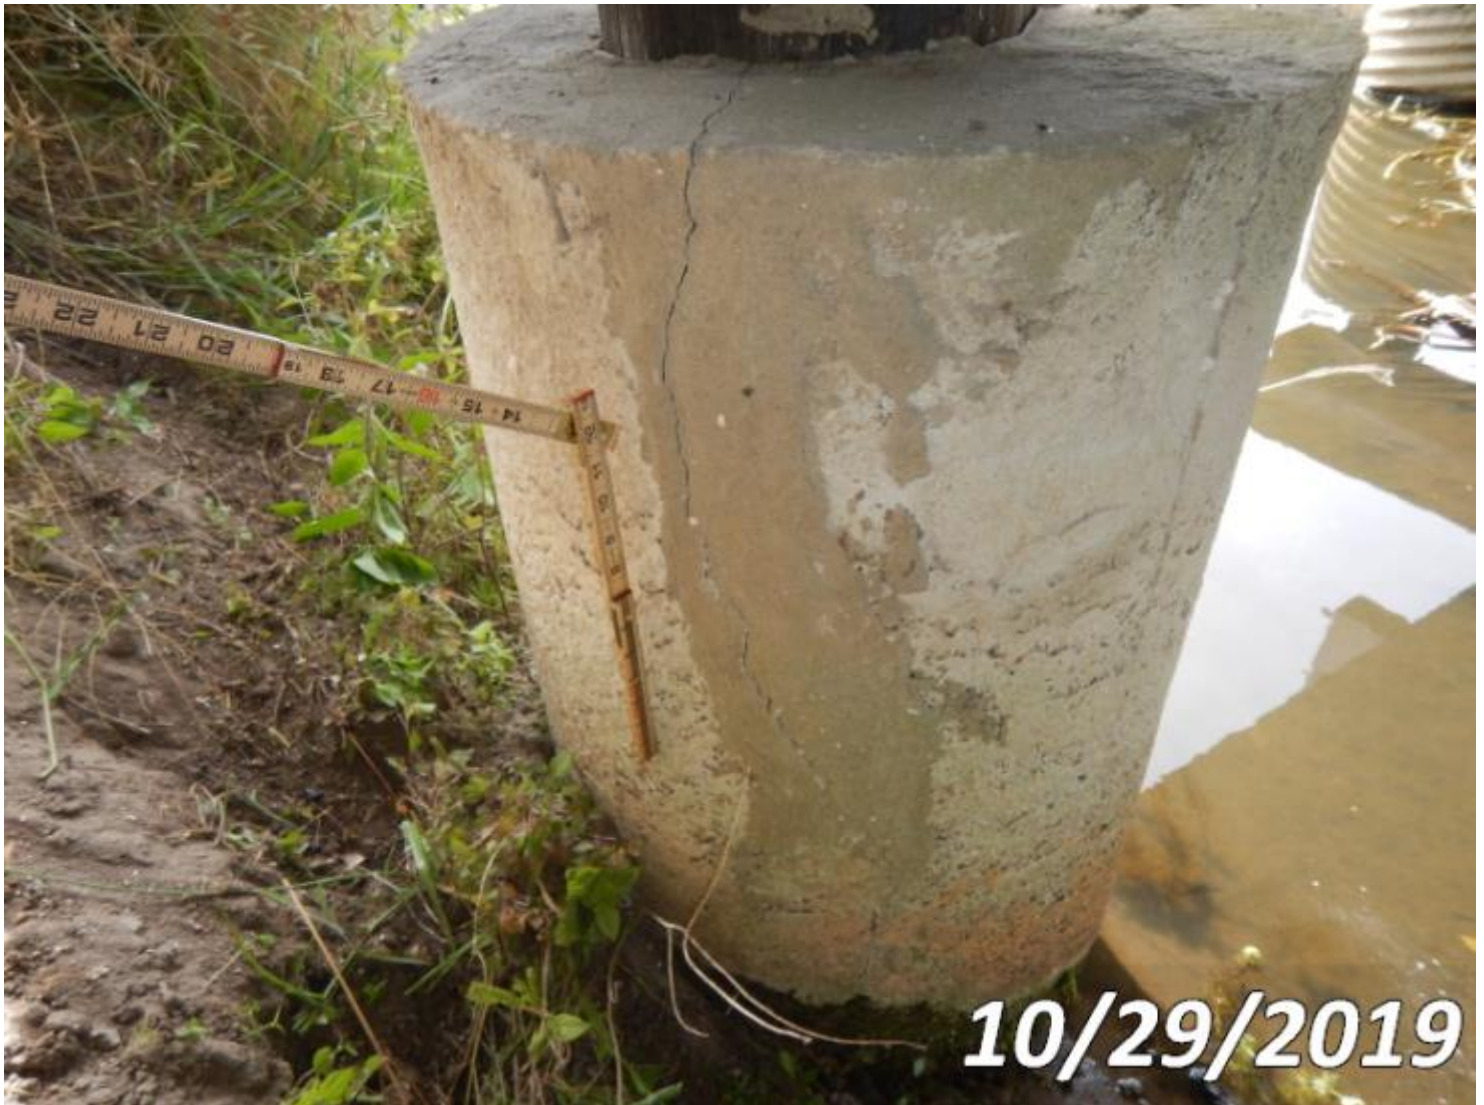
Photo 8298-S03 (Unit 0: Pile Jacket Bare)

4) The east quadrant of the pile jacket at Pile 4-4 exhibits a vertical crack over 3ft. H x 1/8in W (total 1 ea.). NEW. See Photo 8298-S03.

Vertical crack in the east quadrant at the pile jacket of Pile 4-4.

REPAIR RECOMMENDATION:
None.

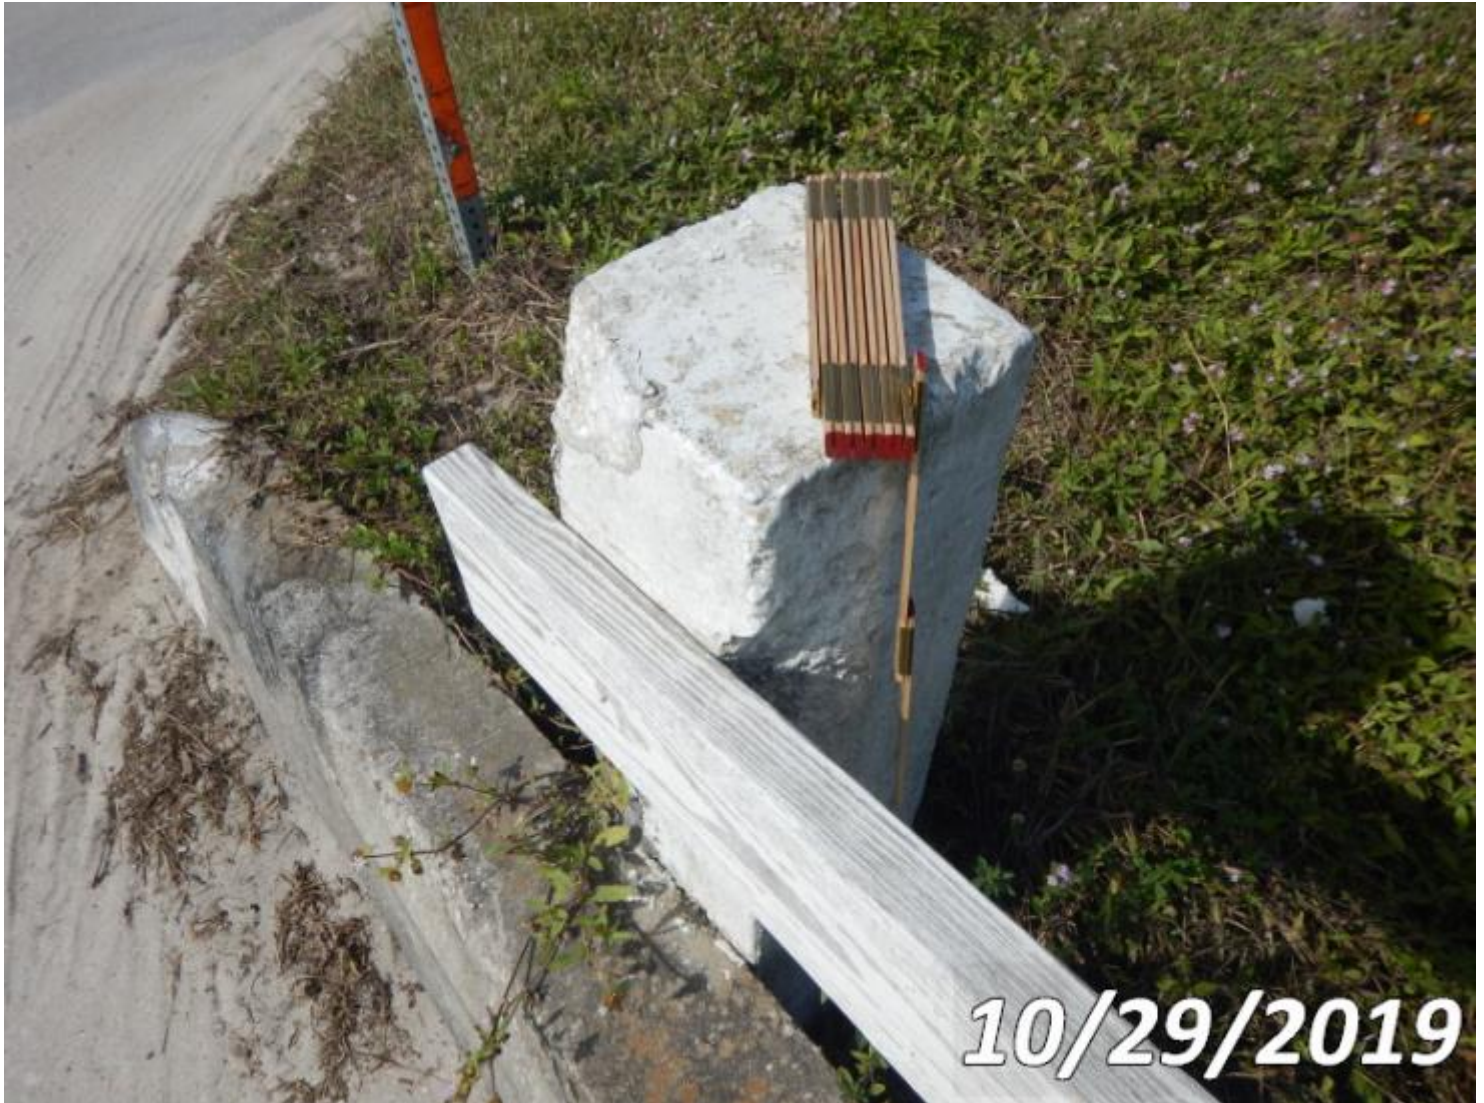
Photo 333-S01 (Unit 0: Other Bridge Railing)

1) Post 1-1 left in the east and west faces exhibits a spalls up to 7in. H x 4in. W x 1in. D with no exposed steel (total 1ft.). Previously noted as one spall. INCREASE. See Photo 333-S01.

Spalls with no exposed steel in the left and west faces of Post 1-1 left.

Repair spalls and delamination in Posts 1-1L/R 1-2L 2-2L 3-1R and 4-2R.

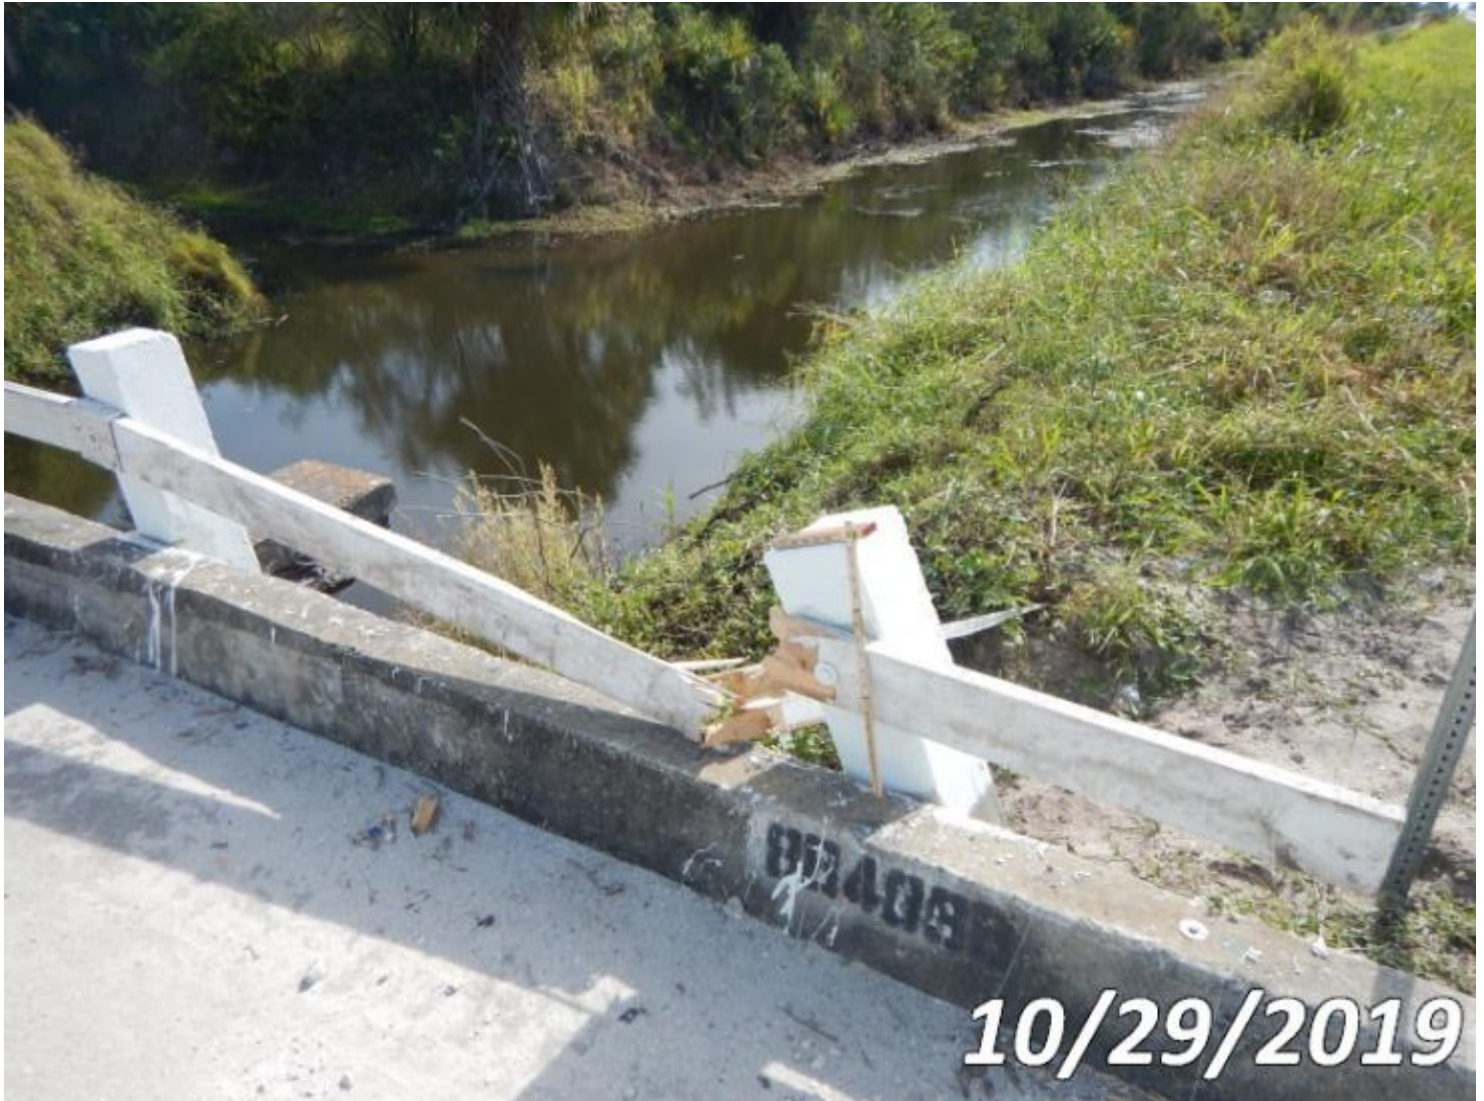
Photo 333-S02 (Unit 0: Other Bridge Railing)

2) Post 1-1 right is loose and leaning to the east due to impact damage. Also the timber rail between Post 1-1 and 1-2 right is broken and loose (total 3ft.). NEW. See Photo 333-S02.

Loose and leaning Post 1-1 right due to impact damage with broken and loose timber railing between Post 1-1 and 1-2 right.

Repair loose and leaning Post 1-1 right and broken and loose timber railing between Posts 1-1 and 1-2 right.
