**FLORIDA DEPARTMENT OF TRANSPORTATION
BRIDGE MANAGEMENT SYSTEM
Inspection/CIDR/Bridge Profile Report
Inspection**

Structure ID: 884038

TYPE OF INSPECTION: Regular NBI

STRUCTURE NAME: Not recorded
 YEAR BUILT: 1964
 SECTION NO.: 88 000 000
 MP: 0.000
 ROUTE: 00000
 FACILITY CARRIED: 61ST./PECAN GROVE
 FEATURE INTERSECTED: LATERAL A CANAL

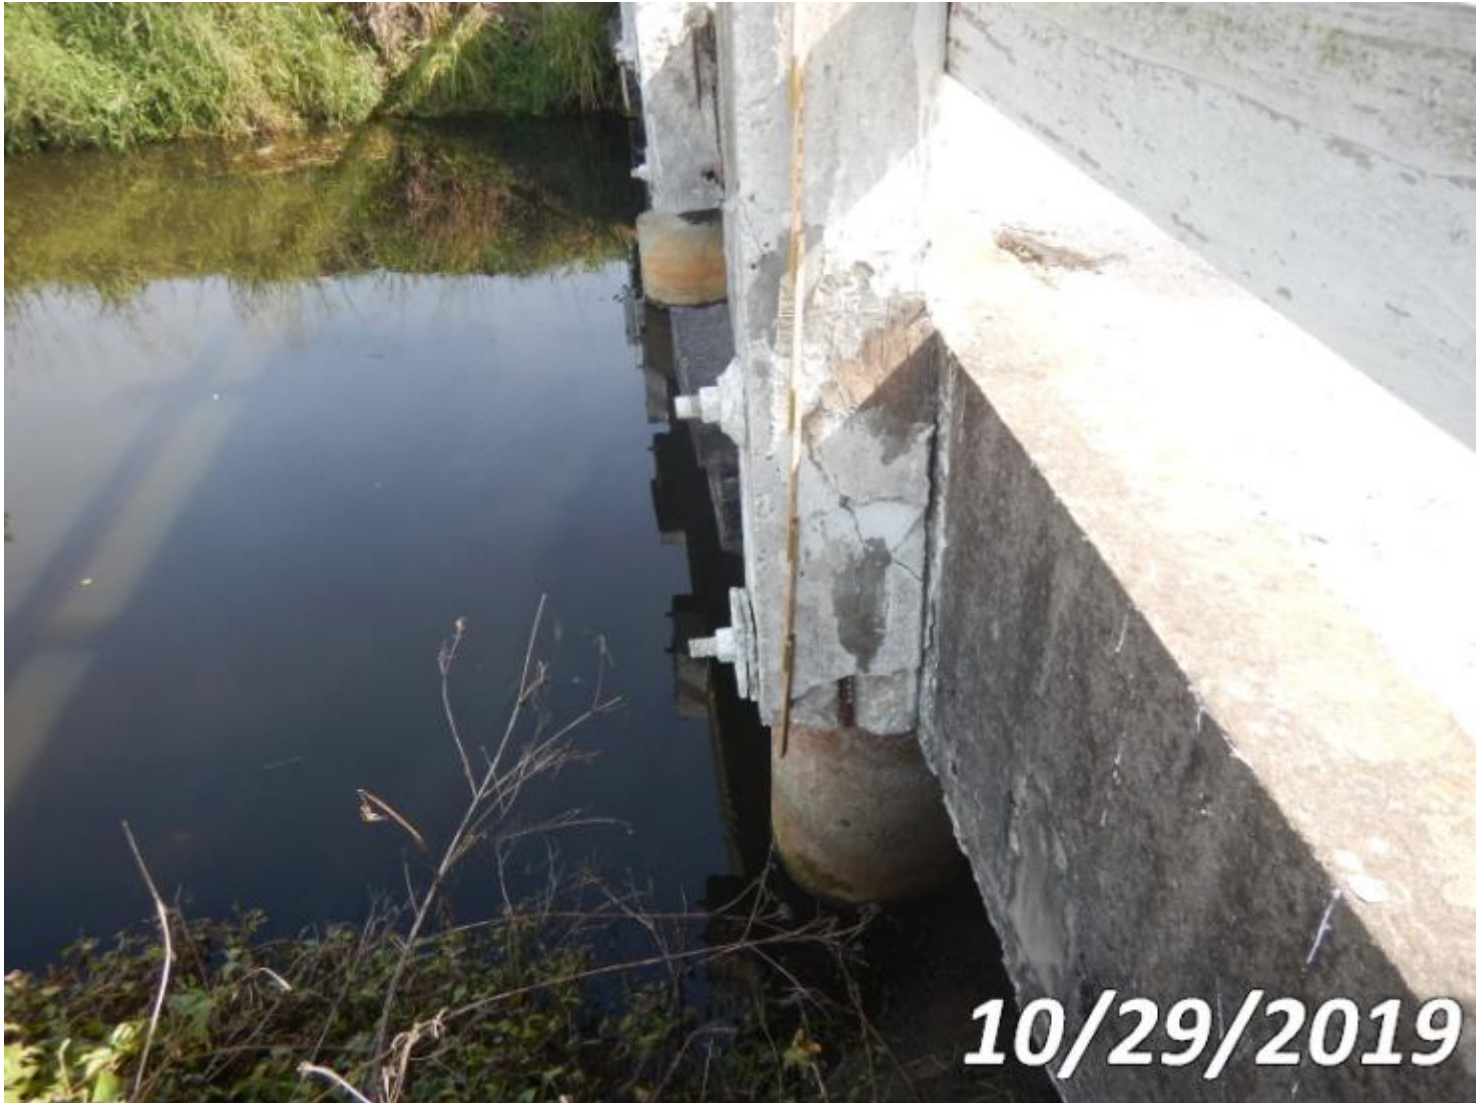
Photo 333-S03 (Unit 0: Other Bridge Railing)

3) Post 1-2 left exhibit spall/delamination 2ft. H x 7in. W x 3in. D with exposed corroded rebar (total 1ft.). Previously noted as a delamination only. INCREASE. See Photo 333-S03.

Spall/delamination with exposed corroded rebar in Post 1-2 left.

Repair spalls and delamination in Posts 1-1L/R 1-2L 2-2L 3-1R and 4-2R.

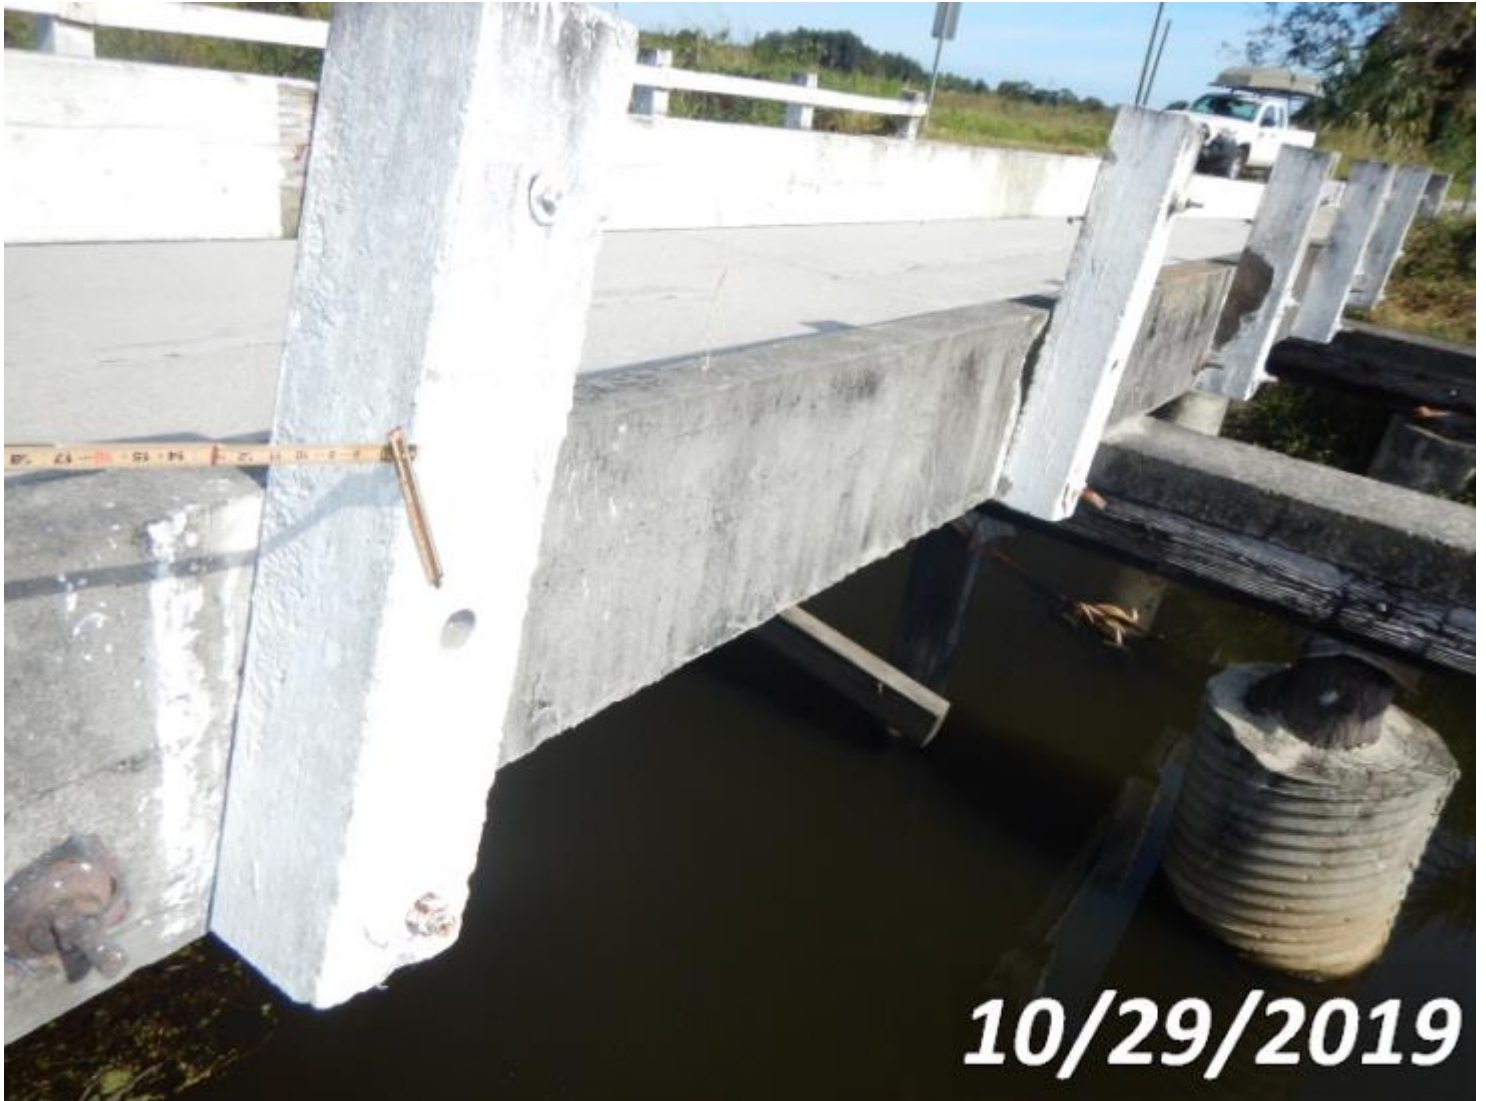
Photo 333-S04 (Unit 0: Other Bridge Railing)

4) Post 2-1 and 2-2 right center anchors are missing (total 1ft.). NEW. See Photo 333-S04.

Missing center anchors for Post 2-1 and 2-2 right.

Install missing center anchors for Posts 2-1 and 2-2 right.

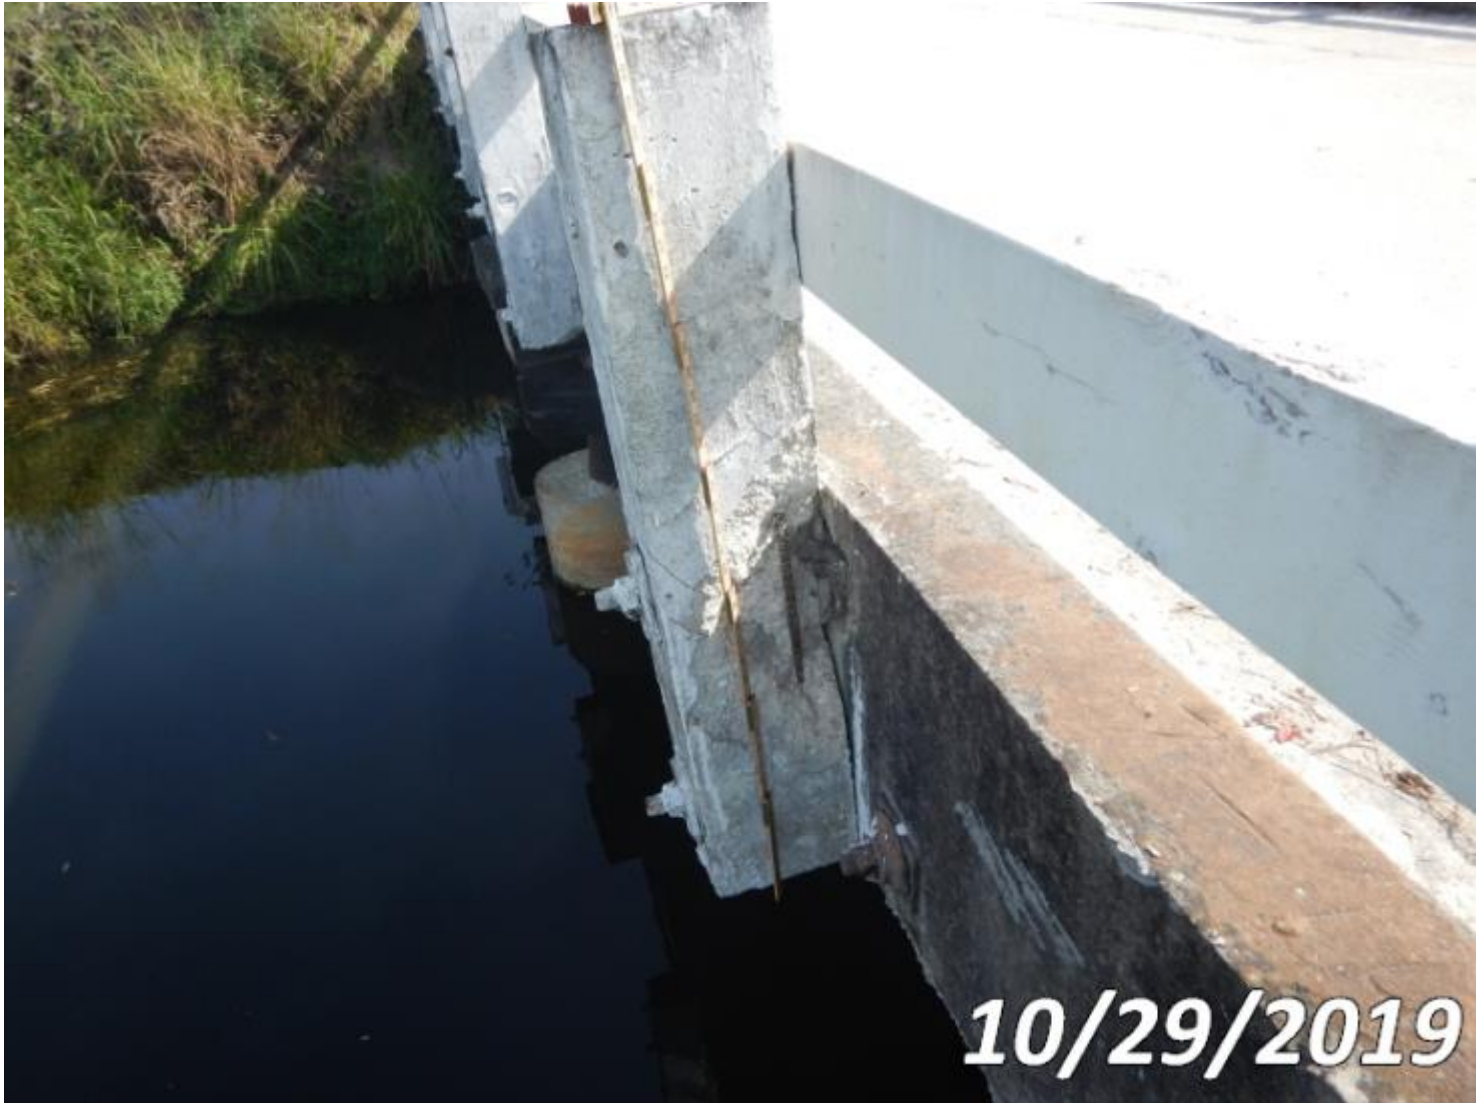
Photo 333-S05 (Unit 0: Other Bridge Railing)

5) Posts 2-1 left in the west face exhibits a spall/delamination up to 18in. H x 8in. W x 3in. D with exposed corroded steel (total 2ft.). Previously noted at Posts 2-1 left and 2-2 left and 5ft. H x 6in. W. INCREASE. See Photo 333-S05.

Spall/delamination with exposed corroded steel in the west face of Post 2-1 left.

Repair spalls and delamination in Posts 1-1L/R 1-2L 2-2L 3-1R and 4-2R.

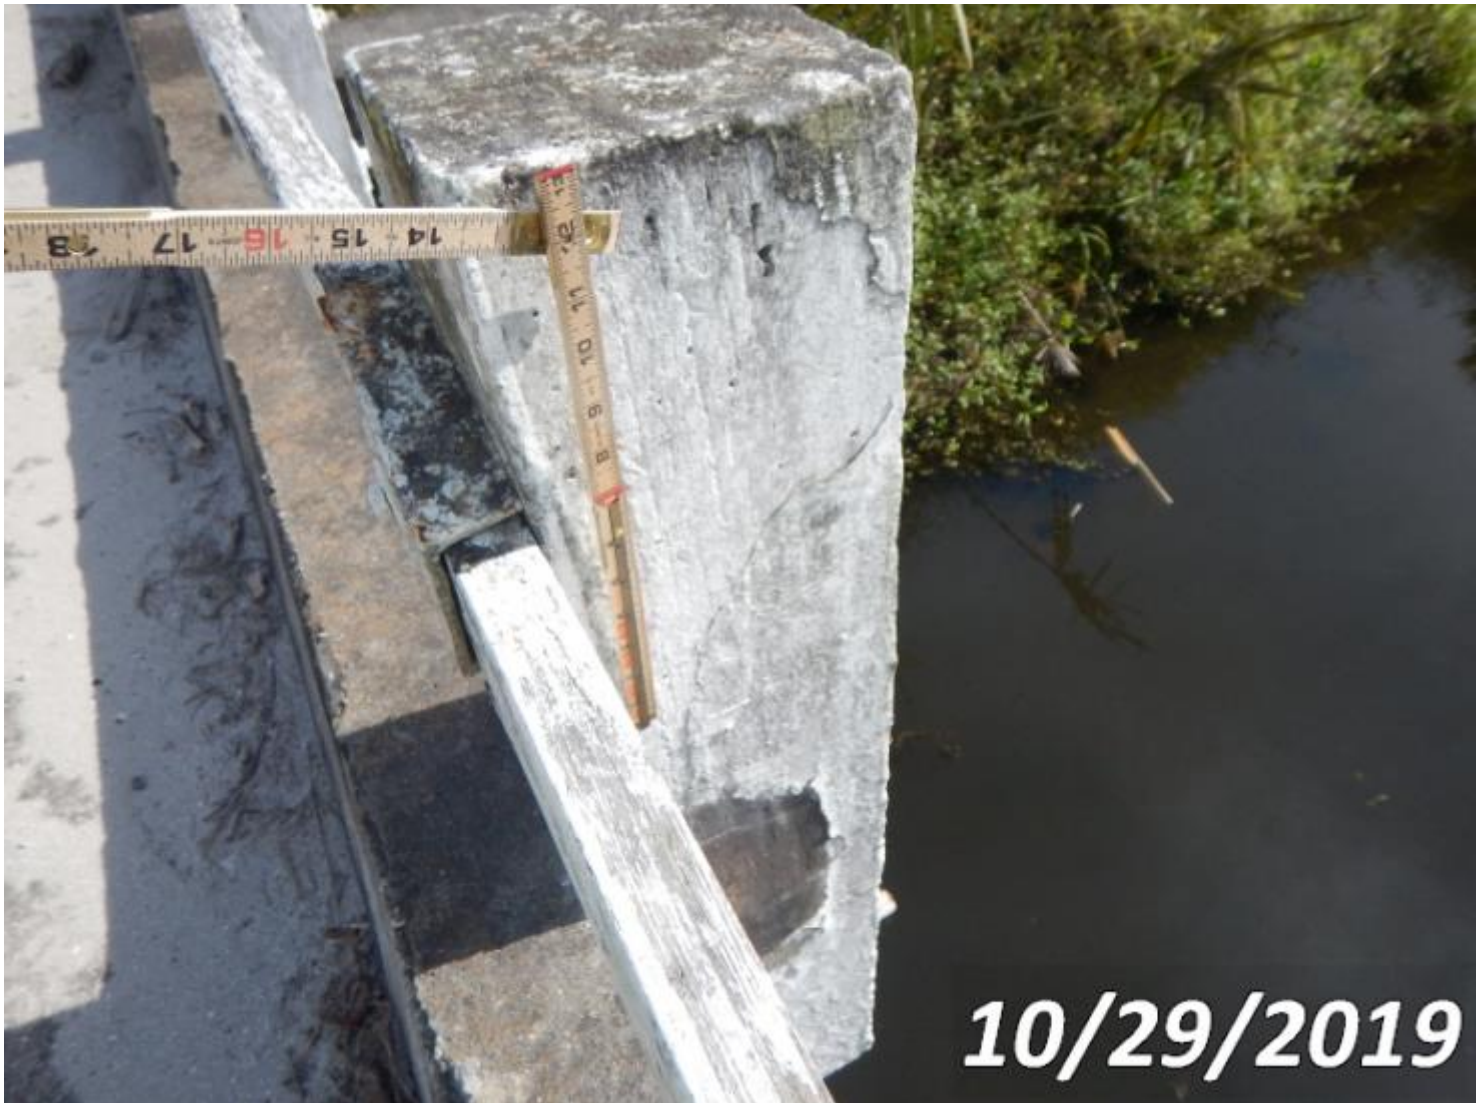
Photo 333-S06 (Unit 0: Other Bridge Railing)

Delamination in the west face of Post 3-1 right.

Repair spalls and delamination in Posts 1-1L/R 1-2L 2-2L 3-1R and 4-2R.

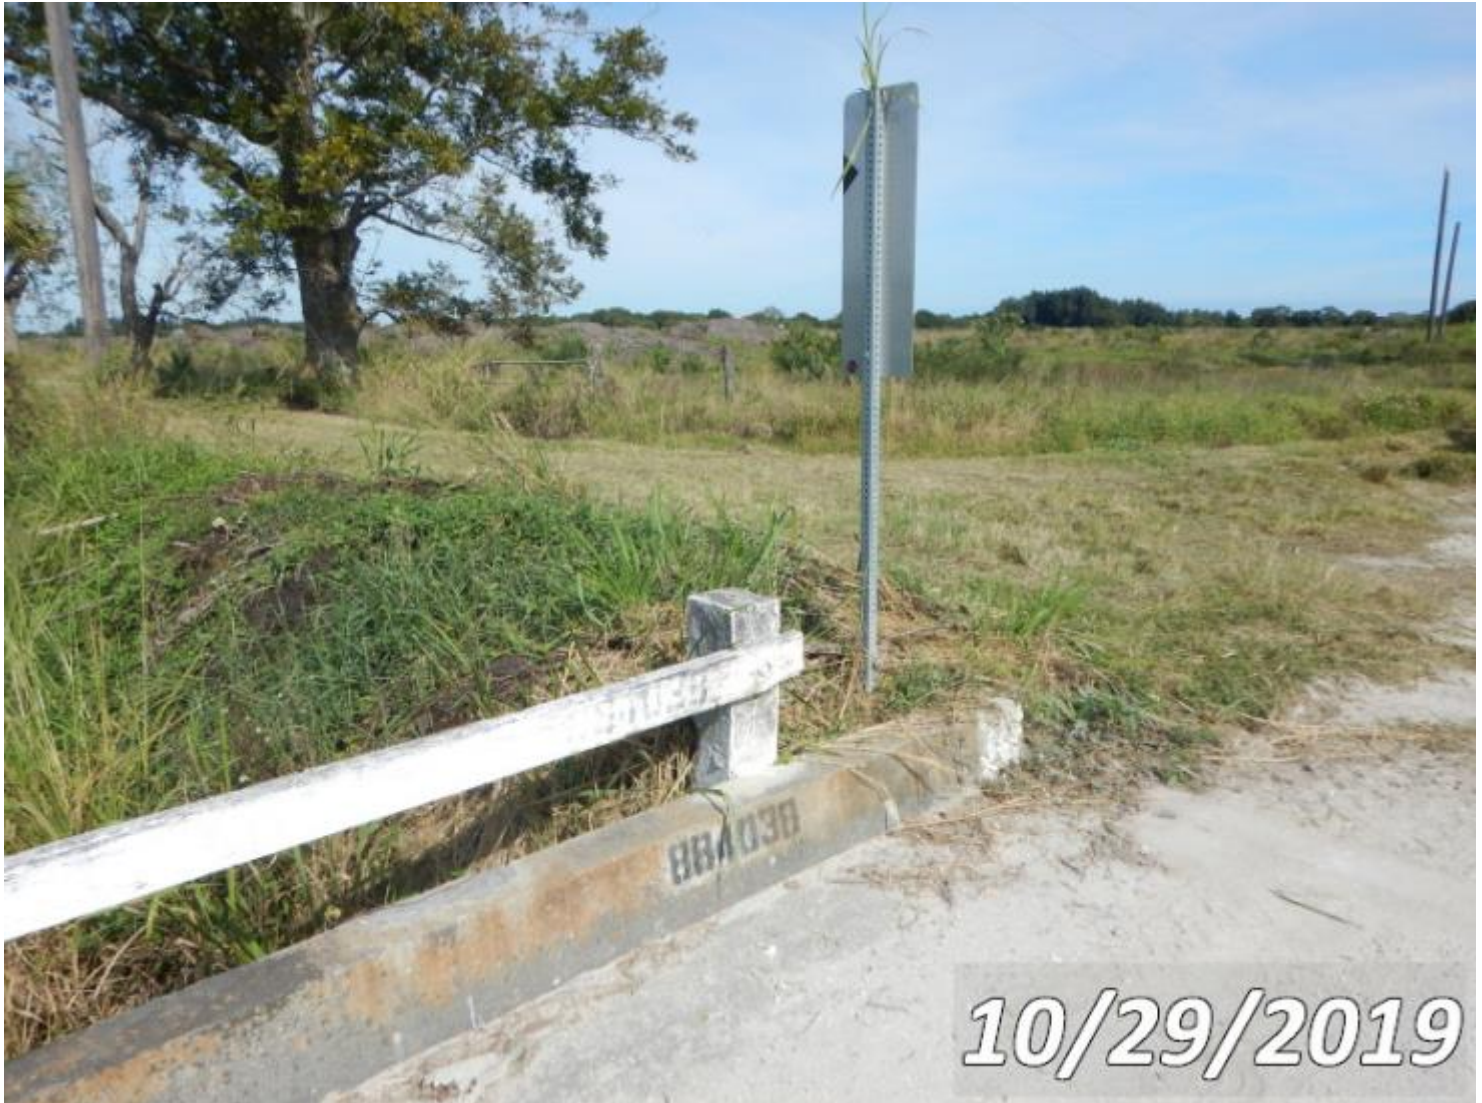
Photo 333-S07 (Unit 0: Other Bridge Railing)

No approach guardrails at the structure.
